THEA FOSS AND WHEELER-OSGOOD WATERWAYS REMEDIATION PROJECT

YEAR 0 BASELINE MONITORING

LOW TIDE SLOPE CAP INSPECTION PRELIMINARY FINDINGS MEMORANDUM

OCTOBER 26, 2006

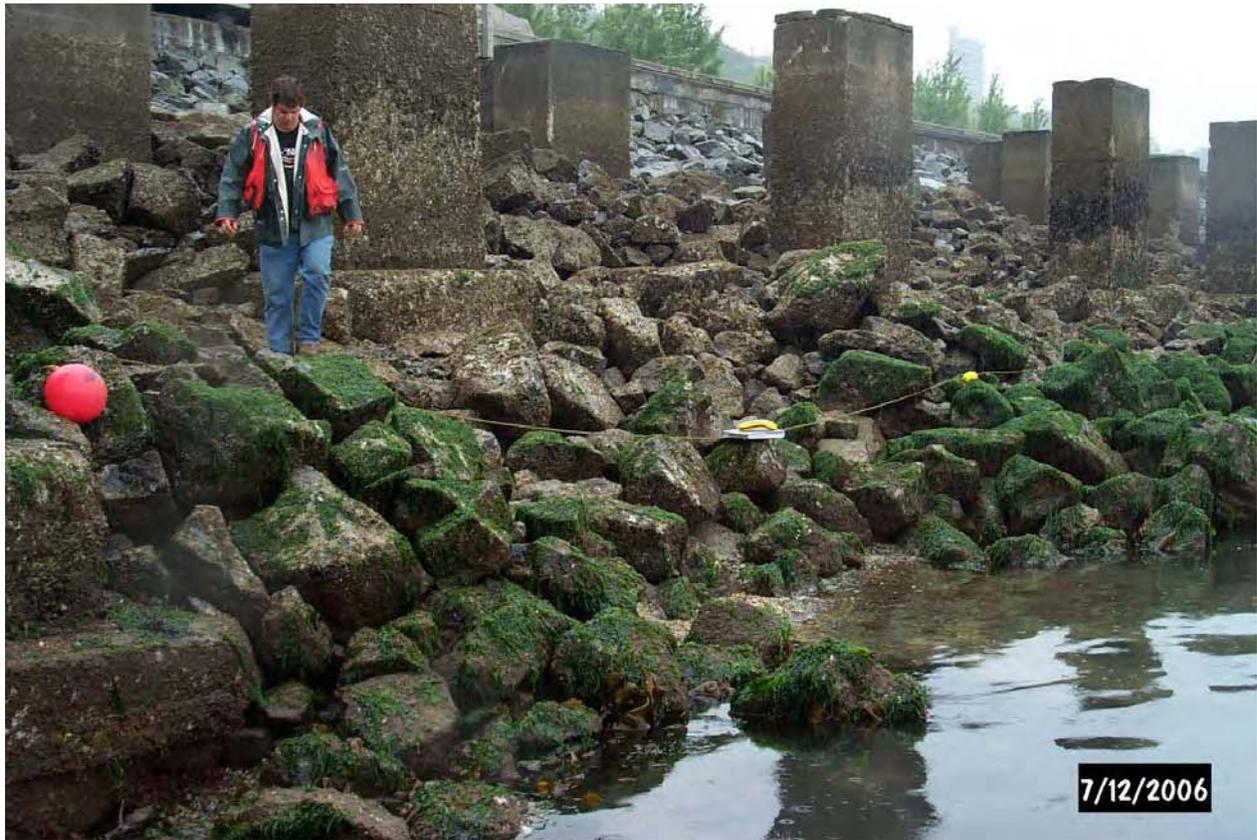
P0001495 7/12/2006 1:04:11 PM

Note: Habitat mix has settled into the cracks of the Rip Rap

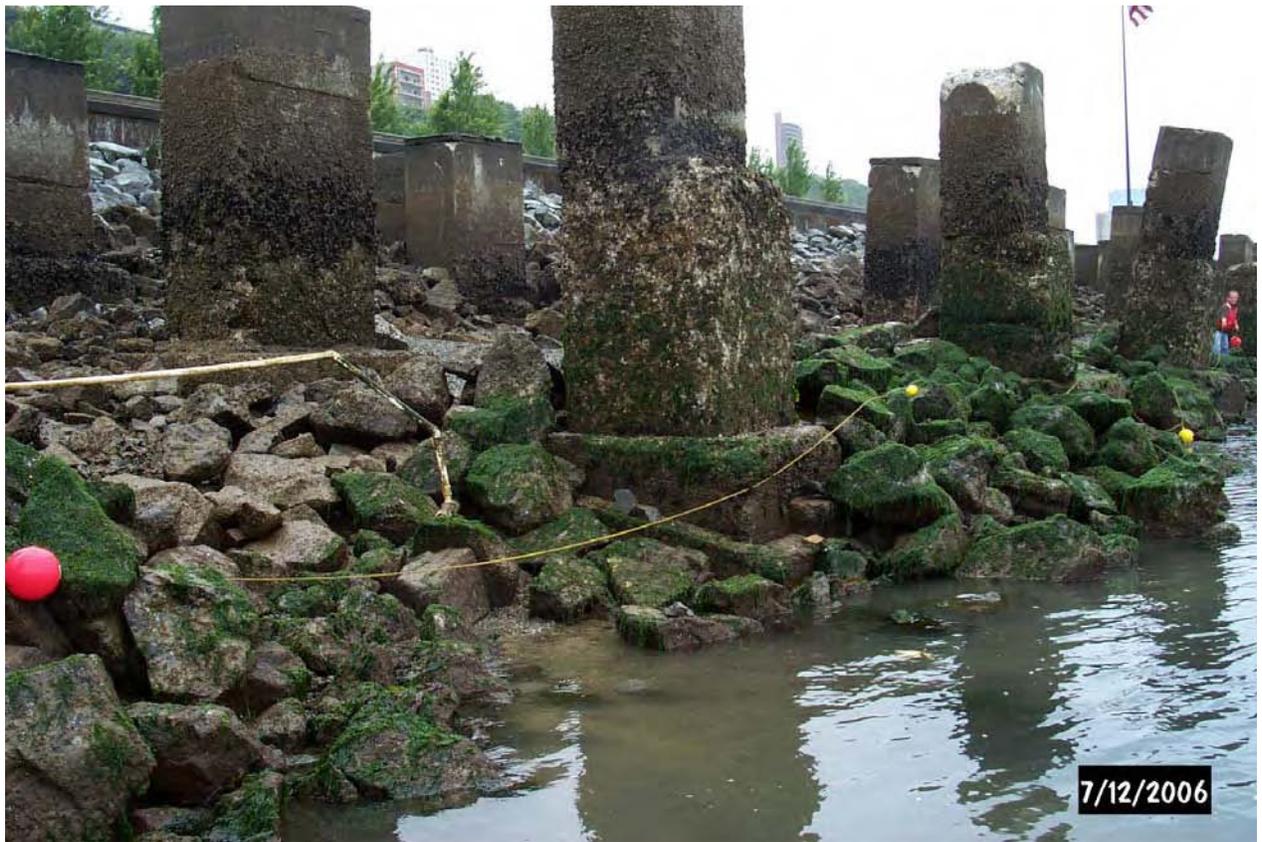
P0001498 7/12/2006 1:18:36 PM

① Concrete monitoring (these are found throughout interval/RA2)

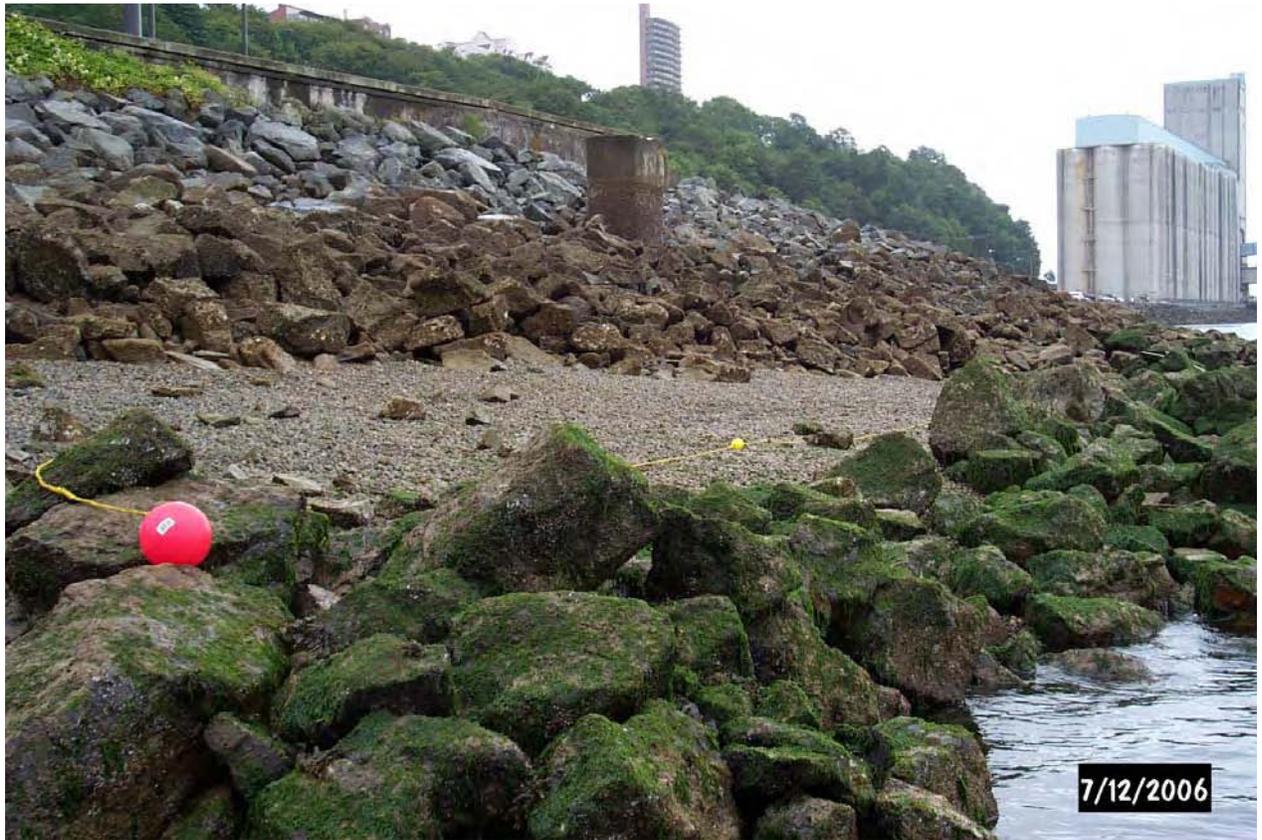
P0001506 7/12/2006 1:50:43 PM

Note: Habitat mix bench extends in this interval, concrete monoliths are not present in this interval

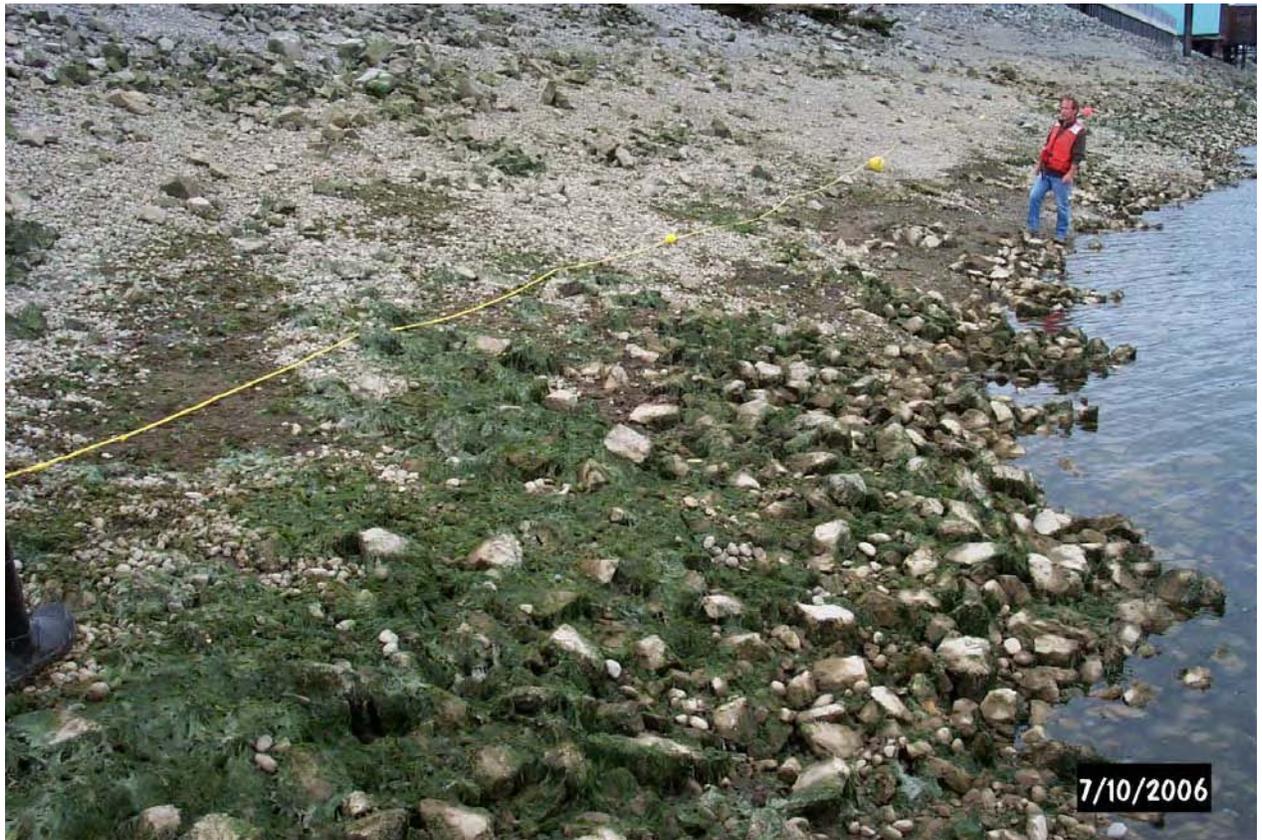
P0001408 7/10/2006 12:37:26 PM

Note: Logs throughout upper slope

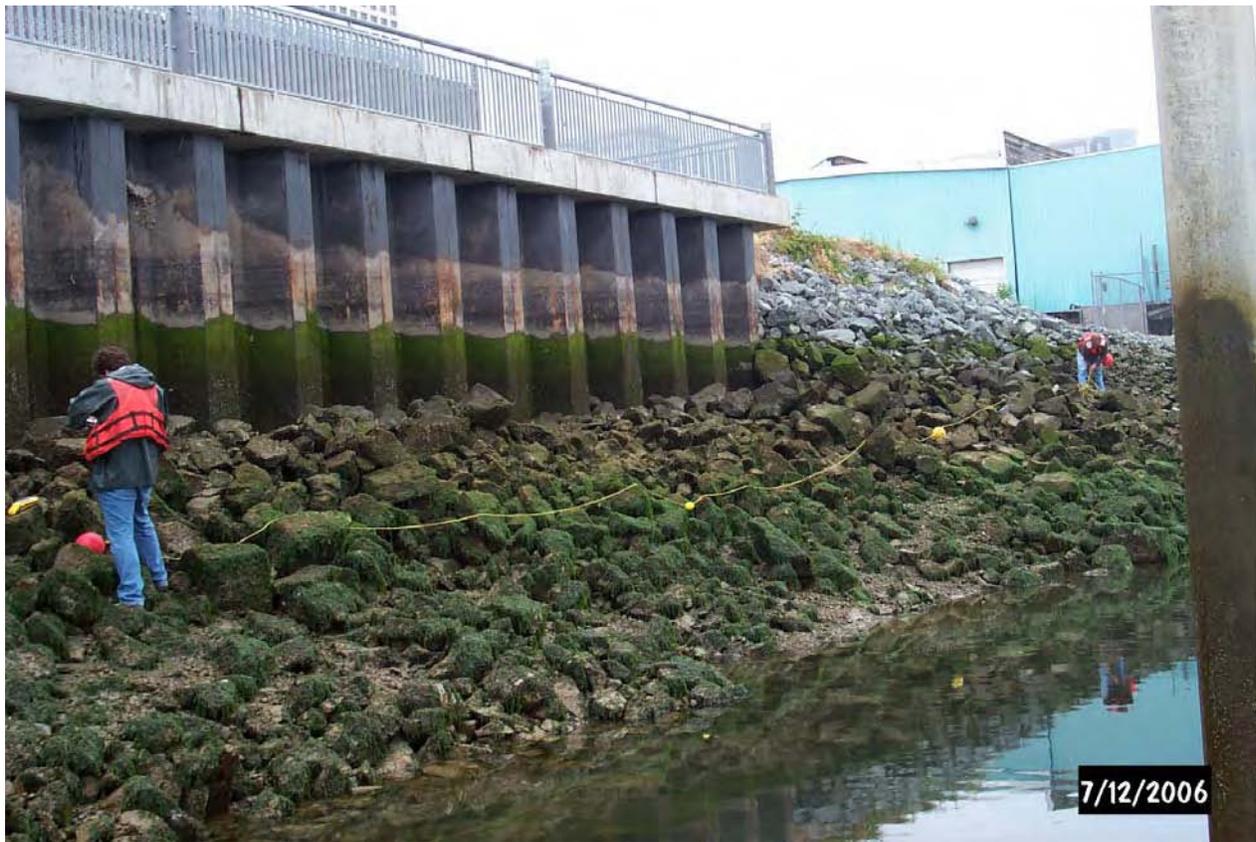
P0001466 7/12/2006 10:33:55 AM

- ① possible sediment excavation
- ② Street-pierced sheet pile wall ends @ 50 ft

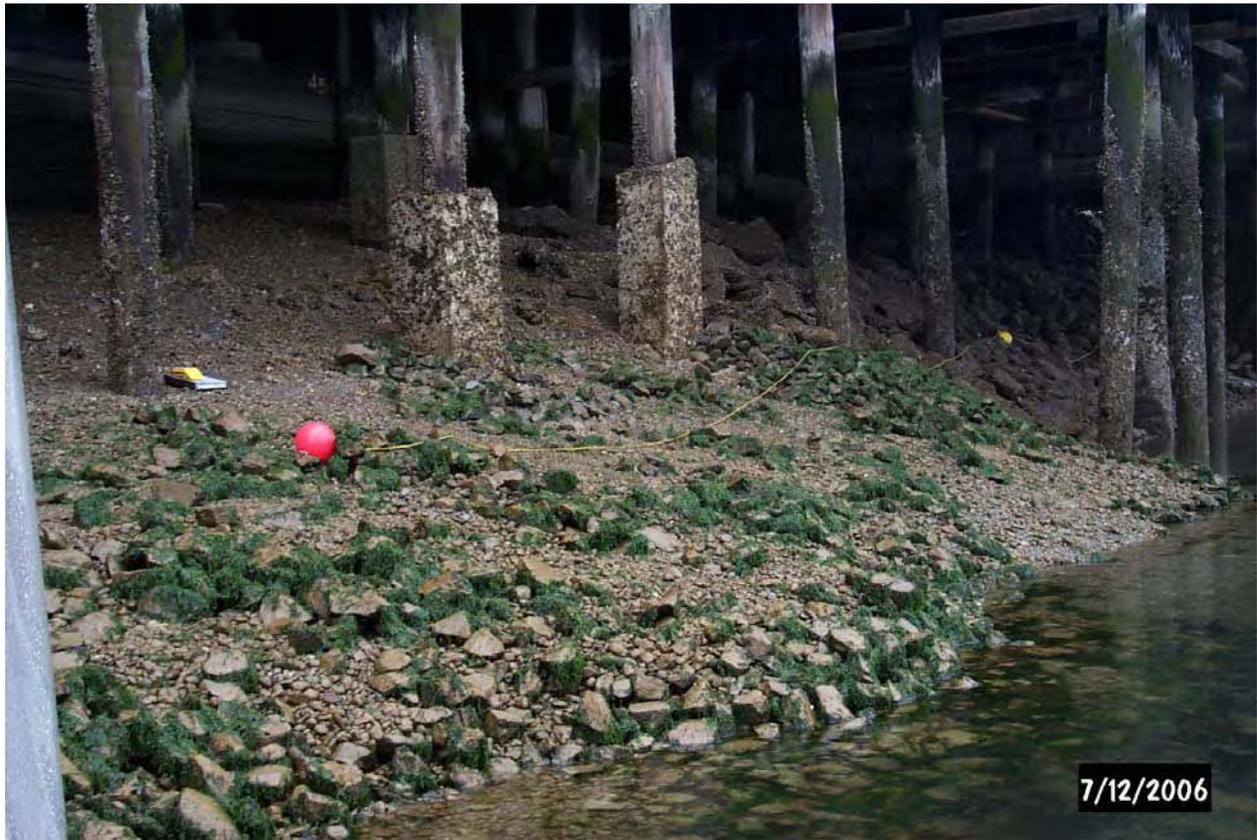
P0001472 7/12/2006 11:03:44 AM

① Block debris

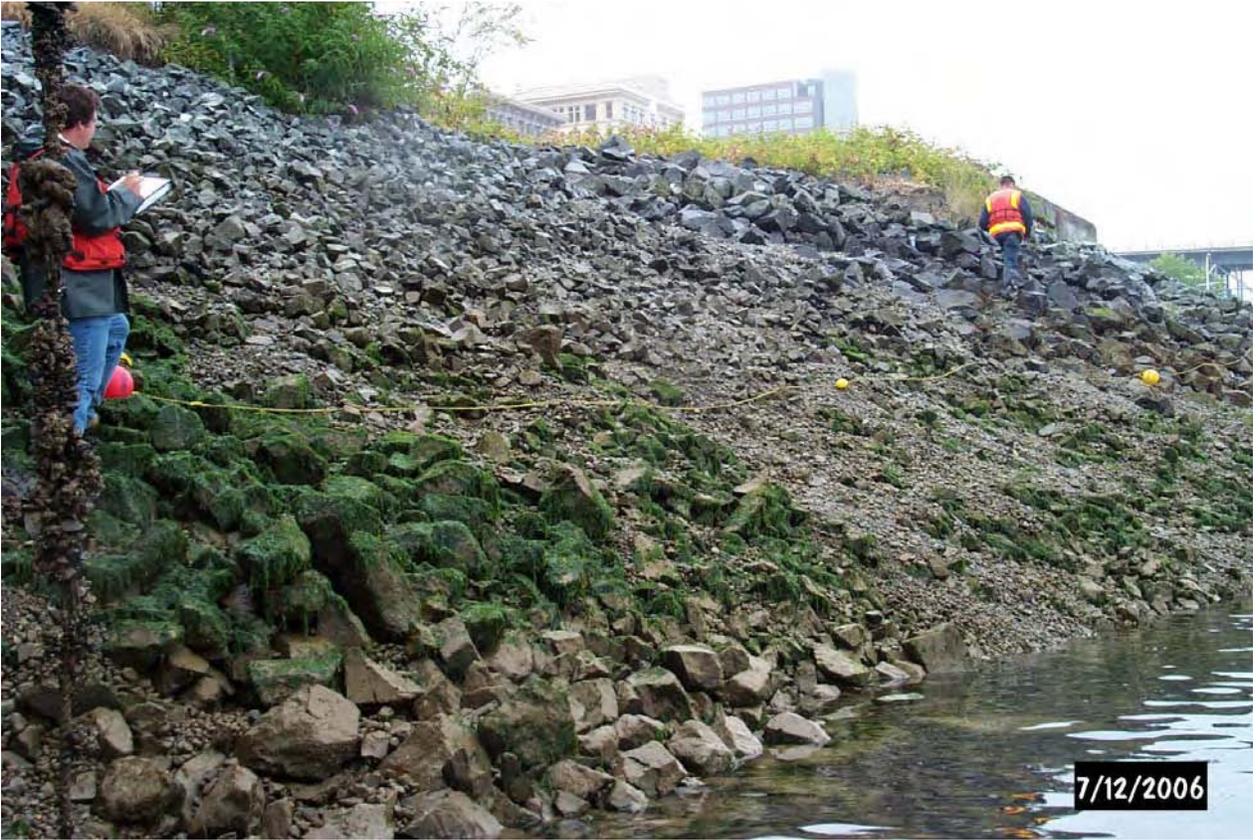
P0001474 7/12/2006 11:17:02 AM

- (1) Buckle (debris)
- (2) Concrete Structure
- (3) Fence

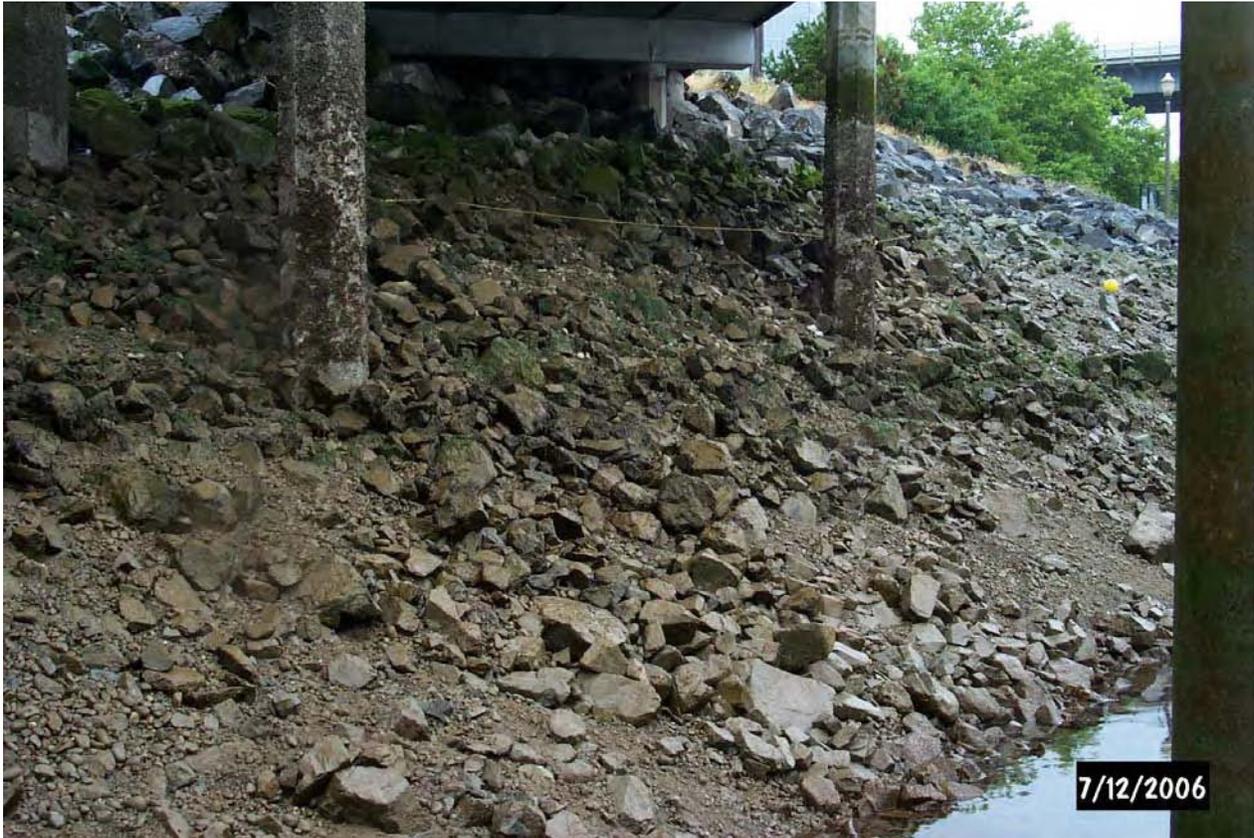
P0001482 7/12/2006 12:01:23 PM

Note: Fibrous mat found on habitat mat. This is not accretion

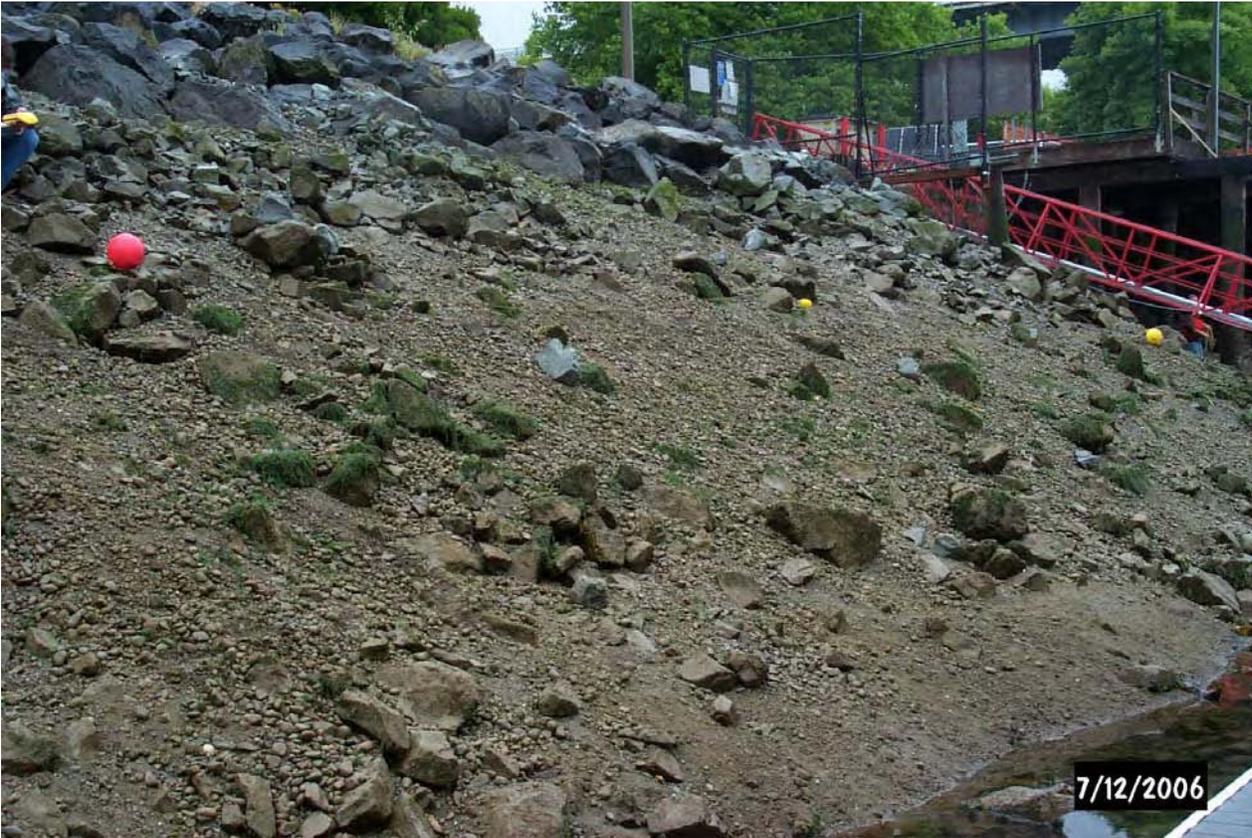
P0001484 7/12/2006 12:08:04 PM

Note: Some ground water seepage @ 85ft

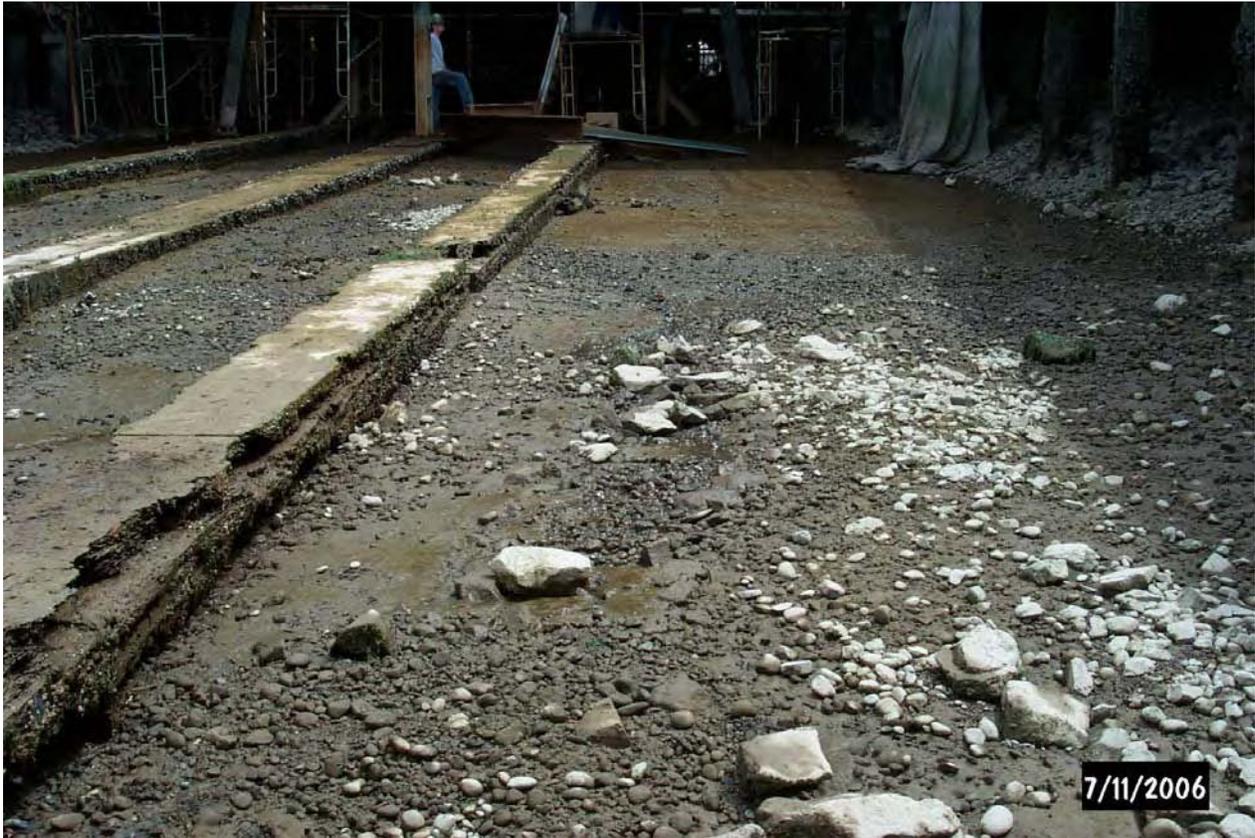
P0001460 7/11/2006 1:14:56 PM

① Possible sediment accretion (from the waterline up into the Shipway Building)

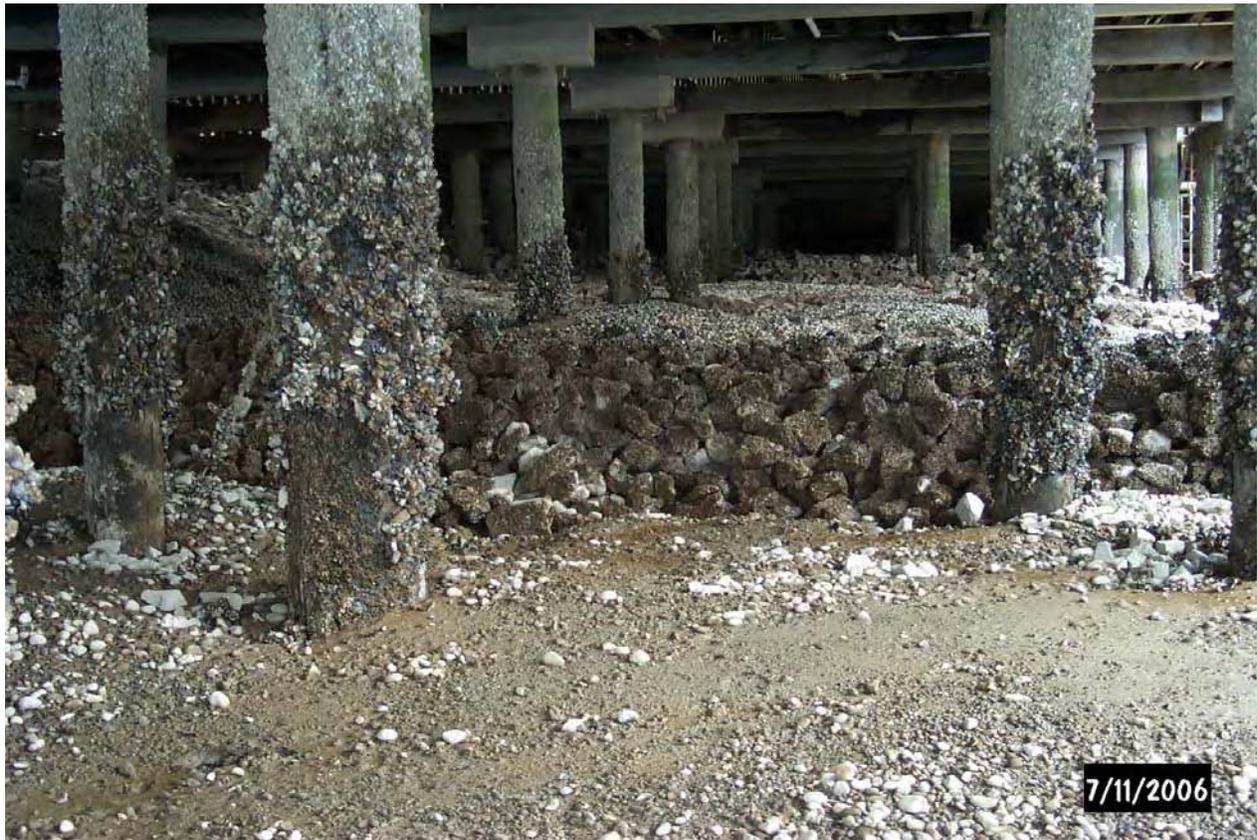
P0001462 7/11/2006 1:21:28 PM

Note: Interval is underneath a Wharf. Mainly Quarry Spill with habitat mix. Some sediment accretion towards the water line

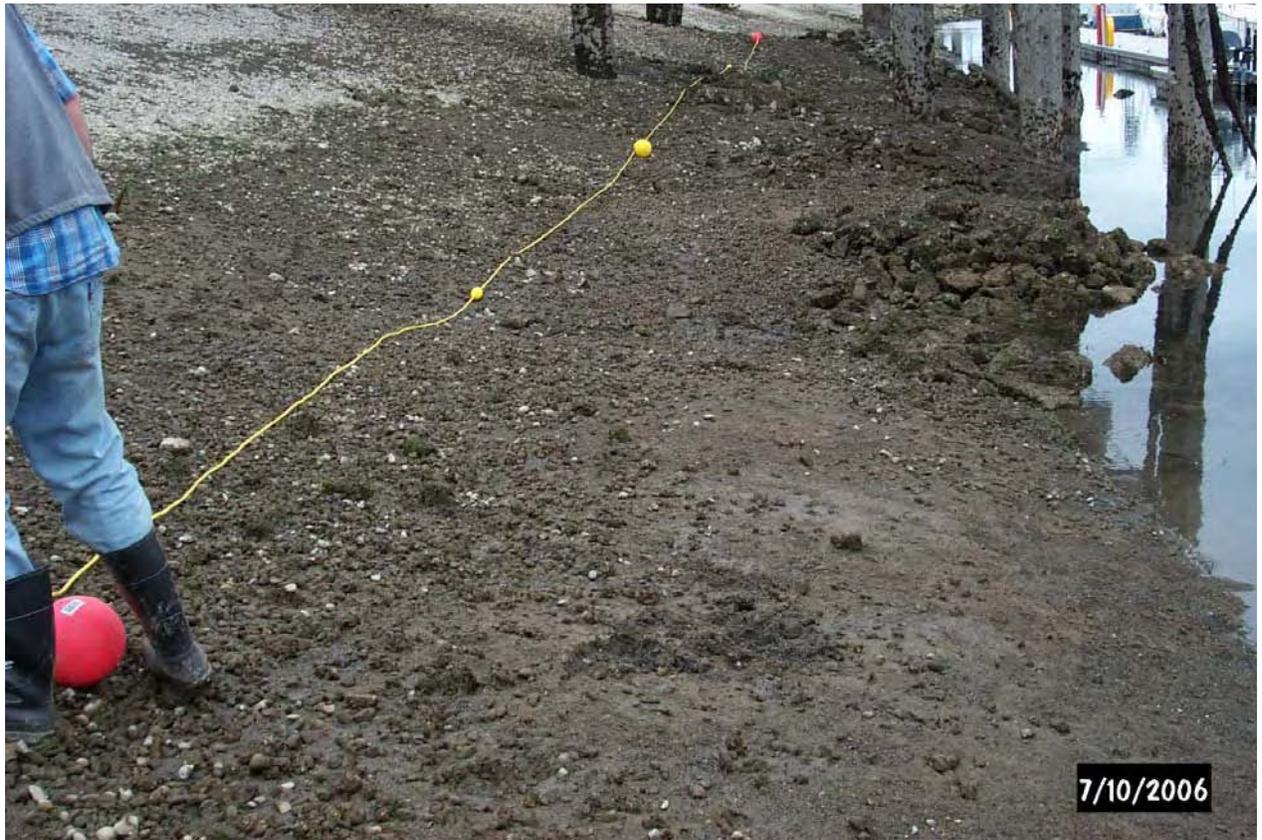
P0001398 7/10/2006 11:42:50 AM

Note: possible sediment accretion along lower slope.

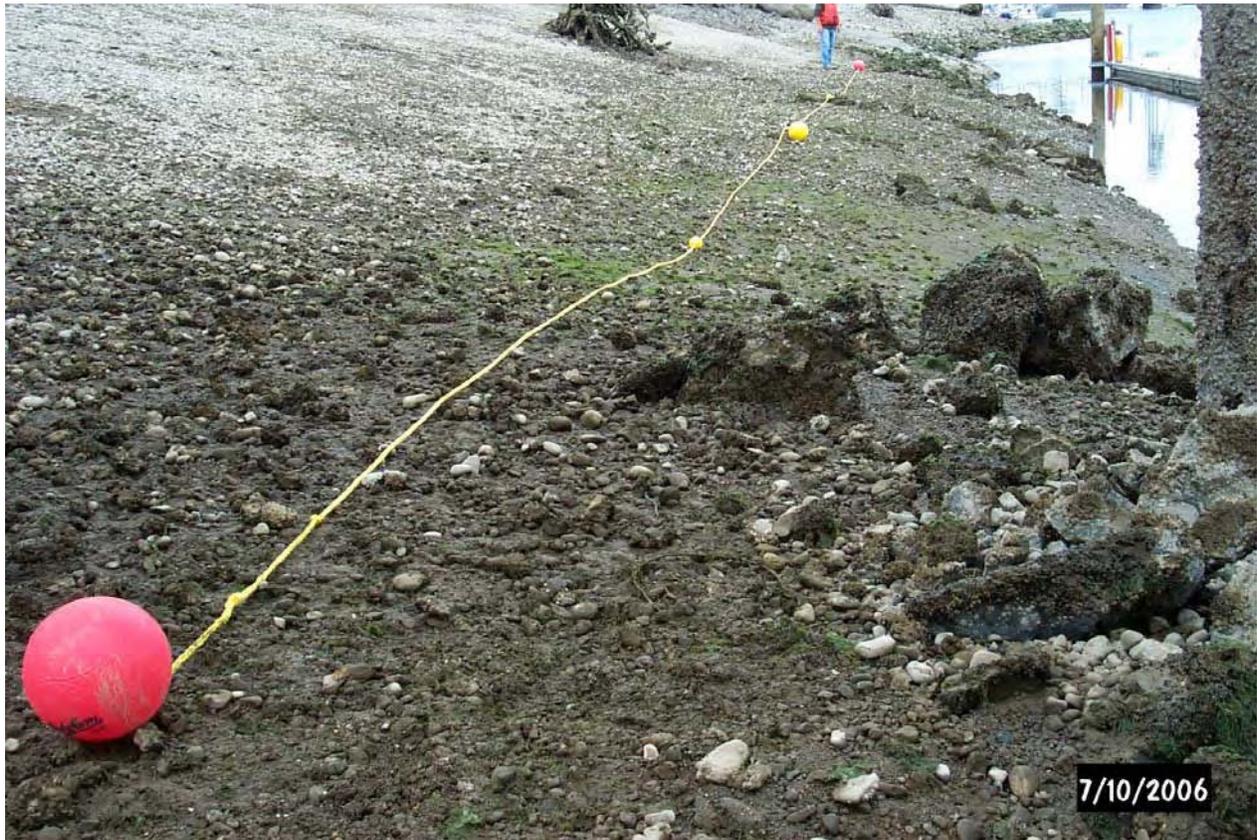
P0001399 7/10/2006 11:53:48 AM

① Log rest embedded in upper slope

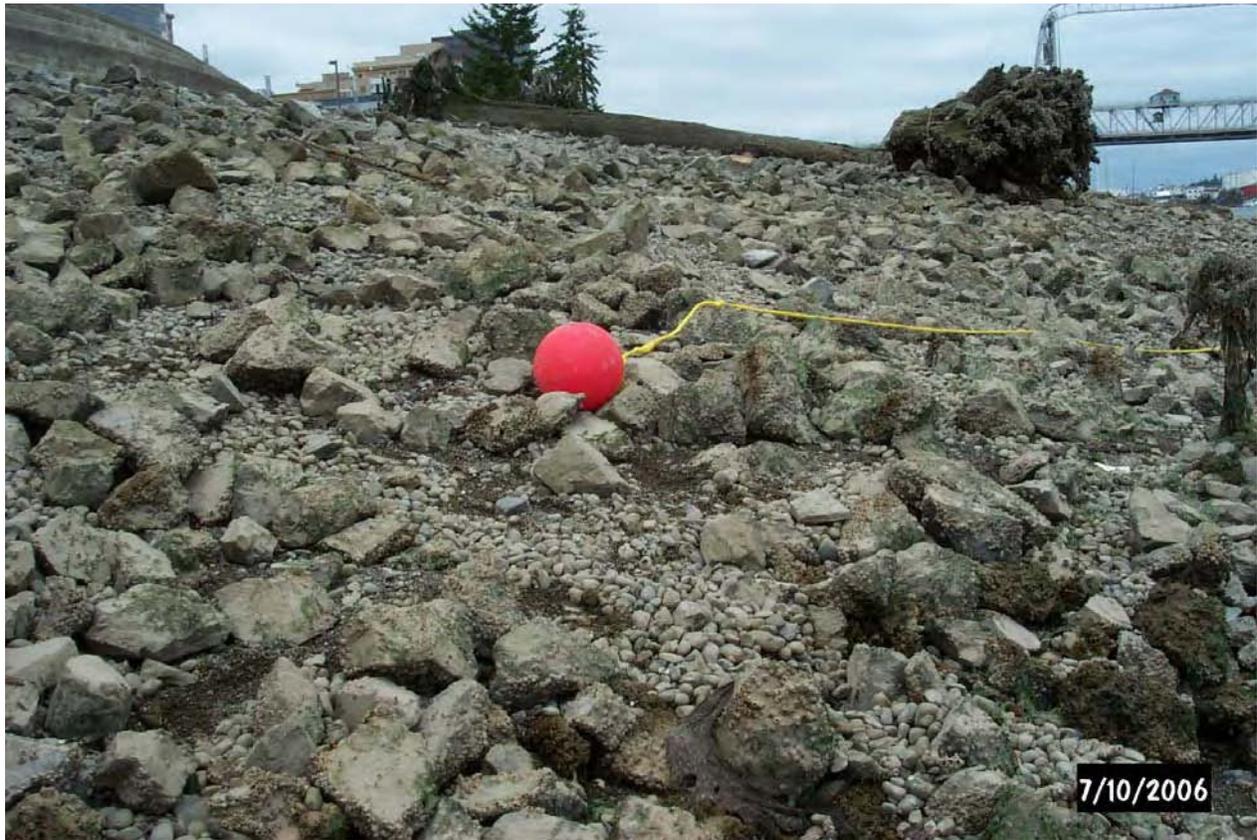
P0001404 7/10/2006 12:24:36 PM

- ① Log root embedded in slope
- ② logs on surface of upper slope

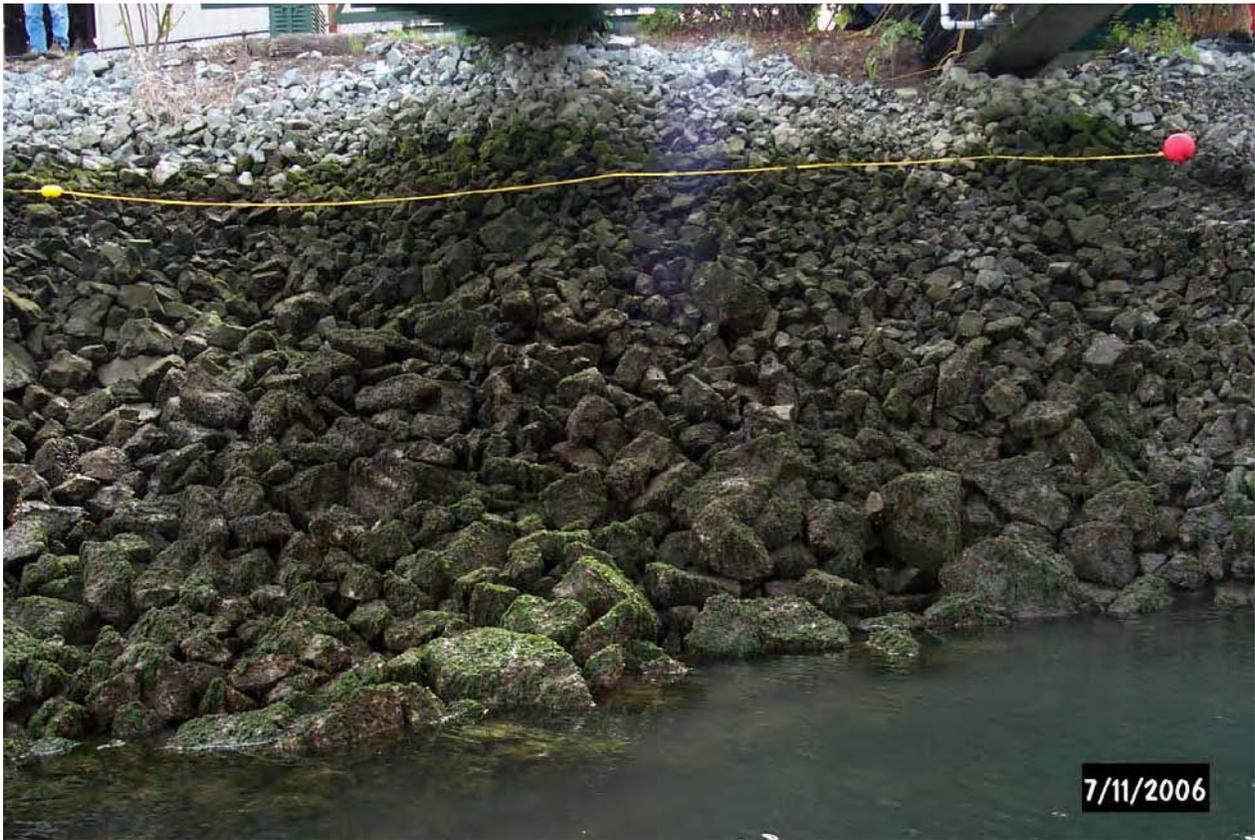
P0001416 7/11/2006 9:23:42 AM

- 1) Boat Slings
- 2) Walkway for dock
- 3) Outfall structure (35) depression around area of outfall structure

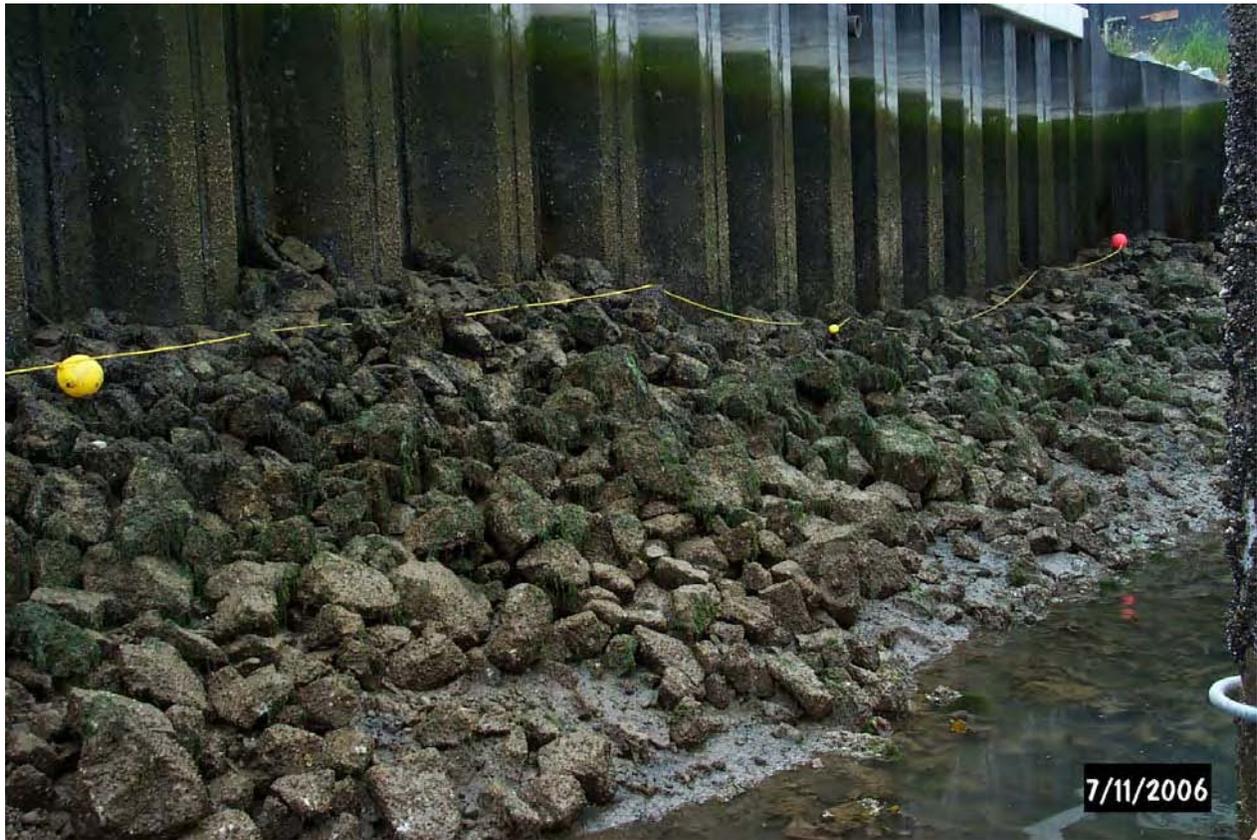
P0001435 7/11/2006 11:07:58 AM

Note: Sediment Accretion throughout lower slope
