Date: June 8, 2007
To: Jacqueline Thiell Wetzsteon, PacifiCorp
From: Pamela Sargent
RE: Site Observations
May 16, 2006
Head of the Thea Foss Waterway Project

This technical memorandum presents a summary of the observed site conditions within the Head of the Thea Foss Waterway, Tacoma, Washington (Figure 1). The observations were made by Pamela Sargent, Principal Environmental Engineer, for Tetra Tech EC, Inc. (TtEC). She visited the site between approximately 10:30 am and 12:15 pm PDT on May 16, 2007 with supplemental observations made of the former SR 509 seep area on May 17, 2007. During this period, a low tide of -3.25 feet Mean Lower Low Water (MLLW) was predicted for 11:12 am PDT.

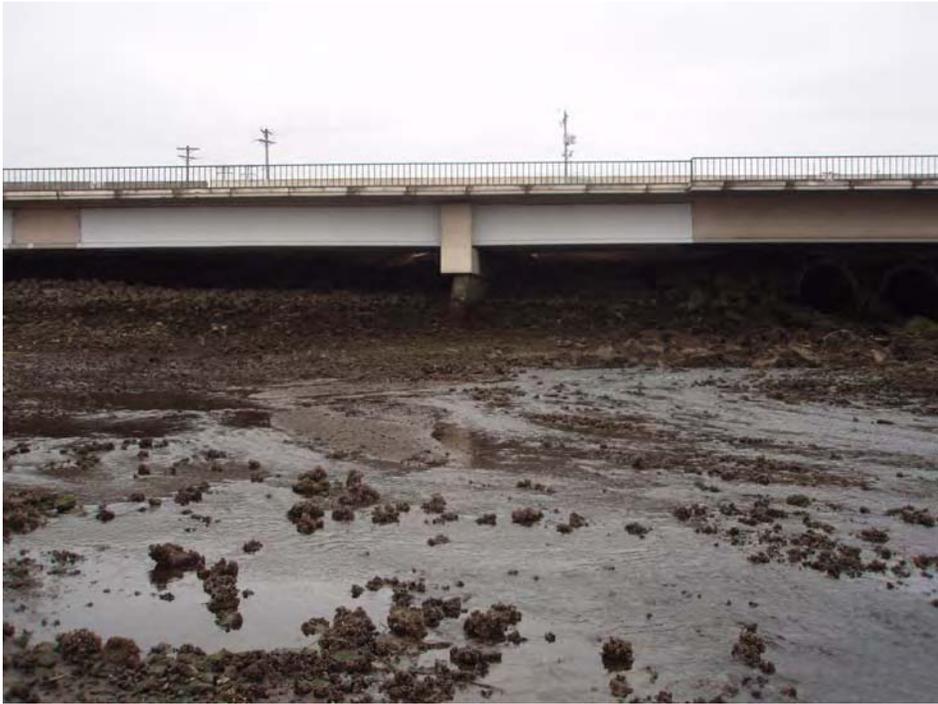
The condition of the scour protection apron at the south end of the waterway is shown in Figures 2 to 6. Water was flowing out of outfalls 237a and 237b during the site visit (Figure 7). The discharge from these outfalls was spreading out over the apron and flowing northward towards the turning basin. As previously noted in the Years 0, 1, and 2 low tide site observations, a small, shallow channel is present in the apron near the southeast corner of the waterway (Figure 7). The configuration and shallow depth of this channel appear unchanged from previous observations and the overall integrity of the cap has not been adversely impacted by the presence

Figure 2 – Looking South Across Scour Apron at Area Just East of the Twin 96-inch Outfalls

of this localized feature. No corrective action is proposed at this time. However, this feature should continue to be monitored during future low tide events for changes.

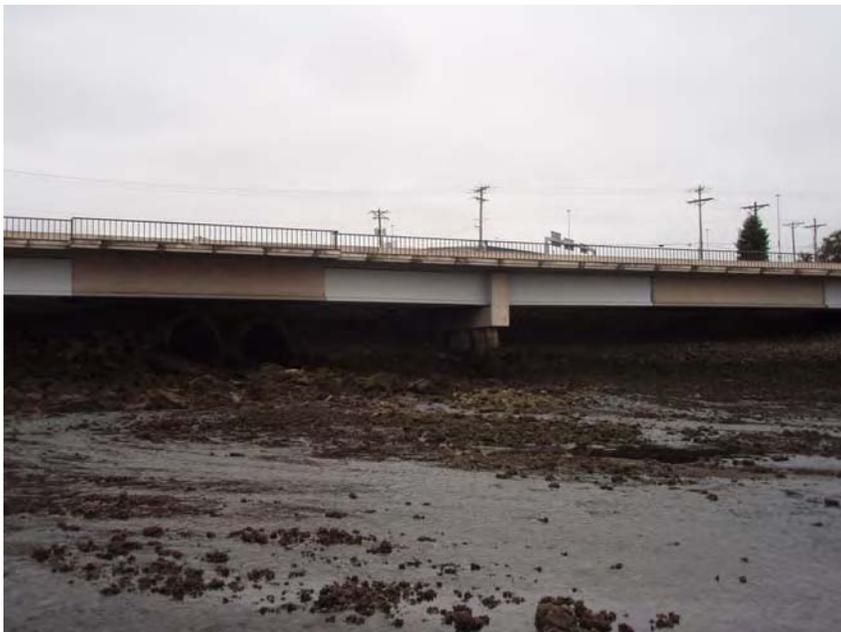
Figure 3 – Looking South Towards East 23rd St Bridge - East Side of Twin 96-inch Outfalls

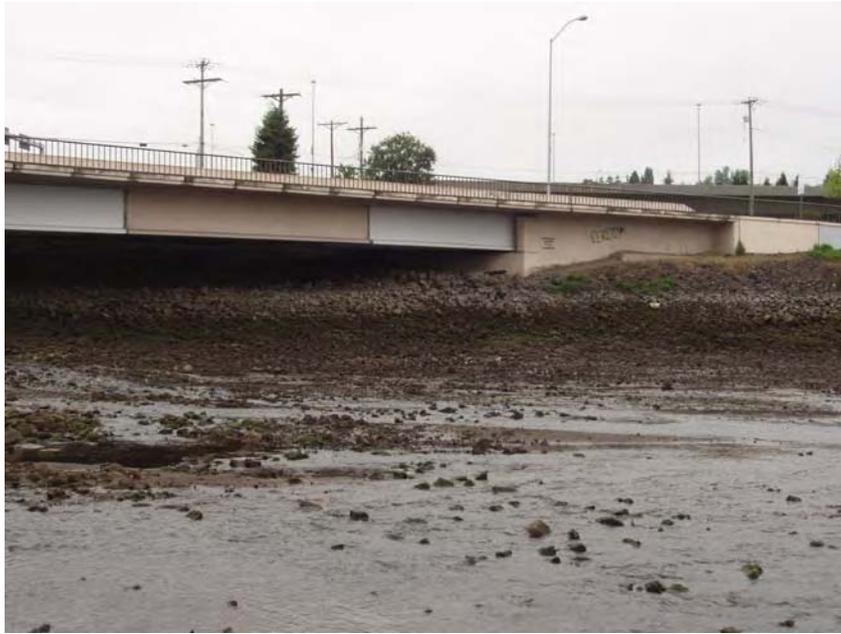
Figure 4 – Looking South Towards
East 23rd St Bridge - West of the Twin
96-inch Outfalls

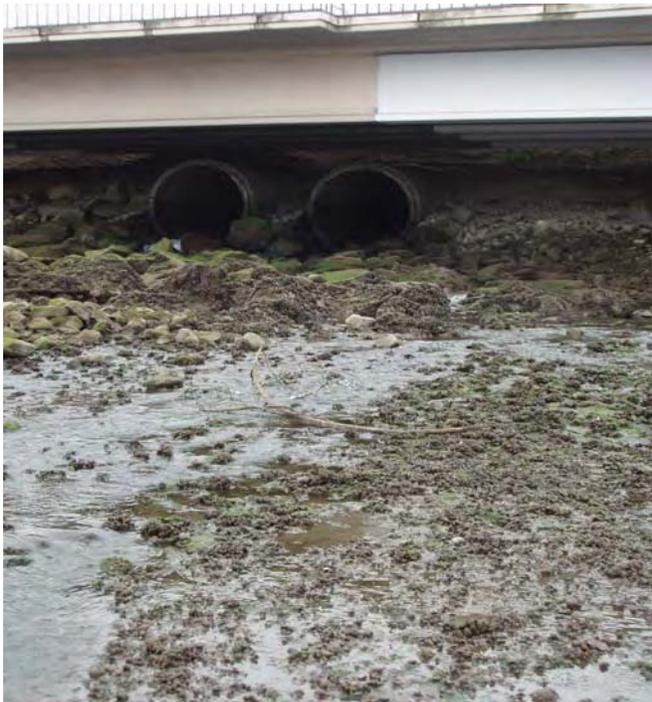
Figure 5 – Close-up of
Outfalls 237a & 237b
Looking South

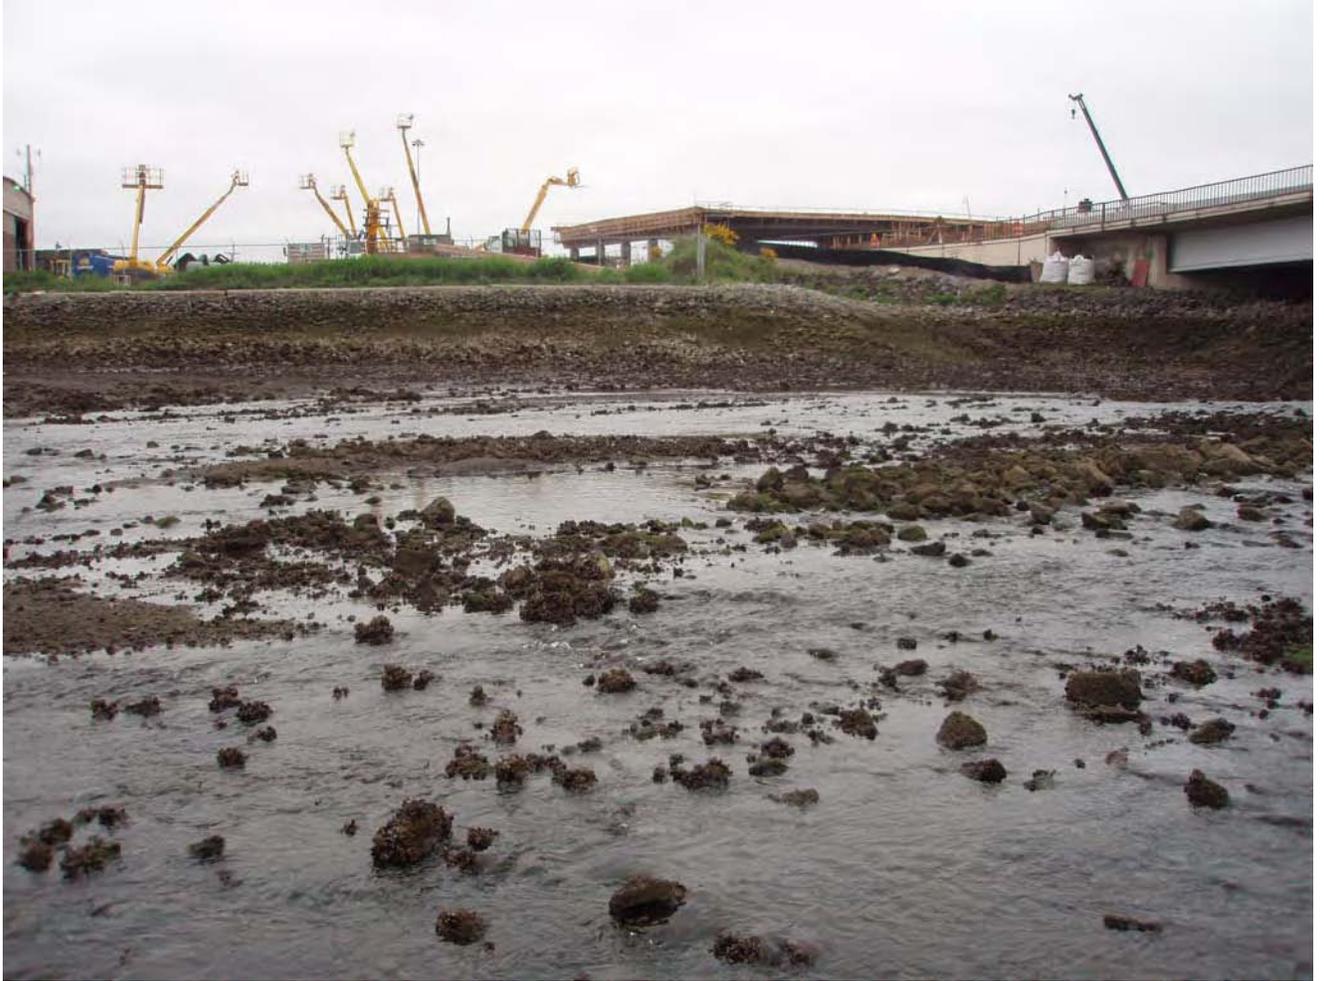
Figure 6 - Looking SE across the Scour Apron at the SE Corner of the Site

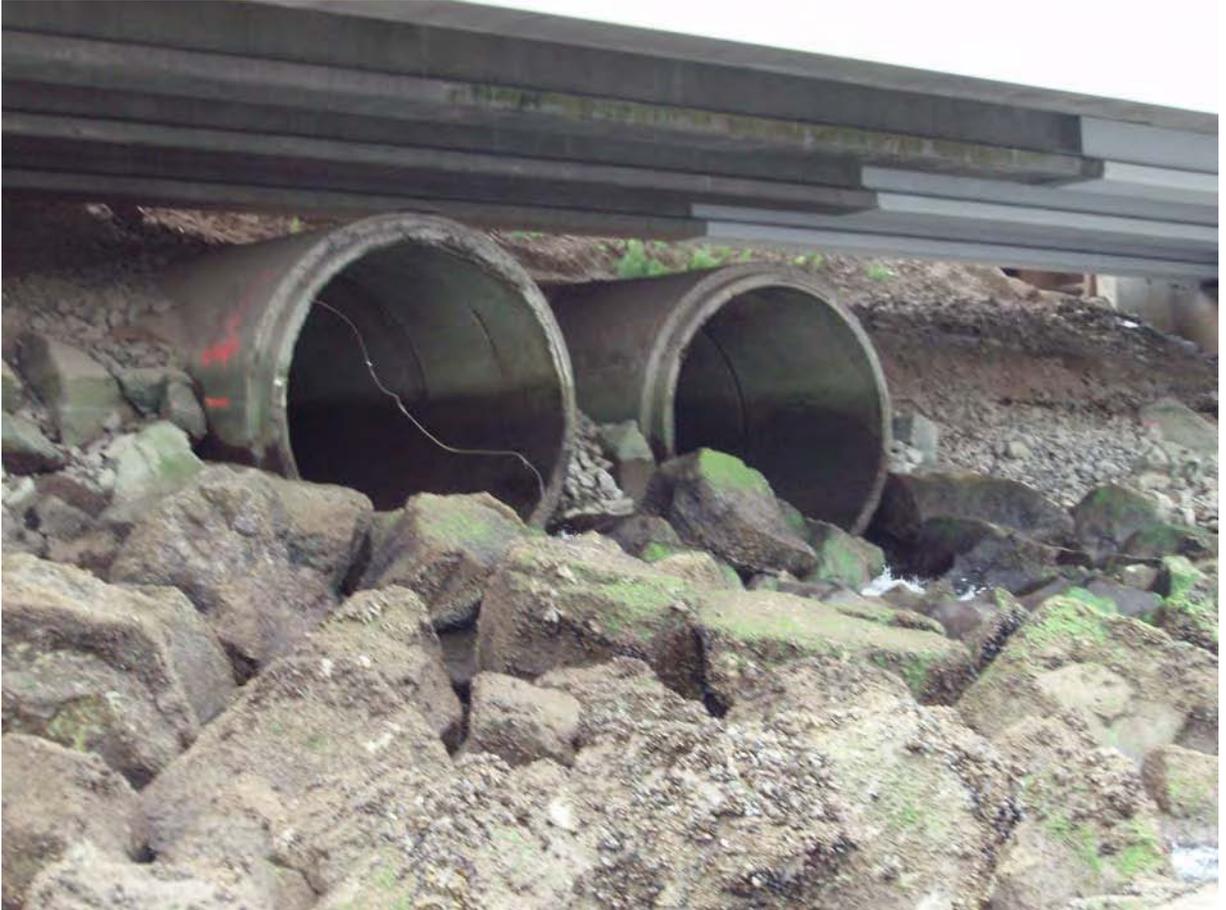
Figure 7 –
Close-up of Outfalls 237a and 237b
Looking Southwest

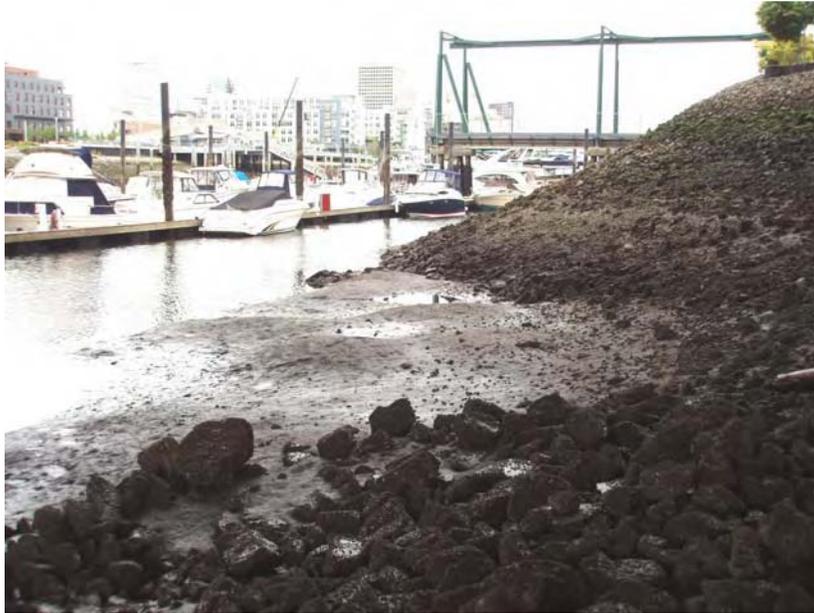
Photographs of the east and west bank slopes exposed during low tide are shown in Figures 8 to 13. No slope erosion or sloughing was observed. As previously noted in the Years 0, 1 and 2 site observation memoranda, the coarser slope cap materials are covered with algae and barnacles. Mussels are also present on these materials. A layer of olive and gray silt is present over capping material on the lower portions of the east and west bank slopes.

Figure 8 – At Outfall 243 Looking North along the East Side of the Waterway

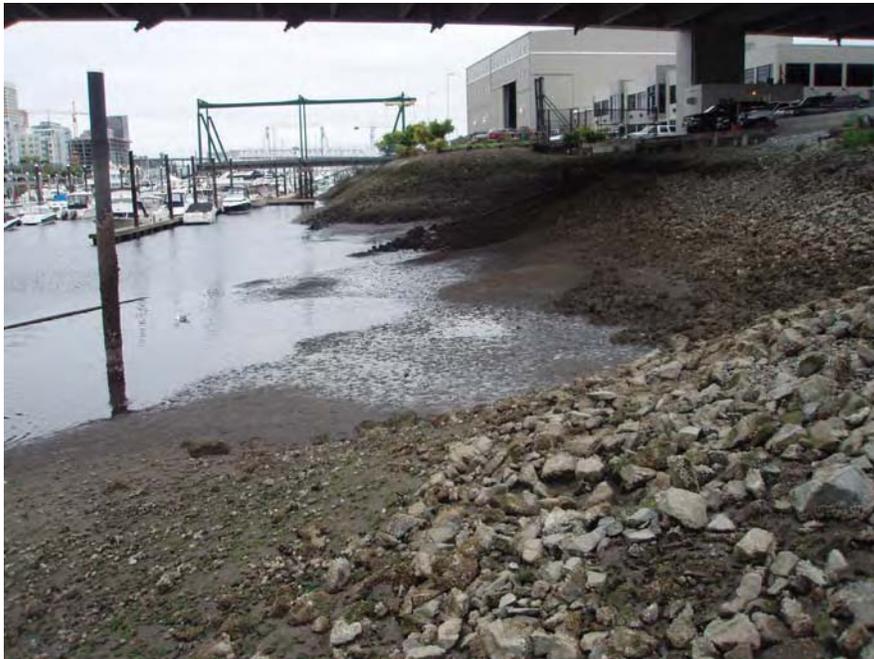
Figure 9 – East Side of the Waterway Including Outfall 243 (From Just South of the SR-509 Bridge)

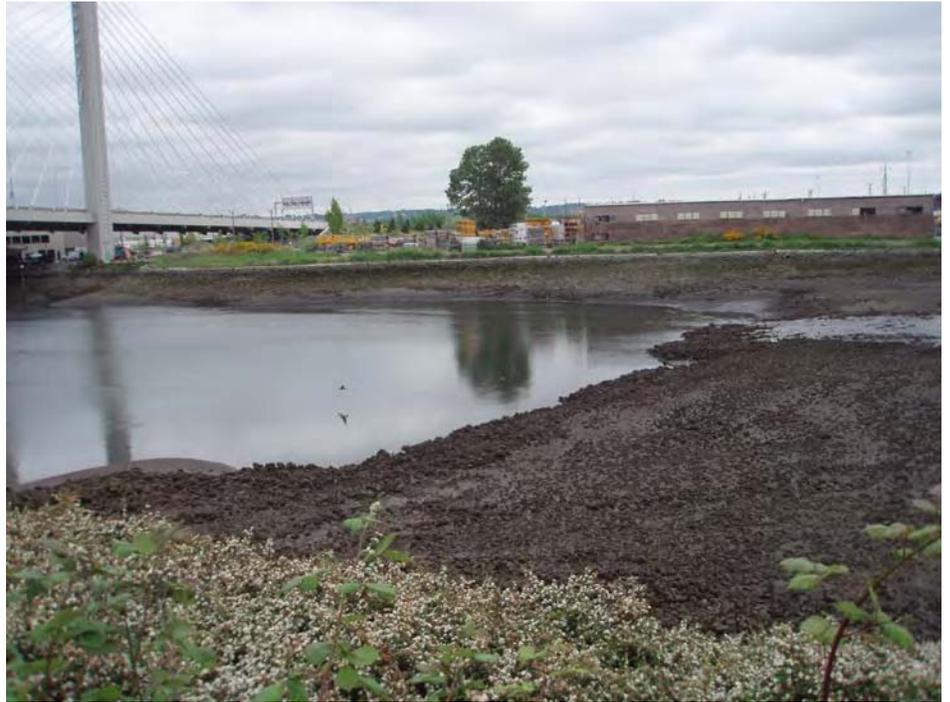
Figure 10 –
Looking
ENE
Across
North End
of Scour
Apron to
East
Slopes in
Front of
Berg
Scaffolding

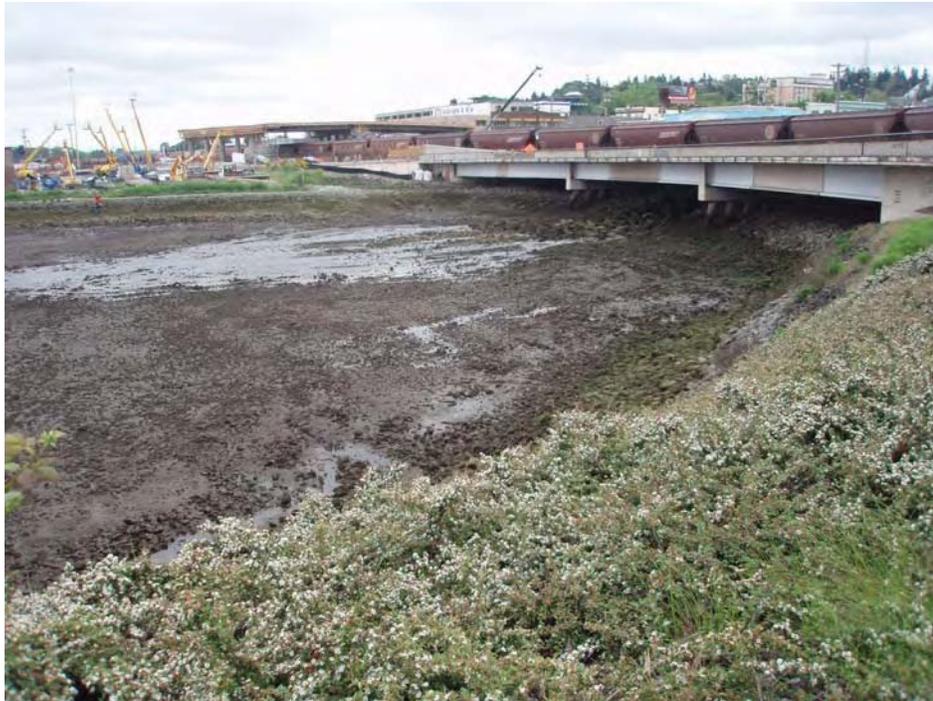
Figure 11 –
Looking SE
from Just
South of the
City Pier
Across Scour
Apron

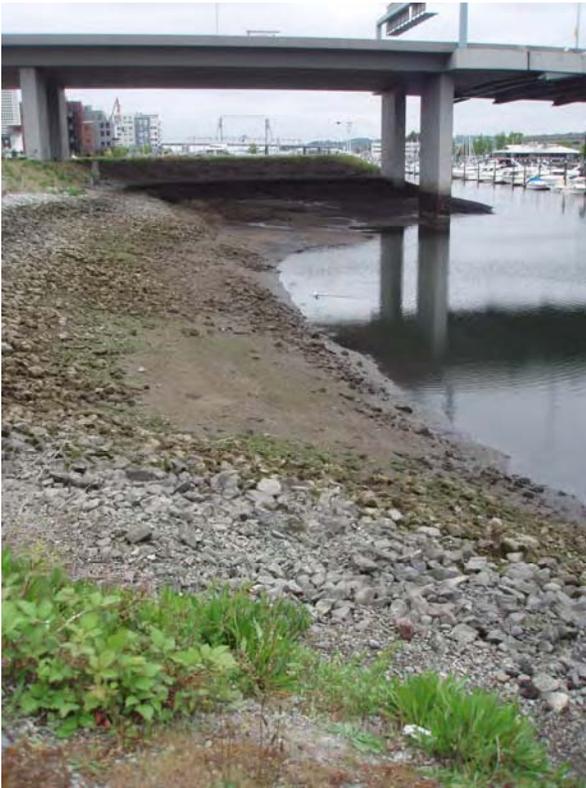
Figure 12 –
Looking North Along
West Side of
Waterway from City
Pier

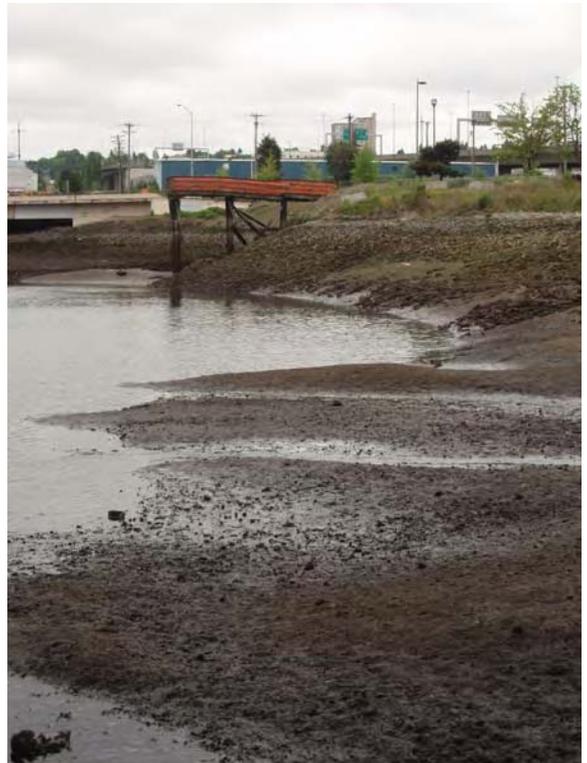
- The weather was partly sunny with light winds during this field visit.
- Extensive gas bubbles were observed throughout the head of the waterway but no sheens were observed (Figure 14).

Figure 14 –
Low Tide
Gas
Bubbles -
Adjacent to
the Central
Portion of
the Bottom
of the Slope
- Former
Standard
Chemical
Site

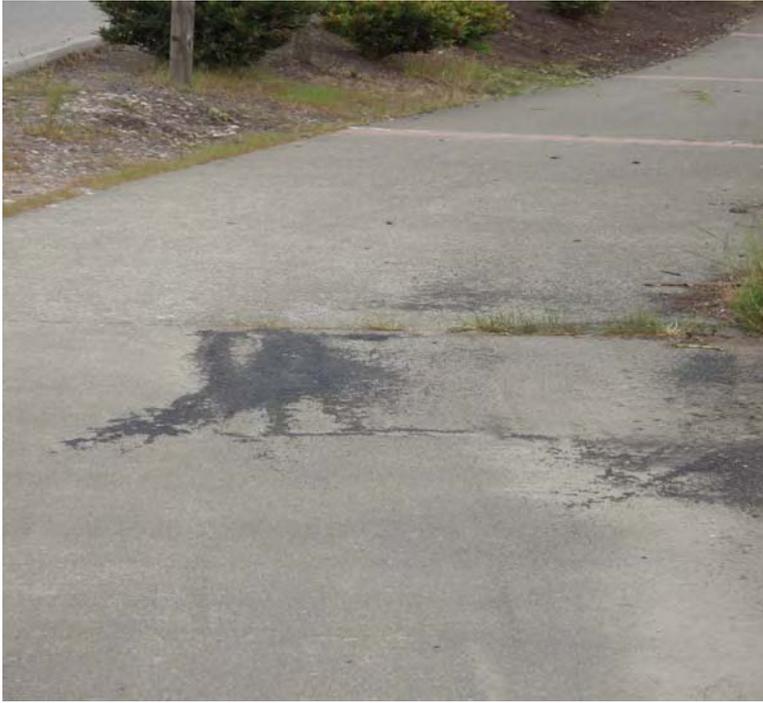
- 2 pieces of pipe scaffolding were observed in the water near Outfalls 237a and 237b.
- Small quantities of sandblast grit (or something similar) were present on the sidewalk of the East 23rd Street Bridge (over the south end of the project site) (Figure 16).

Figure 16 –
Sandblast Grit on
Sidewalk on East
23rd Street
Bridge

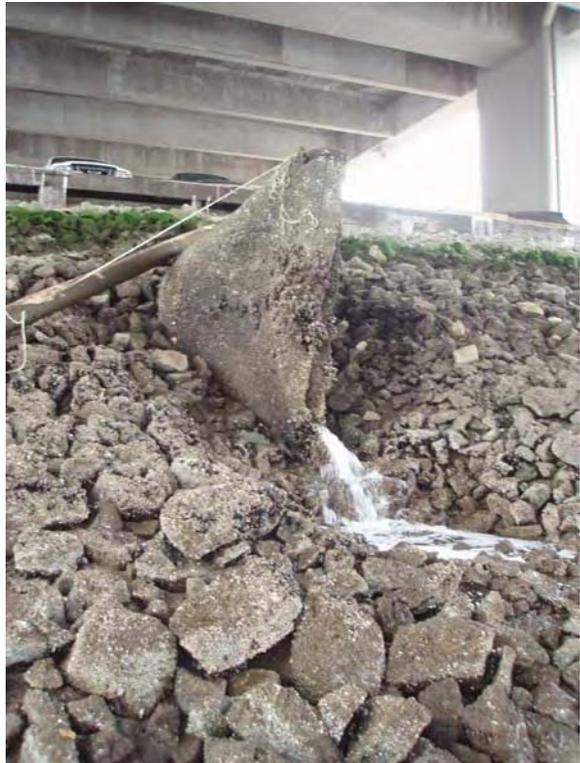
- The new pilings installed under the east end of the SR-509 bridge are all starting to lean slightly in various directions (i.e. not vertical).
- The scour protection adjacent to outfall 243 (at Station 73+40 on the east side of the waterway under the SR-509 bridge) shows no signs of erosion or displacement (Figures 17 to 20). Water was flowing out of Outfall 243 during the site visit. The tideflex valve™ at the end of Outfall 243 is extensively covered with barnacles and at the time of the site visit there was a small diameter, approximately 20-foot long pile with cable or rope attached to end entangled in the metal clip at the top of the tideflex valve™ (Figure 17). The City of Tacoma was notified about this derelict pile (notified Rick Fuller via phone on May 16, 2007). The pile was gone when City personnel went to investigate the following day.

Figure 17 –
Close-up of
Outfall 243

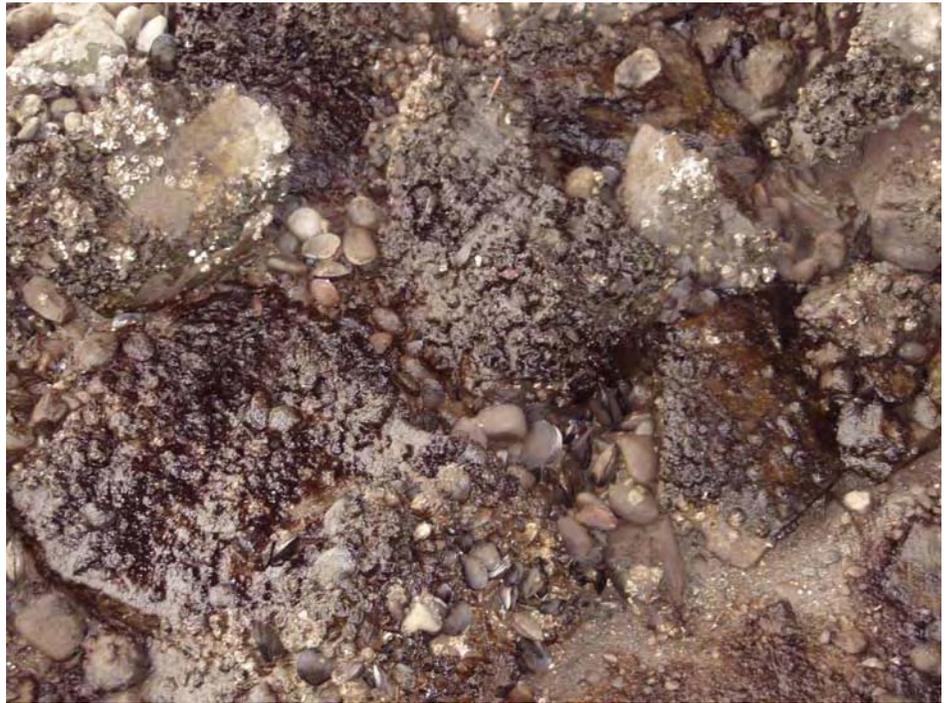
- A black shiny, oil-like substance was noted on the slope between Outfall 243 and Foss Landing localized around high tide line (Figure 18). There was no noticeable smell associated with the substance and this substance produced an orange to rust color slime on blue gloves when touched.

Figure 18 –
Oil-Like
Substance of
Slope just
North of
Outfall 243

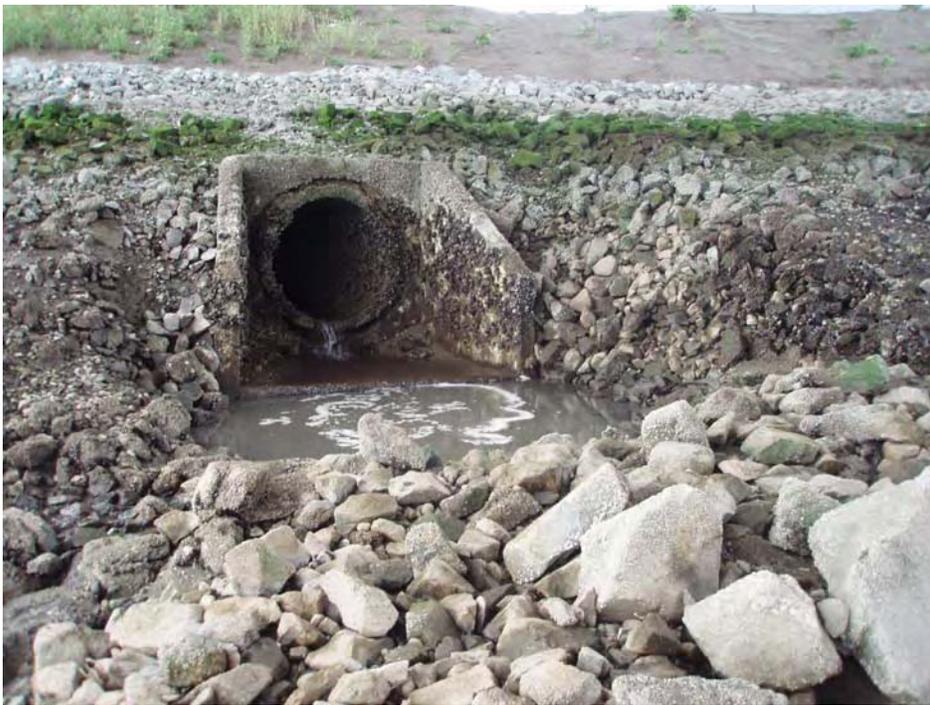
- The scour protection adjacent to Outfall 235 (at Station 73+20 on the west side of the waterway under the SR-509 bridge) shows no further signs of erosion or displacement beyond what was noted during January and February 2007 site visits (Figure 19). Water was flowing out of Outfall 235 during the site visit.

- As previously noted during January and February 2007 site visits, the small outfall scour protection in front of Outfall 235 (at Station 73+20 on the west side of the waterway under the SR-509 Bridge) has been displaced outward approximately 4 to 5 feet. There is a pool in front of the outfall ranging in depth from 12” to 24” deep. The pooling and small outfall scour protection material displacement appears to be the result of high velocity discharge or high flows from the outfall. As recommended, the area around Outfall 235 will be monitored during annual OMMP for further changes in pool depth or small outfall scour protection material displacement. Repairs to this area may be warranted if further changes occur to ensure the integrity of the underlying slope cap.

Figure 19 –
Close-up of
Outfall 235

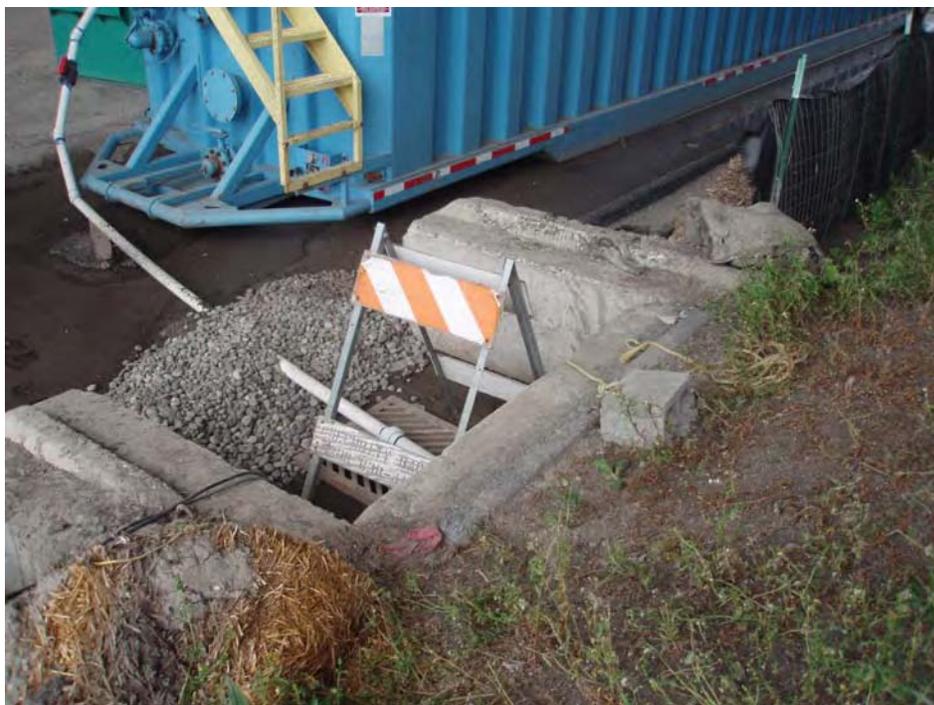
- At the former Standard Chemical Site, a baker tank is discharging into the stormwater system just upstream of Outfall 235 (Figure 20). Water in the pool in front of Outfall 235 was cloudy and a bit foamy (Figure 21).

Figure 20 –
Baker Tank
Discharge to
Stormwater
Inlet Just
Upstream of
Outfall 235

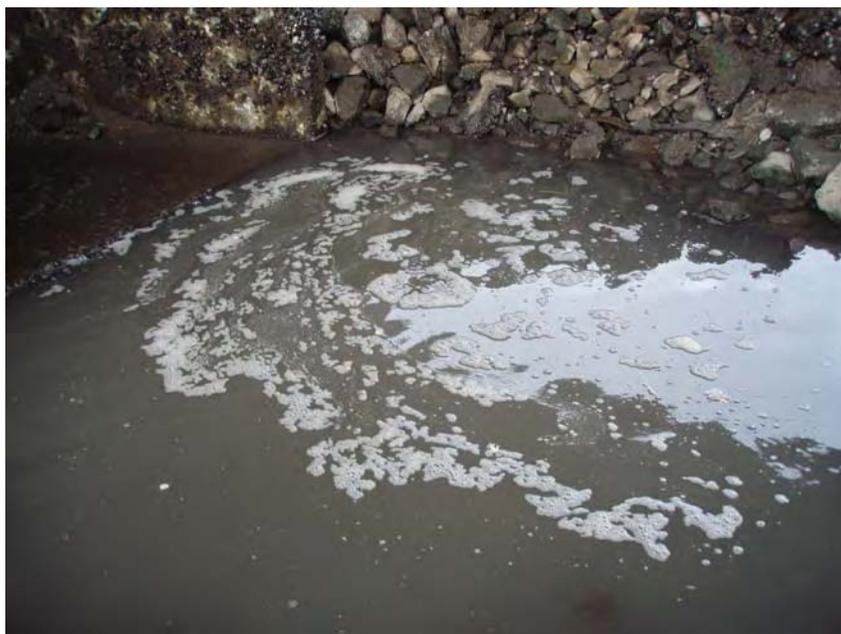
Figure 21 –
Close-up of
Pool In Front of
Outfall 235
Showing
Cloudy Water
