Appendix B

Documentation of Interviews and Site Inspections

Site Inspection Photos for the CAOCs

with Land Use Controls, Caps, and/or Engineered Covers

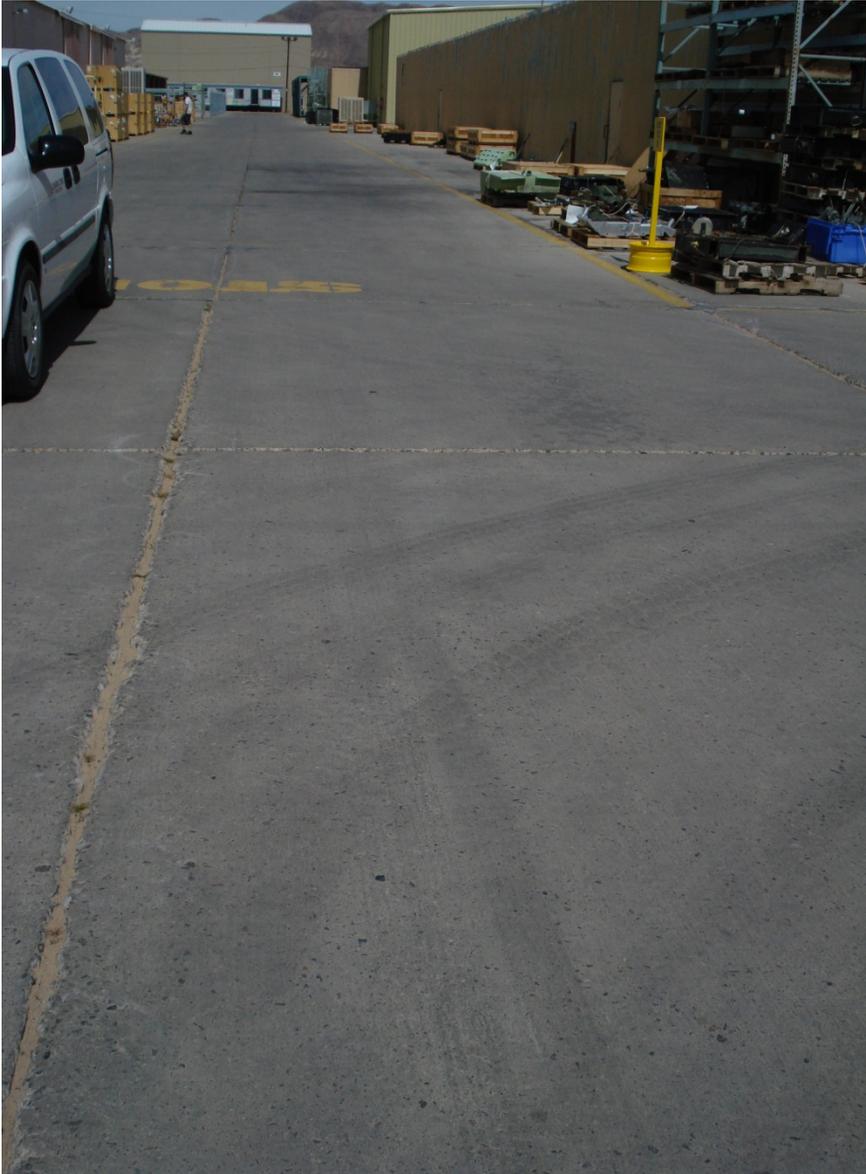
Photo 1a. CAOC 16 Hardstand – View looking northeast at hardstand adjacent to Building 622. Typical of condition of hardstand.

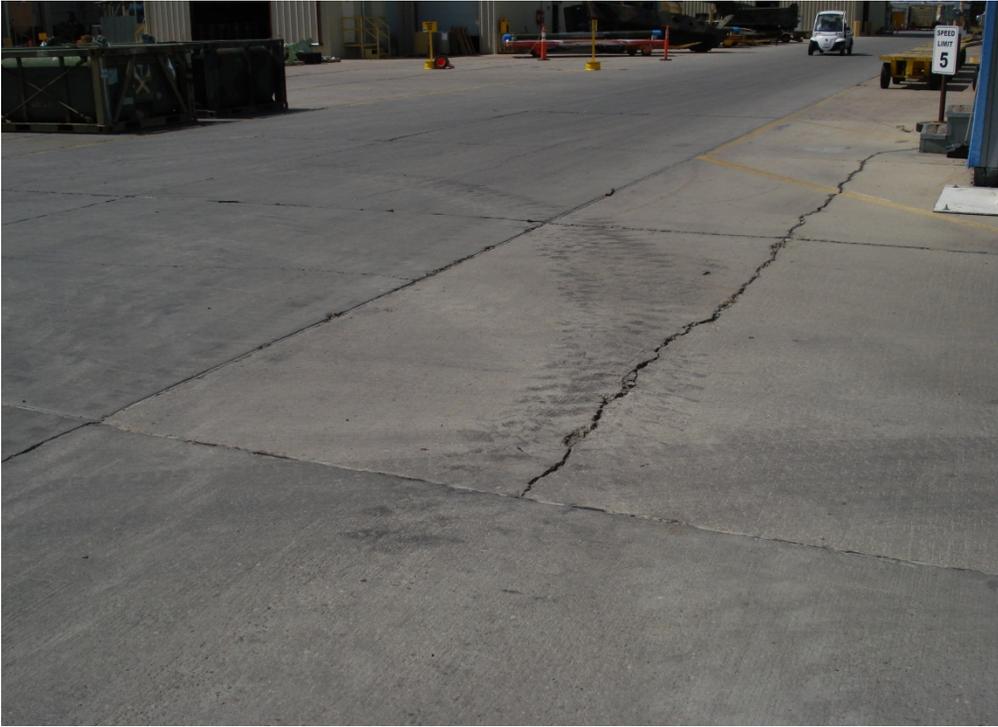
Photo 1b. CAOC 16 Hardstand – View looking northeast, north of Building 573.

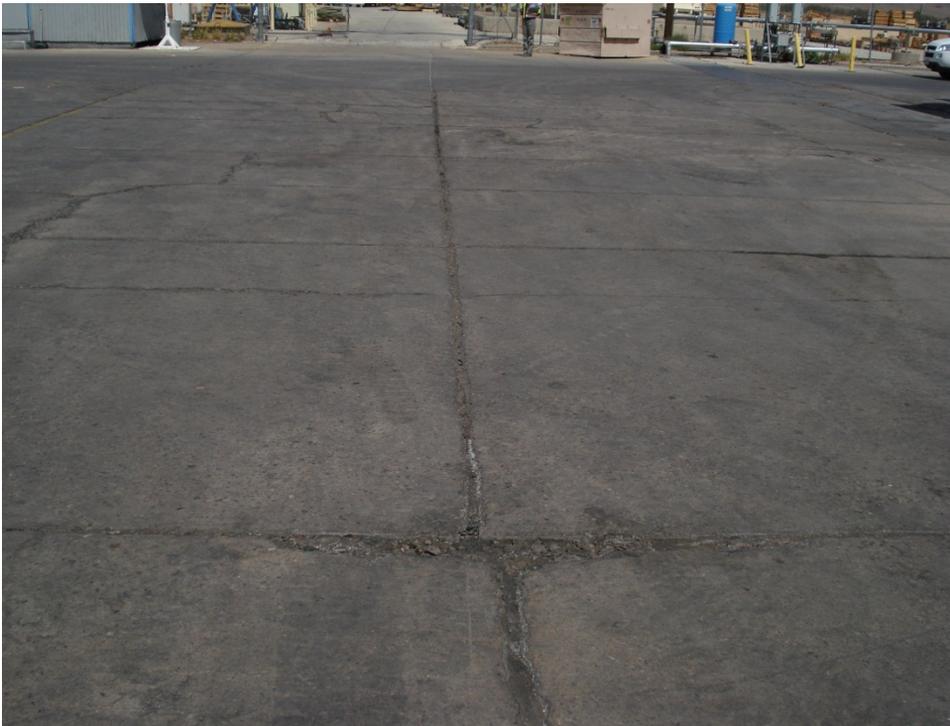
Photo 1c. CAOC 16 Hardstand – View looking southeast; east of Building 573.

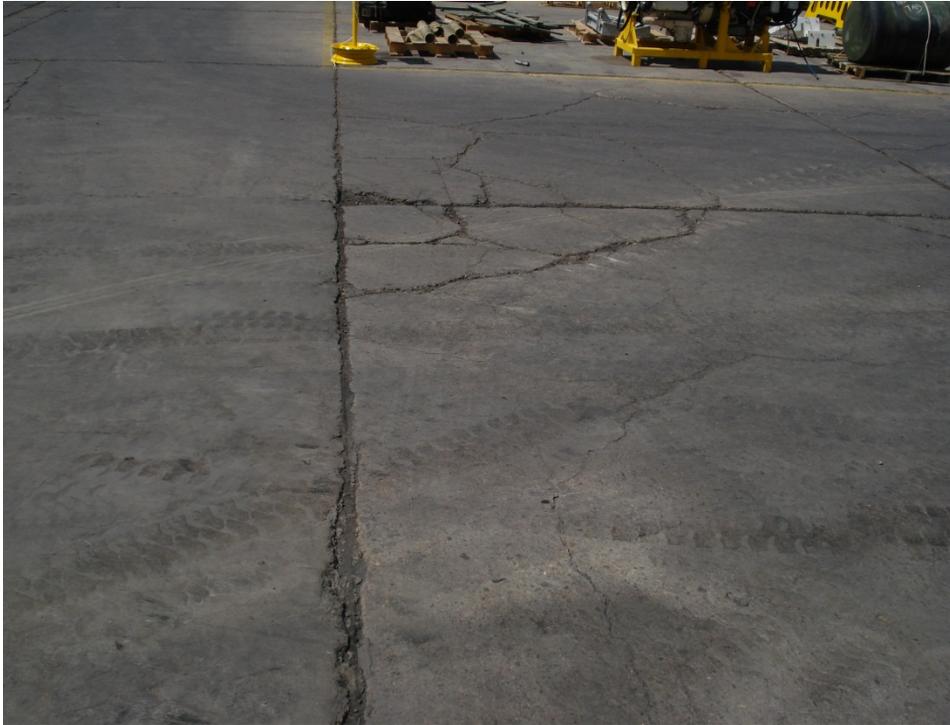
Photo 1d. CAOC 16 Hardstand – Detail of cracks along seam in pavement. View looking northeast.

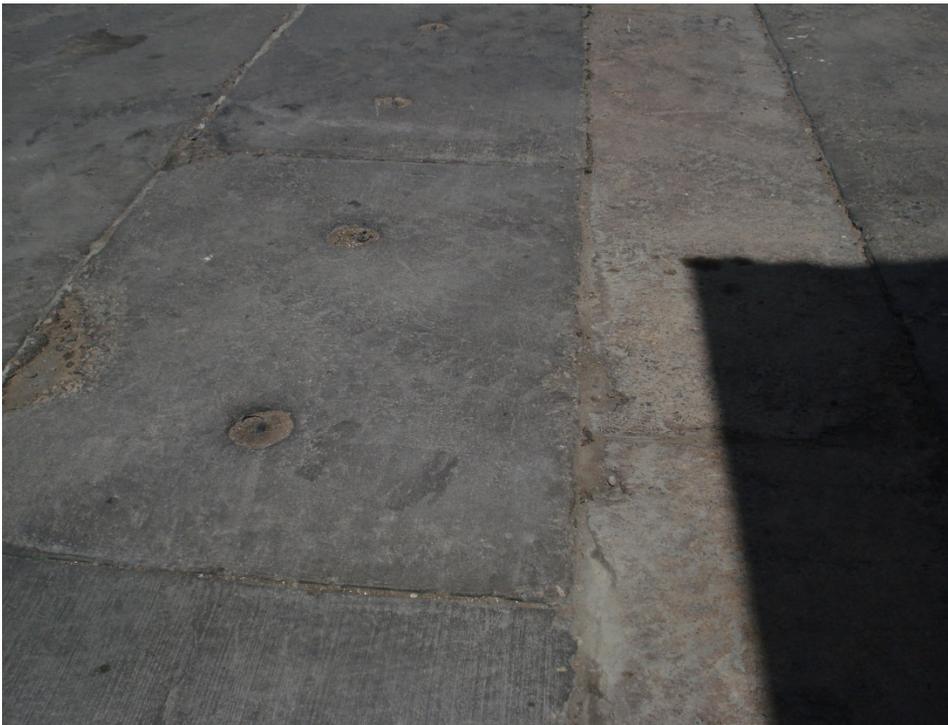
Photo 1e. CAOC 16 Hardstand – Weathered concrete seams in pavement along CAOC 16 Hardstand. View looking northeast.

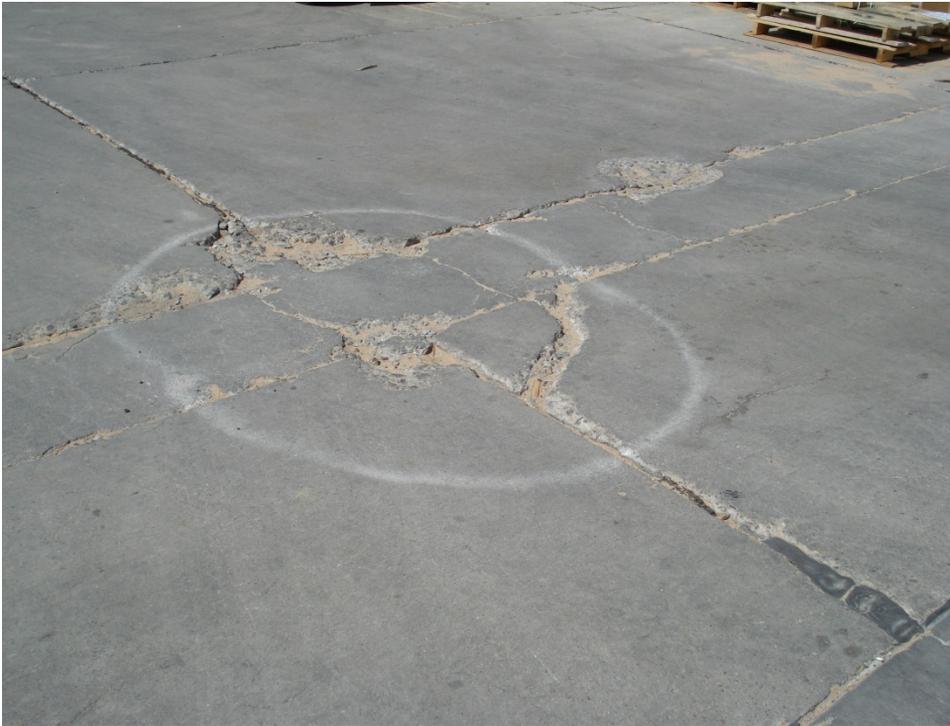
Photo 1f. CAOC 16 Hardstand – Cracked seams and joints in concrete hardstand surface marked for repair. Note crack repair in lower right.

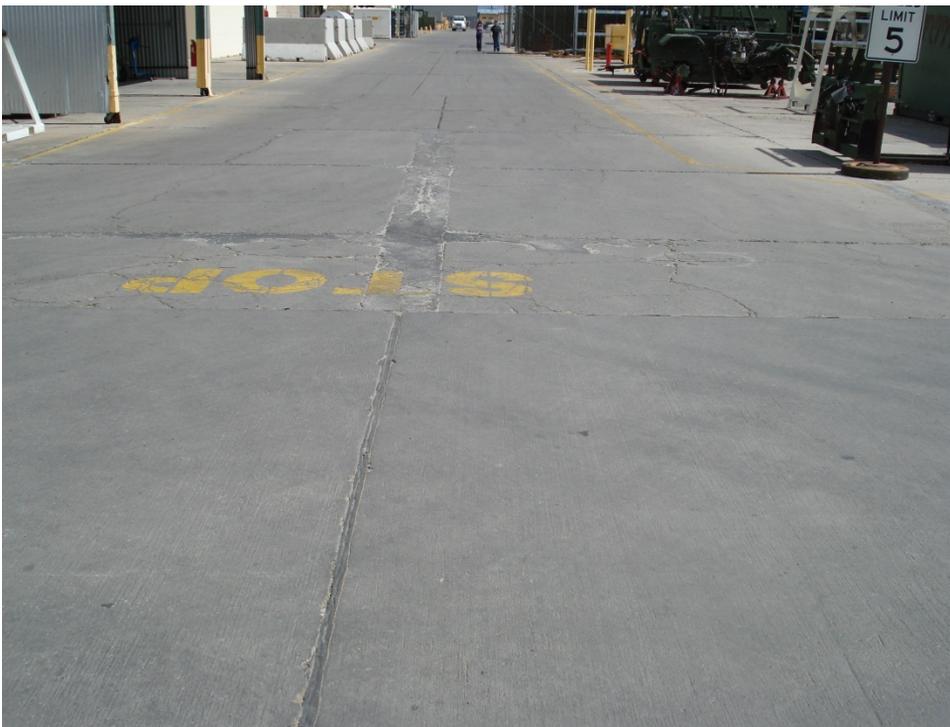
Photo 1g. CAOC 16 Hardstand – View looking southeast, west of Building 573.

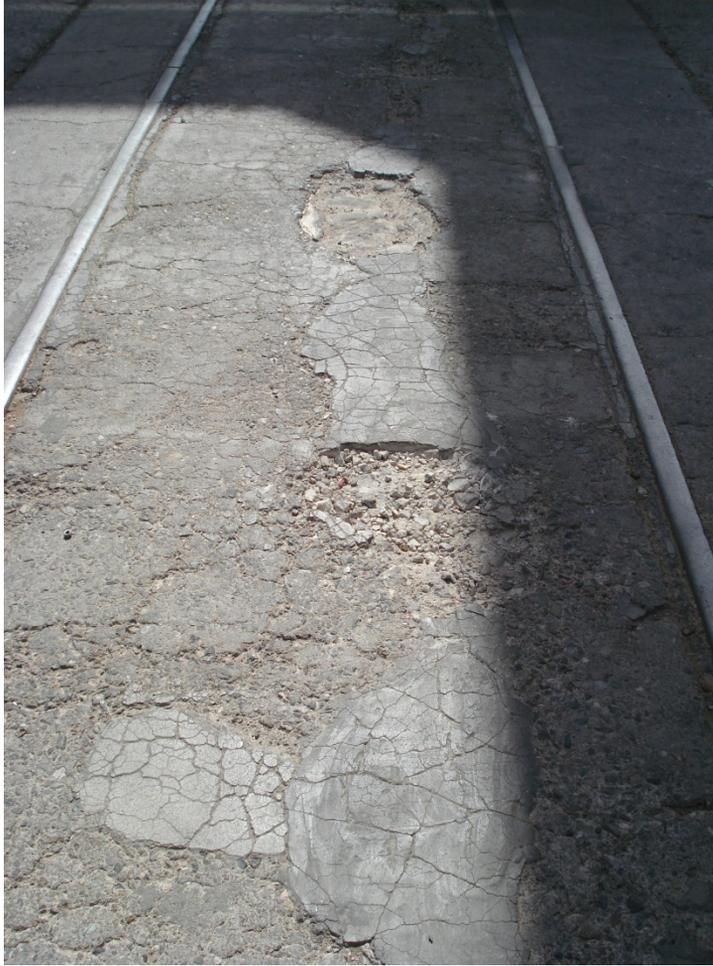
Photo 1h. CAOC 16 Hardstand – Weathered concrete pavement between rail tracks.

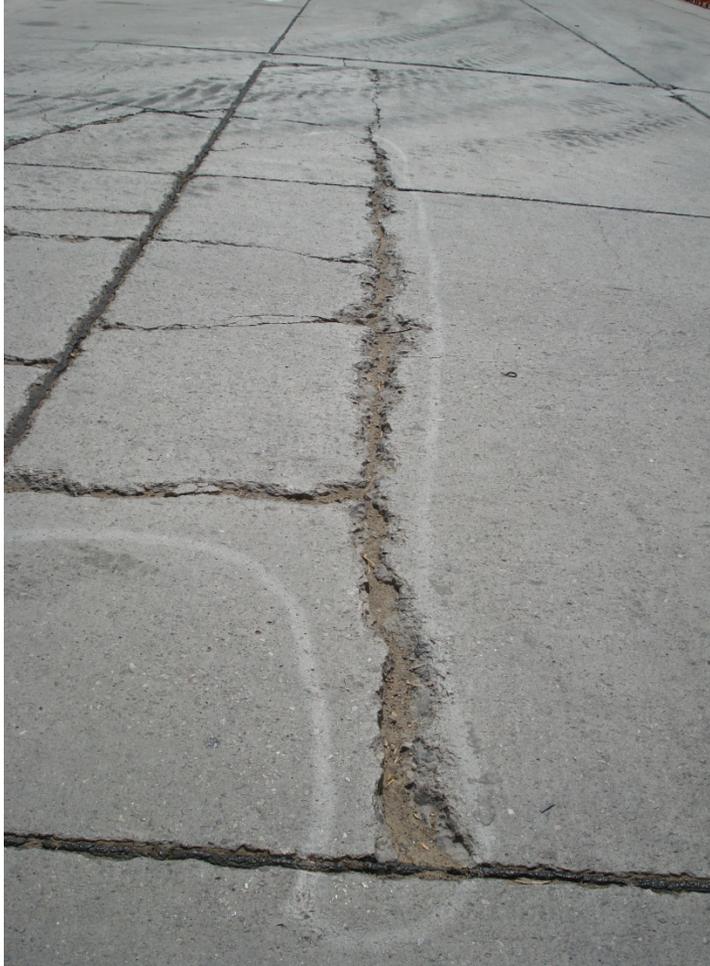
Photo 1i. CAOC 16 Hardstand – Weathering and associated cracks in hardstand concrete. Note surface markings identifying area for repair.

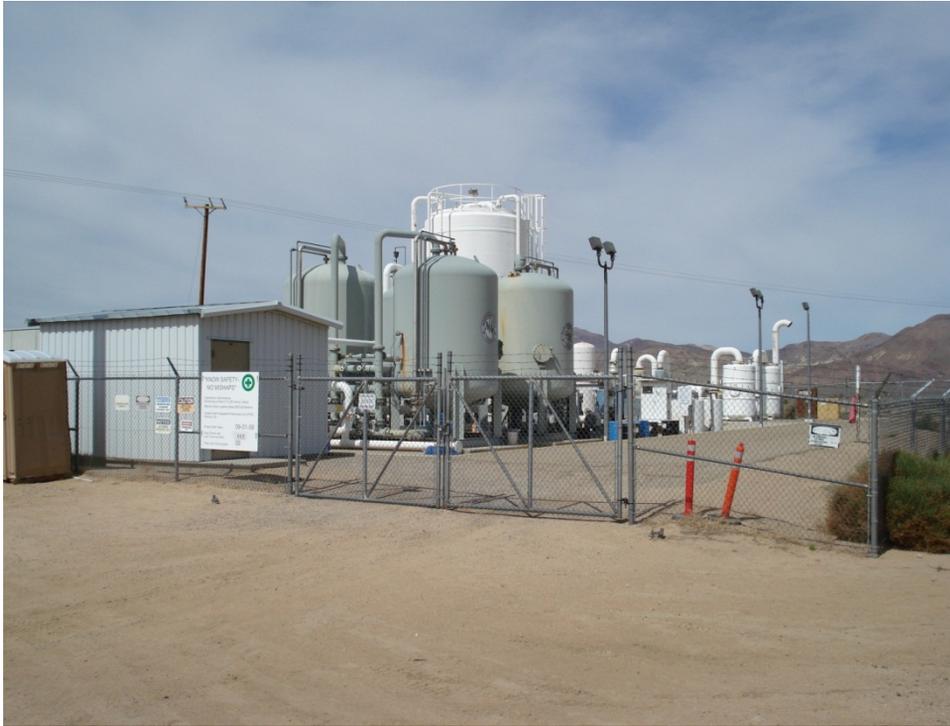
Photo 2a. OU 1 GETS – View looking north of Groundwater Extraction Treatment System (GETS). Fencing and signage in good condition

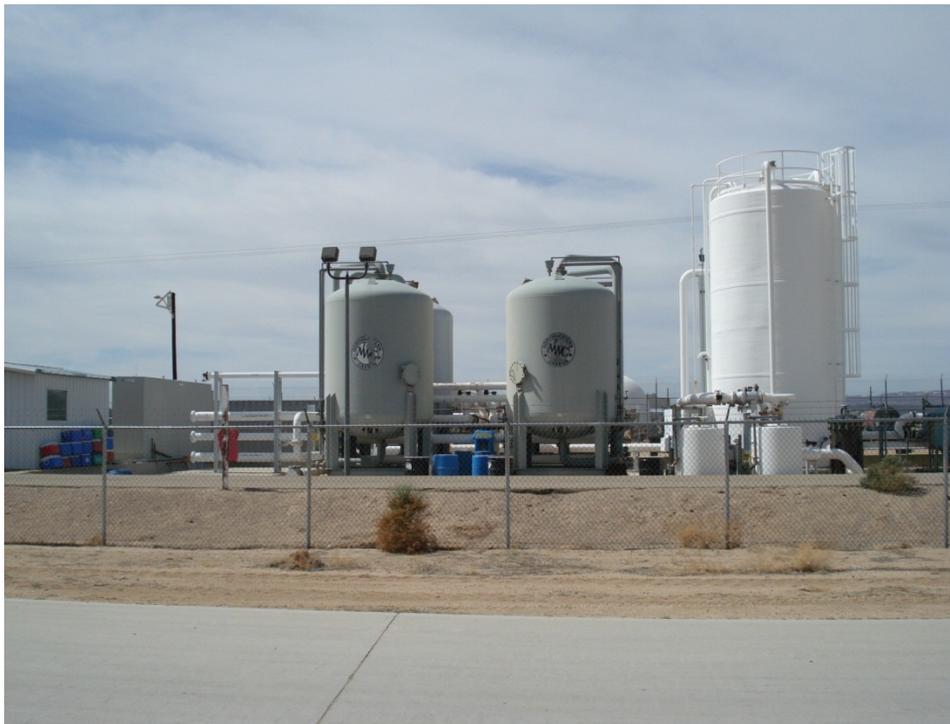
Photo 2b. OU 1 GETS – View looking northwest towards granulated activated carbon (GAC) vessels at the GETS.

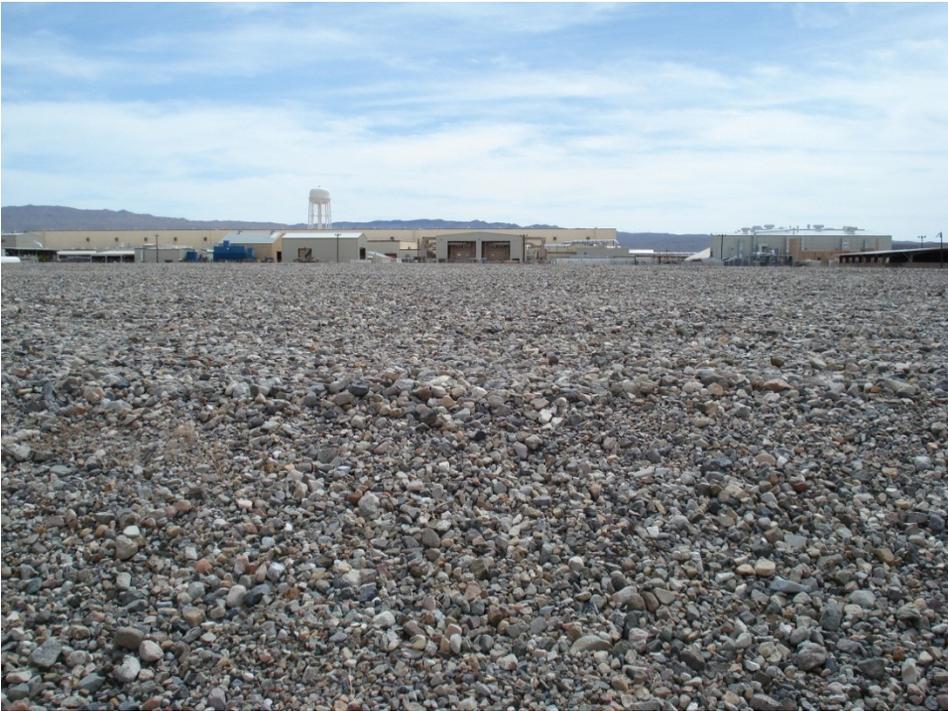
Photo 3a. CAOC 35 – View looking south of engineered landfill cap at CAOC 35.

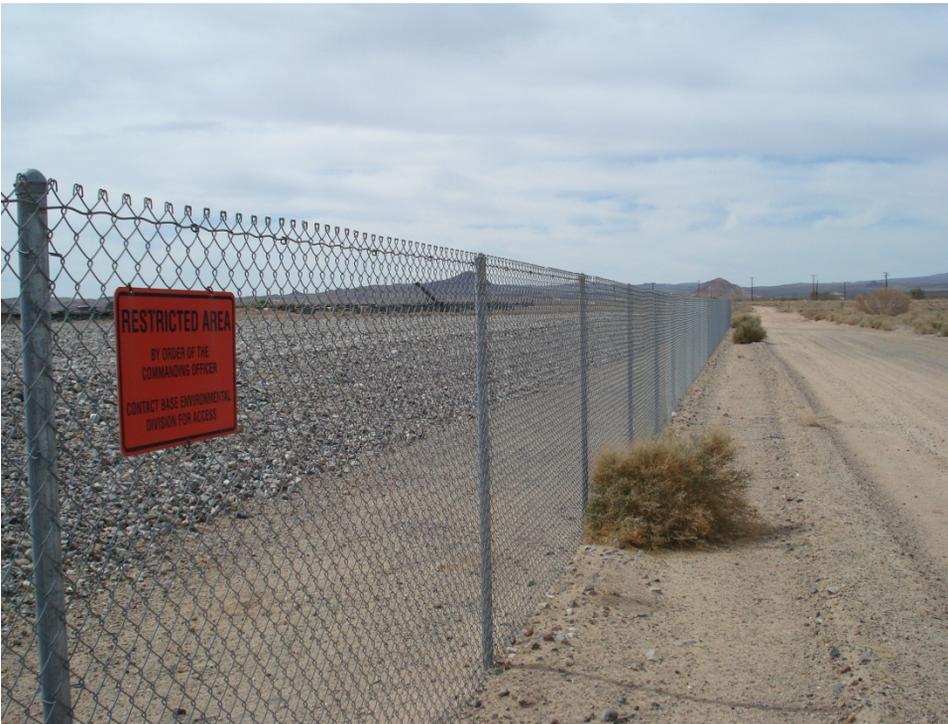
Photo 3b. CAOC 35 – View looking northwest along fenceline at northern CAOC 35 landfill boundary. Signage and fencing in good condition.

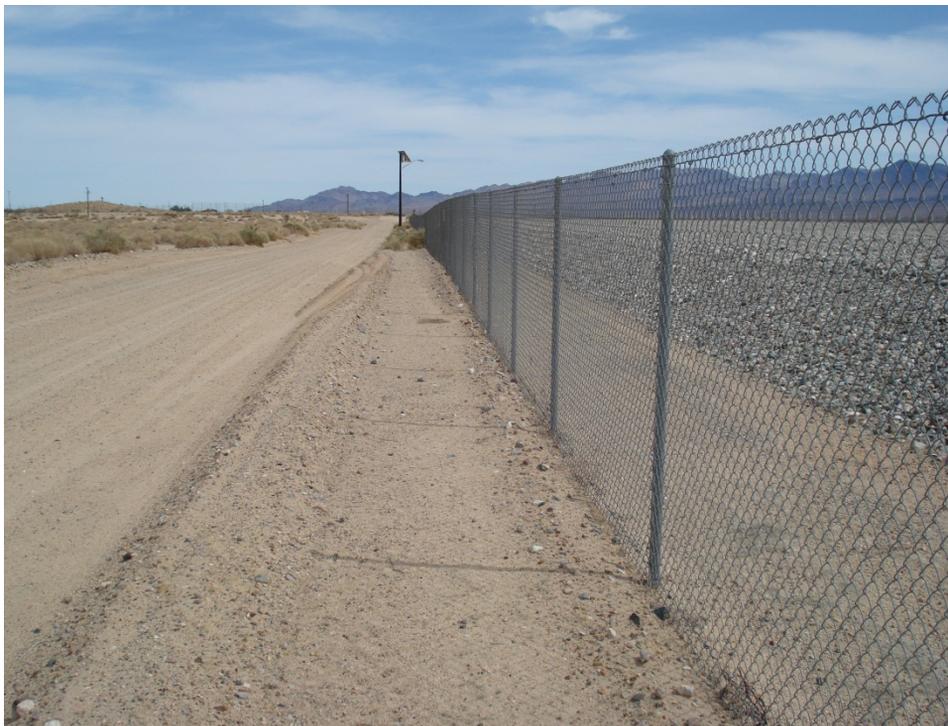
Photo 3c. CAOC 35 – View looking southeast along fenceline at north CAOC 35 landfill boundary.

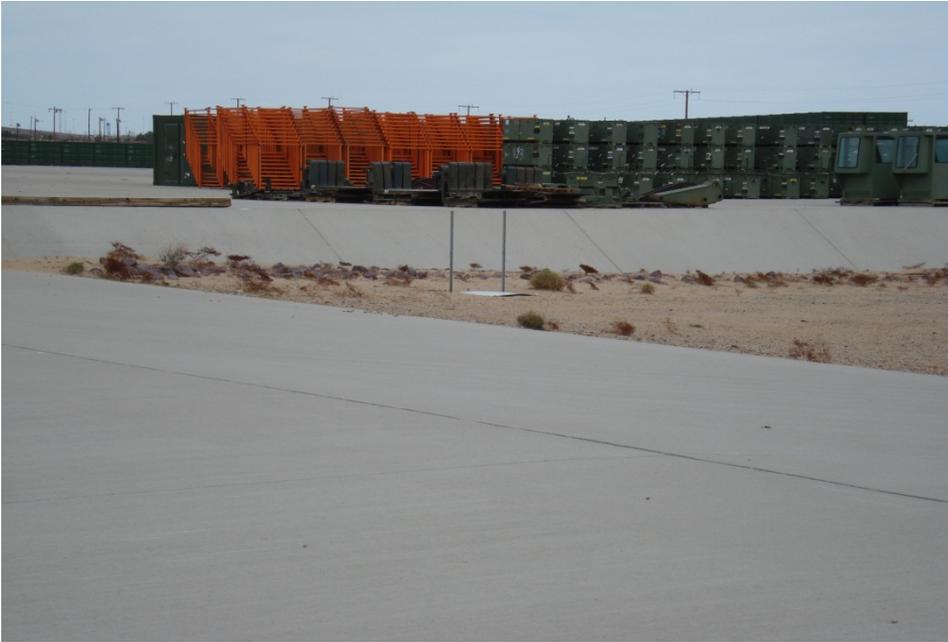
Photo 4a. CAOC 23 – View looking northwest at landfill cap with equipment storage, and adjacent unpaved areas. Cap in good condition.

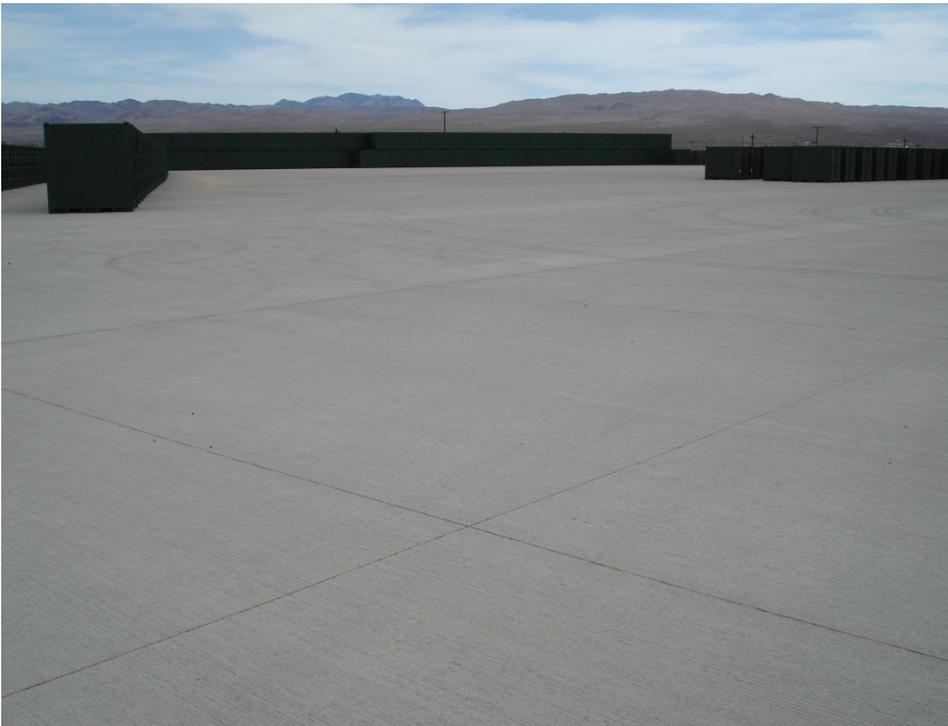
Photo 4b. CAOC 23 – View looking north of concrete landfill cap at CAOC 23. Cap in good condition.

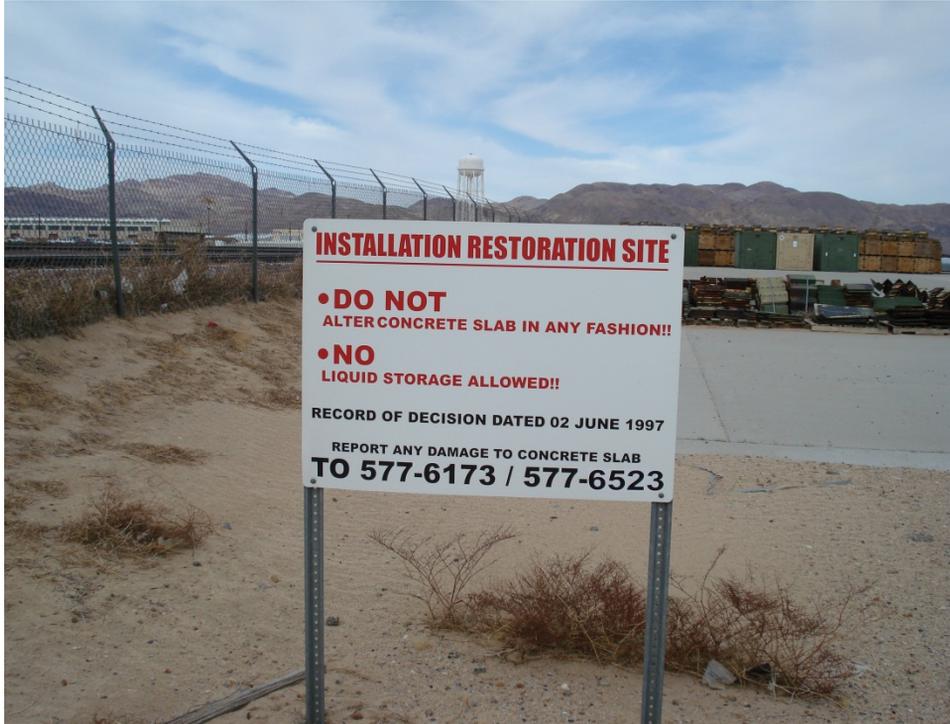
Photo 4c. CAOC 23 – View looking north-northeast, land use control sign at CAOC 23

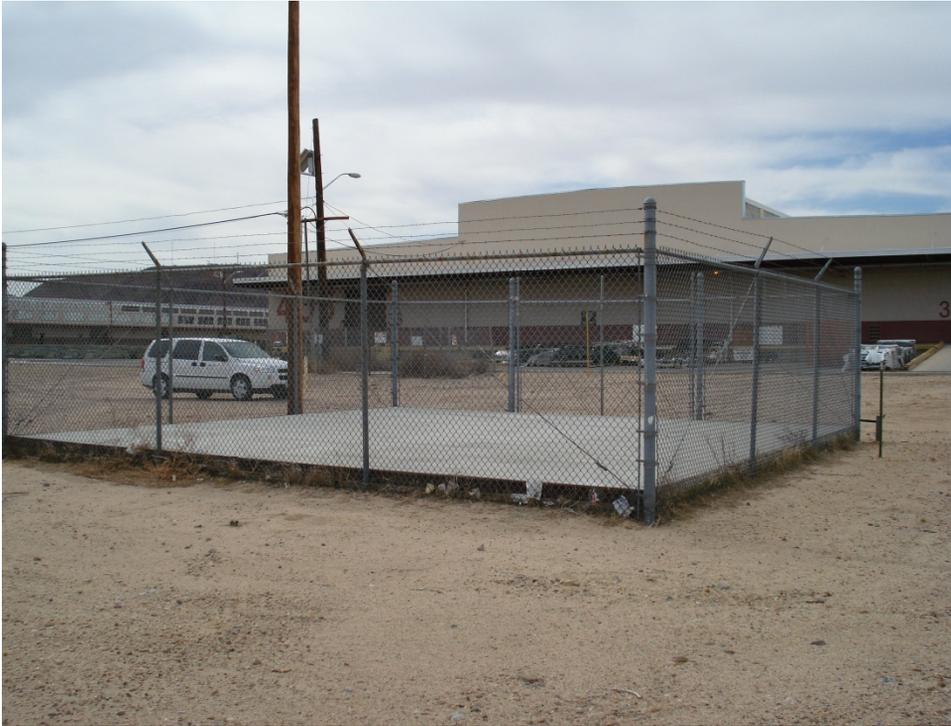
Photo 5a. CAOC 20 – View looking southeast of landfill cap and surrounding fencing at CAOC 20.

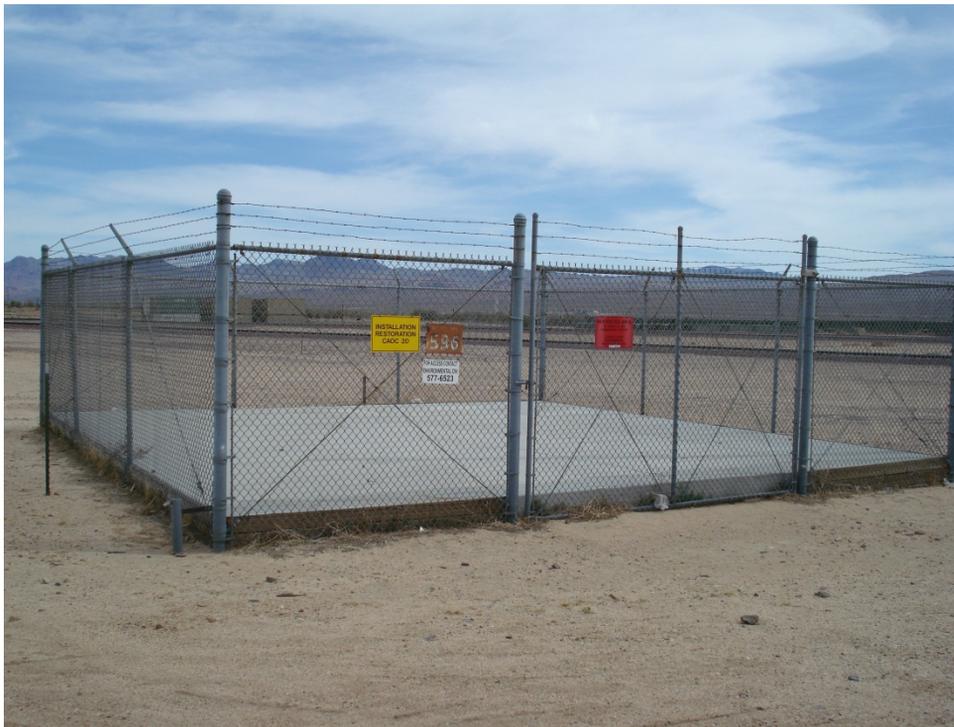
Photo 5b. CAOC 20 – View looking southeast of landfill cap and surrounding signage and fencing.

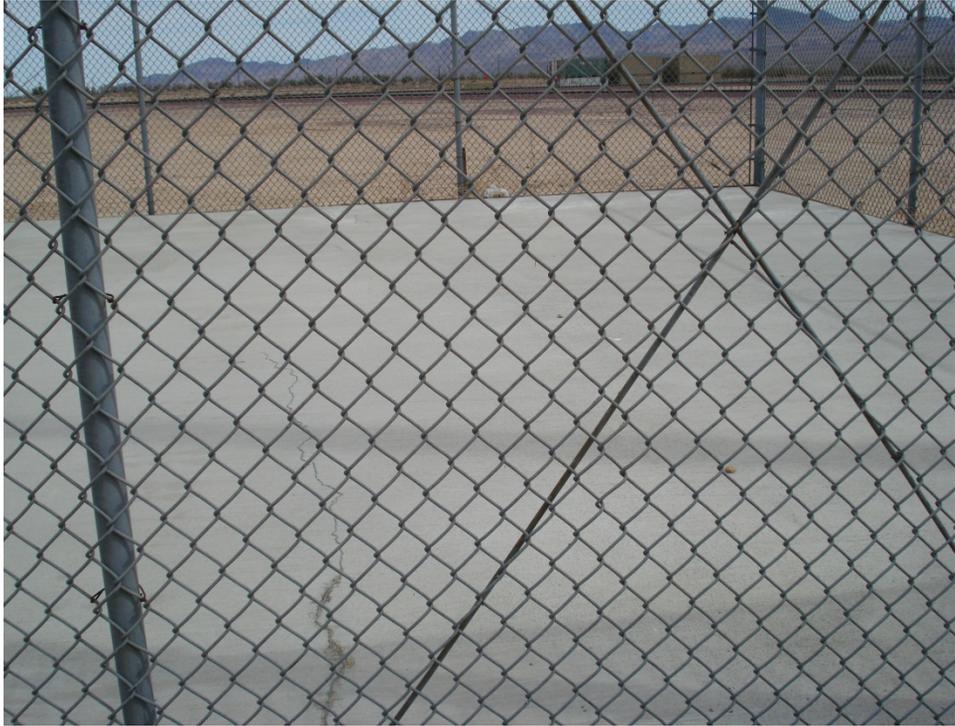
Photo 5c. CAOC 20 – Close-up view of concrete cap at CAOC 20. Note crack left-of-center, repaired with elastomeric sealant. View looking northwest.

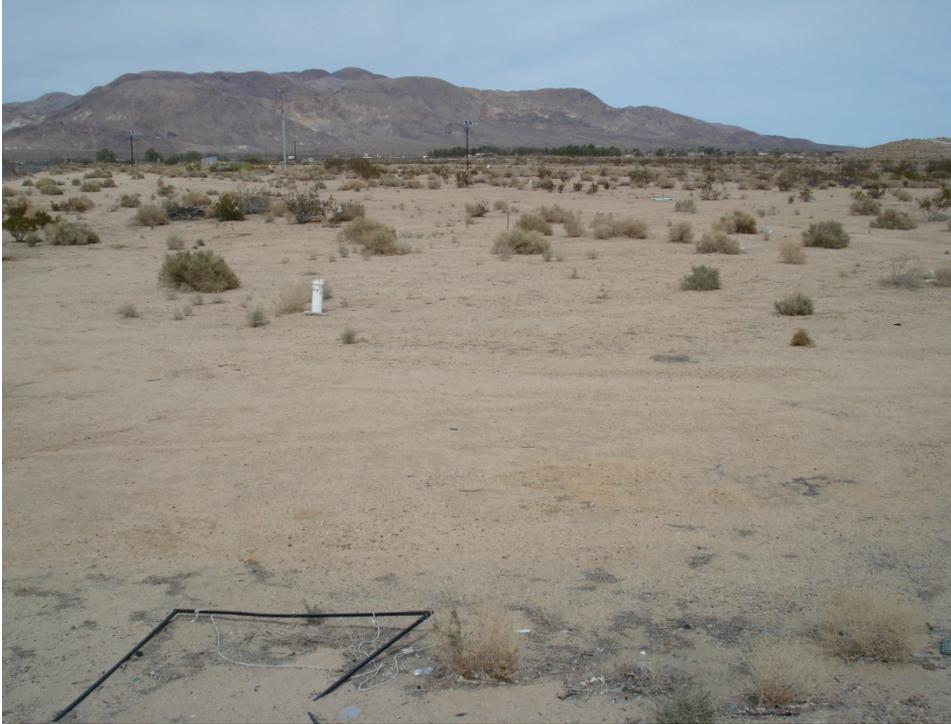
Photo 6a. CAOC 16 AS/SVE wells. View looking northeast.
Note: Well YM-11 in foreground.

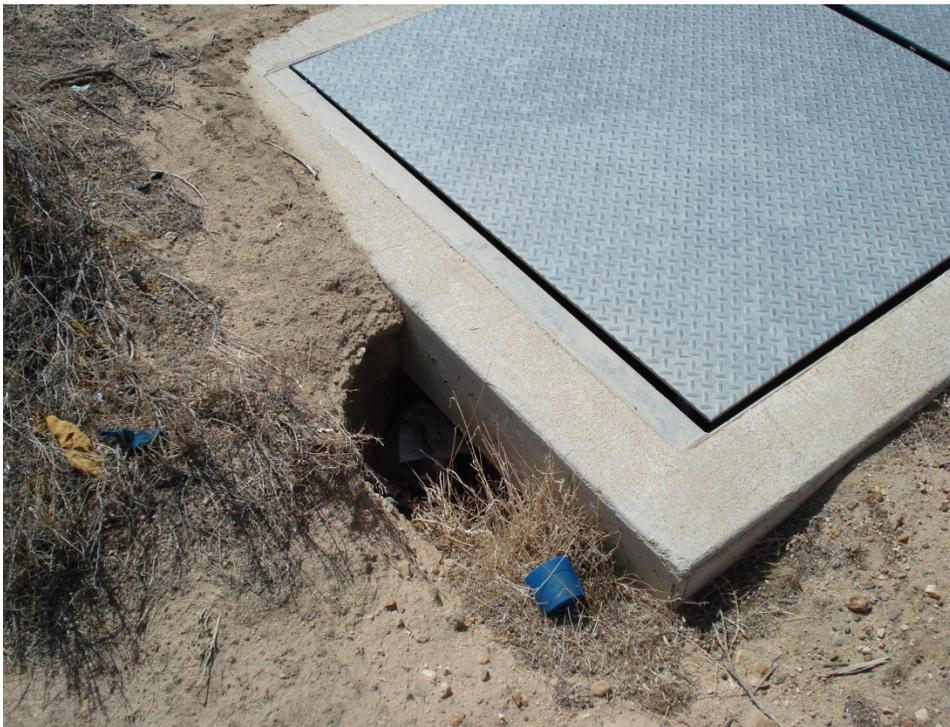
Photo 6b. CAOC 16 AS/SVE system – Erosion along edge of well vault (ASW-8). Note: Edge of vault is 4 feet long for scale.

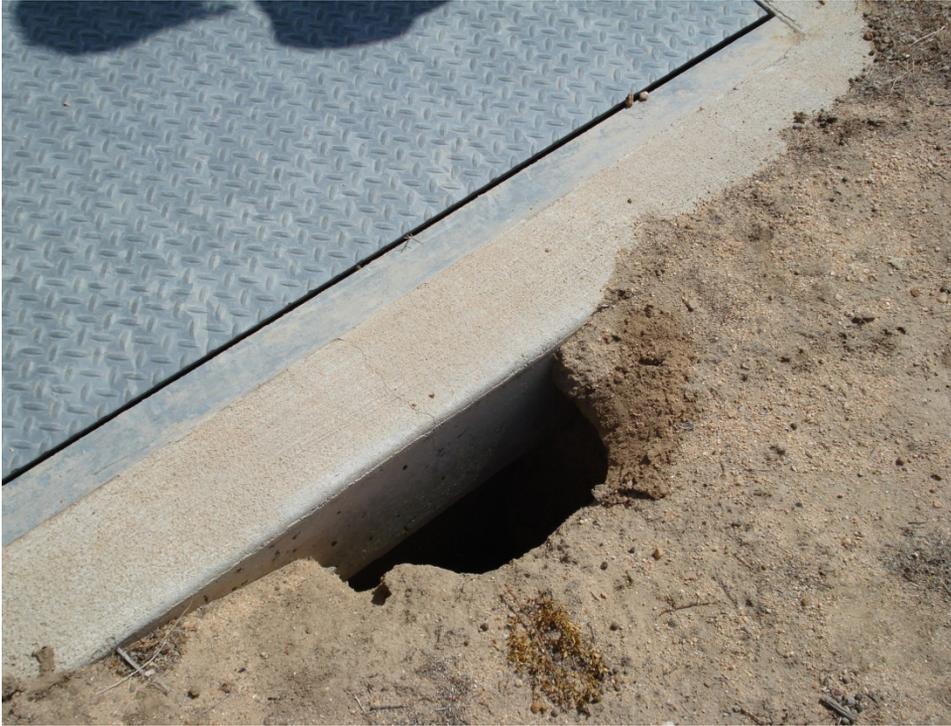
Photo 6c. Yermo Annex – CAOC 16 AS/SVE – Erosion at Well Vault for ASW-5.

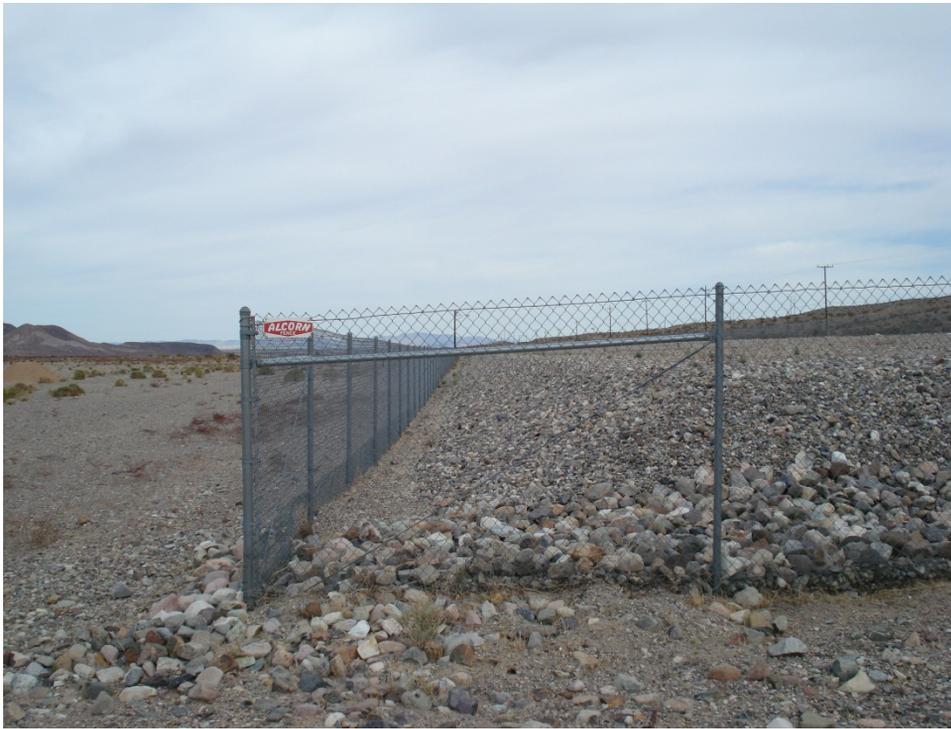
Photo 7a. CAOC 7 – Northwest fence corner of CAOC 7, Stratum 1 landfill cap. Fencing and cap in good condition. View looking east.

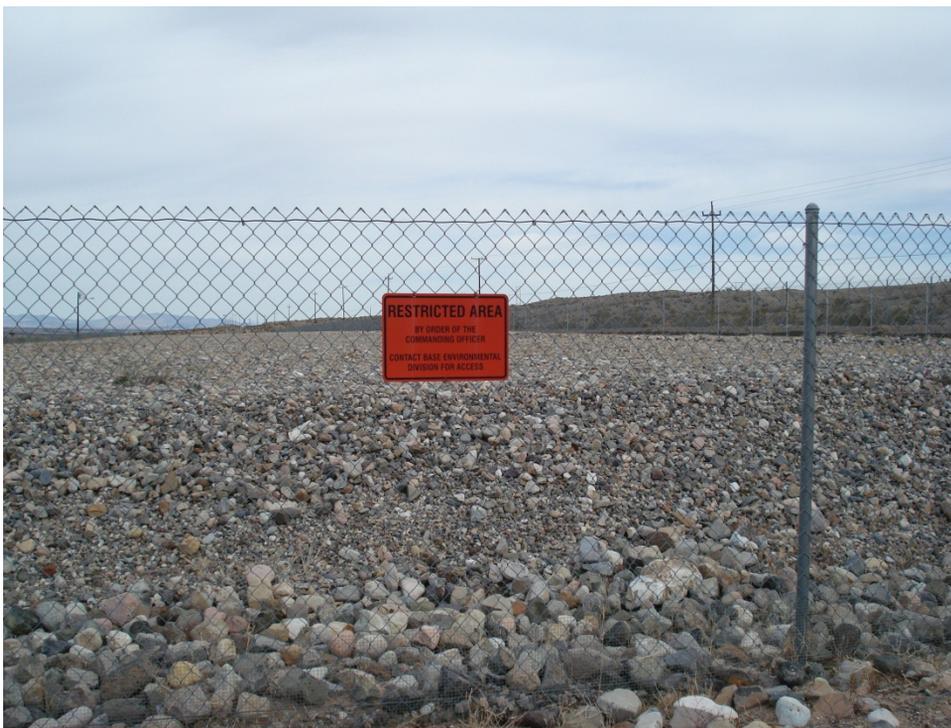
Photo 7b. CAOC 7 – Signage along fence at CAOC 7, Stratum 1 identifying restricted access to landfill cap.

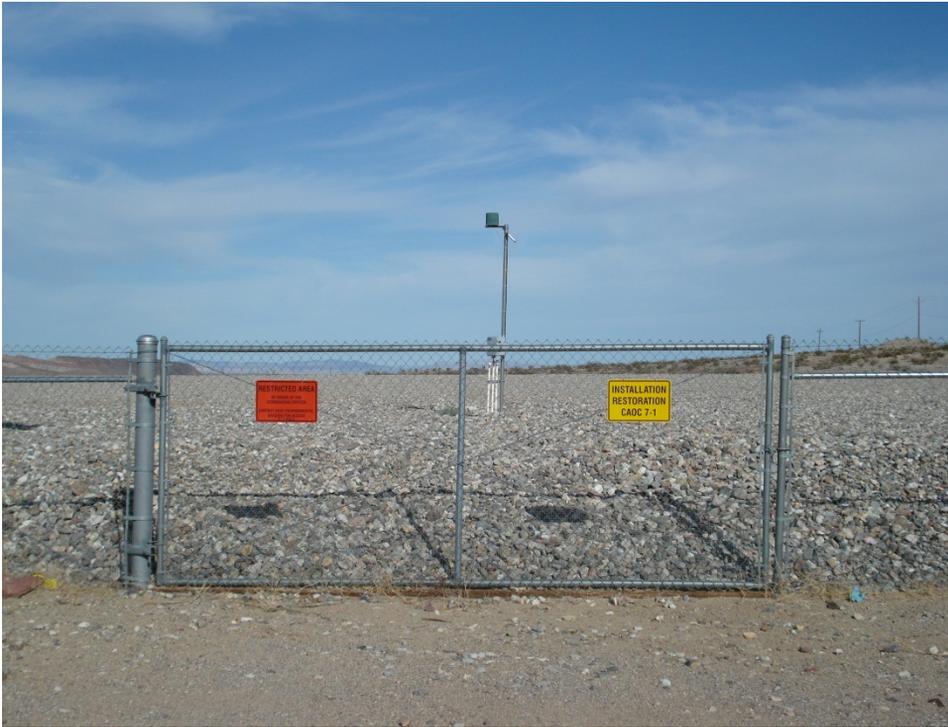
Photo 7c. CAOC 7 – View looking east of entry gate to CAOC 7, Stratum 1 landfill cap. Fencing, gate, and signage in good condition. Note: landfill moisture sensor in background.

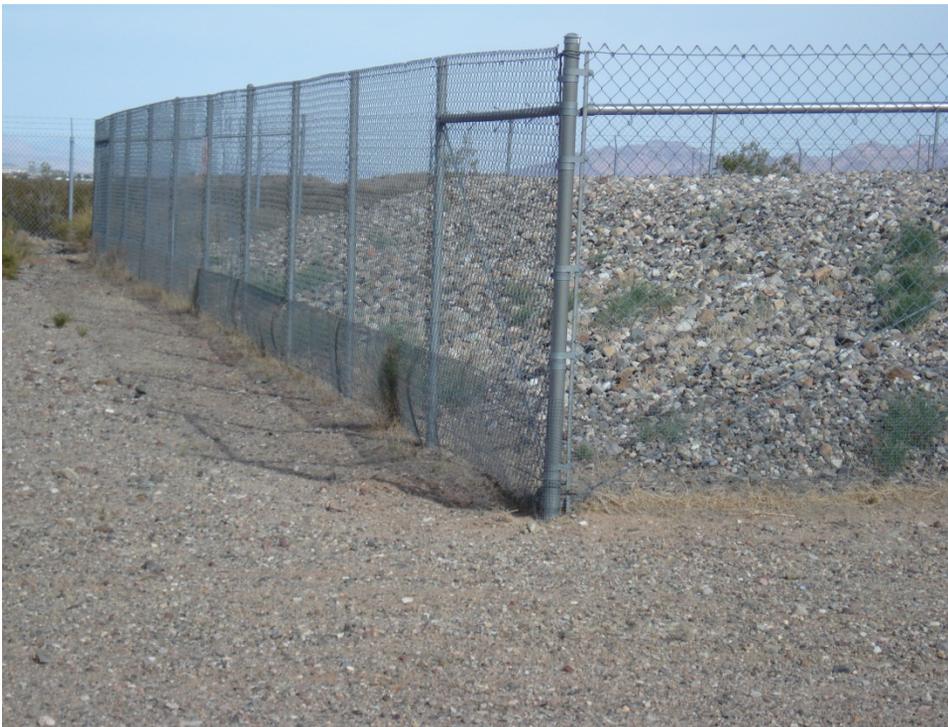
Photo 7d. CAOC 7 – View looking east-southeast at northern boundary fence of CAOC 7, Stratum 1. Note: desert tortoise fencing installed along base of boundary fence. Fencing in good condition.

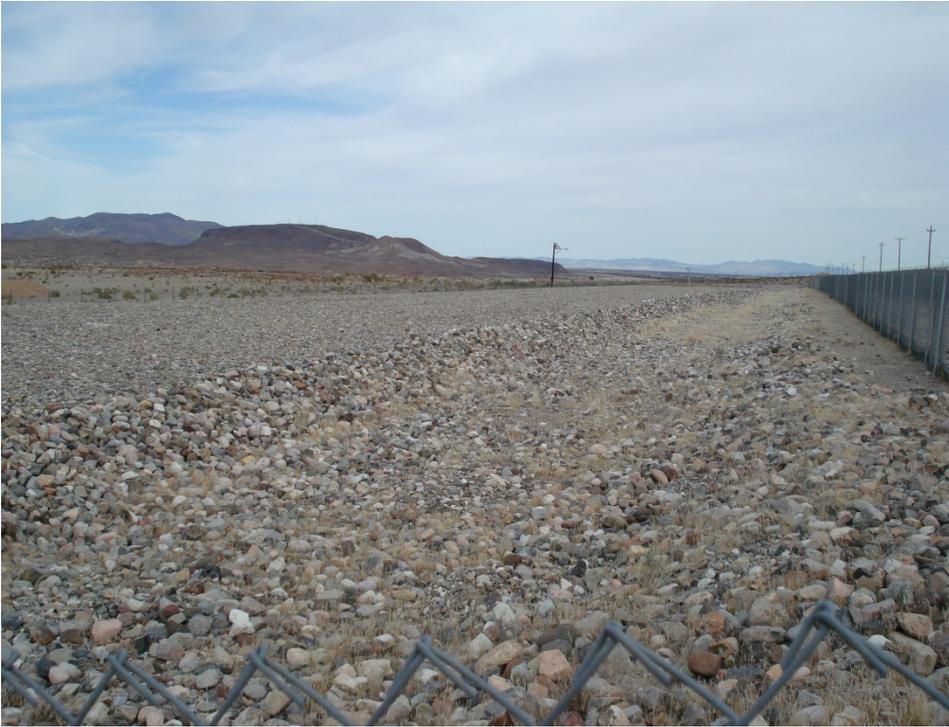
Photo 7e. CAOC 7 – View looking northeast of CAOC 7, Stratum 2 engineered landfill cap. Cap and fencing in good condition.

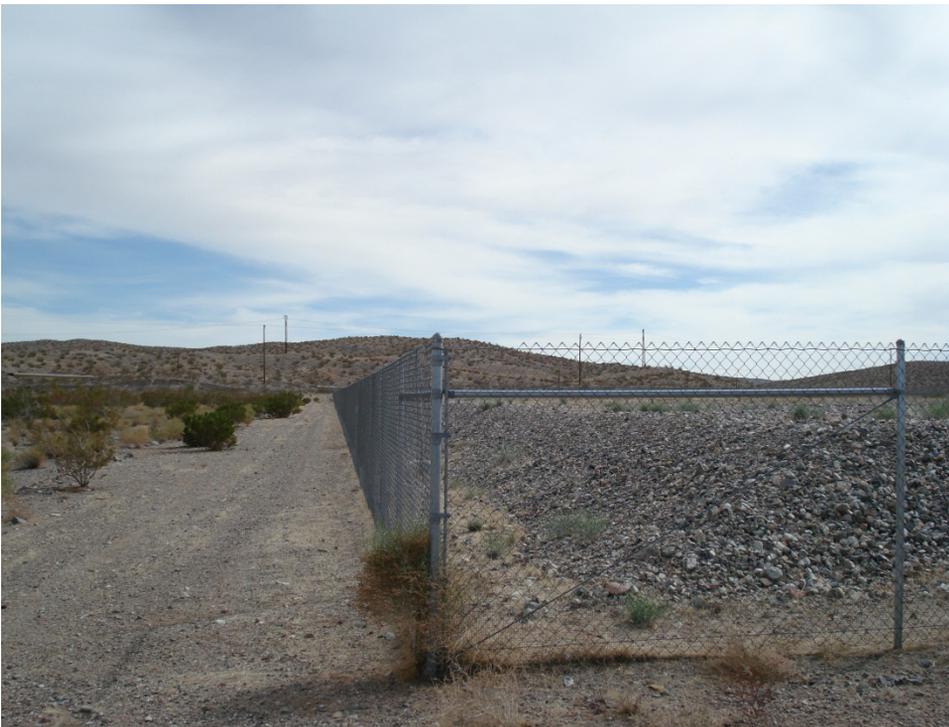
Photo 7f. CAOC 7 – View looking south along eastern edge of CAOC 7, Stratum 2 landfill cap. Fencing in good condition.
Note: desert tortoise barrier visible at base of fence.

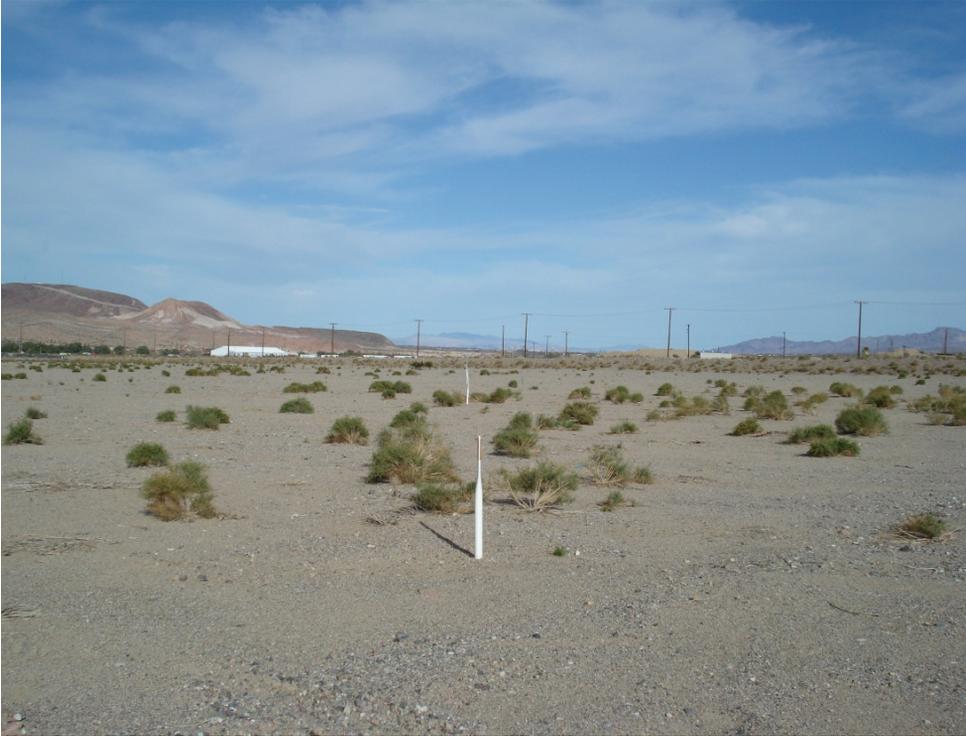
Photo 8a. CAOC 5 and Land Use Control (LUC) boundary for Nebo South (CAOC 6) – View looking northeast of CAOC 5 (former chemical storage area) toward Nebo Main Base. Note delineators identifying LUC boundary for Nebo South (CAOC 6).

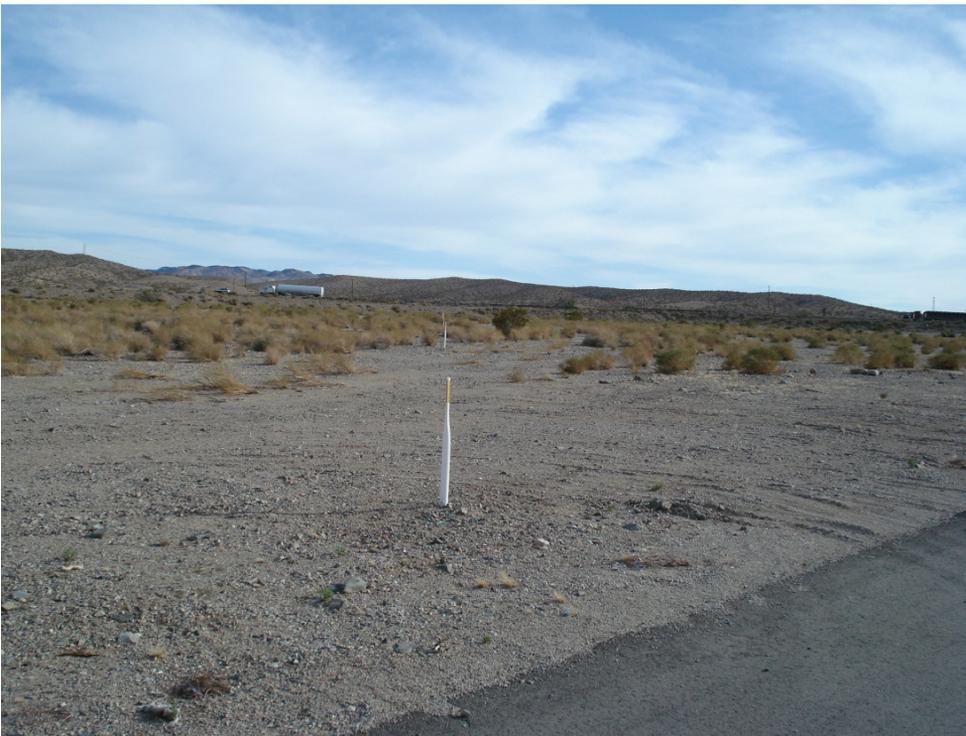
Photo 8b. CAOC 5 and LUC Boundary – View looking southeast towards Interstate 40. Note CAOC 6 LUC boundary markers in foreground.
