Appendix B

Documentation of Interviews and Site Inspections

Site Inspection Photos for the CAOCs

with Land Use Controls, Caps, and/or Engineered Covers

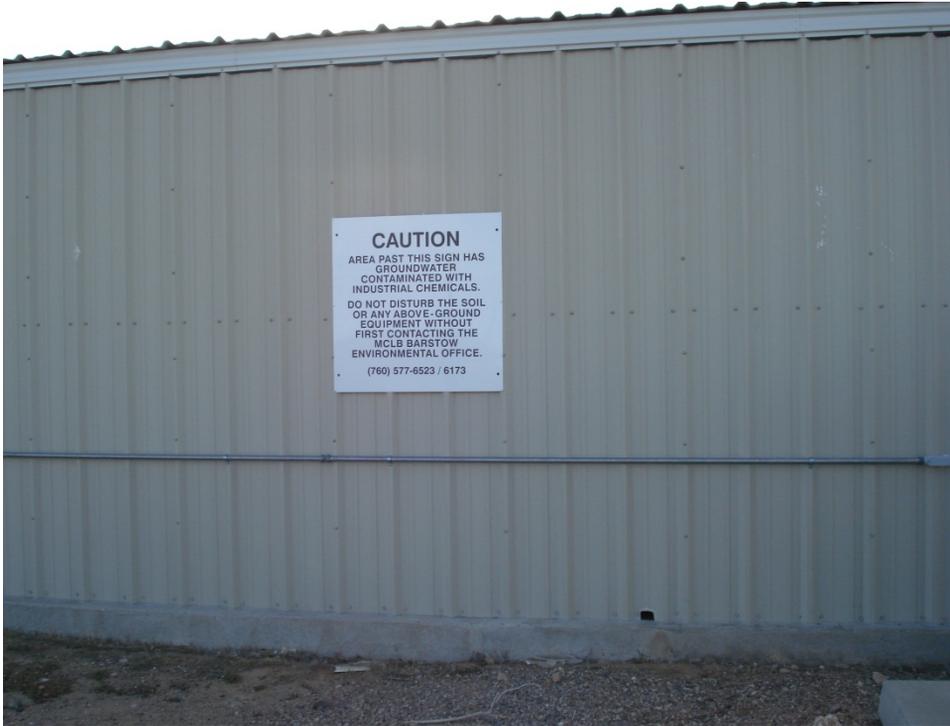
Photo 8c. CAOC 5 LUC Boundary – View looking west of LUC boundary sign placed on Nebo South treatment system building. Sign faces east Nebo Main Base Boundary.

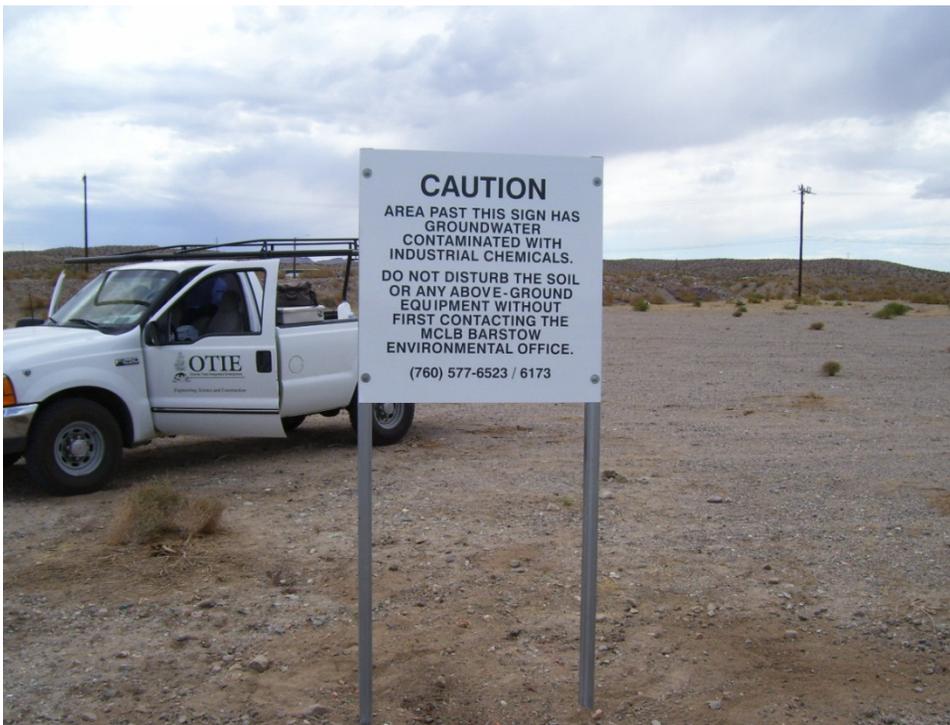
Photo 8d. CAOC 5 and LUC Boundary – View looking southeast towards placard identifying Nebo South LUC boundary.

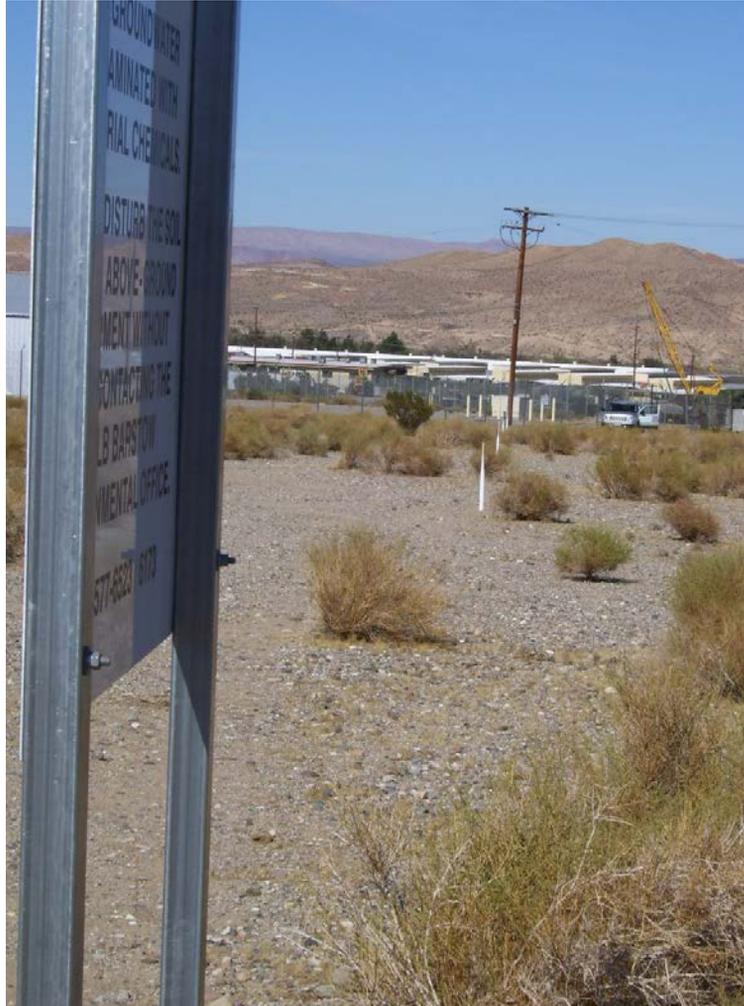
Photo 8e. CAOC 5 and LUC Boundary – View looking northwest towards Nebo Main Base. Note placard in foreground and delineators in background, identifying Nebo South LUC boundary.

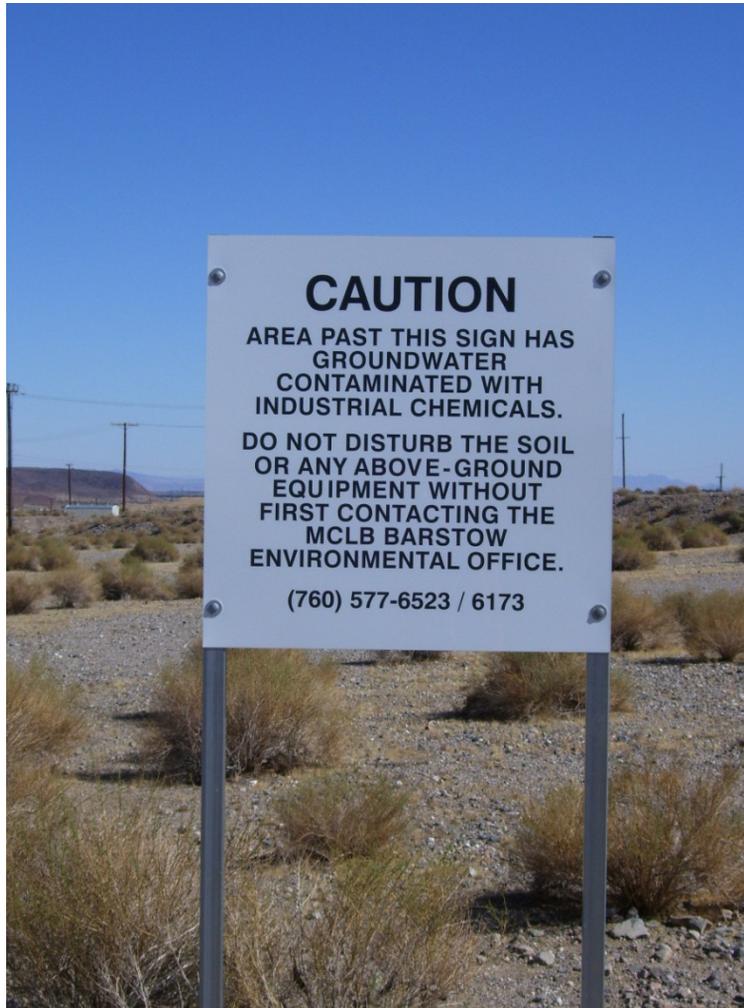
Photo 8f. CAOC 5 and LUC Boundary – View looking east of sign demarcating western edge of Nebo South LUC boundary.
