Site Inspection Checklist for the Arroyo Pasajero Ponding Basin

PREPARED FOR: United States Environmental Protection Agency
PREPARED BY: Alexa Stamets/CH2M HILL
DATE: May 18, 2006

Five-Year Review Site Inspection Checklist
Arroyo Pasajero Ponding Basin, Atlas Mine Superfund Site

I. SITE INFORMATION		
Site name: Arroyo Pasajero Ponding Basin, Atlas Mine Superfund Site	Date of inspection: May 2, 2006	
Location and Region: Coalinga, CA, Region IX	EPA ID: 0934, CAD980496863	
Agency, office, or company leading the five-year review: EPA Region IX	Weather/temperature: Sunny, approximately 70 °F.	
Remedy Includes: (Check all that apply) Landfill cover/containment Access controls Institutional controls Groundwater pump and treatment Surface water collection and treatment Other:		
Attachments: <input checked="" type="checkbox"/> Inspection team roster attached <input checked="" type="checkbox"/> Site map attached [in report]		
II. INTERVIEWS (Check all that apply)

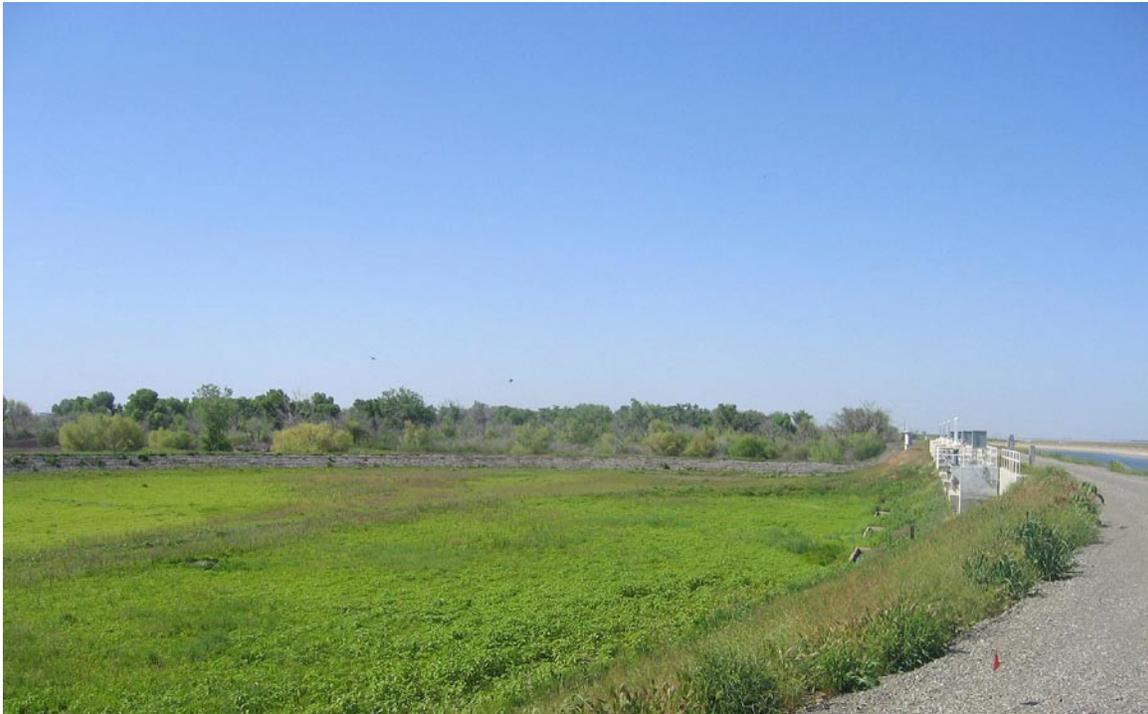
The vegetative detention pond, showing the gabion weir along the perimeter of the pond and the drain control structure that releases water from the pond to the California Aqueduct when necessary for flood control. This detention pond is located immediately north of Gale Avenue on the western side of the California Aqueduct. The California Aqueduct is visible on the right side of the photograph.

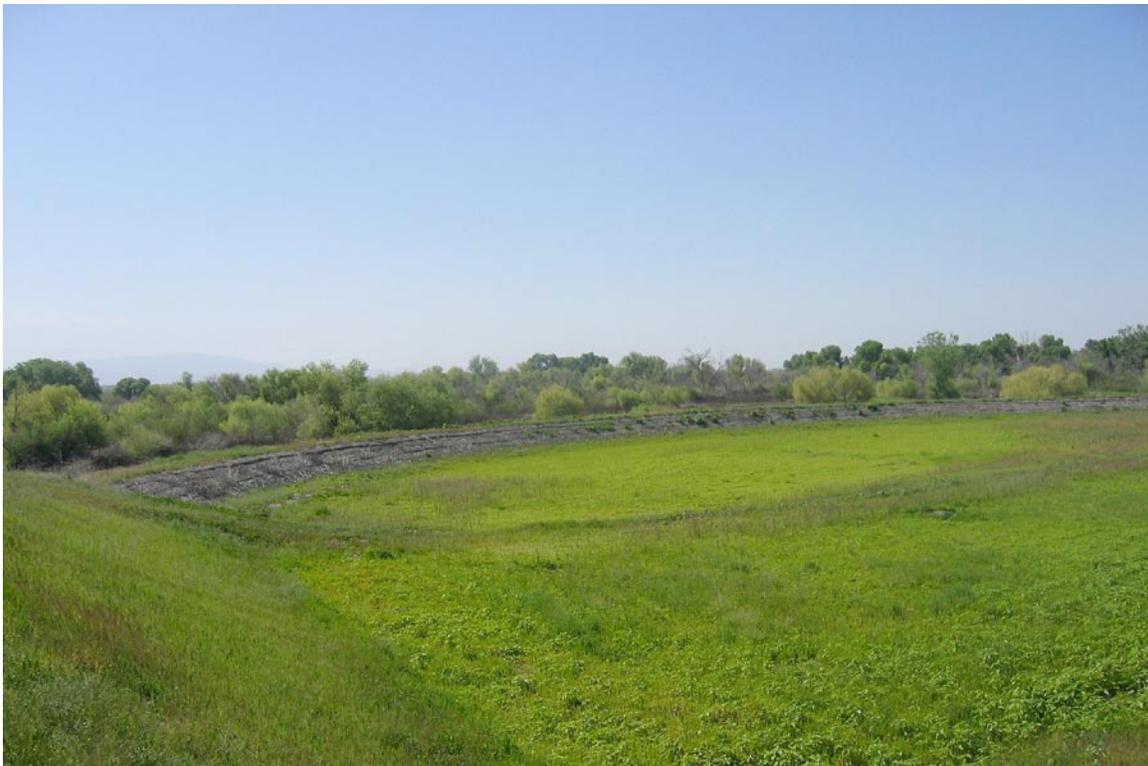
The gabion wall extends along the western side of the vegetative detention pond. The gabion weir prevents water from entering this vegetative area. No significant volume of water was observed in this pond during the site inspection.

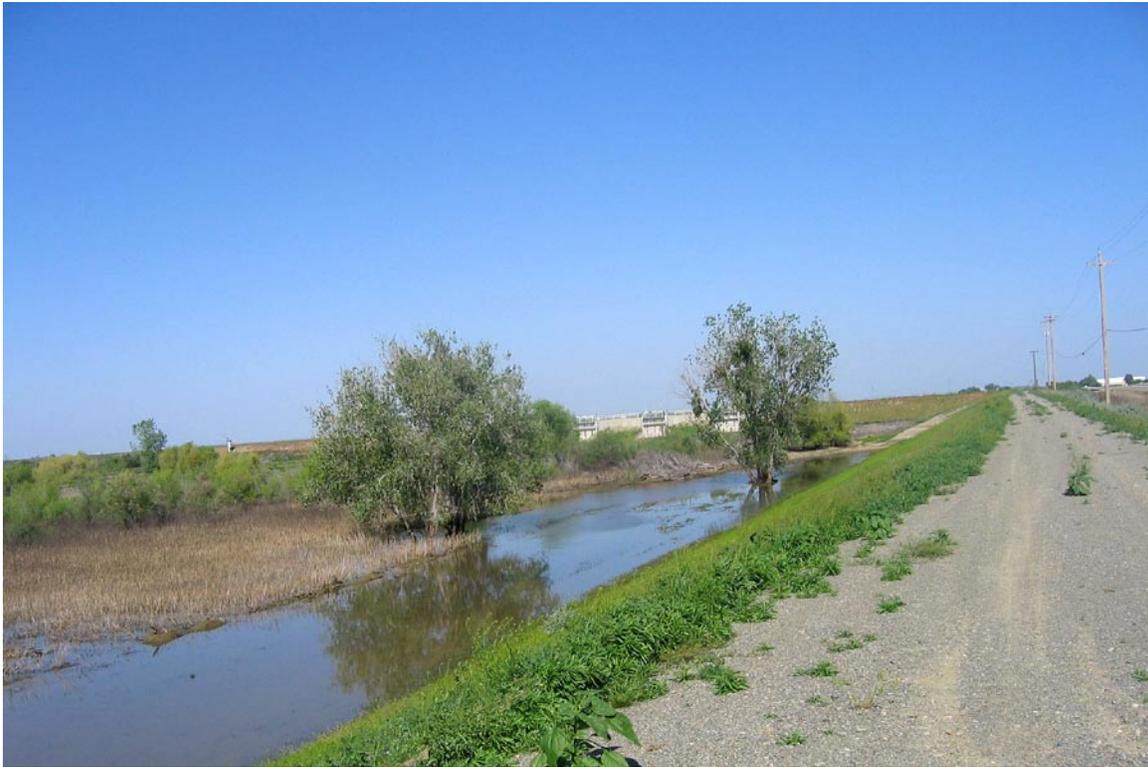
Portion of the ponding basin west (upstream) of the gabion weir along Gale Avenue. Surface water collects behind the gabion weir, as presented in this photograph.

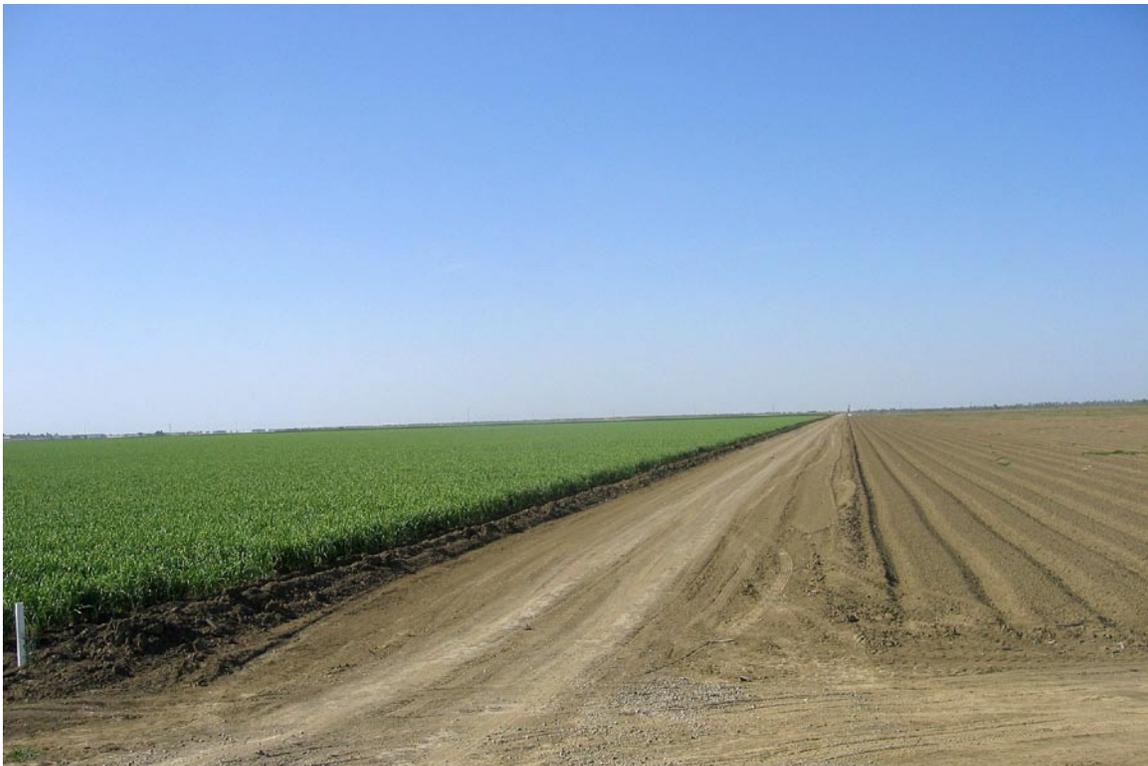
Further west along Gale Avenue, land within the ponding basin is used to grow crops.

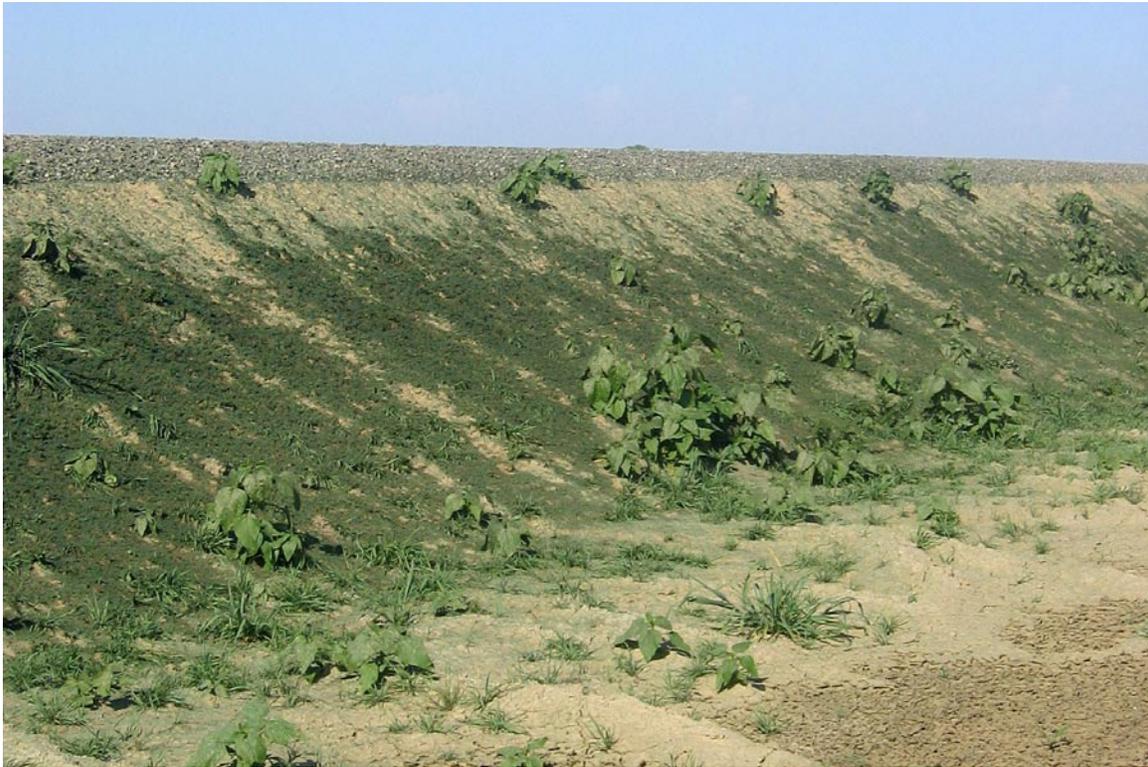
Southern embankment of access road running parallel to Gale Avenue. This slope has been seeded to promote vegetation growth and to prevent erosion. Approximately 4 to 6 inches of gravel was placed over the access road to prevent exposure to elevated asbestos levels in the dirt road. This gravel layer is visible in the photograph.

The existing O&M is inadequate. Routine inspections should be performed to determine if the gravel road or site fencing requires maintenance. Repairs should be made as necessary.

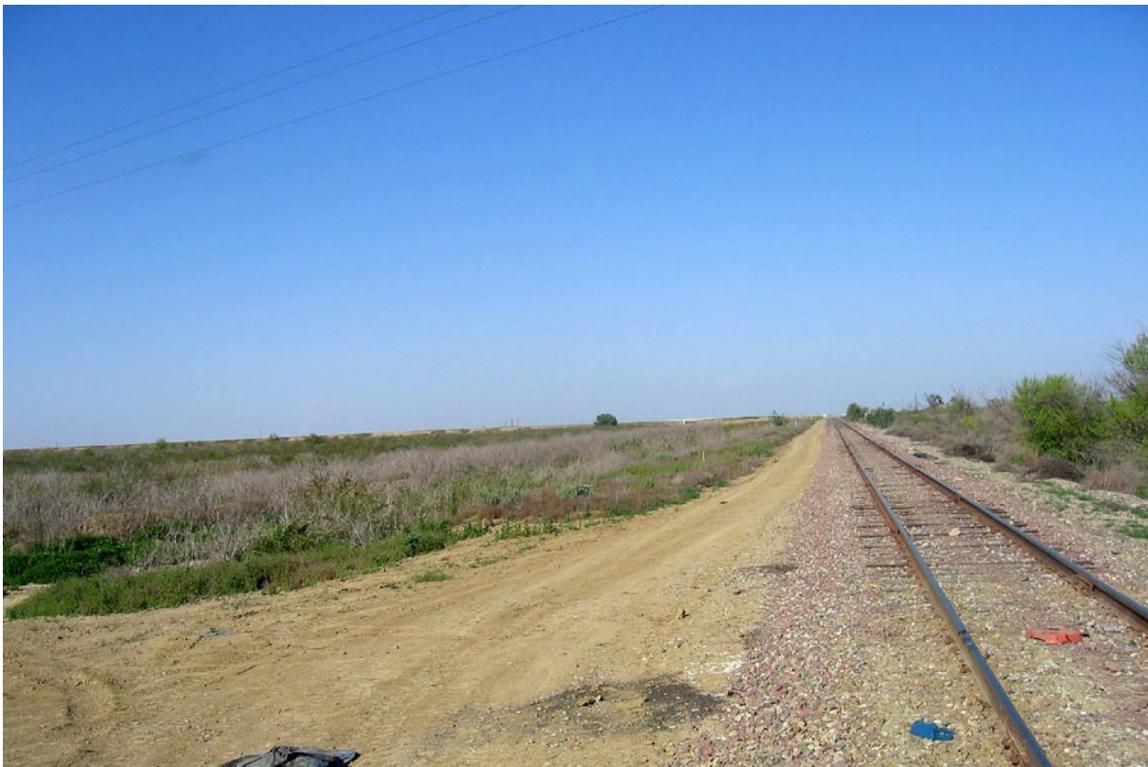
D. General			
1.	Vandalism/trespassing	Location shown on site map	No vandalism evident
Remarks: The presence of trash and tire tracks on the ground surface at the site suggests that trespassers access and use the site. According to Ghassan ALQaser/DWR, trespassers access the site by coming over flood control levees and generally come through the site to fish in the California Aqueduct. Mr. ALQaser indicated large volumes of trash generated by trespassers have been removed from the site.

Railroad tracks that run through the ponding basin and across the California Aqueduct. Tire tracks and garbage in this area of the site suggest that trespassers access this area.

Trespassers to the site may be exposed to asbestos. Additional security measures (i.e., fencing, locks, and signage) should be implemented to prevent trespassers from accessing the site. Institutional controls may be appropriate to prohibit sensitive uses of the site.

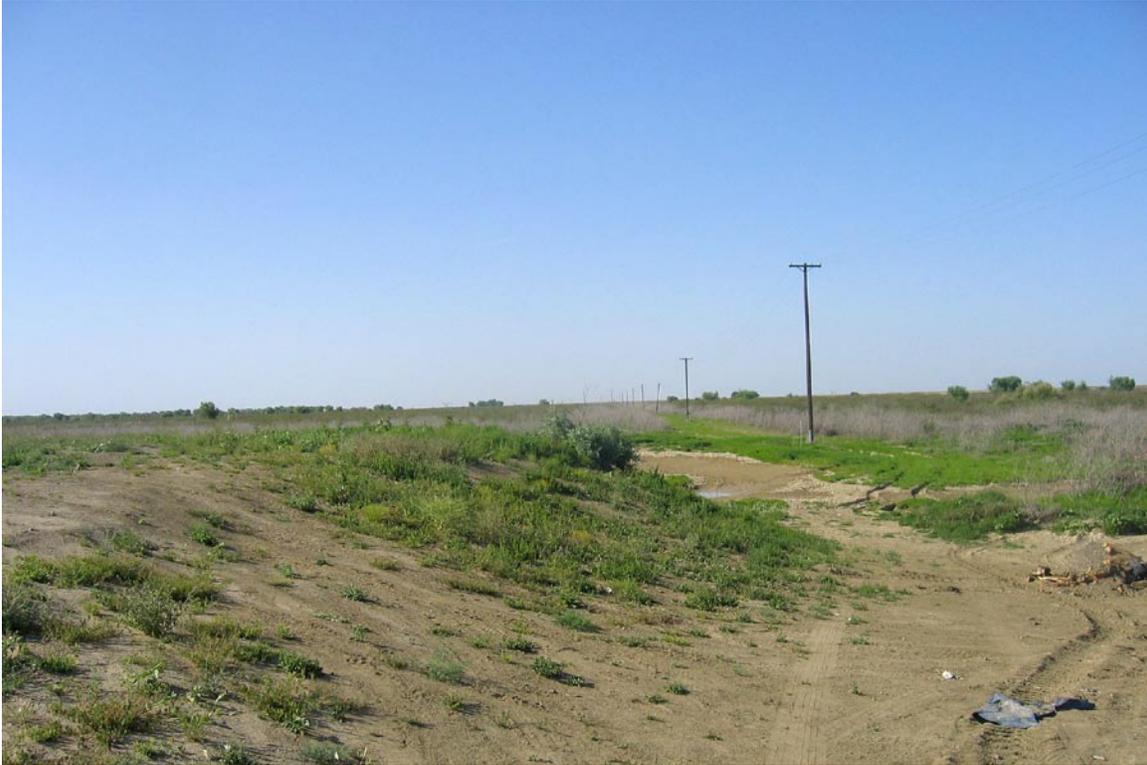
Presence of tire tracks on the dirt surface and garbage suggest that trespassers access this area.

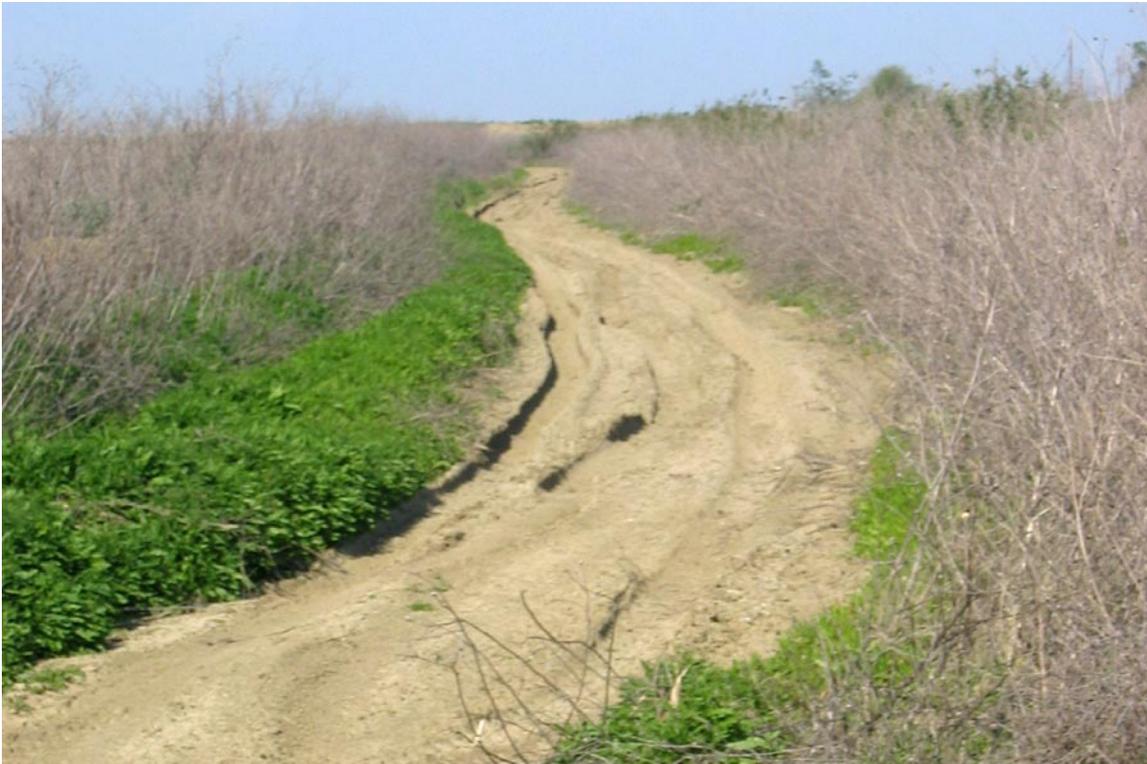
V. ACCESS AND INSTITUTIONAL CONTROLS <input checked="" type="checkbox"/> Applicable				
A. Fencing				
1.	Fencing	Location shown on site map	<input checked="" type="checkbox"/> Gates secured	N/A
Remarks: The site is only partially fenced. Locked gates on the access road along the aqueduct prevent access to the aqueduct. However, because the site is not completely fenced, trespassers continue to access the site and the aqueduct.

Trespass access route through ponding basin.
