Five-Year Review Site Inspection Checklist

TABLE C-1
 Site Inspection Team Roster
 Site Inspection – April 18, 2006
Second Five-Year Review Report for United Heckathorn, Richmond, California

**Five-Year Review Site Inspection Checklist
United Heckathorn Superfund Site**

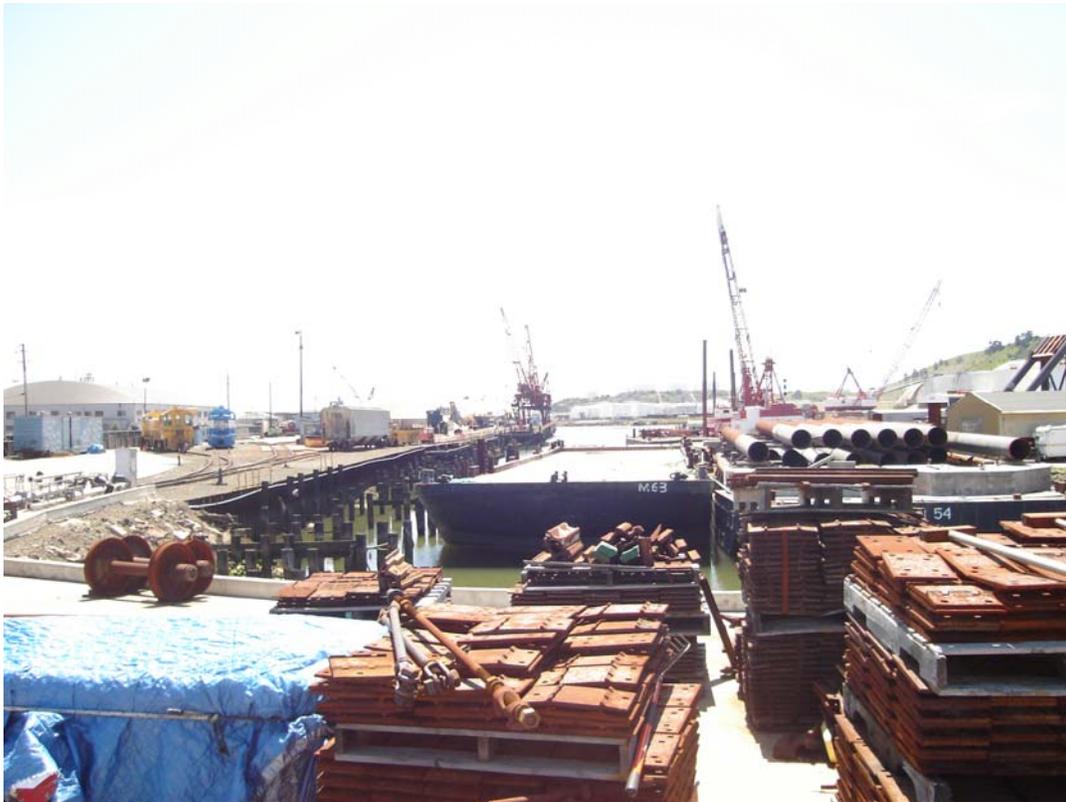
Description: Upland capping area of Levin Richmond Terminal along Lauritzen Channel
 Photographer: Sylvia Chan/CH2M HILL Date: April 18, 2006

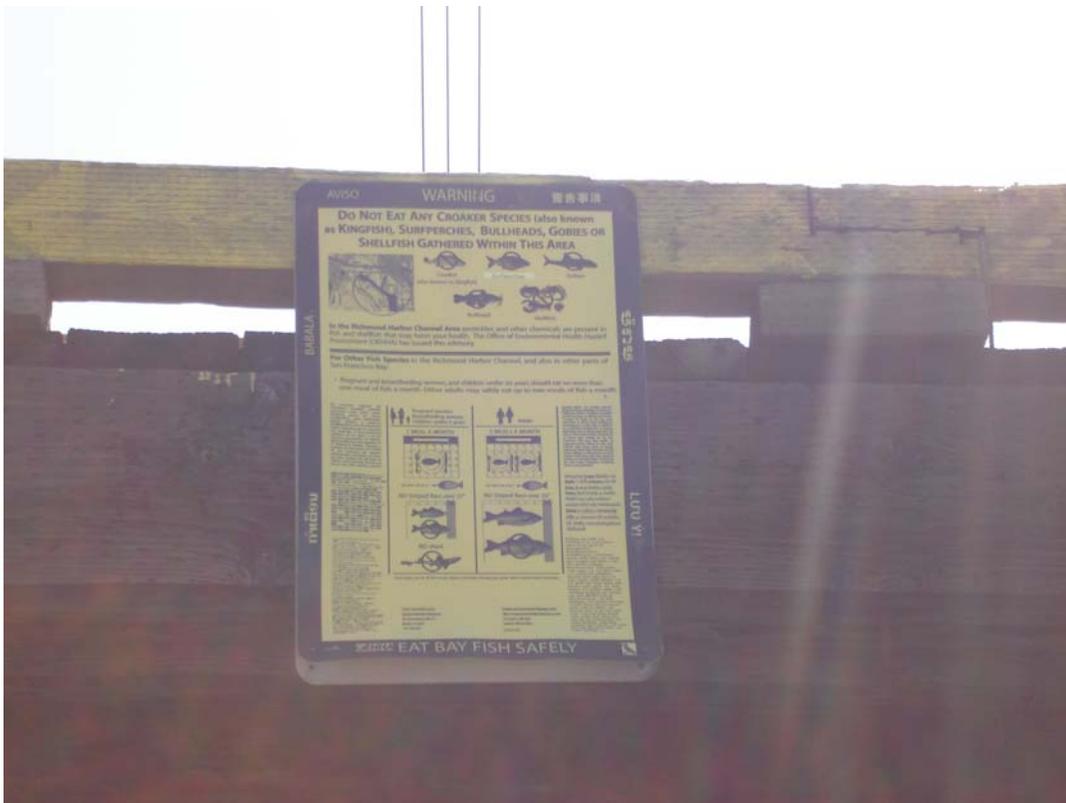
D. General		<input checked="" type="checkbox"/> Applicable	<input type="checkbox"/> N/A
1.	Vandalism/trespassing	<input type="checkbox"/> Location shown on site map	<input checked="" type="checkbox"/> No vandalism evident
Remarks: <u>“No Trespassing” and “No Fishing” signs are displayed at the site.</u>

Description: Advisory sign at Lauritzen Channel
 Photographer: Sylvia Chan/CH2M HILL Date: April 18, 2006

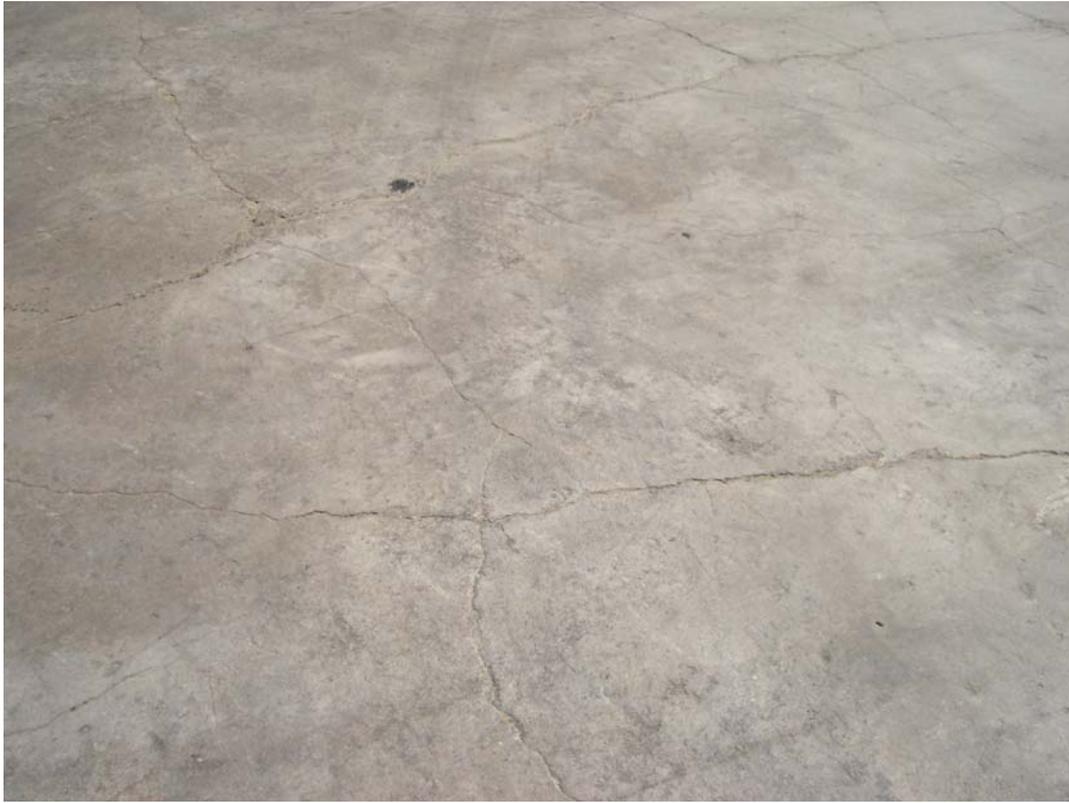
2.	Cracks <input type="checkbox"/> Location shown on site map Length _____ Widths _____ Depths _____ Remarks: <u>Minor surface cracks are observed on the cap. Although it is not a concern at the time of the inspection, attention should be paid to monitor any propagation of the crack; Any further deterioration of the cap would require repair as soon as possible.</u>	<input type="checkbox"/> Cracking not evident

Description: Surface cracks on upland cap
Photographer: Sylvia Chan/CH2M HILL

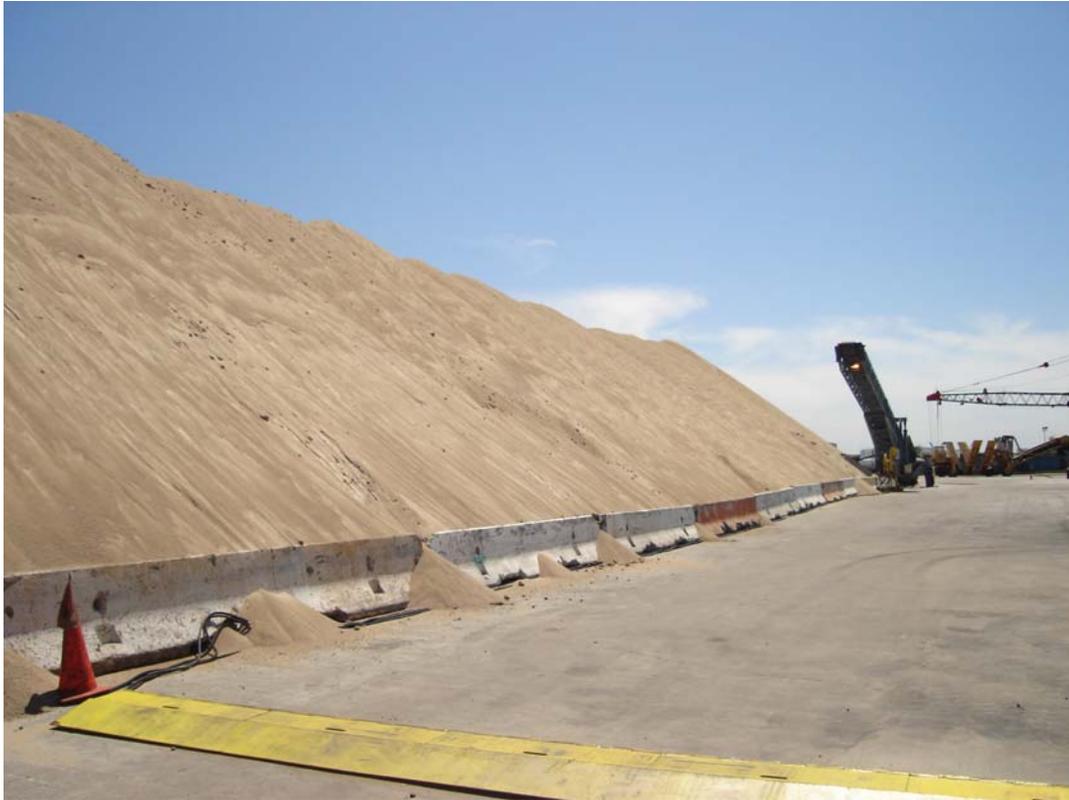
Although stockpiled material (mostly calcite, graphite coke) is surrounded by concrete k-rail barriers, some material is observed to be escaping at the gap in between barriers. Attention should be paid to avoid the possibility of material from migration/release into storm drains. Covering the stockpiled material with a plastic sheet may be considered if needed.

Description: Stockpiled material on upland cap
Photographer: Sylvia Chan/CH2M HILL

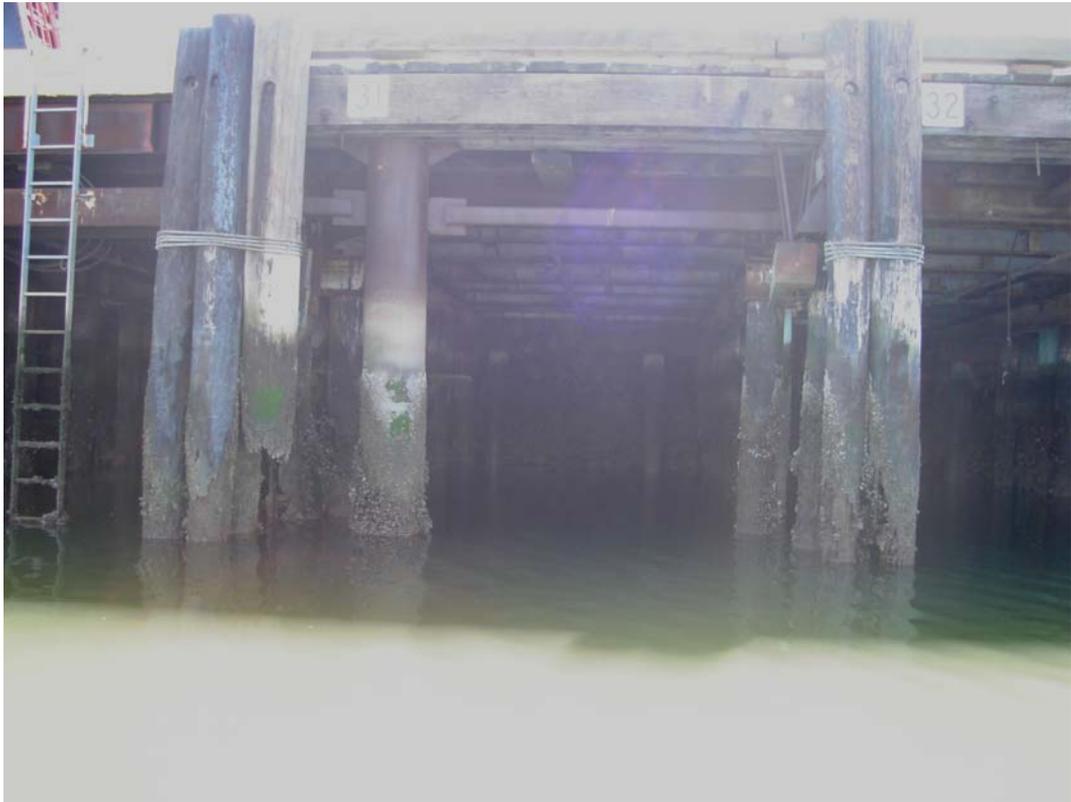
Description: Below the berth at Lauritzen Channel

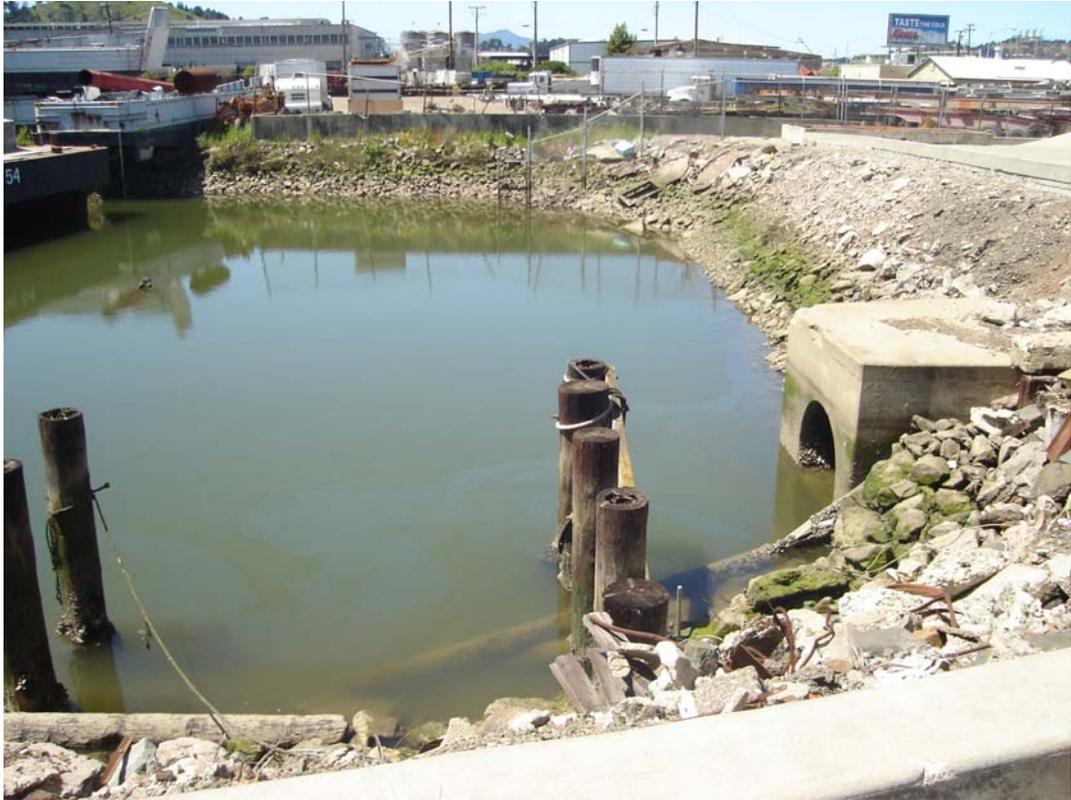
Description: City of Richmond stormwater outlet at northern end of Lauritzen Channel

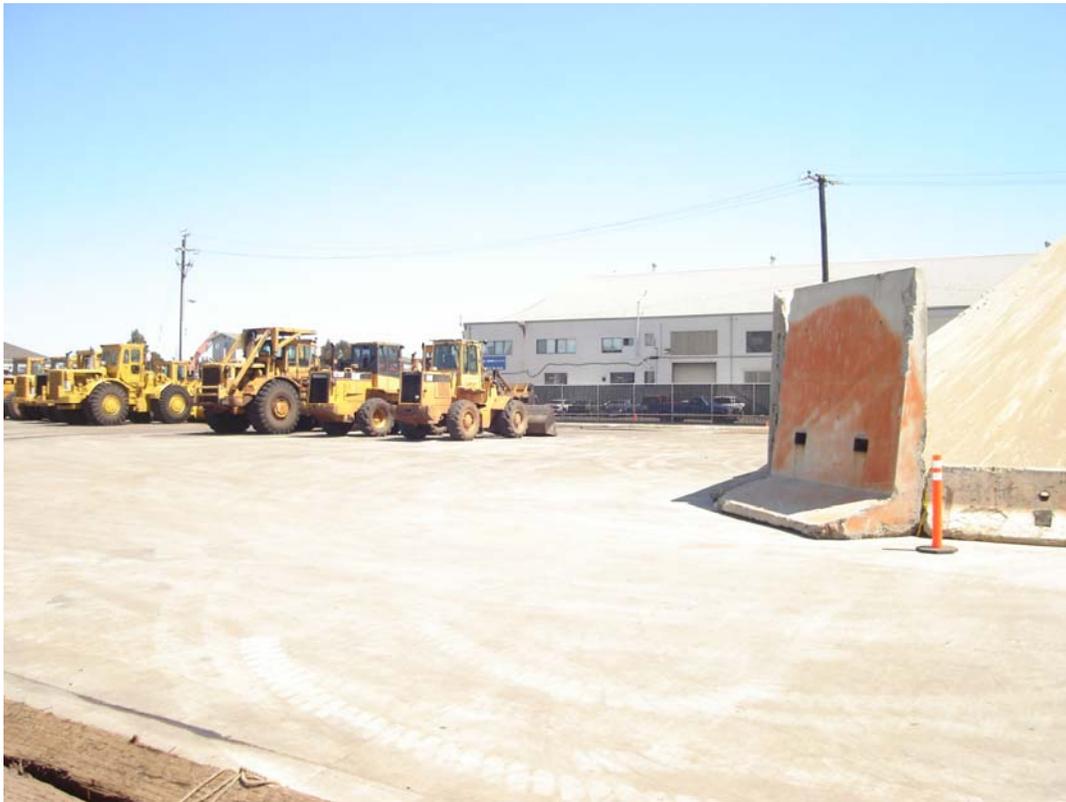
Remarks: Railroad tracks, crane rail, truck/train scale and fuel station are observed at the site for import/export of material through rail transport. Heavy construction equipment (such as tractors, front loaders, cranes, conveyors) are found onsite at the staging area.

Description: Equipment staging area on upland cap

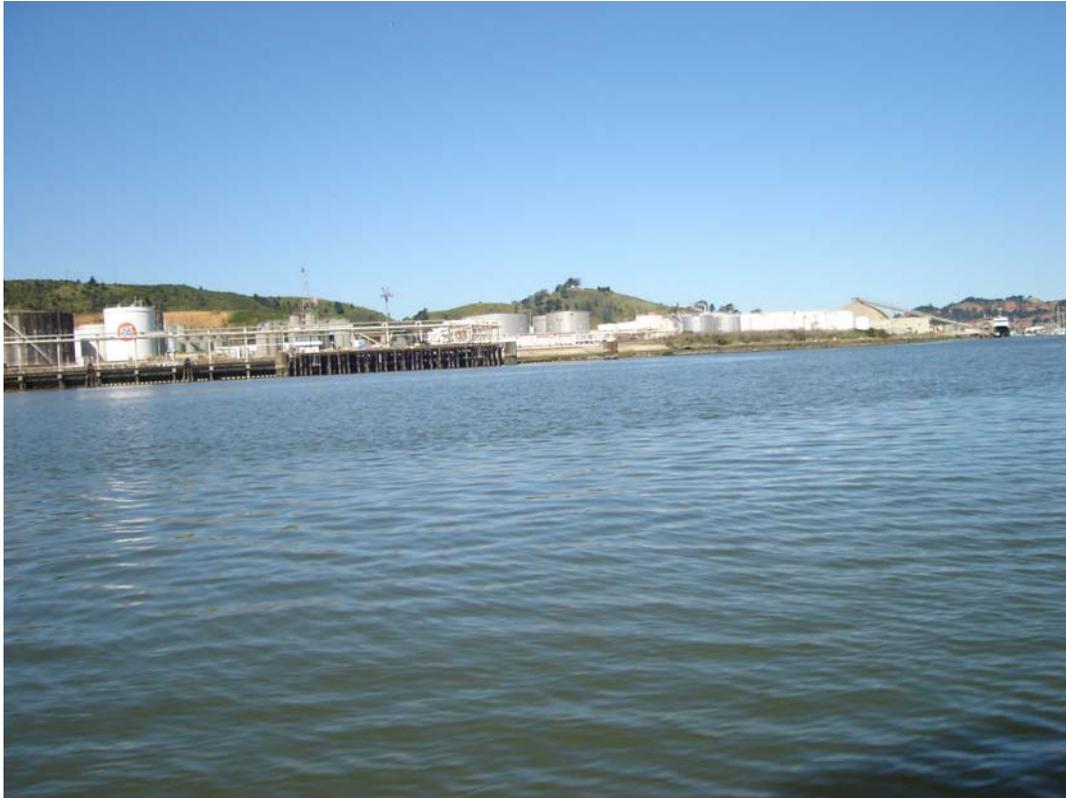
Description: Other industrial activities adjacent to United Heckathorn site

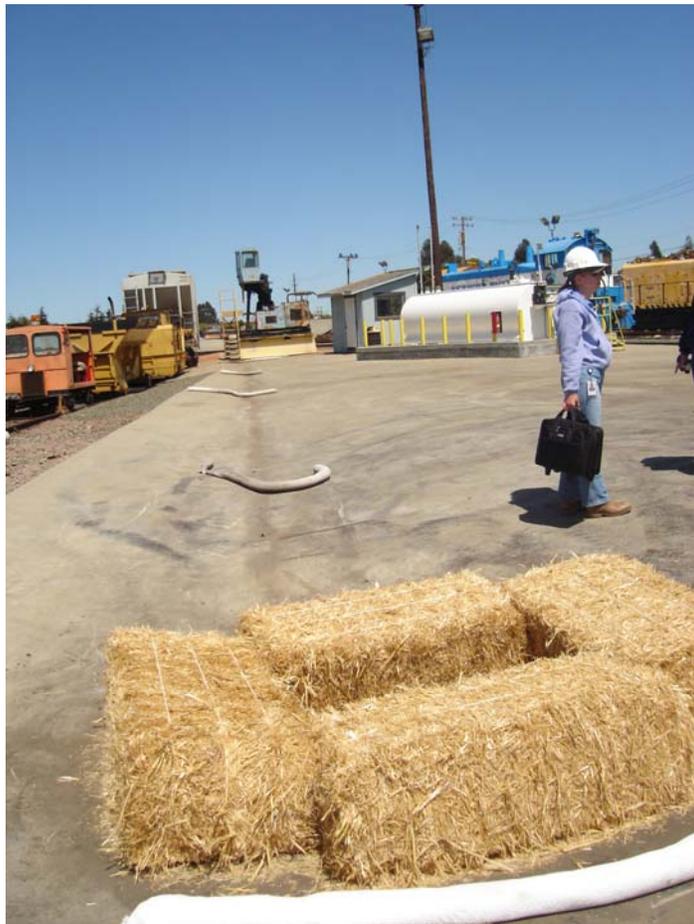
Description: Petroleum sorbent boom along swale at upland area
Photographer: Sylvia Chan/CH2M HILL Date: April 18, 2006

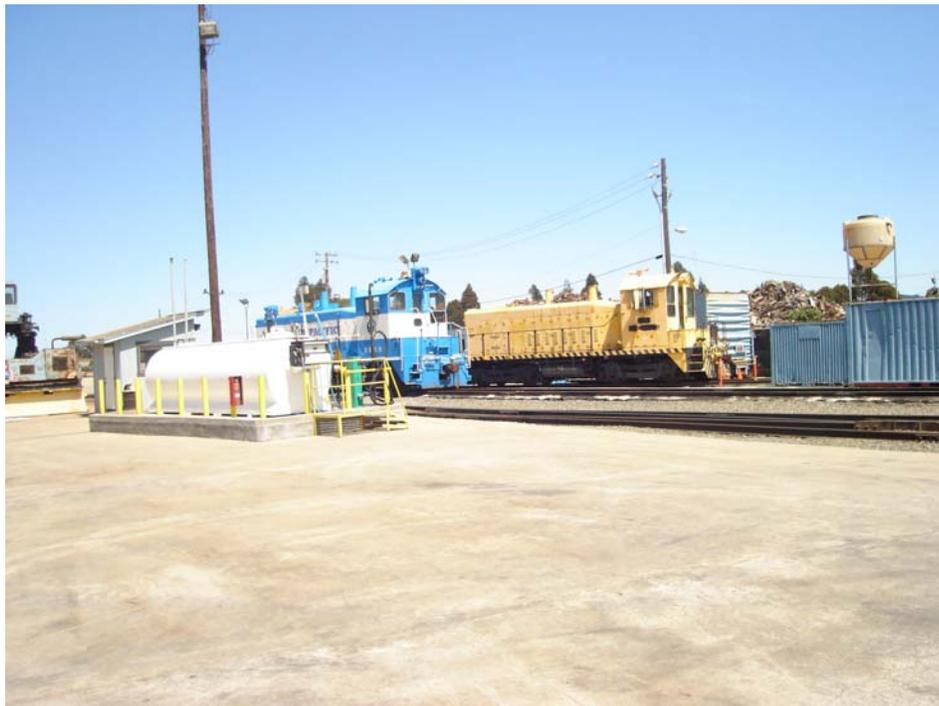
Description: Rail fuel station at upland area
Photographer: Sylvia Chan/CH2M HILL Date: April 18, 2006

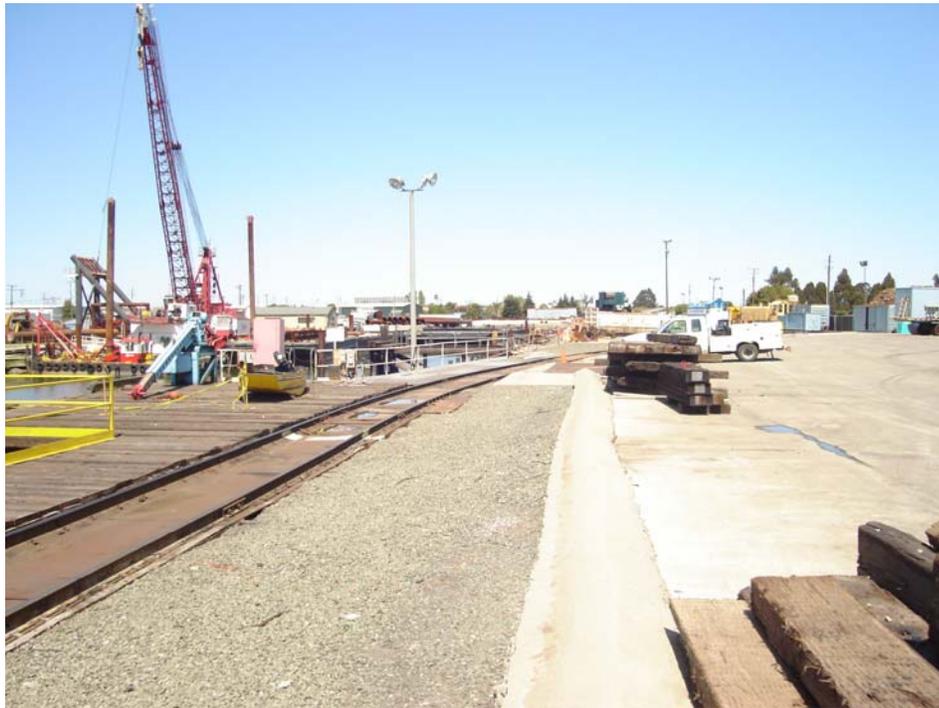
Description: Gravel cover and rail track in adjacent to Lauritzen Channel
Photographer: Sylvia Chan/CH2M HILL Date: April 18, 2006

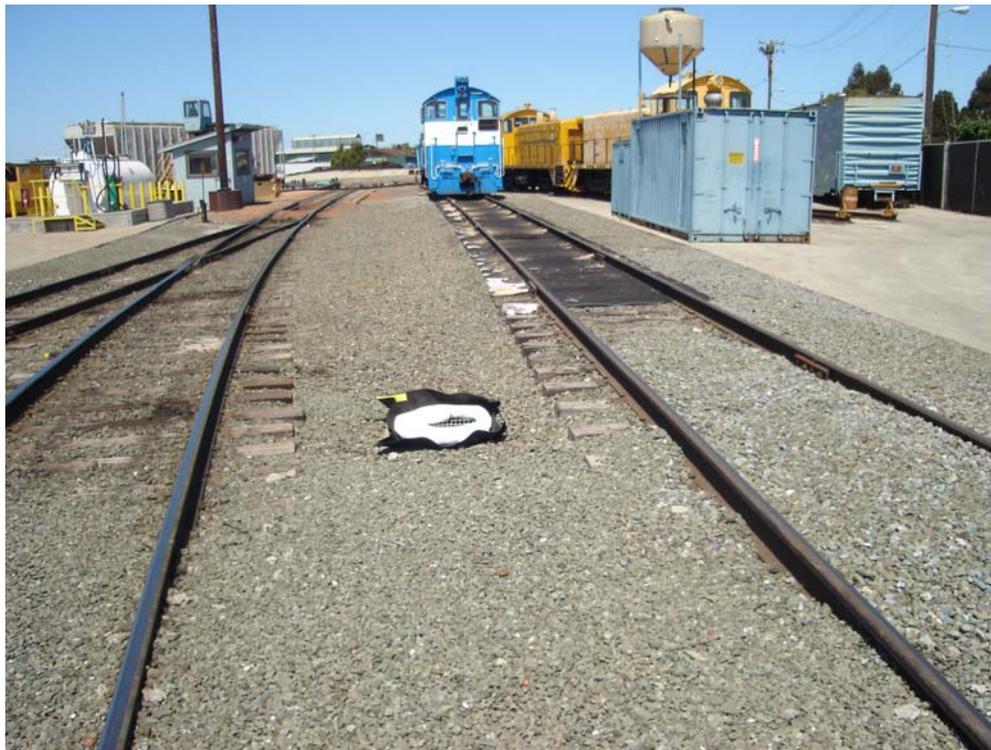
Description: Storm drain equipped with boom and drain guard
Photographer: Sylvia Chan/CH2M HILL Date: April 18, 2006

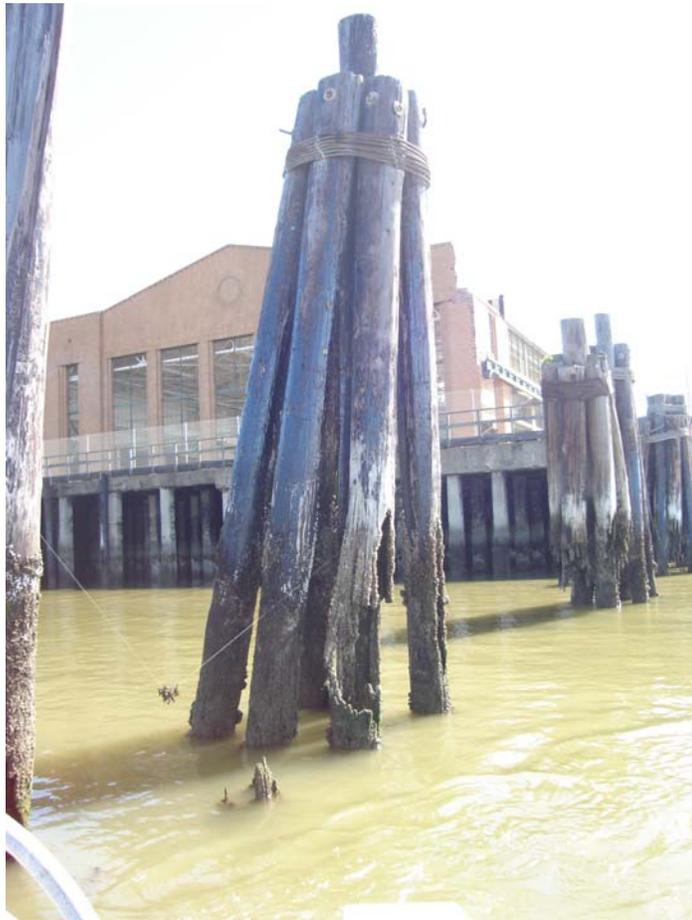
Description: Sampling Location for mussel monitoring

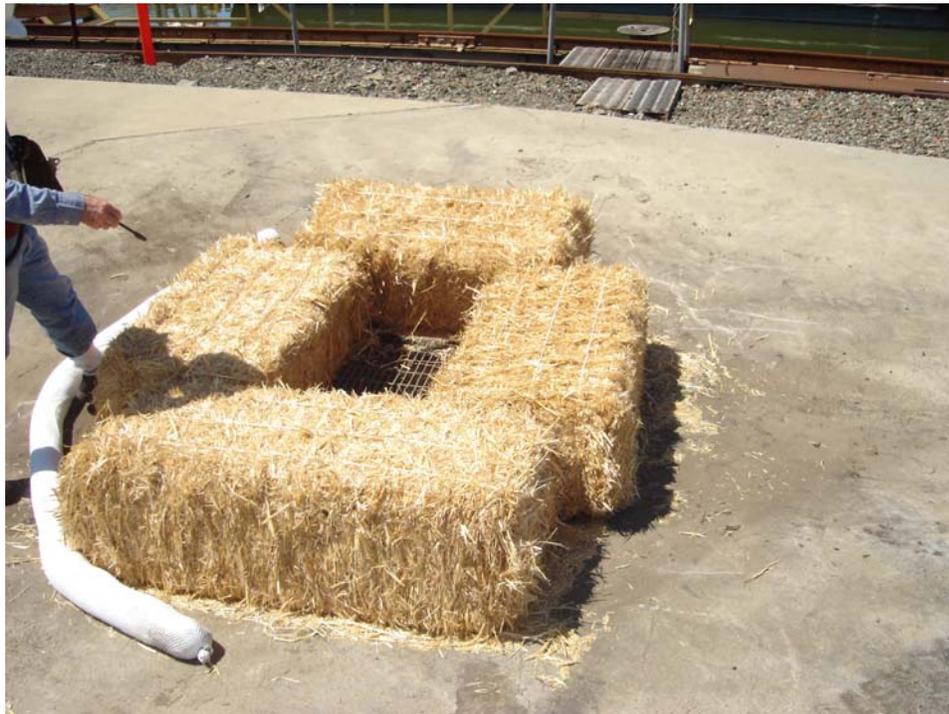
Description: Storm drain with bales and boom

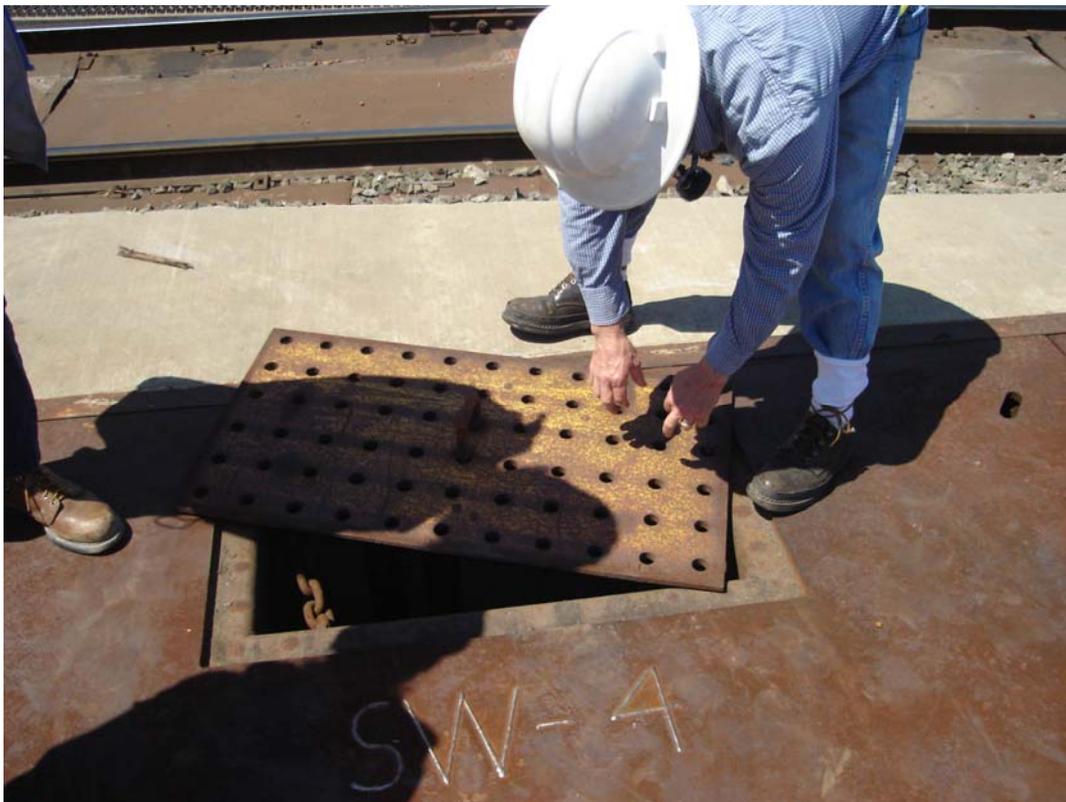
B. Surface Water Collection Structures, Pumps, and Pipelines		<input checked="" type="checkbox"/> Applicable	<input type="checkbox"/> N/A
1.	Collection Structures, Pumps, and Electrical <input checked="" type="checkbox"/> Good condition <input type="checkbox"/> Needs Maintenance Remarks: <u>Stormwater from the former United Heckathorn facility is directed into interceptors (SW-3 to SW-7), which is to be sampled, tested and discharged to the city POTW. Interceptors are cleaned once a year and are observed to be in good condition.</u>

Description: Stormwater Interceptor (SW-4) at upland area

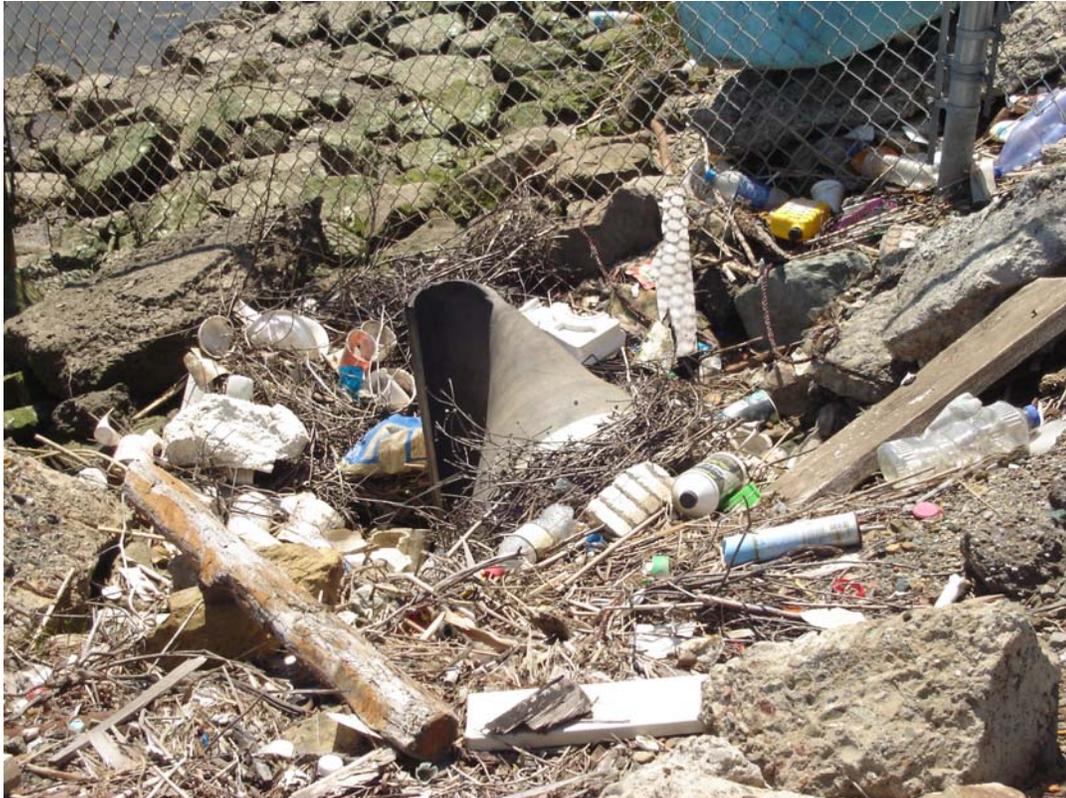
Description: 1-way tidal valve for outlet pipe at SW-7

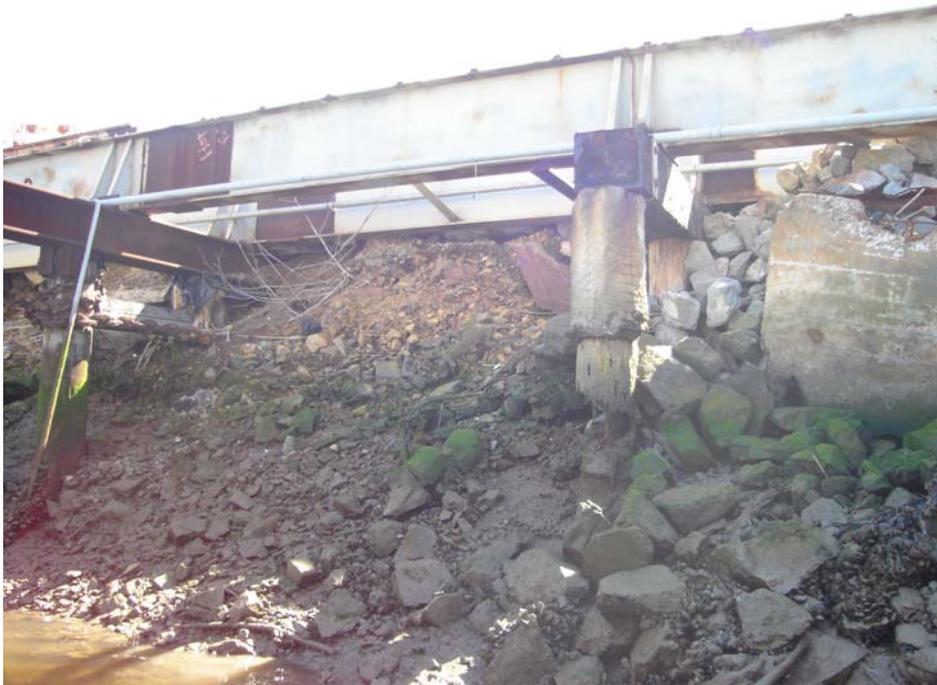
Description: Stormwater interceptor outfall and embankment soil along Lauritzen Channel
Photographer: Sylvia Chan/CH2M HILL Date: April 18, 2006

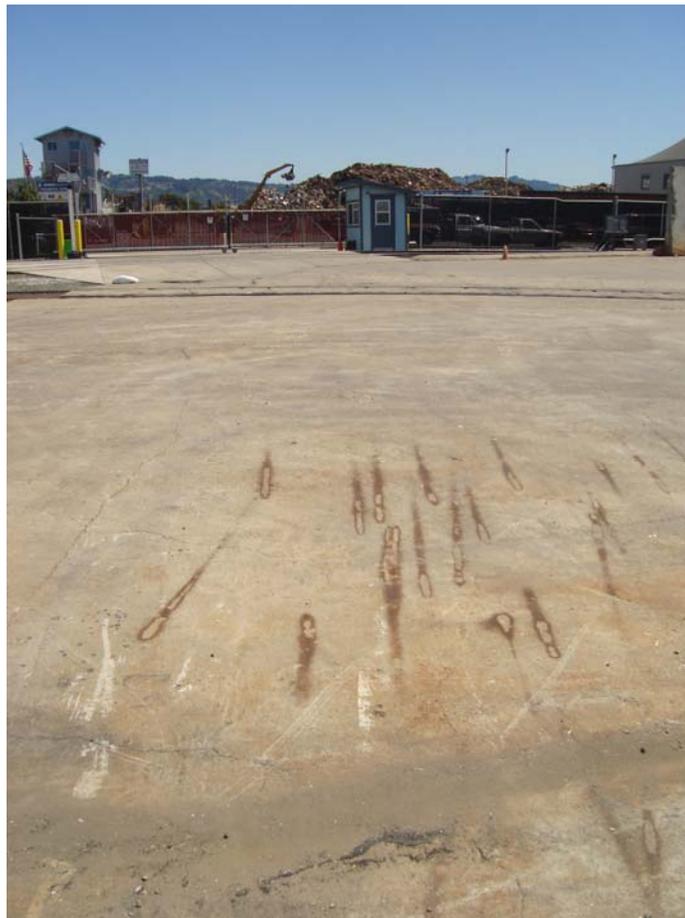
1.	Fencing	<input type="checkbox"/> Location shown on site map	<input checked="" type="checkbox"/> Gates secured <input type="checkbox"/> N/A
<p>Remarks: <u>Fences are in-place at the perimeter of the site. Gates are secured. Security guards are on-site 24 hours a day. Based on personal communication with onsite personnel, there is no issue with illegal access to the site.</u></p>

Description: Upland area with perimeter fence
Photographer: Sylvia Chan/CH2M HILL Date: April 18, 2006

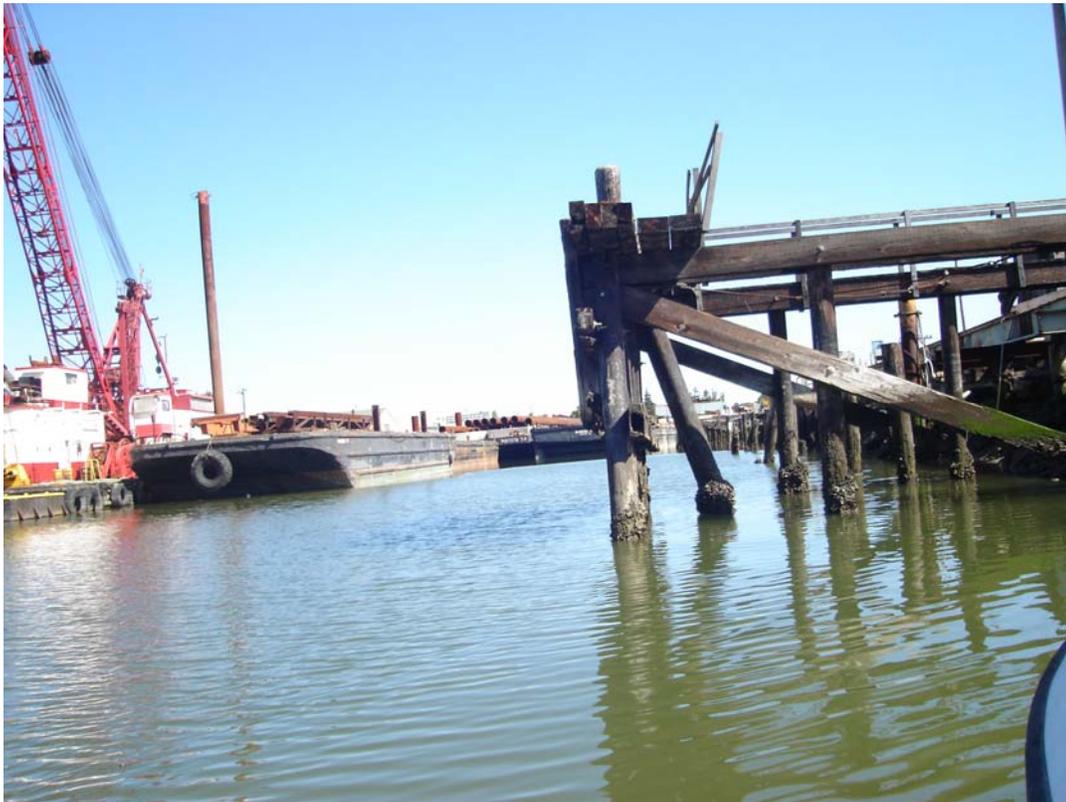
Description: Wooden piles and berth along Lauritzen Channel
