**Appendix A**  
**Site Photographs**

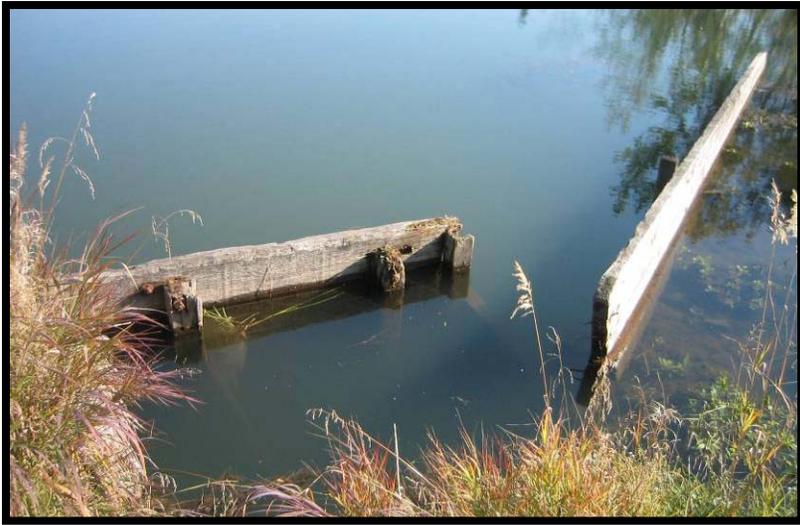
Photo 1: Wooden crib remains in pond south of Whitney Rd.

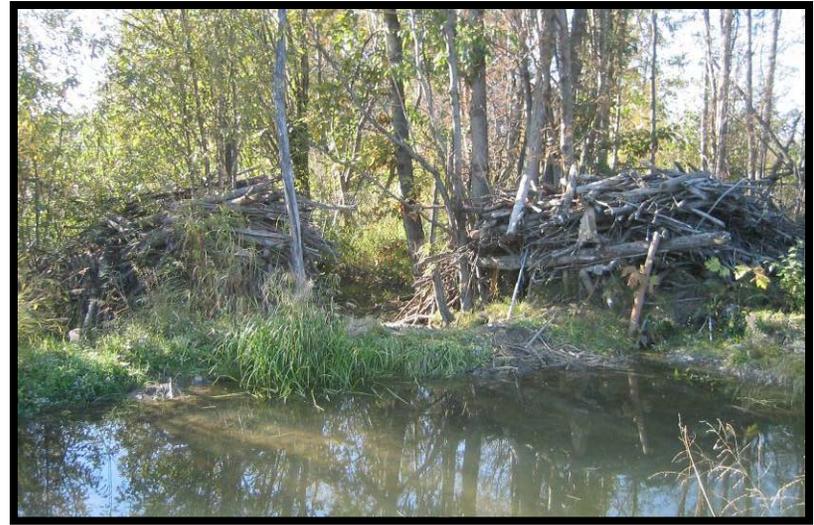
Photo 2: Abandoned and breached beaver lodge at old outlet of pond area

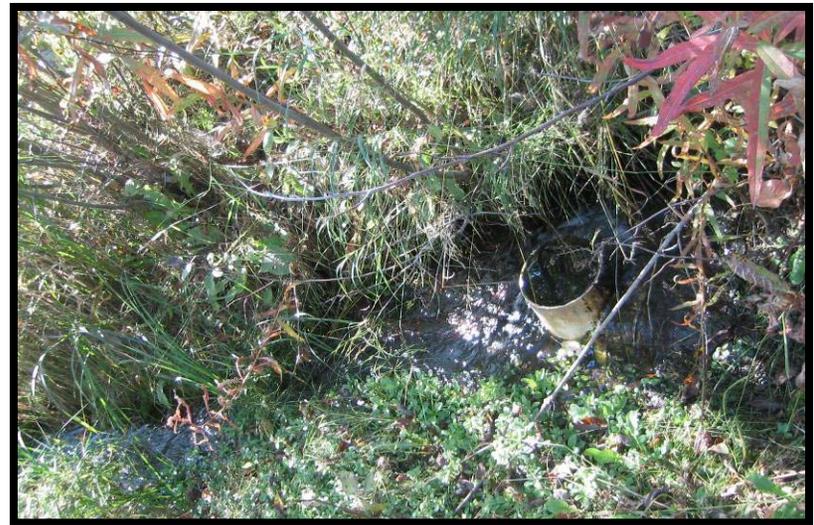
Photo 4: Outfall structure for pond drainage near Ship Creek channel

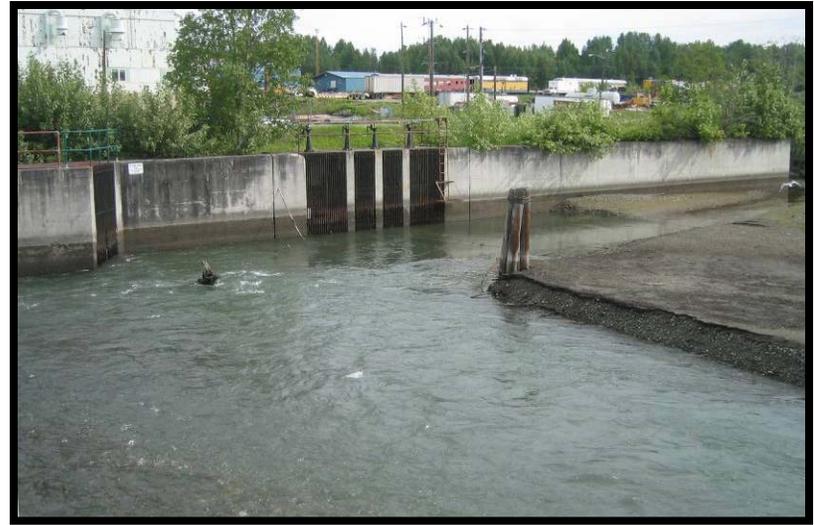
Photo 6: Weir to KAPP pond seen from Ship Creek dam. A backwater area can be seen along upper right.

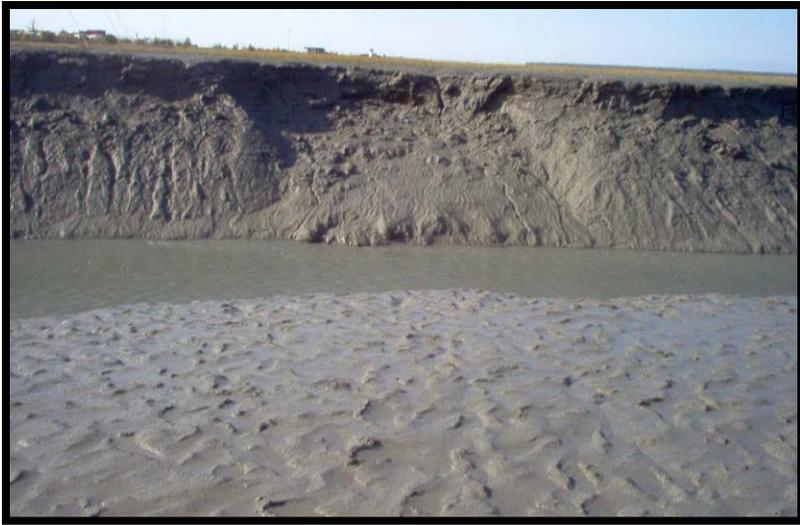
Photo 9: Ship Creek channel through mudflats. Note deep downcut.

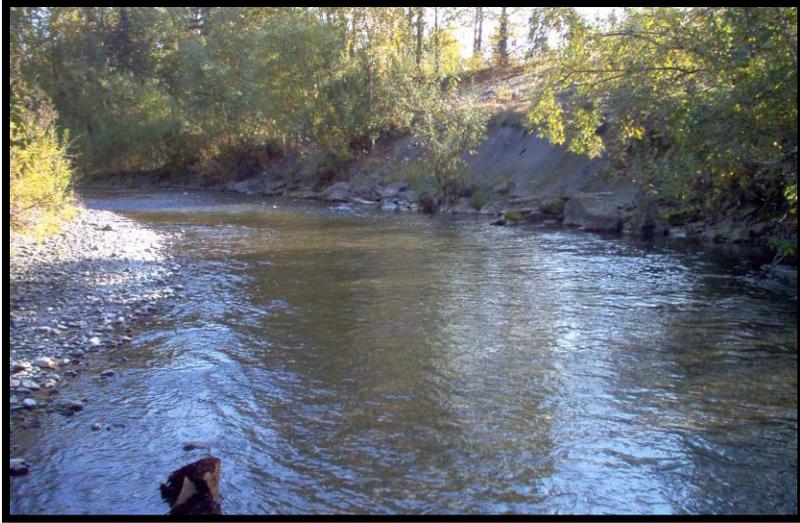
Photo 13: Reach U, Geotextile protected south bank

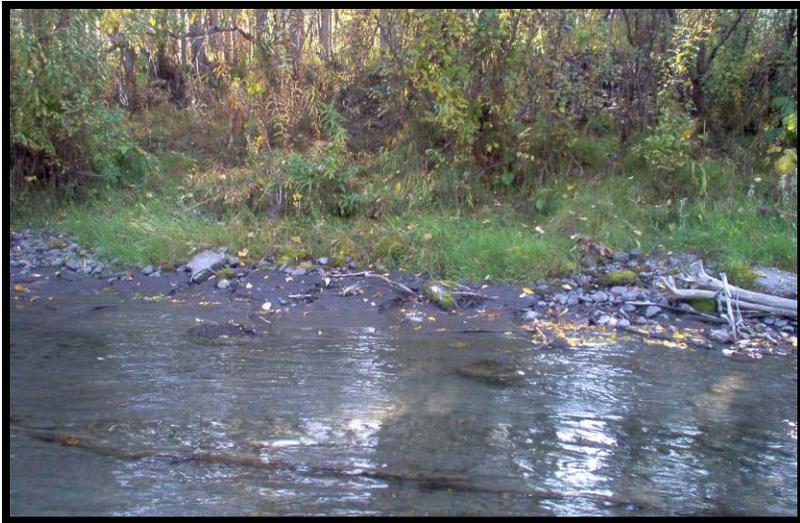
Photo 15: Reach U, where seepages from the golf course enter Ship Creek, including snags and woody debris.

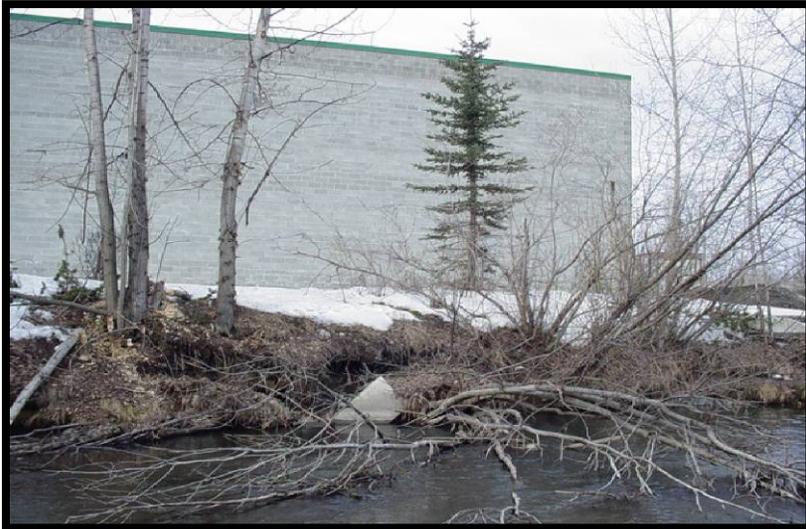
Photo 17: Reach 1, undercut banks and woody debris and snags

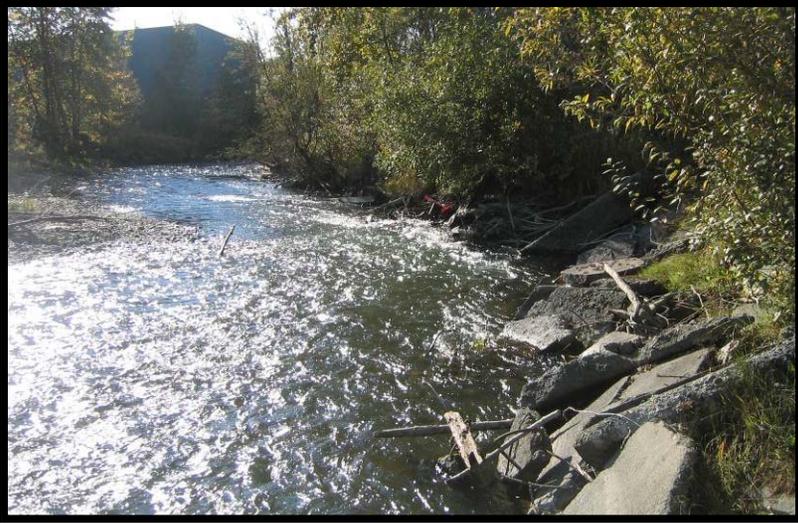
Photo 21: Reach 3, debris reinforced banks. Concrete, rebar, and pieces of railcars can be found.

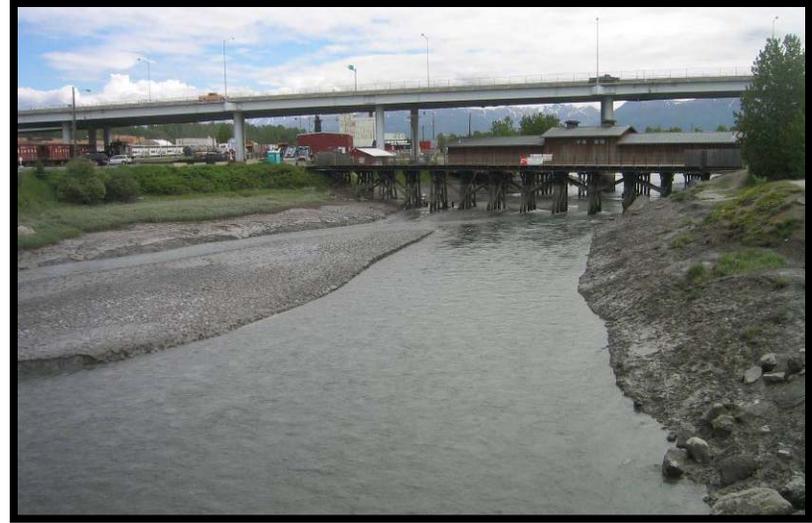
Photo 22 : Reach 4: channel below KAPP dam (looking upstream). Note gravel bars and scoured channel conditions.

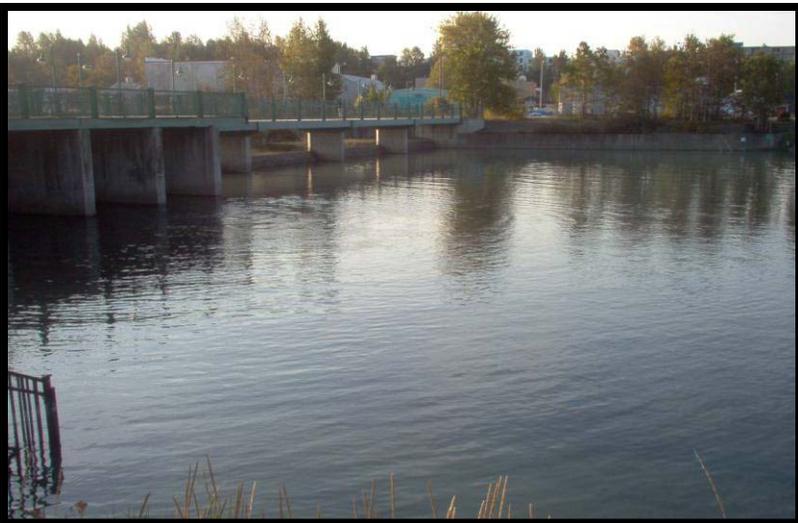
Photo 23: Reach 4, spring tide conditions at KAPP dam. High tide is less than one foot from lip of spillway.

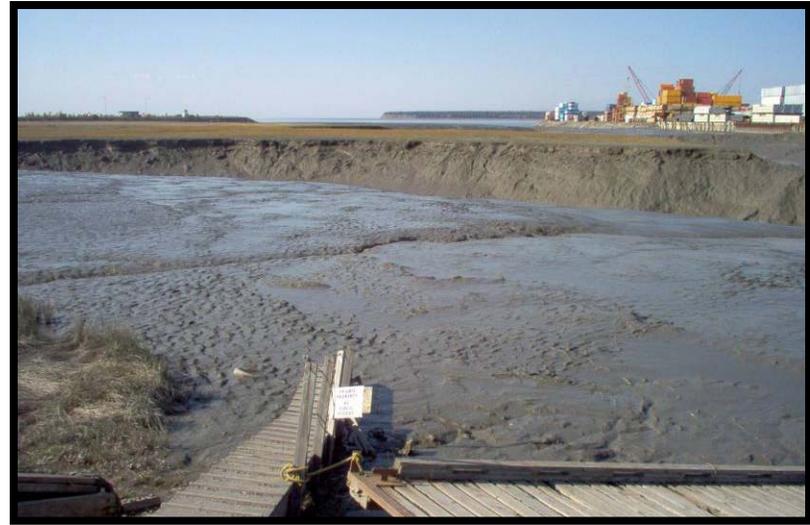
Photo 26: Reach 4: Deeply downcut channel through mudflats at low tide.

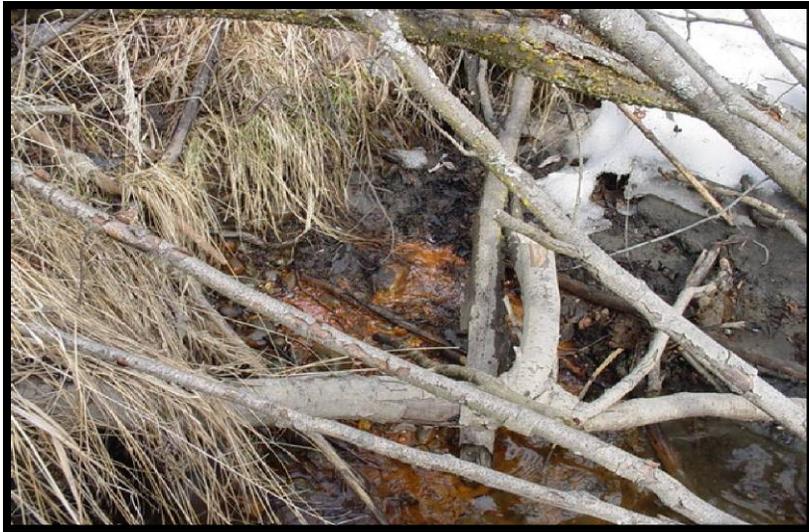
Photo 41: Reach 1: Iron-stained seepages to Ship Creek through gravel/cobble berm separating marsh from the creek.

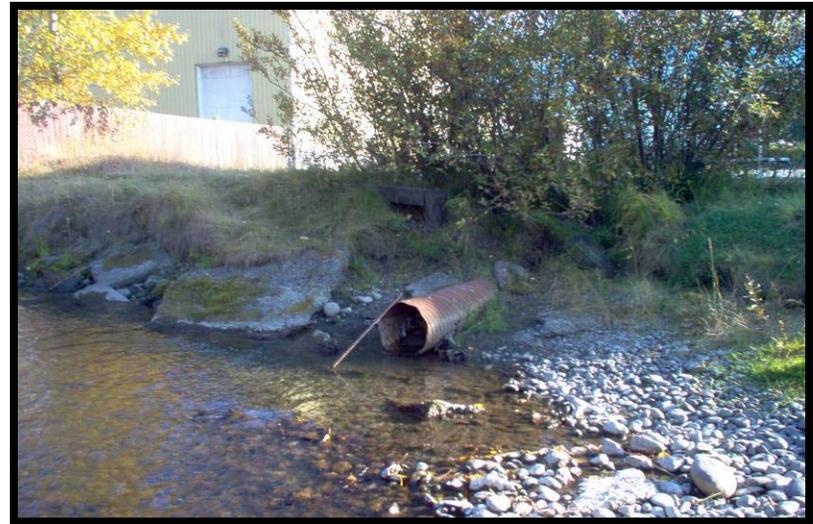
Photo 43: Reach 3, MOA 826 outfall (south side). Strong hydrocarbon odor present.

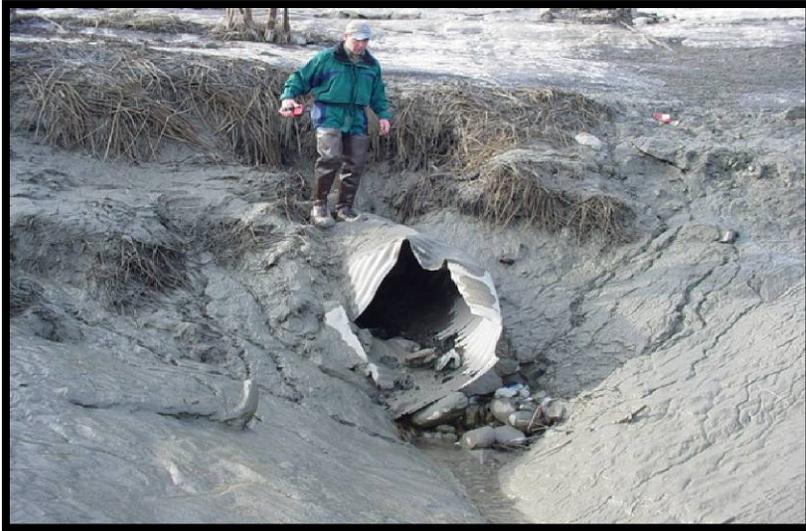
Photo 53: Reach 4: MOA 808 outfall, partially crushed by ice flows

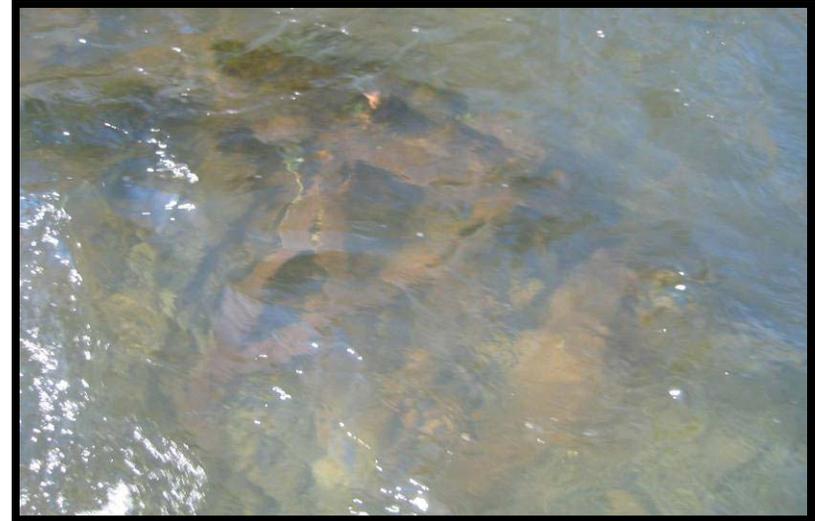
Photo 64: Reach 3, remains of railroad couplings in creek north bank adjacent to location in Photo 63

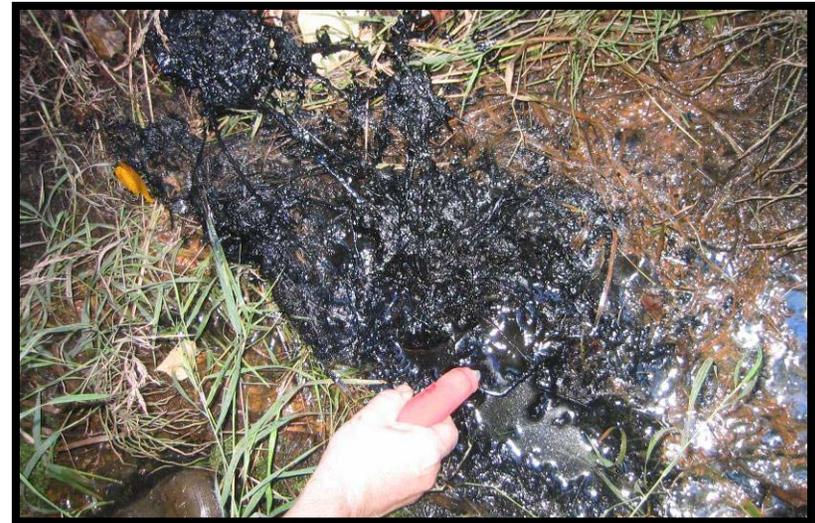
Photo 68: Reach 1, black sludgy material in ditch just below berm behind Commercial Truck Services. Strong hydrocarbon odor, although little sheening.

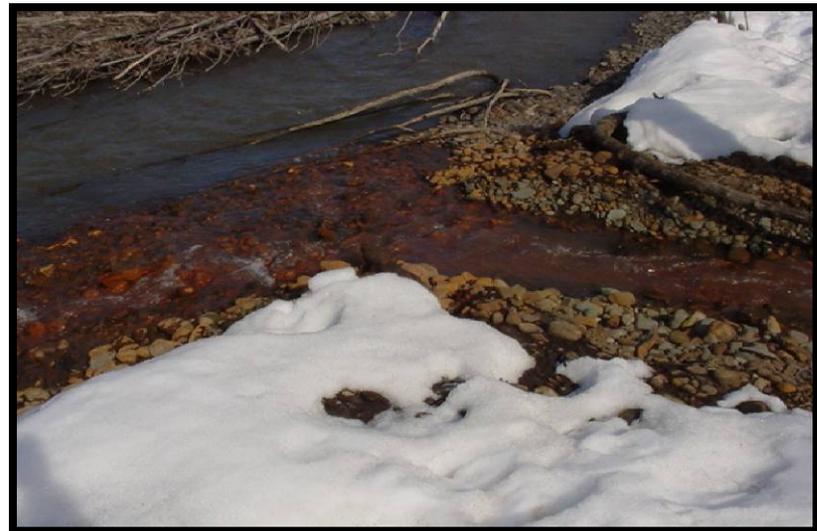
Photo 70: Outlet of ditch from MOA 826 outfall

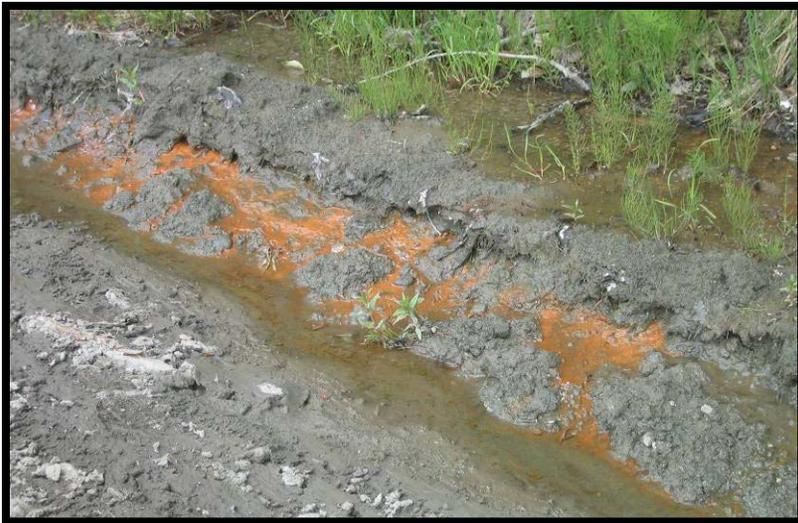
Photo 83: North Bluffs: typical seepage along roadway with iron-related stained soils.

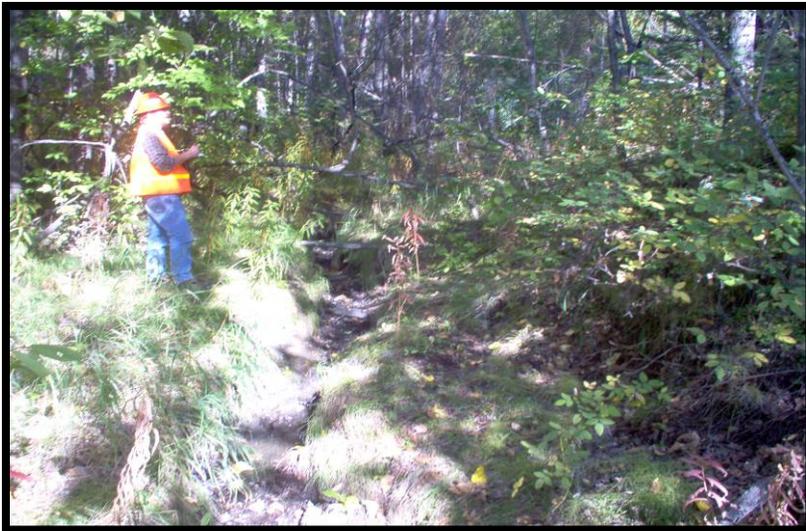
Photo 91: North Bluffs: ditch carrying meltwater and runoff from top of bluff. Boggy area towards the left (west). Abundant debris and garbage was noted in the ditch
