**Five-Year Review for
Naval Reactors Facility
Operable Unit 8-05/06 Inactive Landfill Areas
and
Operable Unit 8-08 Remedial Action Sites**

December 2006

Prepared for the
U. S. Department of Energy
Pittsburgh Naval Reactors Office
Idaho Branch Office
P. O. Box 2469
Idaho Falls, Idaho 83403-2469

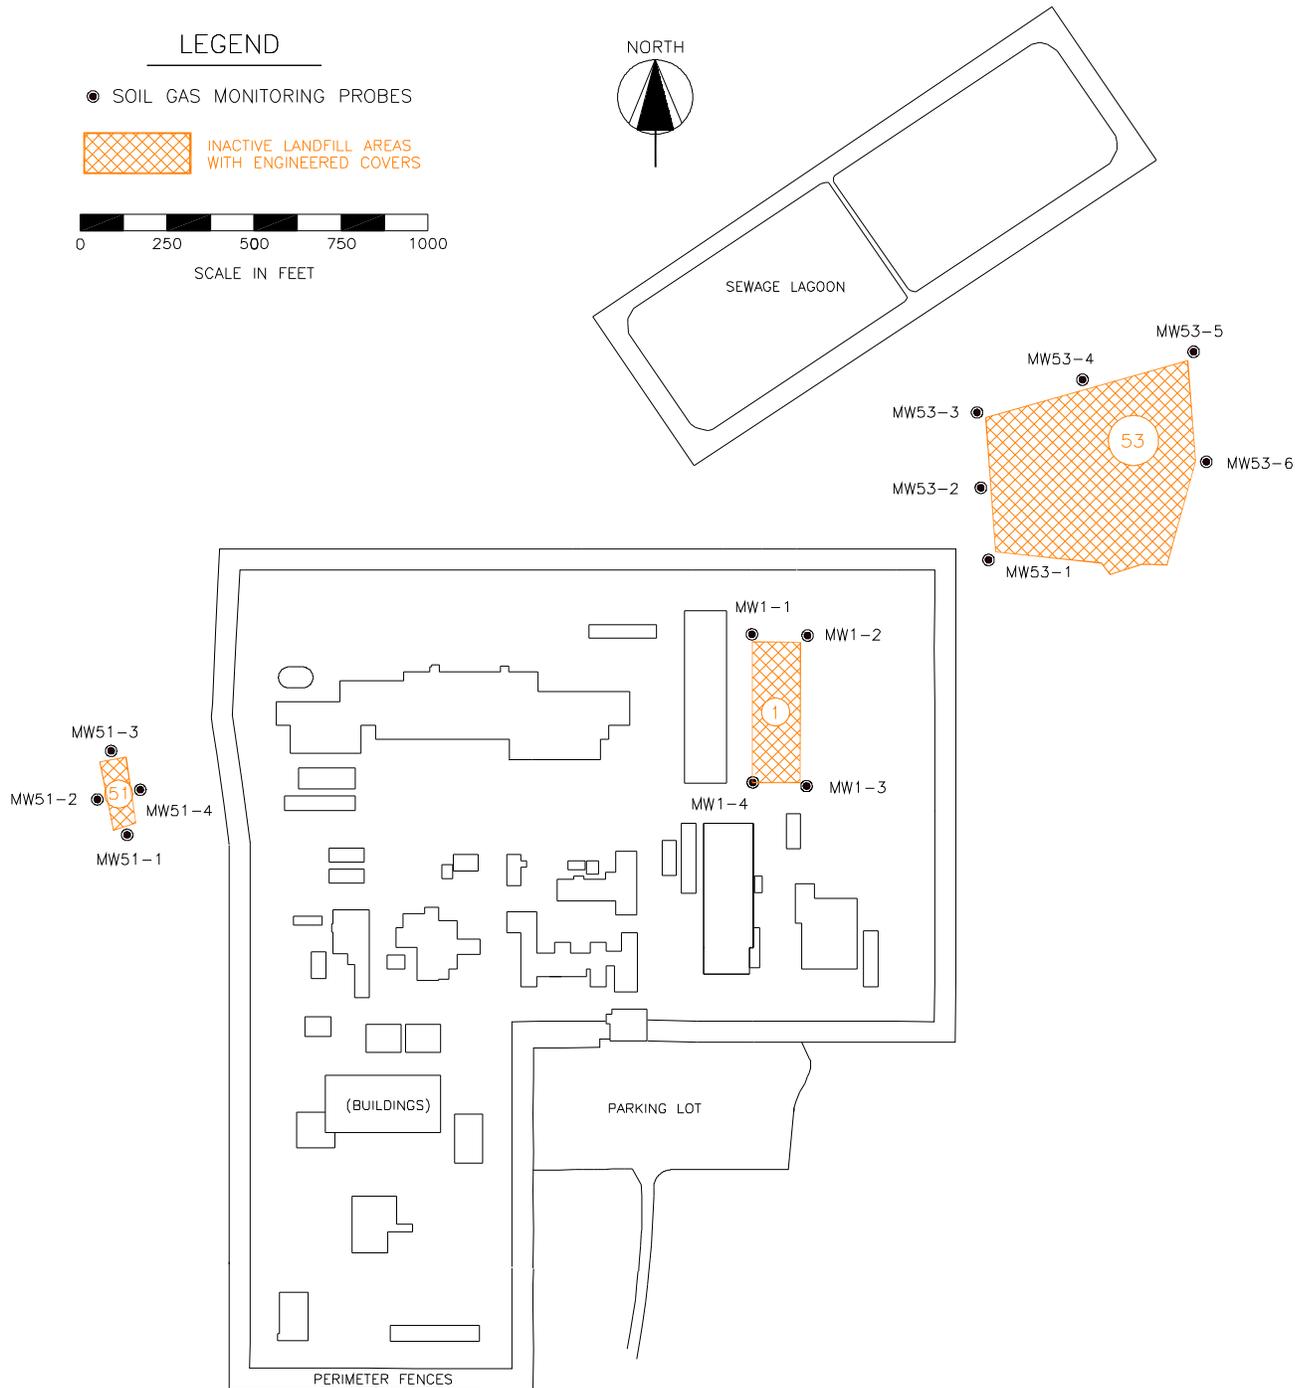
Figure 1-1 Location of NRF OU 8-05/6 Inactive Landfill Areas

In addition, during the operational period of these landfills, major construction activities were carried out. These activities included the construction of two prototype plants and other support buildings (i.e., training facilities, storage buildings, etc.). These construction activities would have contributed a considerable amount of construction debris to these landfills, therefore decreasing the estimated hazard (i.e., reduced percentage of chemicals). Figure 1-1 shows the location of the landfills.

Soil gas monitoring was part of the remedy selected for the Landfill Areas. To assess the effectiveness of the three landfill covers in limiting water infiltration and soil gas emissions, soil gas monitoring (utilizing a soil gas emissions survey) was implemented at the cover and probe locations shown in Figure 1-1.

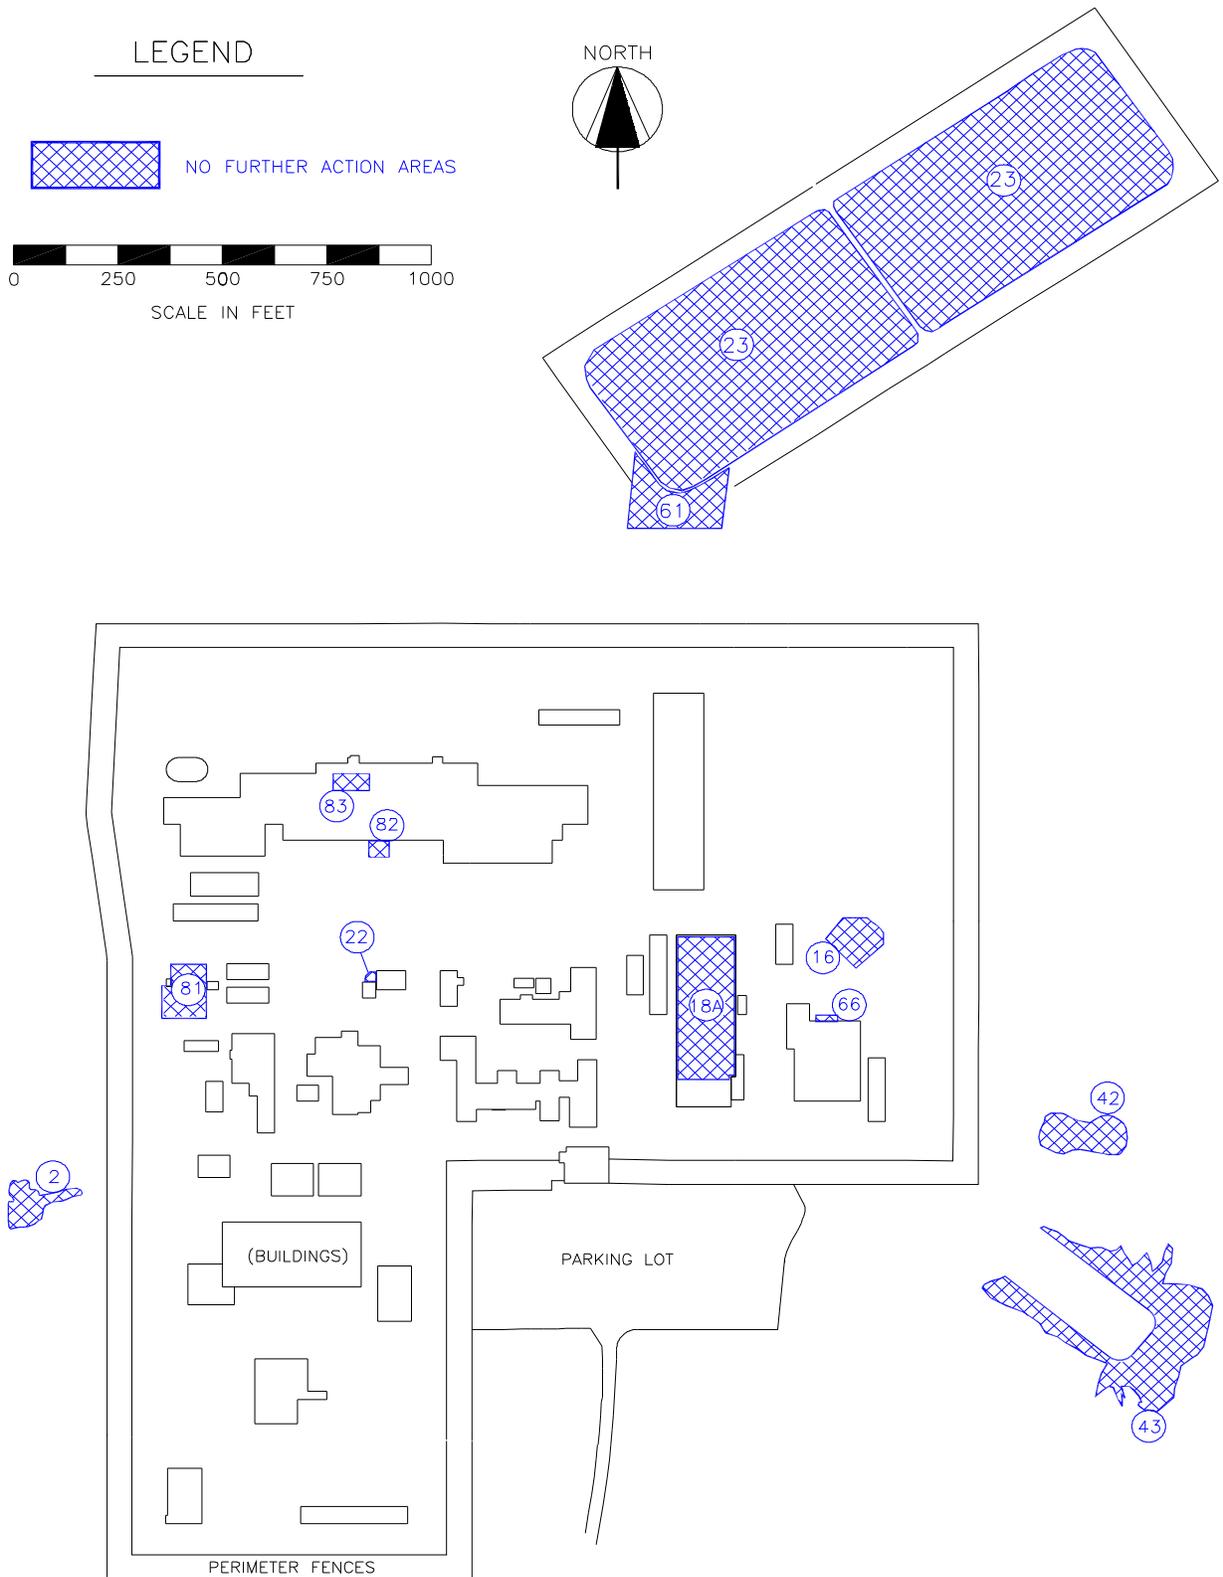
Figure 1-2 Location of OU 8-08 No Further Action Sites

The NFA designation was created by the FFA/CO signatory agencies for those sites with a source or potential source present, but for which an exposure route was not available. The following sections discuss each of the NFA Sites. Figure 1-2 shows the location of the NFA Sites.

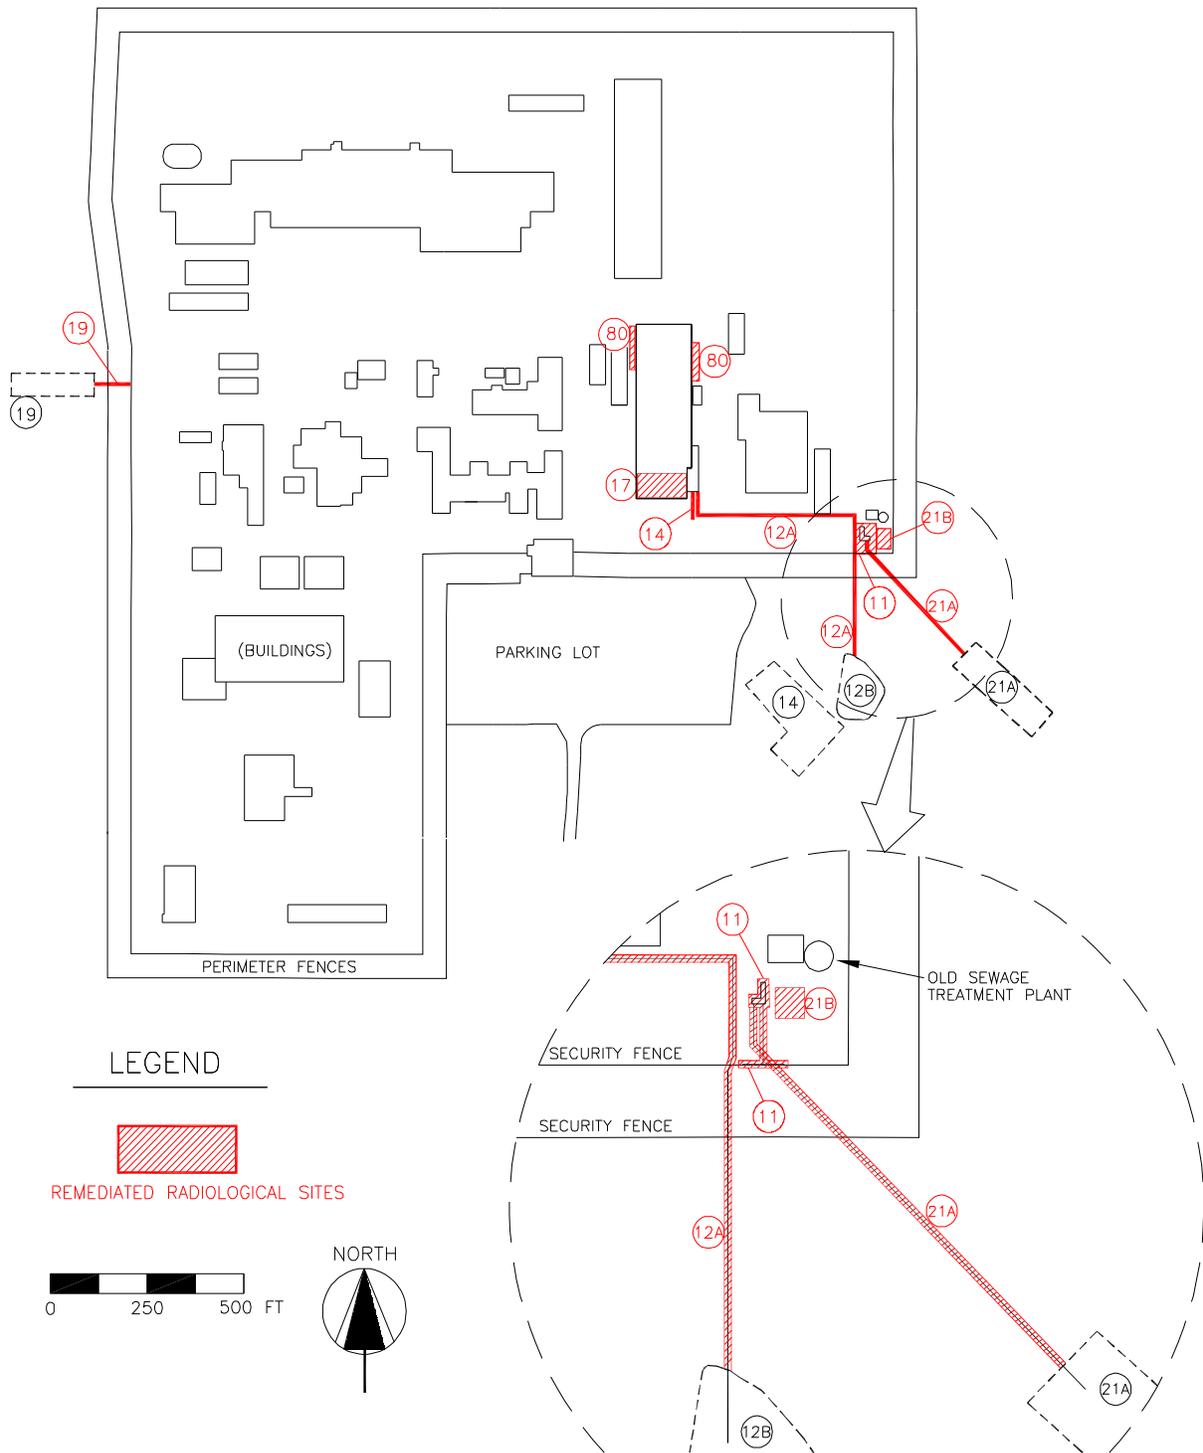
Figure 1-3 Location of OU 8-08 Remediated Radiological Sites

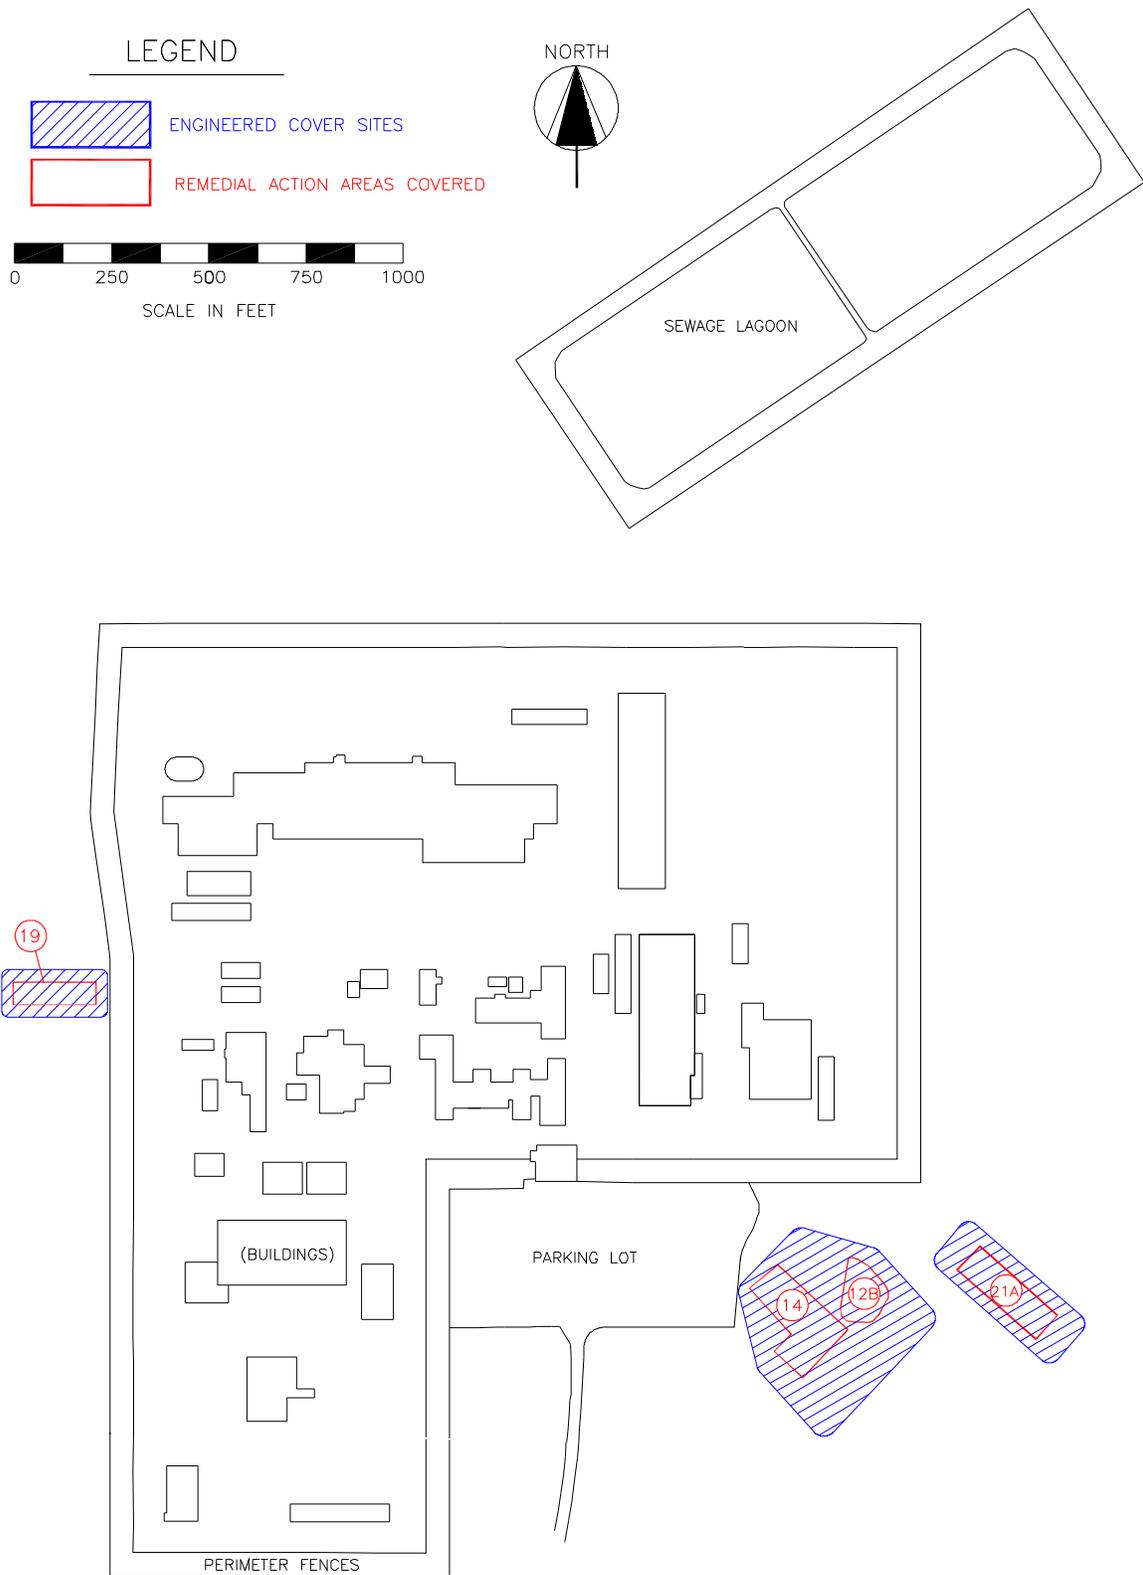
Figure 1-4 Location of OU 8-08 Engineered Covers

Nine sites were determined in the NRF Comprehensive RI/FS (WEC, 1997b) to have unacceptable or potentially unacceptable risks that must be addressed. The primary radionuclides of concern were cesium-137 and strontium-90, both of which have a 30-year half-life. During remedial activities, contaminated soil was removed from eight sites (three of which were associated with sites that were later capped) and consolidated in the S1W Leaching Beds area. These eight sites are referred to as Remediated Radiological Sites. Figure 1-3 shows the location of the Remediated Radiological Sites. Four sites are topped with three engineered covers (two sites are under one cover). These sites are referred to as OU 8-08 Engineered Cover Sites. Figure 1-4 shows the location of the Engineered Cover Sites.

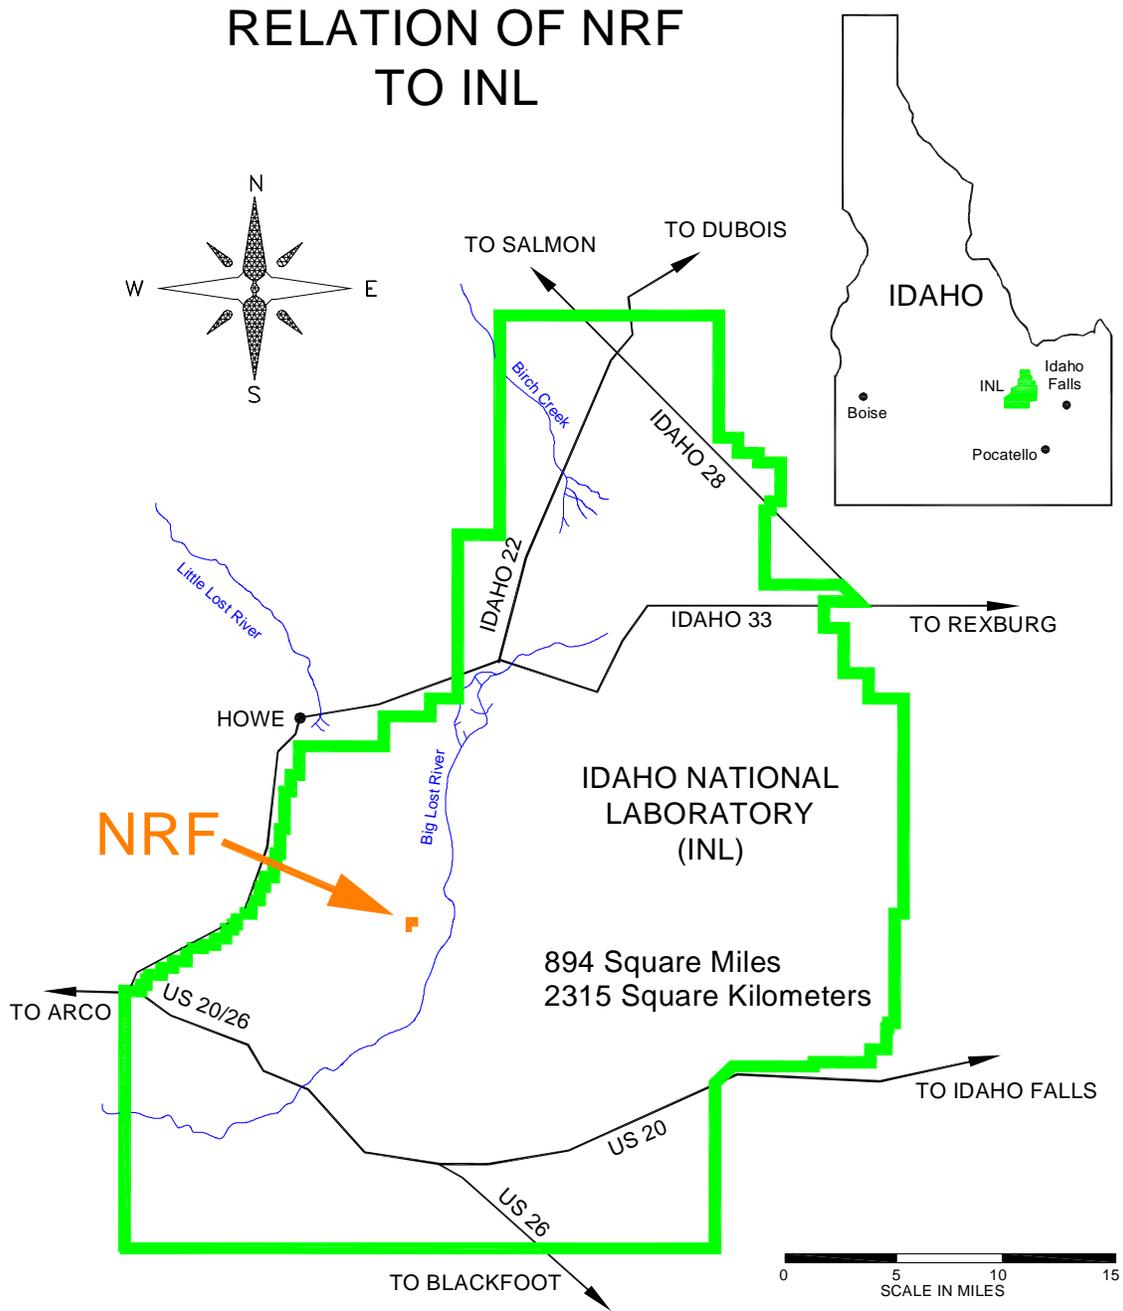
Figure 3-1 Location of the Naval Reactors Facility (Waste Area Group 8)

NRF is located on the west central side of INL, as shown in Figure 3-1, approximately 50 miles west of Idaho Falls, Idaho. NRF was established in 1949 as a testing site for the Naval Nuclear Propulsion Program. The Westinghouse Electric Company (WEC) operated NRF for DOE, Office of Naval Reactors from 1949 through the fall of 1998, at which time site operations were turned over to BBI. NRF covers seven mi², of which 80 acres are developed. At various times, up to 3,300 people occupied the site. Approximately 965 Bechtel employees and 200 long-term subcontractor and DOE employees are currently working at NRF. The nearest public roads to NRF are approximately seven miles west, ten miles north, and ten miles south.

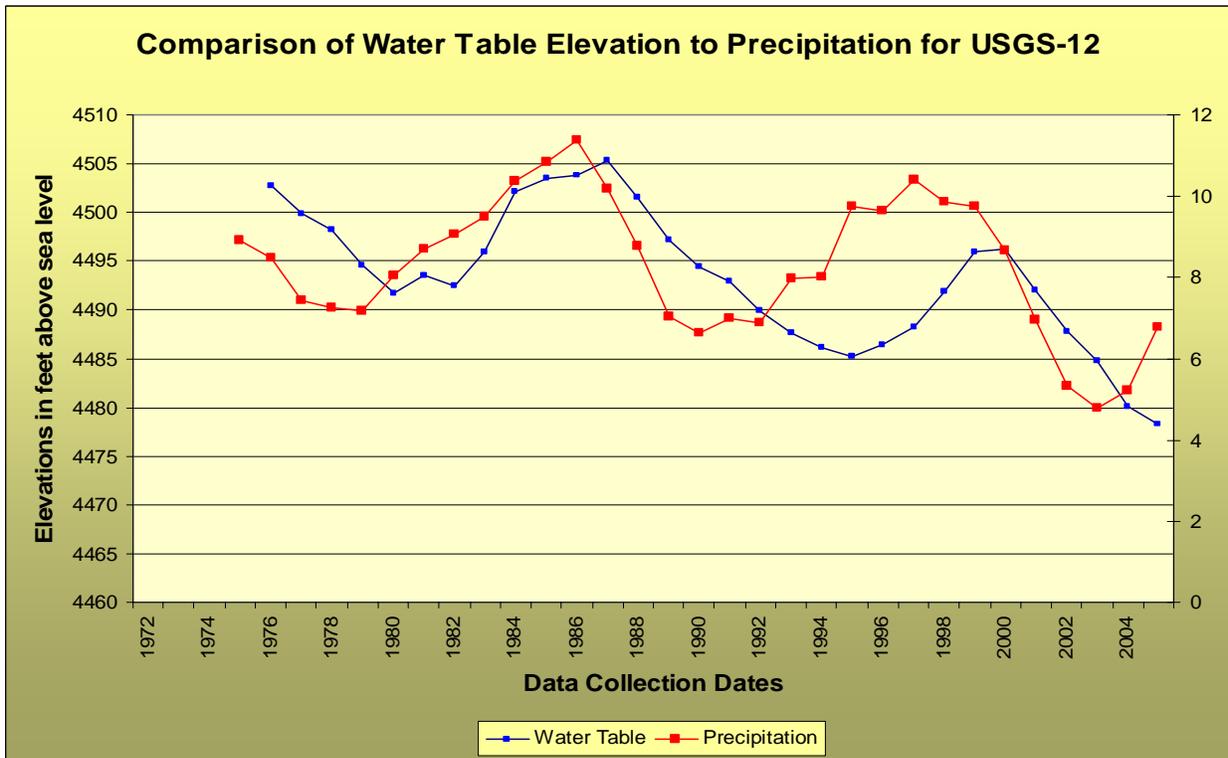
Figure 3-3 Precipitation and Water Table Elevation

Figure 3-3 also indicates that precipitation to the Snake River Plain near NRF appears to be trending downward. During three dry periods, the trough that formed in the graph represented successively lower yearly precipitation. Between January 1972 and January 1989, CFA received a total of 149 inches of precipitation. In comparison, between January 1989 and the present, a period representing the same amount of time, CFA received a total of 136 inches of precipitation. Furthermore, the regional decline in SRPA water levels follows an identical pattern which indicates that these water levels may be as much influenced by declining long-term precipitation totals as by increased water usage from the SRPA.

This analysis suggests that in the future NRF may be adversely affected by cyclical droughts in two ways. First, declining water levels, over time, may require NRF to lower pump intake levels in the wells. Second, vegetation located on the earthen covers that may be suitable for temperate climates may become severely stressed (where some of the less drought tolerant plant species may not survive) under drier conditions than those that occurred between May 2003 and April 2004, when the INL received 3.71 inches of precipitation.

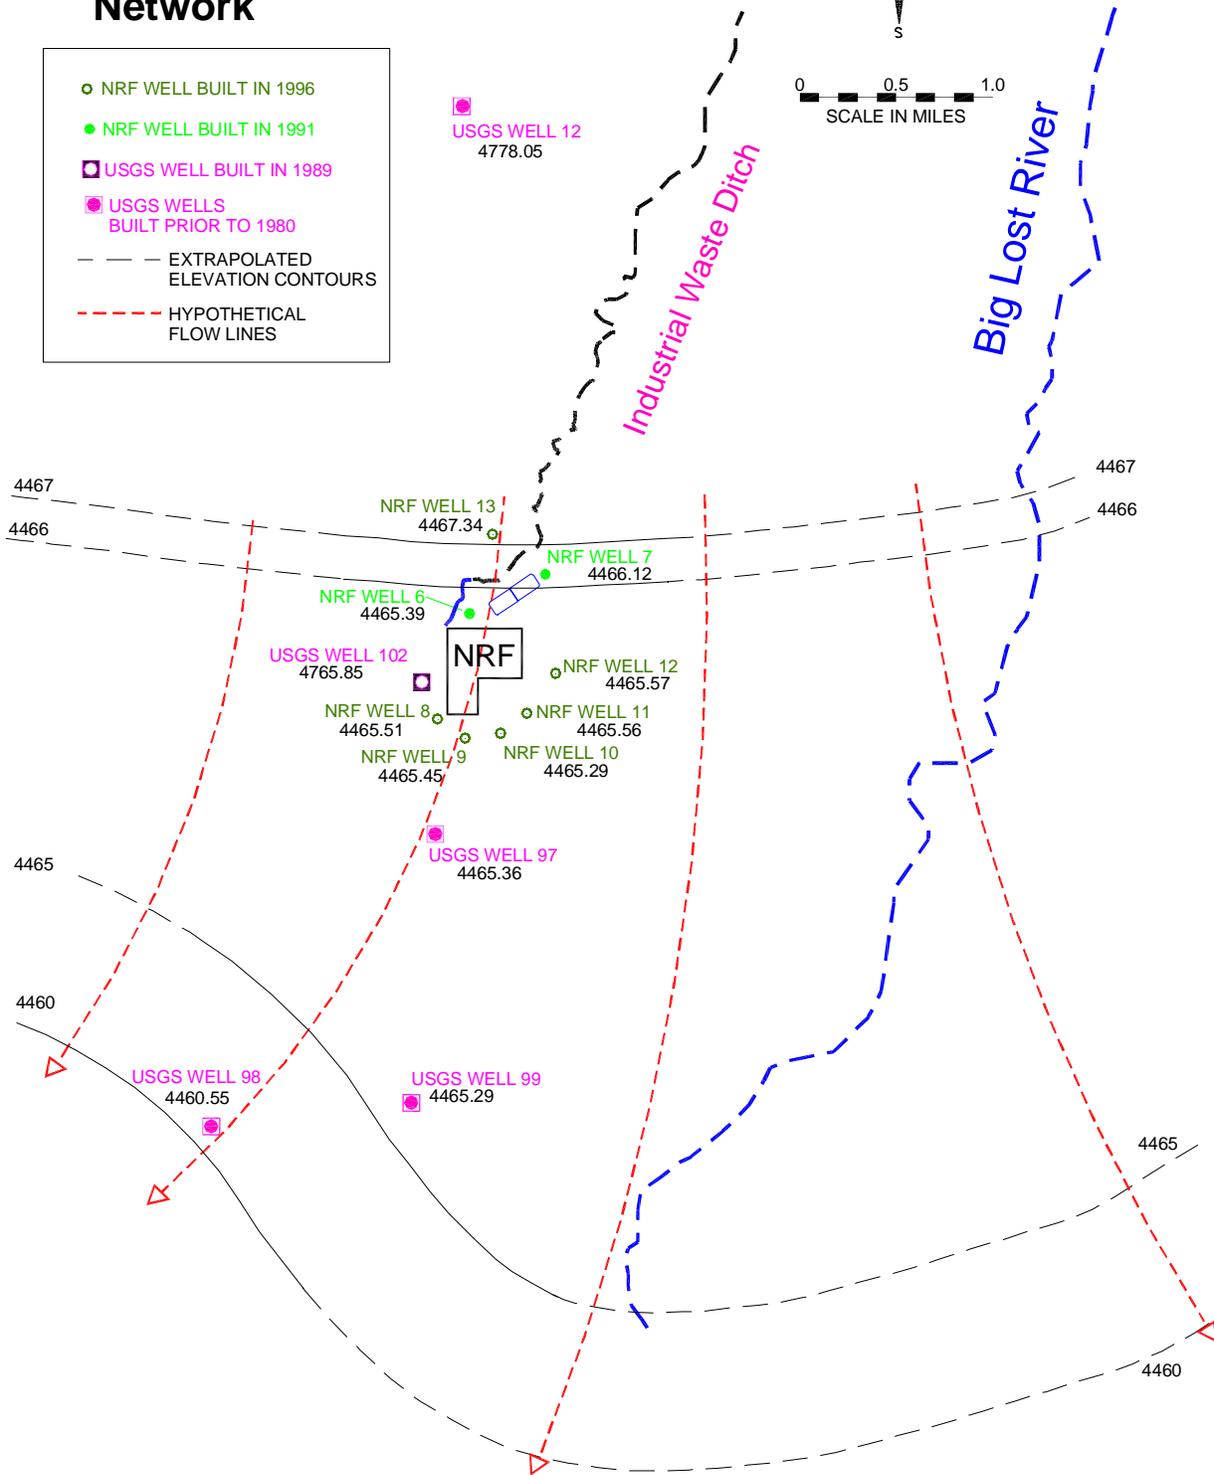
The SRPA occurs approximately 375 feet below NRF, and consists of a series of water saturated basalt flows and interlayered volcanic and sedimentary material. Drinking water for employees at NRF comes from several production wells located in the central portion of the facility. Figure 3-4 is a map showing the top of the aquifer near NRF during March 2006 based on water table elevation data collected from NRF wells. Currently water flows beneath NRF from the northeast to the southwest.

Figure 3-4 Top of Aquifer March 2006

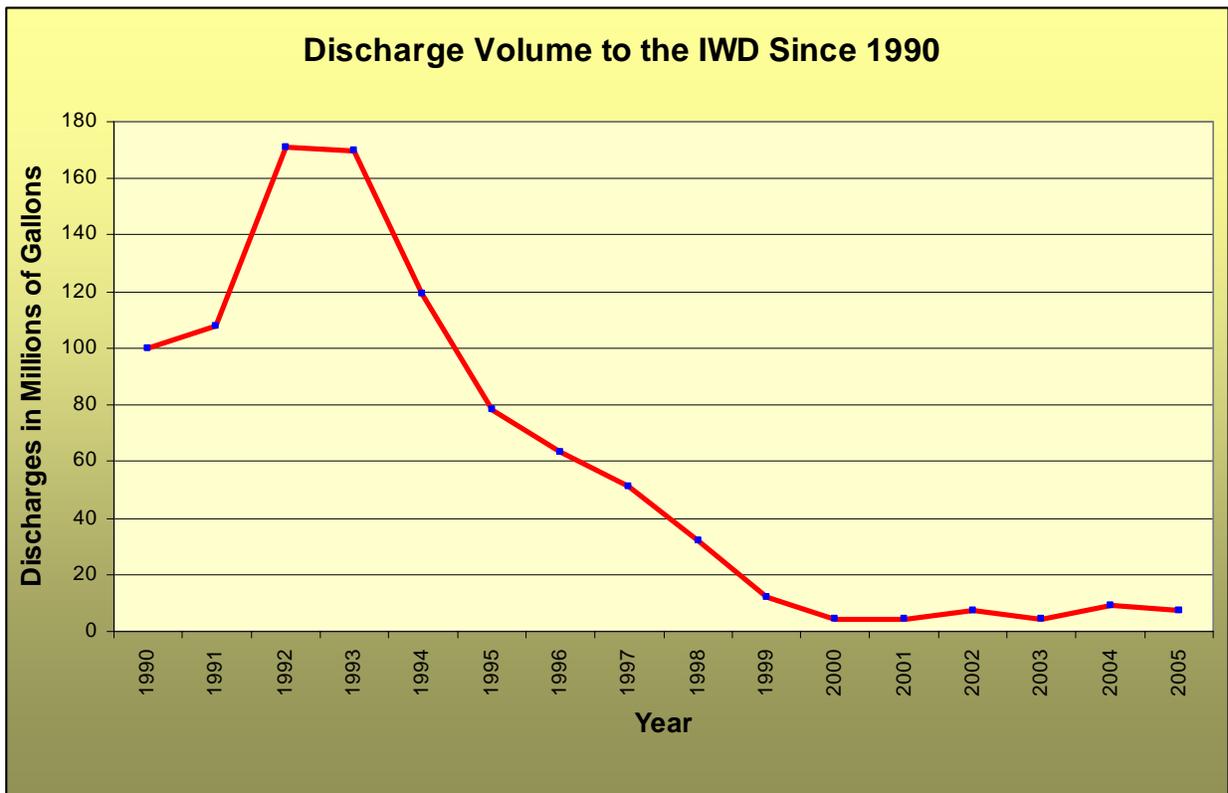
Figure 3-5 Volume of Water Discharged to the NRF IWD

Because of reduced discharge volume to the IWD, the perched water observed at PS-6 (located approximately 1000 ft northeast of well NRF-6) in 1993 is now gone. Similarly, the perched water zone located at the outfall of the IWD has been reduced in areal extent by approximately 20 percent of what it was in 1993. The Sewage Lagoon (SL) perched water zone is estimated to be approximately the same size as in 1993.

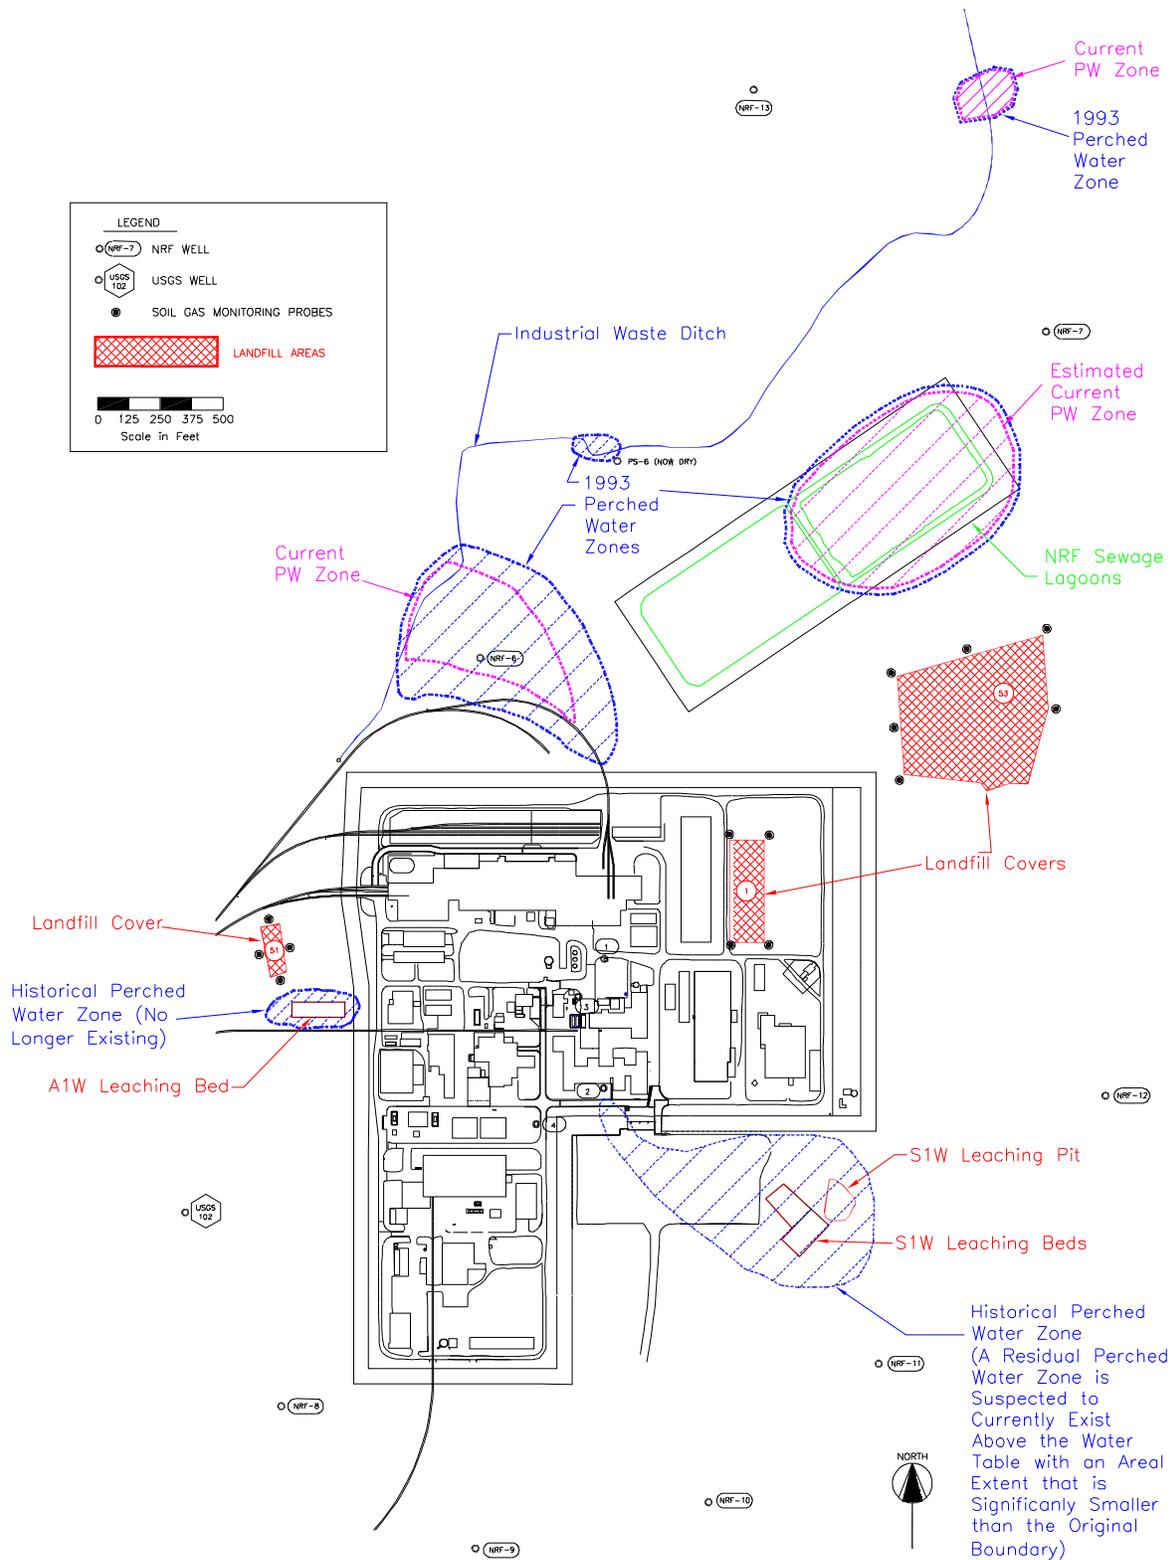
Figure 3-6 Current and Historical Perched Water at NRF

Perched water, which lies above the regional water table between 20 and approximately 100 feet below land surface, occurs in several locations at NRF including beneath the IWD, the sewage lagoons, and historically the leaching beds/pits. In general, perched water forms at any location where a substantial surface recharge source is present. The most significant perched water at NRF is located beneath the outfall of the NRF IWD. Figure 3-6 provides a historical perspective to perched water located at NRF. This figure shows the estimated current extent of perched water (from the most current water level measurements) along the IWD and at the sewage lagoons versus its extent in 1993. Figure 3-6 also shows the locations and extent of historical perched water zones at the A1W and S1W Leaching Beds and an area located approximately 1000 ft north of the sewage lagoons.

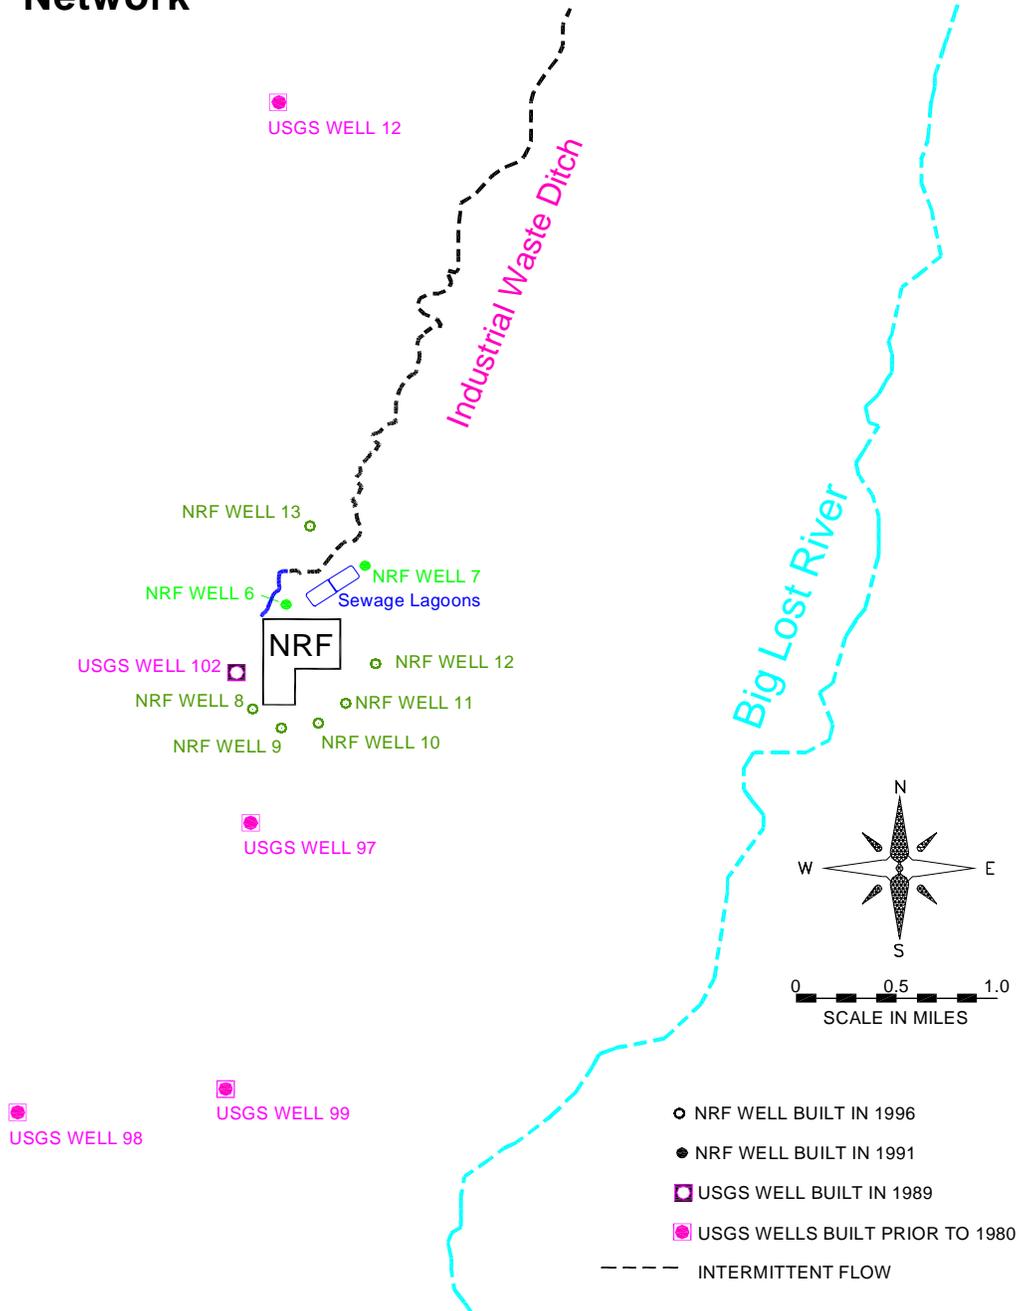
NRF has been routinely collecting groundwater monitoring data since 1989. The NRF Groundwater Monitoring Network consists of 13 wells strategically located to monitor upgradient and downgradient water quality. Figure 3-7 shows the location of the NRF groundwater monitoring wells.

Figure 3-7 Location of NRF Groundwater Monitoring Wells

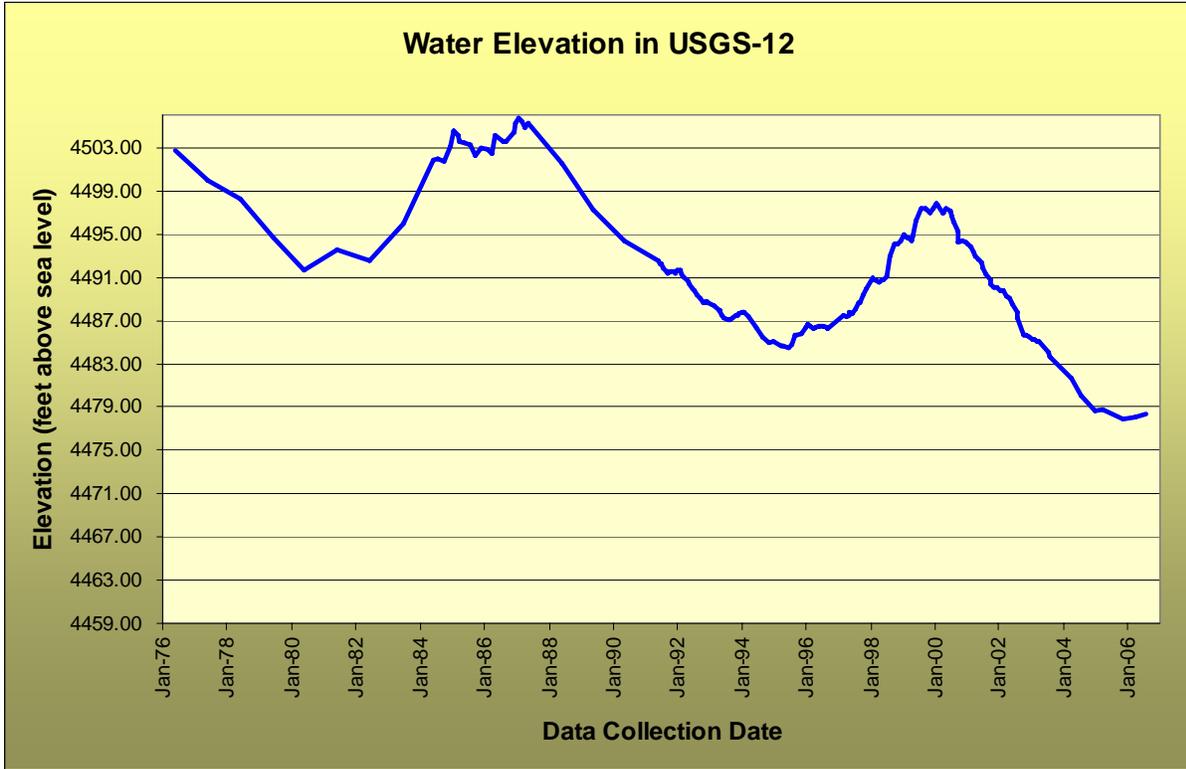
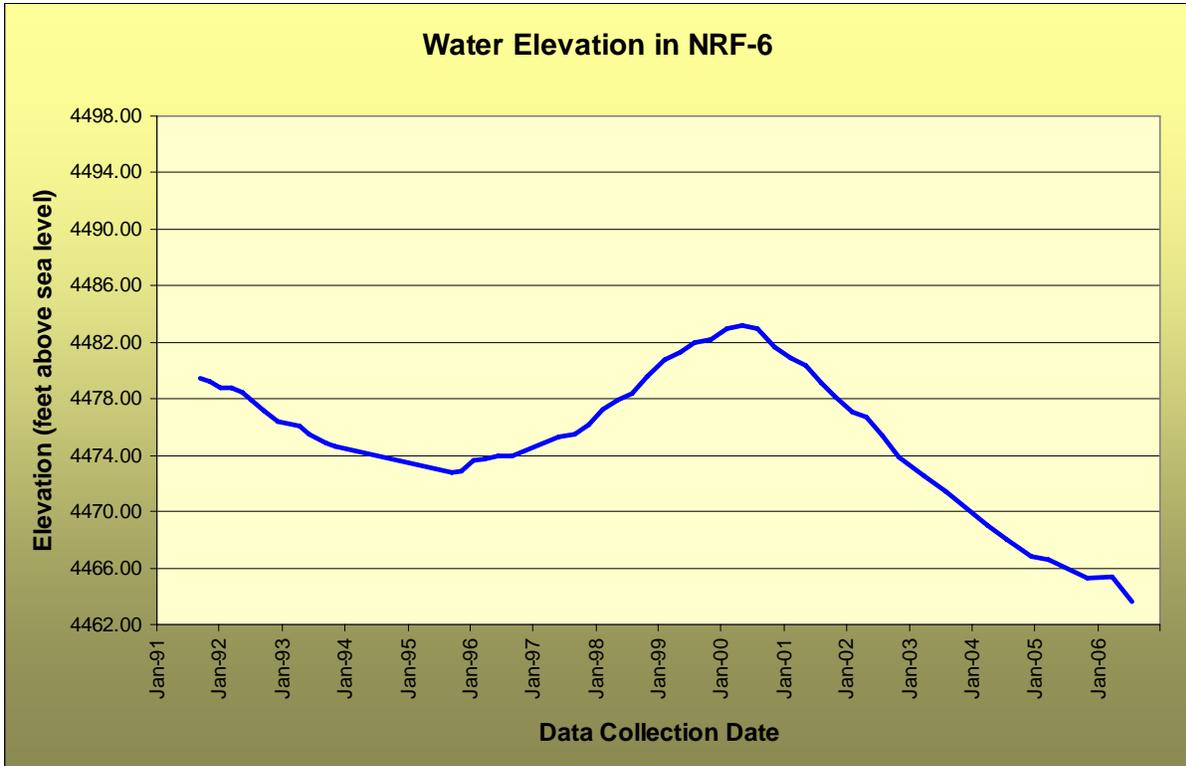
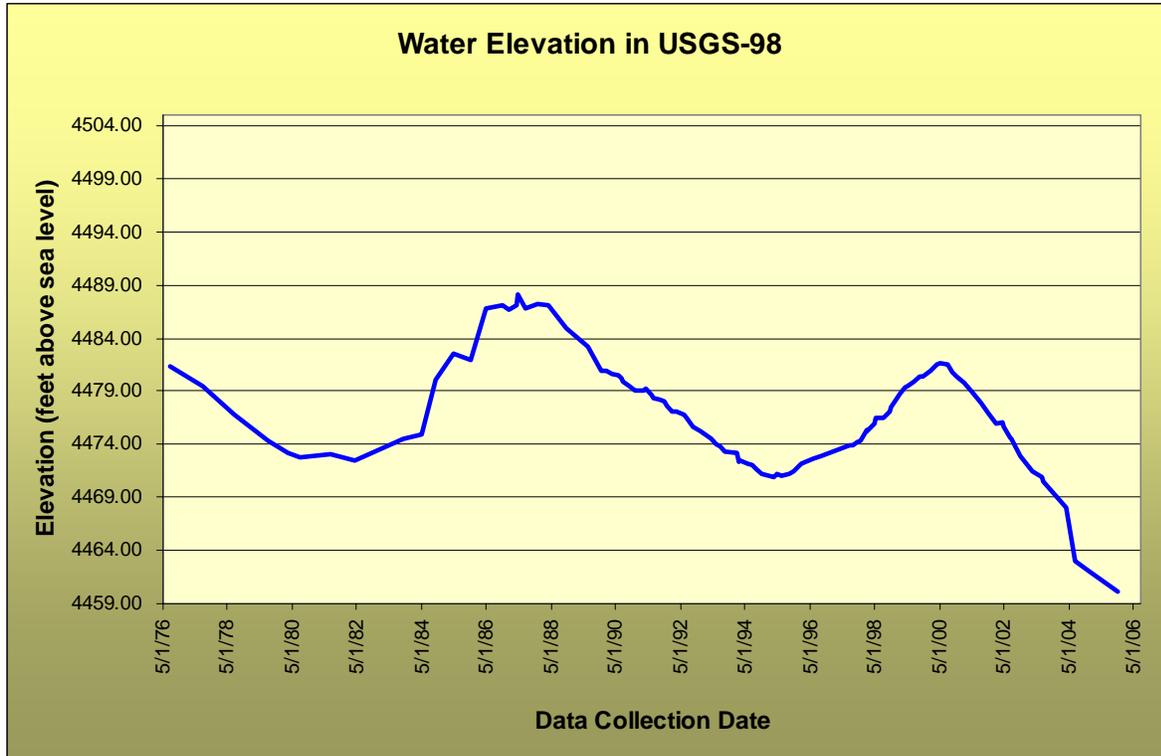
The water table in the SRPA has been declining for the past several decades. A direct consequence of this decline is that many domestic and agricultural wells in eastern Idaho had to be deepened to prevent them from going dry. The wells at NRF have been similarly affected. In 2005, well USGS-98 was deepened because the pump intake level was approximately one foot below the water level. Hydrographs for wells USGS-12, NRF-6, and USGS-98 (from north to south) have been plotted and are shown in Figure 3-8, Figure 3-9, and Figure 3-10, respectively. These wells are typical of the aquifer conditions near NRF.

These graphs display the same horizontal and vertical scales for ease of comparison and show both cyclical and long-term trends in water table elevation. The graph for USGS-12 best exemplifies the stair-step pattern of decline in water table elevation. In this well, the water level has declined about 15 feet since 1980 (valley to valley on the graph). The water level in NRF-6 has declined almost 10 feet since 1994. The most important information from these graphs is that water levels can drop rapidly; therefore, NRF must continually track water level changes to ensure ample time is available to deepen wells, if needed. Table 3-2 shows the physical characteristics of the NRF wells. This table indicates that all NRF wells have ample water above the well intake with the exception of USGS-97 (8.28 feet) and USGS-99 (15.59 feet). Presently, NRF does not anticipate the need to deepen the wells for possibly five to ten years if current trends continue.

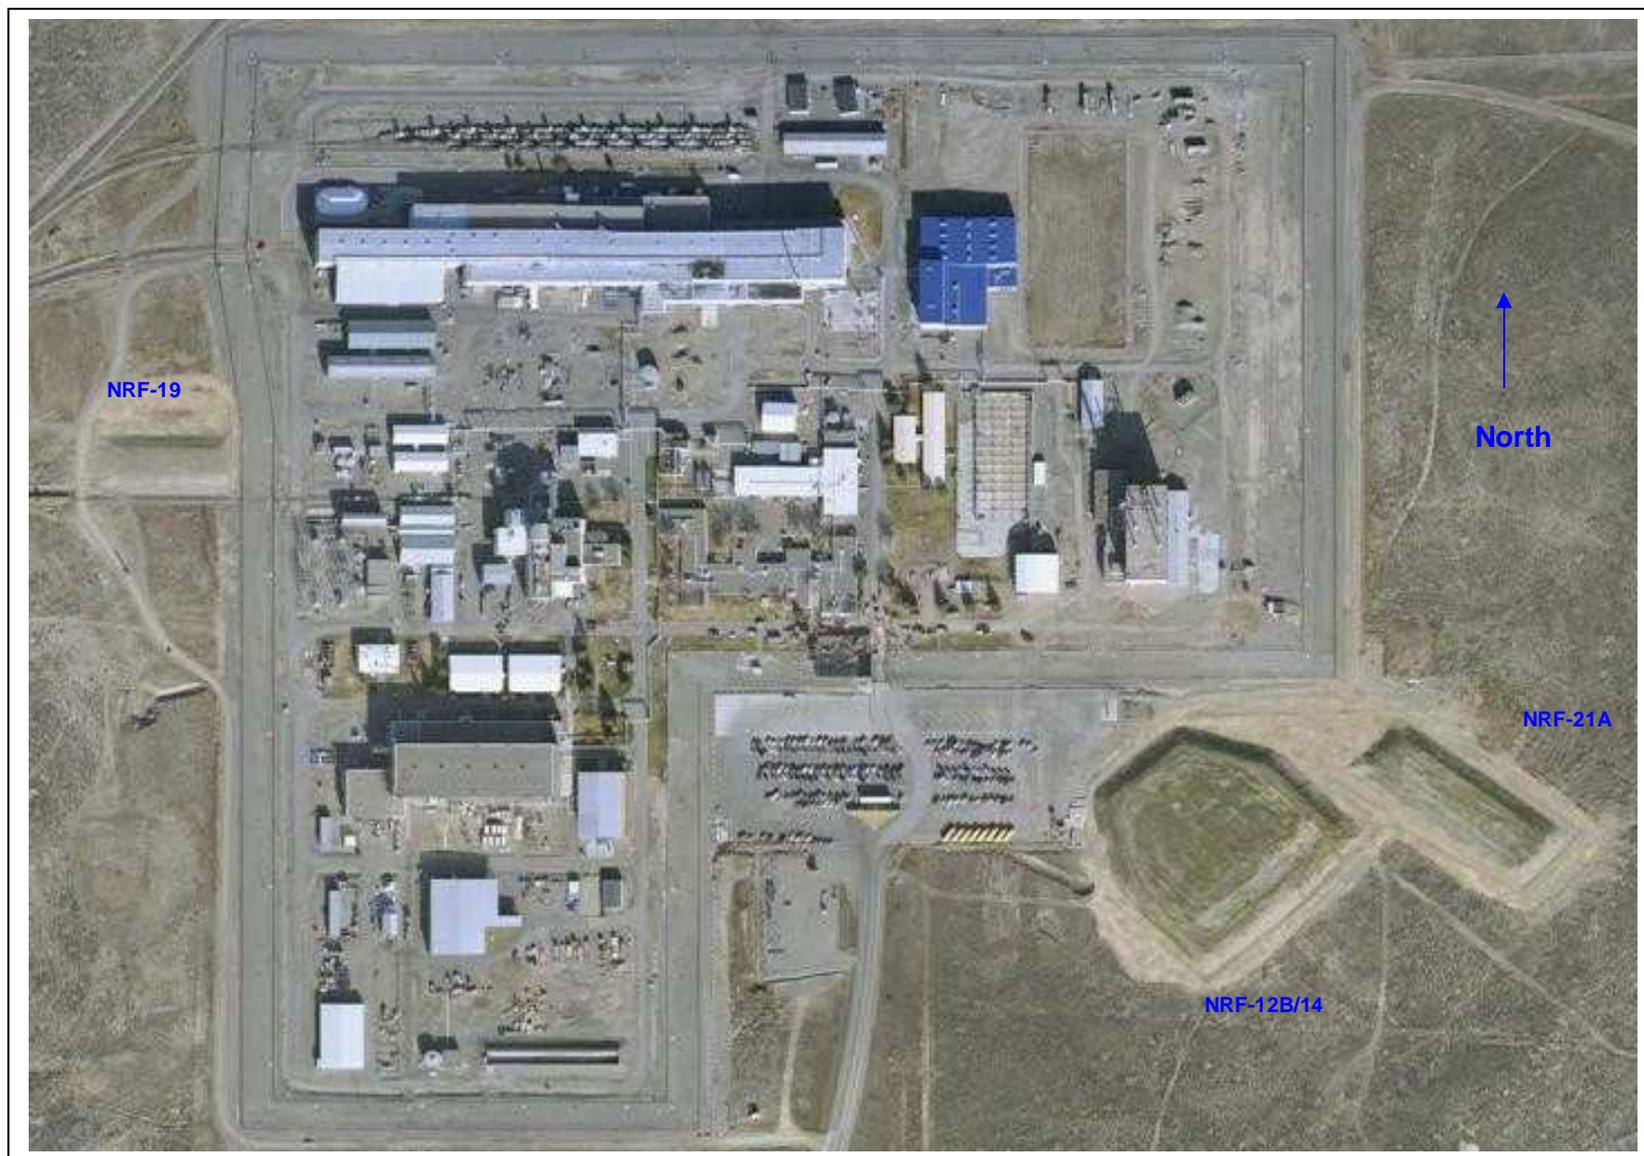
Figure 4-4 NRF-12B/14, NRF-21A, and NRF-19 OU 8-08 Engineered Cover Areas

The general cross-section of the engineered covers is shown in Figure 4-3. The engineered cover top view with finished grade for each of the three areas is shown in Figure 4-4 and Figure 4-5.
