**Five-Year Review for
Naval Reactors Facility
Operable Unit 8-05/06 Inactive Landfill Areas
and
Operable Unit 8-08 Remedial Action Sites**

December 2006

Prepared for the
U. S. Department of Energy
Pittsburgh Naval Reactors Office
Idaho Branch Office
P. O. Box 2469
Idaho Falls, Idaho 83403-2469

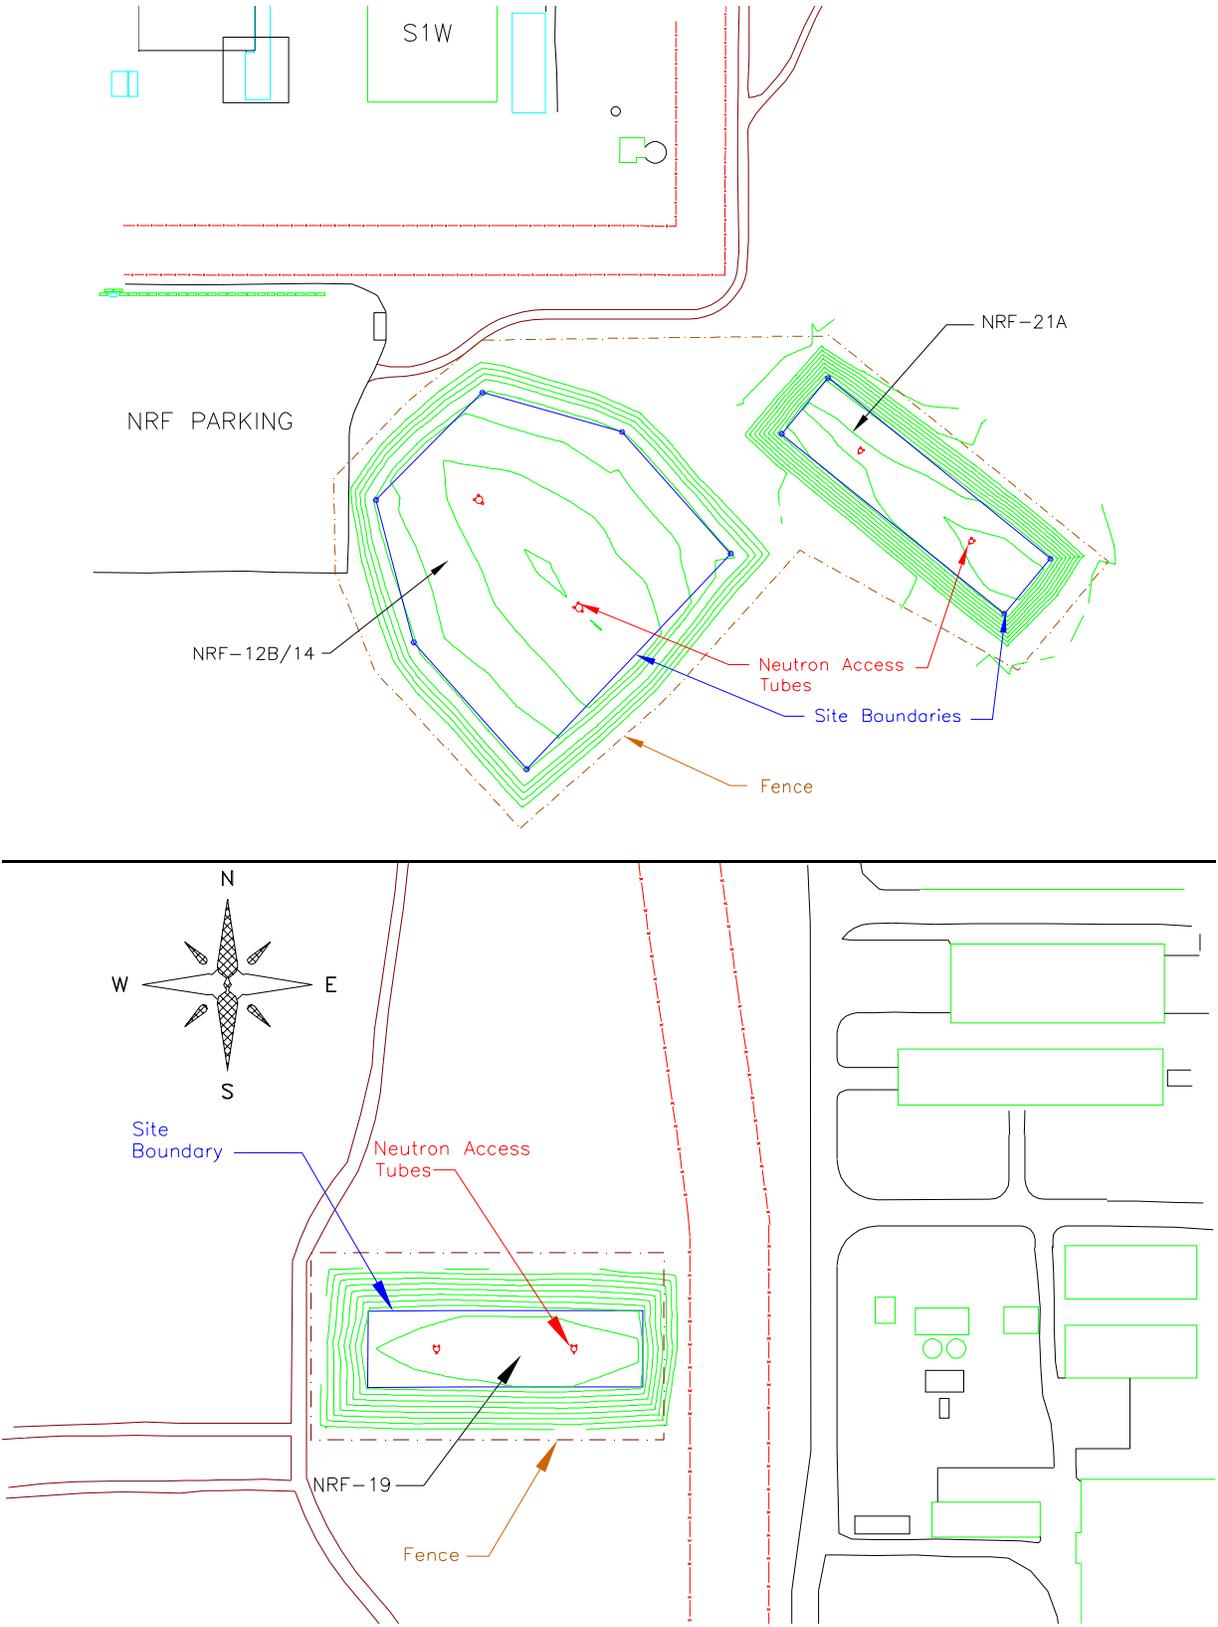
Figure 4-5 NRF-12B/14, NRF-21A, and NRF-19 Engineered Cover Areas

The general cross-section of the engineered covers is shown in Figure 4-3. The engineered cover top view with finished grade for each of the three areas is shown in Figure 4-4 and Figure 4-5.

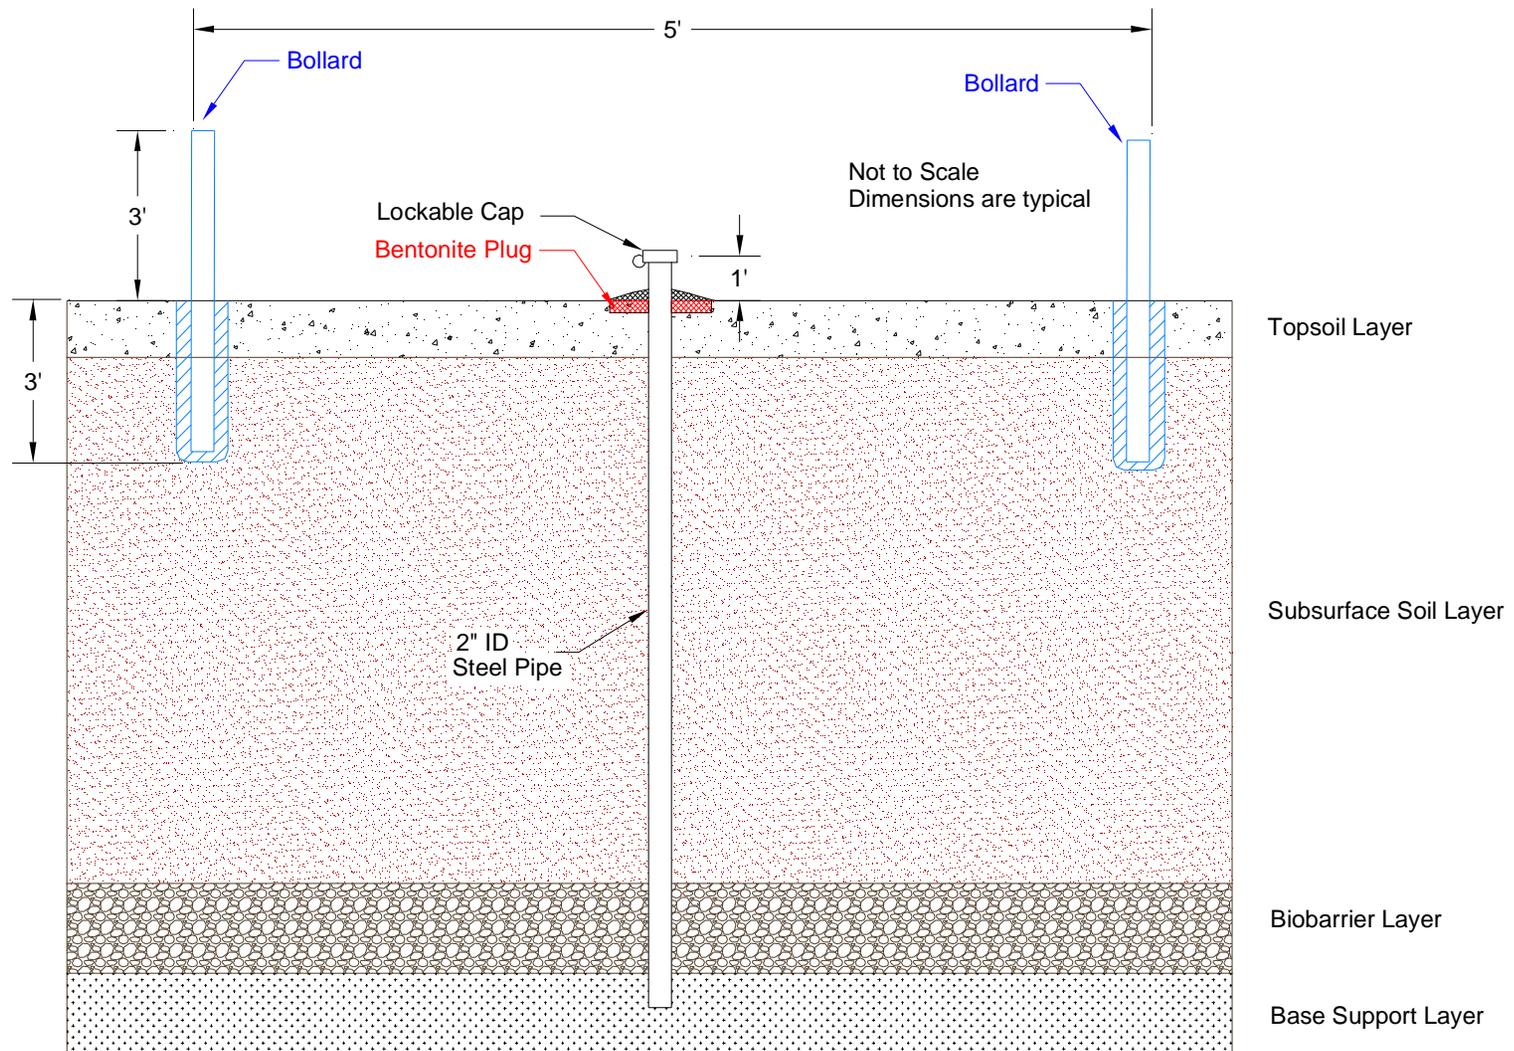
Figure 4-6 Typical Soil Moisture Neutron Access Tube Construction

Six neutron access tubes were installed. The access tubes were placed about a foot deep into the base support layer (i.e., they are located in the central portion of the covers where the base support layer is thickest). Tubes consisted of two-inch nominal size steel pipe, approximately seven feet in length. Two monitoring locations were selected per site. A bentonite seal was placed at the surface around each access tube, and then soil was placed on top of the bentonite seal and mounded to shed precipitation away from the access tube. Figure 4-6 depicts the typical access tube construction.

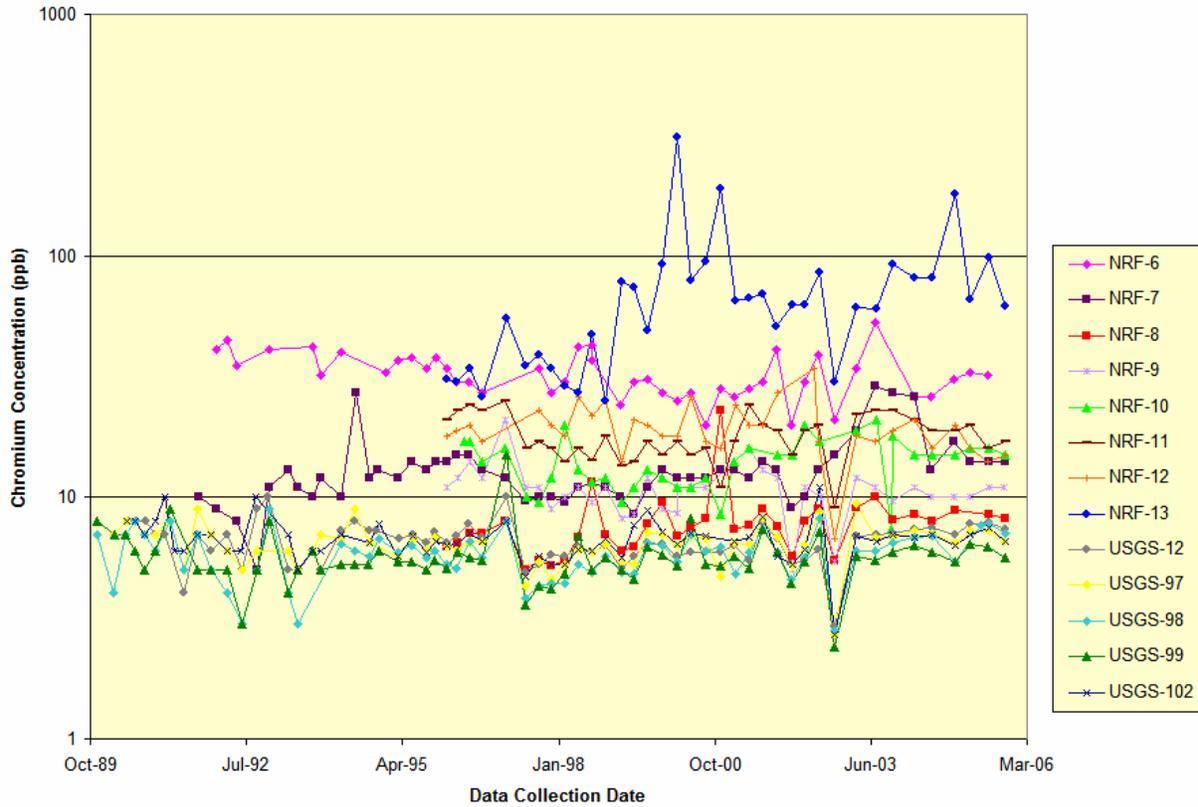
Figure 6-1 Chromium Concentration in NRF Wells

has historically contained elevated metal concentrations primarily due to sedimentation in the well and not necessarily from the IWD. For an in-depth discussion of chromium and its presence in NRF-13, see Appendix A.

Concentration data that were considered to be extreme outliers both with respect to the overall trend of the well and in comparison with trends in other wells were excluded from Figure 6-1. Outliers were considered to be values that are significantly different from the remainder of the data set. Specifically, values greater than three times the well average were removed (with the exception of NRF-13 that considered the outliers with values above the MCL).

Most chromium, chloride, and tritium concentrations are stable or trending downward, but each for different reasons. Chromium concentration decreases are probably related to two causes; decreased wastewater discharges to the IWD (result in less potential migration of historical chromium in sediments) and localized changes in flow patterns. The few wells showing increasing chromium concentrations are likely from a natural source, since chromium is no longer discharged to the IWD in significant amounts. The overall current chloride concentration decreases may be attributed to two possibilities: 1) the lower chloride concentration in the regional upgradient groundwater (as seen in USGS-12) that flows past NRF and/or 2) much less effluent to IWD thus less total chloride discharged. As previously mentioned, the current downward trends in tritium activities are expected given normal decay.

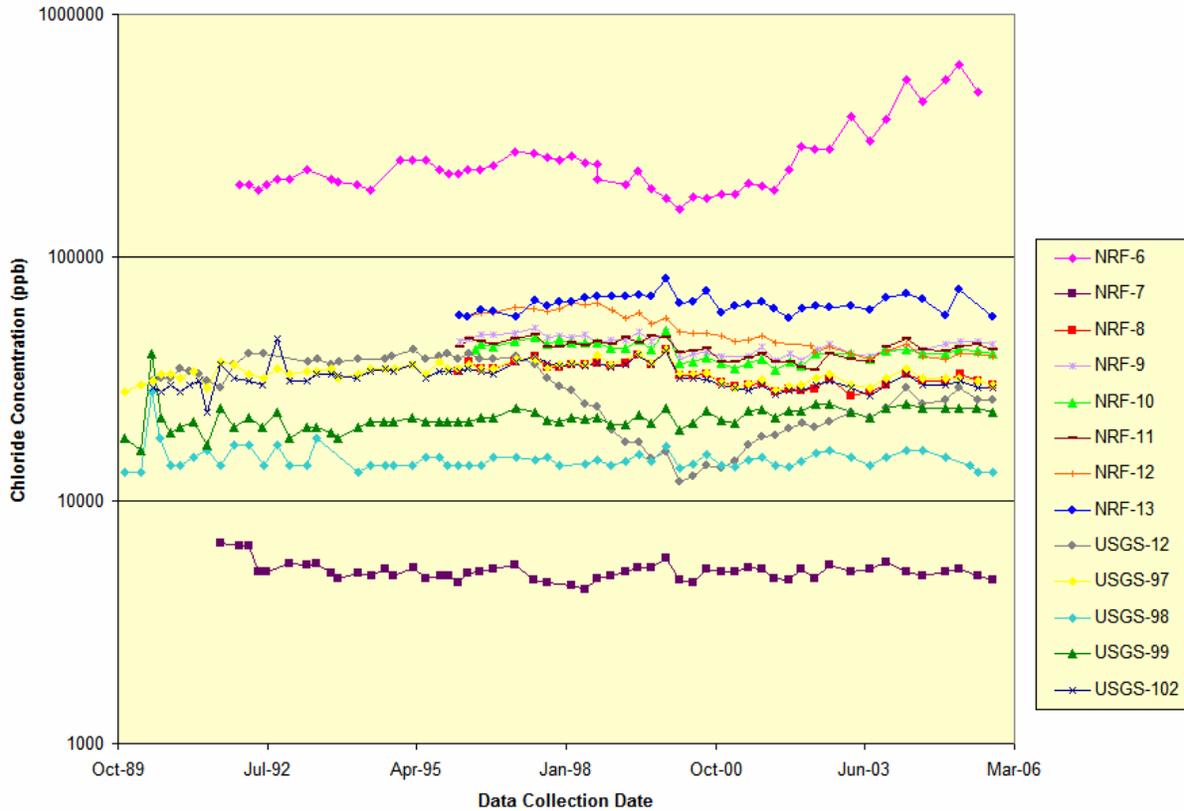
Figure 6-2 Chloride Concentrations in NRF Wells

Concentration versus time graphs for chloride are shown for the NRF wells in Figure 6-2. Appendix B provides plots for each individual wells along with the trending line. Chloride, which is also a naturally occurring constituent in groundwater, is a good tracer because it is relatively unaffected by common retardation mechanisms associated with the aquifer system, thus allowing flow path and contaminant distribution analyses to be performed. Chloride concentrations are trending downward in all but two NRF wells. NRF-6 is generally higher in chloride concentration than the other NRF wells due to the influence of the IWD as discussed in Appendix A. The largest decreasing trends are in NRF-12 and USGS-12 falling 46% each. Trends in NRF-9, NRF-13, USGS-97, 98, and 99 were generally small.

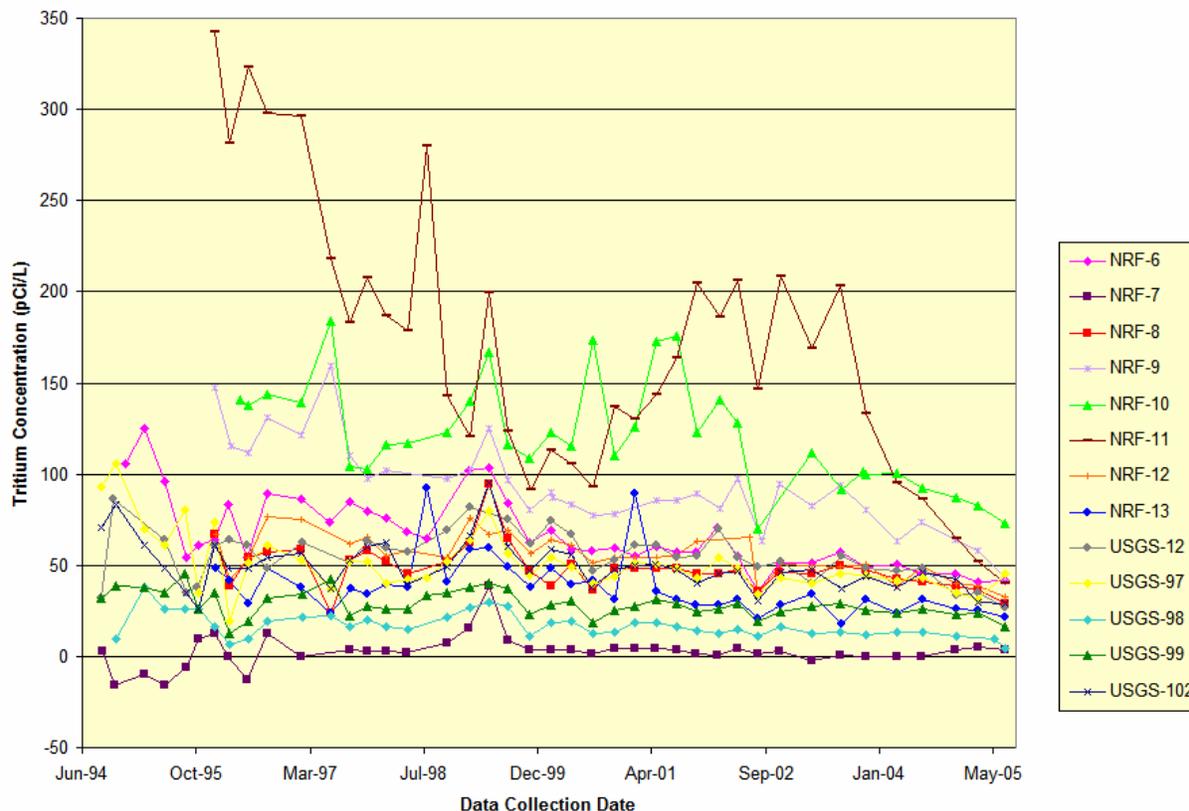
Figure 6-3 Tritium Concentrations in NRF Wells

Figure 6-3 shows the tritium concentration vs. time plots for the NRF wells. In most NRF wells, the tritium concentration is trending downward, while the tritium concentration has stabilized in the remaining wells. The tritium levels in NRF-10 and NRF-11, although decreasing significantly, are elevated with respect to background concentrations, though the concentrations in these wells are still significantly lower than MCLs. These wells are located downgradient of the S1W Leaching Beds/Pit. It is therefore likely that residual contamination from historical tritium releases to this site is responsible for these elevated concentrations, as water with trace amounts of tritium has not been released from NRF since 1978. A residual perched water zone, which is releasing small quantities of water to the aquifer, is suspected as the mechanism causing the current elevated tritium activities. The current downward trends in tritium activities are expected given normal decay.

Extreme outliers that were more than three times as large as well averages were excluded for wells NRF-13 and USGS-98. In addition, tritium concentrations measured for the third sample date in 1998 were excluded for wells NRF-6, NRF-7, NRF-8, NRF-9, NRF-10, NRF-12, NRF-13, USGS-12, USGS-98, and USGS-102, as most of these values were approximately twice the well average. The tritium concentrations were significantly greater than the well average in the cases of USGS-98 (nearly ten times the well average) and NRF-7 (nearly 19 times the well average).
