THEA FOSS AND WHEELER-OSGOOD WATERWAYS REMEDIATION PROJECT

YEAR 0 BASELINE MONITORING SUPPLEMENTAL BASELINE NATURAL RECOVERY MONITORING PRELIMINARY FINDINGS MEMORANDUM

FEBRUARY 1, 2007

**Figure 1
Baseline Natural Recovery Sample Locations**

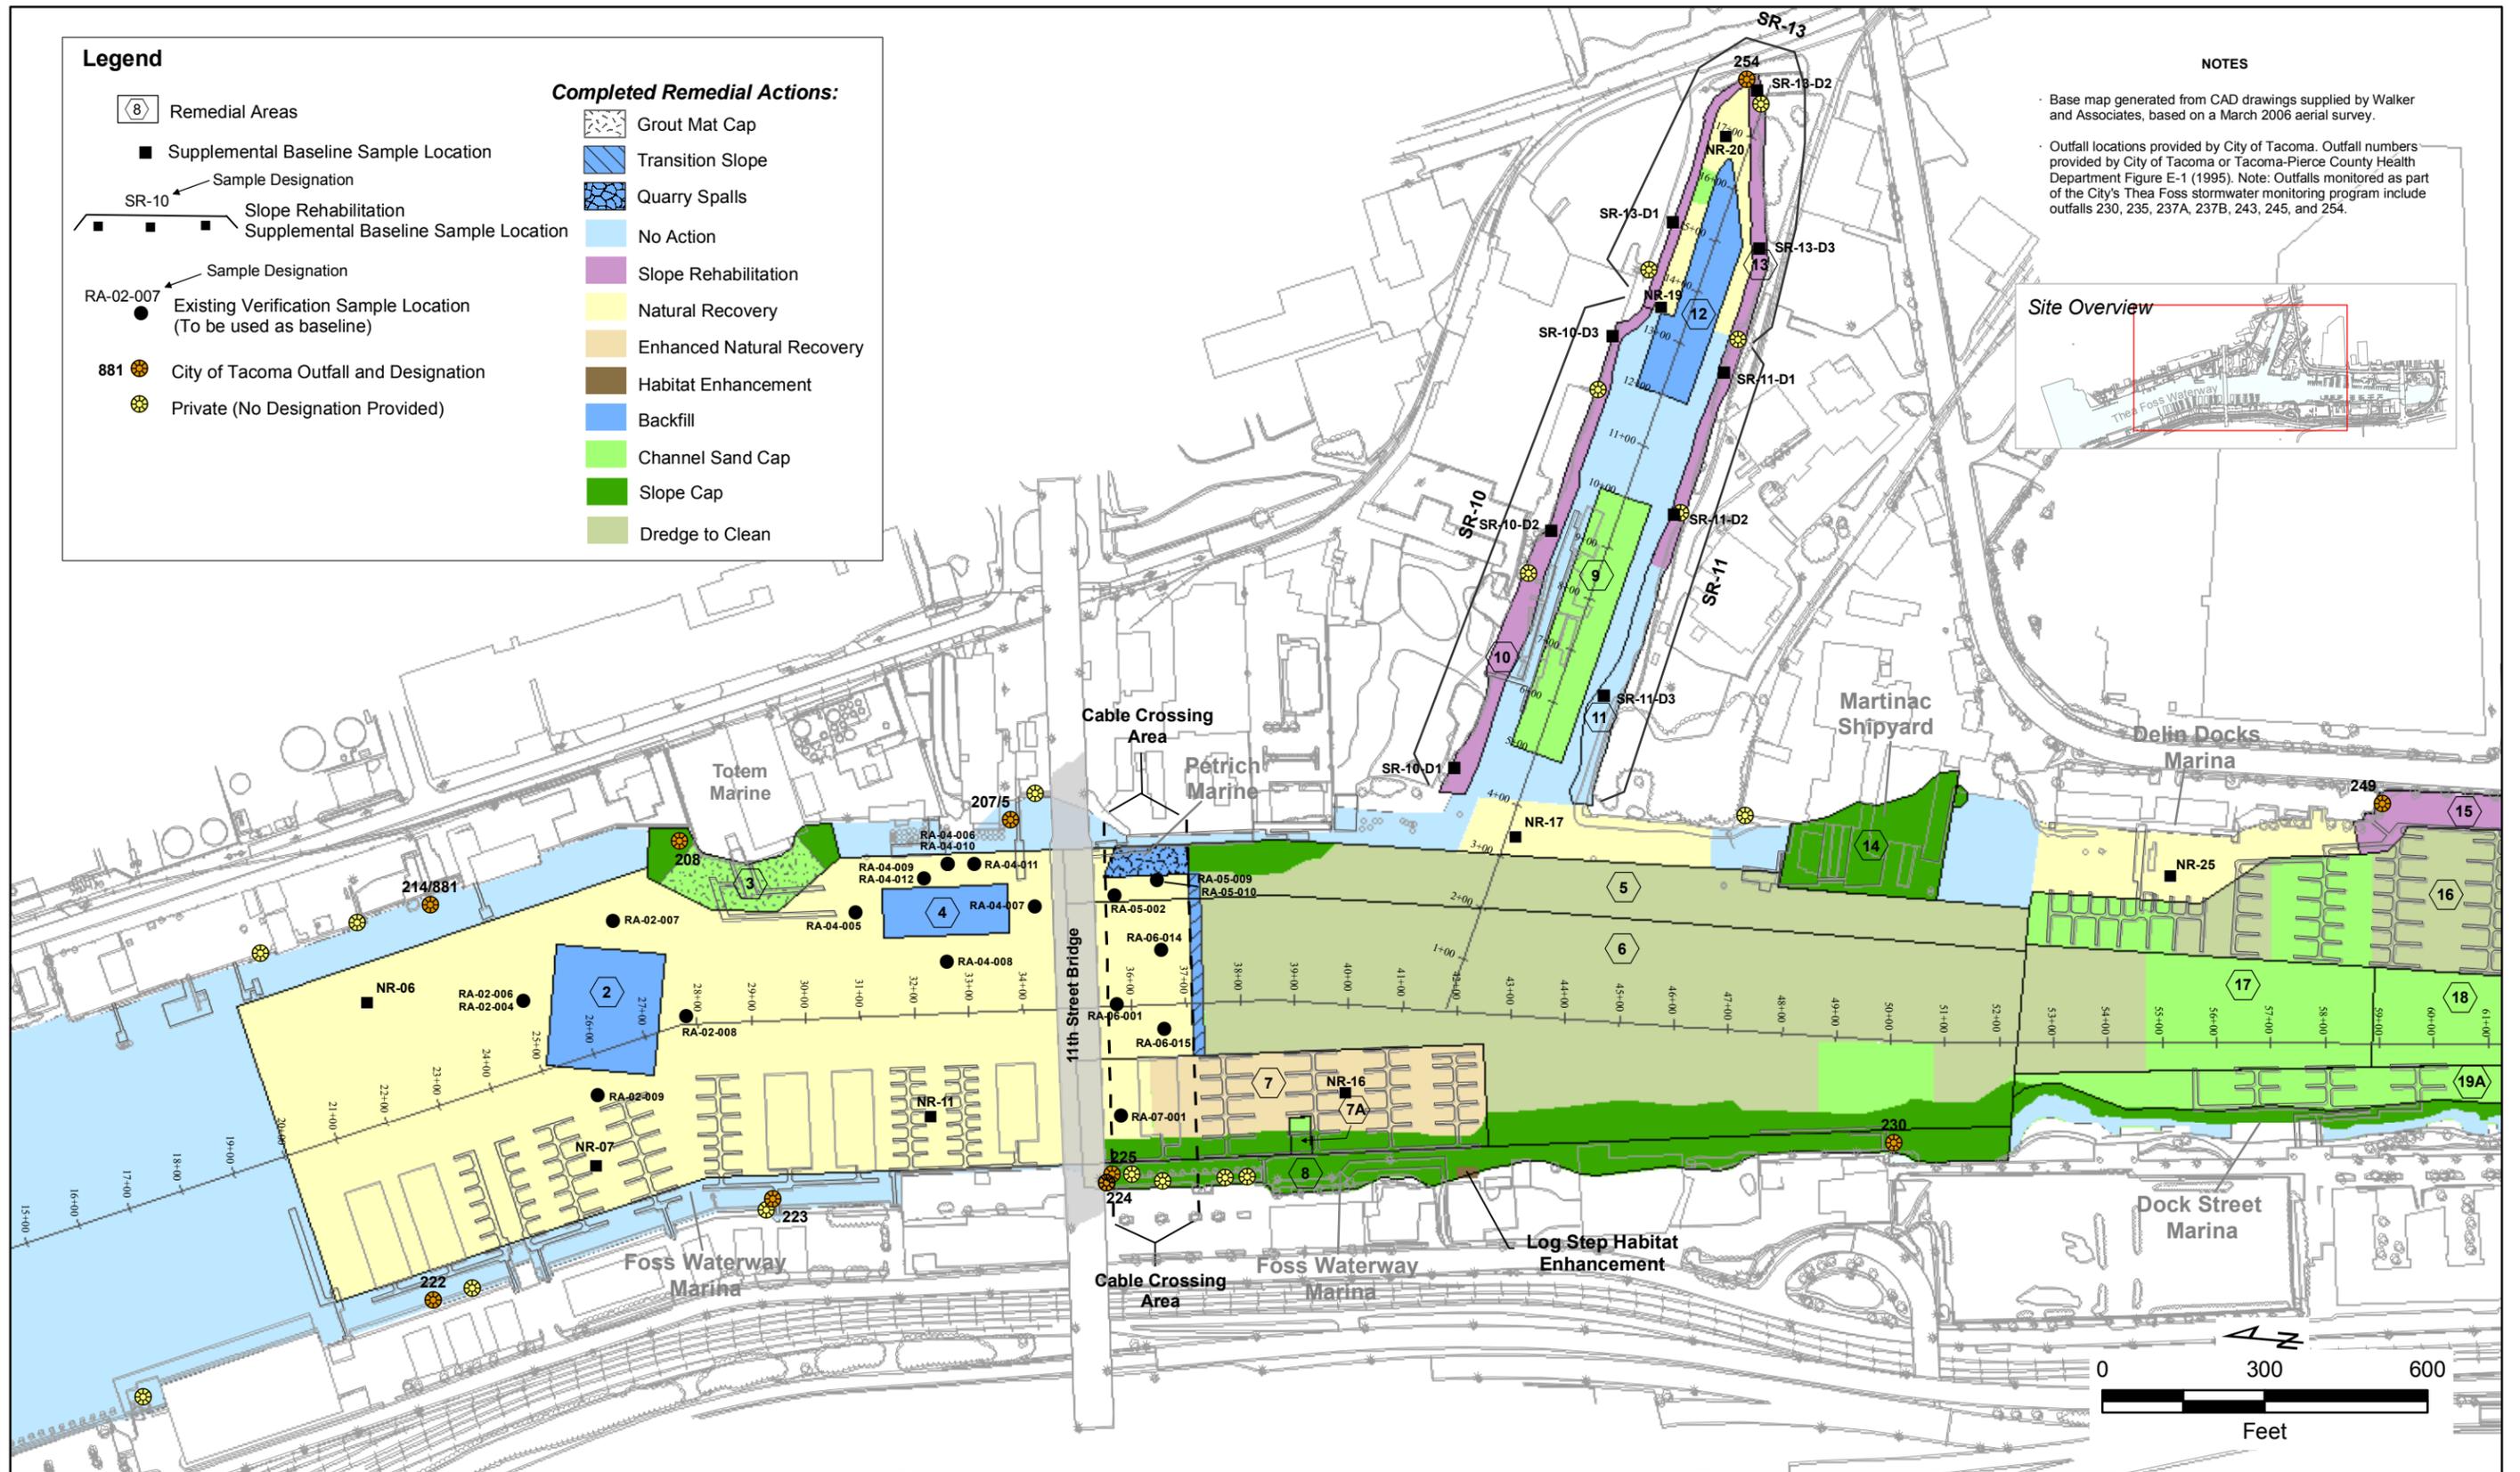
The coordinates for sample locations in channel and harbor areas in the Thea Foss and Wheeler-Osgood Waterways were generated based on the locations identified on figures presented in the OMMP. During sample collection, the sampling vessel was maneuvered to the sample coordinates and a buoy was deployed to mark the sample location. Then the sampling vessel was maneuvered to the position of the buoy and the Van Veen sampler was deployed at the sample location. The actual sample coordinates where the sampler was deployed were collected at each location at the time of sample collection. The actual sample coordinates are provided on the field forms in Attachment A and actual sample locations are shown on Figure 1.

Samples collected from the shoreline of the Wheeler-Osgood Waterway are composites comprised of subsamples collected from three locations in each RA (i.e., RA 10, RA 11, and RA 13). The locations of the shoreline subsamples were established by installing stakes at each sample location prior to sample collection. Shoreline sample locations were established at the approximate mid-point of the slope at three evenly spaced locations within each RA (Figure 1). The approximate mid-point of the slope within each RA and at each sample location was identified from post-construction hydrographic surveys of the shoreline areas and locations identified on figures presented in the OMMP. Stakes were installed at the sample locations during low tides on October 18-19, 2006. Photographs of the shoreline sample location stakes within the Wheeler-Osgood Waterway are presented in Attachment A. The actual sample coordinates were collected at each location at the time of sample collection and are provided on the field forms in Attachment A. The actual sample locations are shown on Figure 1.

Samples collected in the natural recovery area north of the 11th Street Bridge (i.e., NR-06, NR-07, and NR-11) (Figure 1) consisted of a soft, olive to gray colored silt containing shells, worms, and worm tubes. Multiple casts were necessary to acquire sample material that was not over-penetrated by the sampler. No odor or sheen was detected in the samples collected from the area north of the 11th Street Bridge (Attachment A).

Collection of supplemental baseline samples from shoreline areas in the Wheeler-Osgood Waterway generally progressed from sample locations with higher elevations to sample locations with lower elevations as the samples were collected as the tide receded. Samples were collected from three locations in RA-10 (i.e., SR-10-D1, SR-10-D2, and SR-10-D3), RA-11 (i.e., SR-11-D1, SR-11-D2, and SR-11-D3), and RA-13 (i.e., SR-13-D1, SR-13-D2, and SR-13-D3) and combined to comprise a composite for each RA. The samples were collected from shoreline areas in the Wheeler-Osgood Waterway on October 25, 2006 (Figure 1).

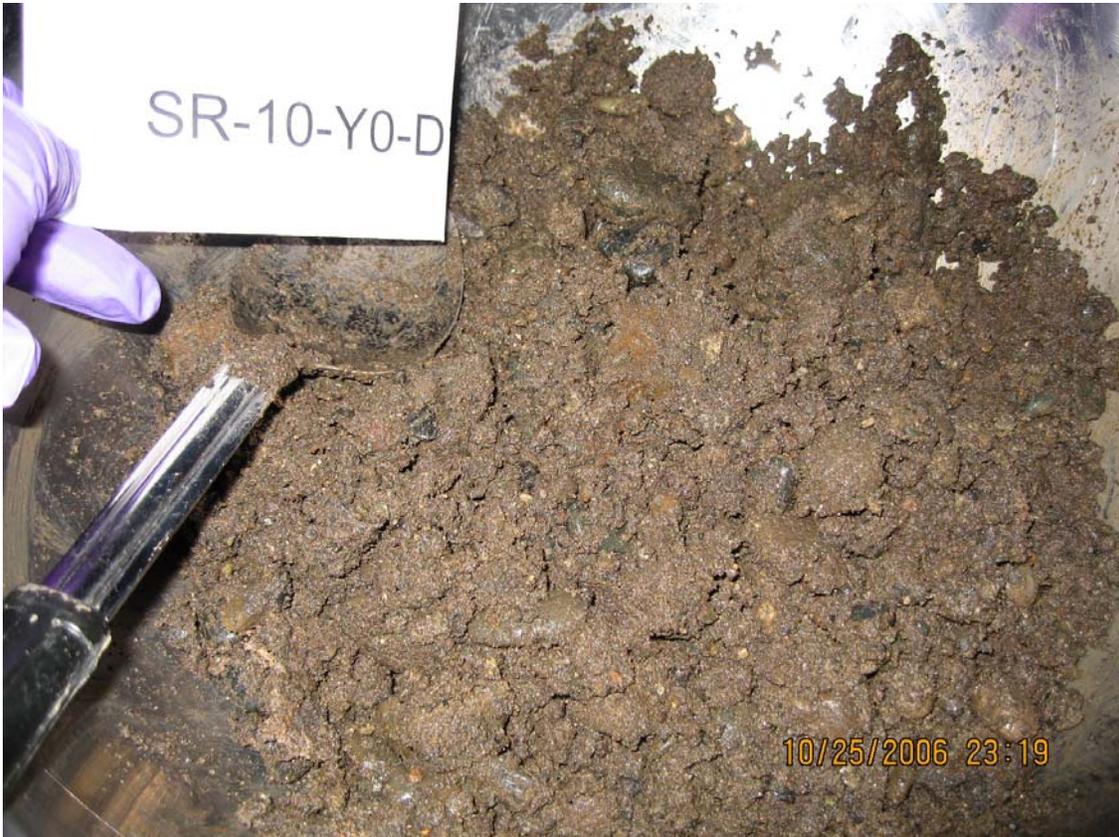
Composite Sample SR-10-Y0-D

The samples collected from the natural recovery and slope rehabilitation areas on the shorelines of the Wheeler-Osgood Waterway consisted of an olive, dark gray, or brown colored sand with gravel or silt. Samples also contained wood pieces and shells. No odor or sheen was detected in the samples collected from the shorelines in the Wheeler-Osgood Waterway.
