THEA FOSS AND WHEELER-OSGOOD WATERWAYS REMEDIATION PROJECT

YEAR 0 BASELINE MONITORING

HABITAT MITIGATION AREA MONITORING PRELIMINARY FINDINGS MEMORANDUM

NOVEMBER 30, 2006

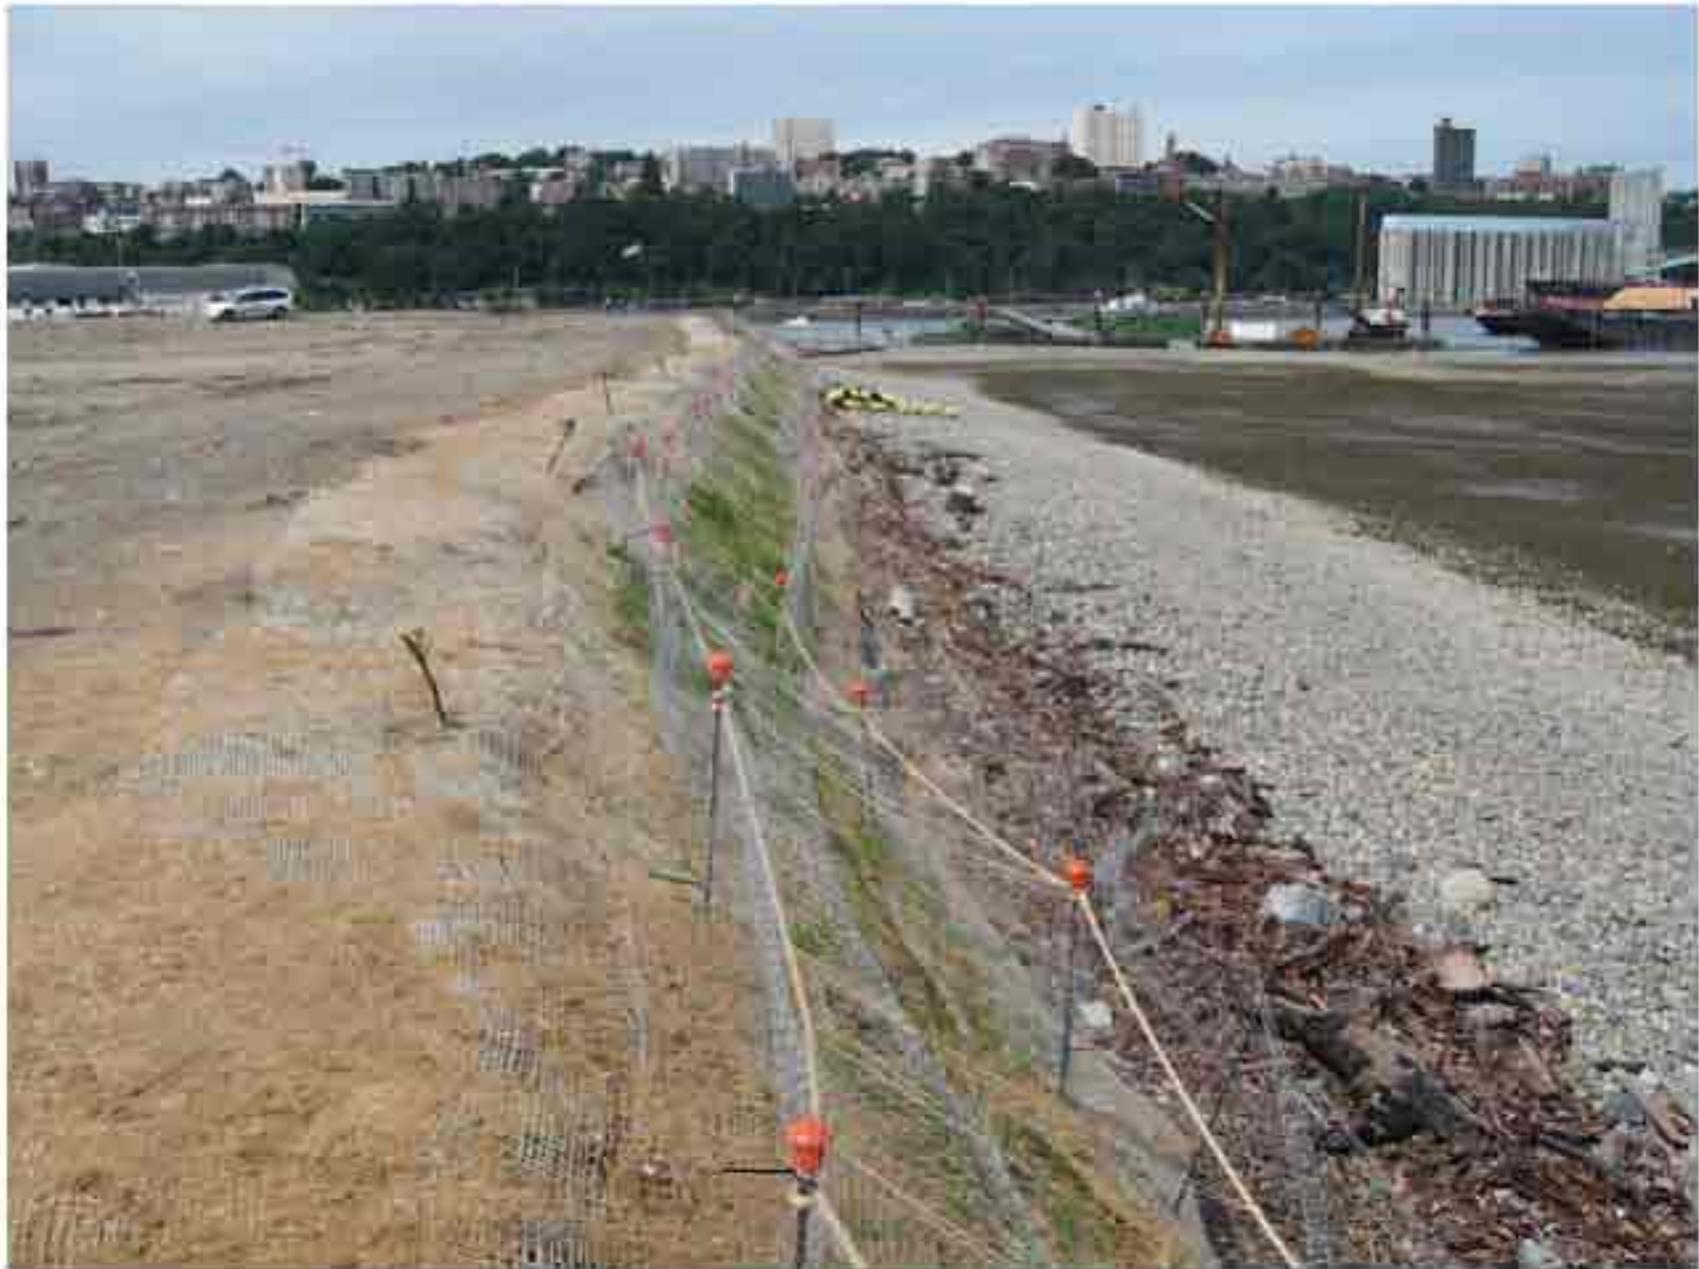
North Beach Habitat, Photo Point 1A, facing west. Photo taken July 11, 2006 at 10:53 AM, tide at approximately -2.72 feet MLLW. [IM G_0006]

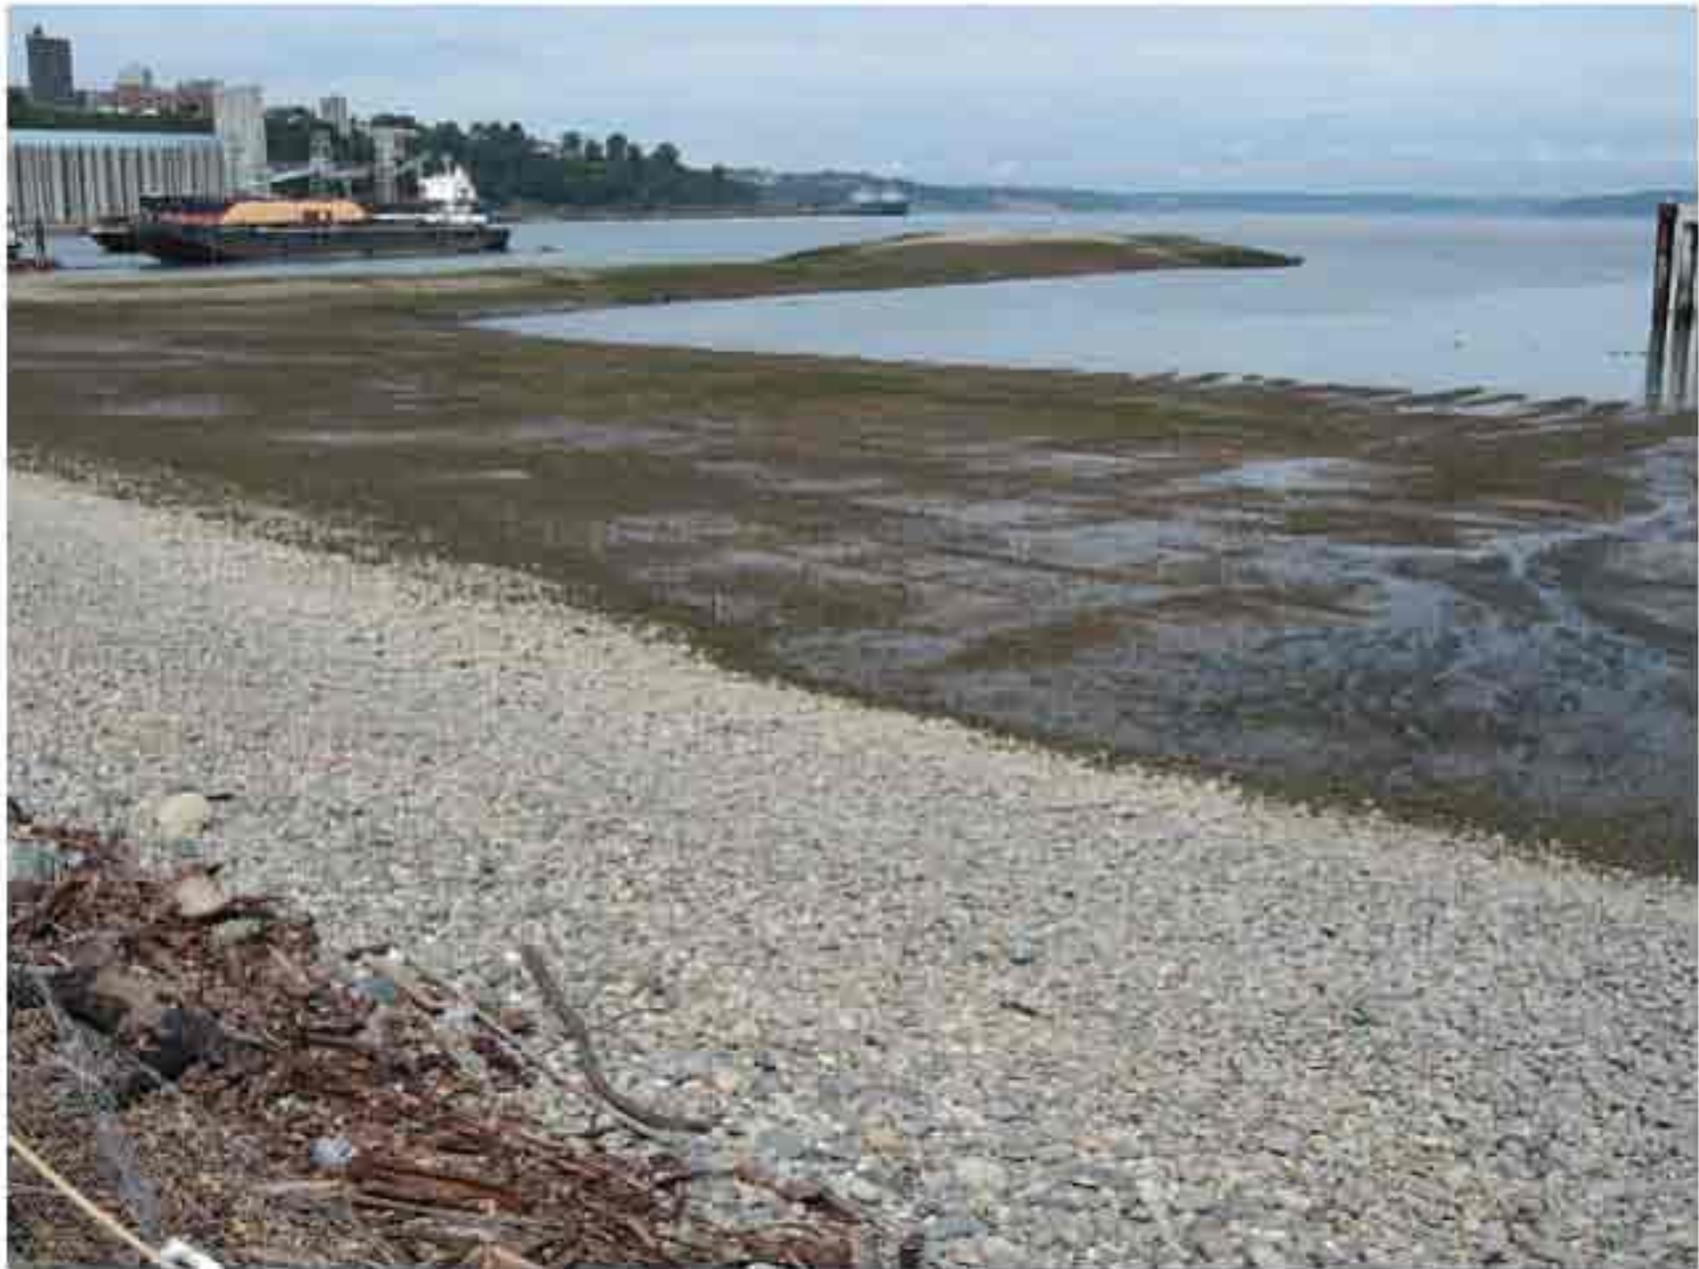
North Beach Habitat, Photo Point 1B, facing northwest. Photo taken July 11, 2006 at 10:54 AM, tide at approximately -2.72 feet MLLW. [M G_0007]

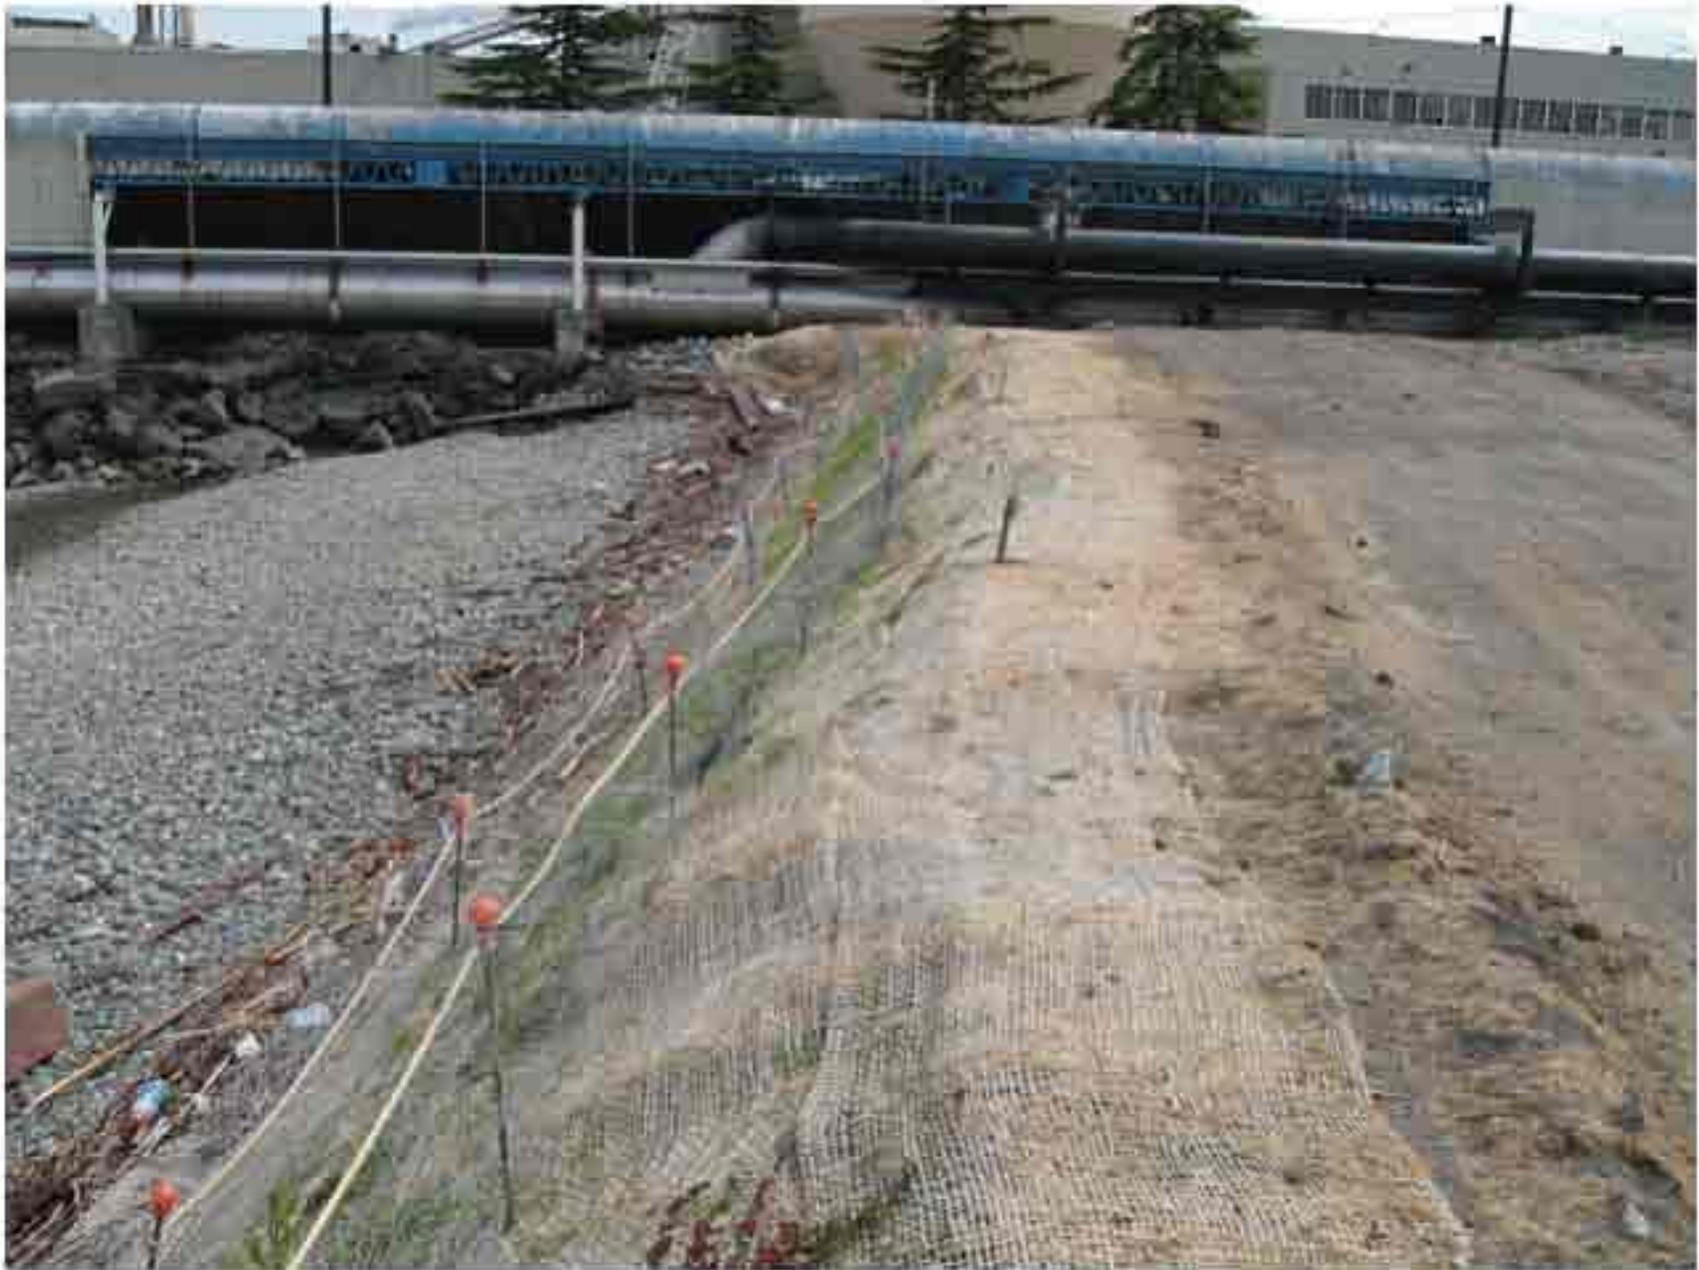
North Beach Habitat, Photo Point 2A, facing east. Photo taken July 11, 2006 at 10:56 AM, tide at approximately -2.76 feet MLLW.
[M G_0008]

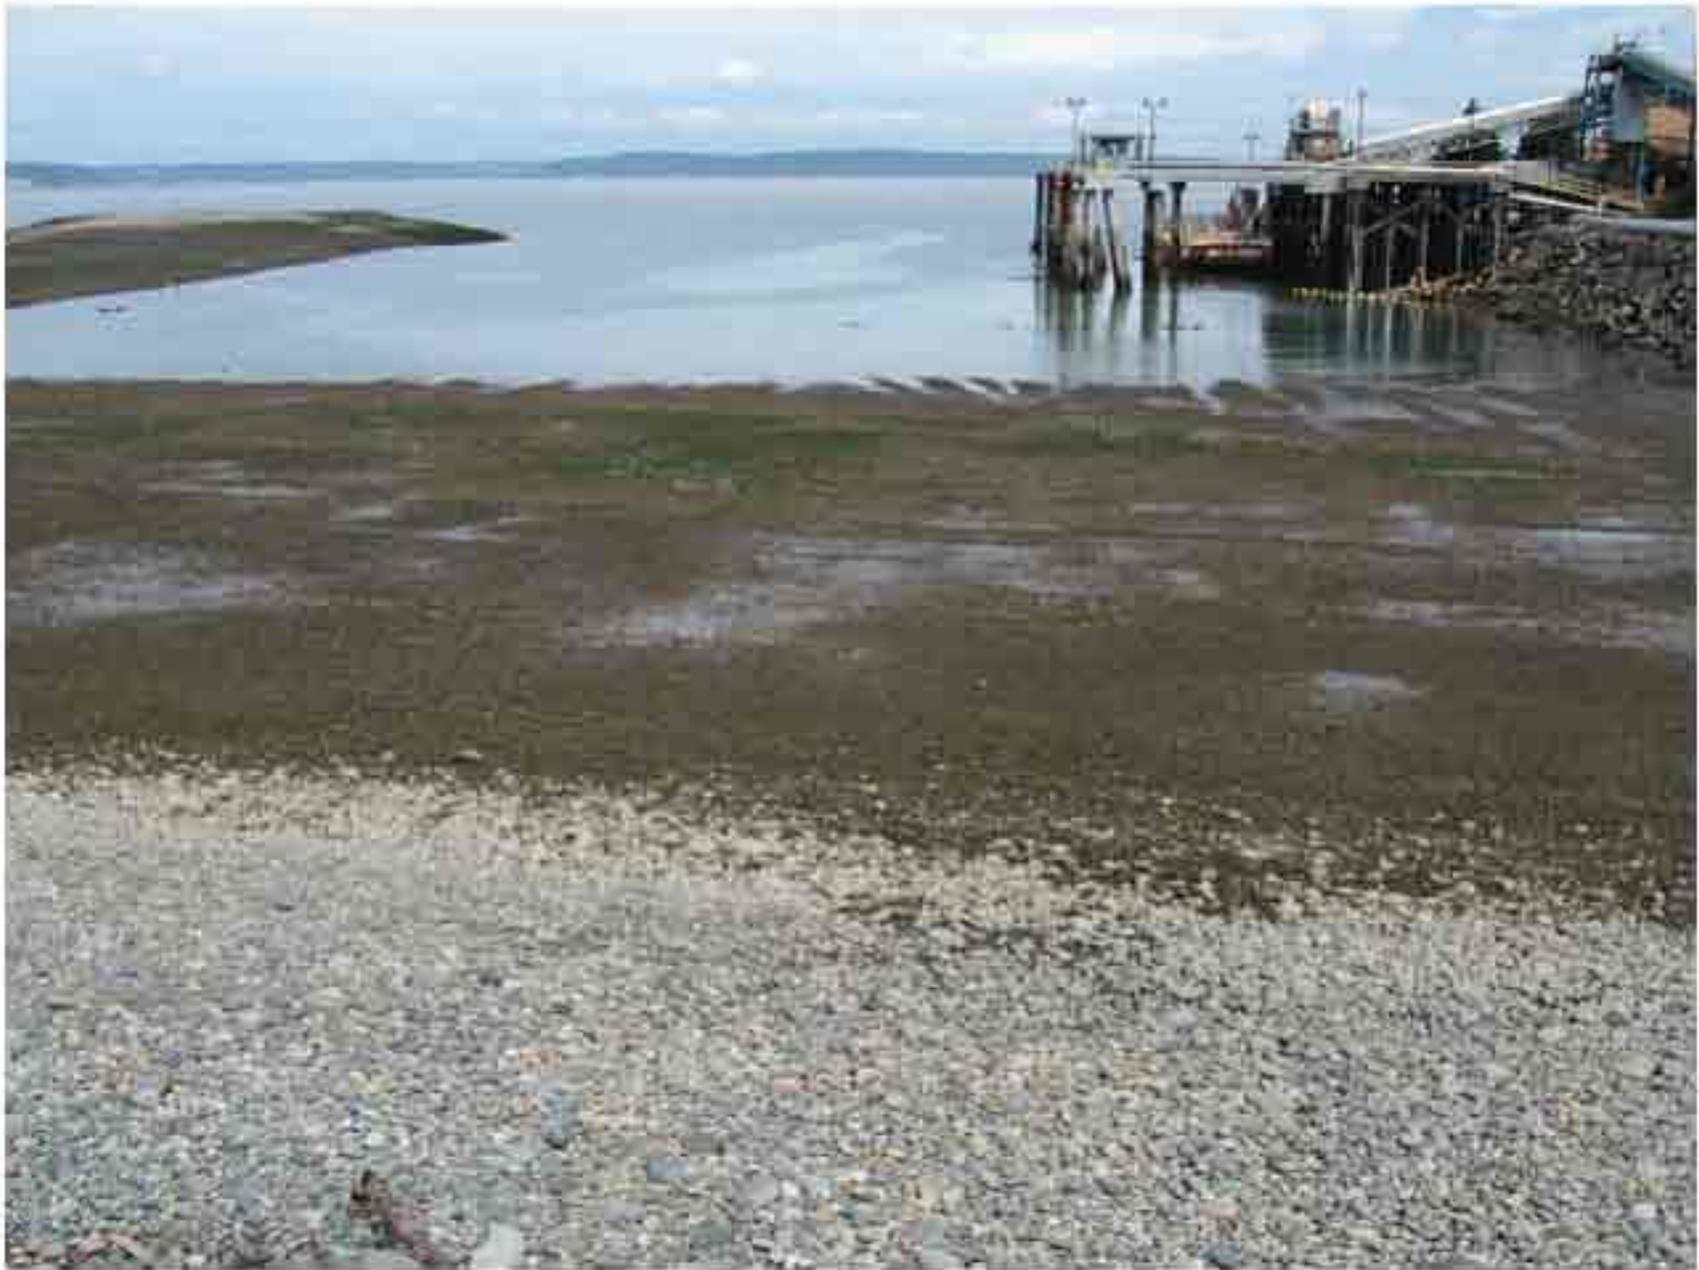
North Beach Habitat, Photo Point 2B, facing north. Photo taken July 11, 2006 at 11:56 AM, tide at approximately -2.76 feet MLLW [M G_0009]

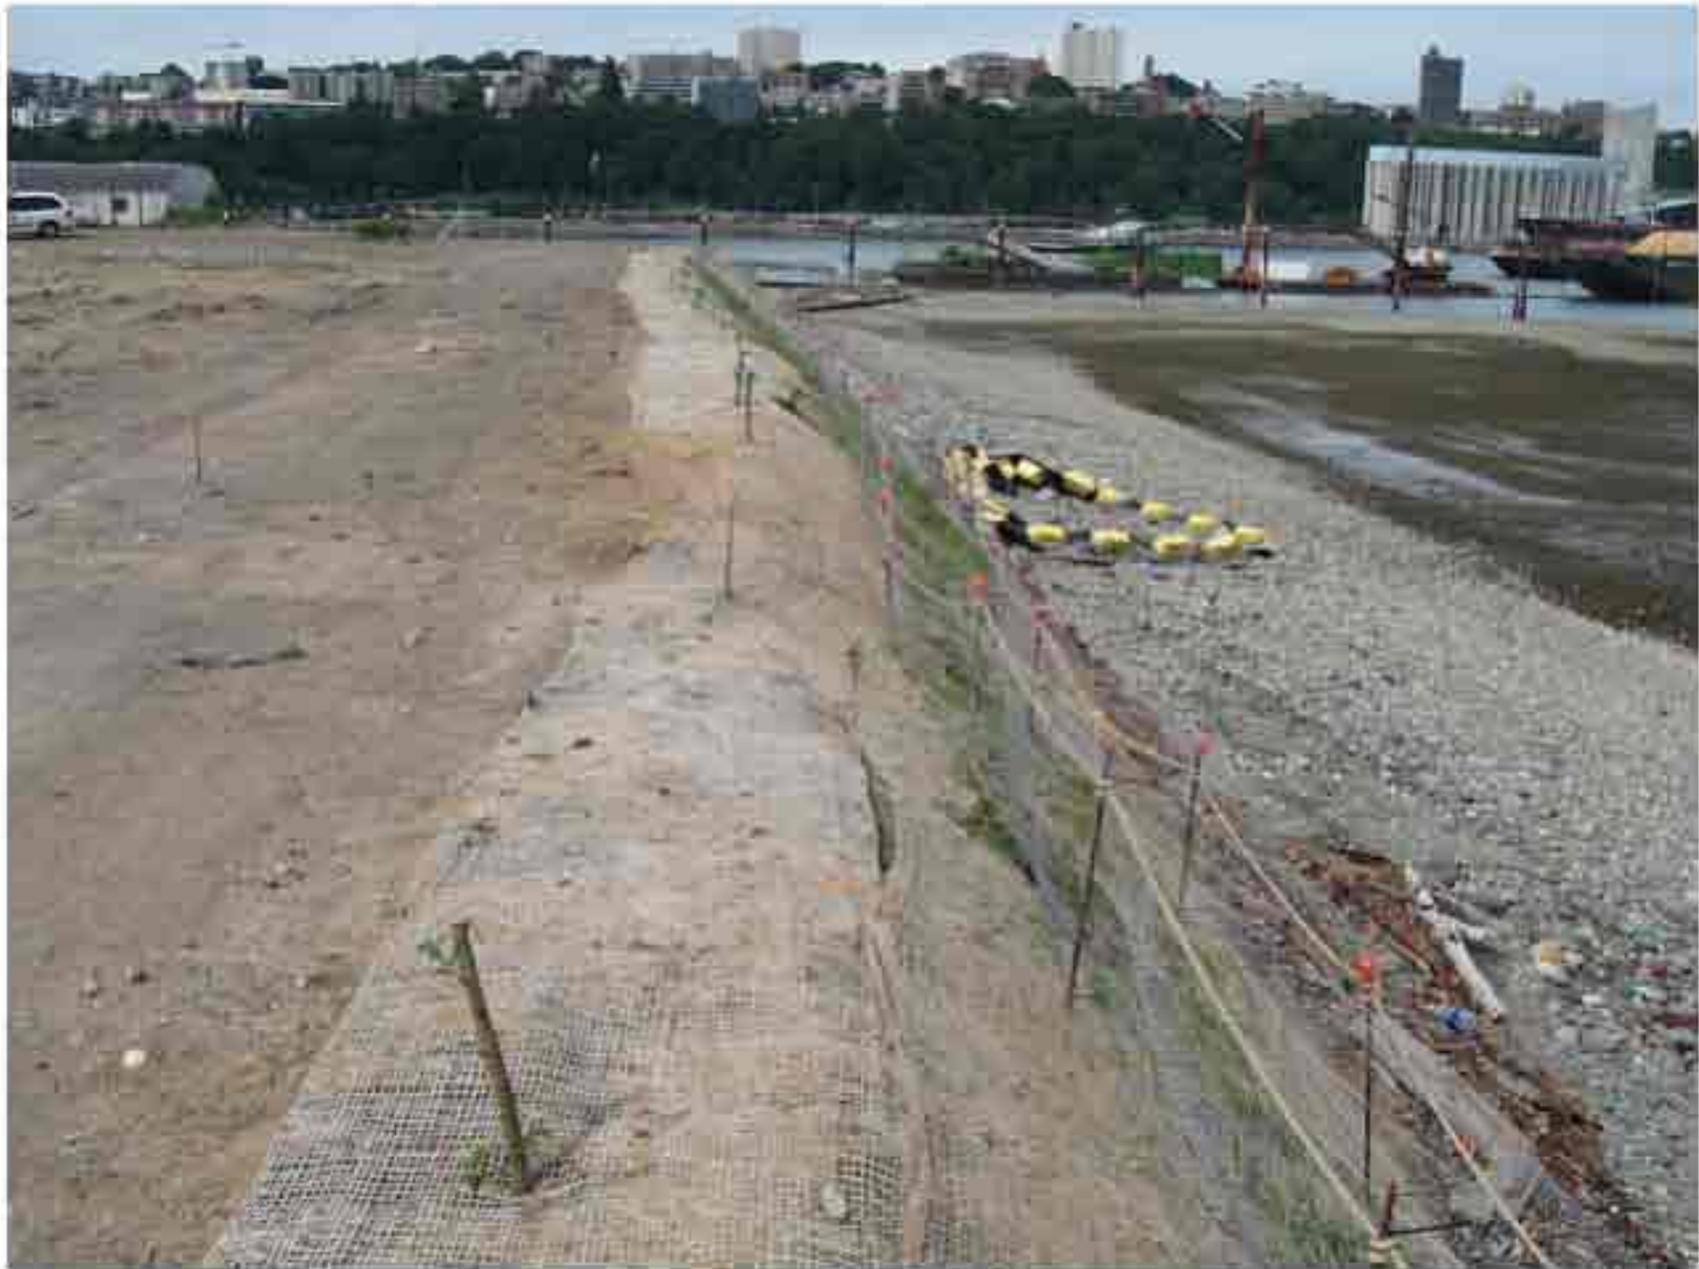
North Beach Habitat, Photo Point 2C, facing west. Photo taken July 11, 2006 at 10:56 AM, tide at approximately -2.76 feet MLLW. [IM G_0010]

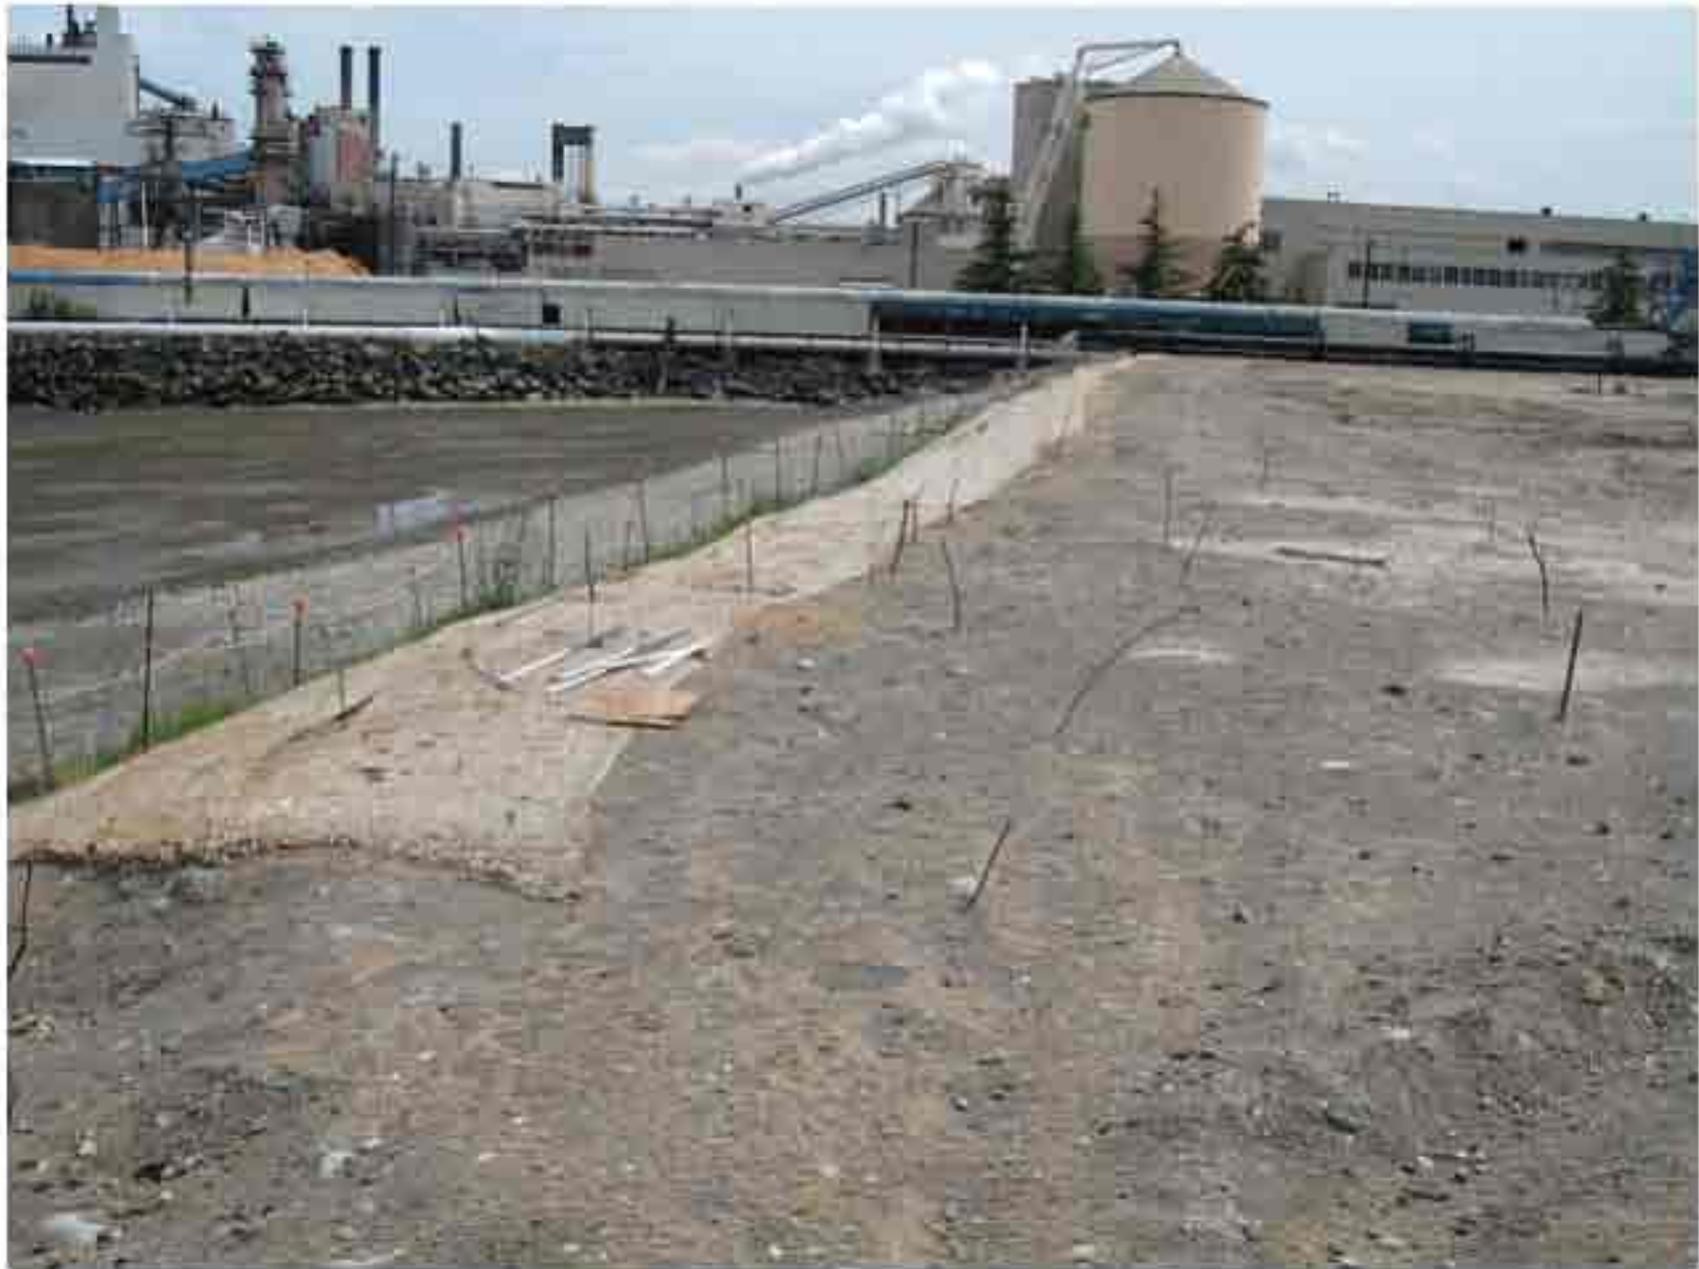
North Beach Habitat, Photo Point 3A, facing east. Photo taken July 11, 2006 at 11:10 AM, tide at approximately -3.03 feet MLLW. [M G_0011]

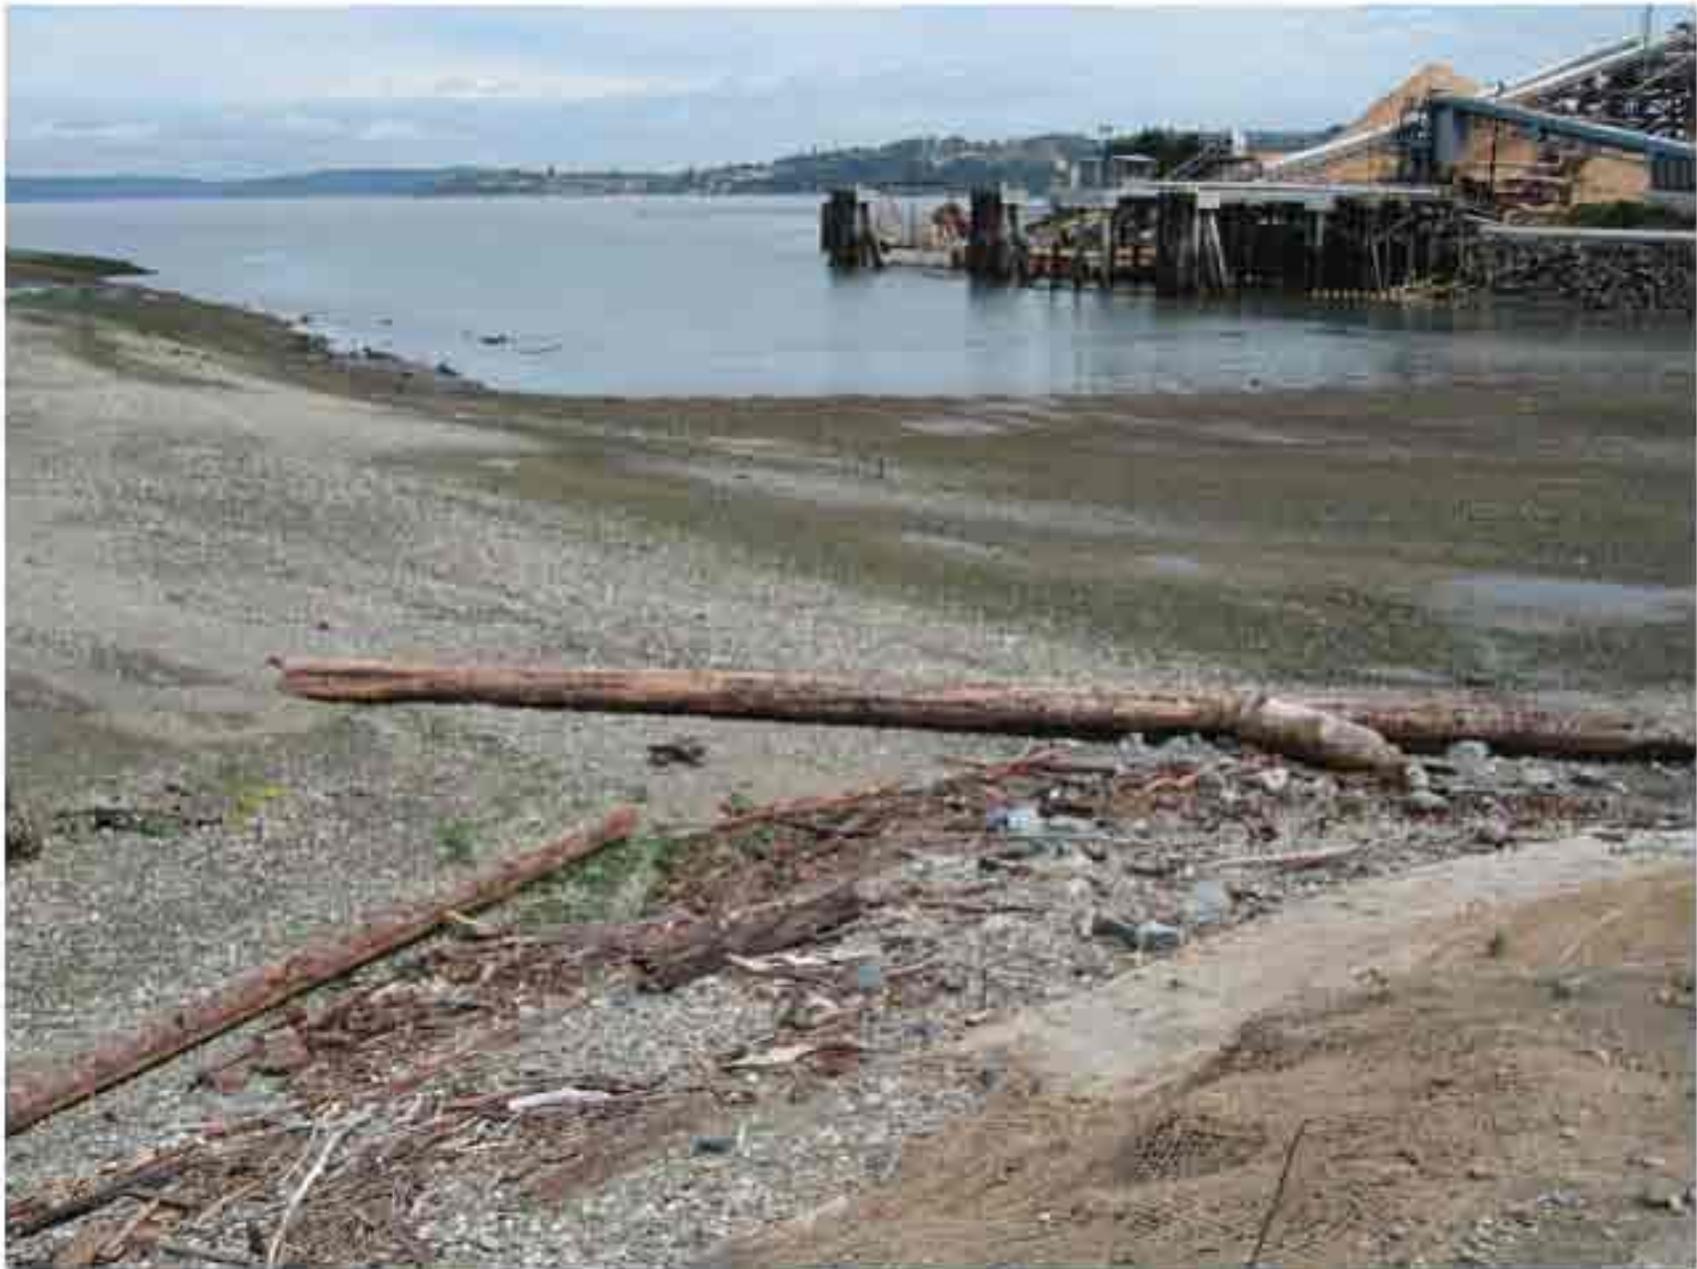
North Beach Habitat, Photo Point 3B, facing north. Photo taken July 11, 2006 at 11:10 AM, tide at approximately -3.03 feet MLLW [IM G_0012]

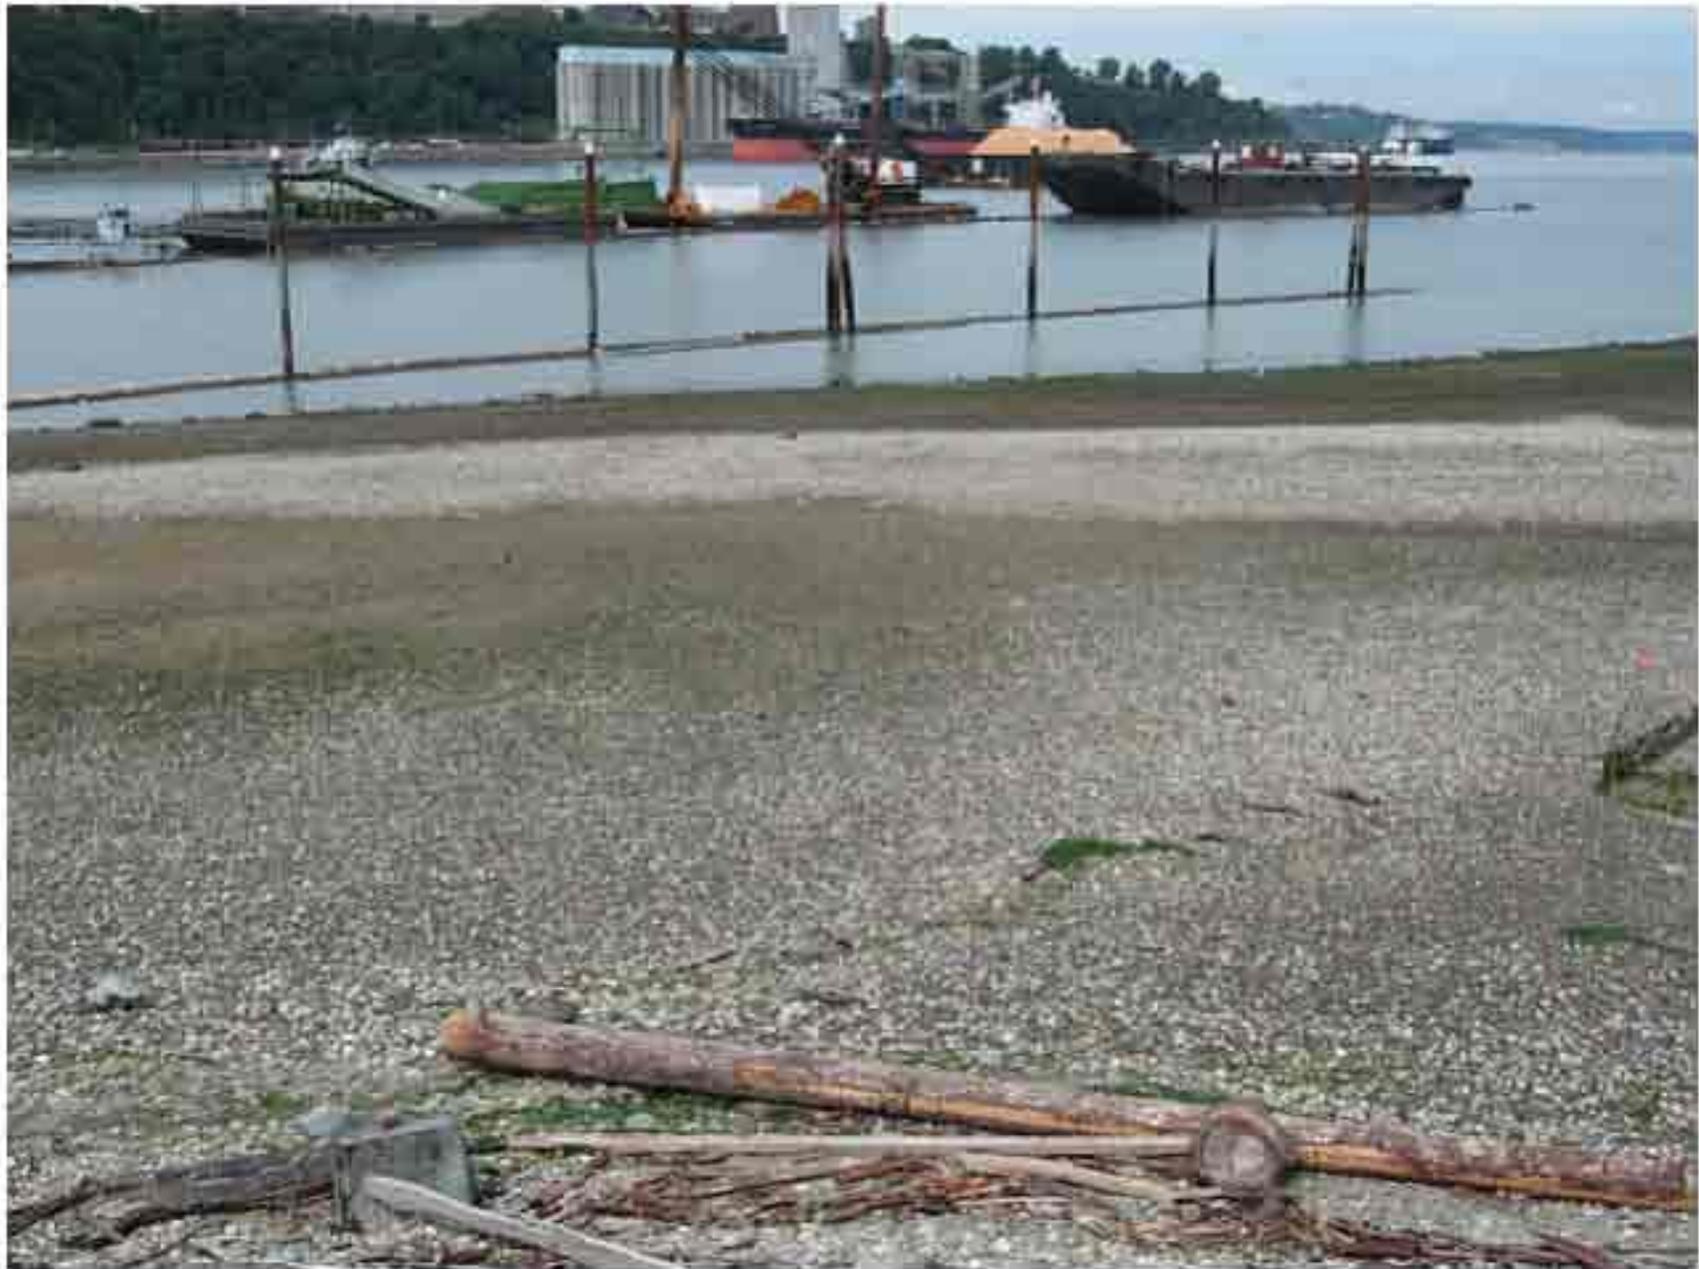
North Beach Habitat, Photo Point 3C, facing northwest. Photo taken July 11, 2006 at 11:10 AM, tide at approximately -3.03 feet MLLW. [IM G_0013]

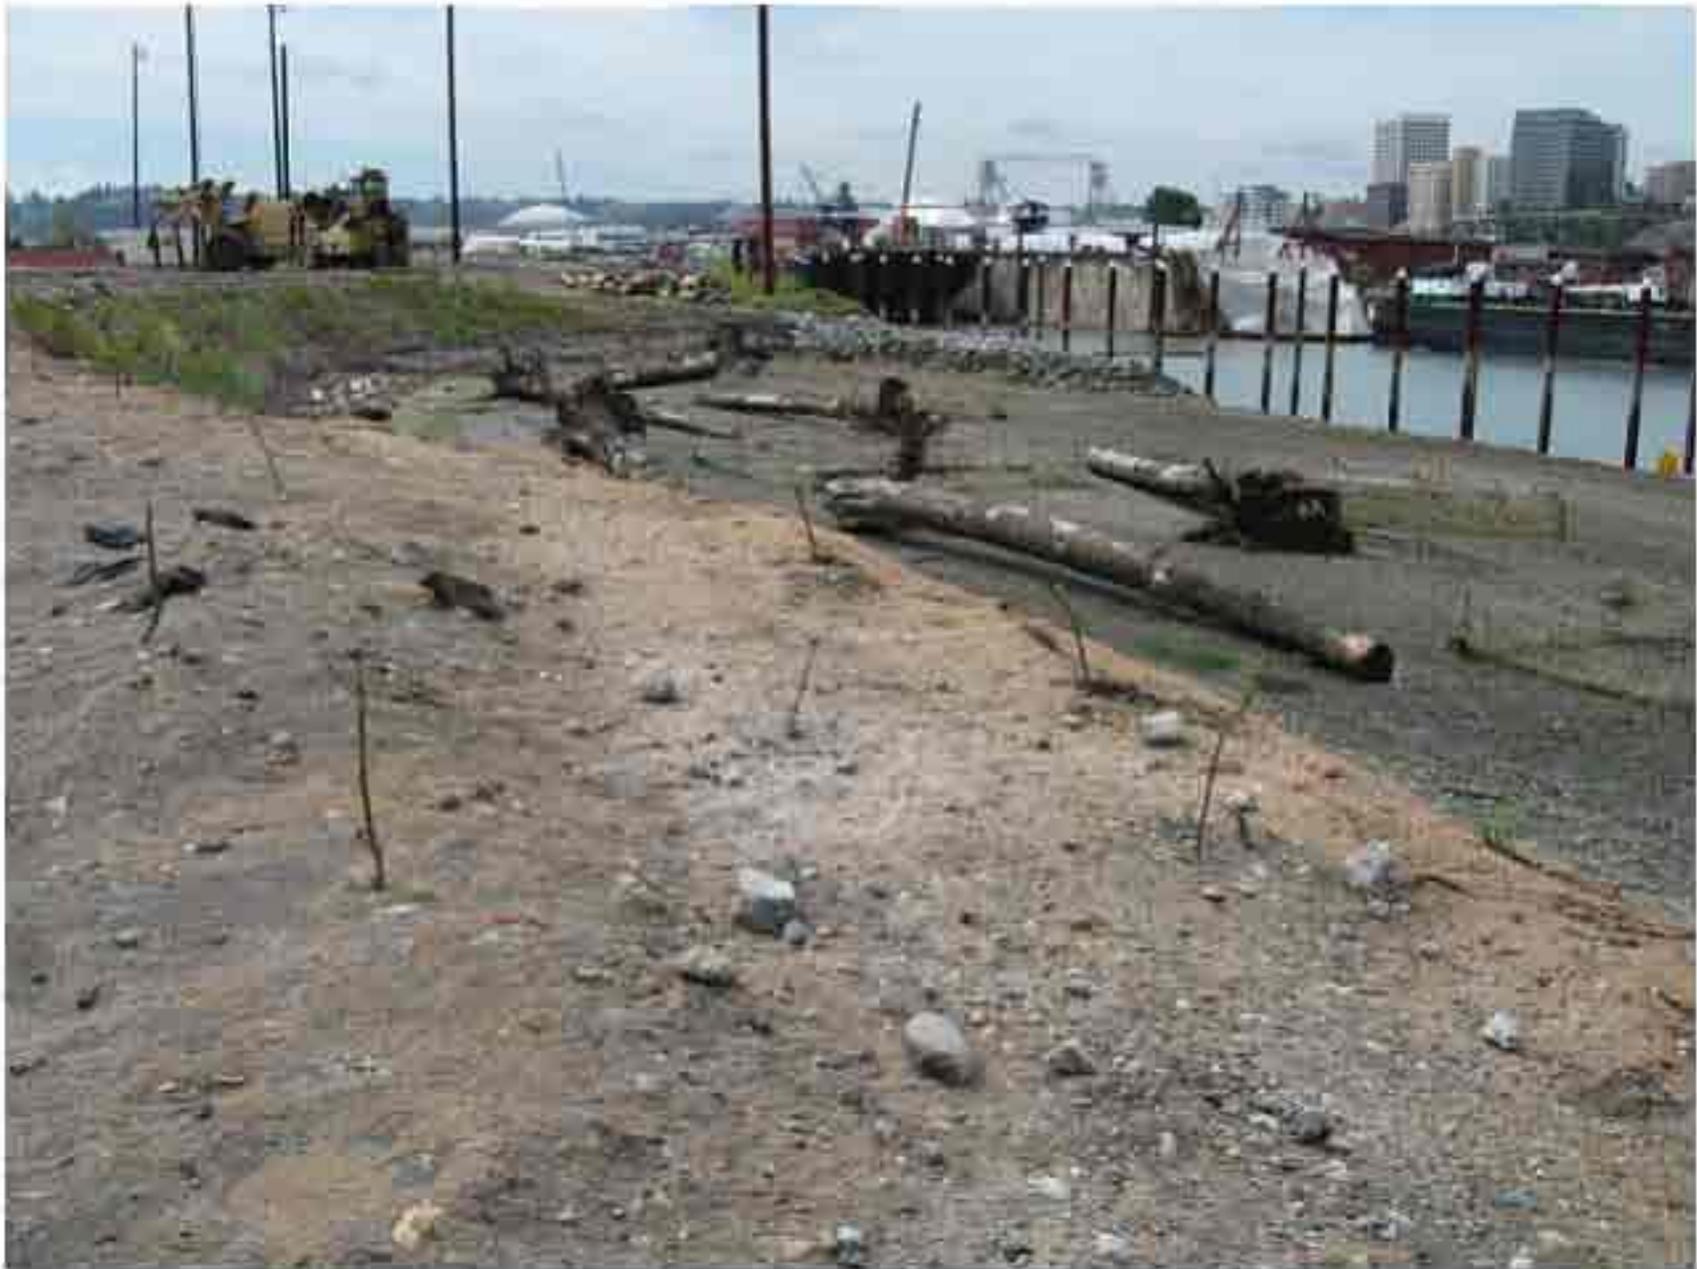
North Beach Habitat, Photo Point 3D, facing south. Photo taken July 11, 2006 at 11:10 AM, tide at approximately -3.03 feet MLLW. [M G_0014]

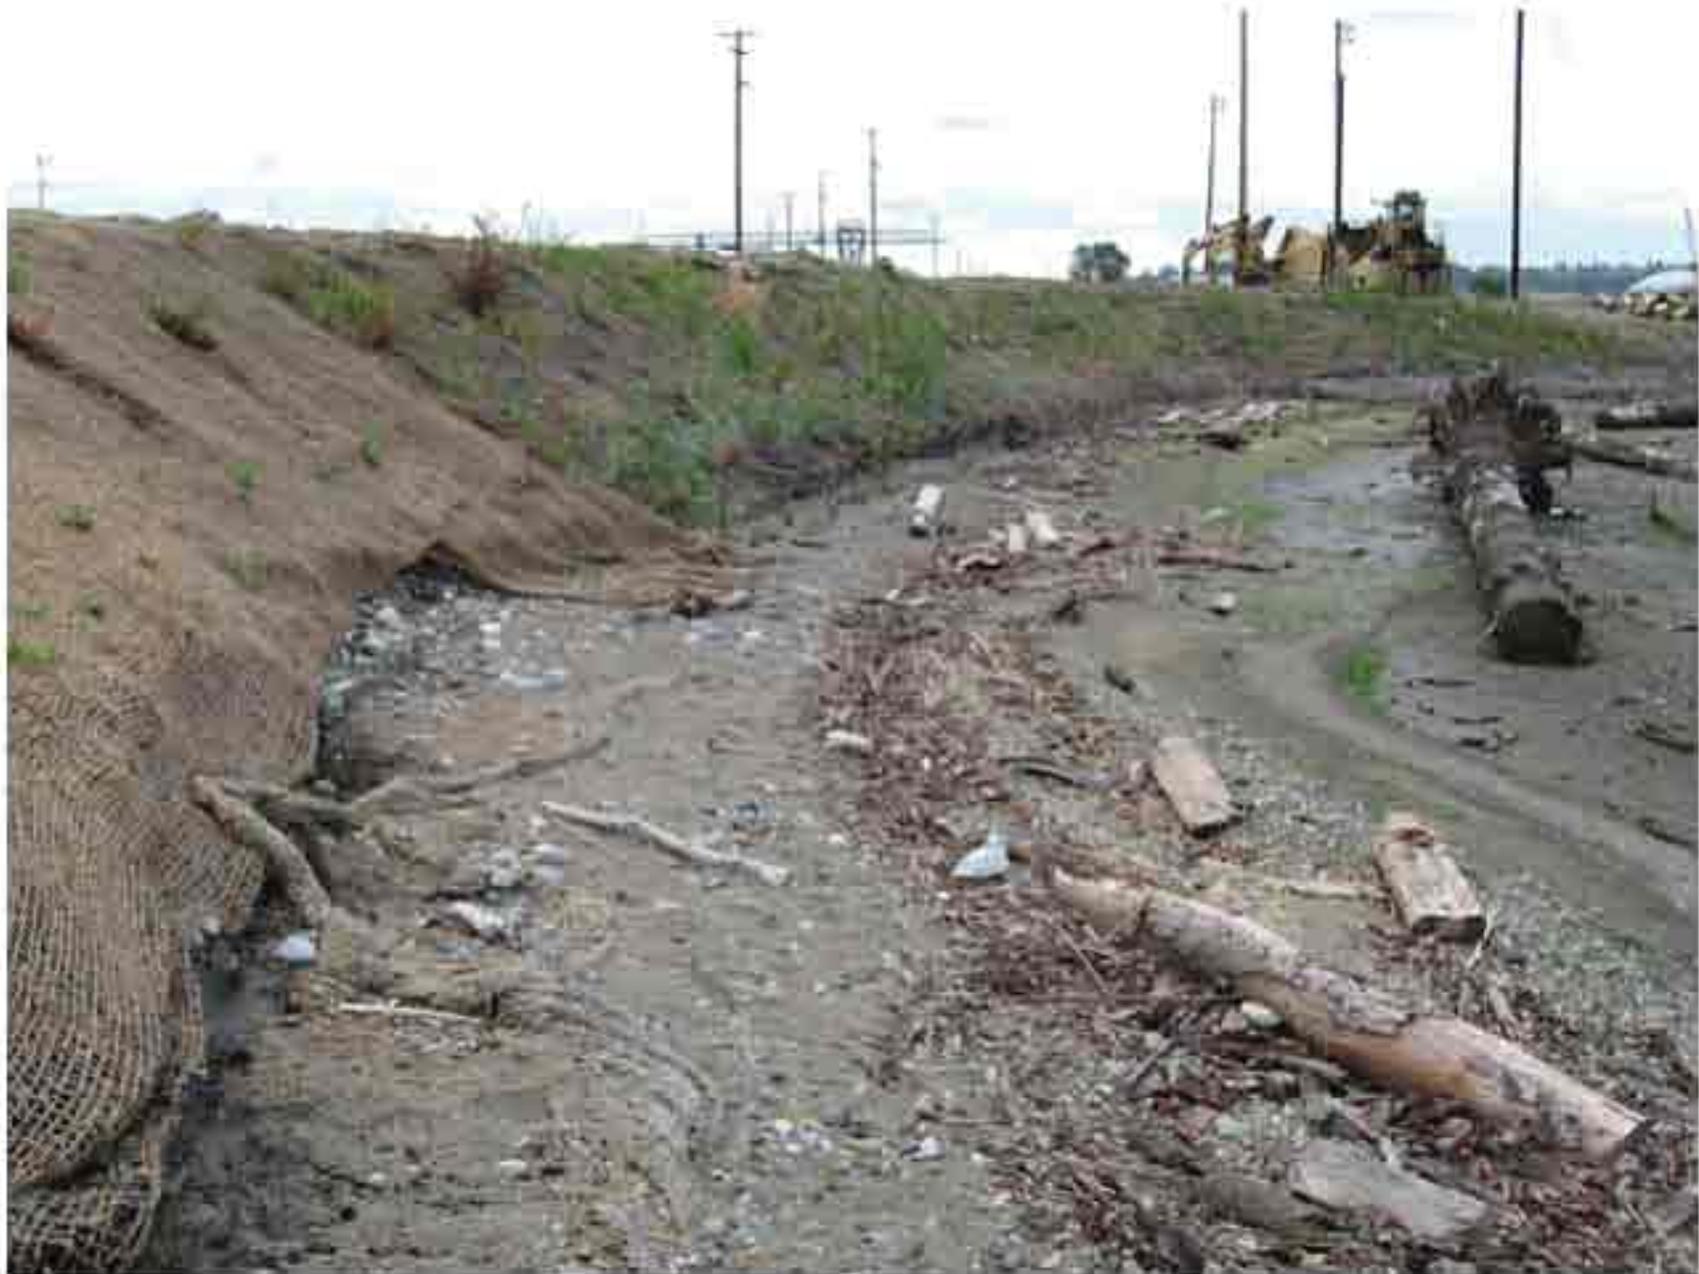
North Beach Habitat, Photo Point 4A, facing south. Photo taken July 11, 2006 at 11:19 AM, tide at approximately -3.15 feet MLLW [IMG_0015]
