THEA FOSS AND WHEELER-OSGOOD WATERWAYS REMEDIATION PROJECT

YEAR 0 BASELINE MONITORING

HABITAT MITIGATION AREA MONITORING PRELIMINARY FINDINGS MEMORANDUM

NOVEMBER 30, 2006

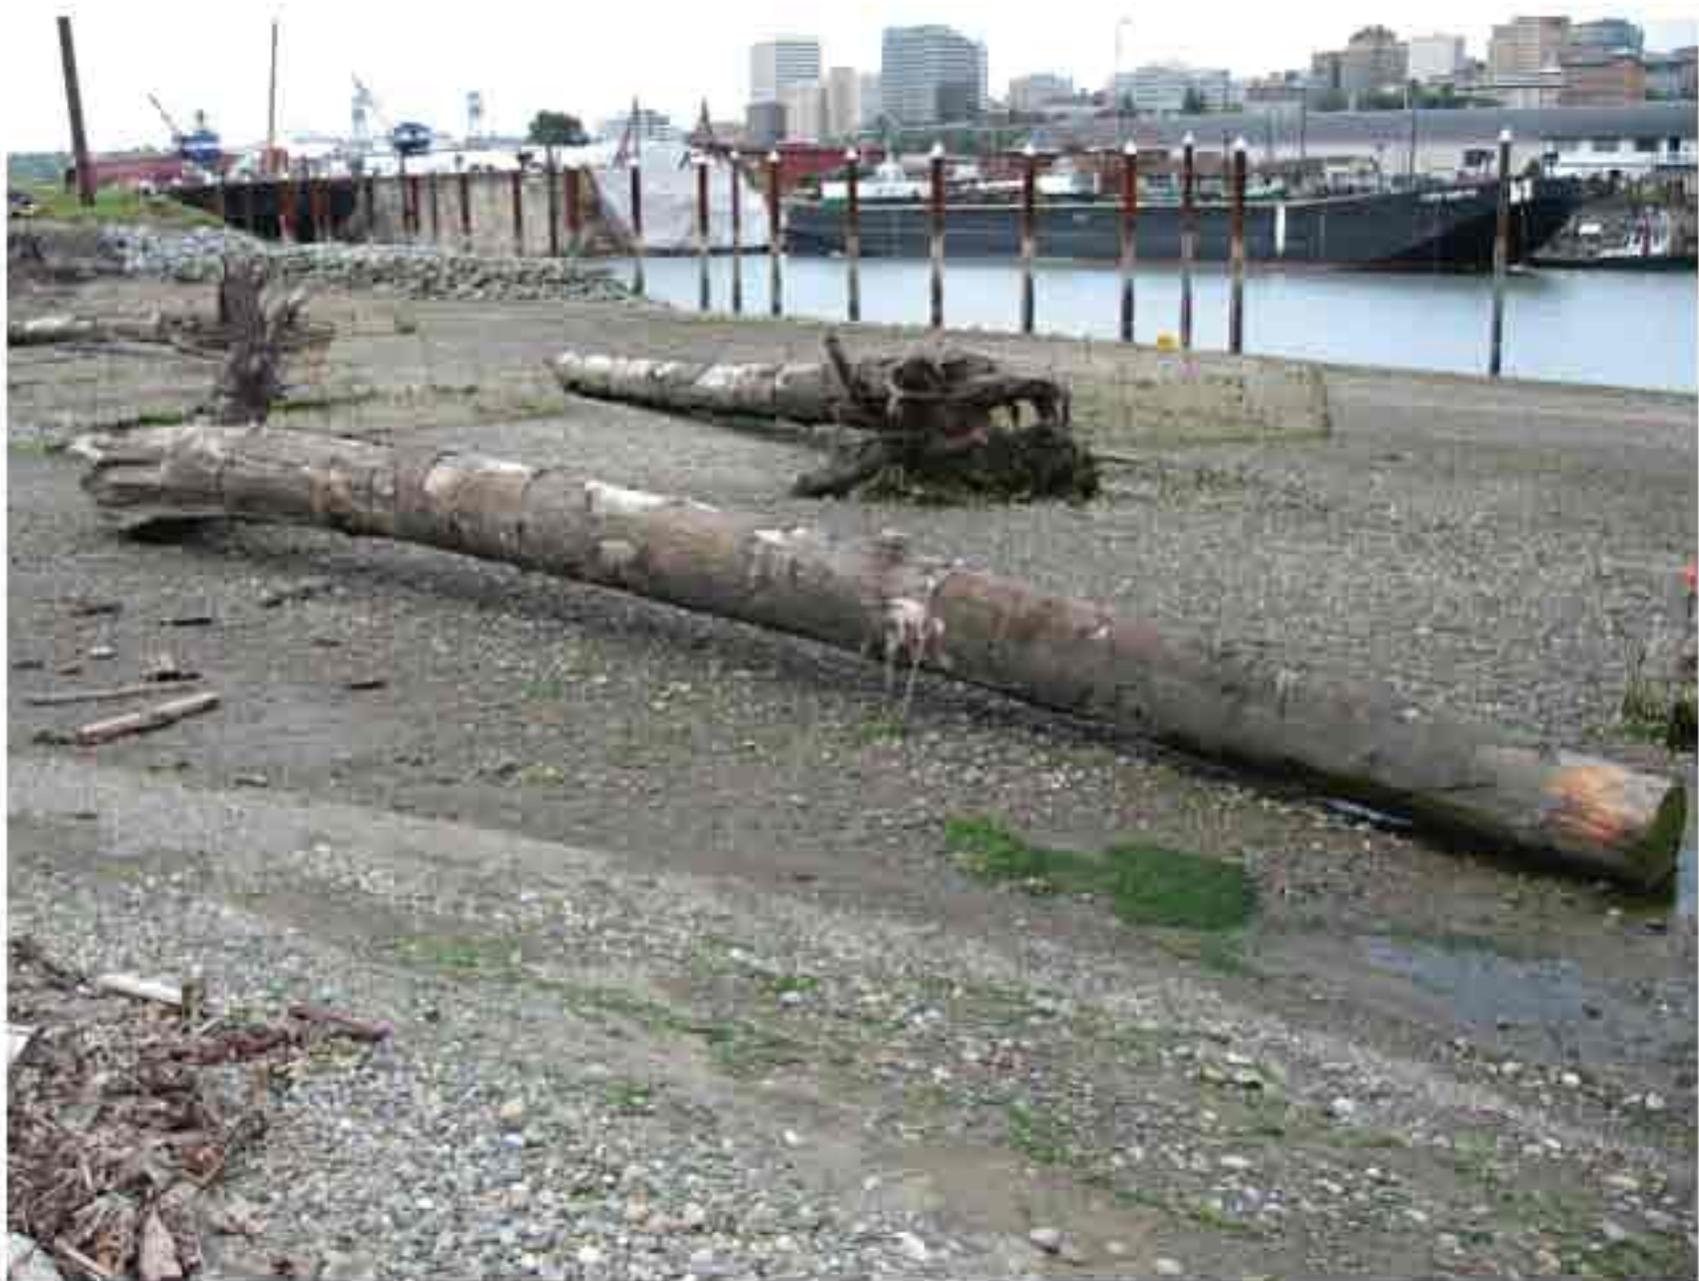
North Beach Habitat, Photo Point 4B, facing southwest. Photo taken July 11, 2006 at 11:19 AM, tide at approximately -3.15 feet MLLW. [M G_0016]

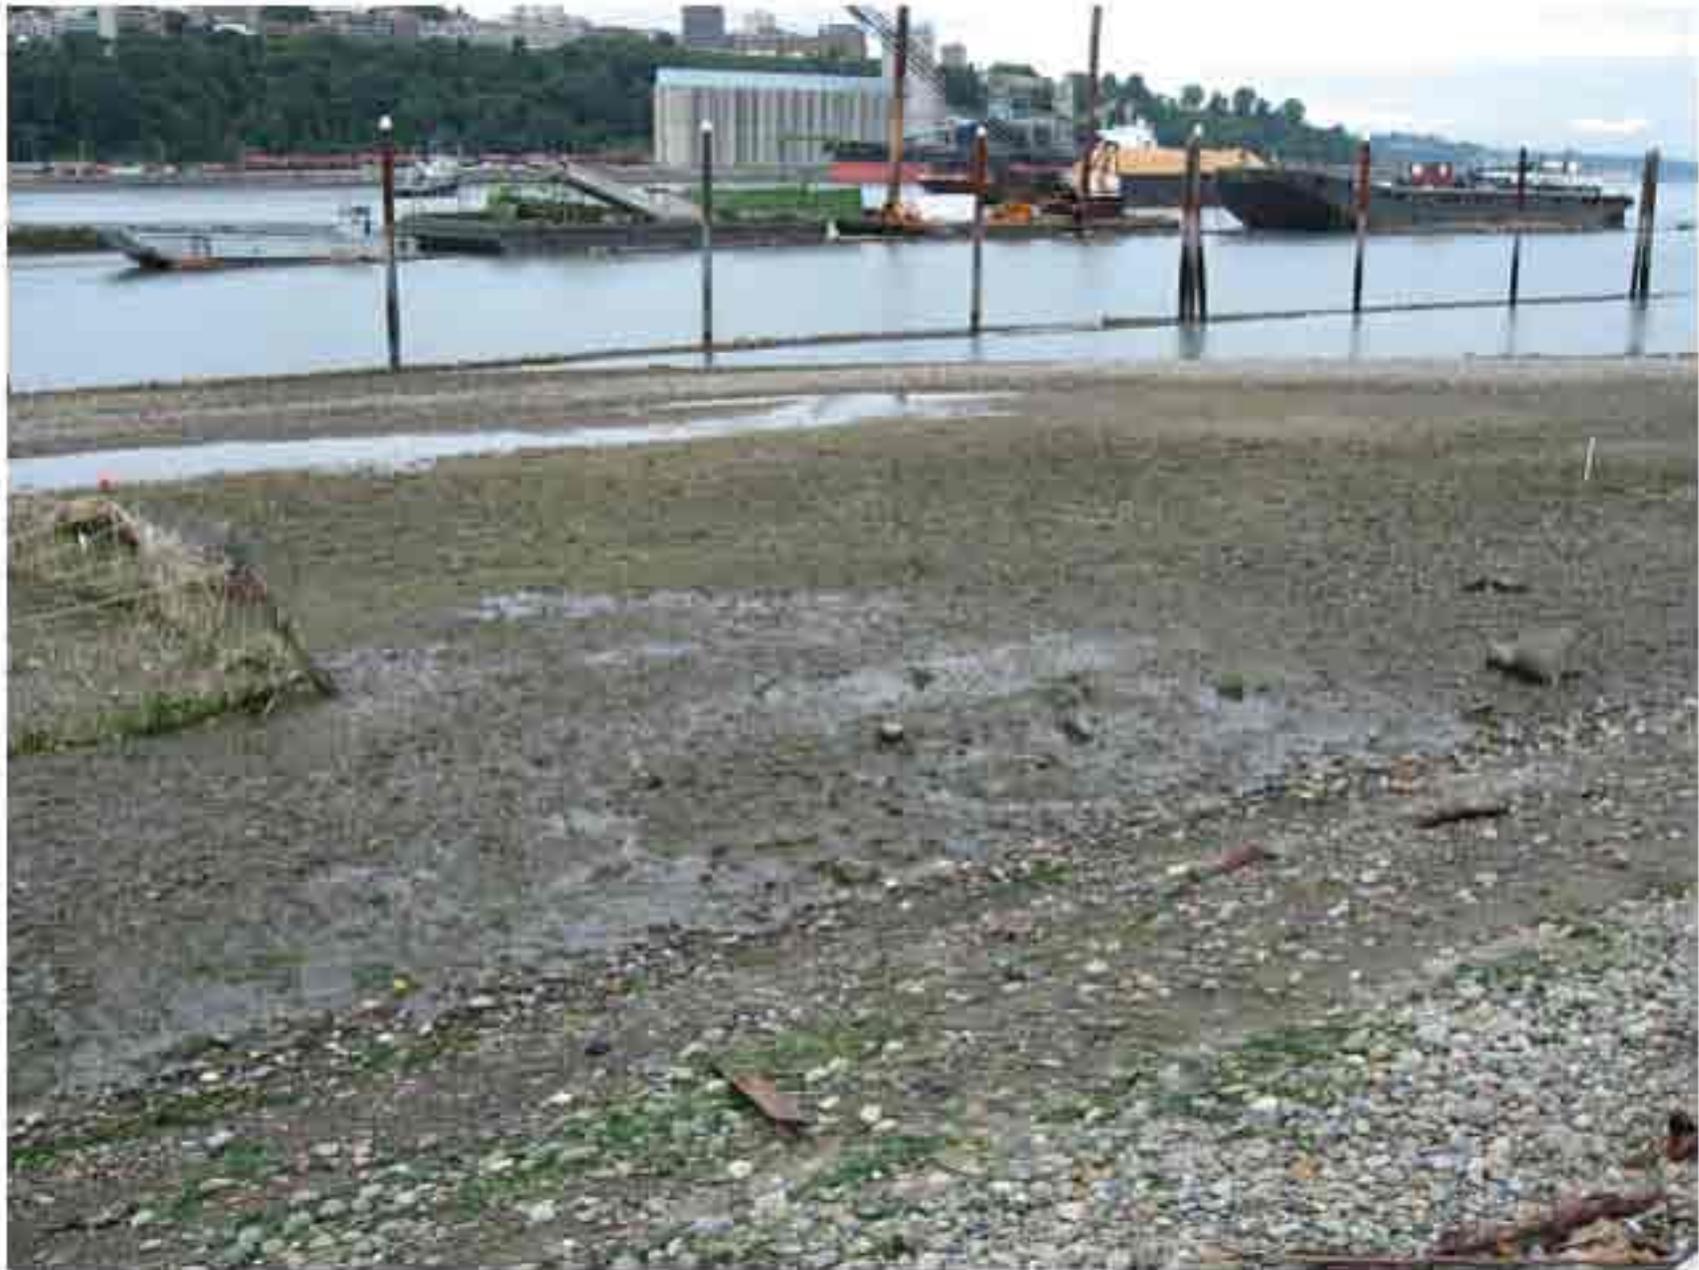
North Beach Habitat, Photo Point 4C, facing northwest. Photo taken July 11, 2006 at 11:19 AM, tide at approximately -3.15 feet MLLW. [IMG_0017]

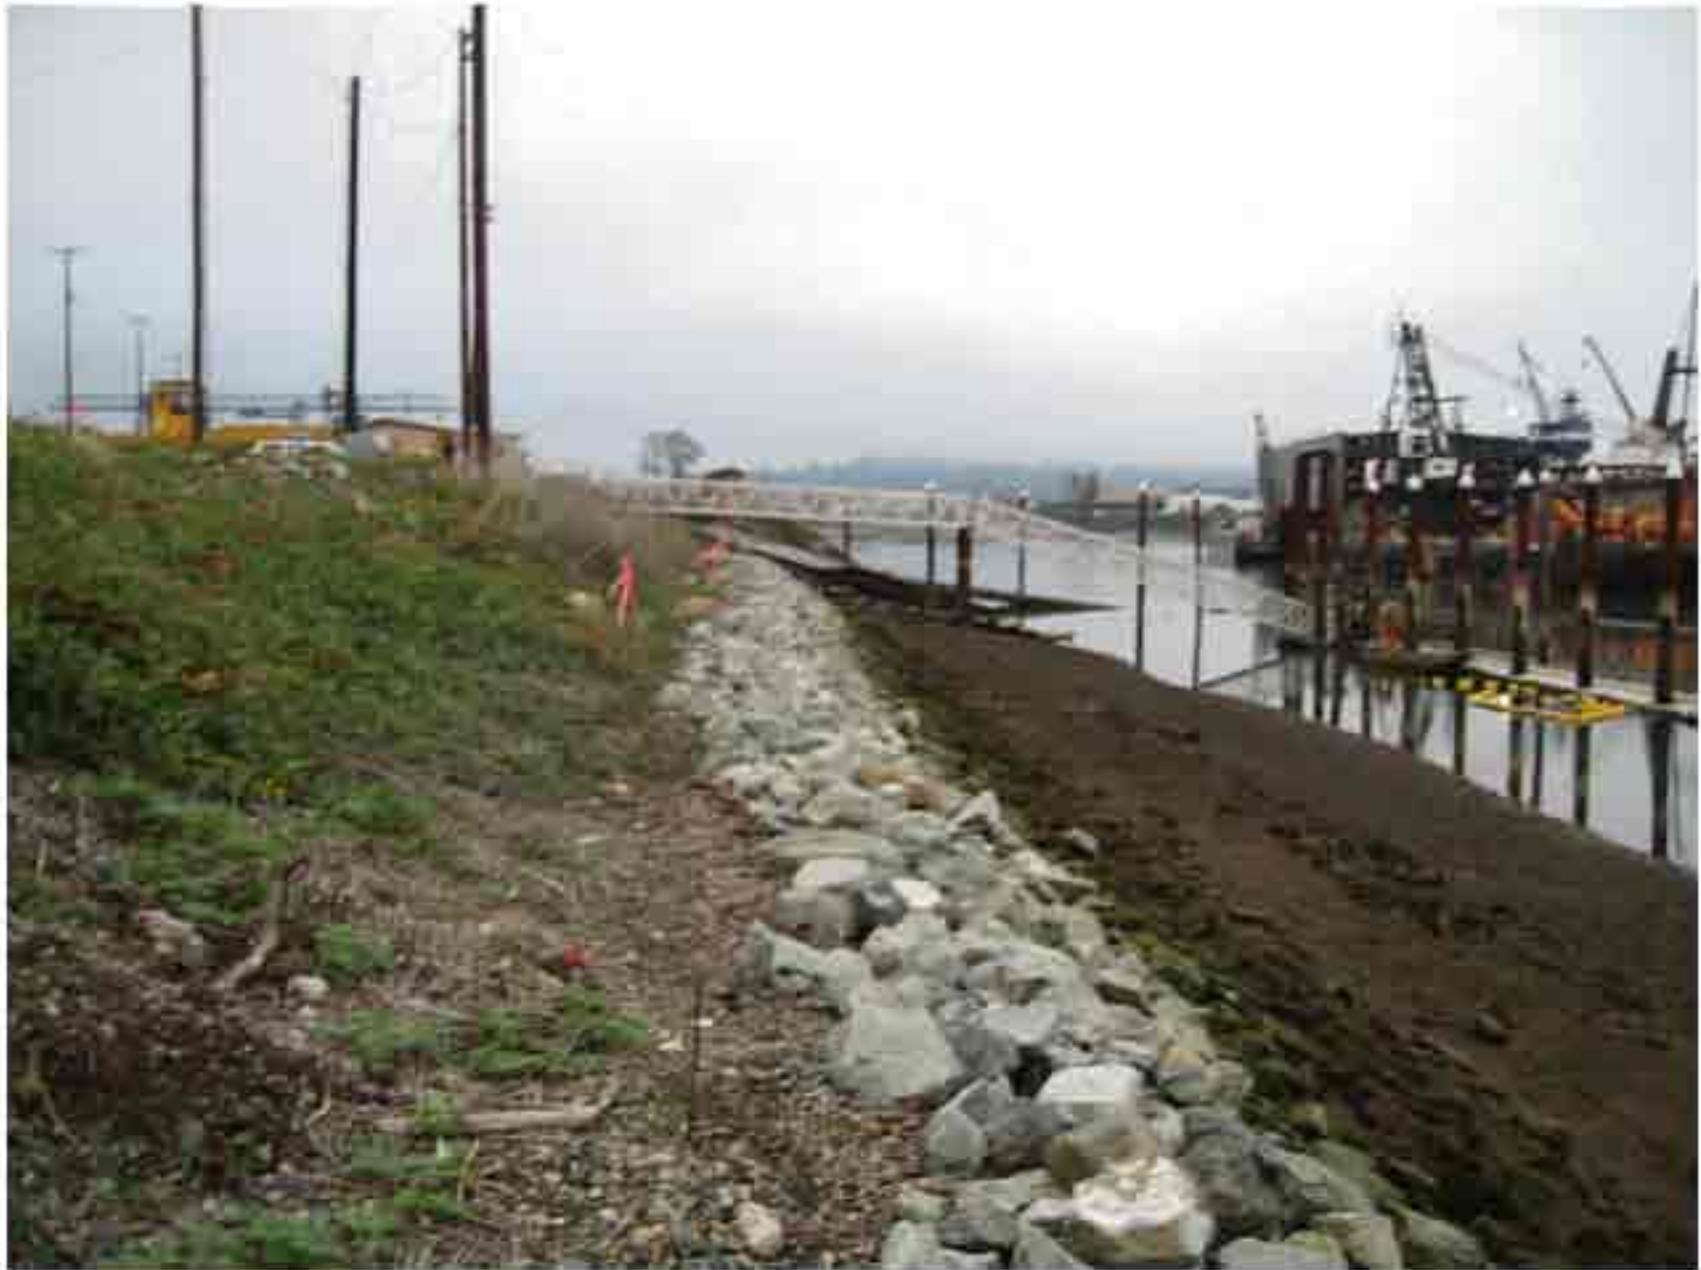
North Beach Habitat, Photo Point 5A, facing south. Photo taken October 17, 2006 at 8:40 AM, tide at approximately 1.91 feet MLLW. [M G_0058]

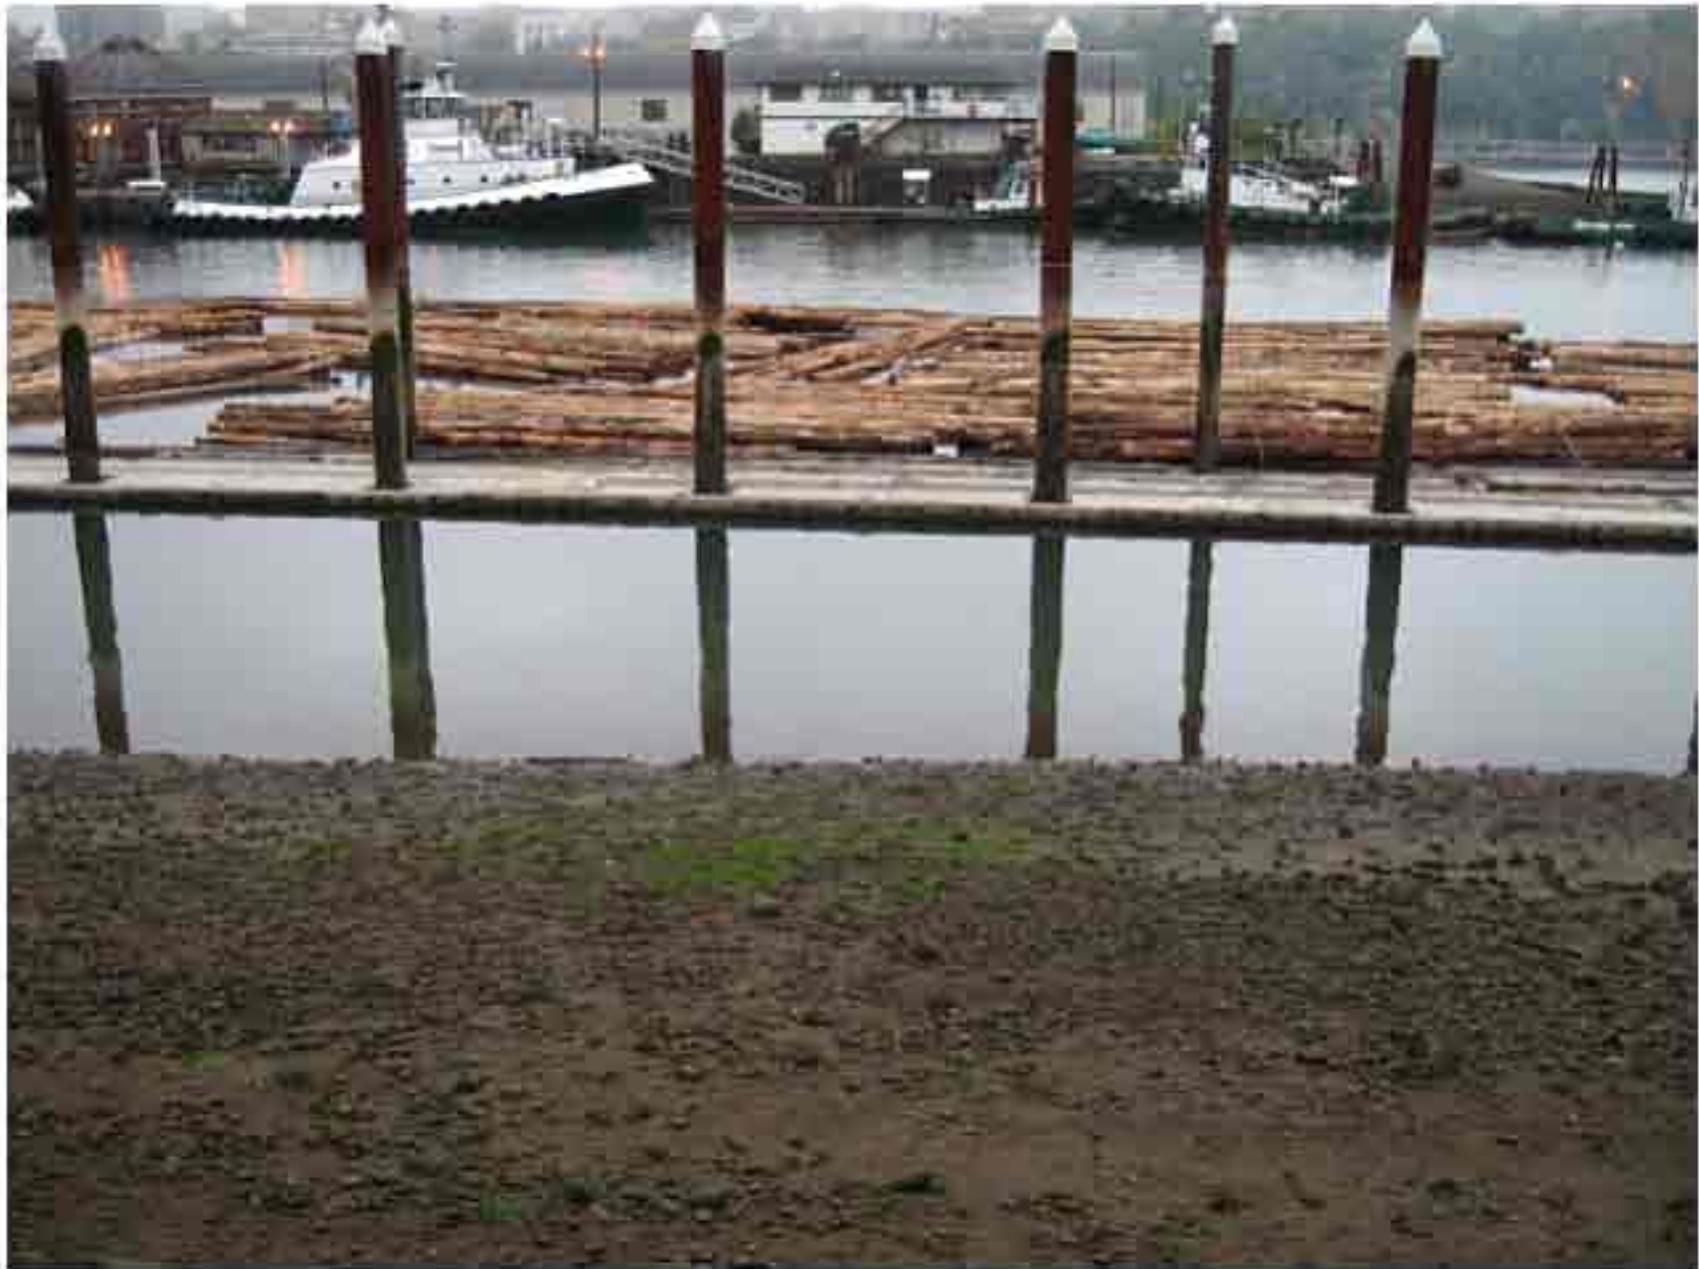
North Beach Habitat, Photo Point 5B, facing west. Photo taken October 17, 2006 at 8:40 AM, tide at approximately 1.91 feet MLLW. [IM G_0059]

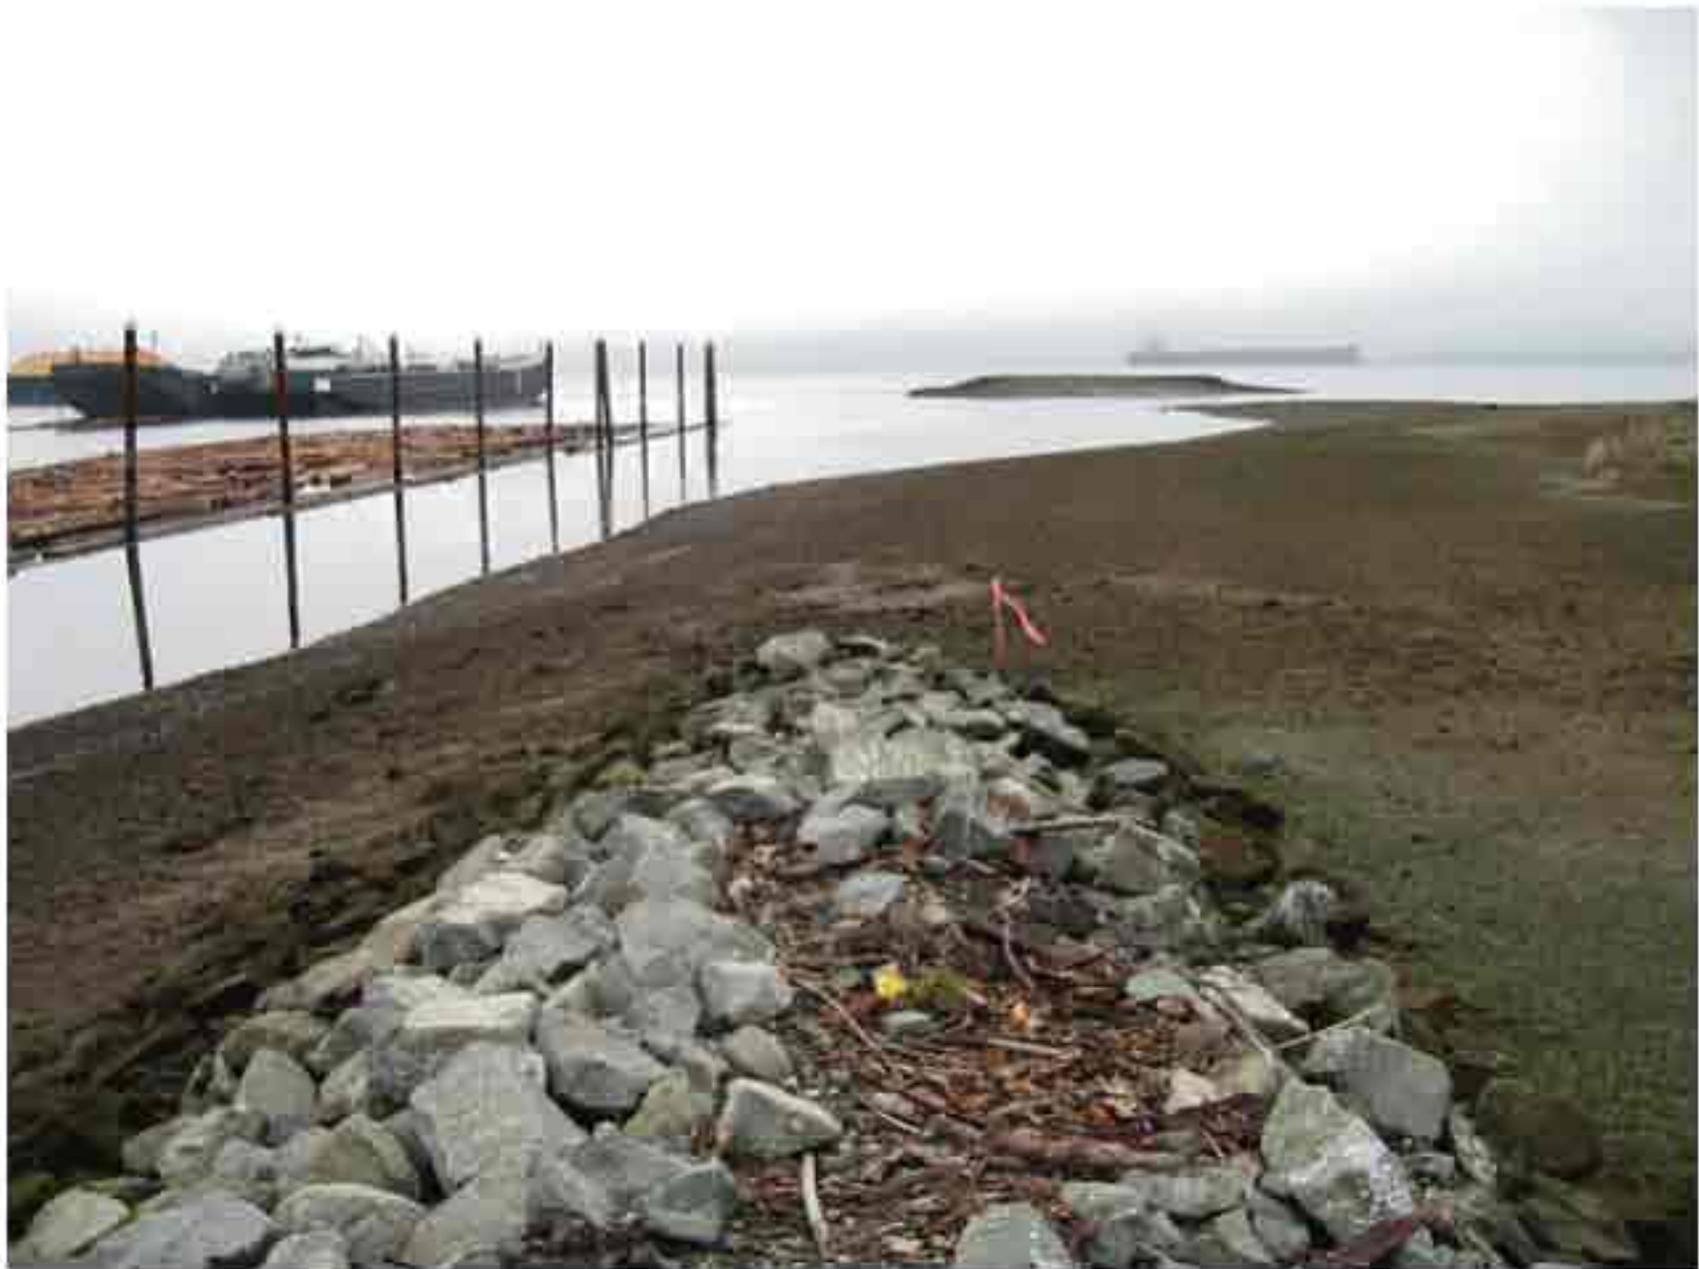
North Beach Habitat, Photo Point 5C, facing north. Photo taken October 17, 2006 at 8:40 A.M., tide at approximately 1.91 feet MLLW. [M G_0060]

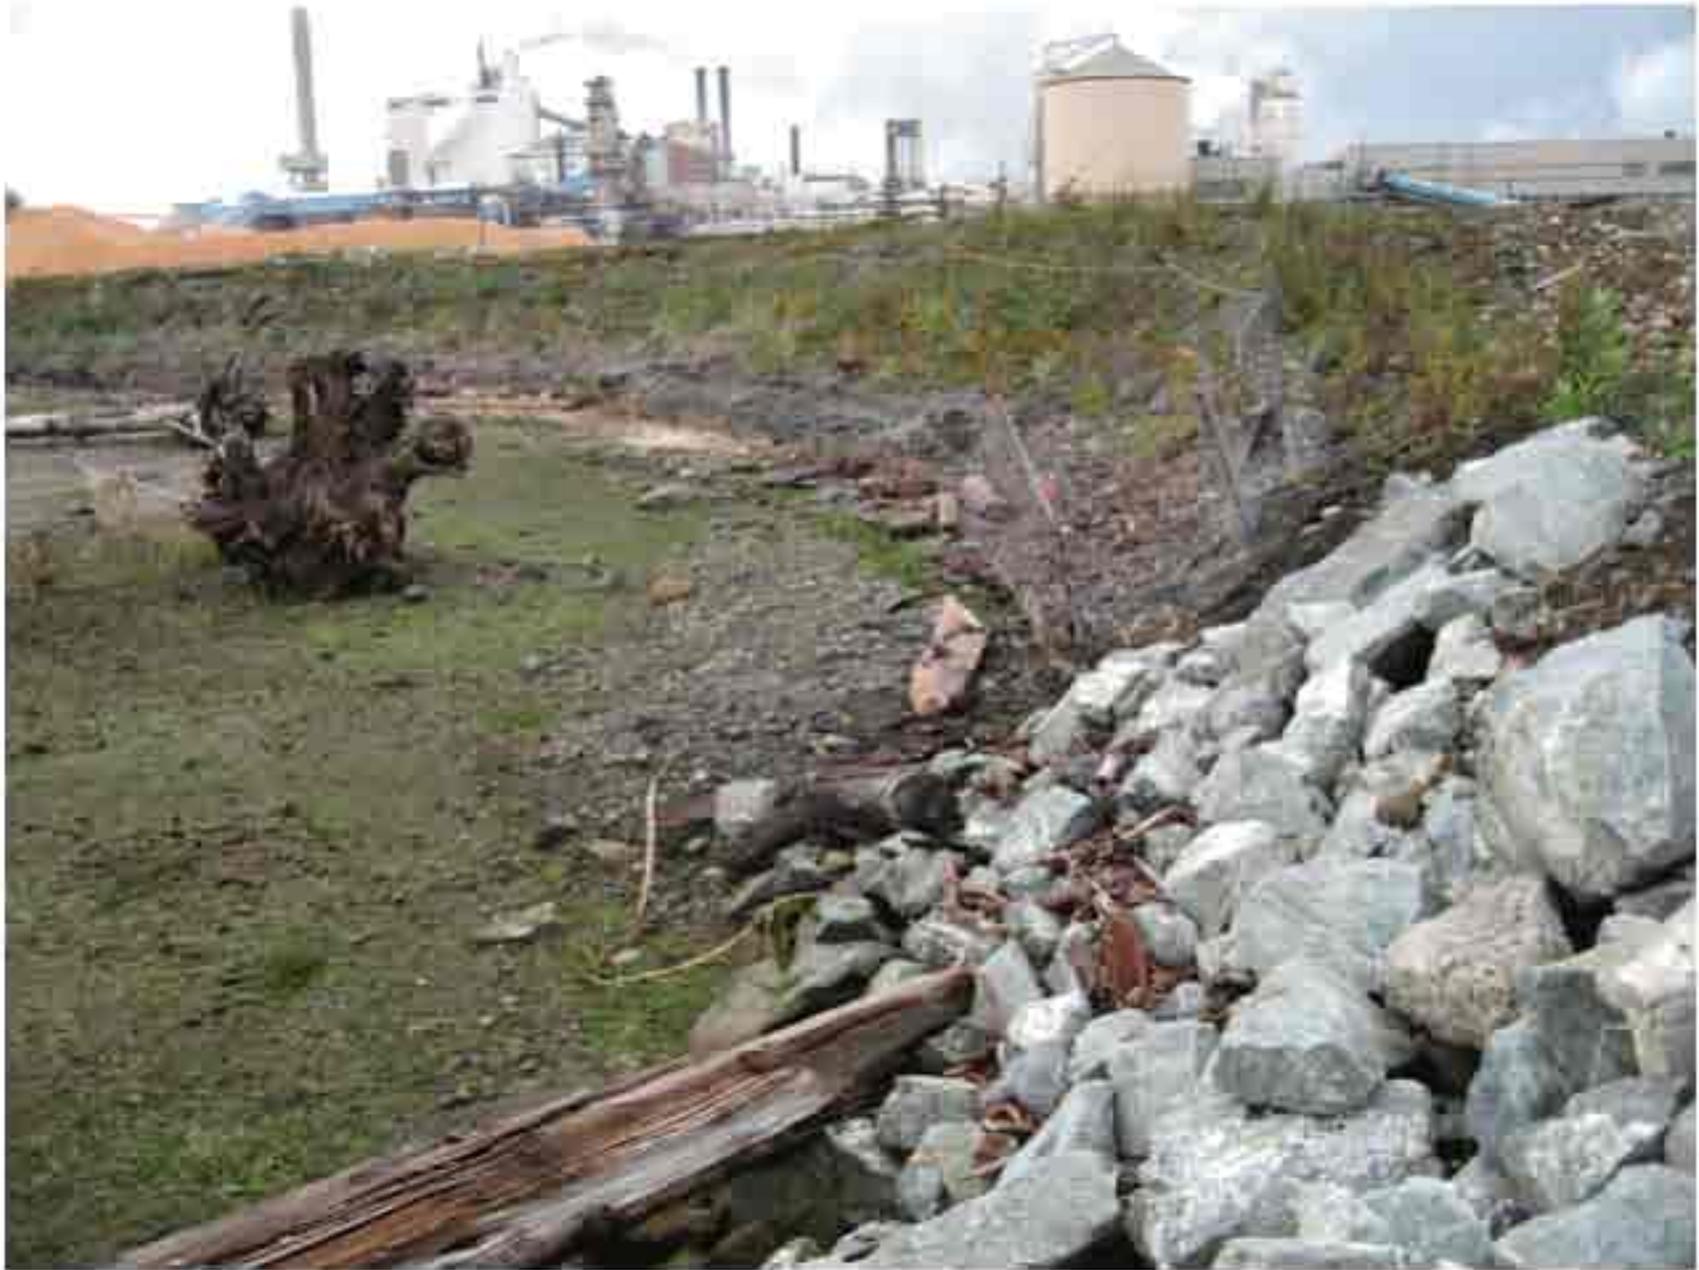
North Beach Habitat, Photo Point 5D, facing east. Photo taken October 17, 2006 at 8:40 AM, tide at approximately 1.91 feet MLLW. [M G_0061]

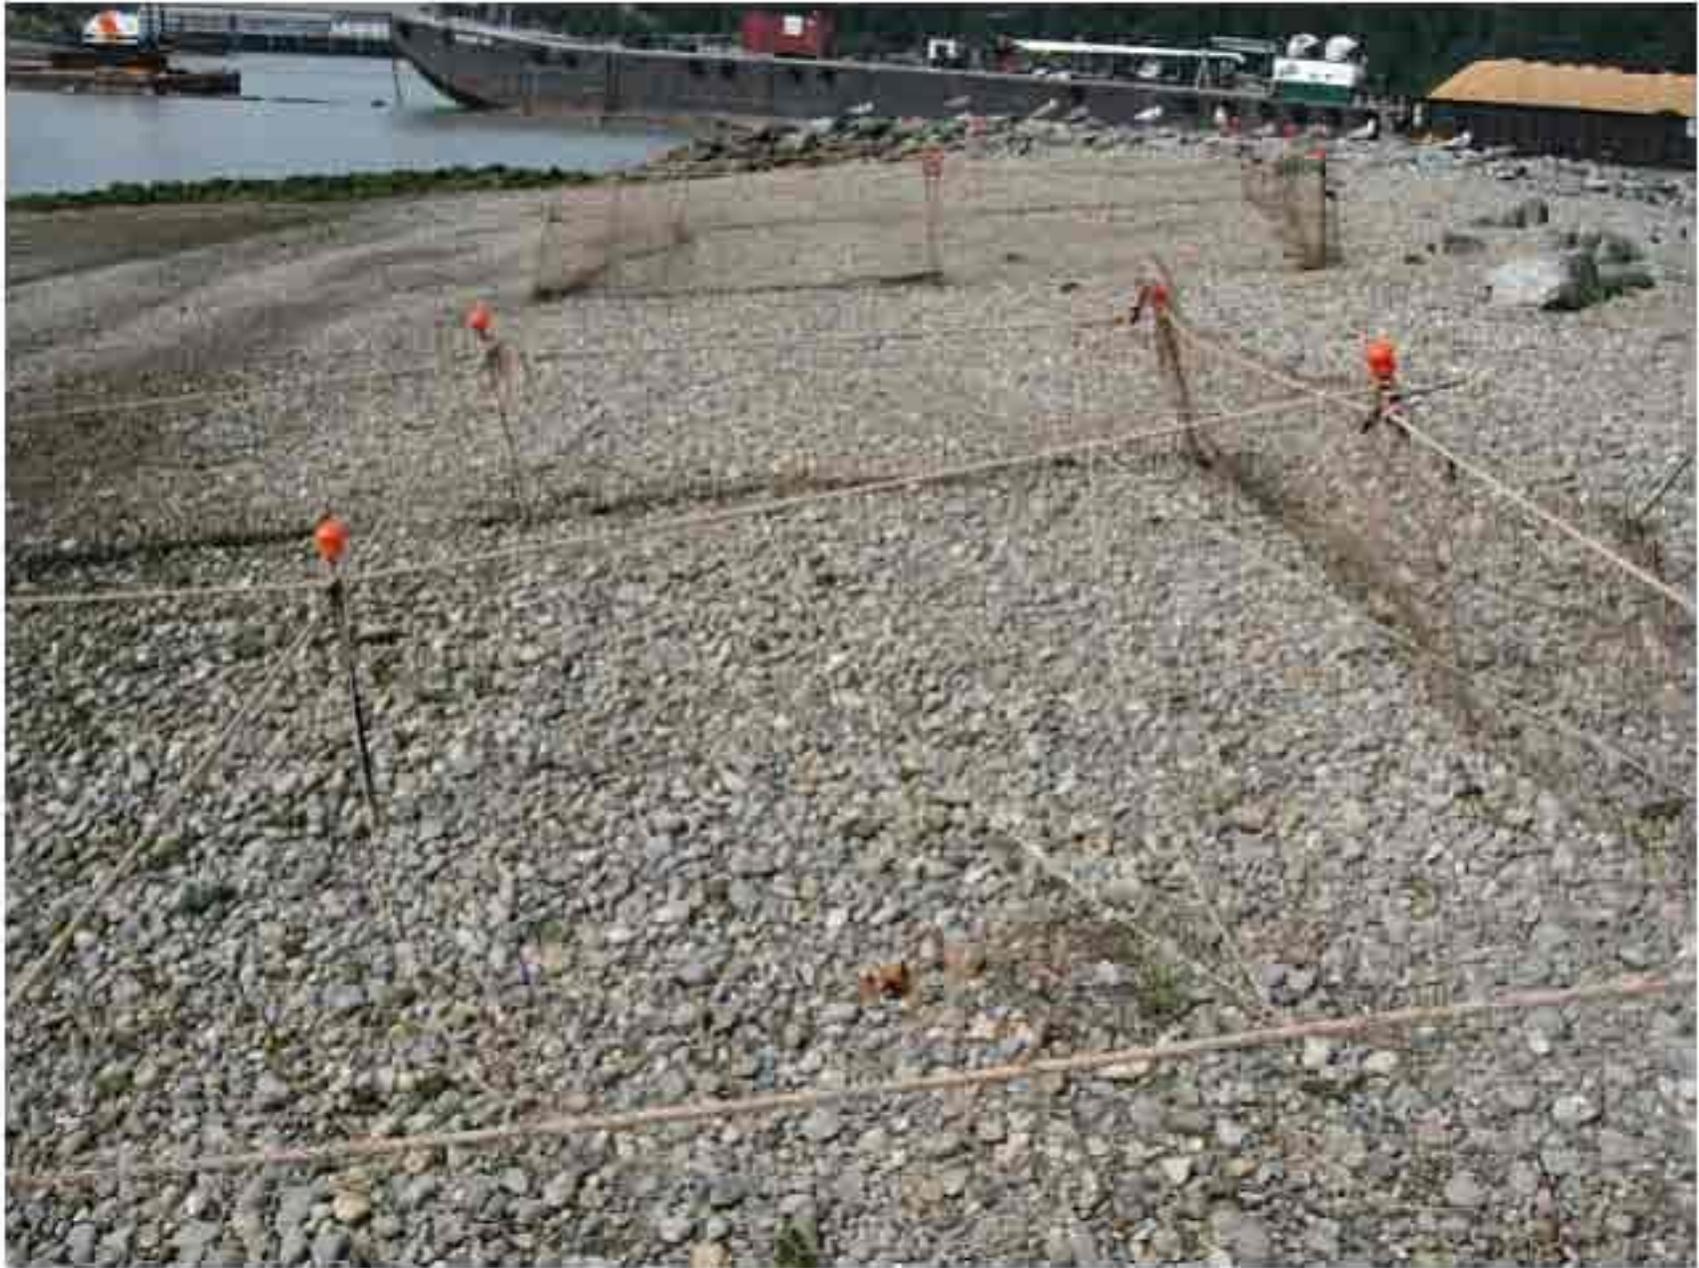
North Beach Habitat, Photo Point P6, facing west. Photo taken July 11, 2006 at 10:18 AM, tide at approximately -1.66 feet MLLW. [M G_0003]

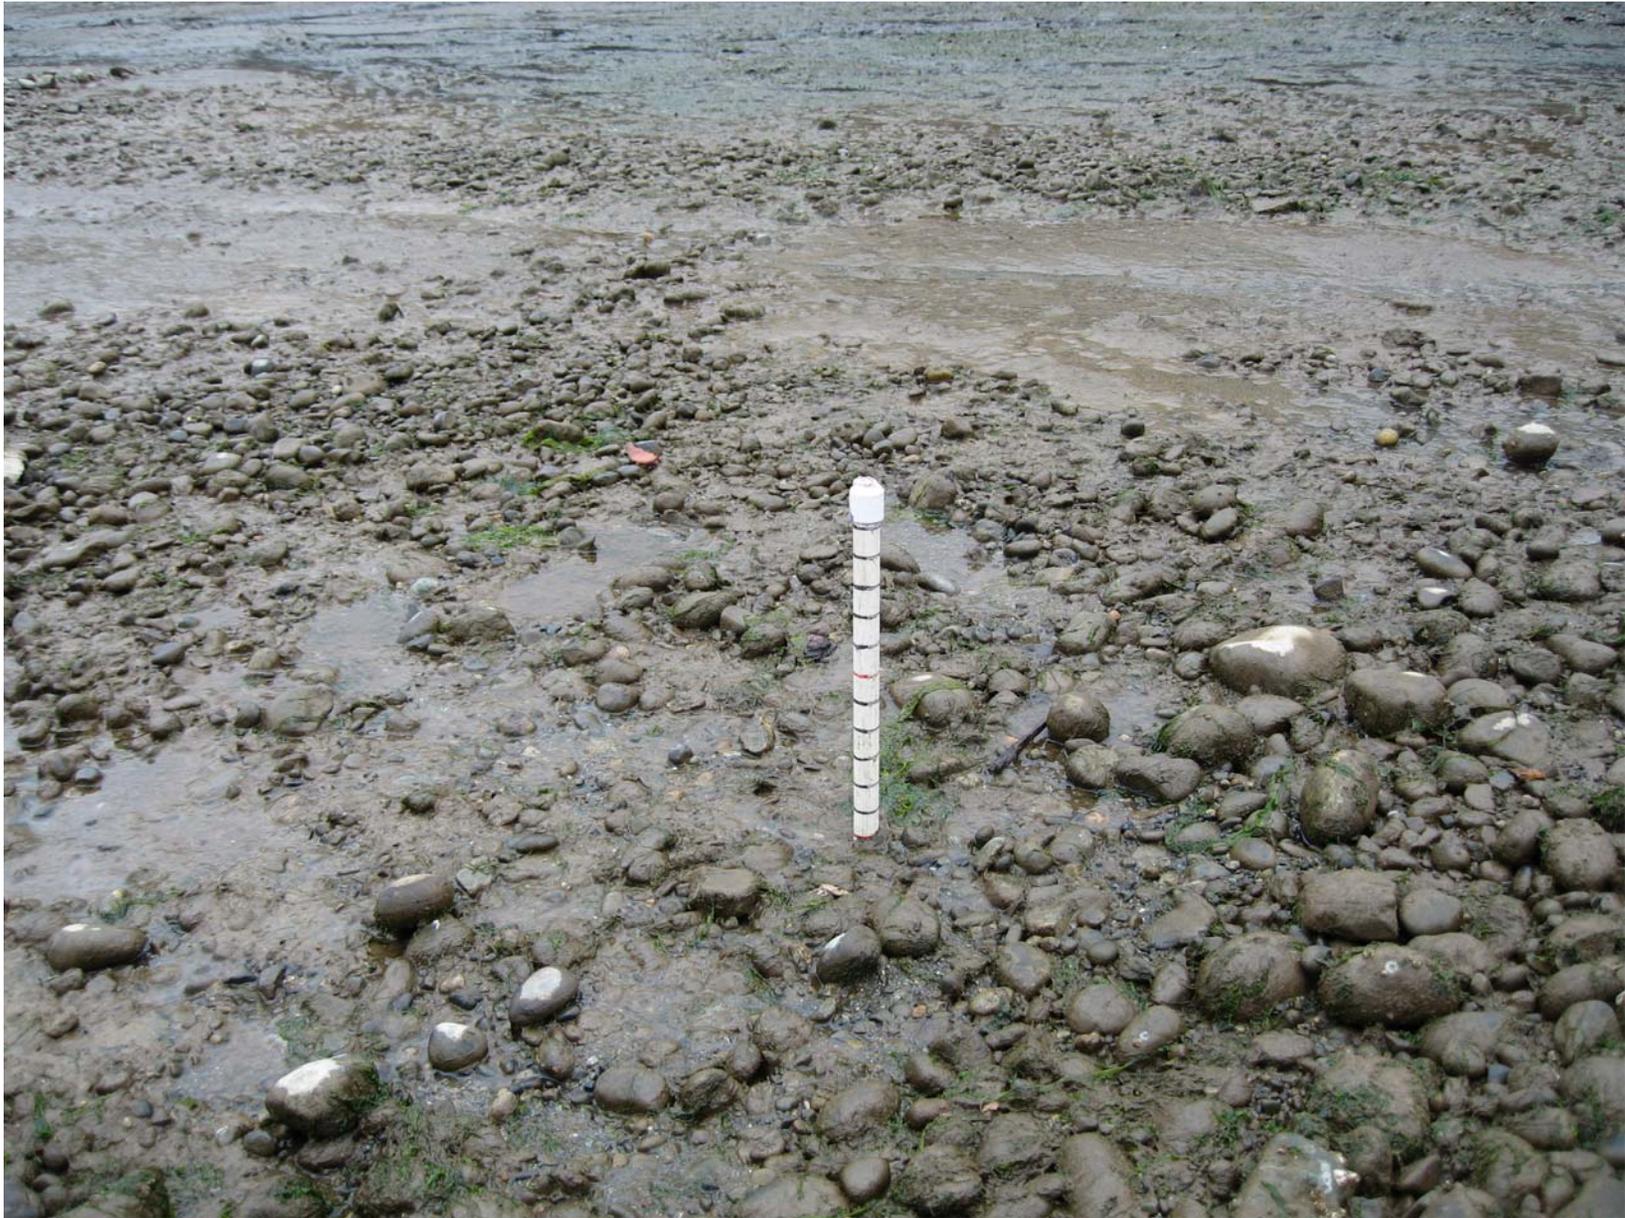
North Beach Habitat, elevation stake E1. Photo taken July 13, 2006.
[IMG_0075]

Elevation Monitoring – Five elevation stakes were placed at the locations shown on Figure E-5 of the OMMP. These graduated stakes are embedded one-foot into the ground and two feet of the stake is visible above ground. One-inch increments are marked on the stakes both above and below the ground surface to allow for measurement of erosion/sedimentation in subsequent monitoring years. The stakes were surveyed following installation to allow for replacement if needed, and the top and ground surface elevations were also measured. Photographs showing the elevation stakes in place are included in Attachment A.

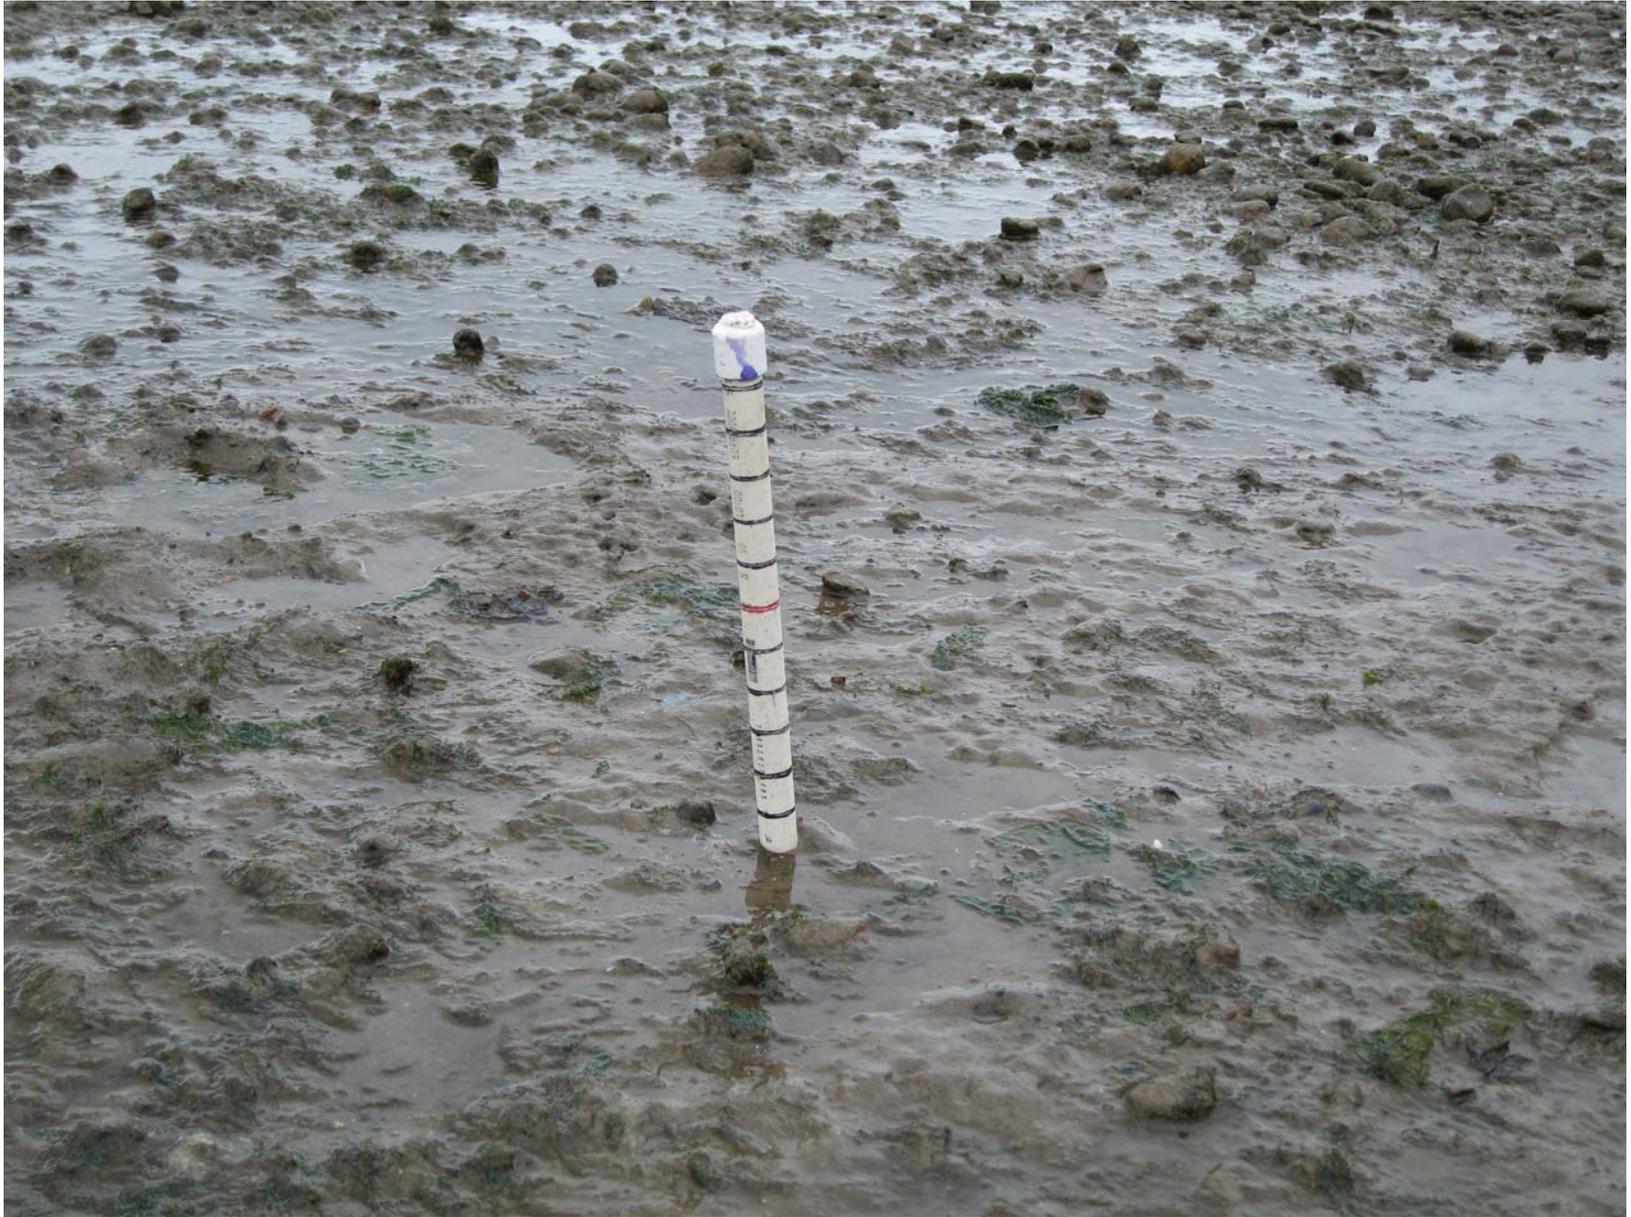
North Beach Habitat, elevation stake E2. Photo taken July 13, 2006.
[IMG_0076]

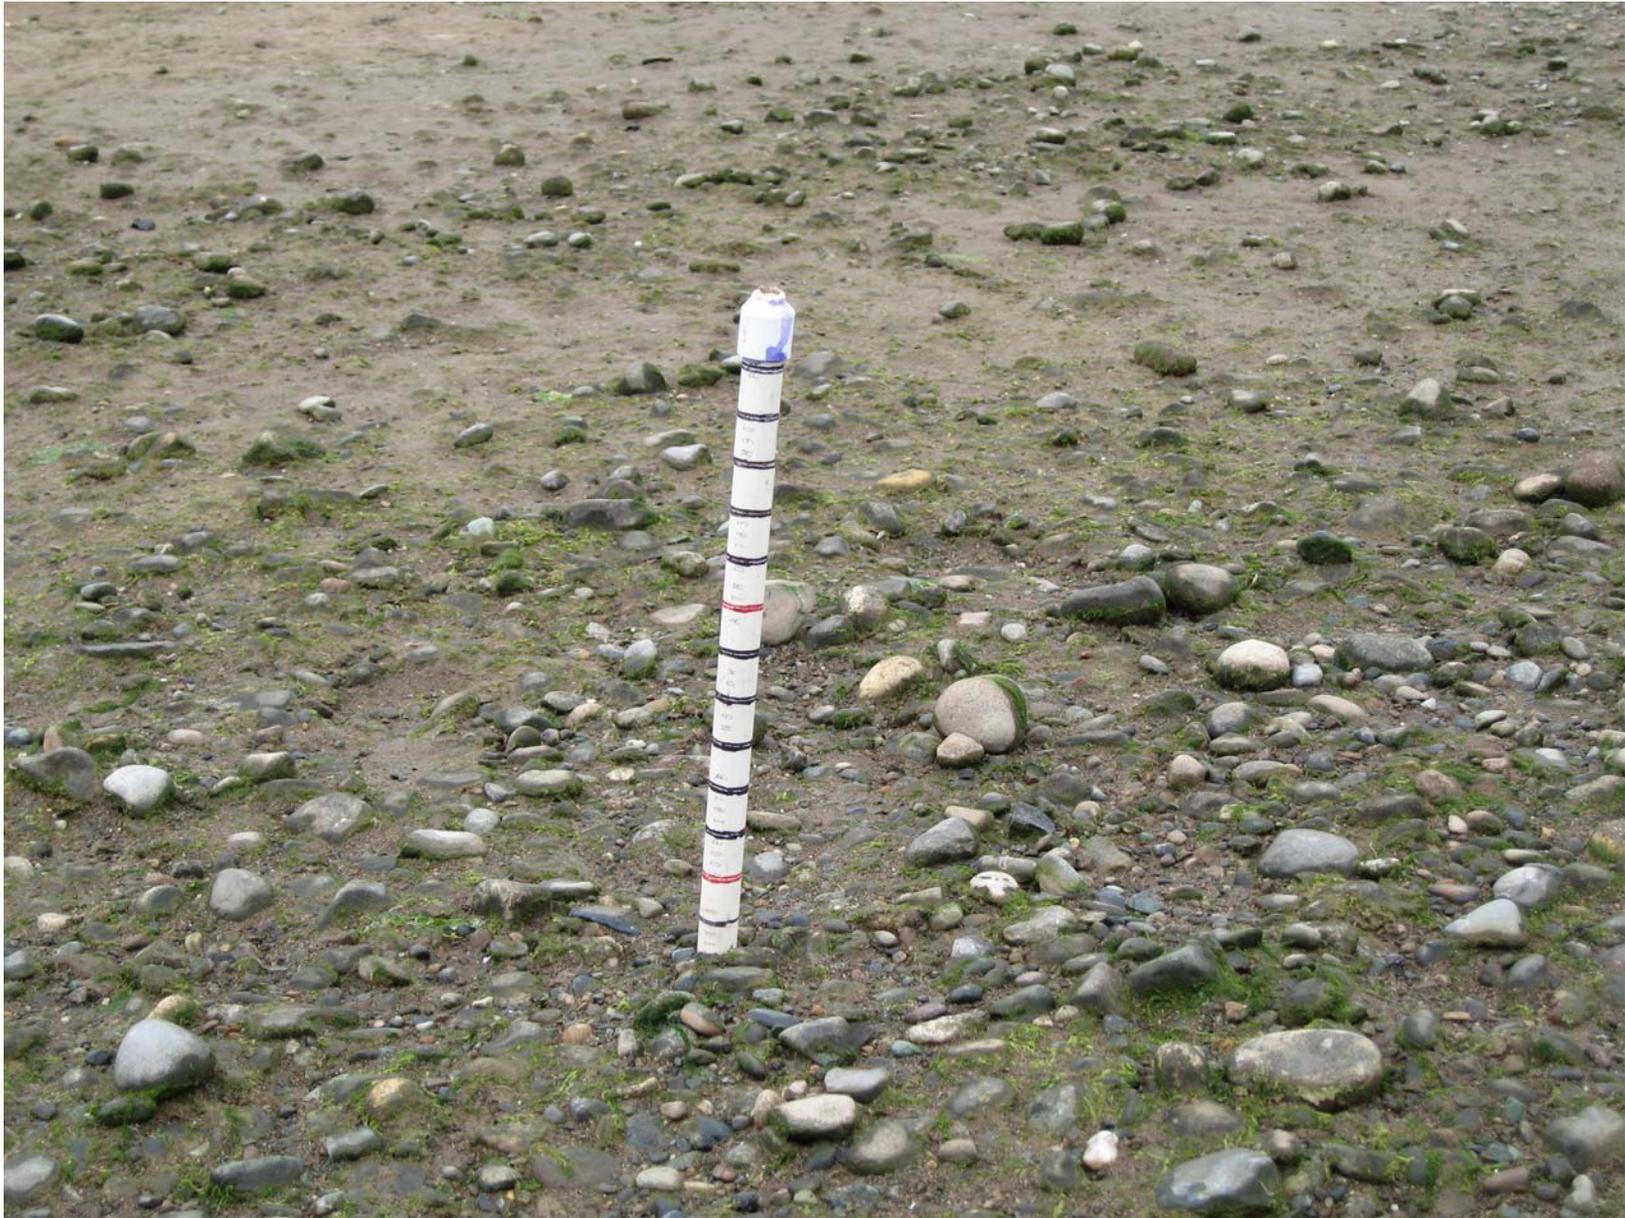
[IMG_0077]

North Beach Habitat, elevation stake E3. Photo taken July 13, 2006.
