THEA FOSS AND WHEELER-OSGOOD WATERWAYS REMEDIATION PROJECT

YEAR 0 BASELINE MONITORING

HABITAT MITIGATION AREA MONITORING PRELIMINARY FINDINGS MEMORANDUM

NOVEMBER 30, 2006

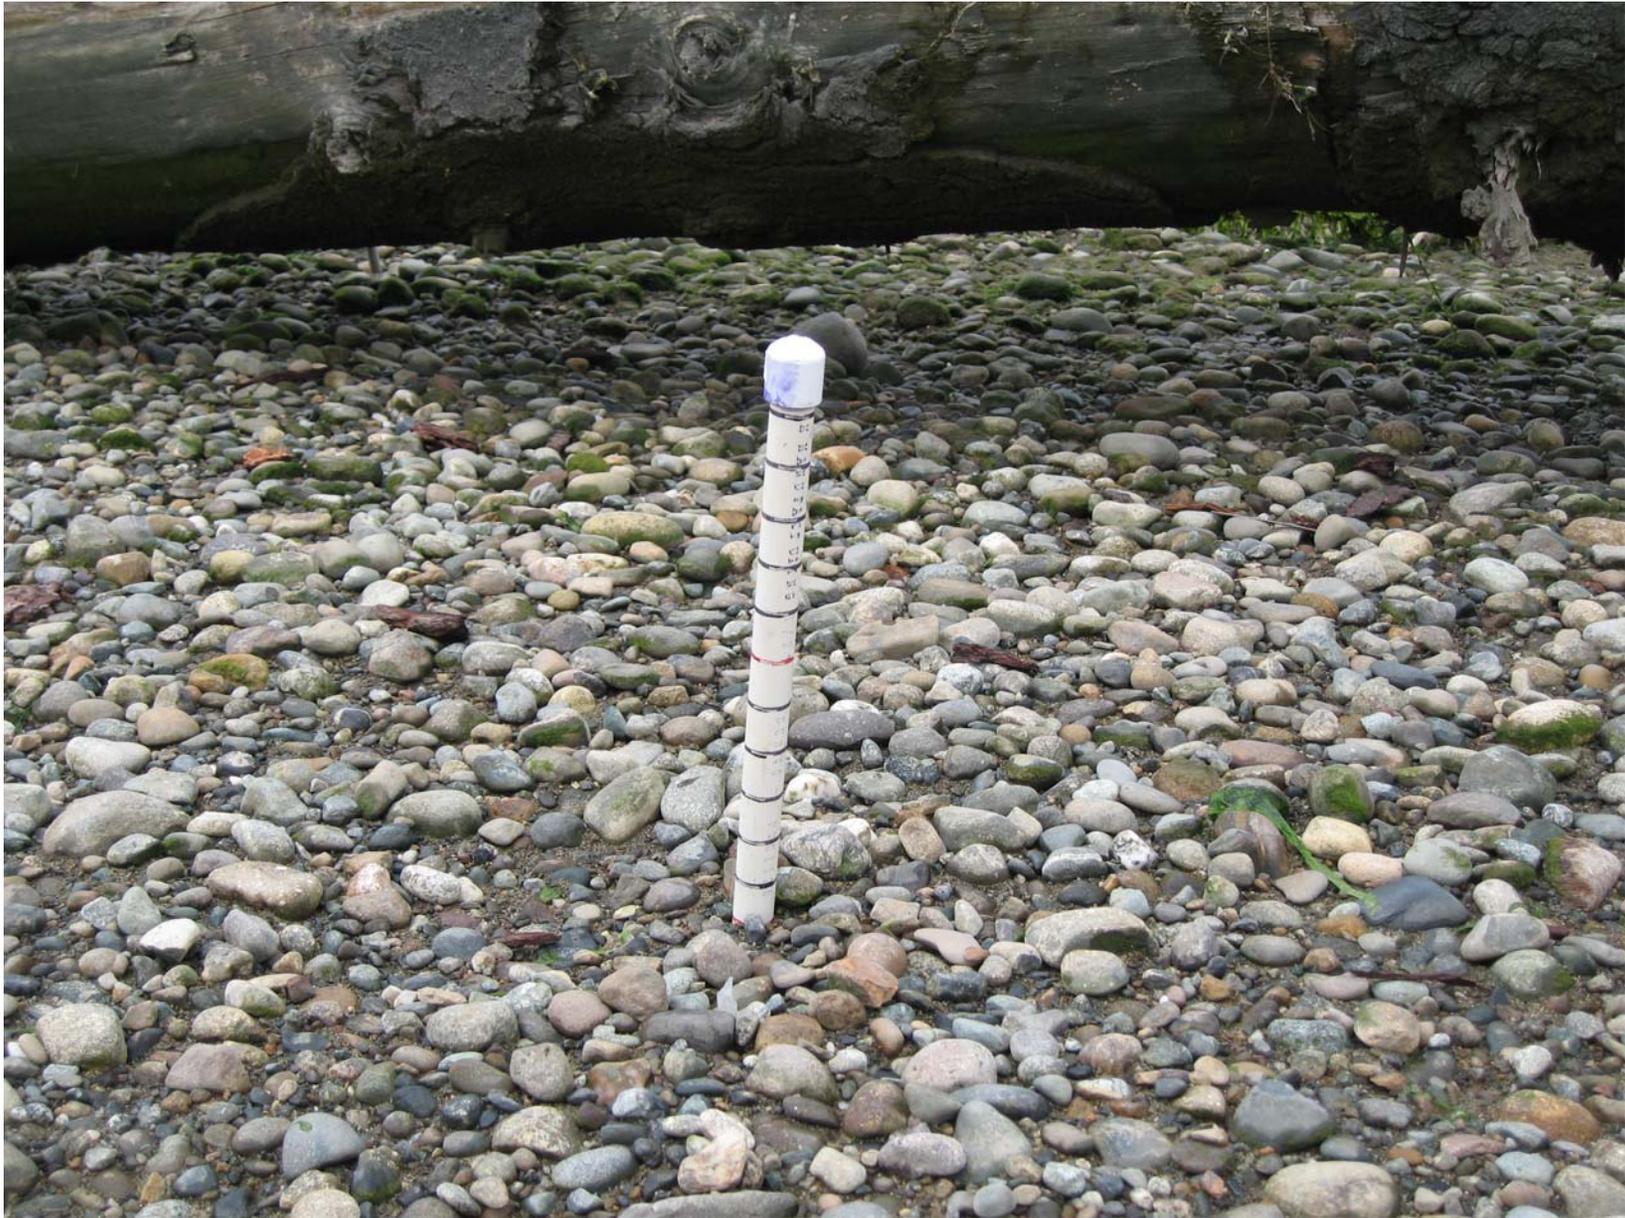
[IMG_0078]

North Beach Habitat, elevation stake E4. Photo taken July 13, 2006.

Elevation Monitoring – Five elevation stakes were placed at the locations shown on Figure E-5 of the OMMP. These graduated stakes are embedded one-foot into the ground and two feet of the stake is visible above ground. One-inch increments are marked on the stakes both above and below the ground surface to allow for measurement of erosion/sedimentation in subsequent monitoring years. The stakes were surveyed following installation to allow for replacement if needed, and the top and ground surface elevations were also measured. Photographs showing the elevation stakes in place are included in Attachment A.

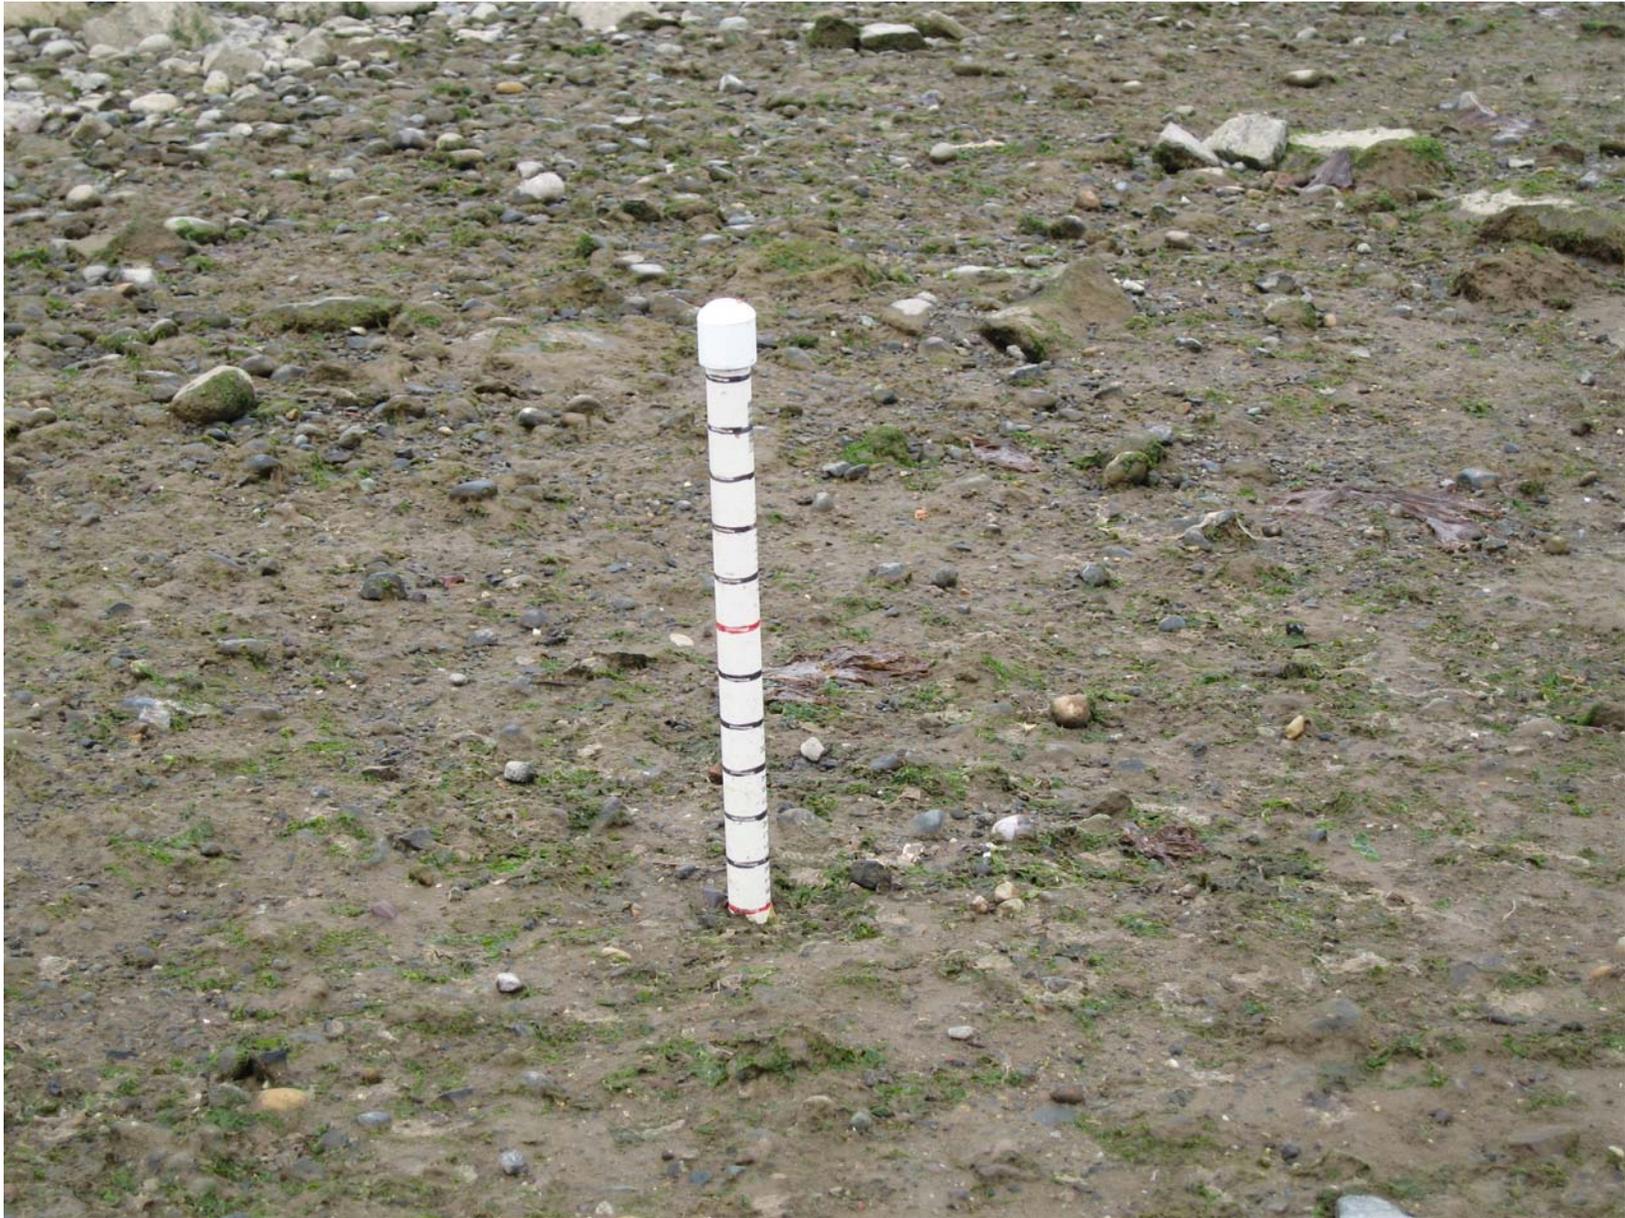
[IMG_0079]

North Beach Habitat, elevation stake E5. Photo taken July 13, 2006.

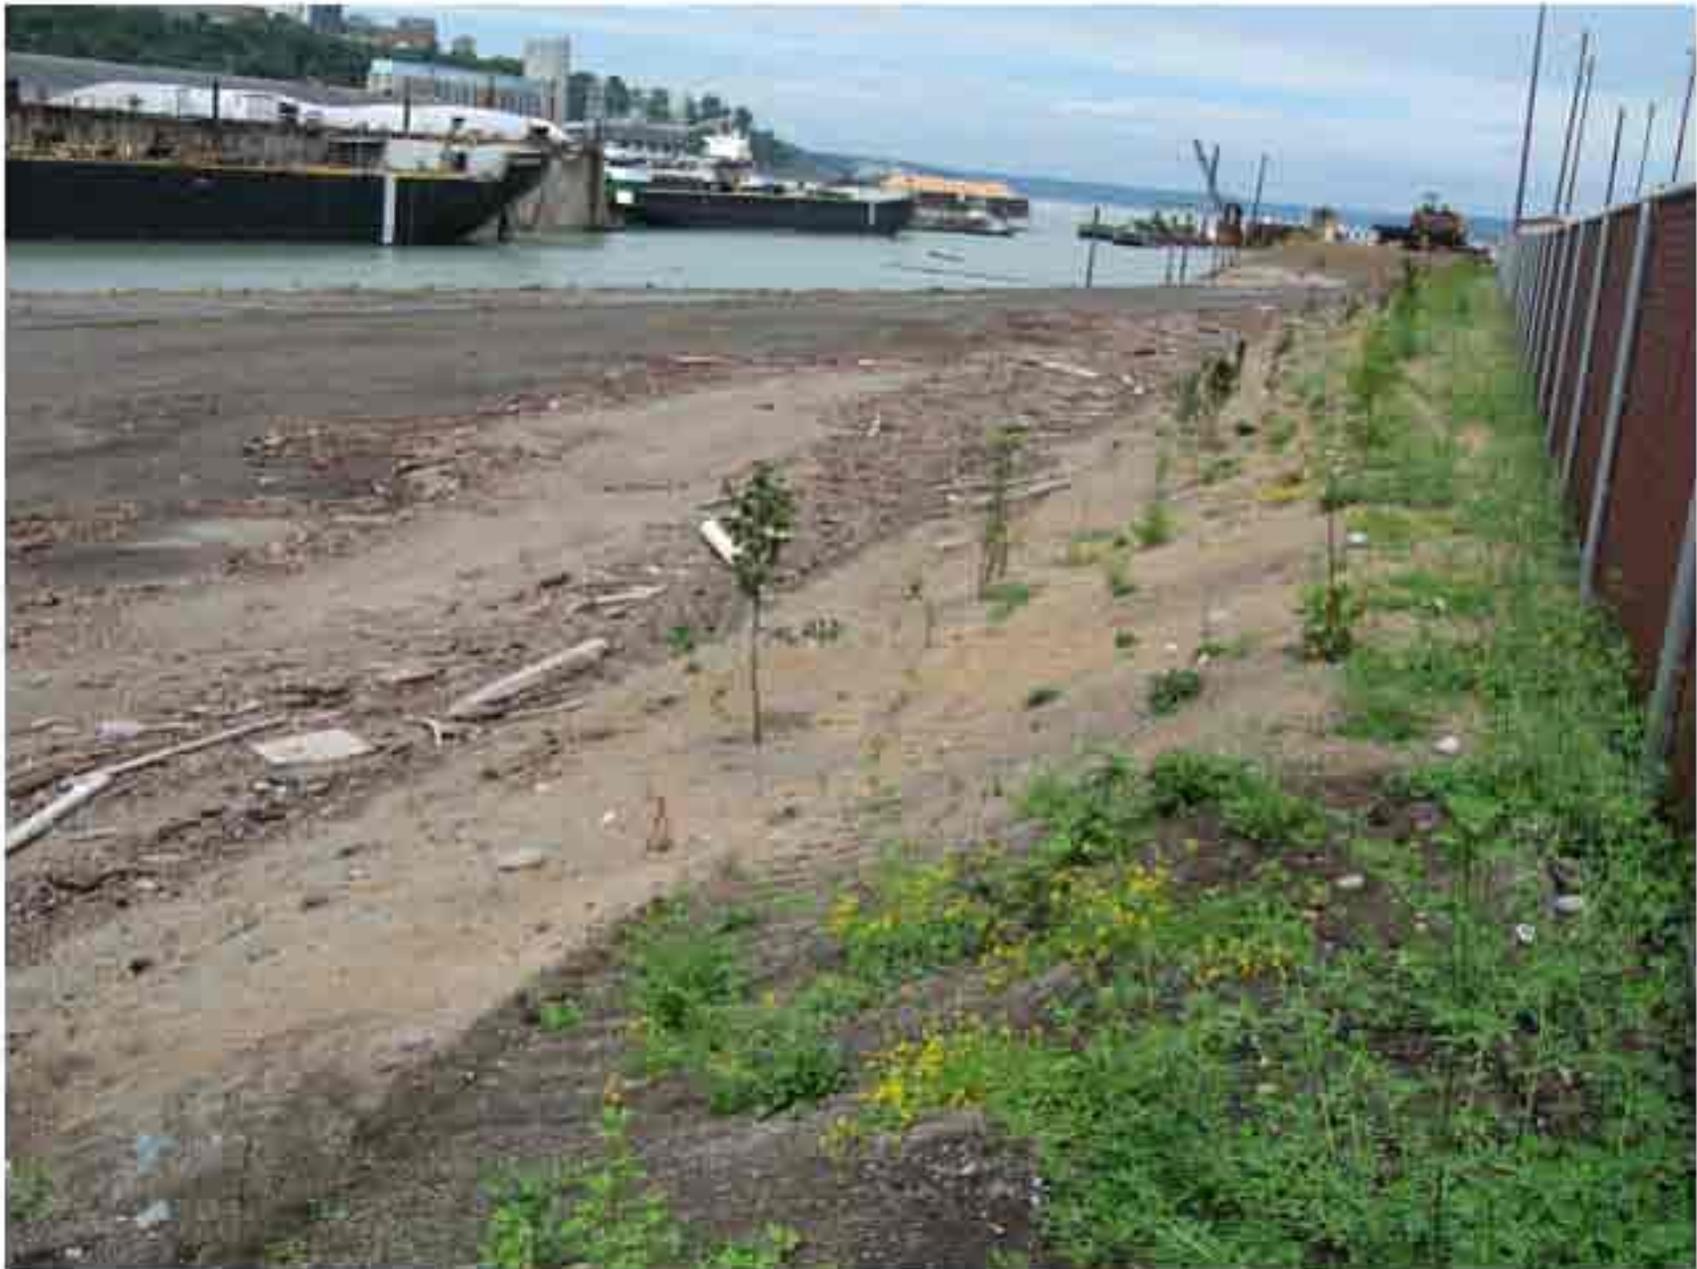
Middle Waterway Tideflat Habitat, Photo Point 1A, facing northwest. Photo taken July 11, 2006 at 11:59 AM, tide at approximately -3.25 feet MLLW.
[IMG_0018]

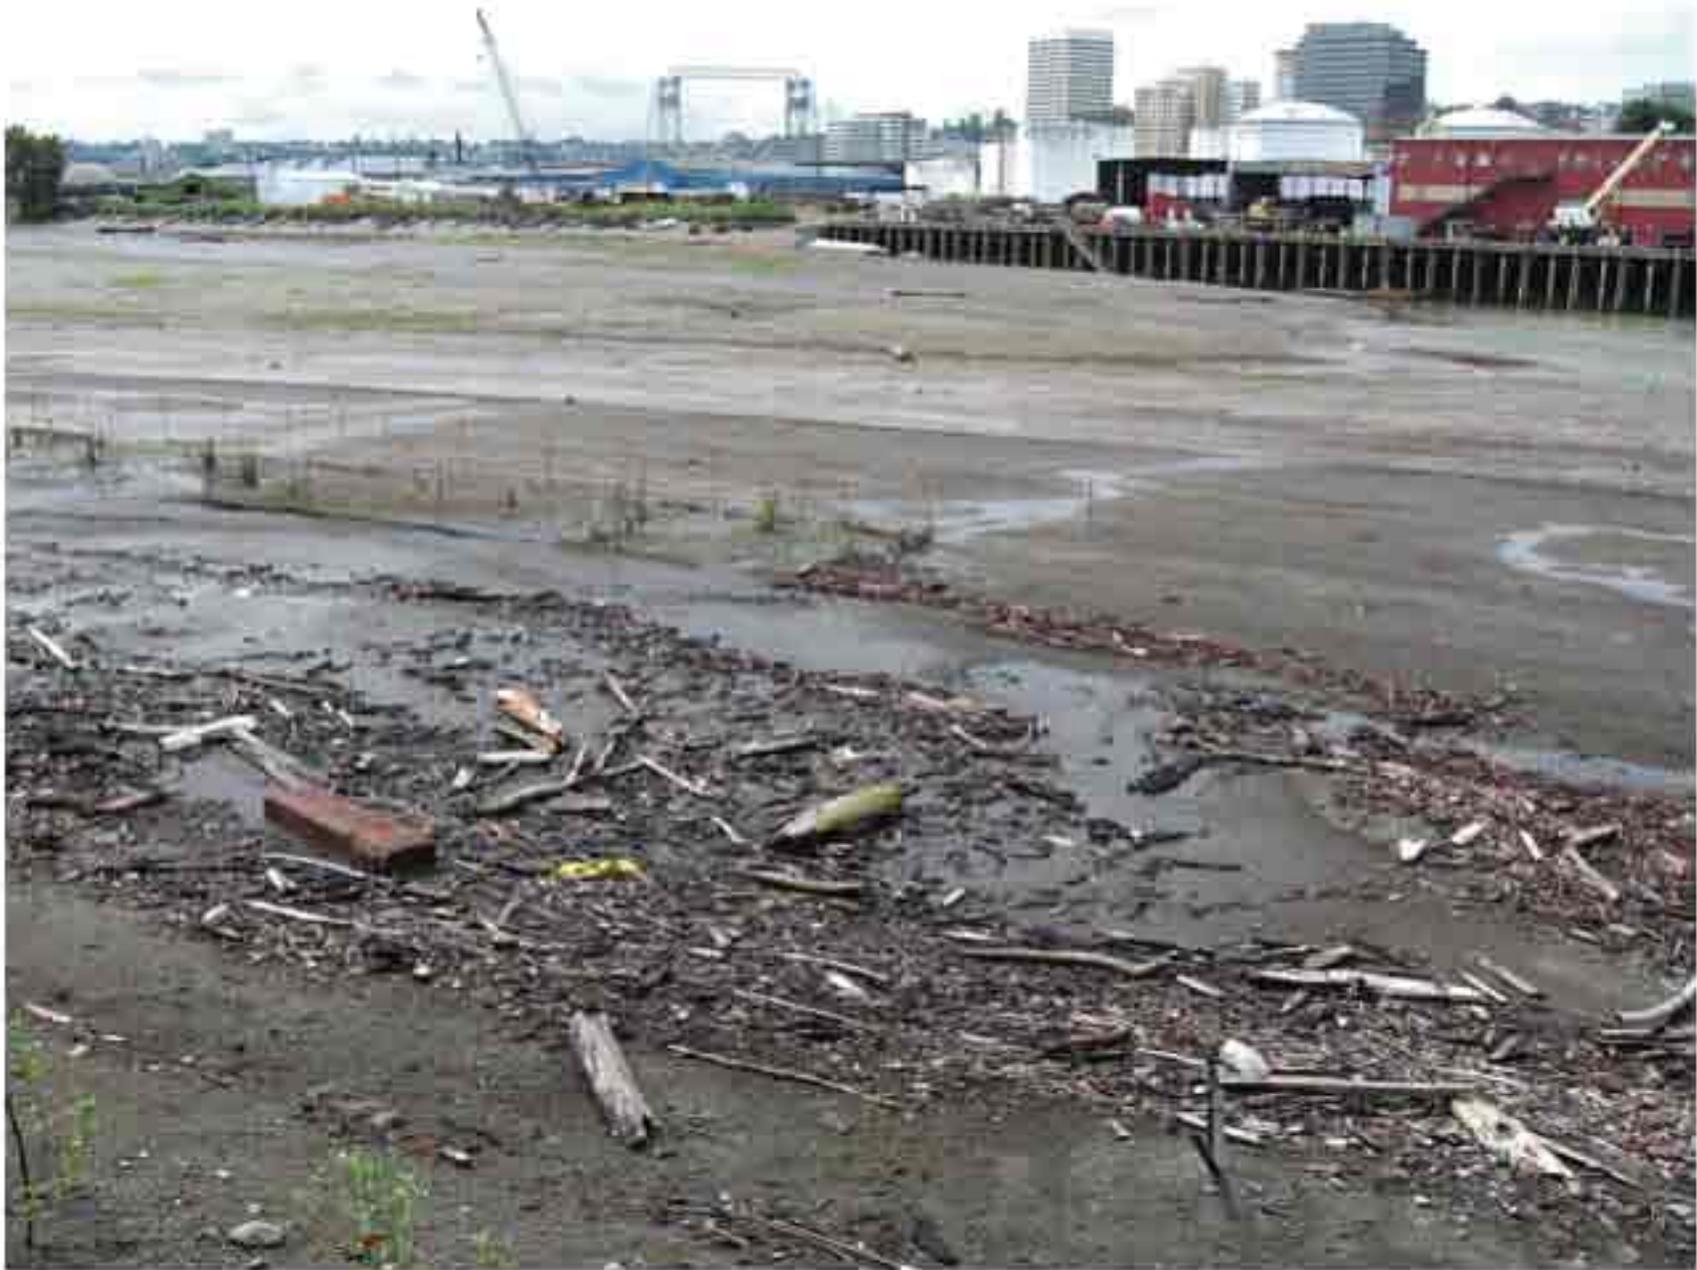
Middle Waterway Tideflat Habitat, Photo Point 1B, facing southwest. Photo taken July 11, 2006 at 11:59 AM, tide at approximately -3.25 feet MLLW.
[IMG_0019]

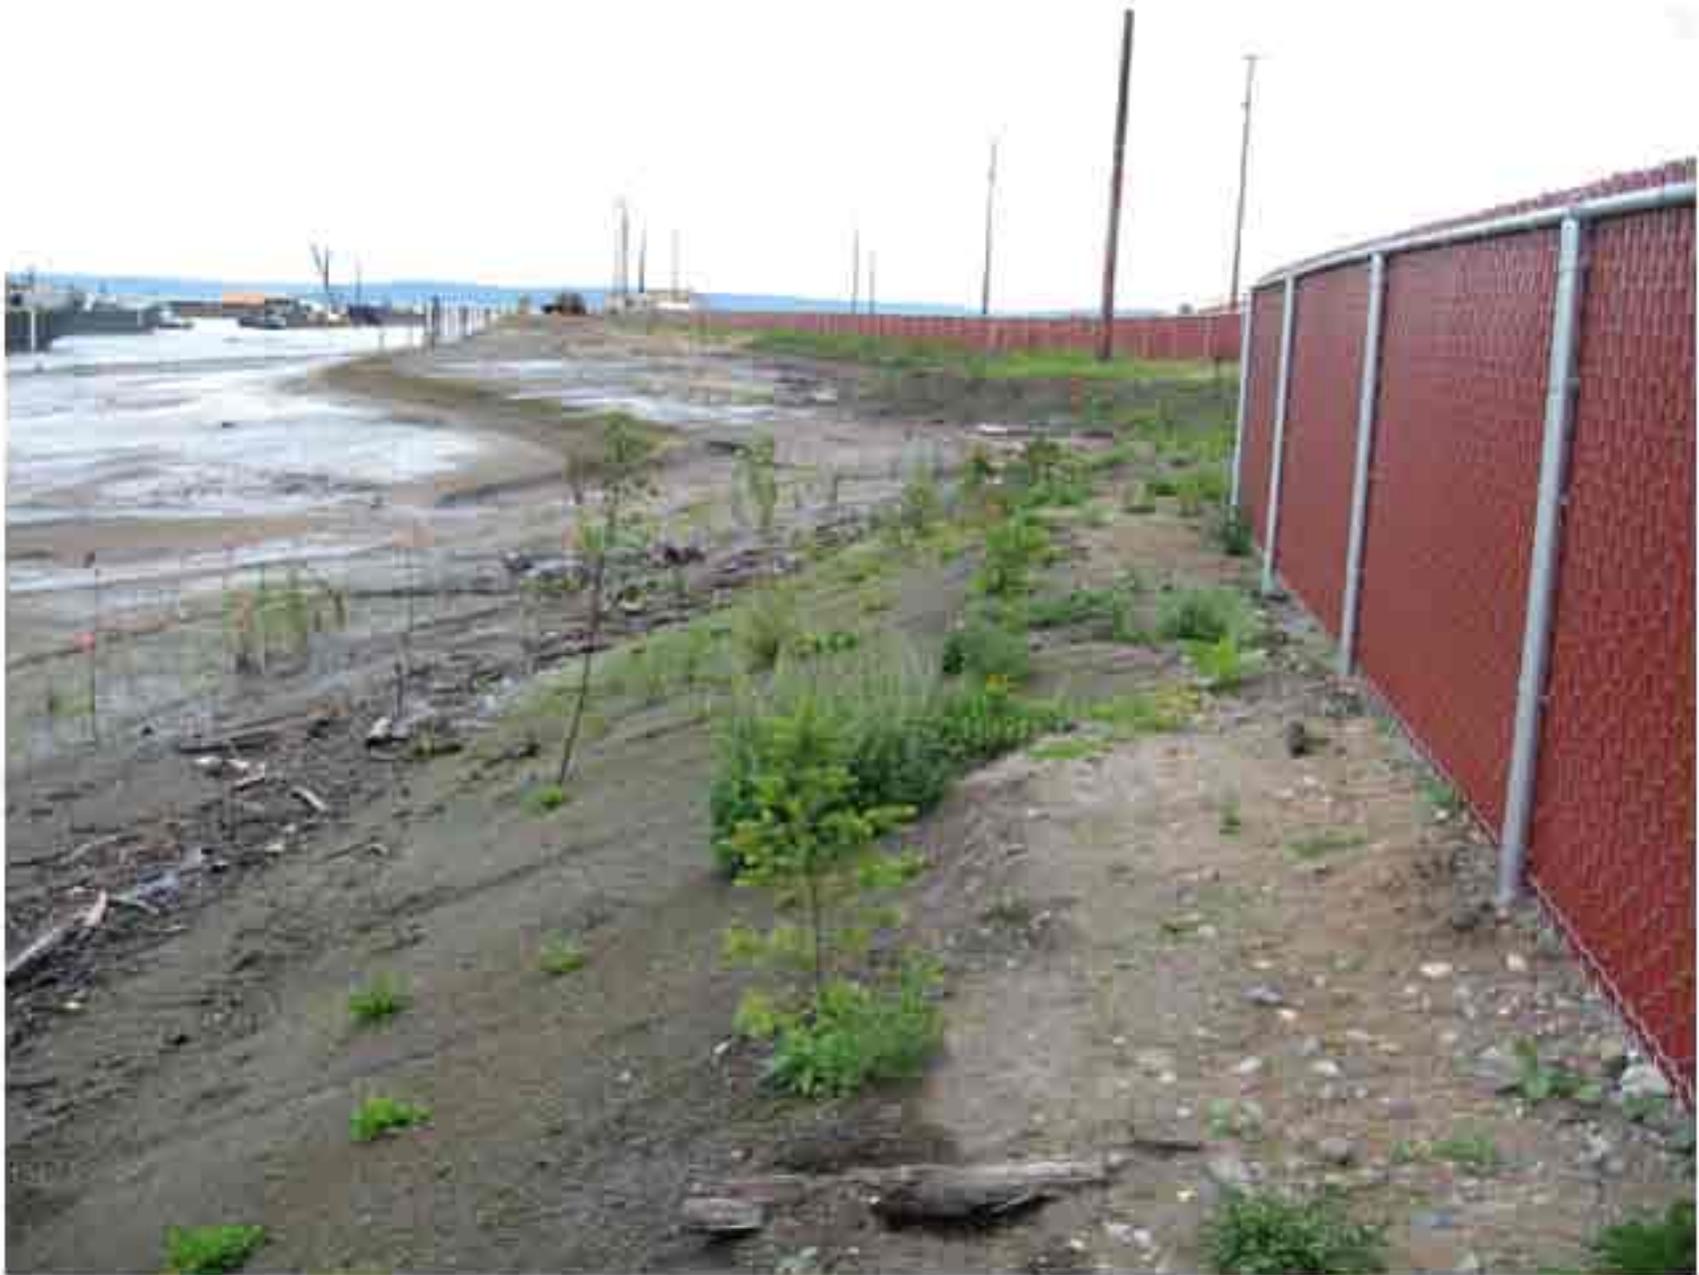
Middle Waterway Tideflat Habitat, Photo Point 2A, facing north. Photo taken July 11, 2006 at 12:15 PM, tide at approximately -3.08 feet MLLW.
[IMG_0020]

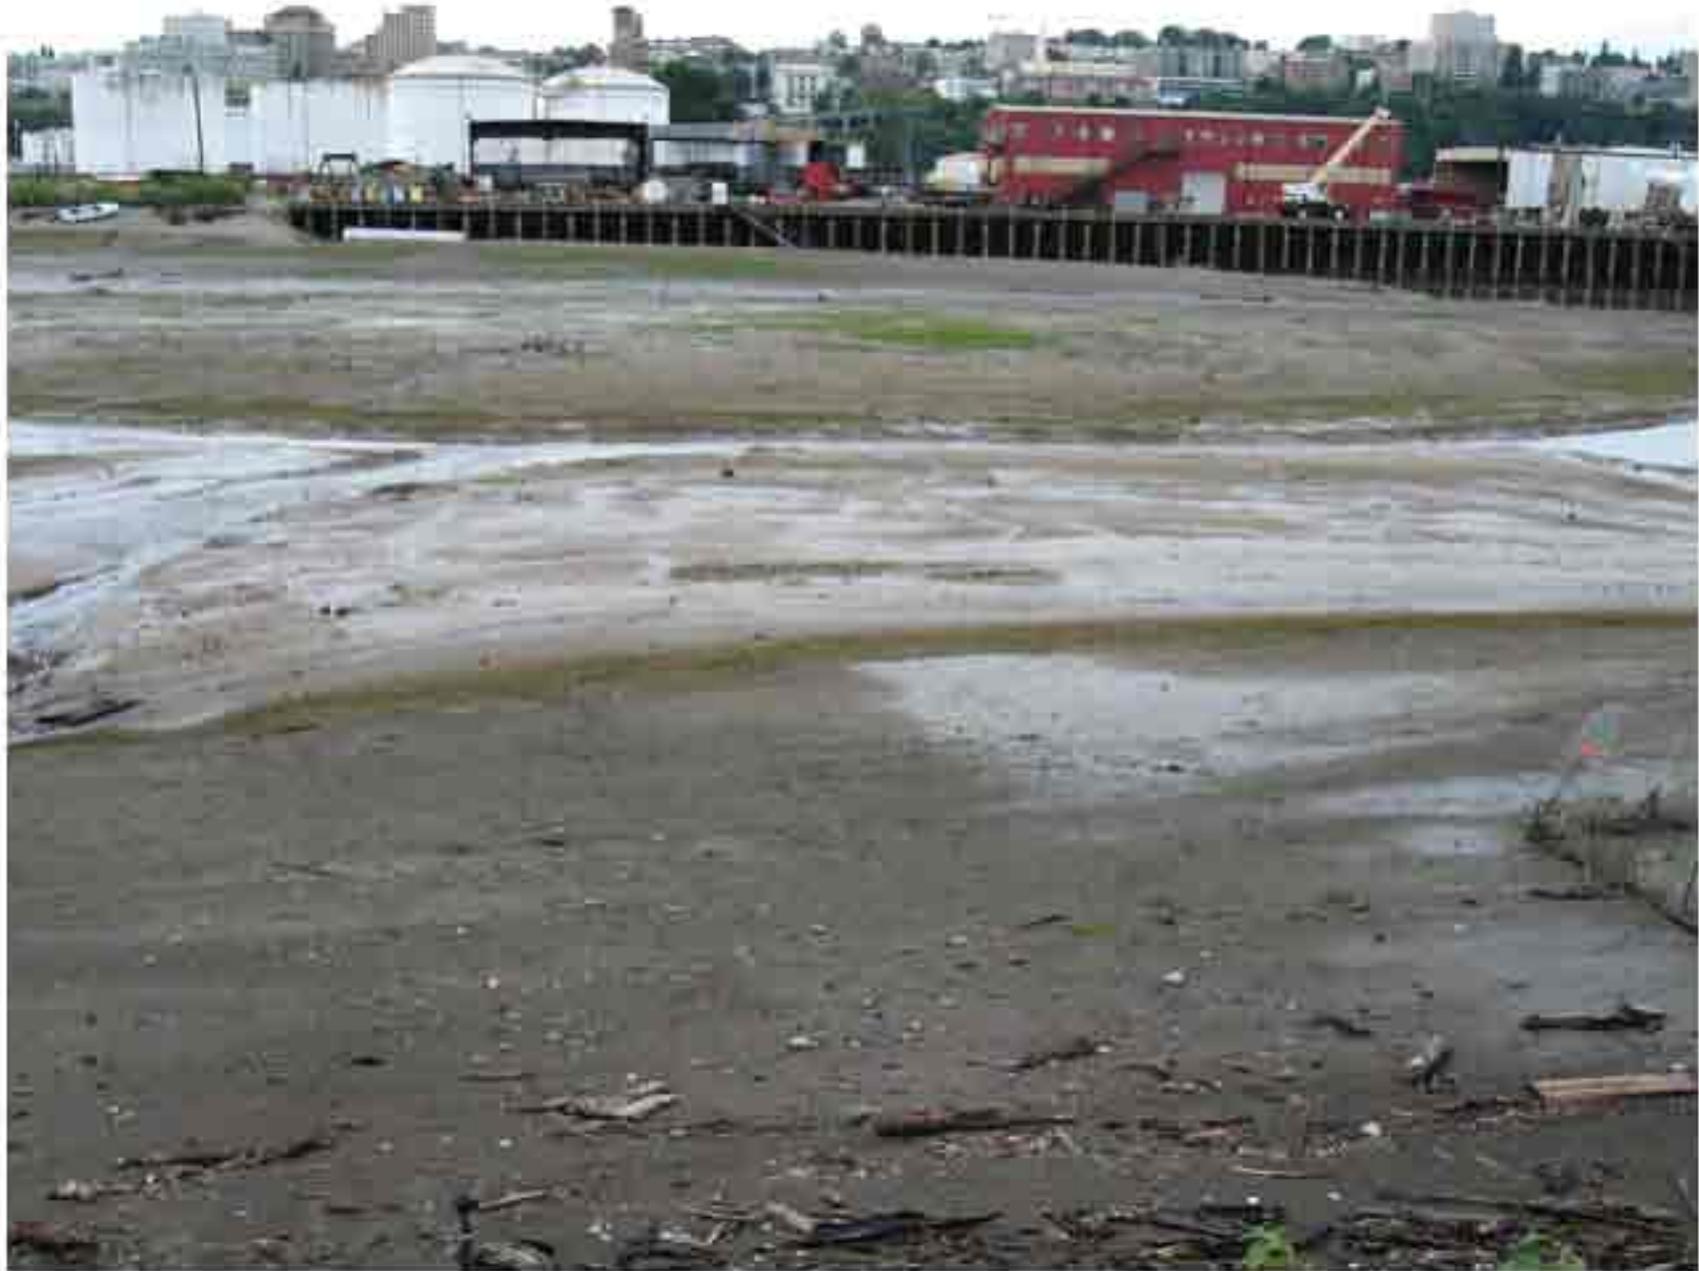
Middle Waterway Tideflat Habitat, Photo Point 2B, facing west. Photo taken July 11, 2006 at 12:15 PM, tide at approximately -3.08 feet MLLW.
[IMG_0021]

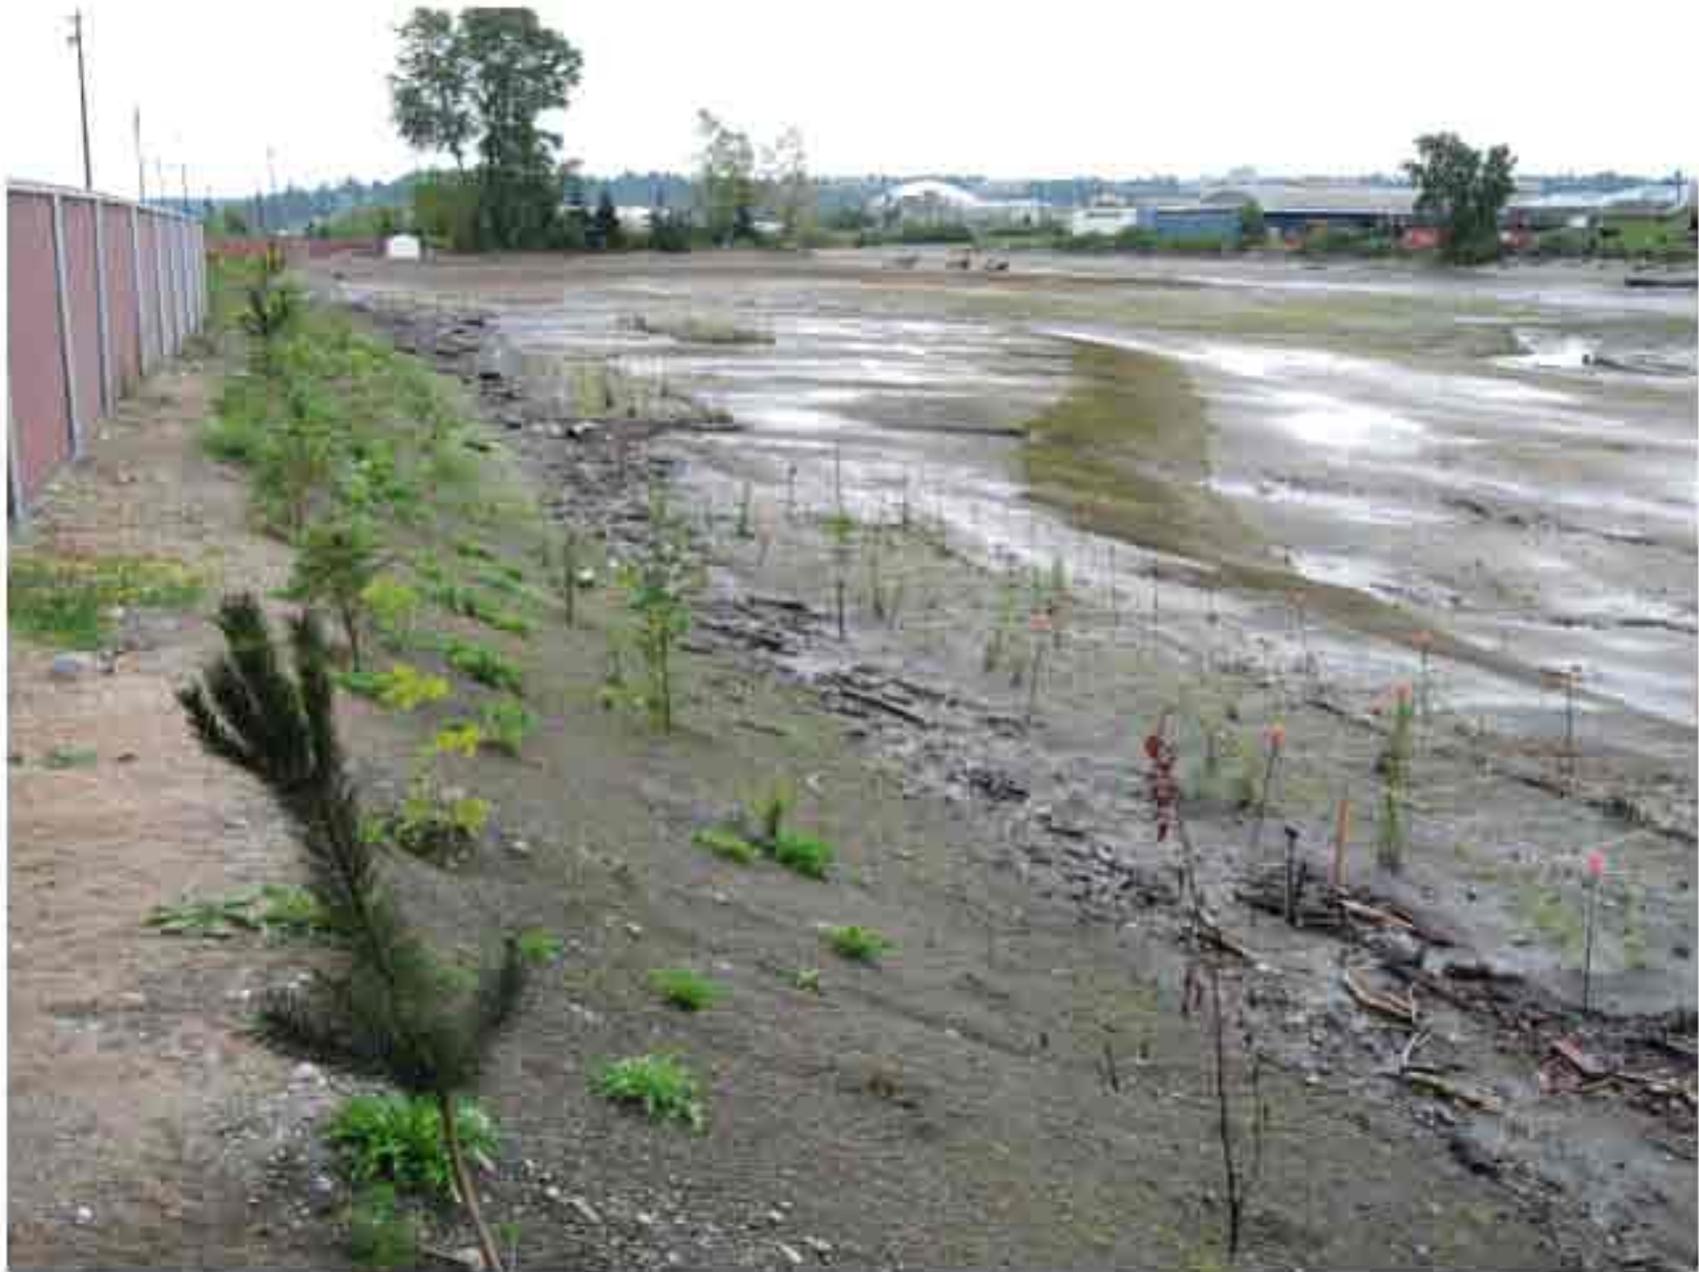
Middle Waterway Tideflat Habitat, Photo Point 2C, facing south. Photo taken July 11, 2006 at 12:15 PM, tide at approximately -3.08 feet MLLW.
[IMG_0022]

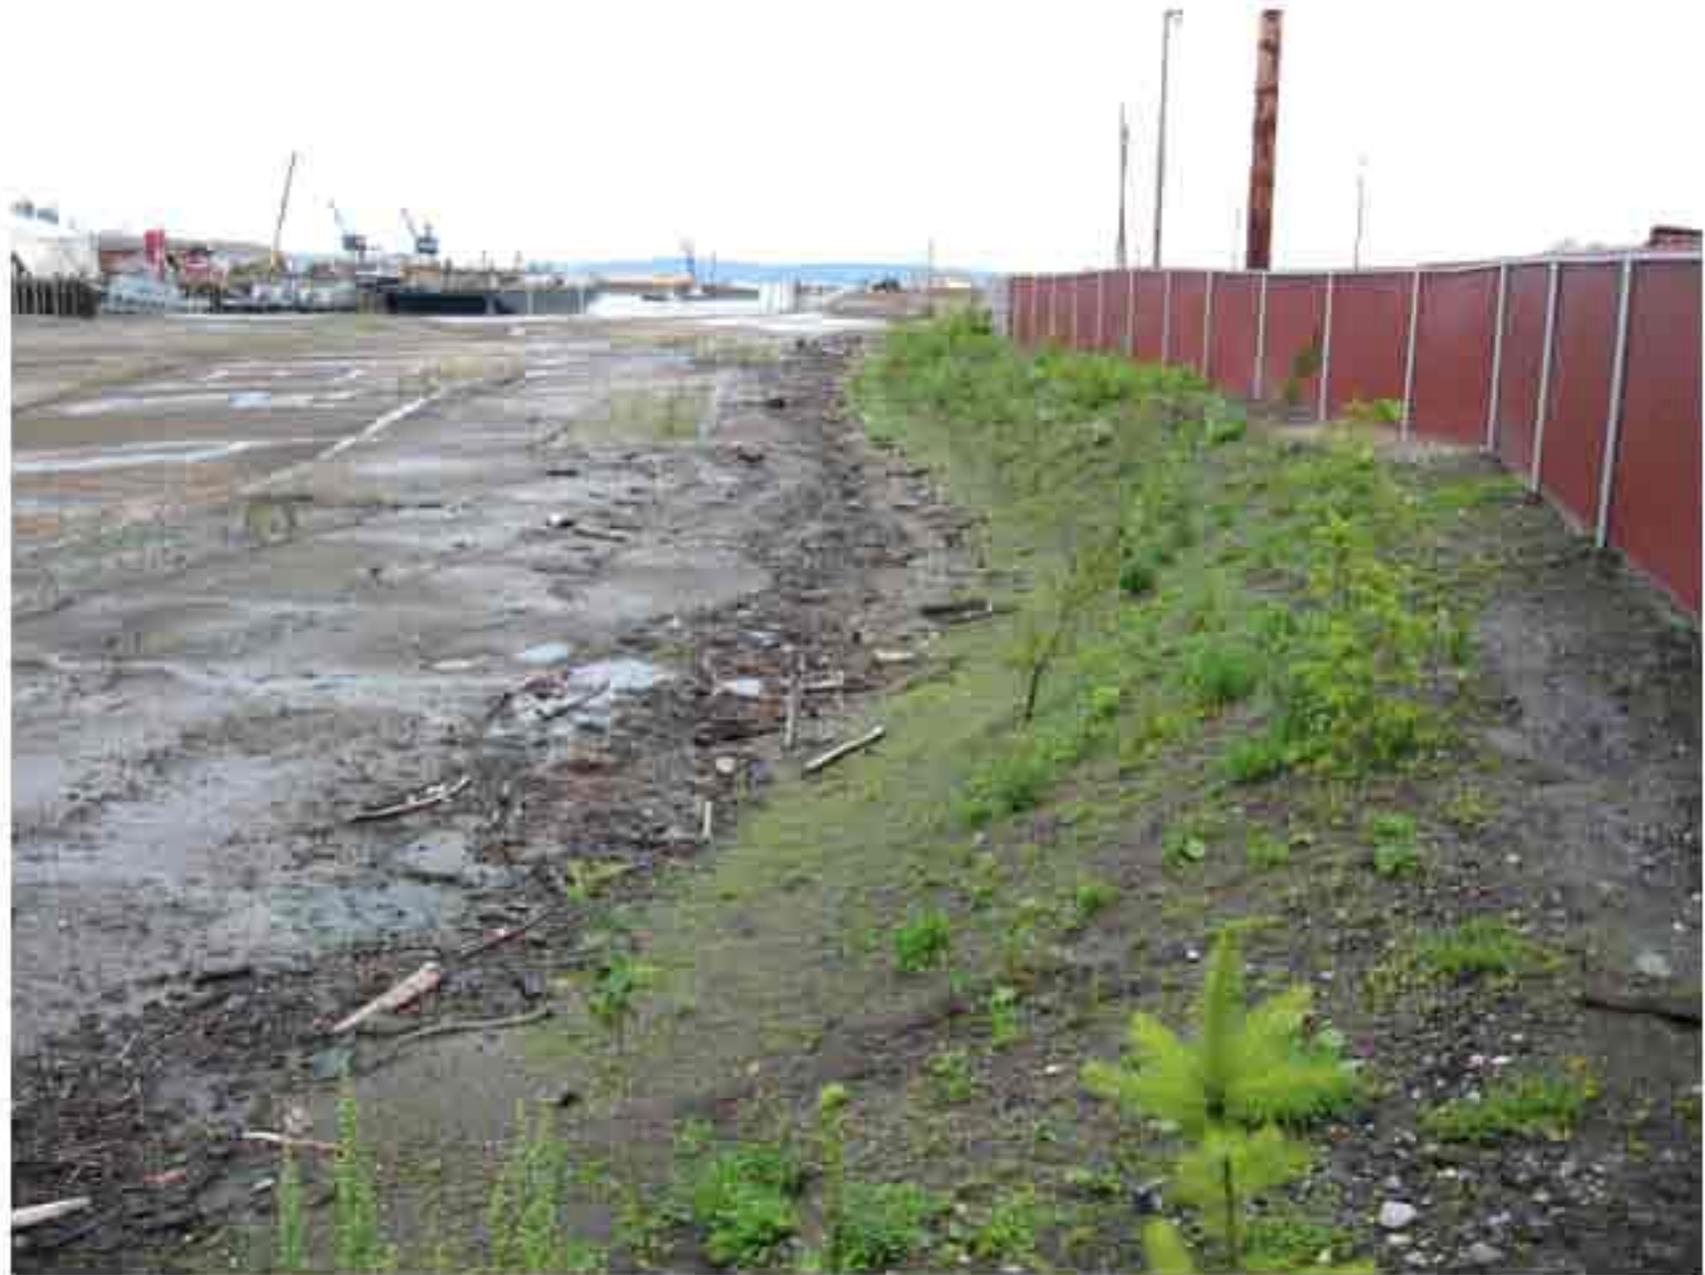
Middle Waterway Tideflat Habitat, Photo Point 3A, facing north. Photo taken July 11, 2006 at 12:30 PM, tide at approximately -2.83 feet MLLW.
[IMG_0023]

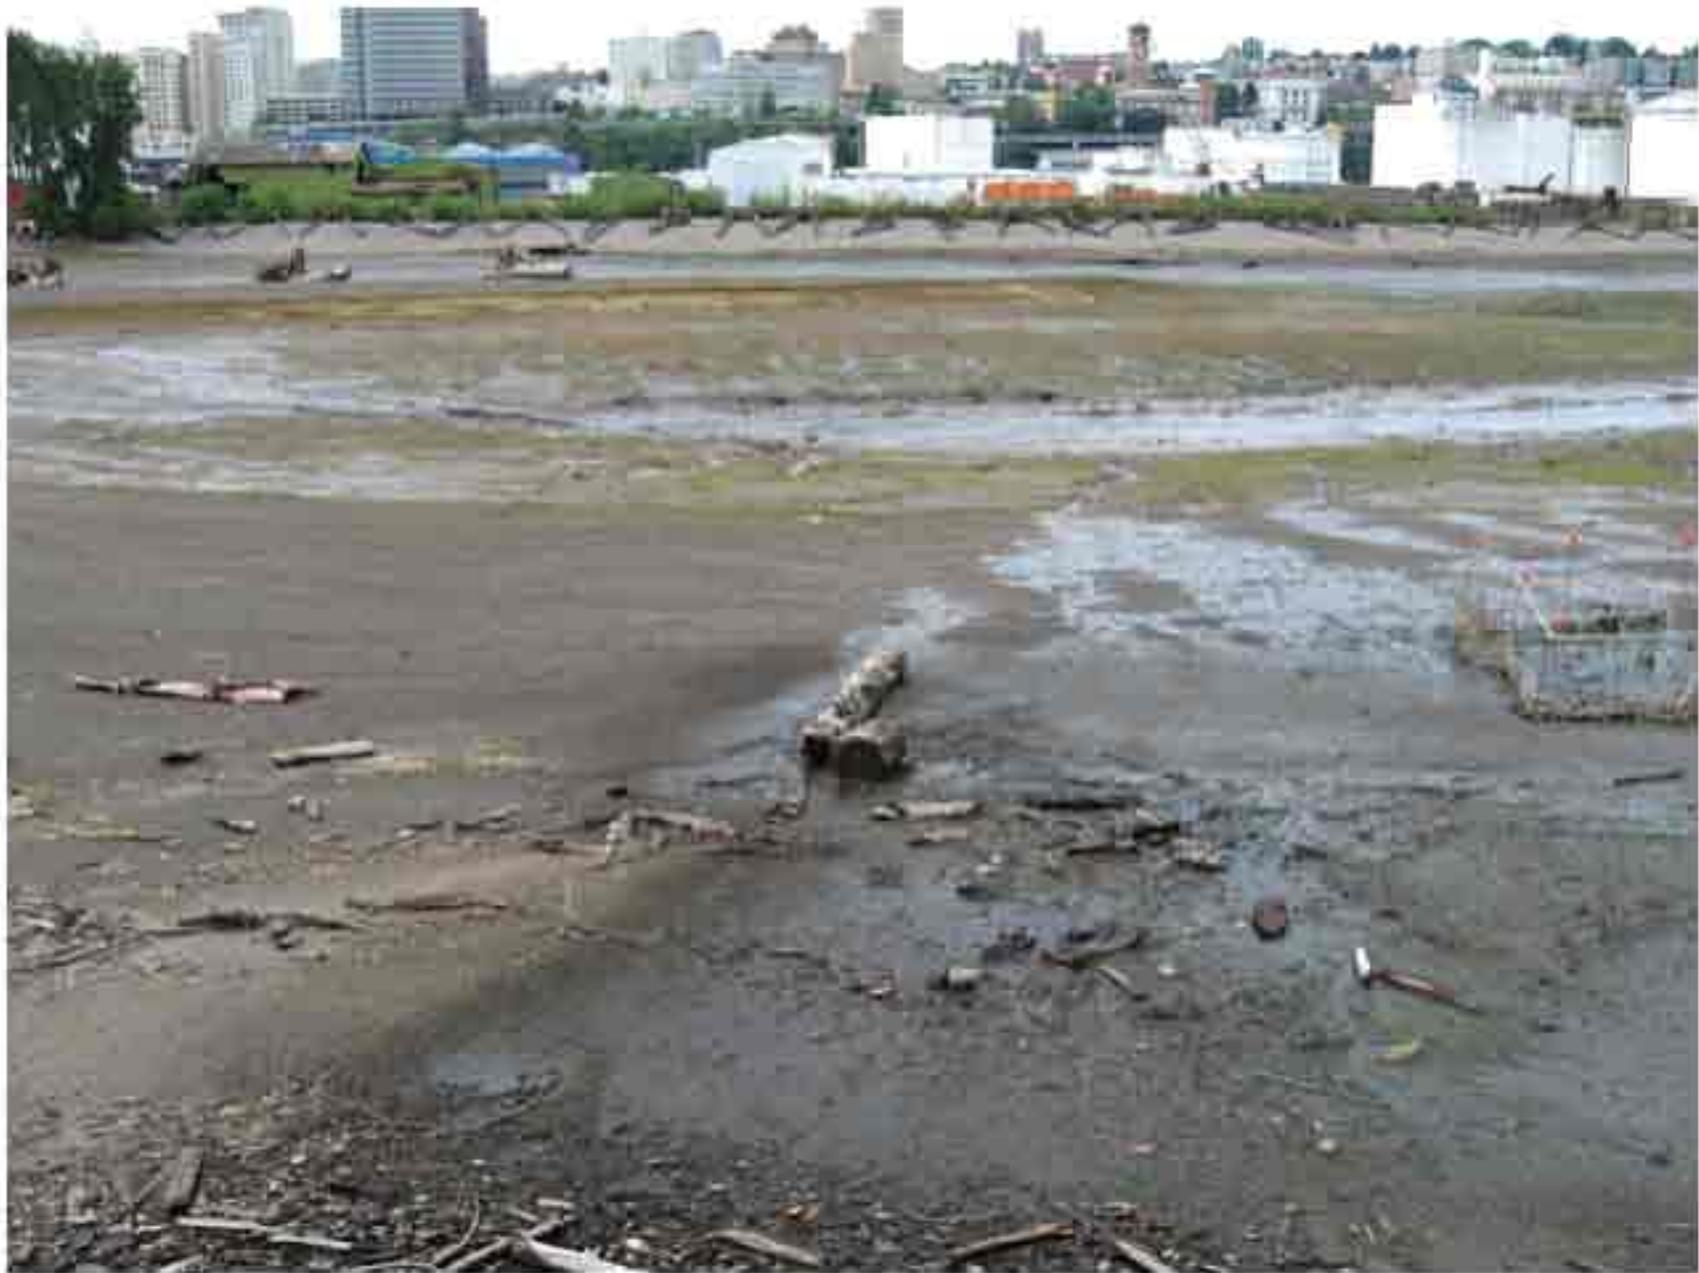
Middle Waterway Tideflat Habitat, Photo Point 3B, facing west. Photo taken July 11, 2006 at 12:30 PM, tide at approximately -2.83 feet MLLW.
[IMG_0024]

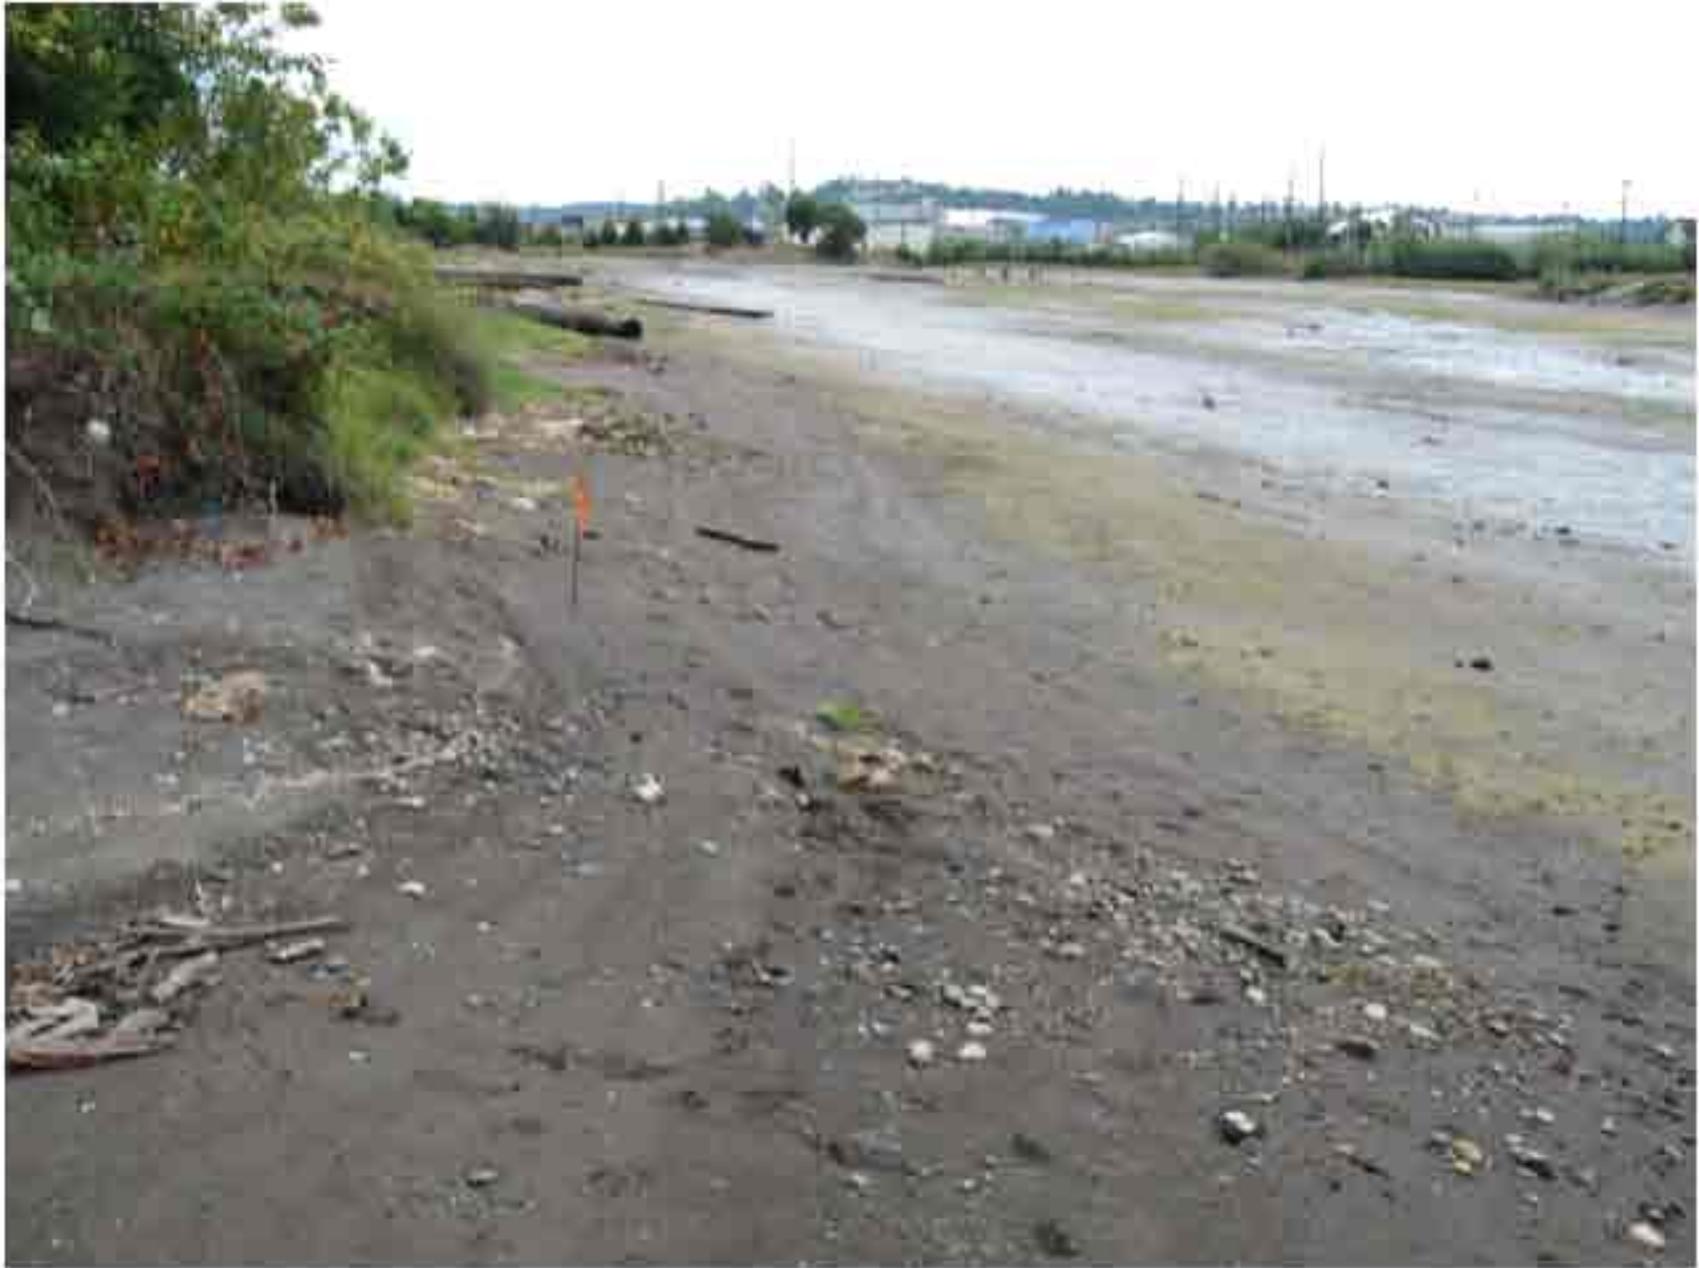
Middle Waterway Tideflat Habitat, Photo Point 4A, facing south. Photo taken July 11, 2006 at 12:33 PM, tide at approximately -2.77 feet MLLW.
[IMG_0025]
