THEA FOSS AND WHEELER-OSGOOD WATERWAYS REMEDIATION PROJECT

YEAR 0 BASELINE MONITORING

HABITAT MITIGATION AREA MONITORING PRELIMINARY FINDINGS MEMORANDUM

NOVEMBER 30, 2006

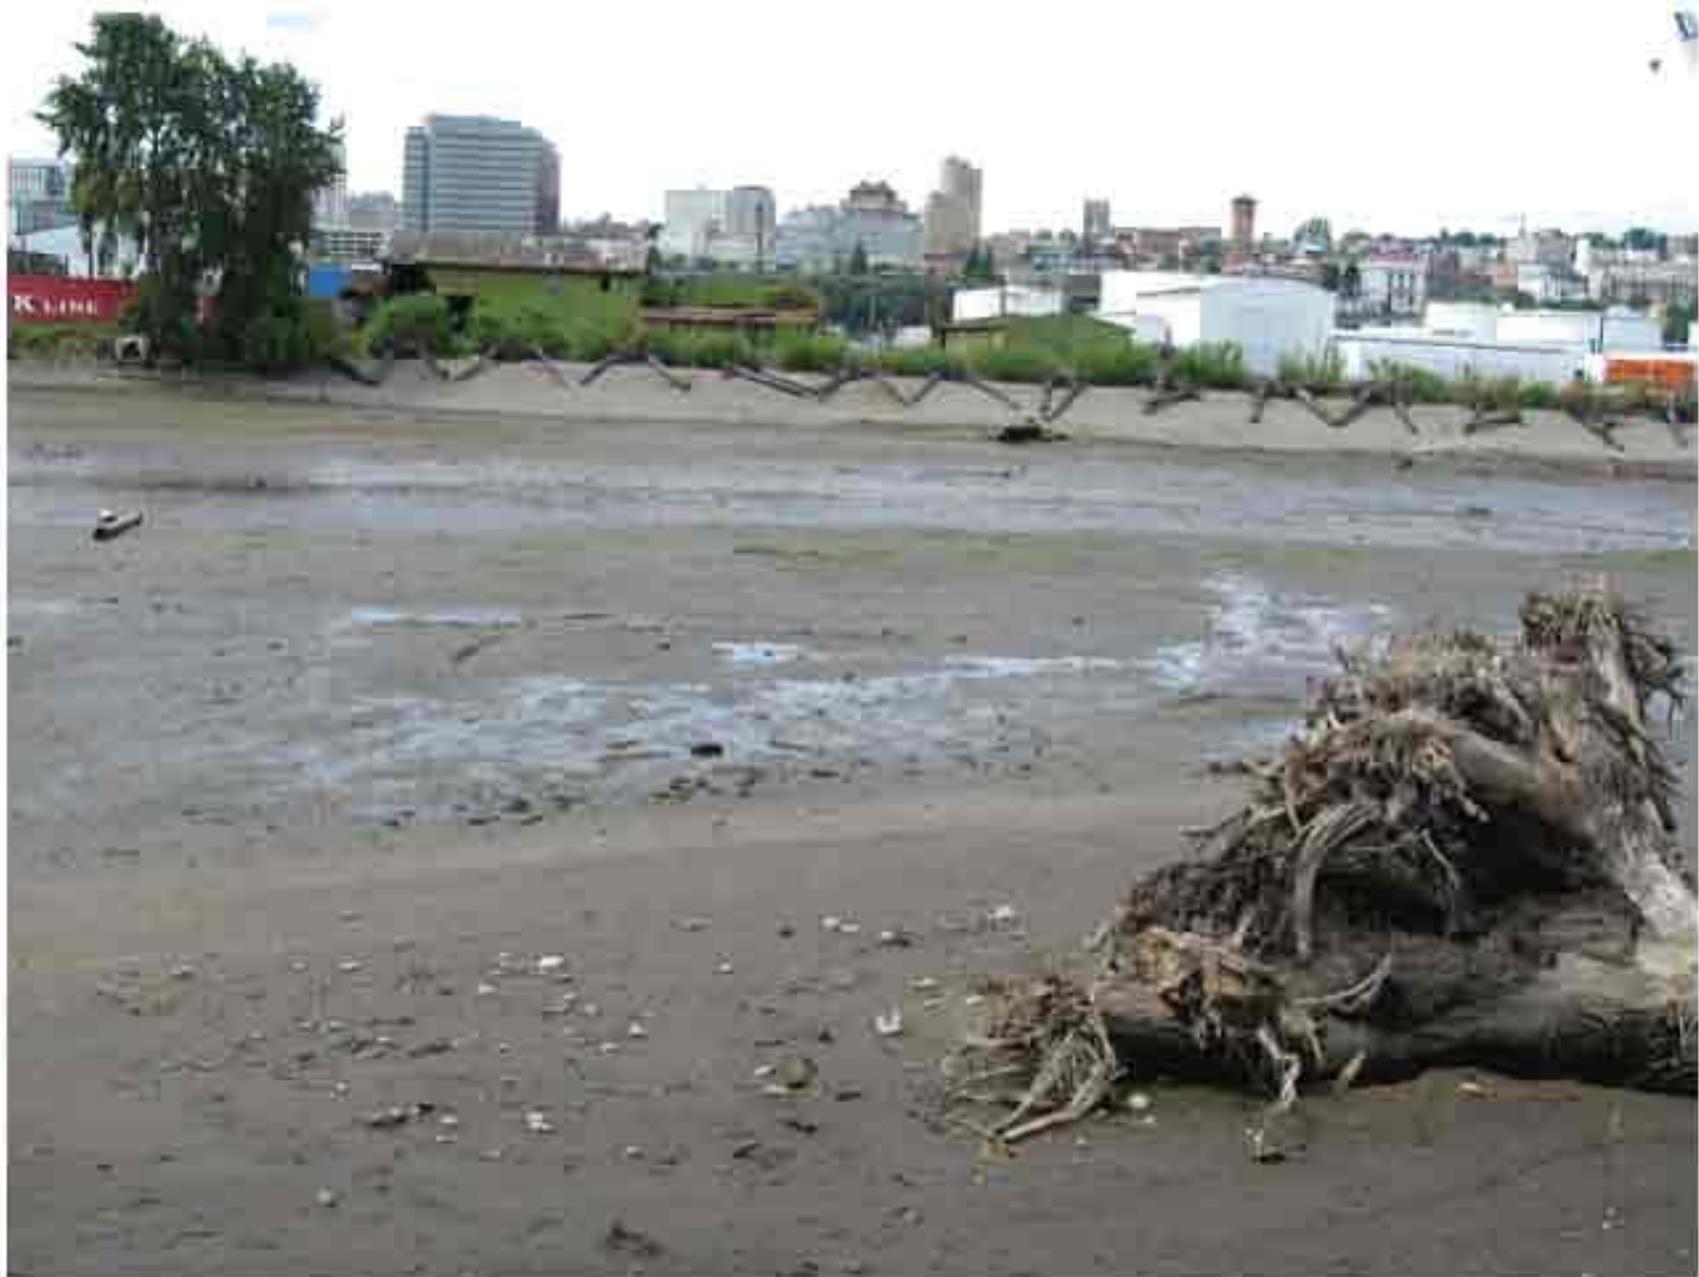
Middle Waterway Tideflat Habitat, Photo Point 4B, facing west. Photo taken July 11, 2006 at 12:33 PM, tide at approximately -2.77 feet MLLW.
[IMG_0026]

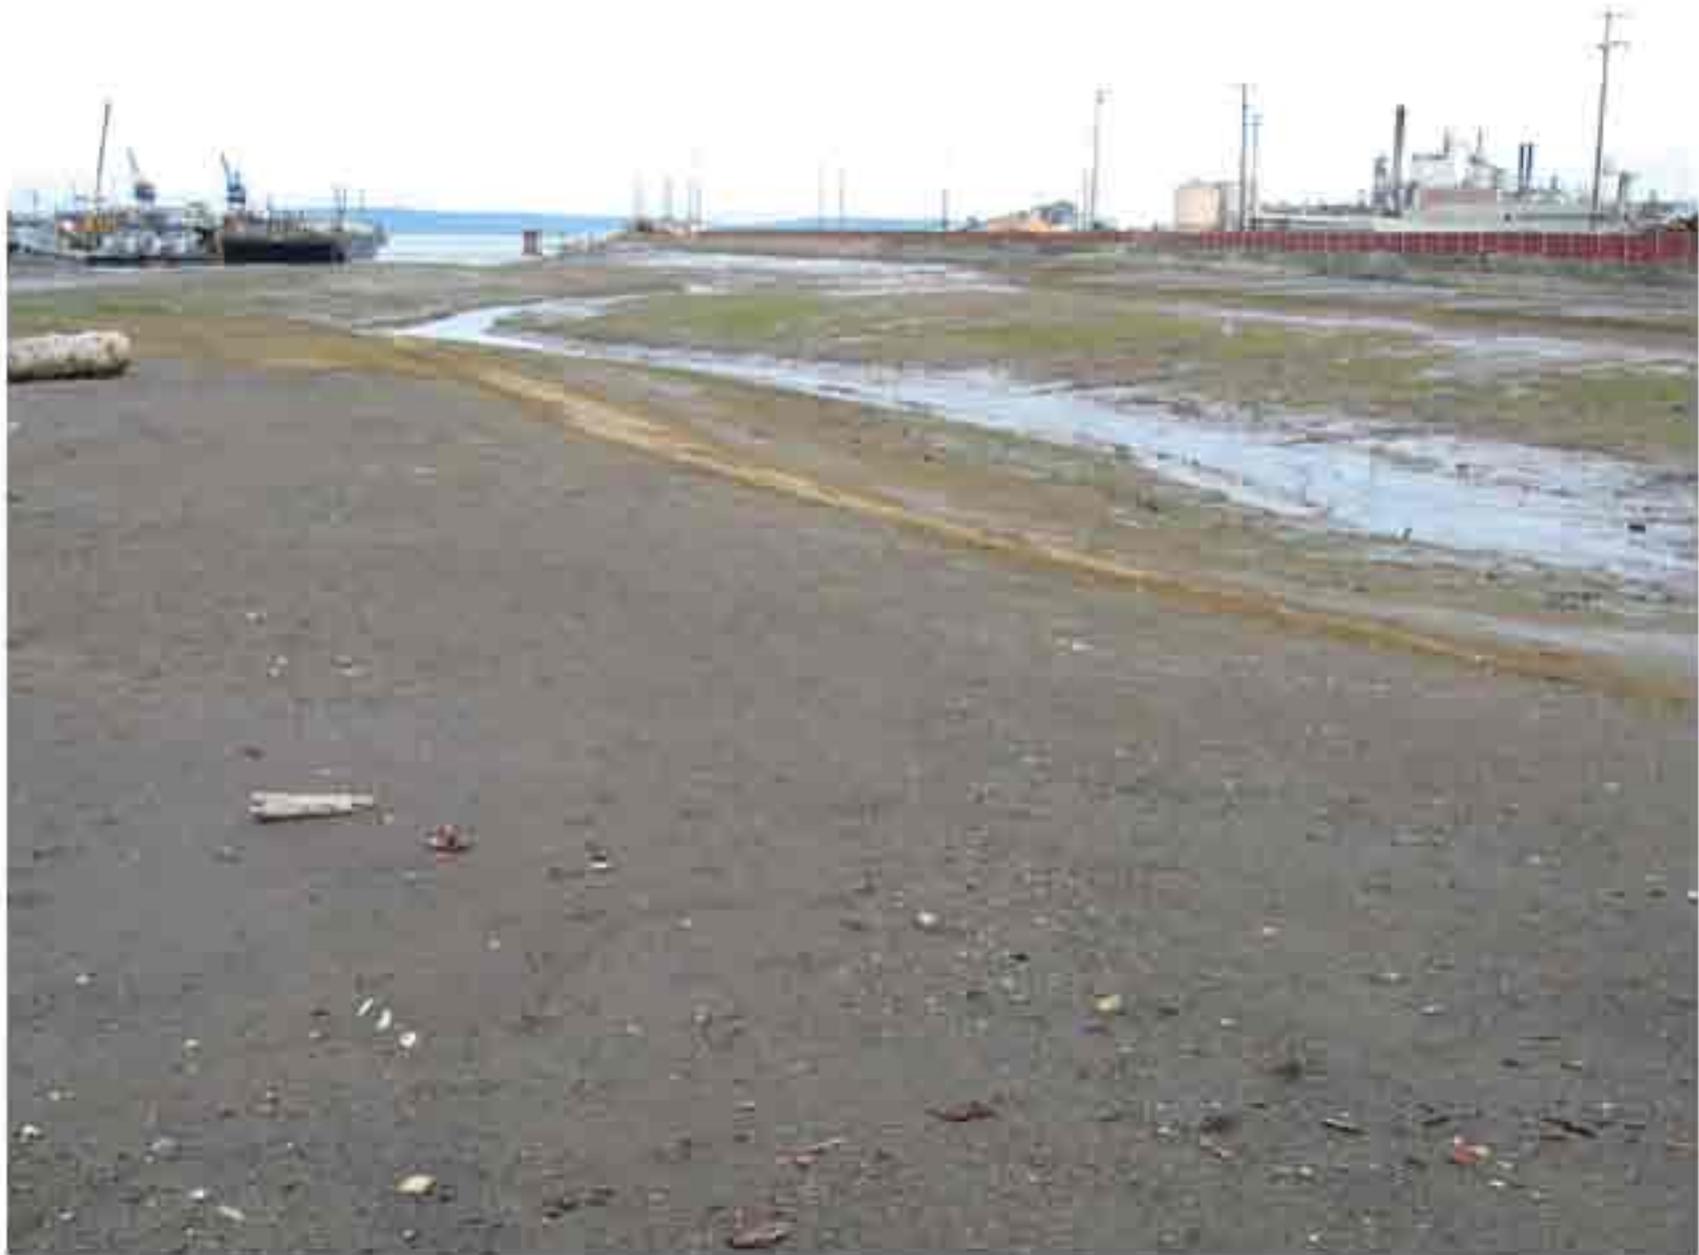
Middle Waterway Tideflat Habitat, Photo Point 4C, facing north. Photo taken July 11, 2006 at 12:33 PM, tide at approximately -2.77 feet MLLW.
[IMG_0027]

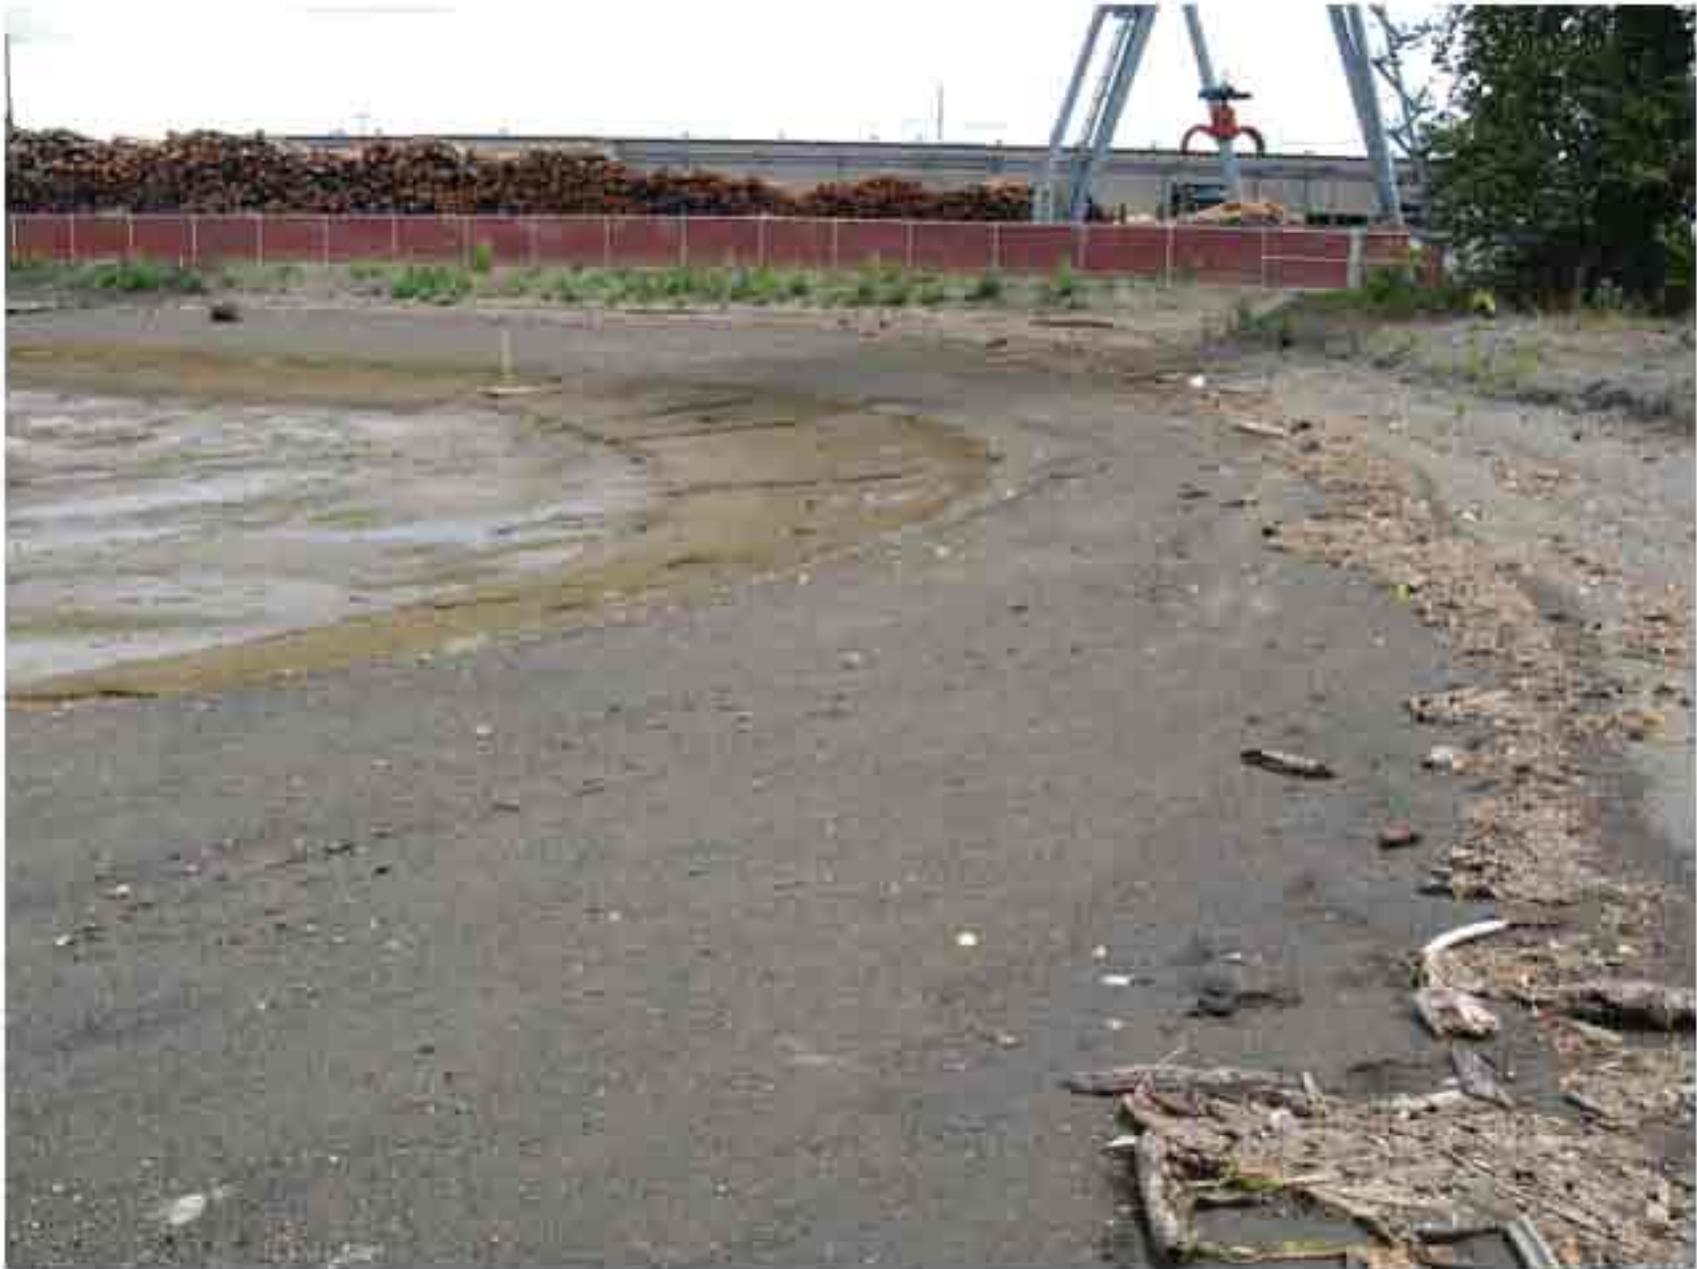
Middle Waterway Tideflat Habitat, Photo Point 4D, facing east. Photo taken July 11, 2006 at 12:33 PM, tide at approximately -2.77 feet MLLW.
[IMG_0028]

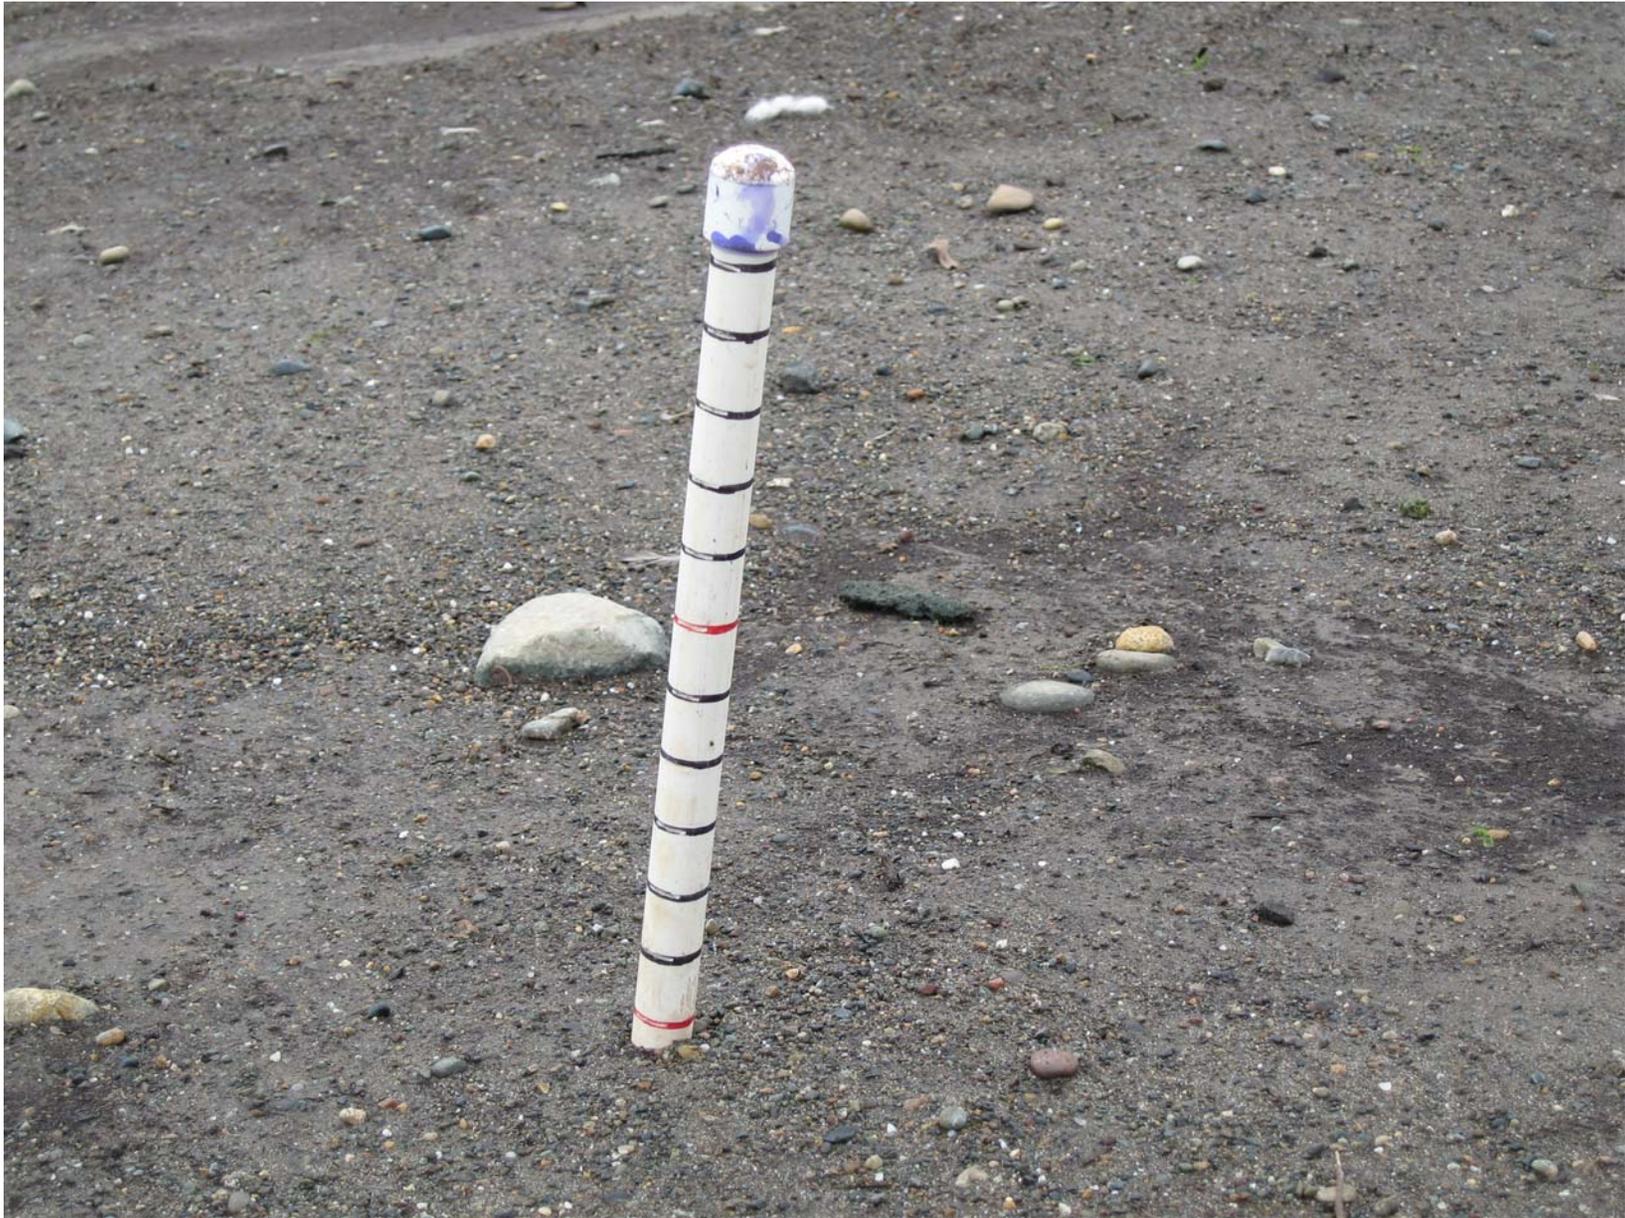
[IMG_0070]

Middle Waterway Tideflat Habitat, elevation stake E1. Photo taken July 13, 2006.

Elevation Monitoring – Six elevation stakes were placed at the locations shown on Figure E-6 of the OMMP. These graduated stakes are embedded one-foot into the ground and two feet of the stake are visible above ground. One inch increments are marked on the stakes both above and below the ground surface to allow for measurement of erosion/sedimentation in subsequent monitoring years. The stakes were surveyed following installation to allow for replacement if needed, and the top and ground surface elevations were also measured. Photographs showing the elevation stakes in place are included in Attachment A.

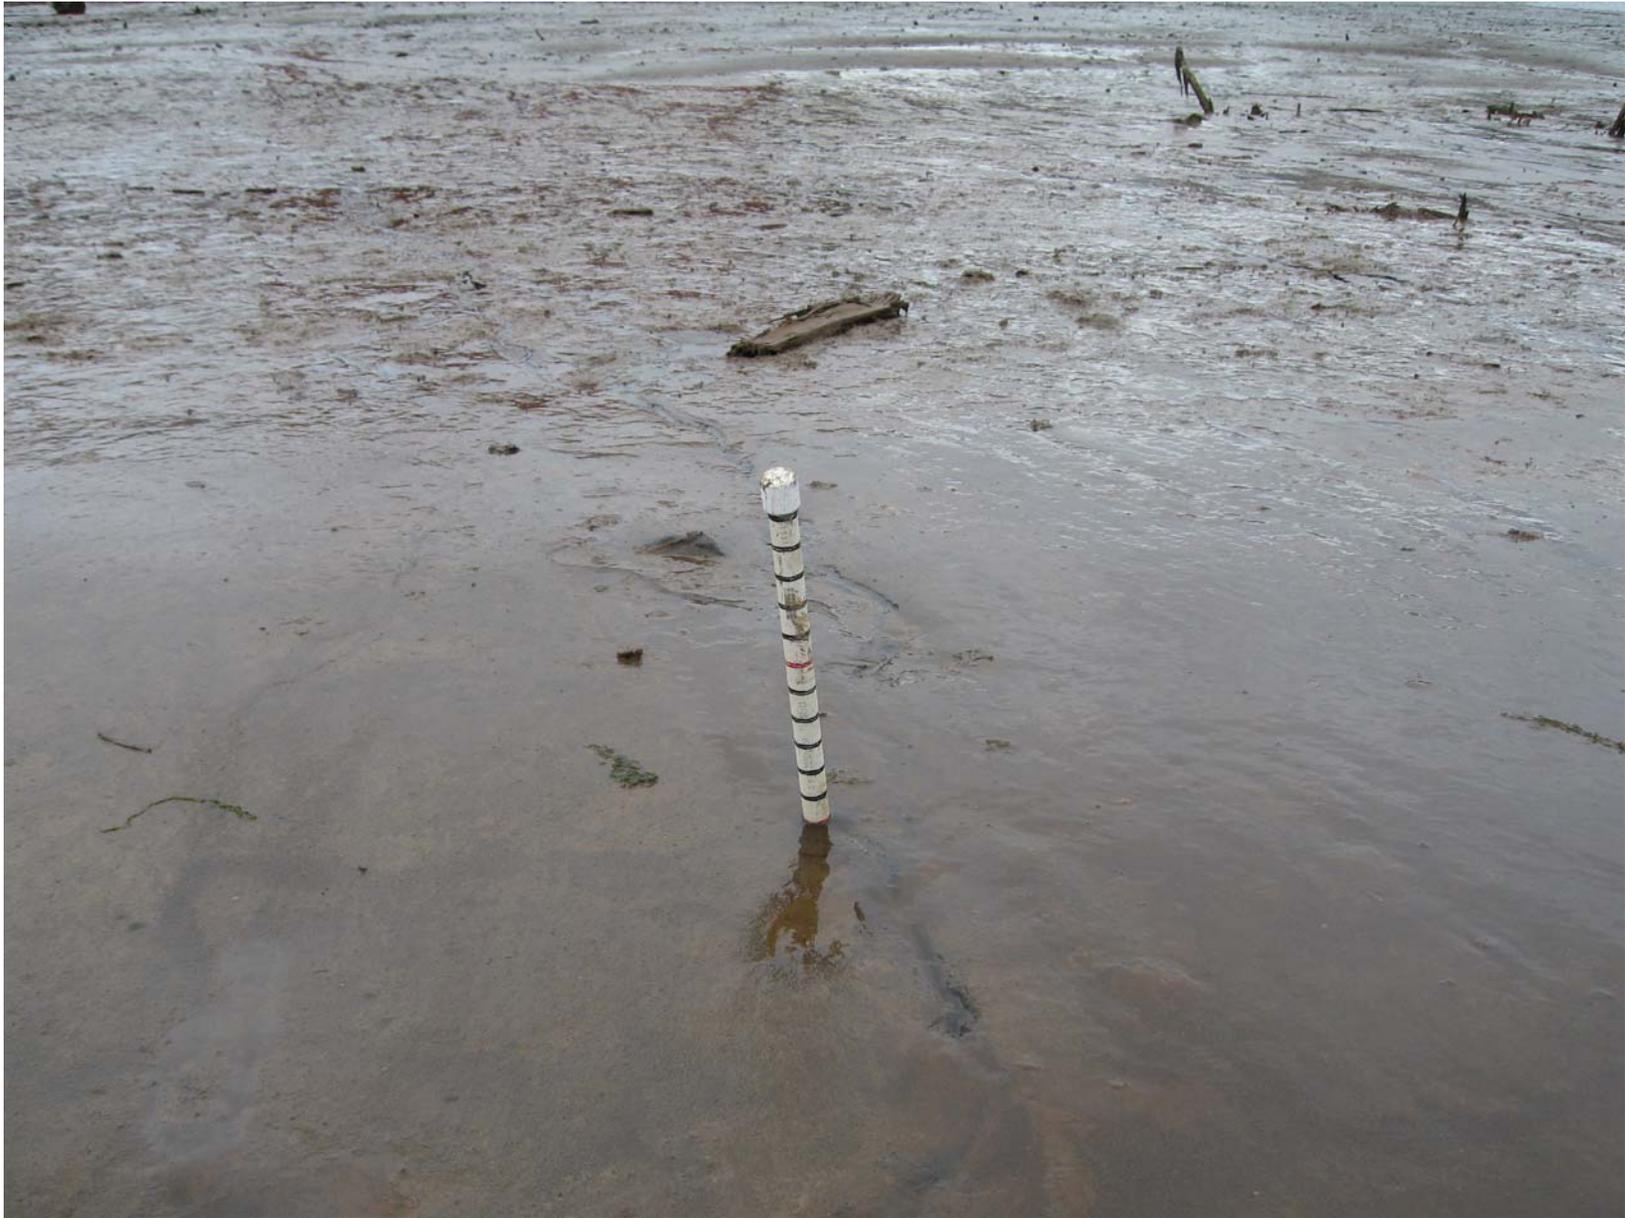
Middle Waterway Tideflat Habitat, elevation stake E2. Photo taken July 13, 2006.
[IMG_0071]

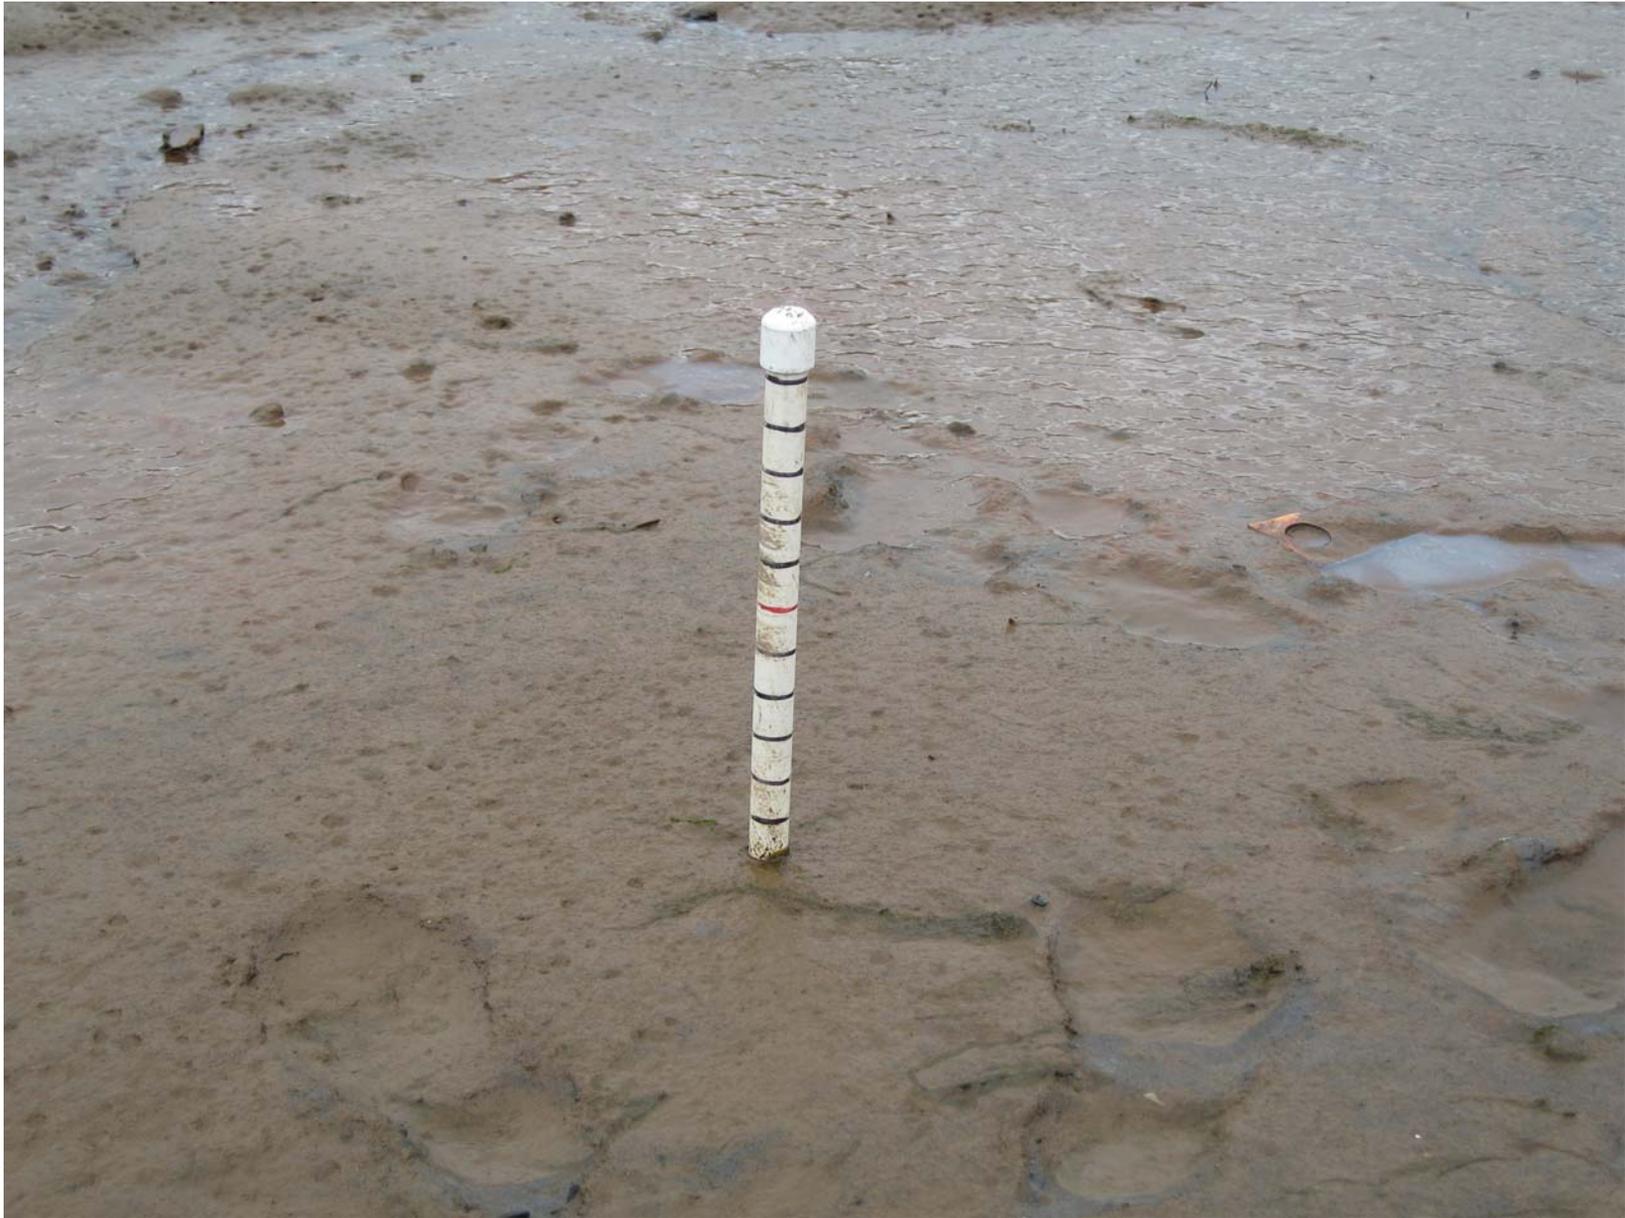
[IMG_0072]

Middle Waterway Tideflat Habitat, elevation stake E3. Photo taken July 13, 2006.

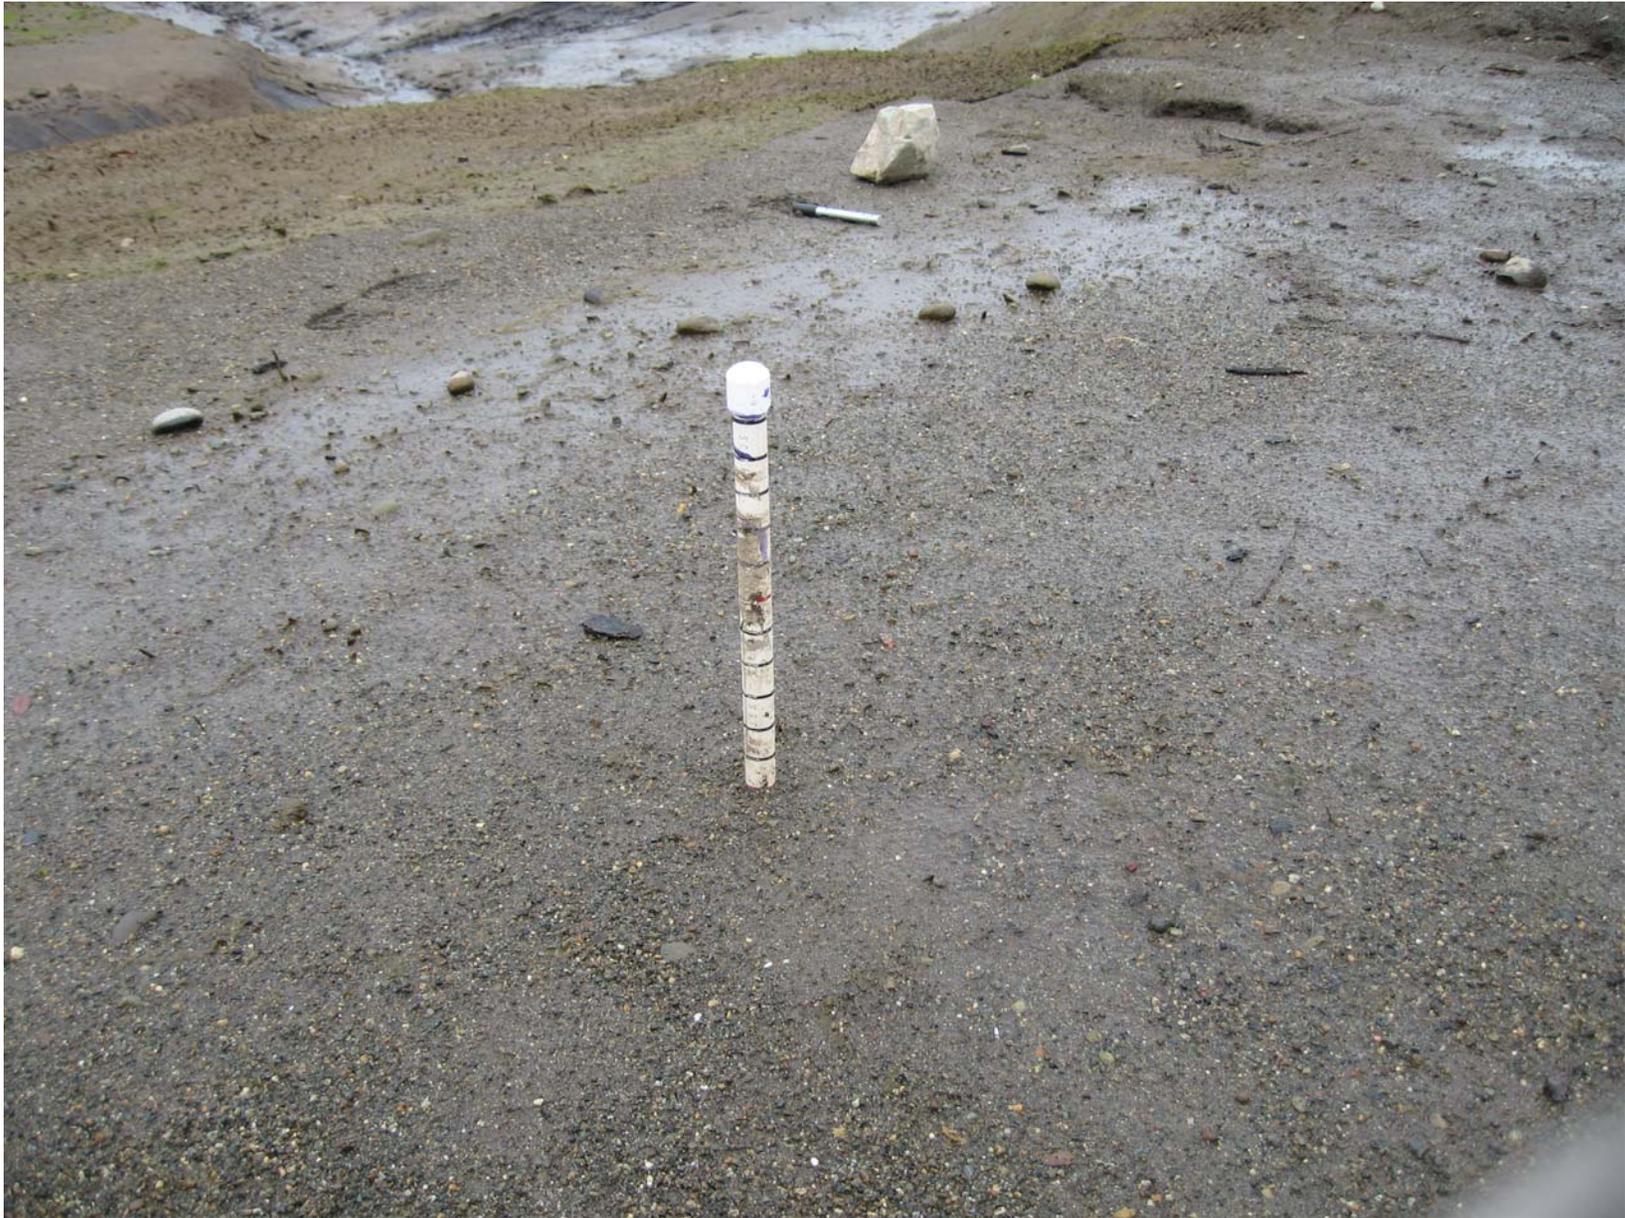
[IMG_0073]

Middle Waterway Tideflat Habitat, elevation stake E4. Photo taken July 13, 2006.

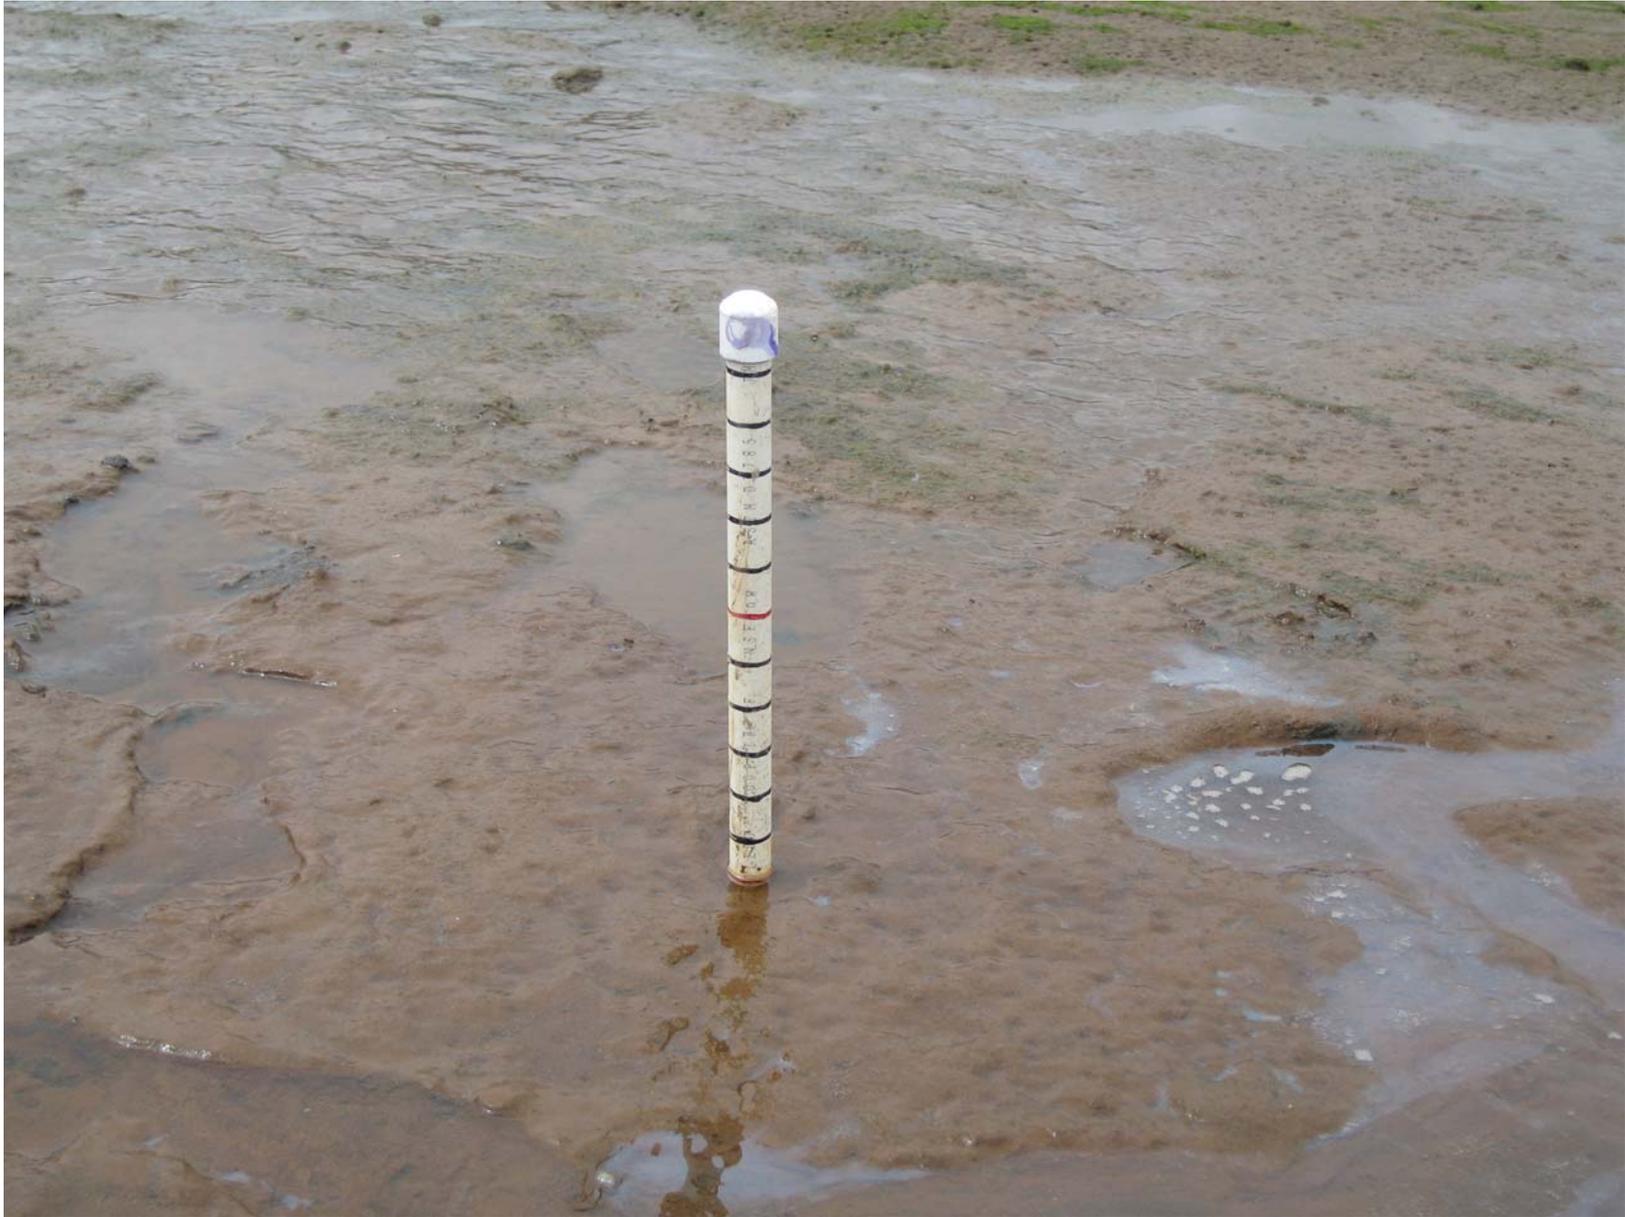
Middle Waterway Tideflat Habitat, elevation stake E5. Photo taken July 13, 2006.
[IMG_0074]

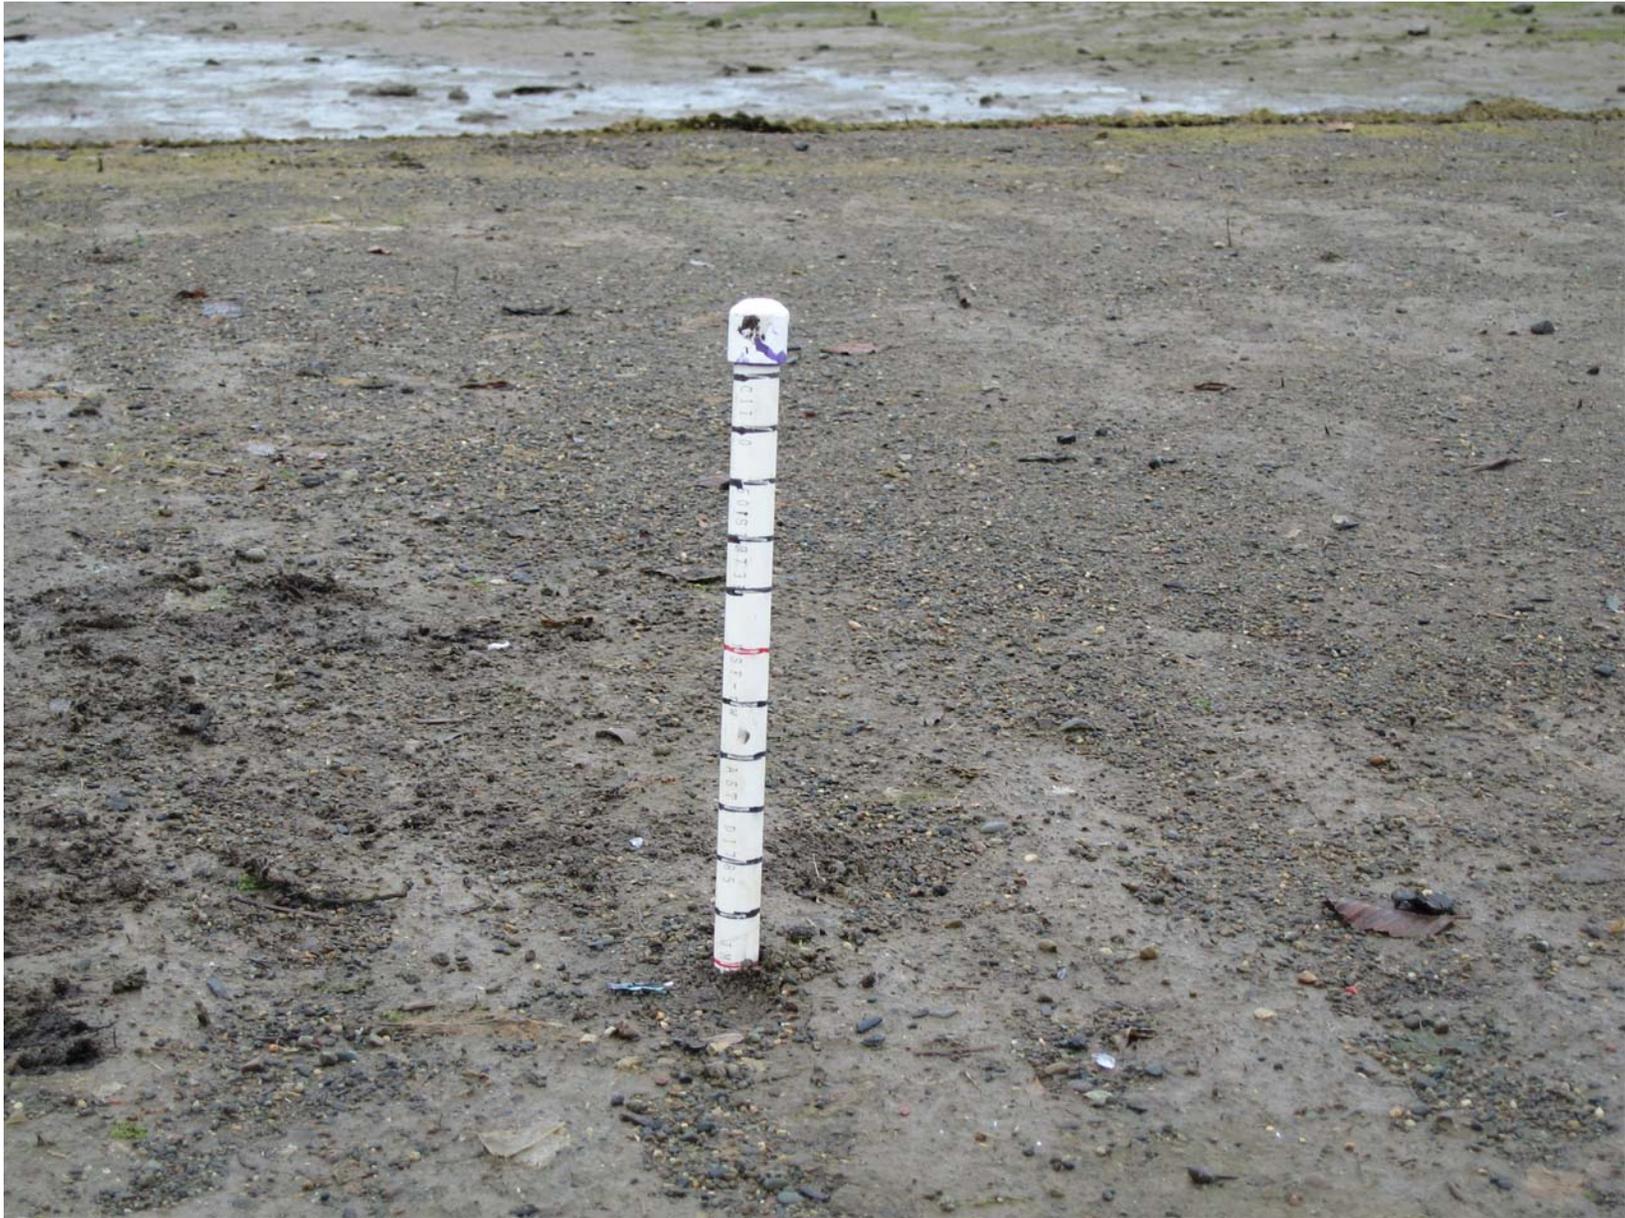
[IMG_0092]

Middle Waterway Tideflat Habitat, elevation stake E6. Photo taken July 13, 2006.

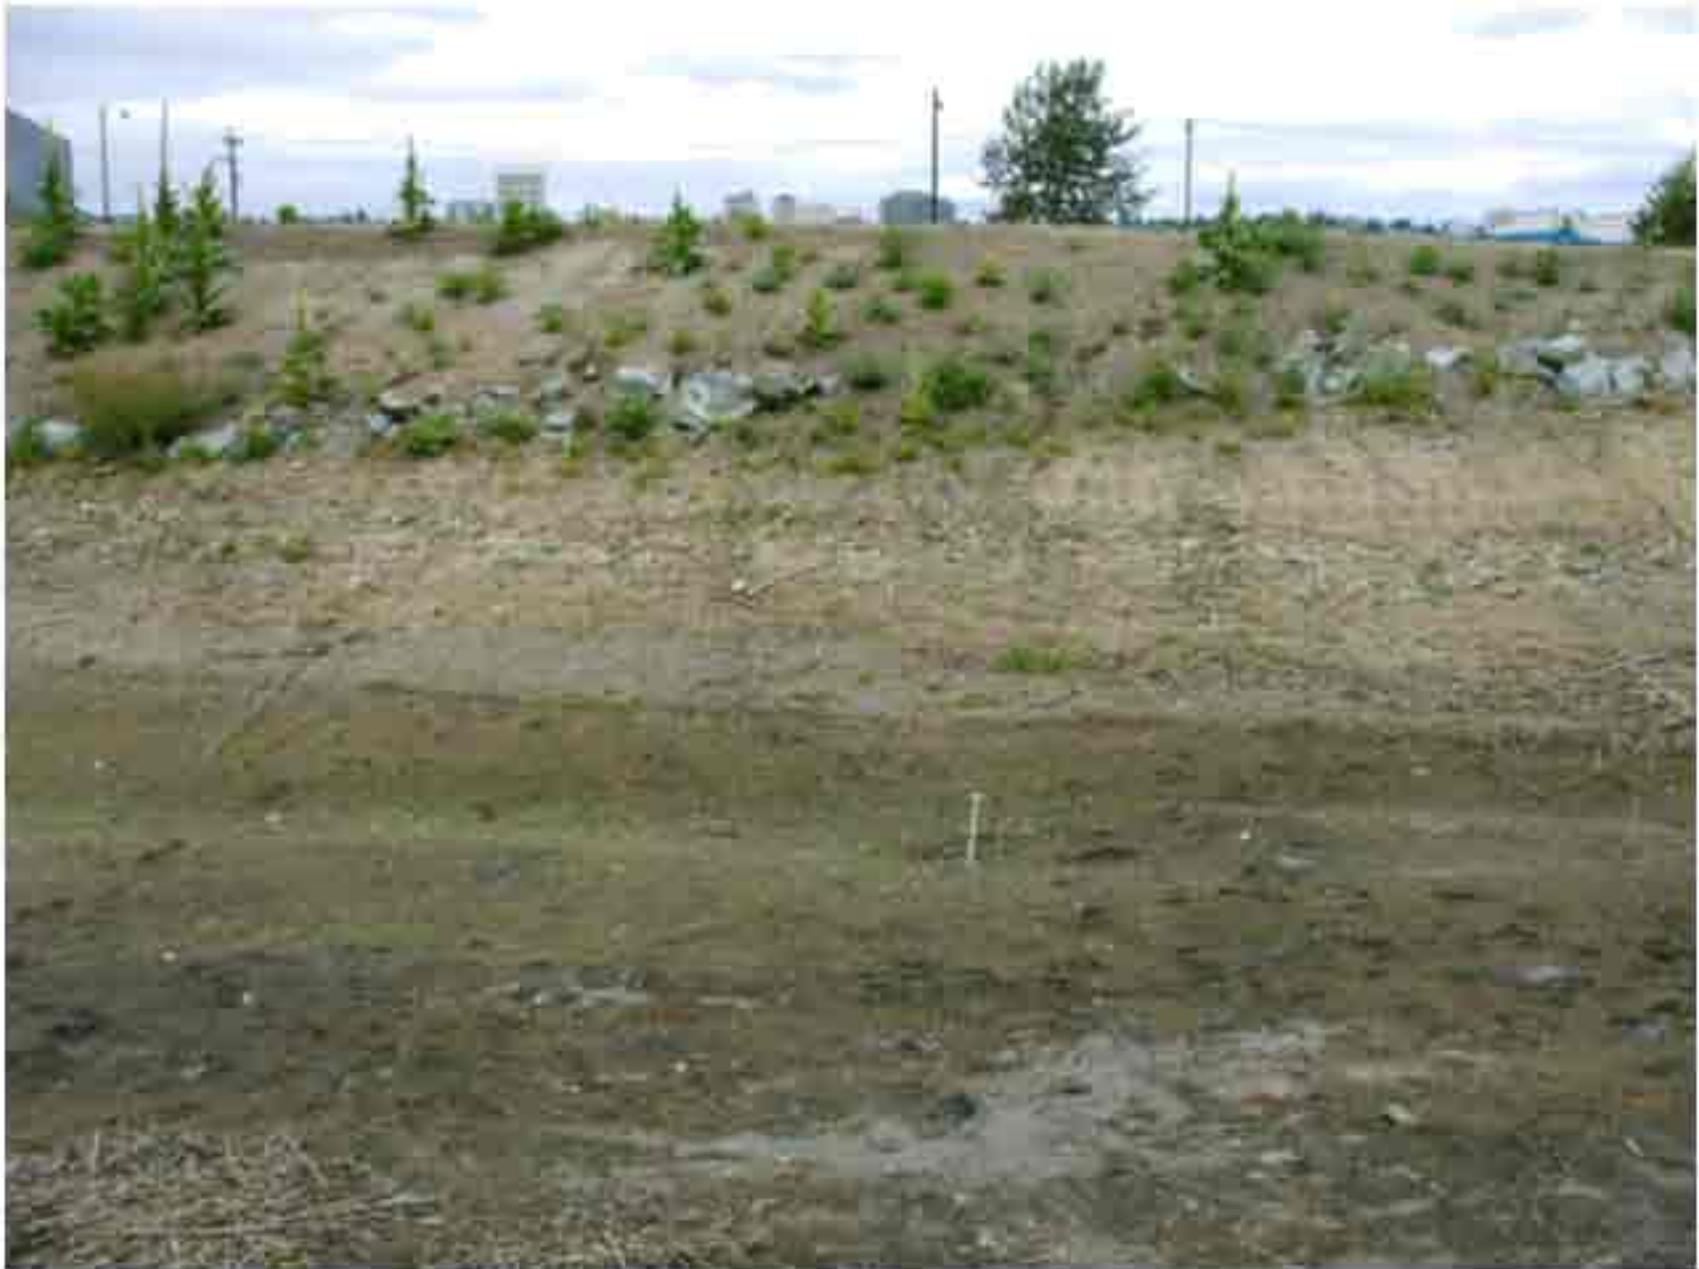
Puyallup River Side Channel, Photo Point 1, facing west. Photo taken July 10, 2006 at 12:12 PM, tide at approximately -1.86 feet MLLW [MAG0014]

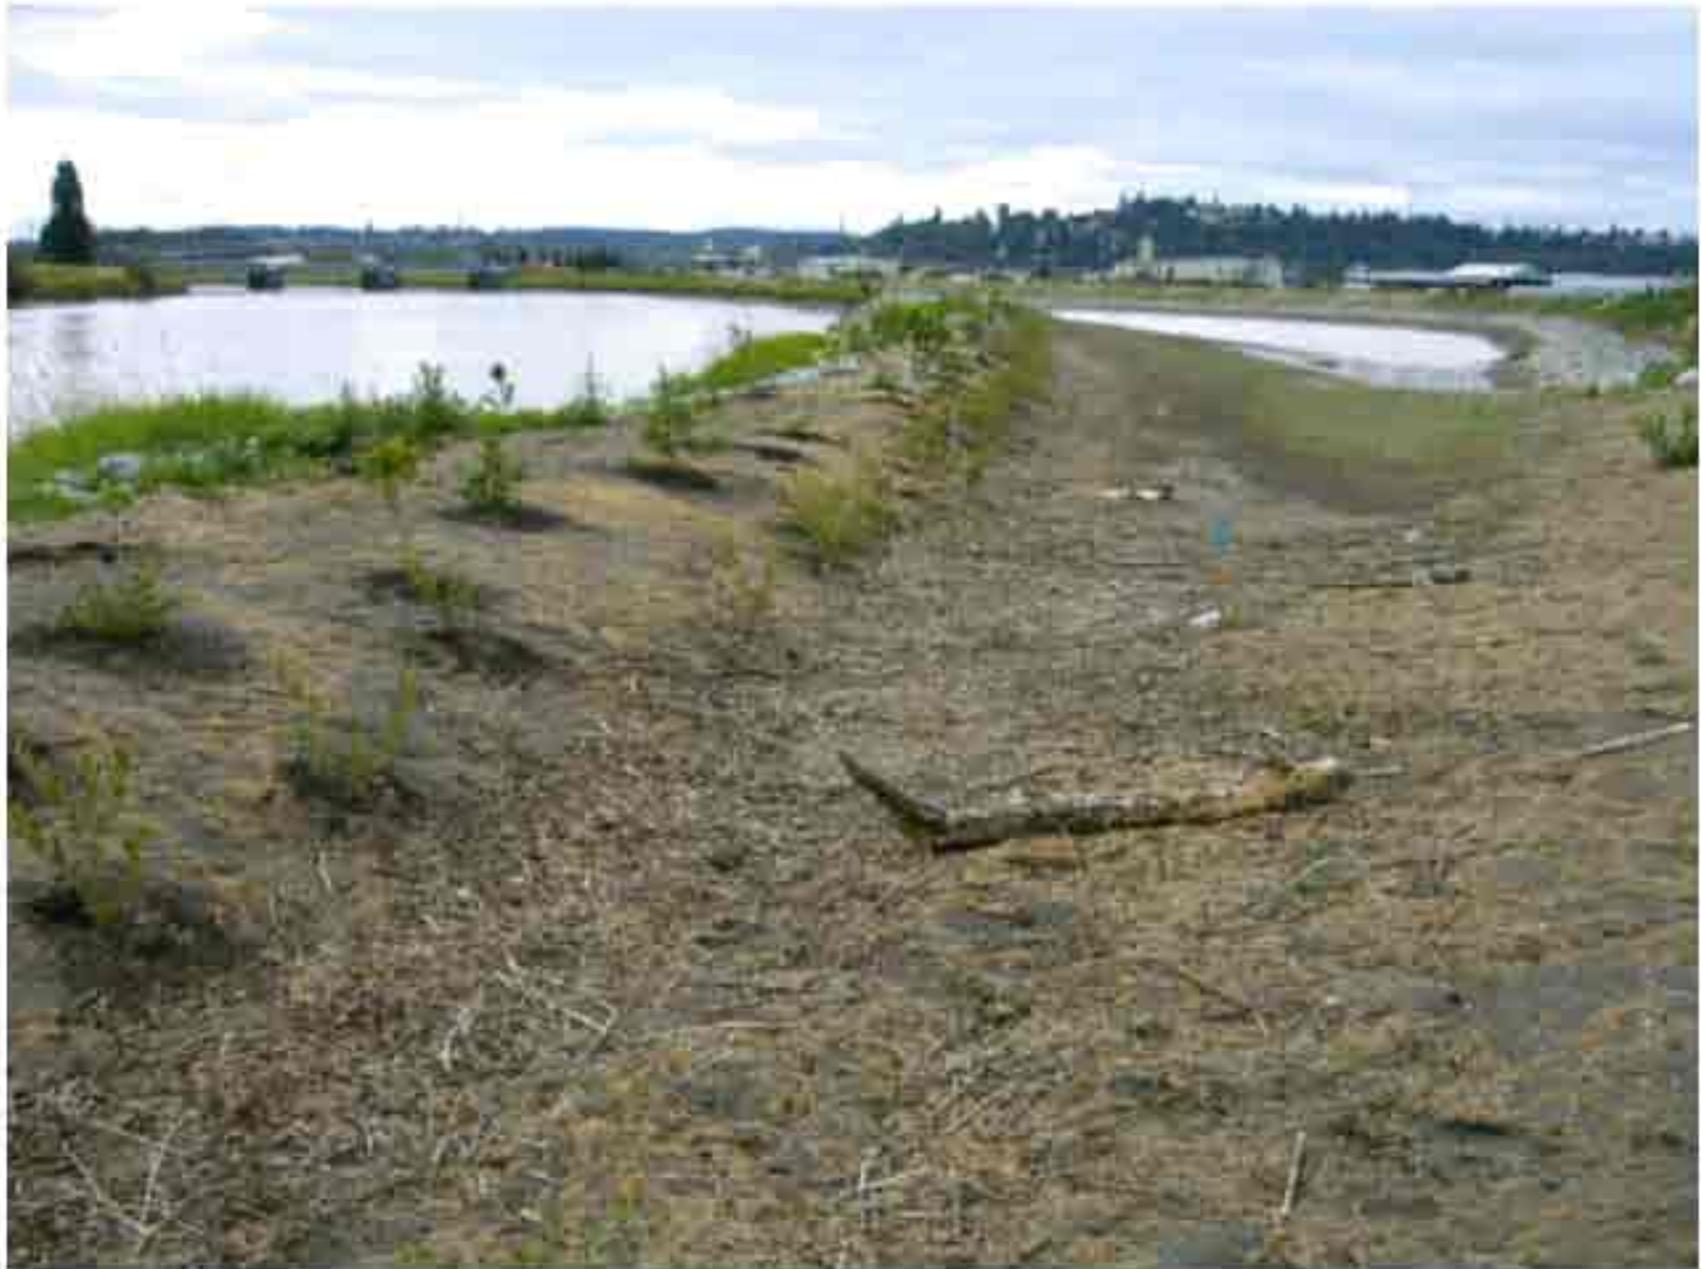
Puyallup River Side Channel, Photo Point 2A, facing south. Photo taken July 10, 2006 at 12:27 PM, tide at approximately -1.38 feet MLLW. [MAG0015]
