THEA FOSS AND WHEELER-OSGOOD WATERWAYS REMEDIATION PROJECT

YEAR 0 BASELINE MONITORING

HABITAT MITIGATION AREA MONITORING PRELIMINARY FINDINGS MEMORANDUM

NOVEMBER 30, 2006

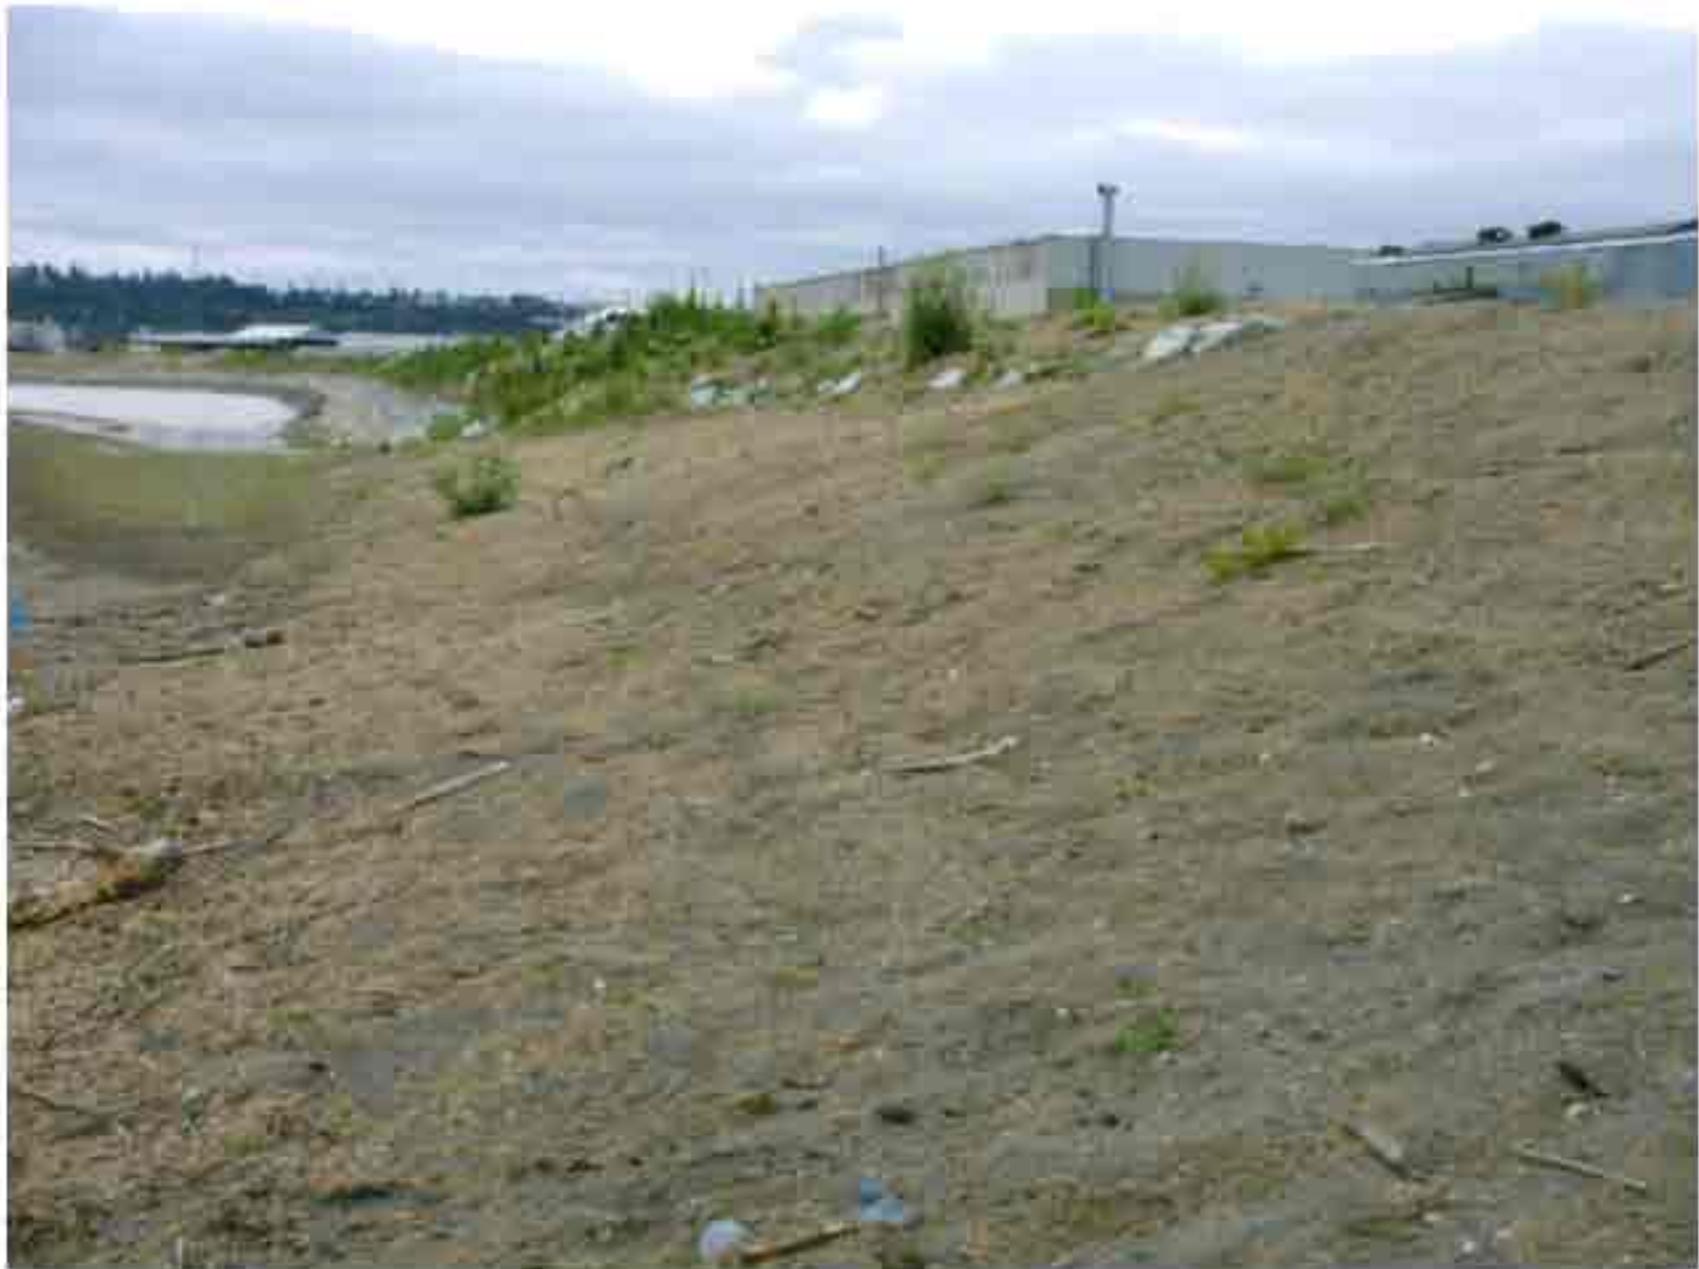
Puyallup River Side Channel, Photo Point 2B, facing southwest. Photo taken July 10, 2006 at 12:27 PM, tide at approximately -1.38 feet MLLW.
[IMAG0016]

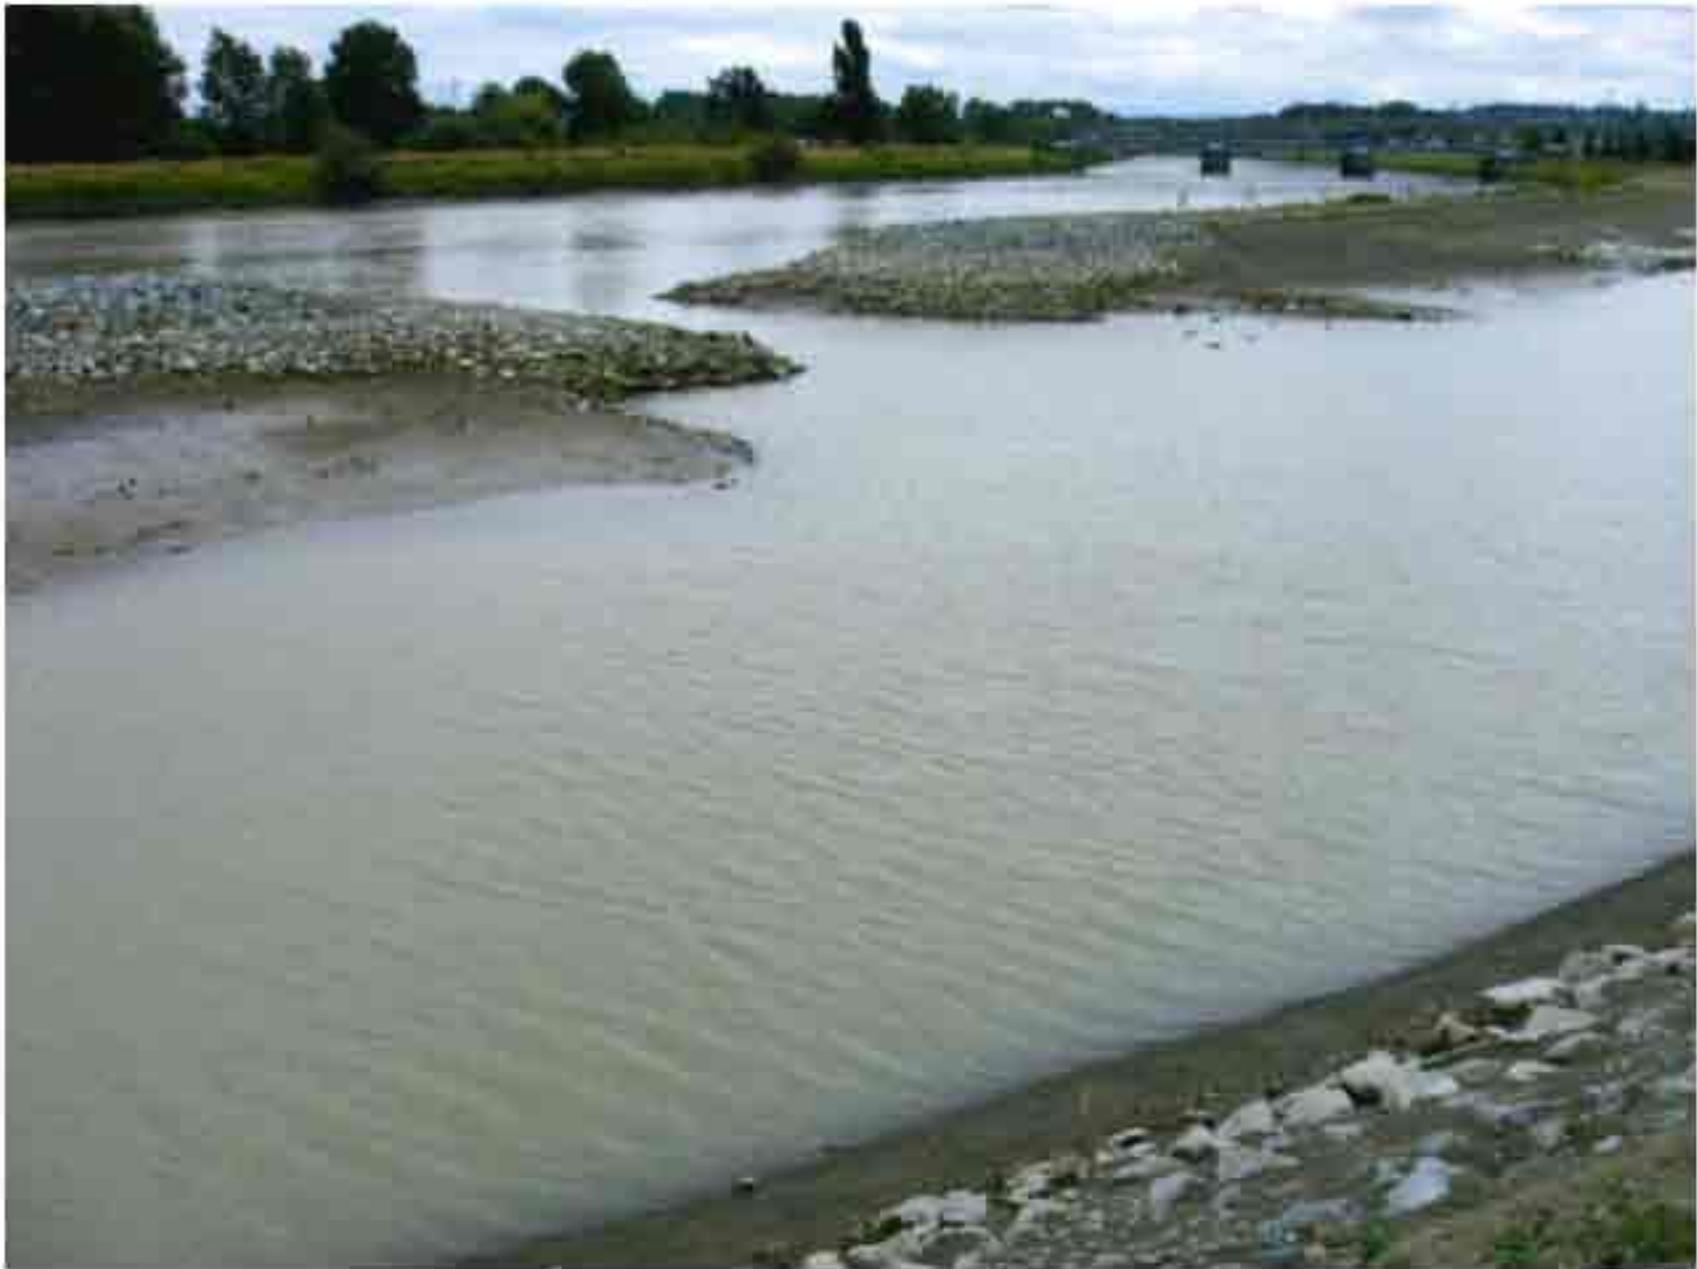
Puyallup River Side Channel, Photo Point 3A, facing southeast. Photo taken July 10, 2006 at 12:30 PM, tide at approximately -1.28 feet MLLW.
[IMAG0017]

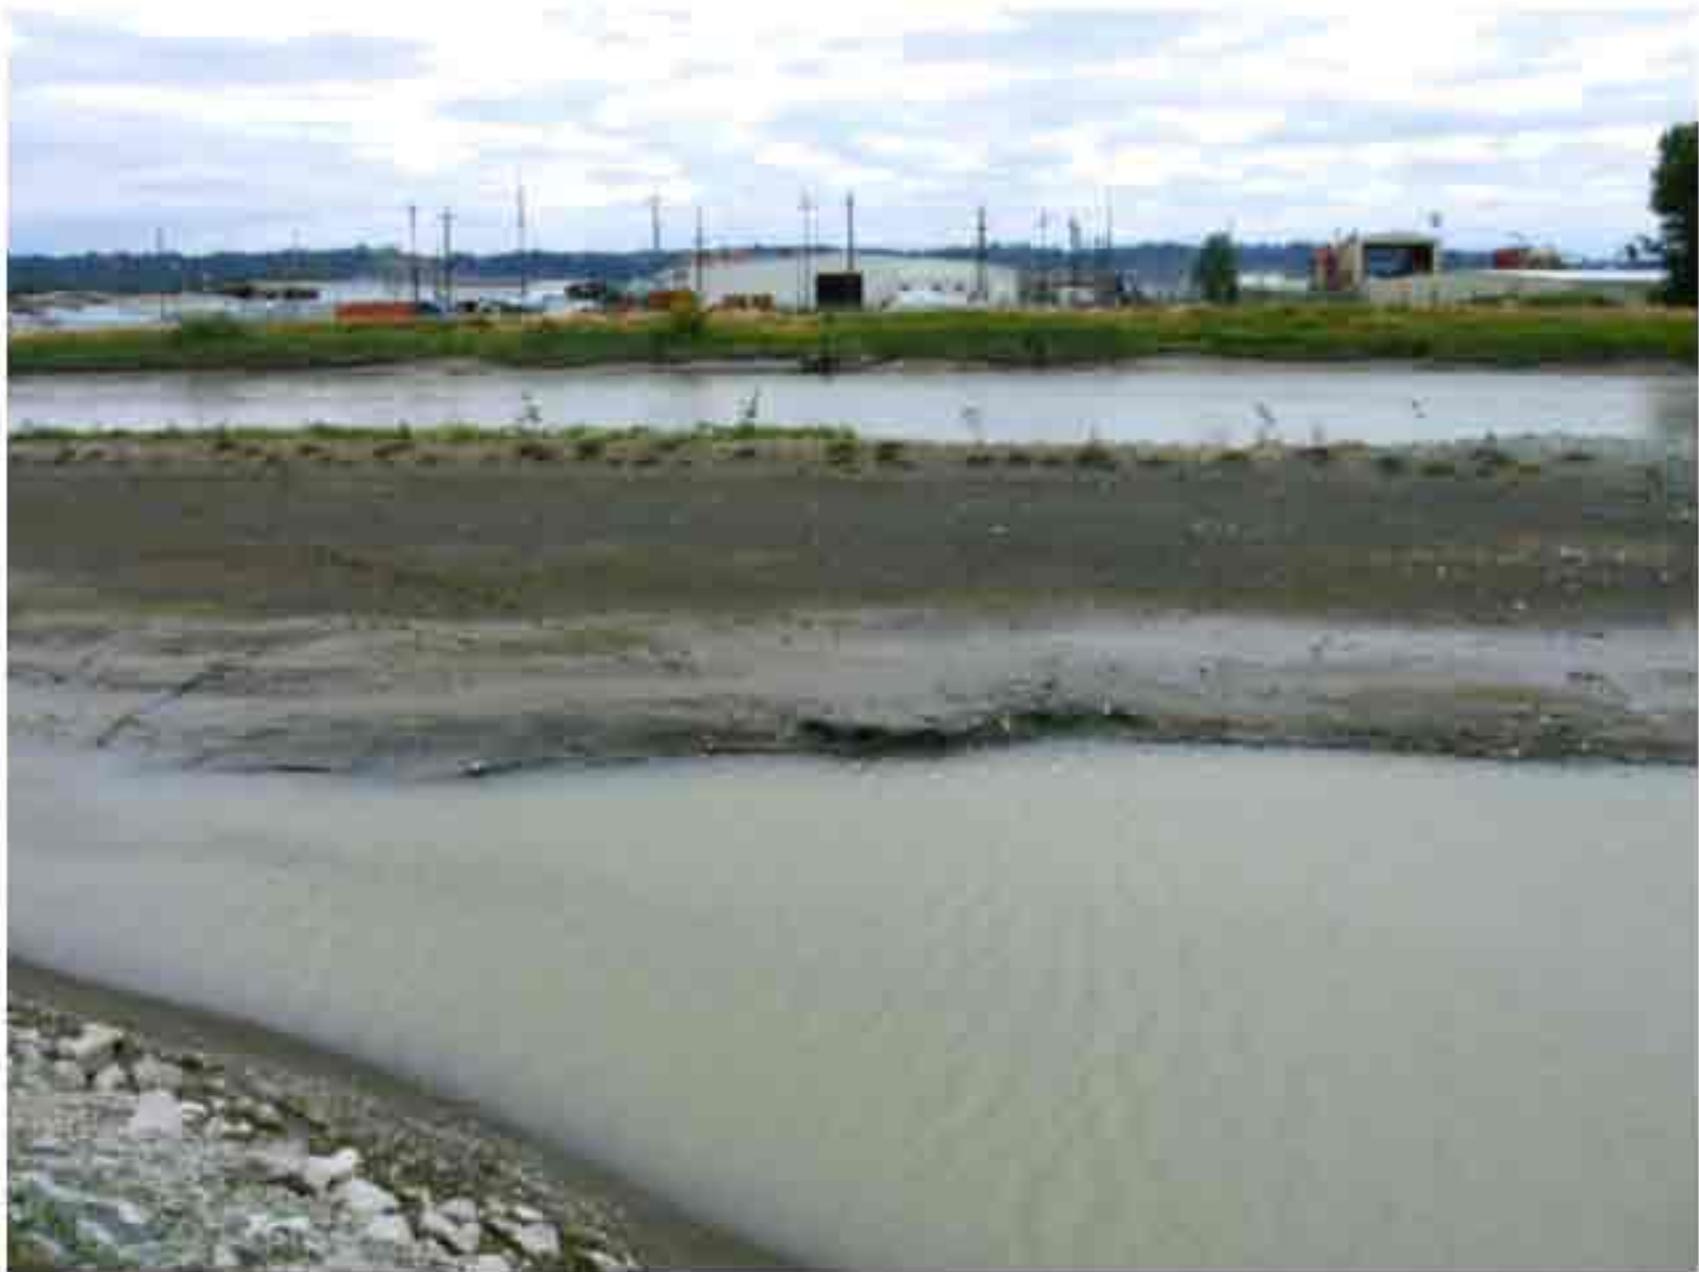
Puyallup River Side Channel, Photo Point 3B, facing east. Photo taken July 10, 2006 at 12:30 PM, tide at approximately -1.28 feet MLLW. [MAG0001]

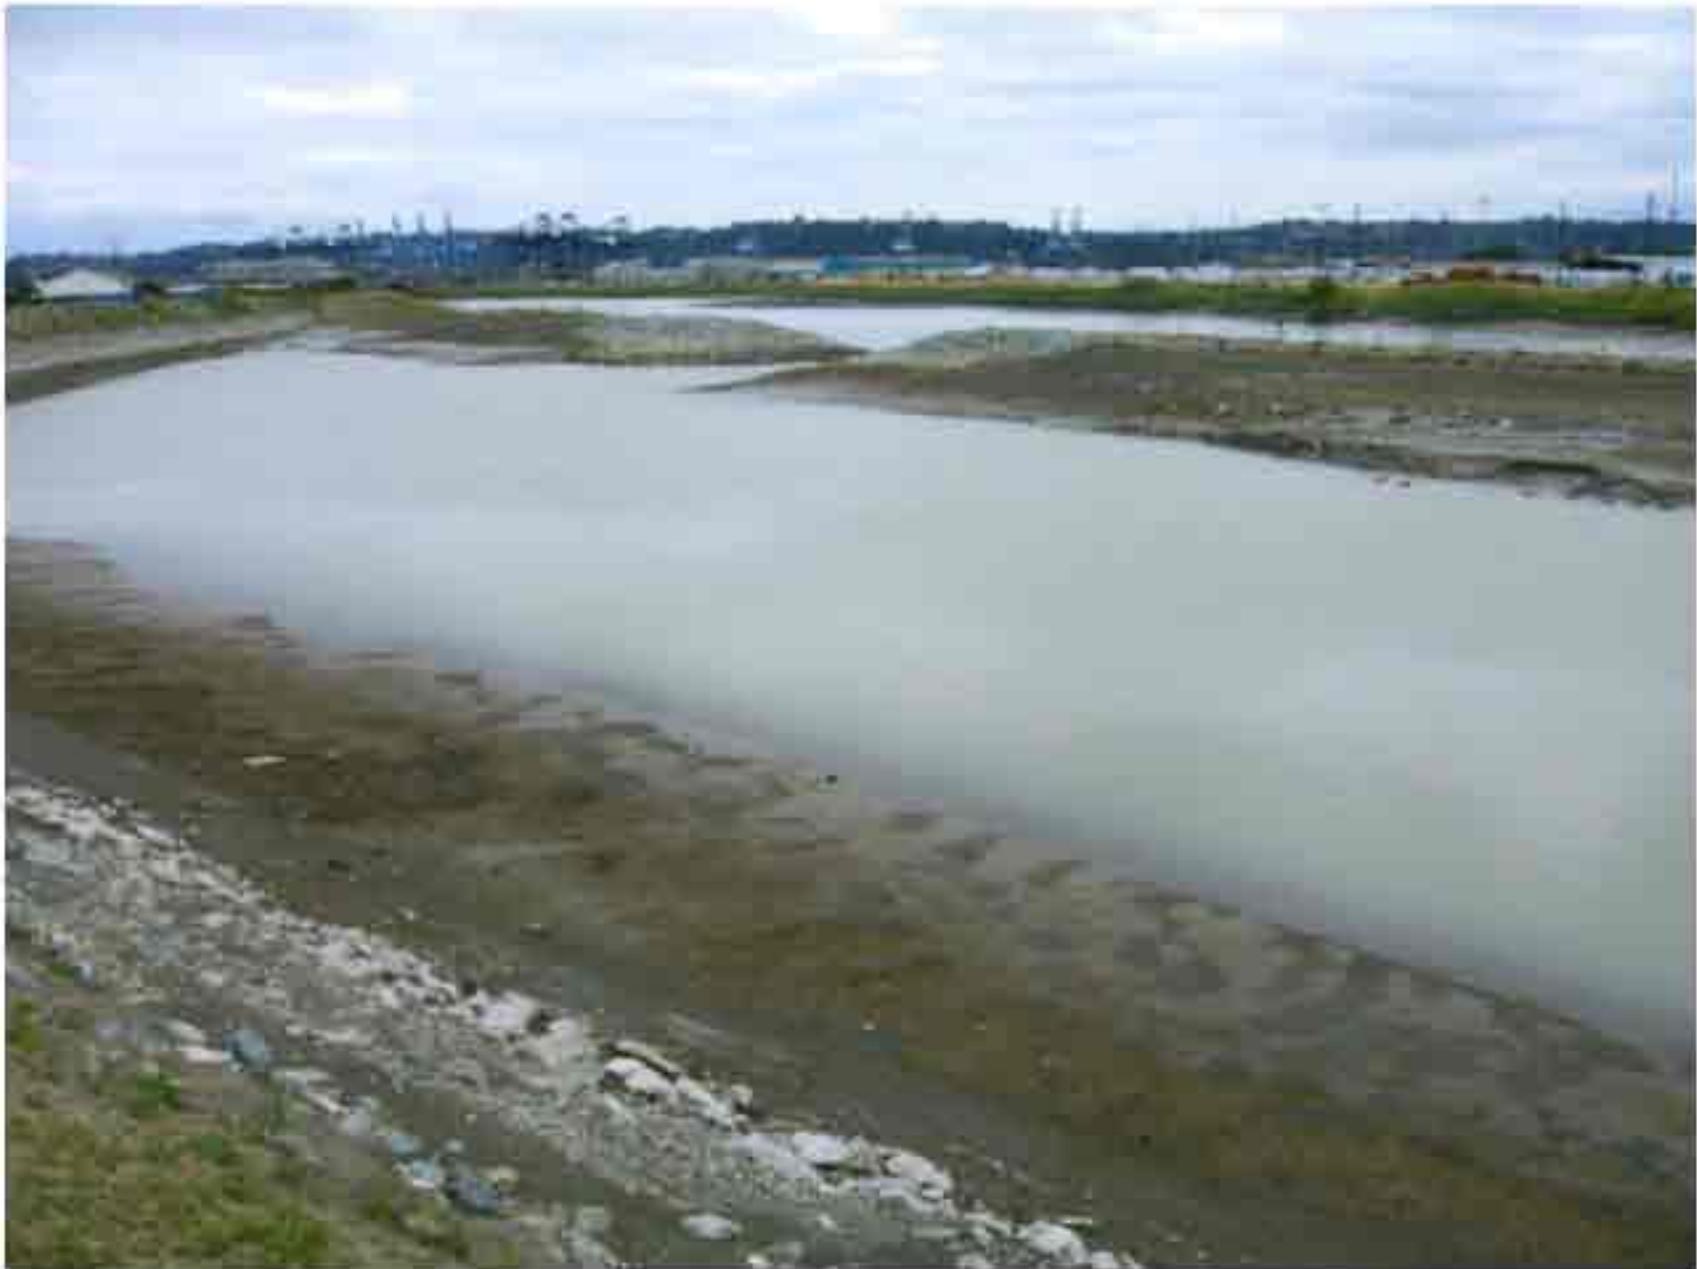
Puyallup River Side Channel, Photo Point 4A, facing northeast. Photo taken July 10, 2006 at 12:37 PM, tide at approximately -1.02 feet MLLW.
[IMAG0002]

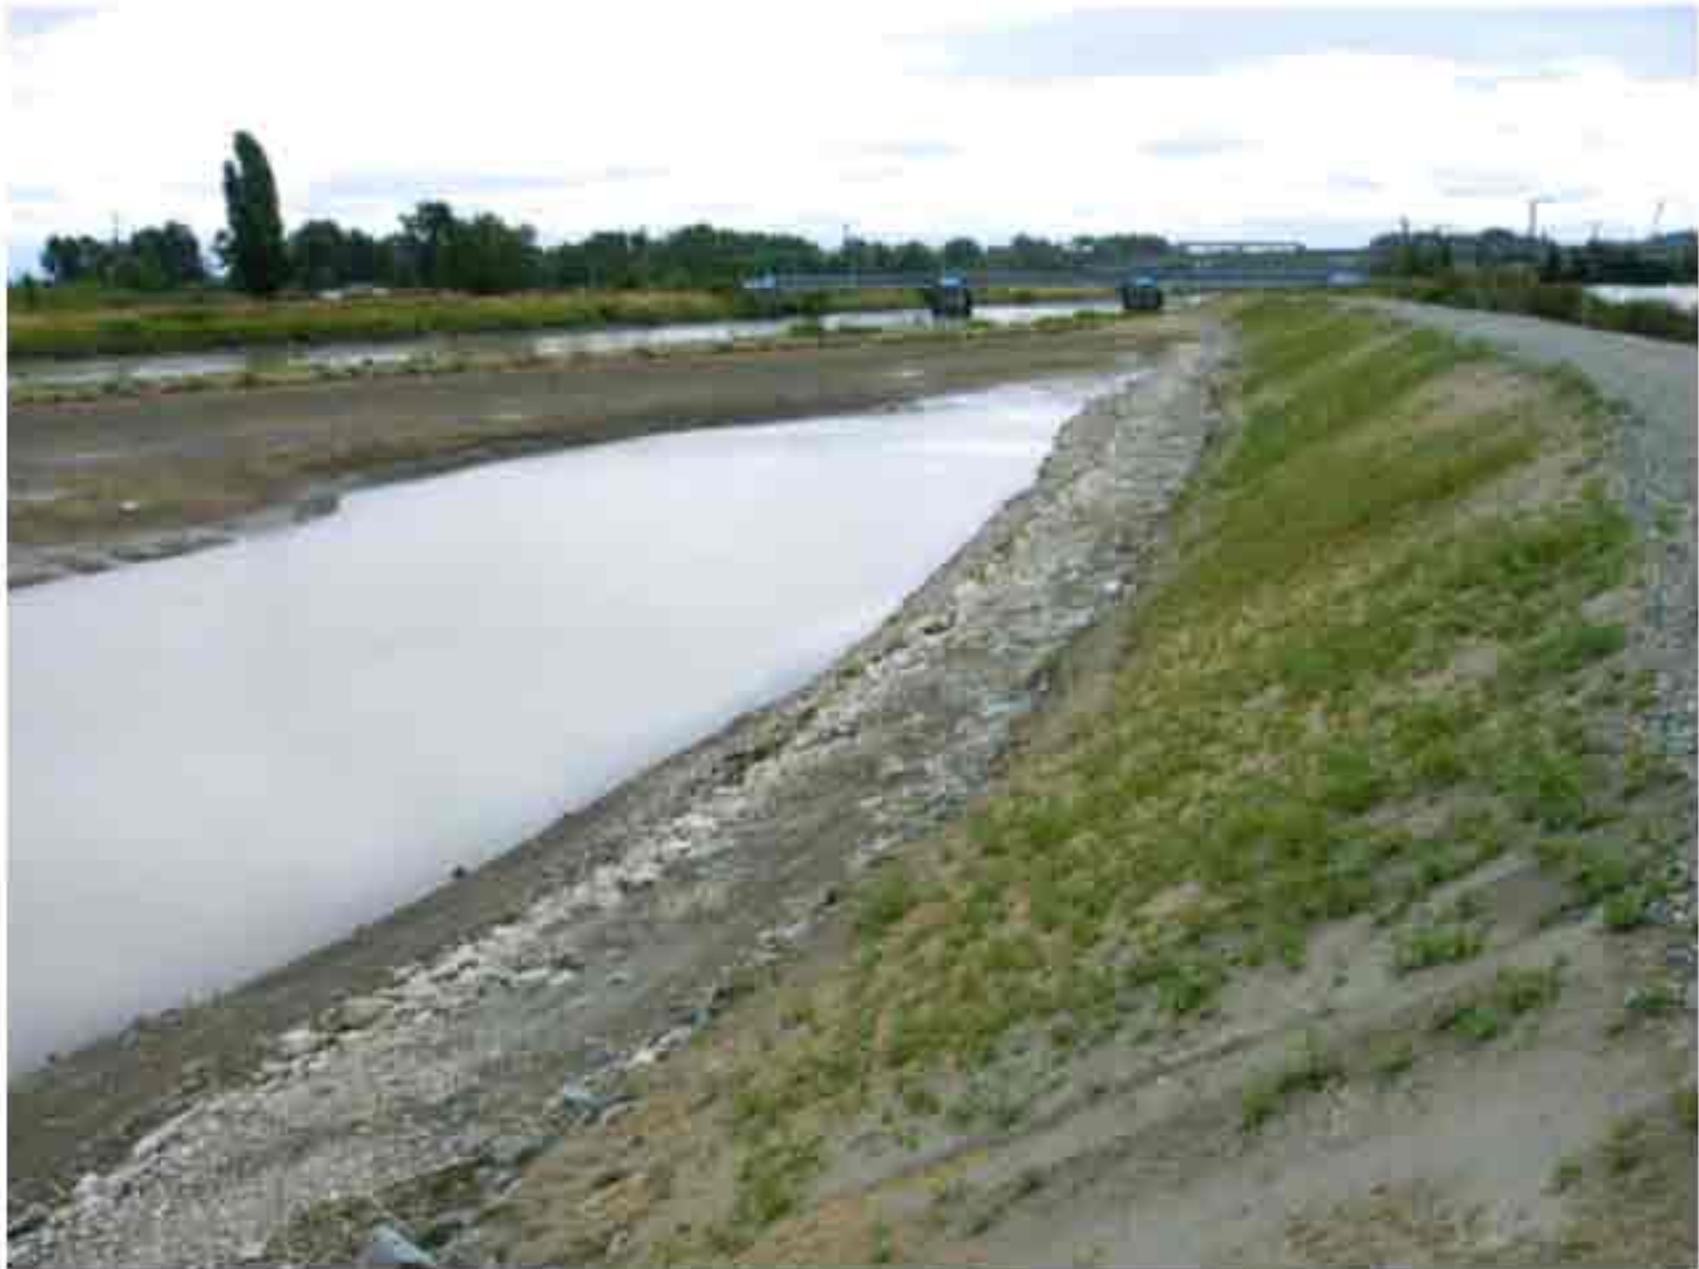
Puyallup River Side Channel, Photo Point 4B, facing southeast. Photo taken July 10, 2006 at 12:37 PM, tide at approximately -1.02 feet MLLW.
[IMAG0003]

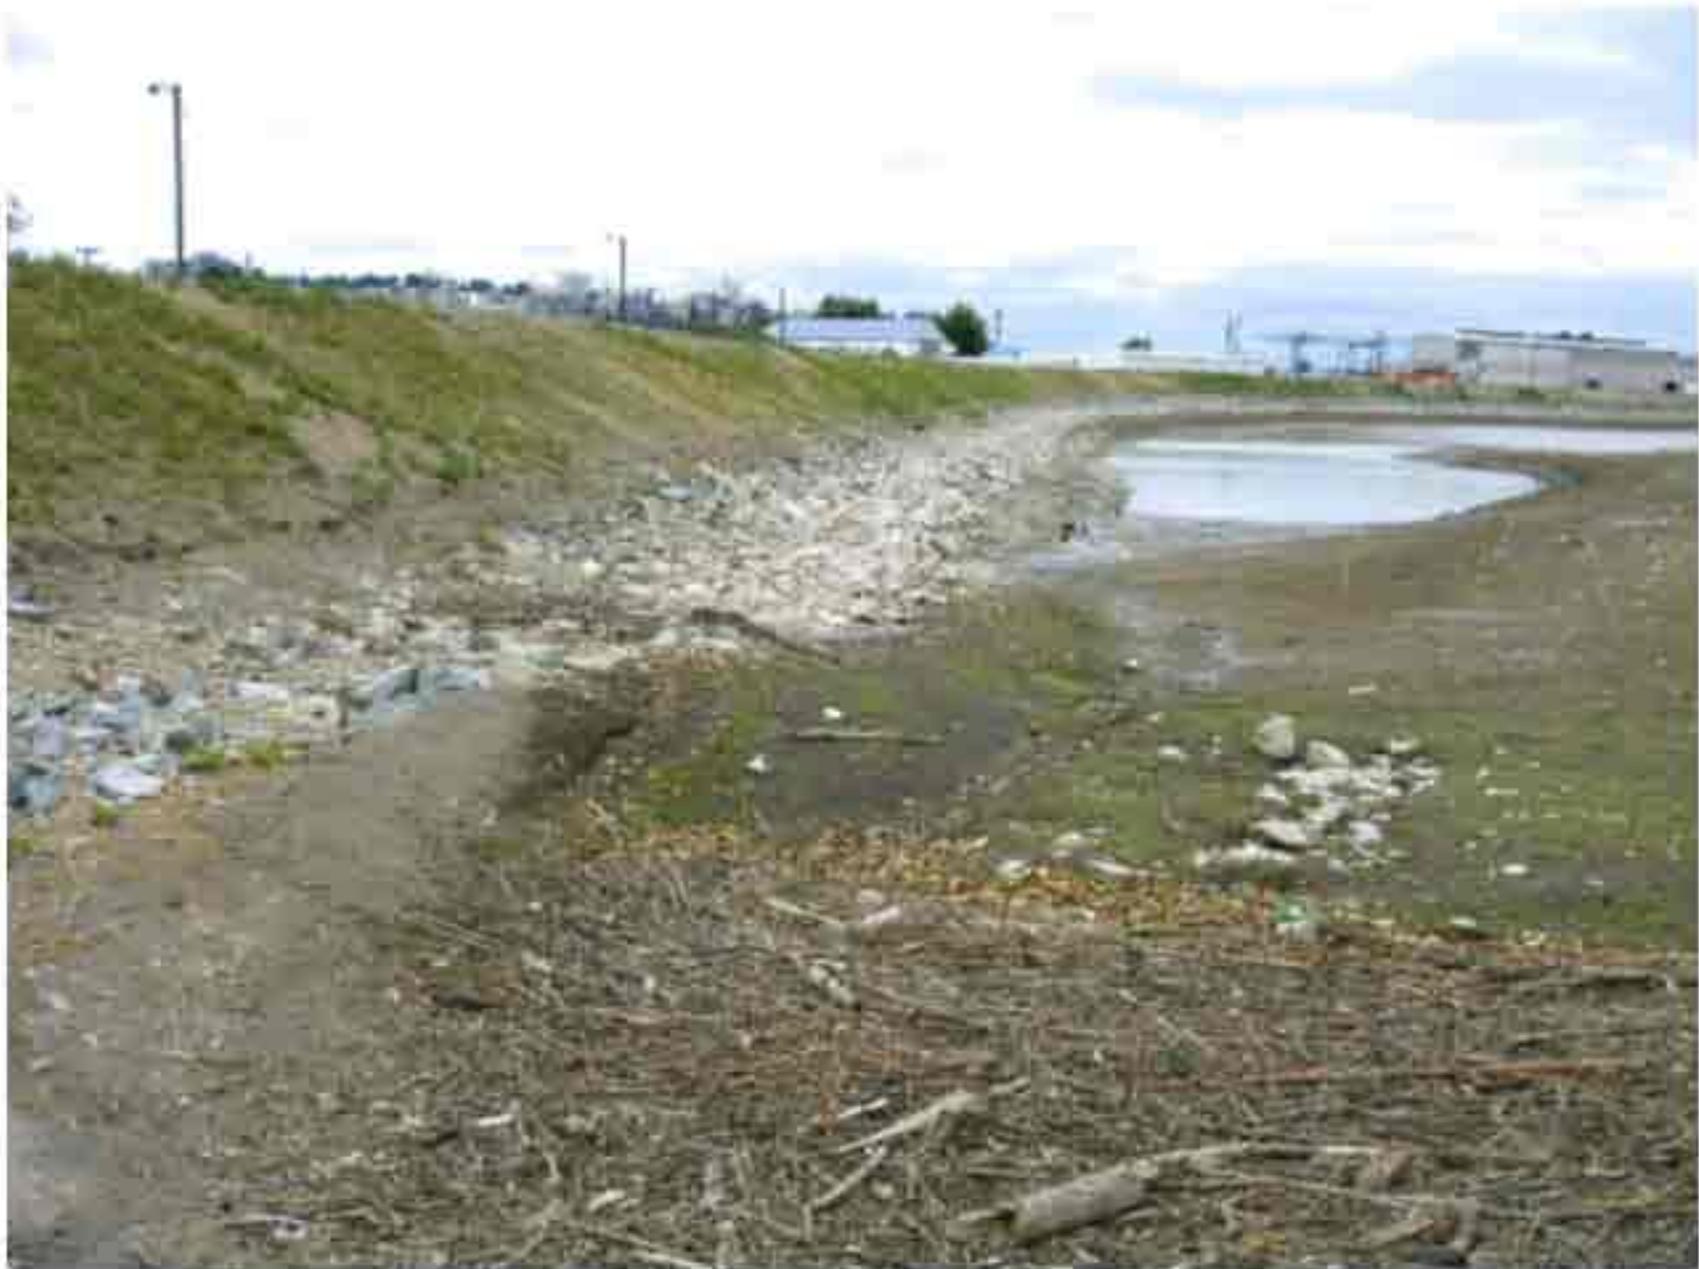
Puyallup River Side Channel, Photo Point 5A, facing north. Photo taken July 10, 2006 at 12:42 PM, tide at approximately -0.83 feet MLLW. [MAG0004]

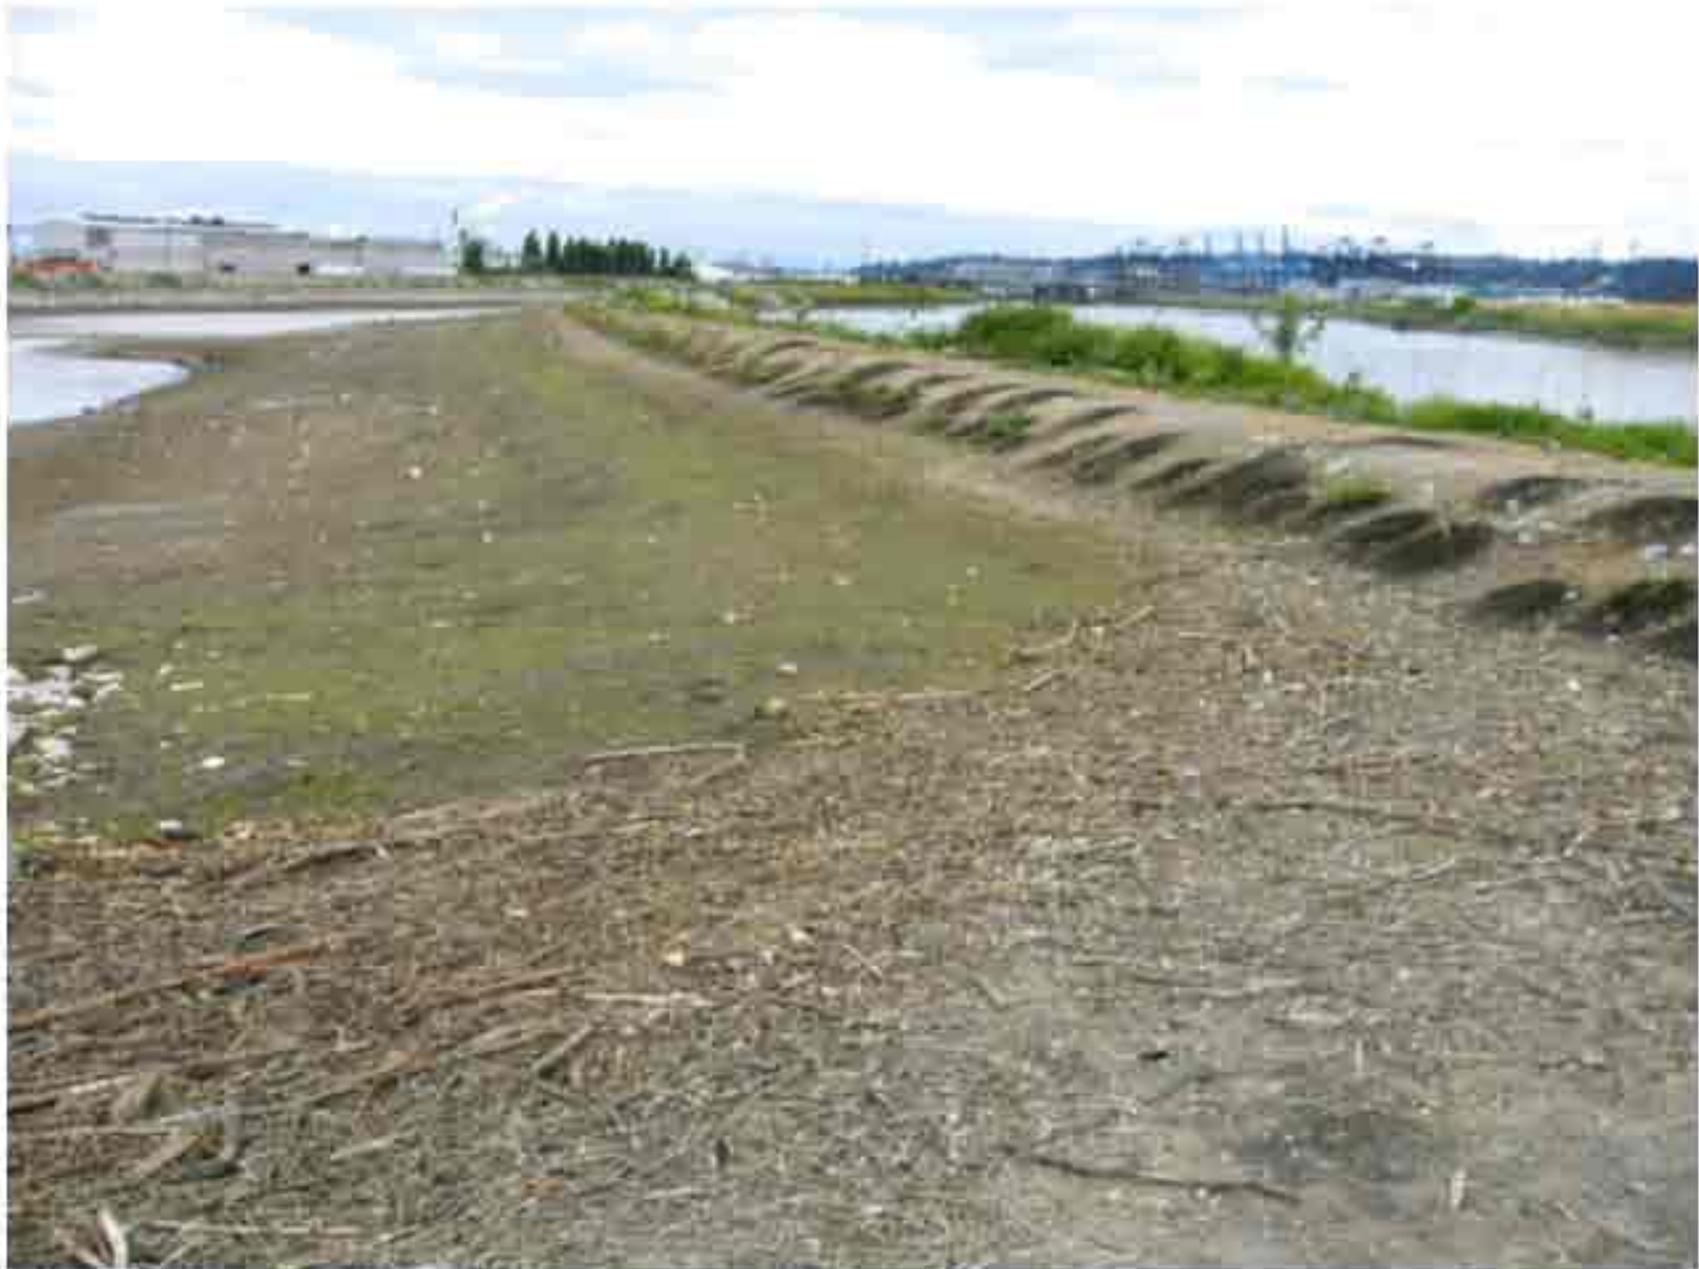
Puyallup River Side Channel, Photo Point 5B, facing northeast. Photo taken July 10, 2006 at 12:42 PM, tide at approximately -0.83 feet MLLW.
[IMAG0005]

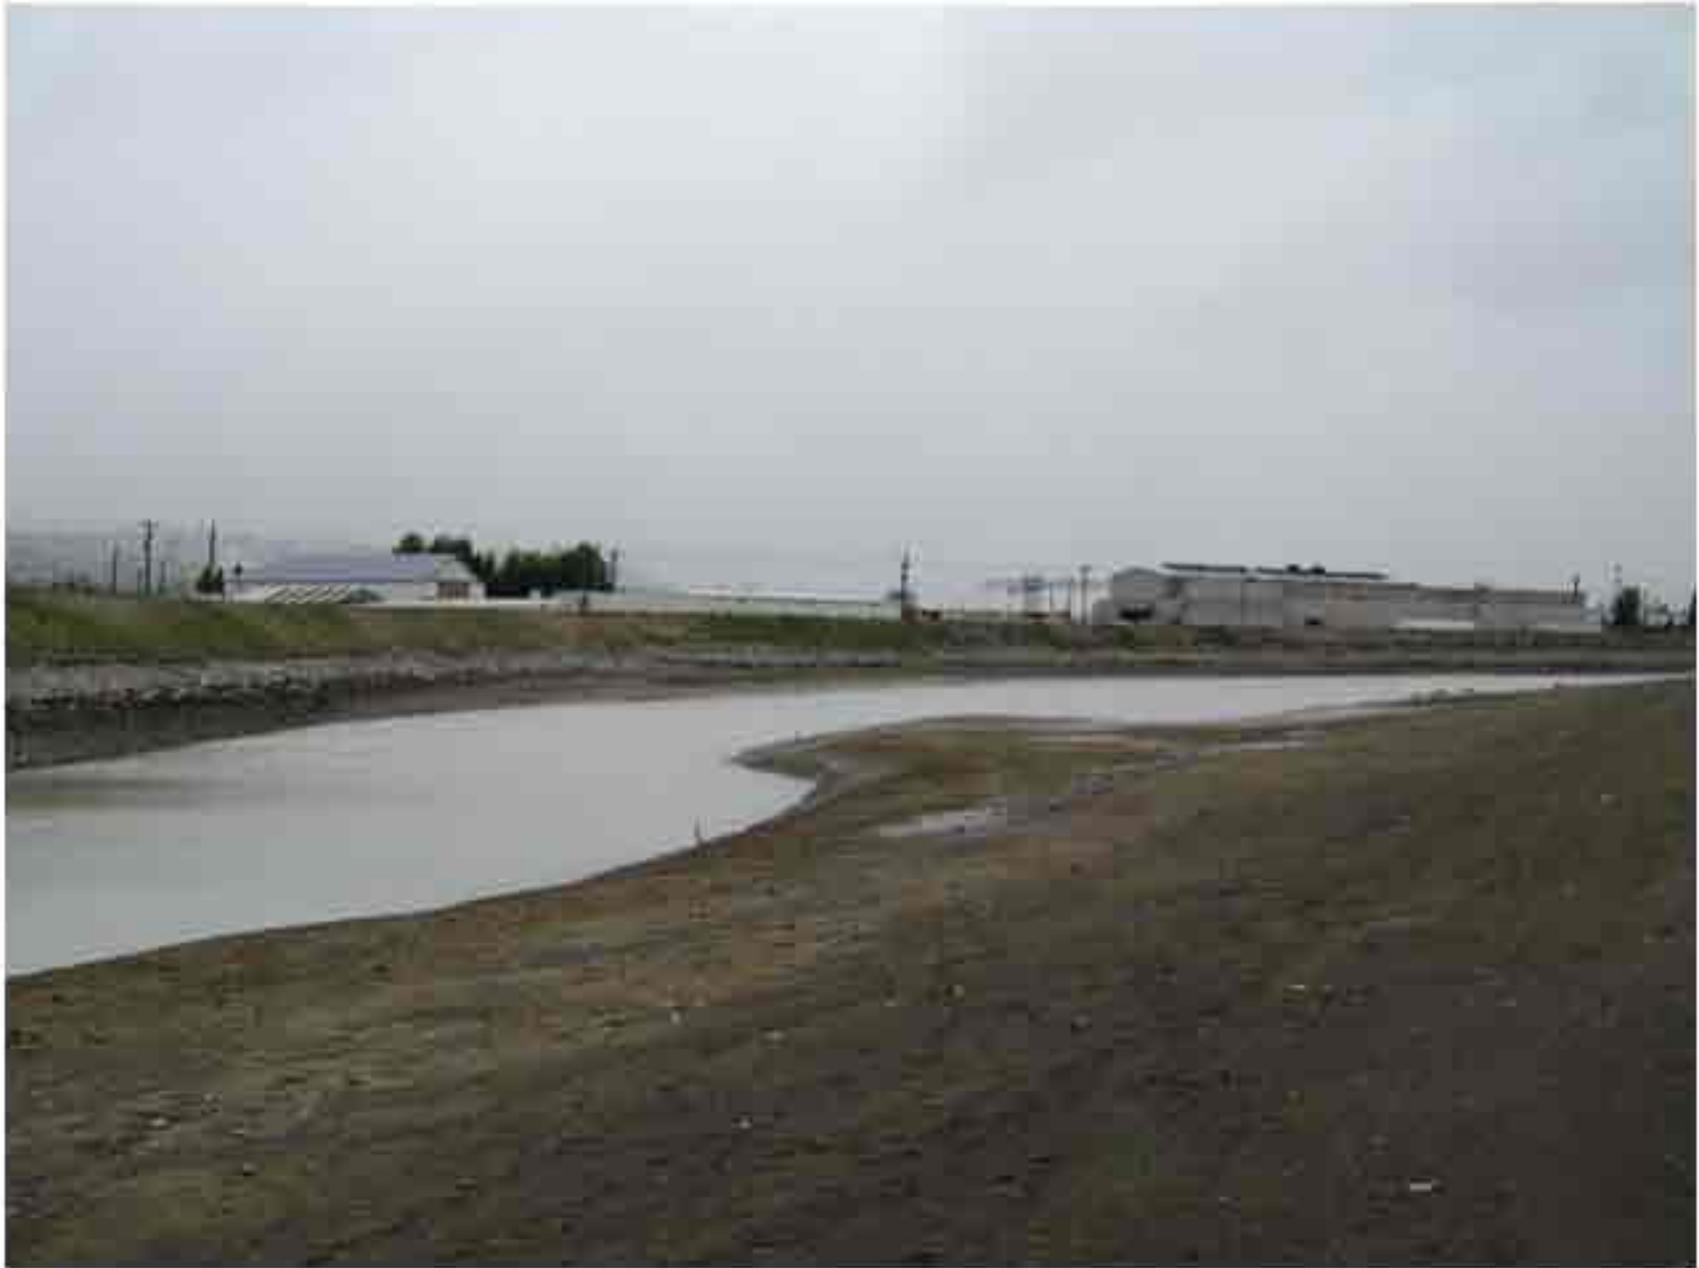
Puyallup River Side Channel, Photo Point 6, facing west. Photo taken July 12, 2006 at 12:57 PM, tide at approximately -3.10 feet MLLW [IM G_0069]

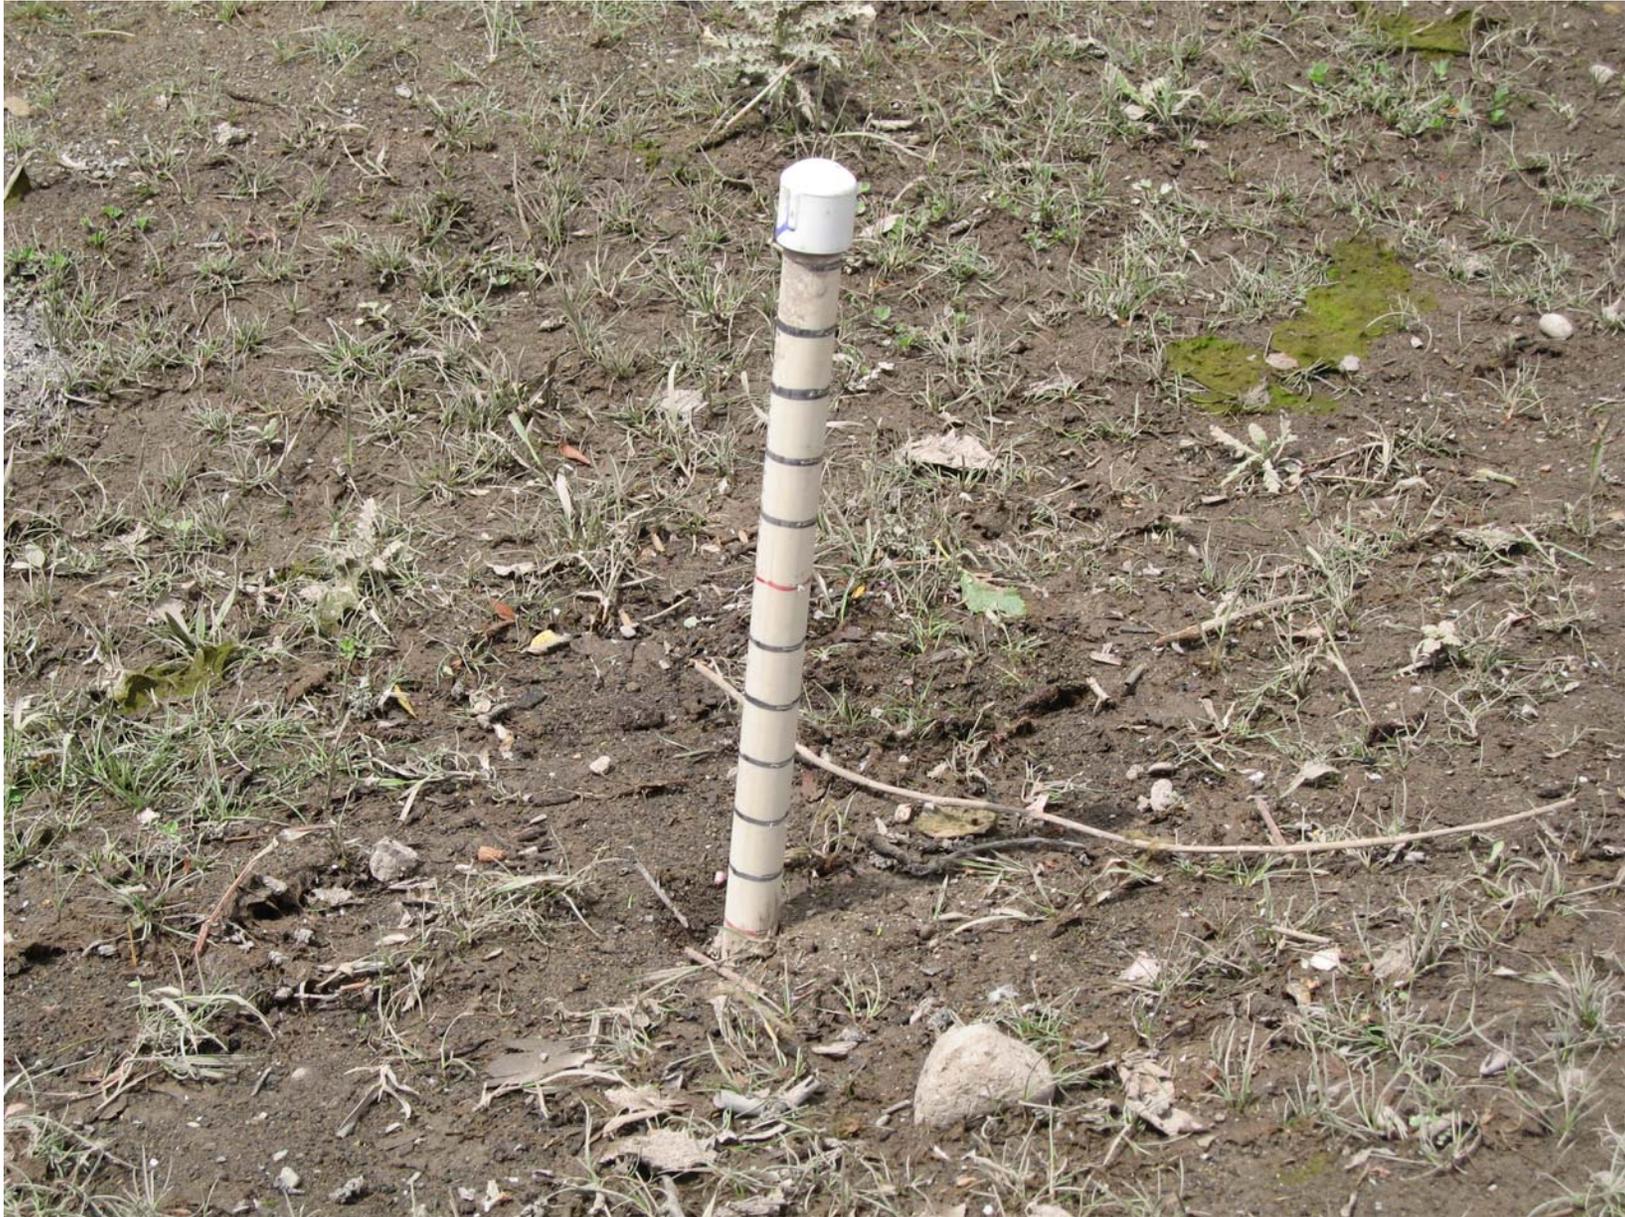
[IMG_0080]

Puyallup River Side Channel, elevation stake E1. Photo taken July 13, 2006.

stake is visible above ground. One-inch increments are marked on the stakes both above and below the ground surface to allow for measurement of erosion/sedimentation in subsequent monitoring years. The stakes were surveyed following installation to allow for replacement if needed, and the top and ground surface elevations were also measured. Photographs showing the elevation stakes in place are included in Attachment A.

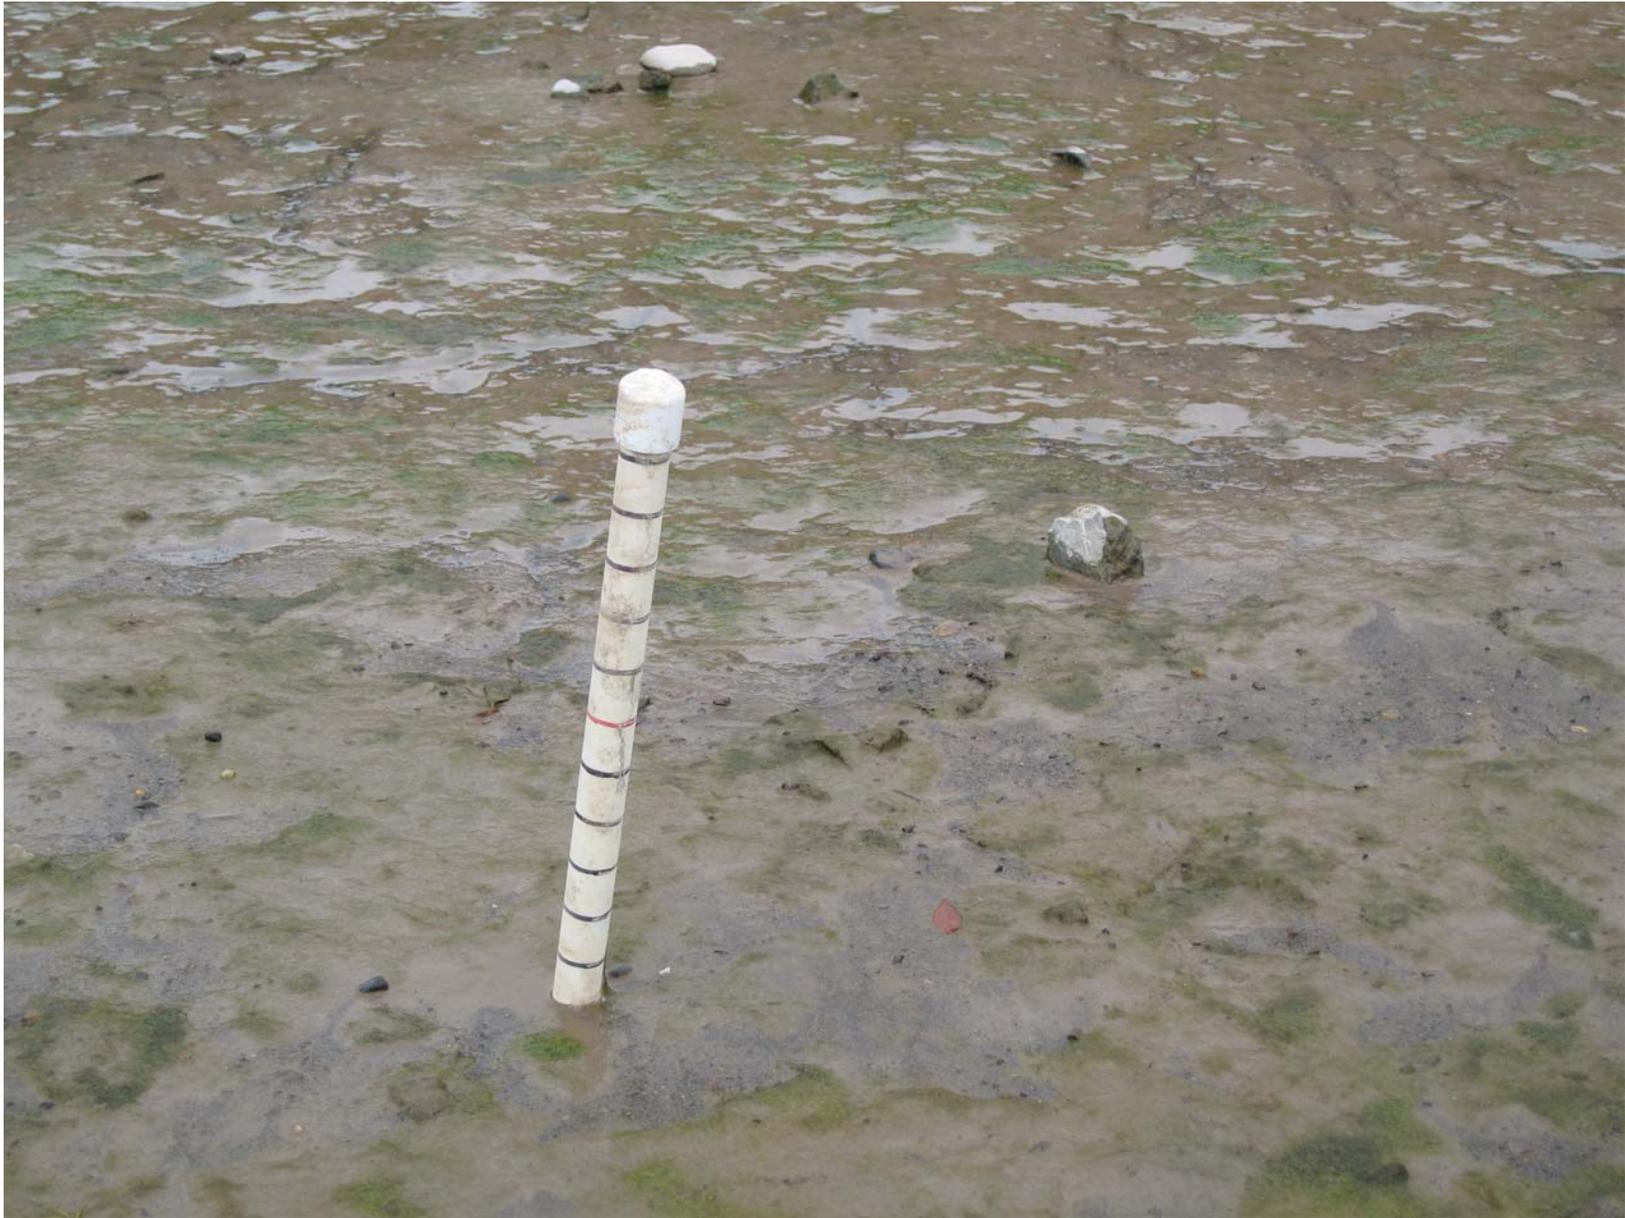
[IMG_0081]

Puyallup River Side Channel, elevation stake E2. Photo taken July 13, 2006.
