THEA FOSS AND WHEELER-OSGOOD WATERWAYS REMEDIATION PROJECT

YEAR 0 BASELINE MONITORING

HABITAT MITIGATION AREA MONITORING PRELIMINARY FINDINGS MEMORANDUM

NOVEMBER 30, 2006

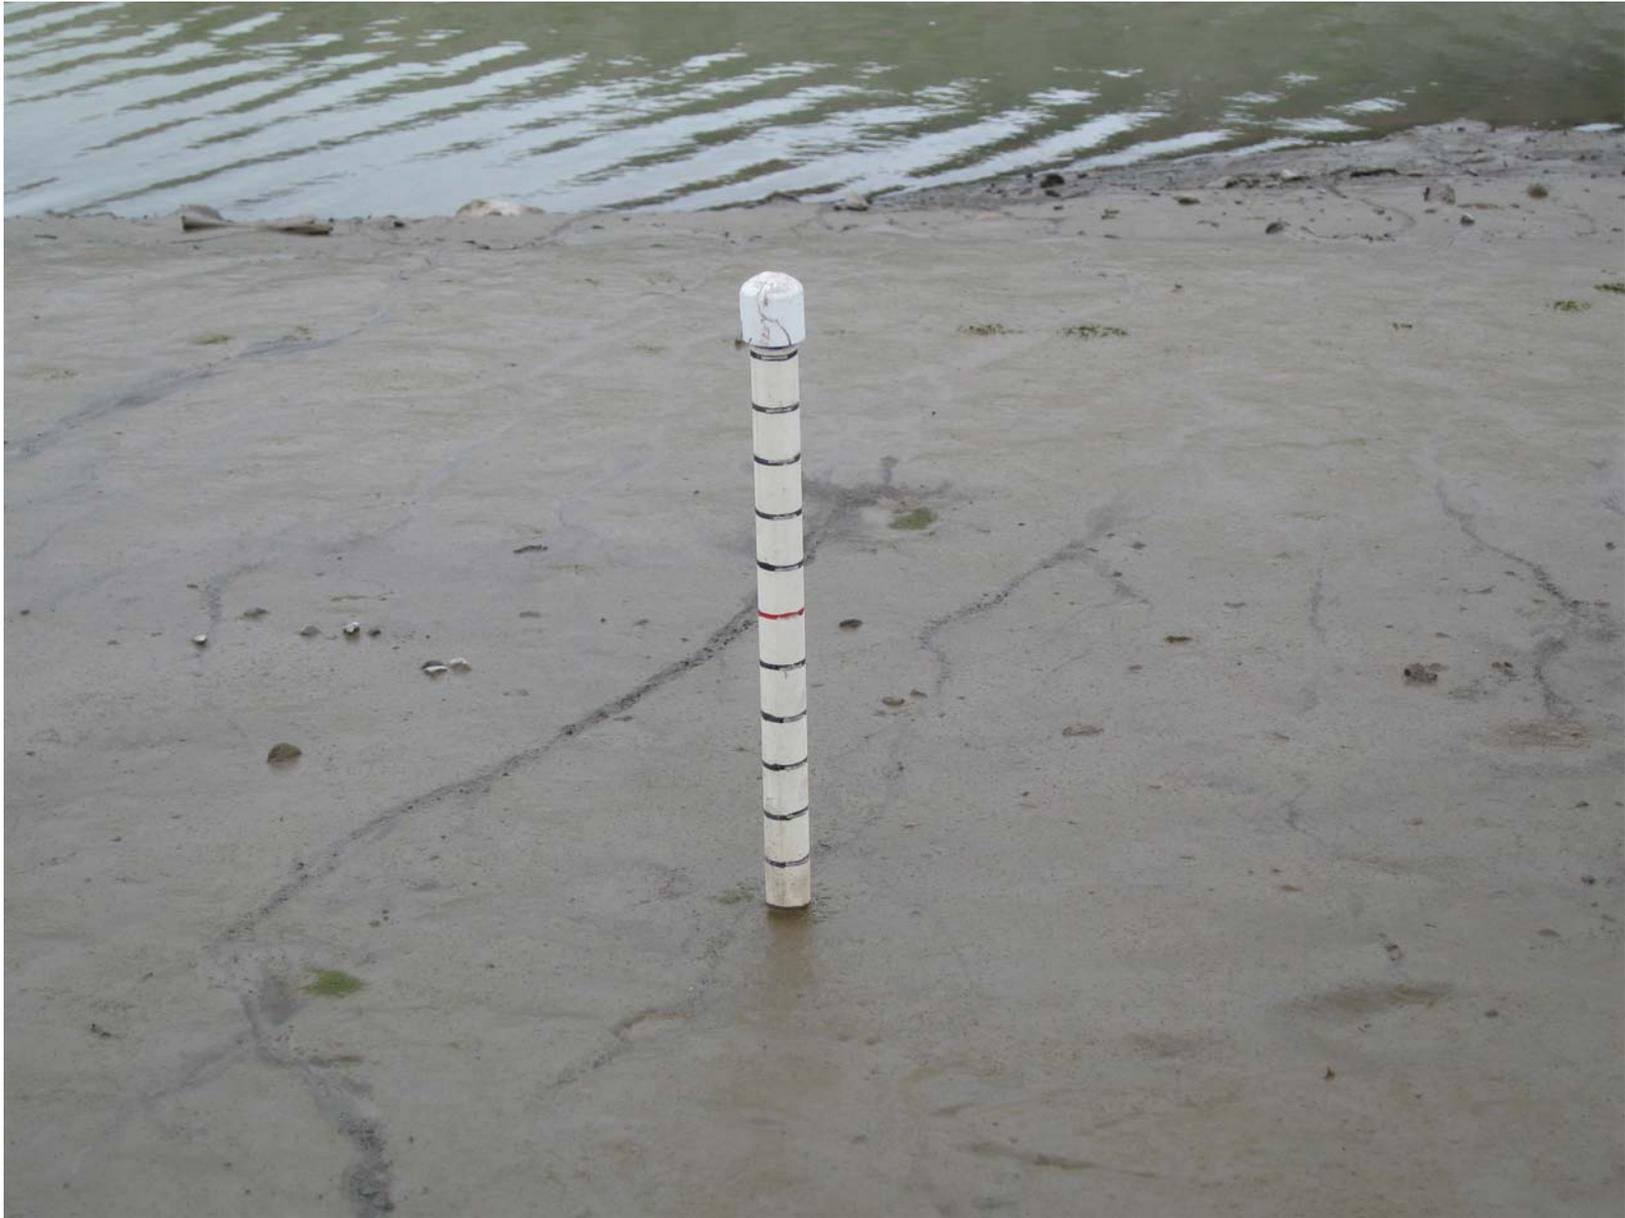
[IMG_0082]

Puyallup River Side Channel, elevation stake E3. Photo taken July 13, 2006.

stake is visible above ground. One-inch increments are marked on the stakes both above and below the ground surface to allow for measurement of erosion/sedimentation in subsequent monitoring years. The stakes were surveyed following installation to allow for replacement if needed, and the top and ground surface elevations were also measured. Photographs showing the elevation stakes in place are included in Attachment A.

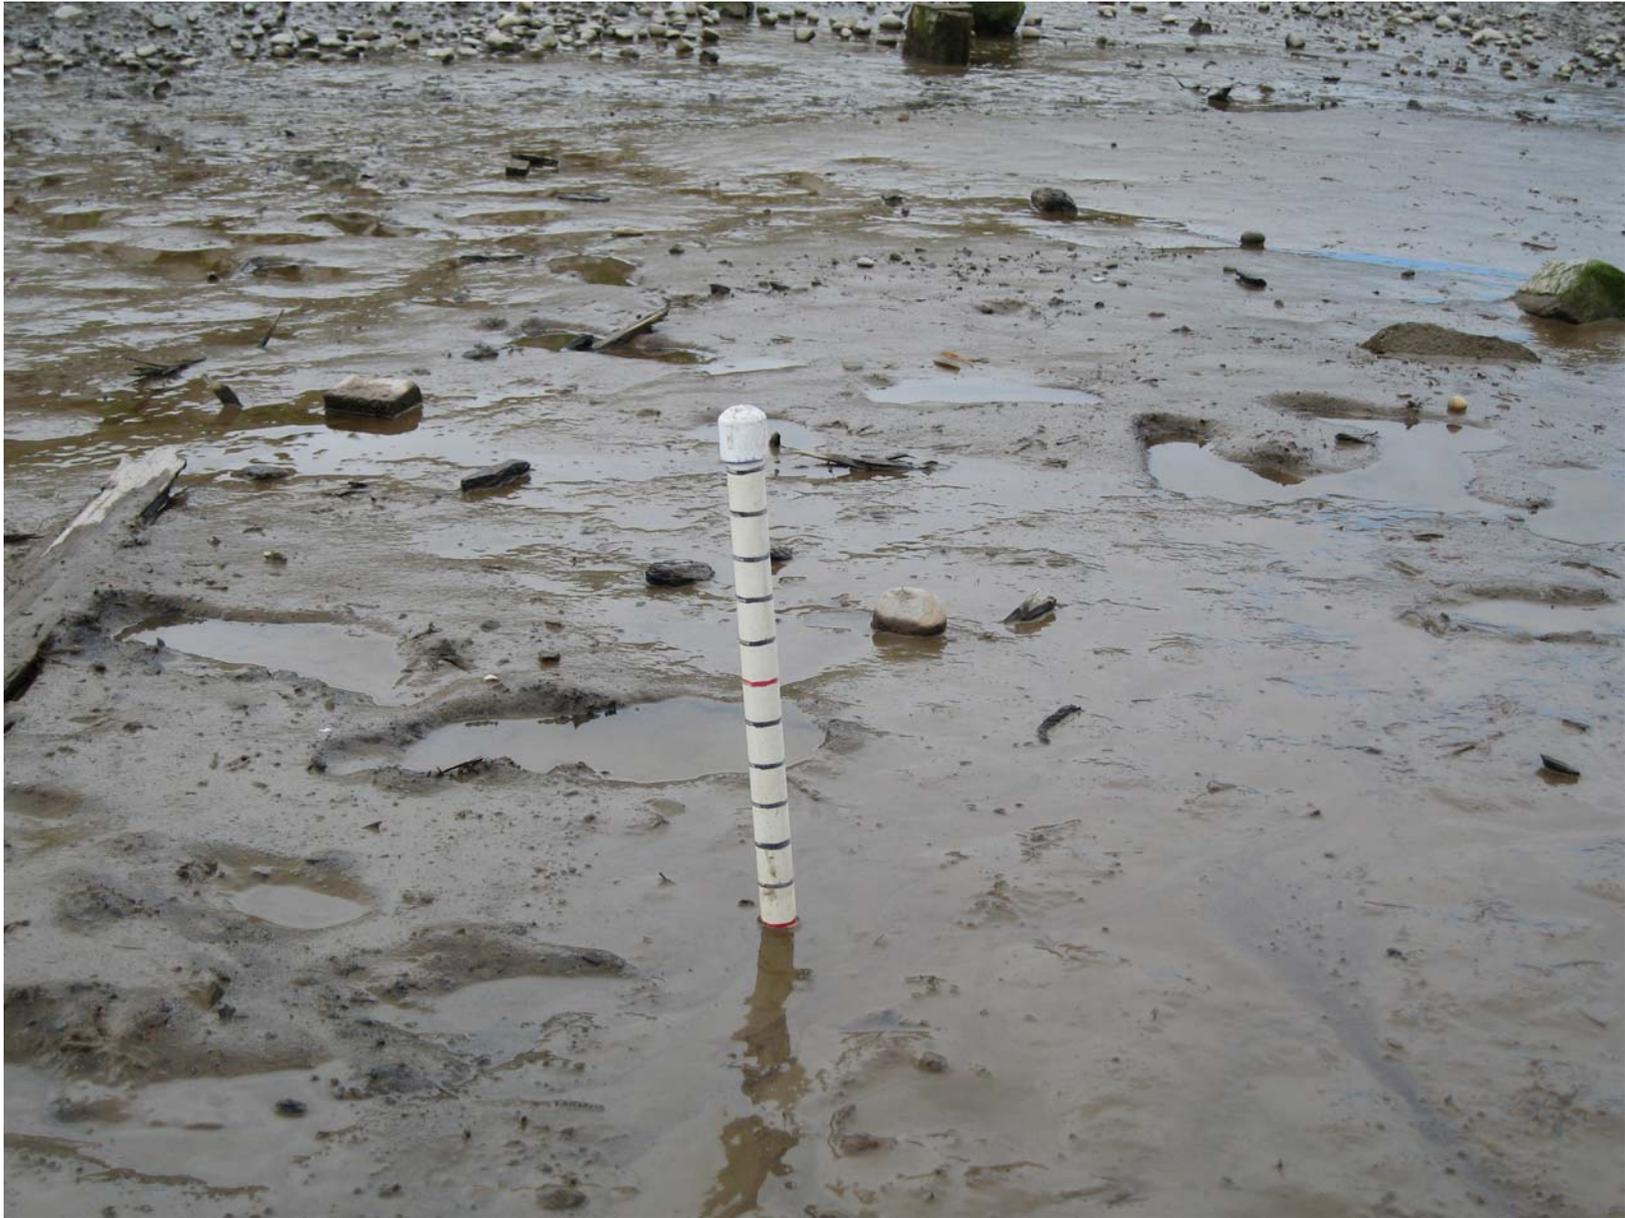
[IMG_0083]

Puyallup River Side Channel, elevation stake E4. Photo taken July 13, 2006.

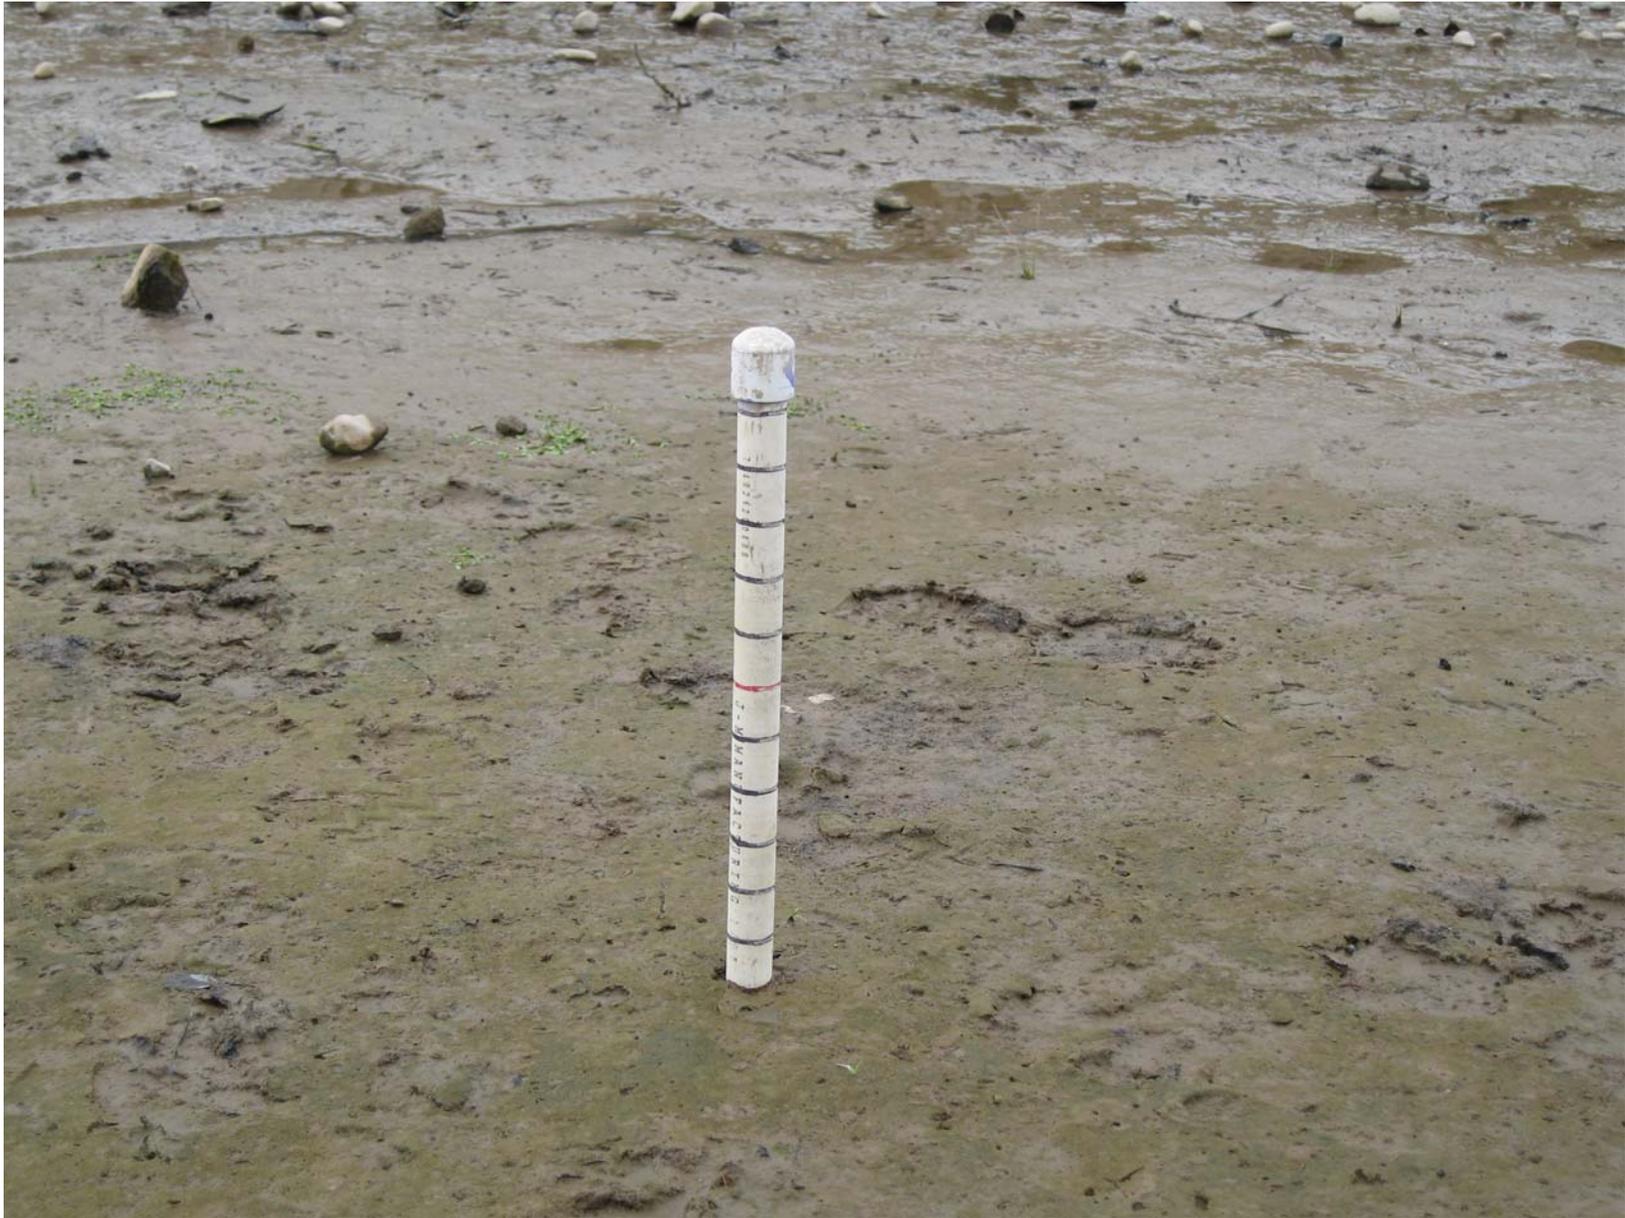
[IMG_0084]

Puyallup River Side Channel, elevation stake E5. Photo taken July 13, 2006.

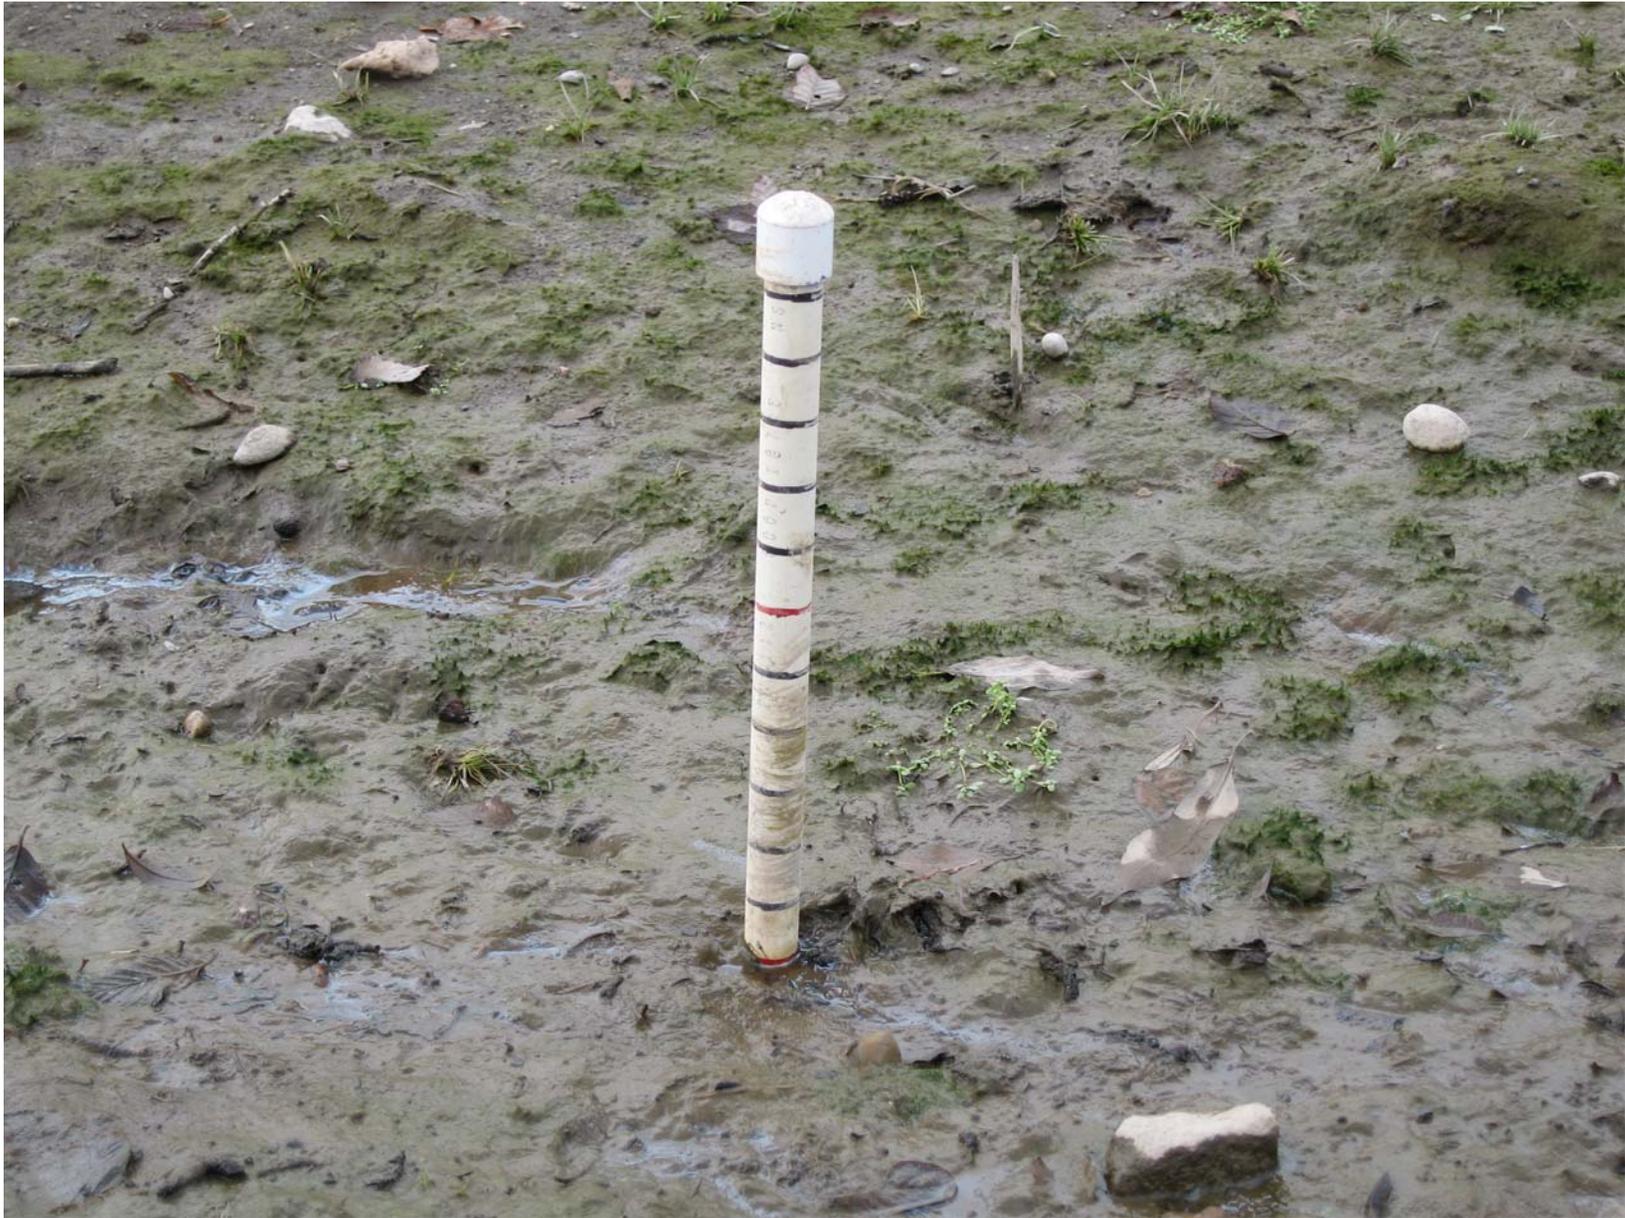
[IMG_0085]

Puyallup River Side Channel, elevation stake E6. Photo taken July 13, 2006.

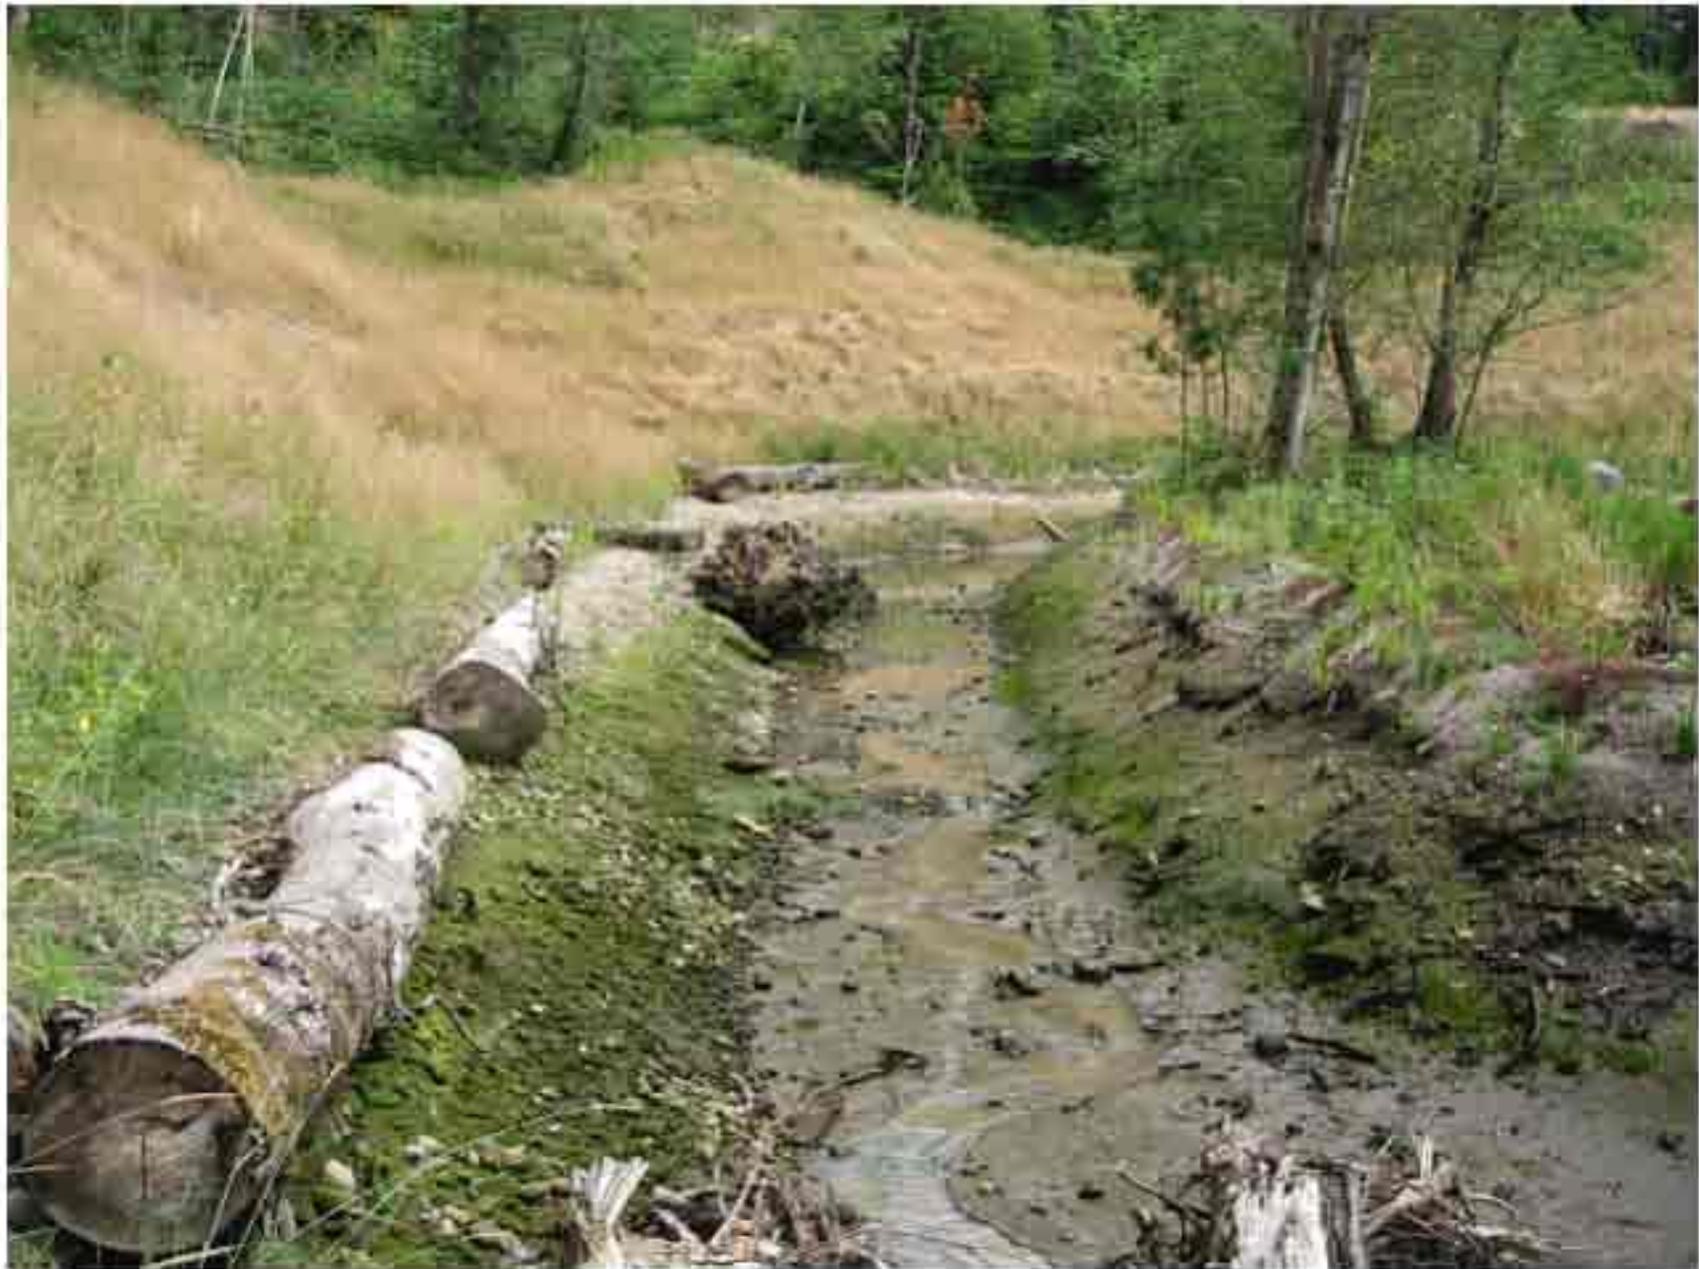
Hylebos Creek, Photo Point 1A, facing east. Photo taken July 11, 2006 at 2:53 PM, tide at approximately 3.30 feet MLLW. [IM G_0048]

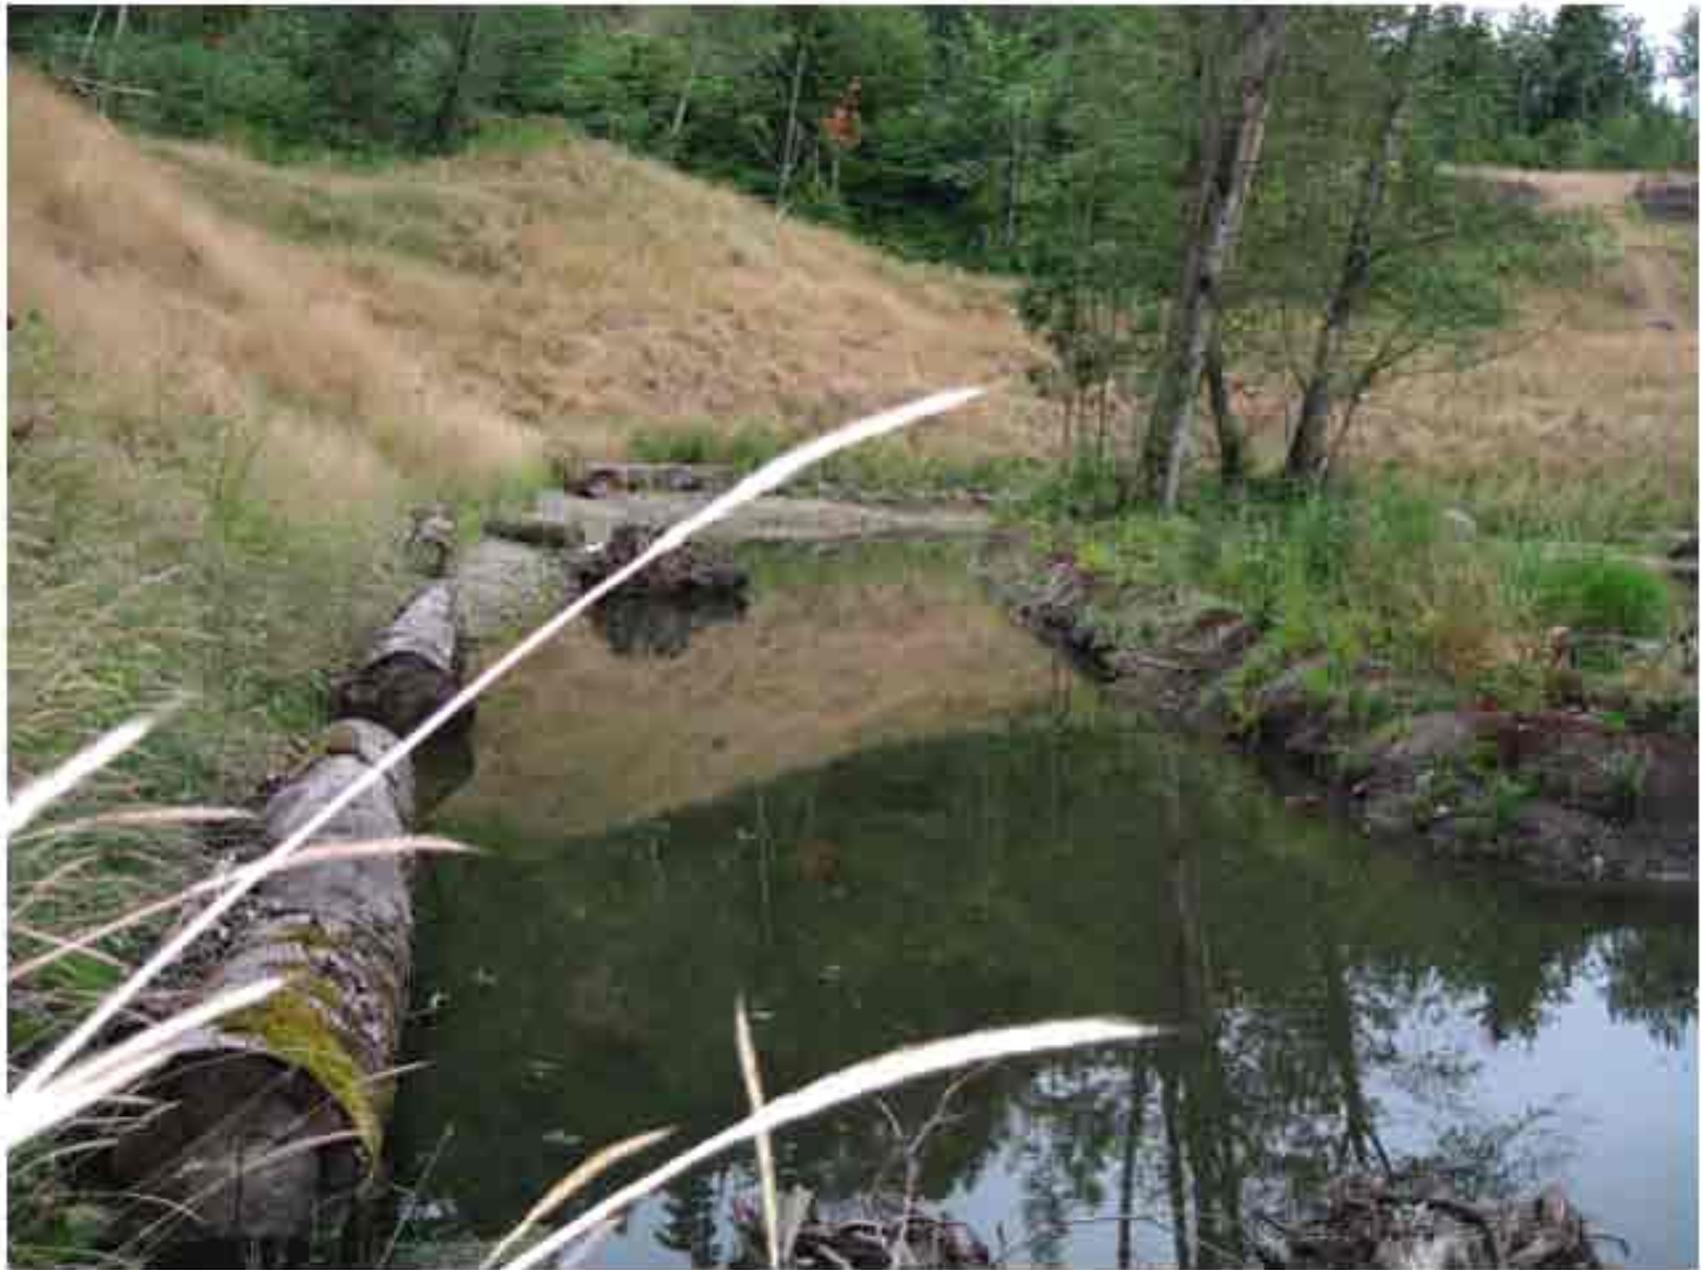
Hylebos Creek, Photo Point 1A, facing east. Photo taken July 13, 2006 at 8:20 PM, tide at approximately 12.69 feet MLLW. [IM G_0094]

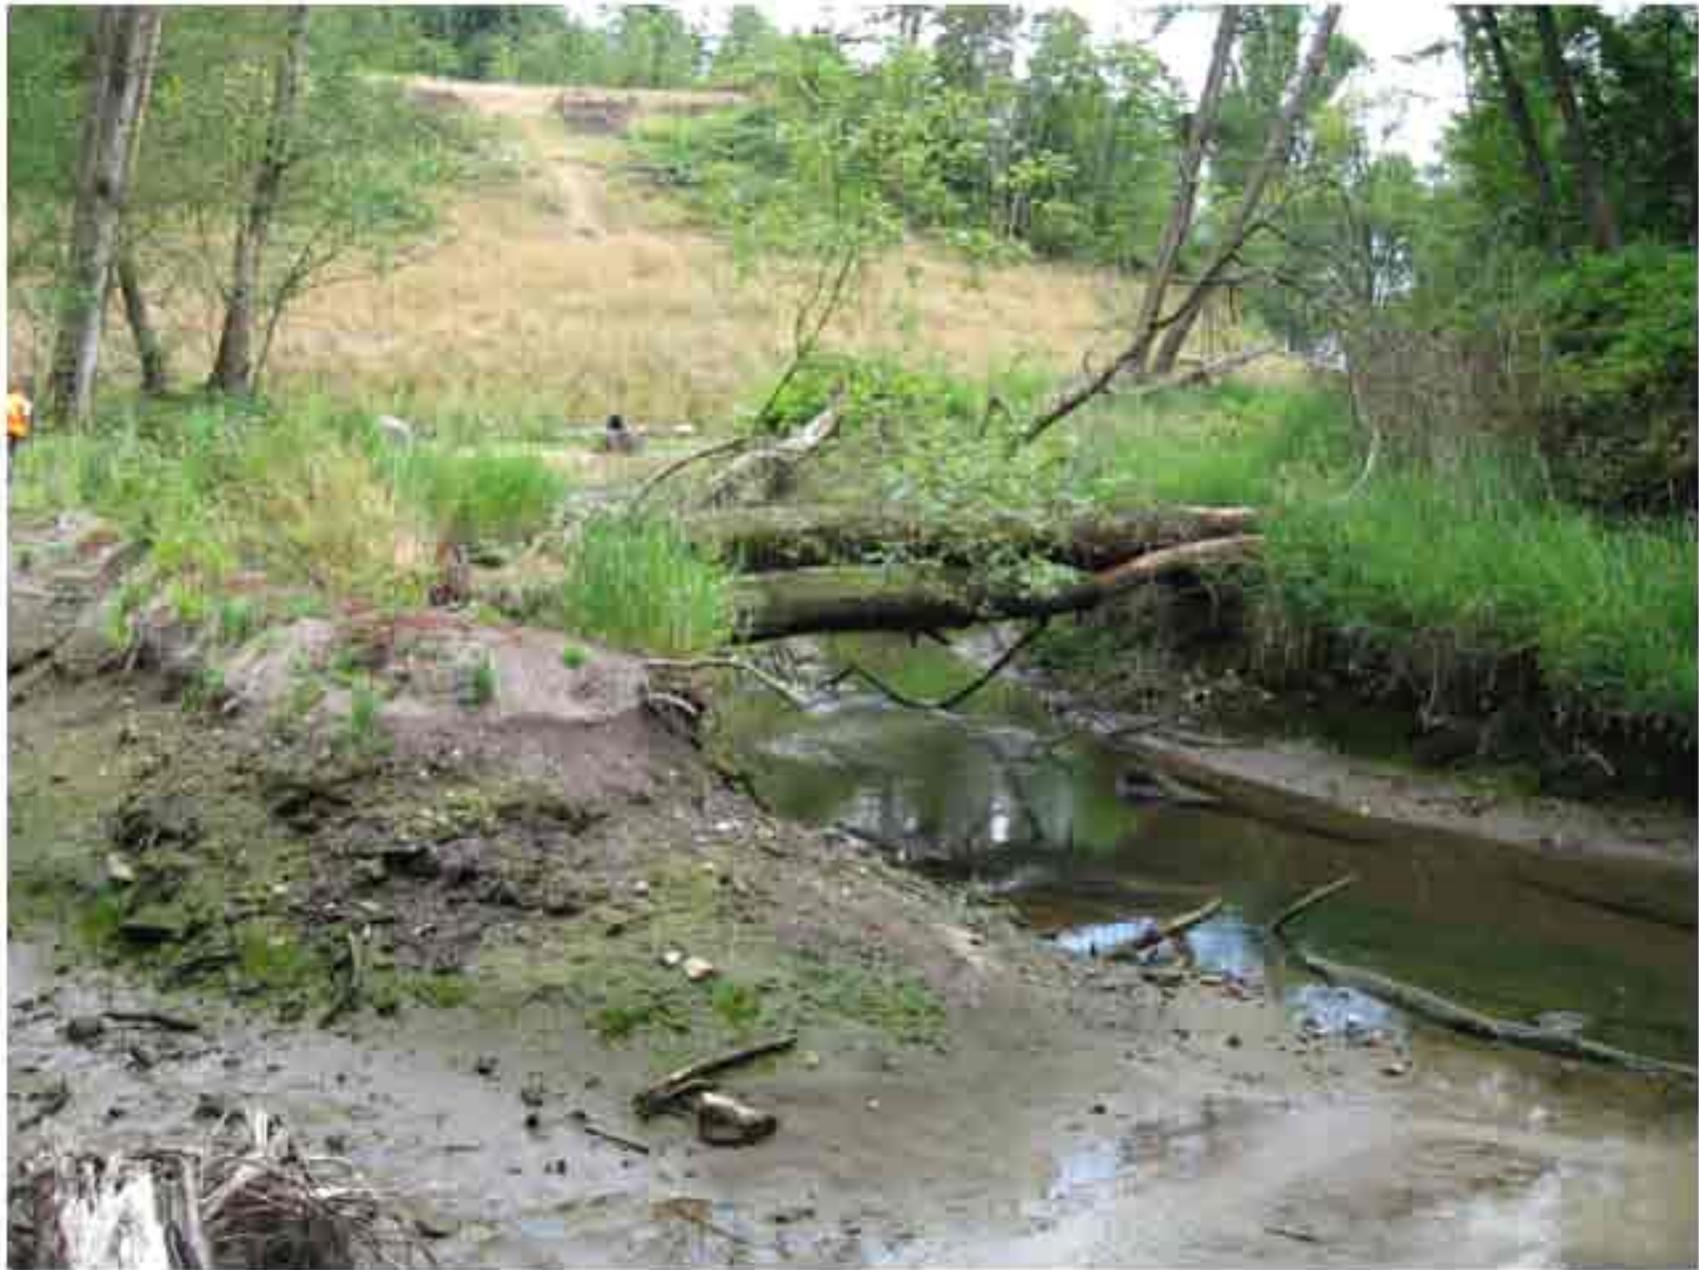
Hylebos Creek, Photo Point 1B, facing south. Photo taken July 11, 2006 at 2:53 PM, tide at approximately 3.30 feet MLLW. [M G_0050]

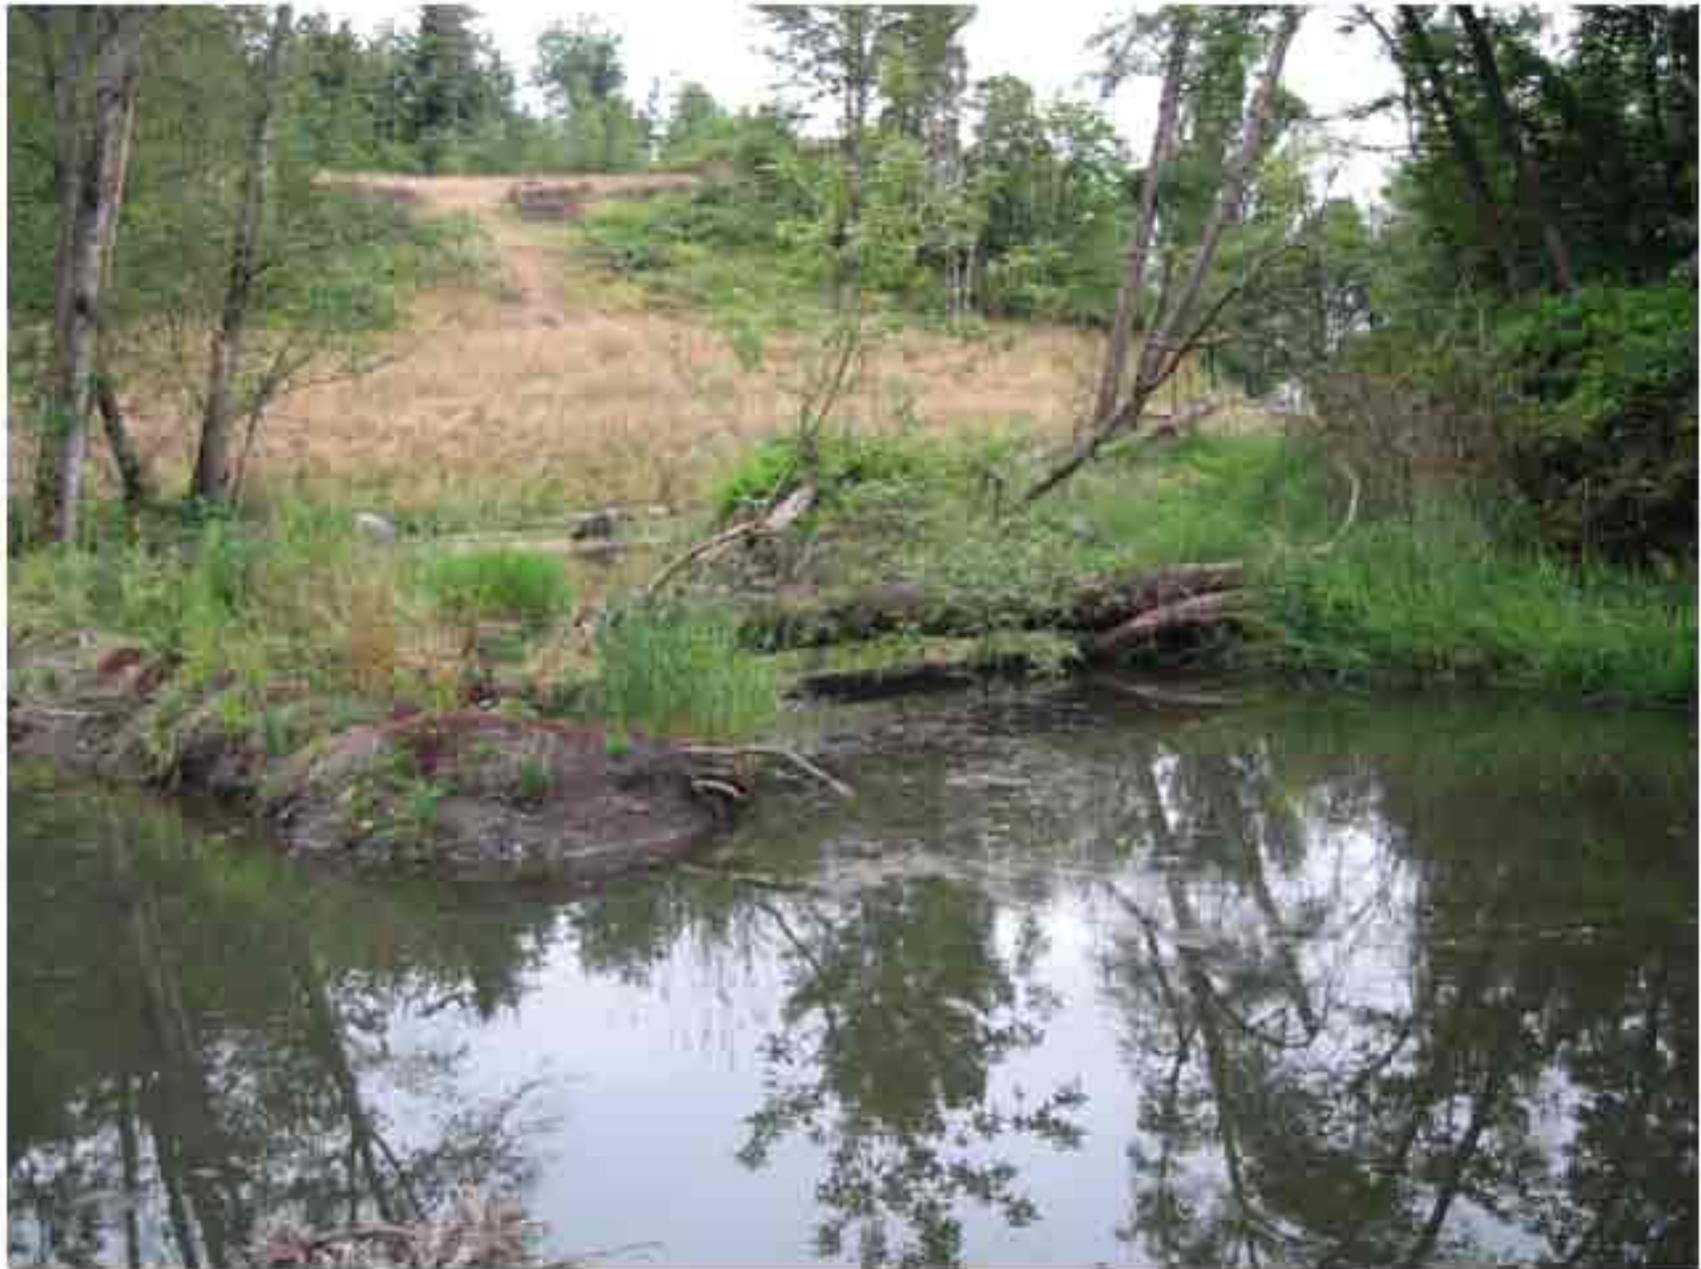
Hylebos Creek, Photo Point 1B, facing south. Photo taken July 13, 2006 at 8:20 P.M., tide at approximately 12.69 feet MLLW. [IM G_0095]

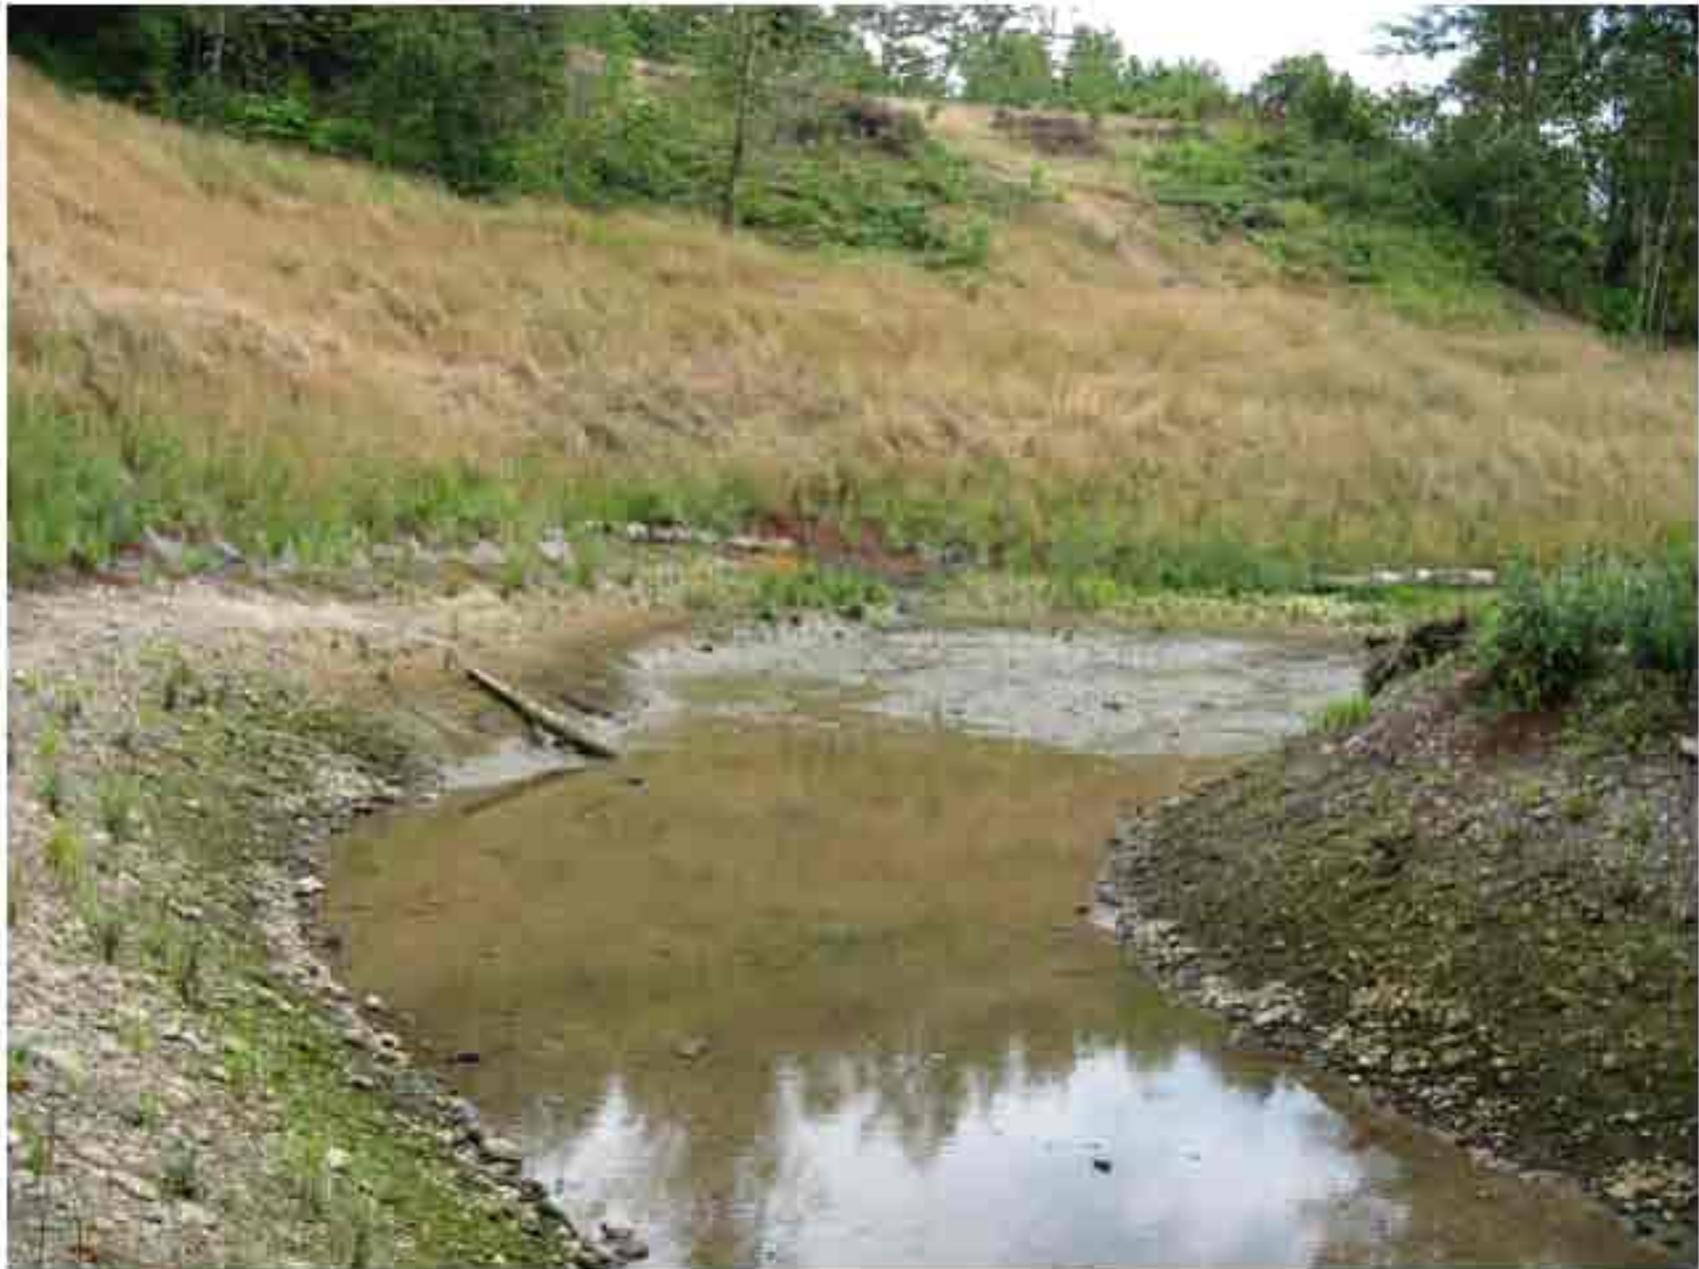
Hylebos Creek, Photo Point 2A, facing southeast. Photo taken July 11, 2006 at 2:49 PM, tide at approximately 3.05 feet MLLW. [IM G_0045]

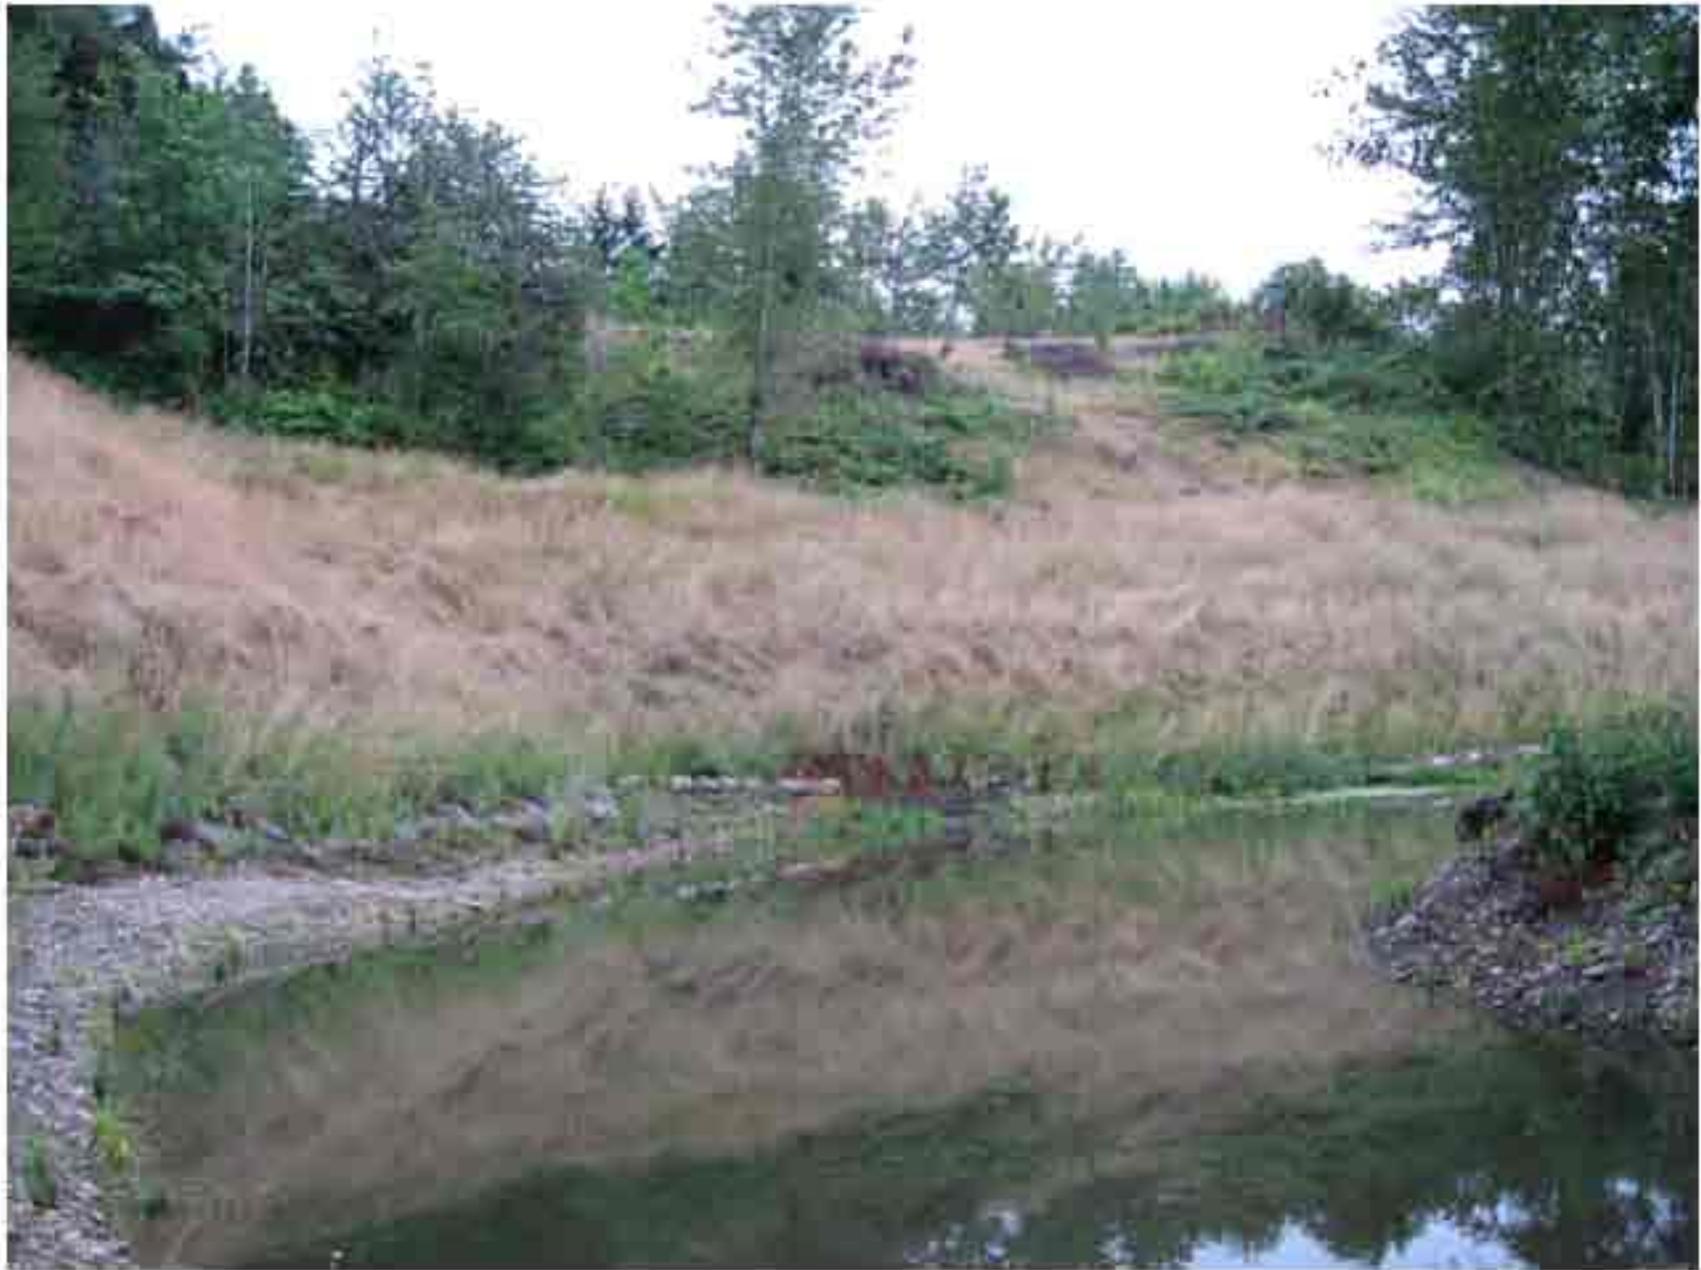
Hylebos Creek, Photo Point 2A, facing southeast. Photo taken July 13, 2006 at 8:22 PM, tide at approximately 12.7 feet MLLW. [IM G_0096]
