THEA FOSS AND WHEELER-OSGOOD WATERWAYS REMEDIATION PROJECT

YEAR 0 BASELINE MONITORING

HABITAT MITIGATION AREA MONITORING PRELIMINARY FINDINGS MEMORANDUM

NOVEMBER 30, 2006

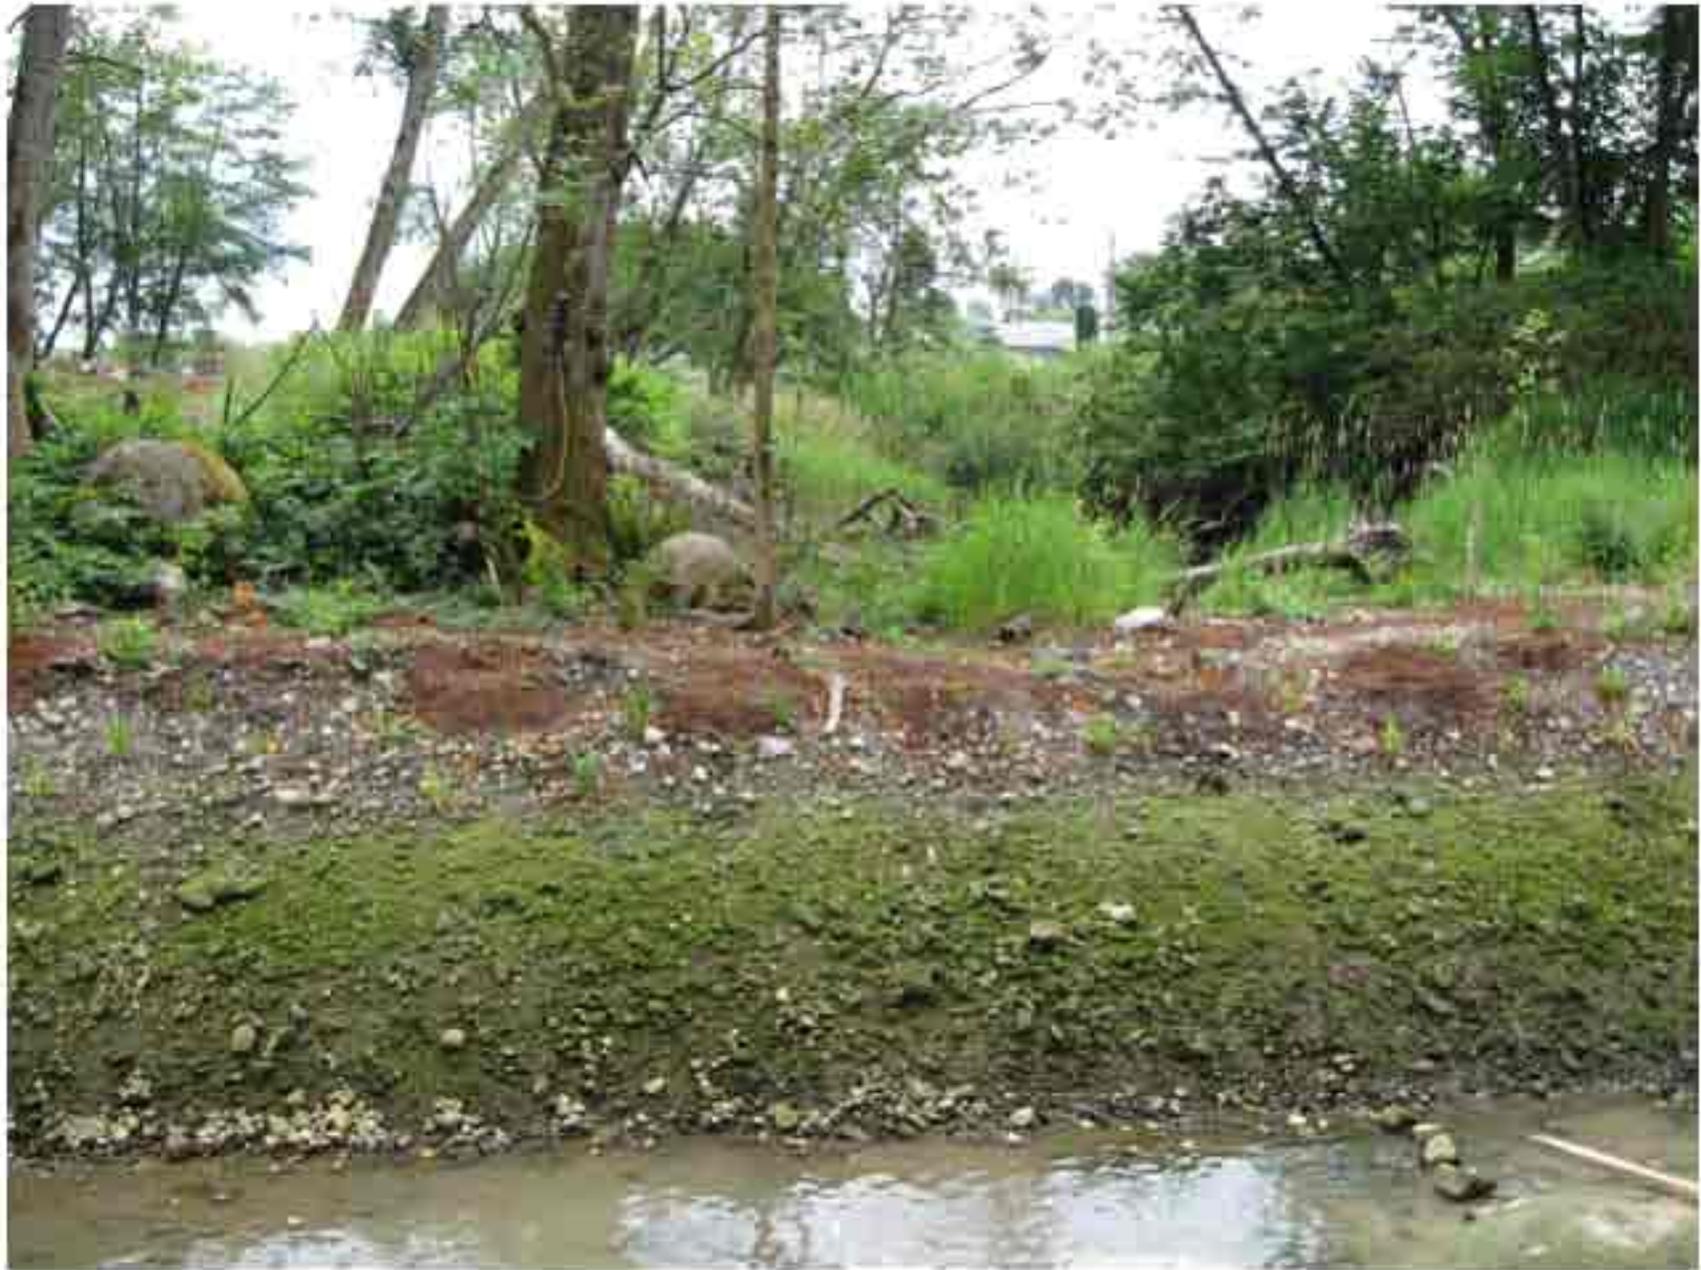
Hylebos Creek, Photo Point 2B, facing southwest. Photo taken July 11, 2006 at 2:49 PM, tide at approximately 3.05 feet MLLW. [M G_0047]

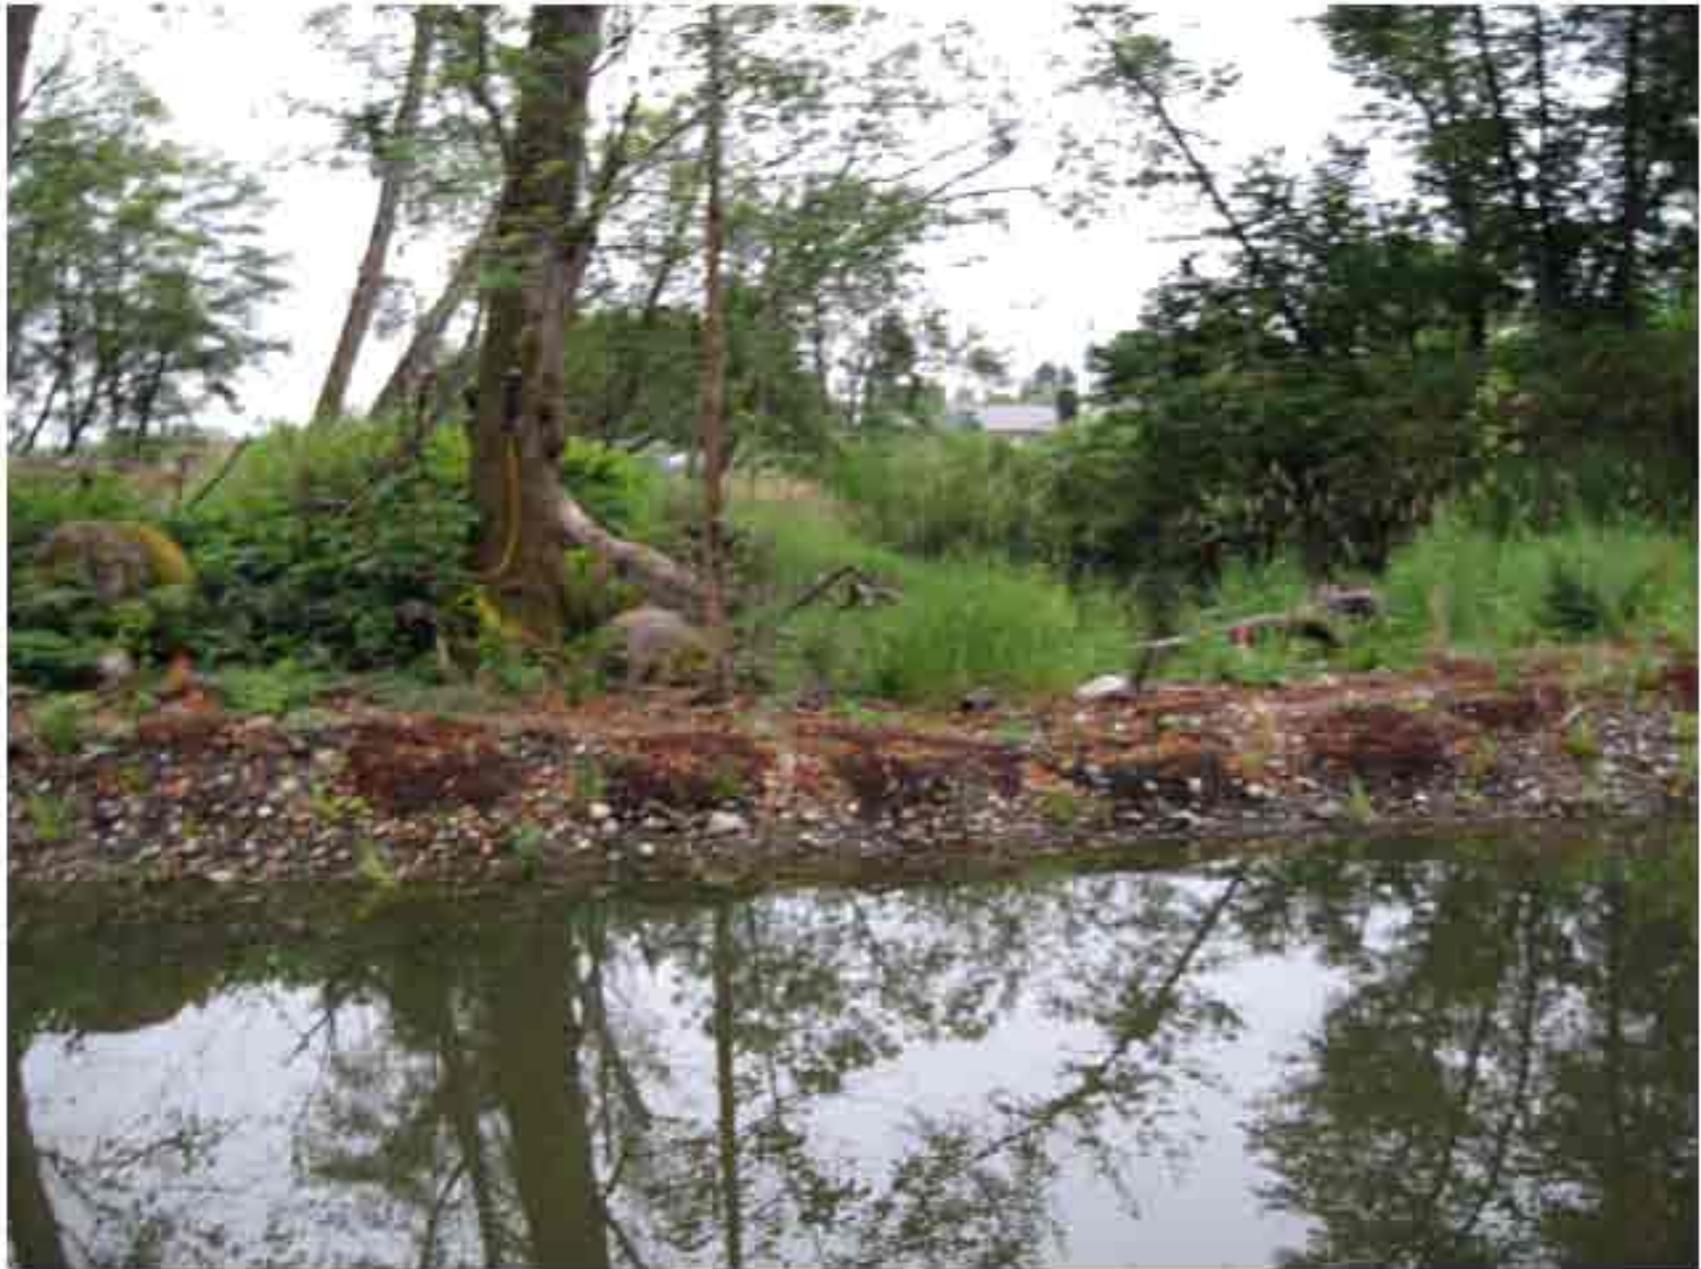
Hylebos Creek, Photo Point 2B, facing southwest. Photo taken July 13, 2006 at 8:22 PM, tide at approximately 12.7 feet MLLW. [M G_0097]

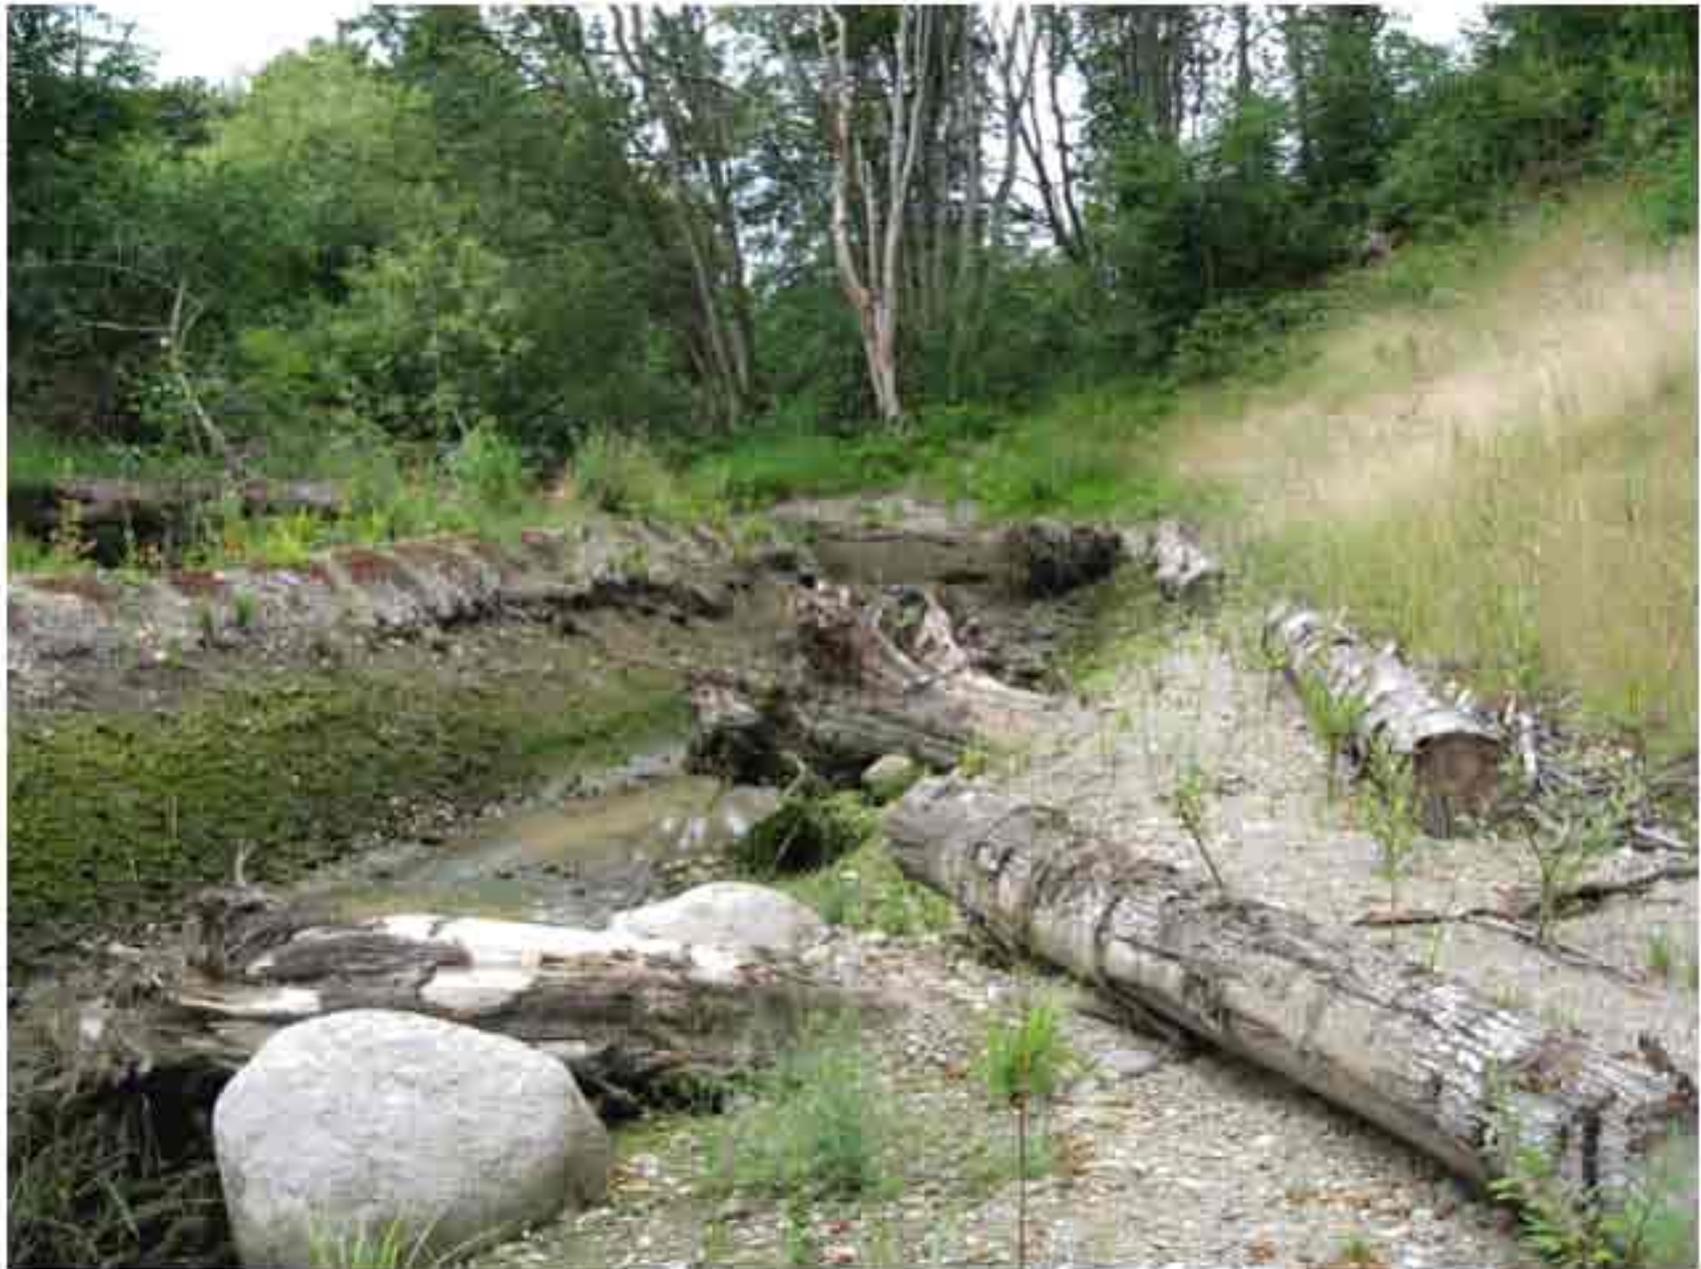
Hylebos Creek, Photo Point 2C, facing west. Photo taken July 11, 2006 at 2:49 PM, tide at approximately 3.05 feet MLLW. [IM G_0046]

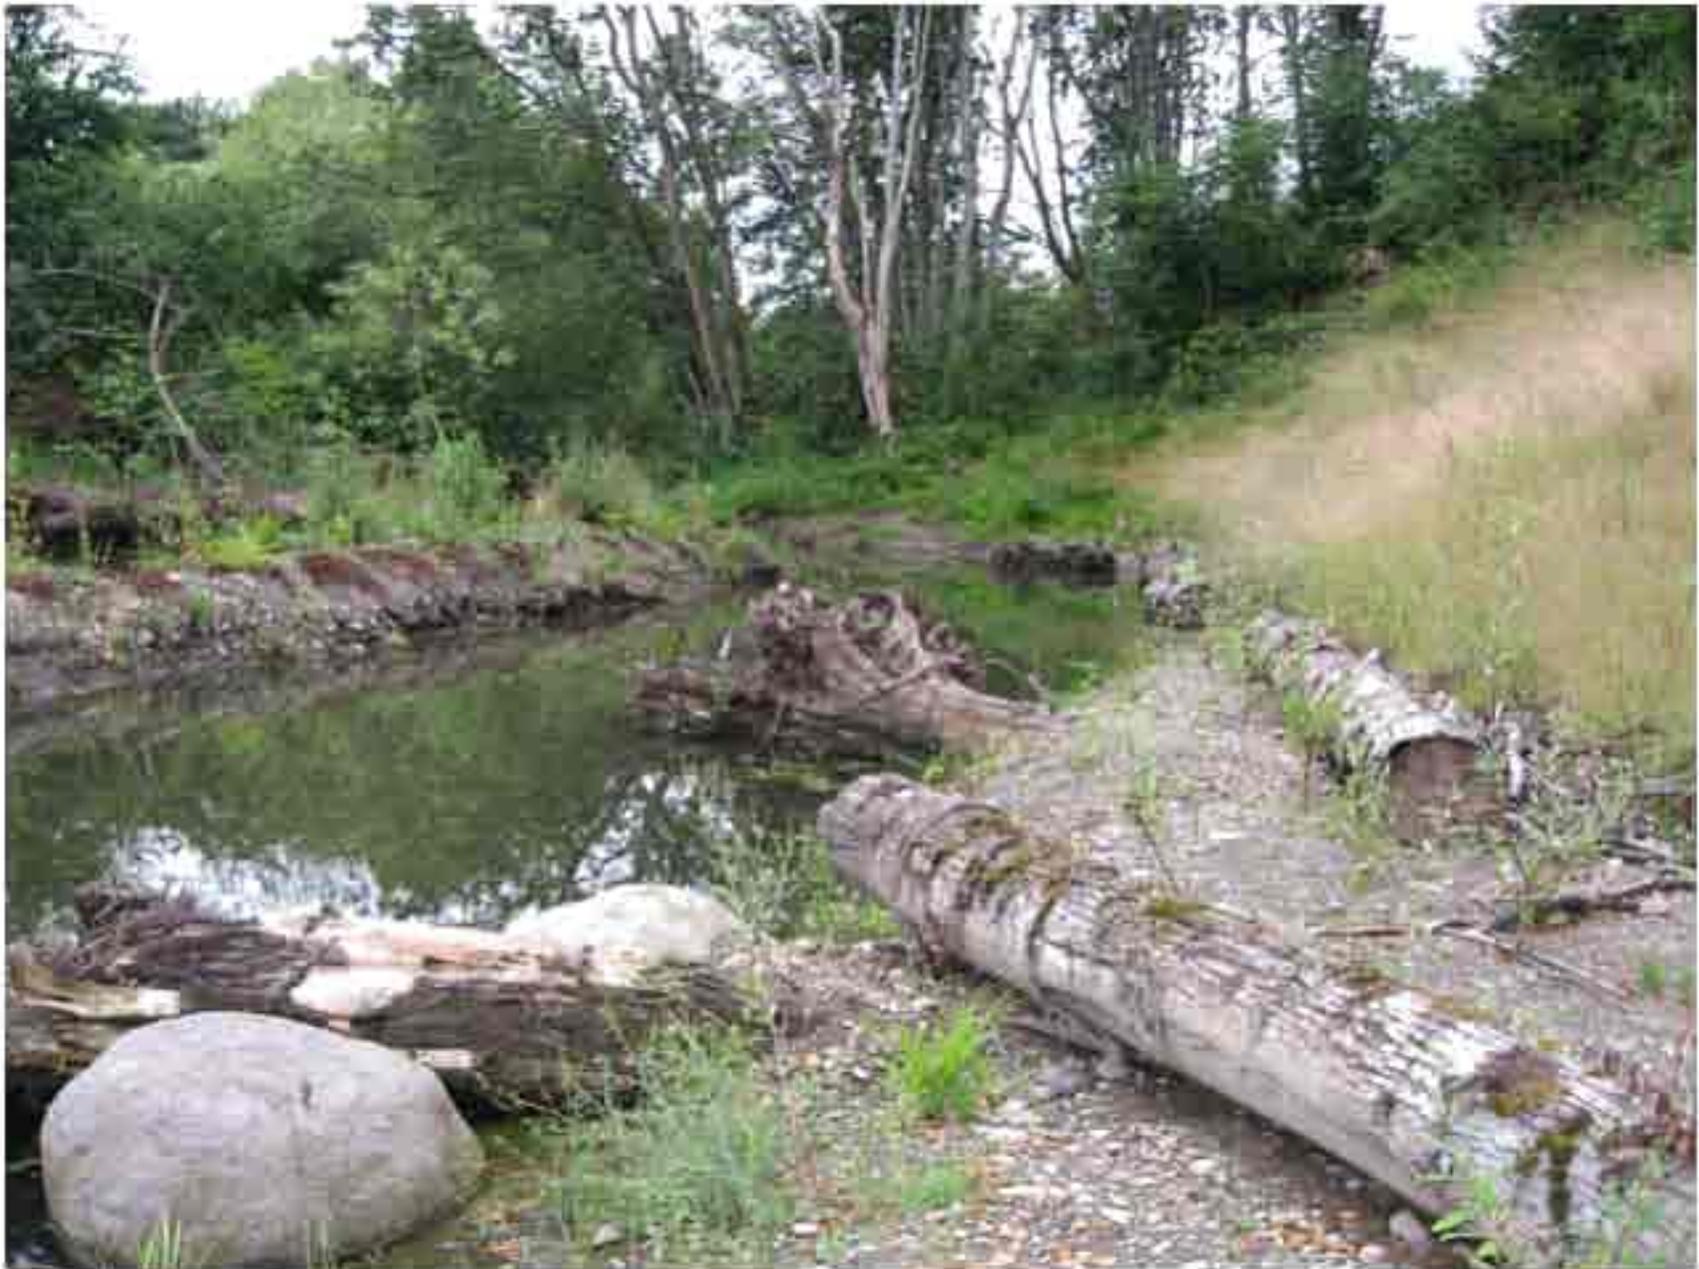
Hylebos Creek, Photo Point 2C, facing west. Photo taken July 13, 2006 at 8:22 PM, tide at approximately 12.7 feet MLLW. [IM G_0098]

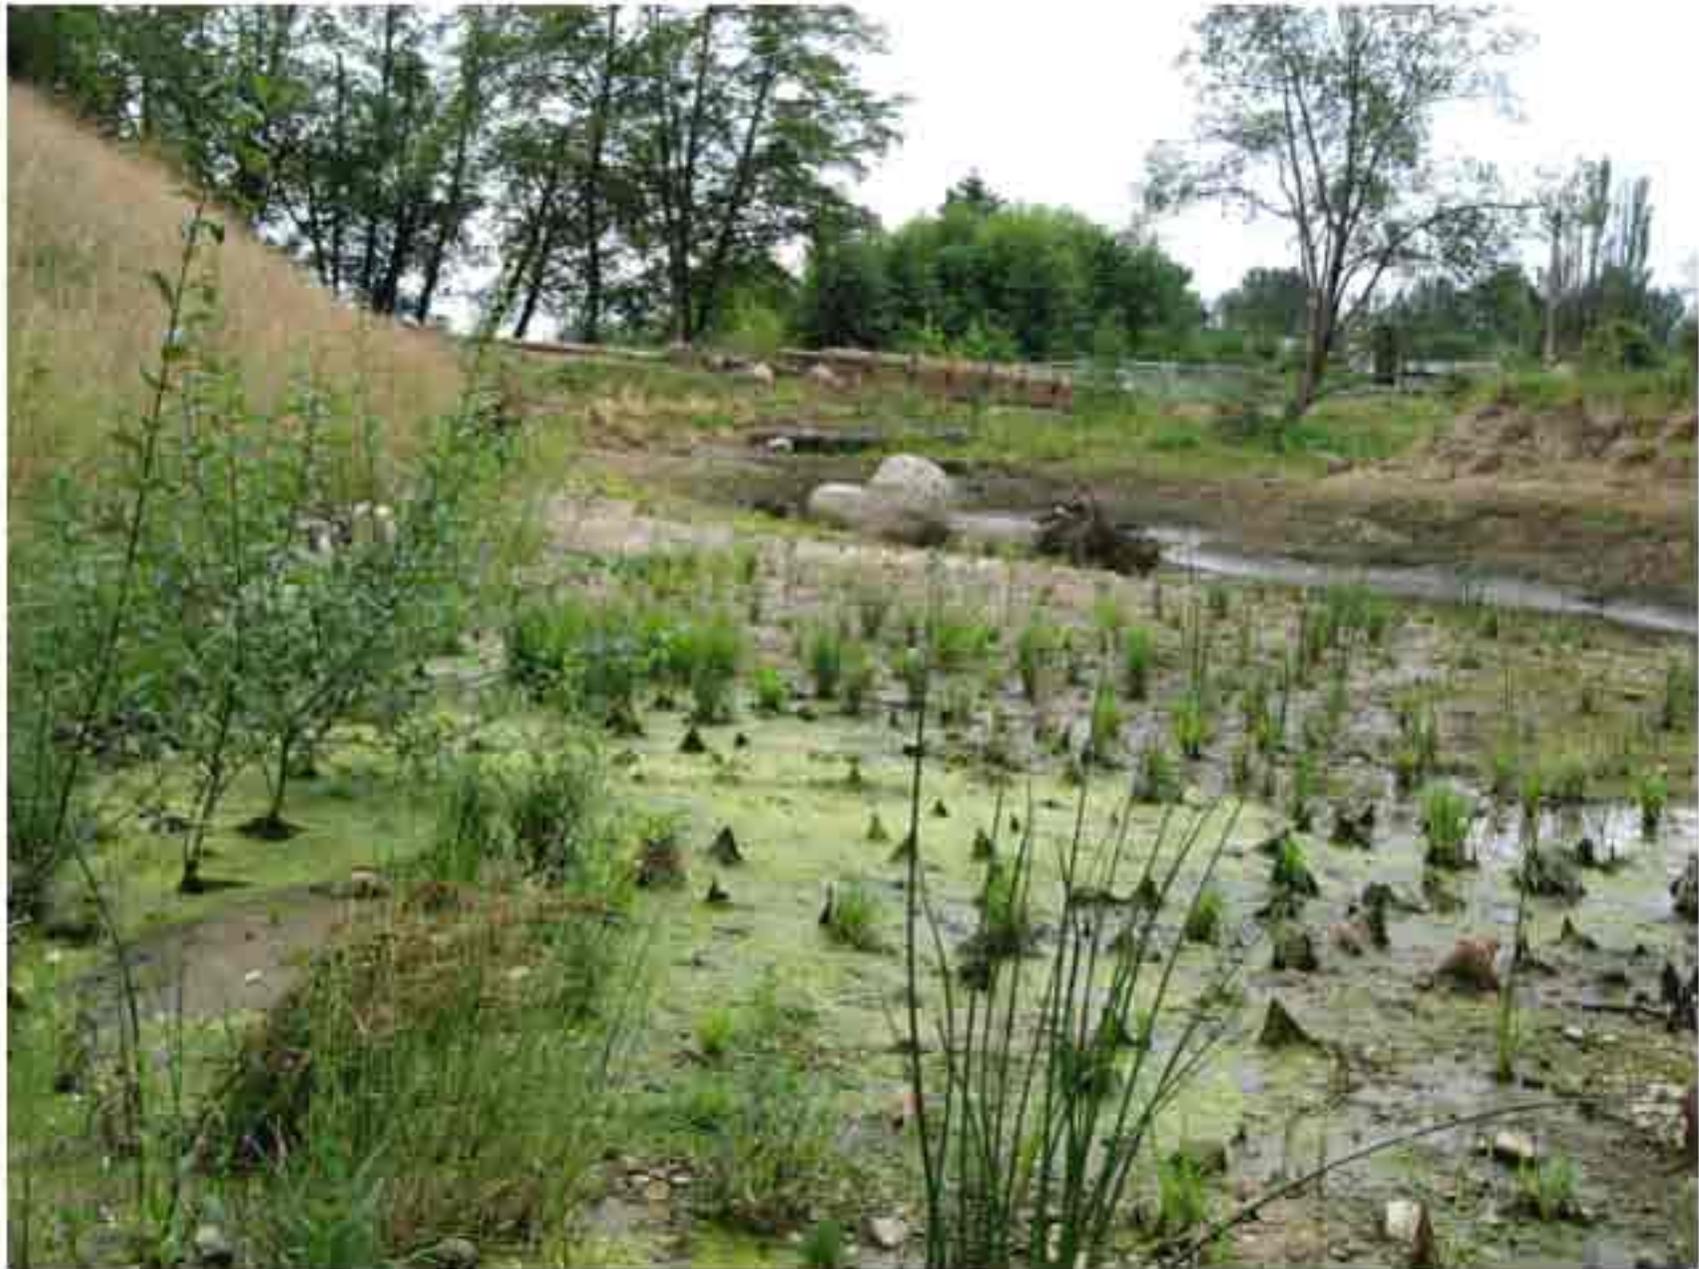
Hylebos Creek, Photo Point 3A, facing southwest. Photo taken July 11, 2006 at 2:32 PM, tide at approximately 2.14 feet MLLW. [IM G_0038]

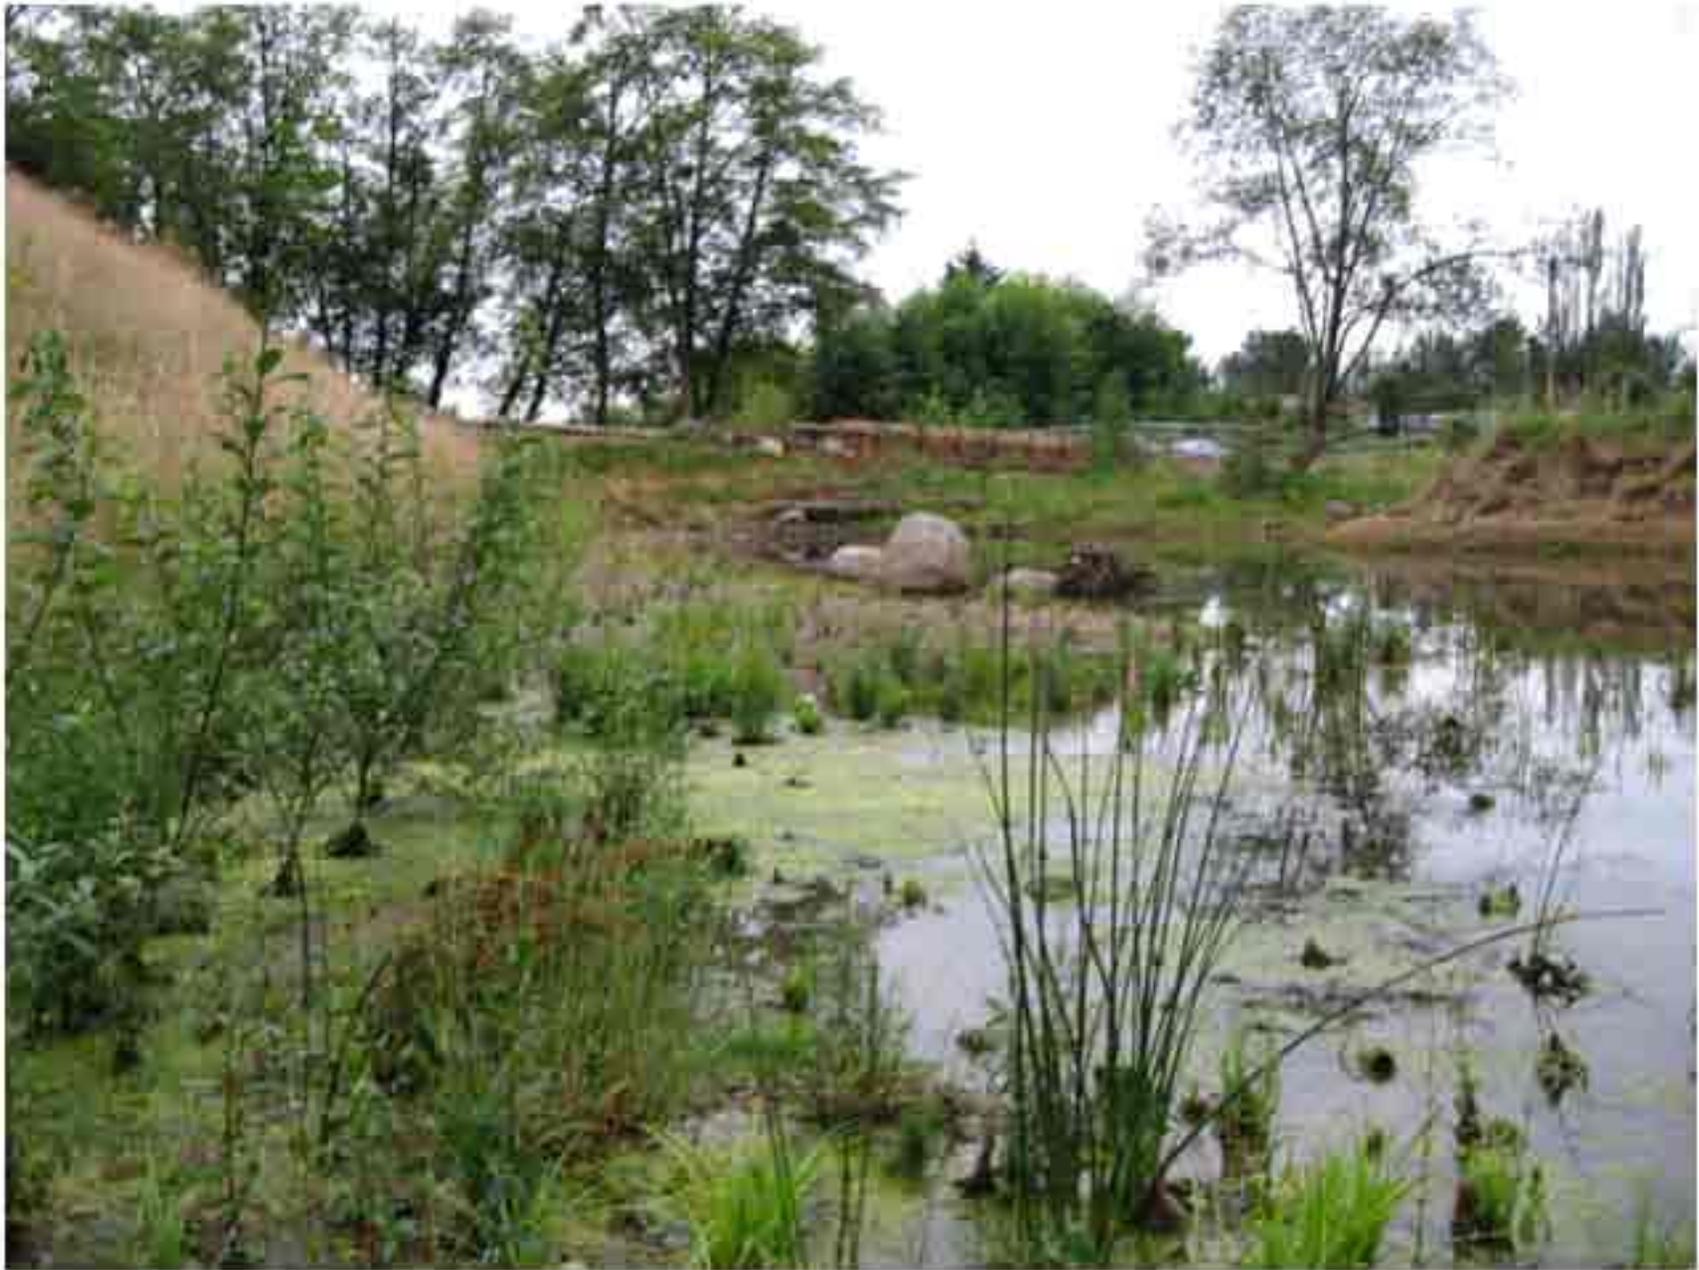
Hylebos Creek, Photo Point 3A, facing southwest. Photo taken July 13, 2006 at 8:28 PM, tide at approximately 12.73 feet MLLW. [M G_0099]

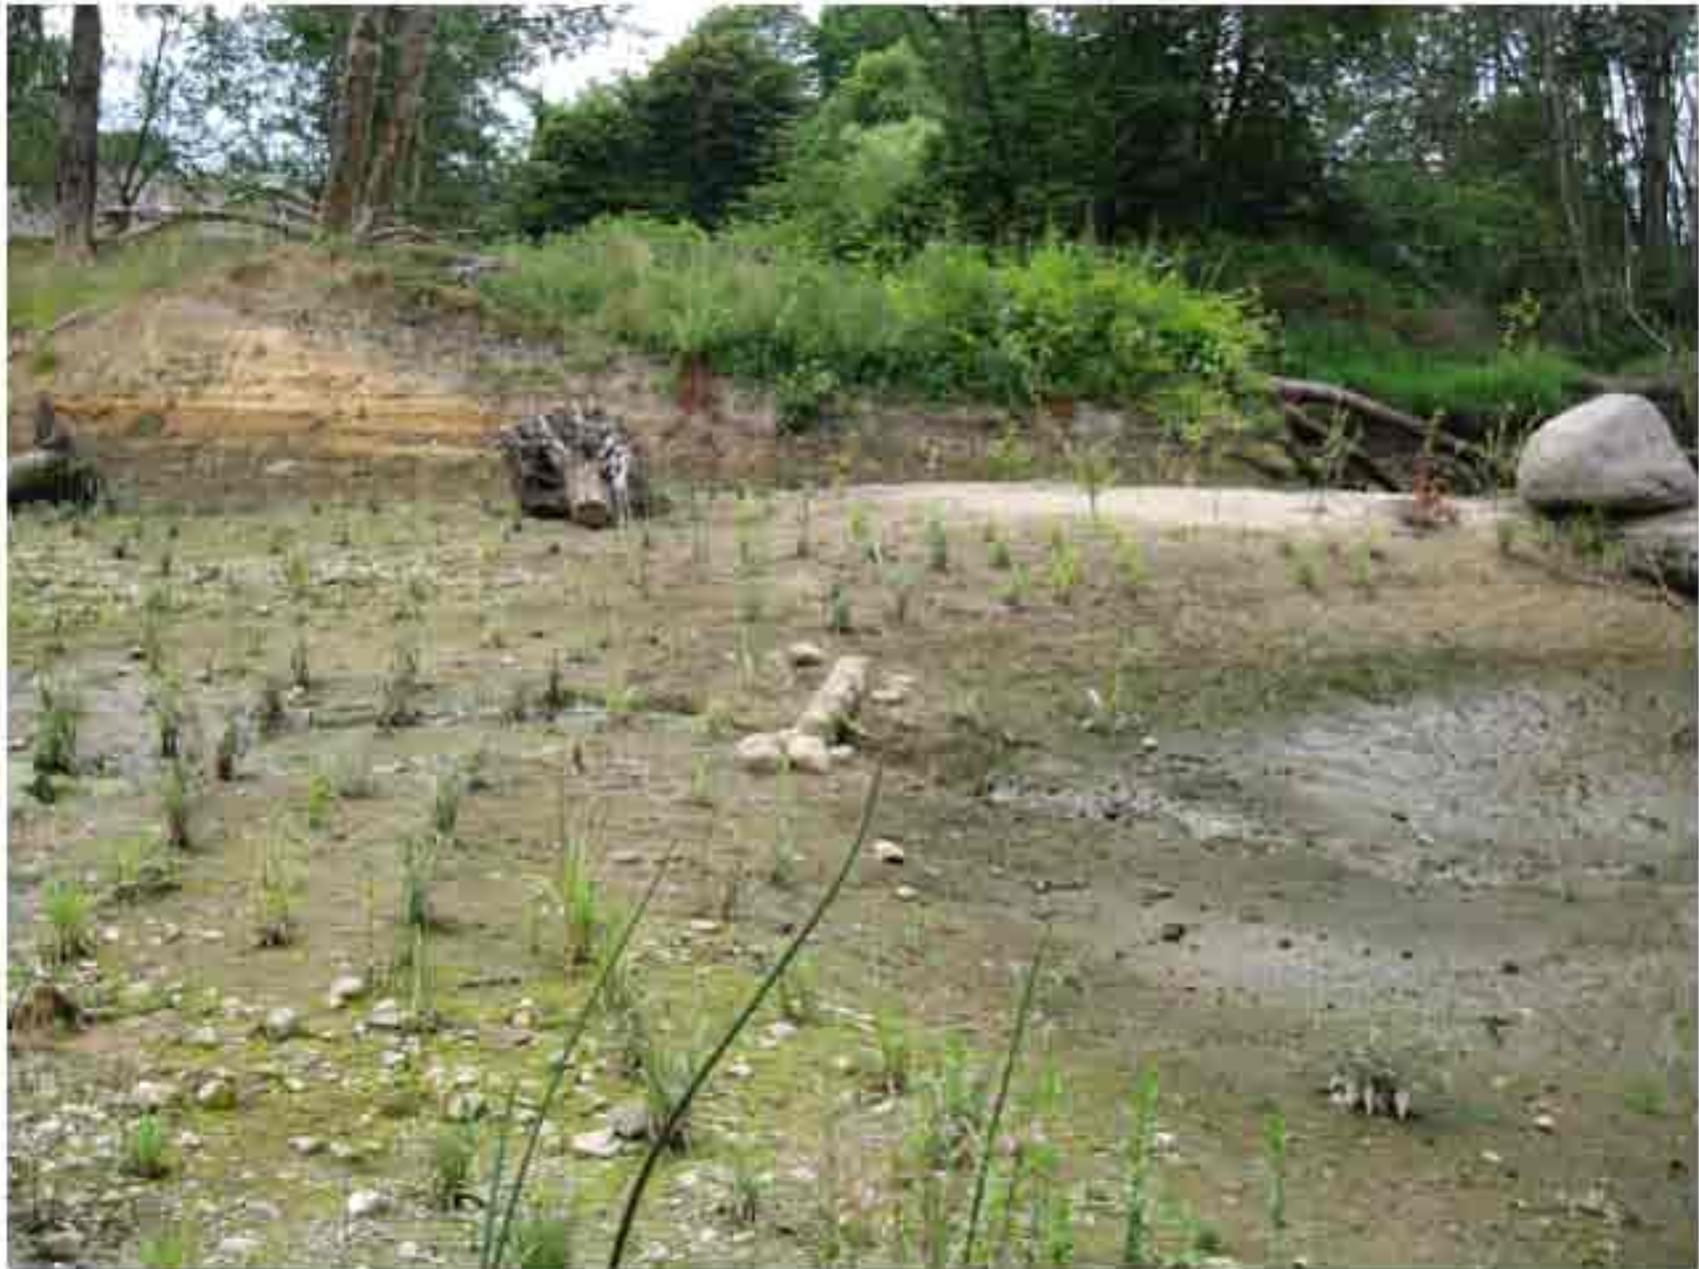
Hylebos Creek, Photo Point 3B, facing west. Photo taken July 11, 2006 at 2:32 PM, tide at approximately 2.14 feet MLLW. [M G_0039]

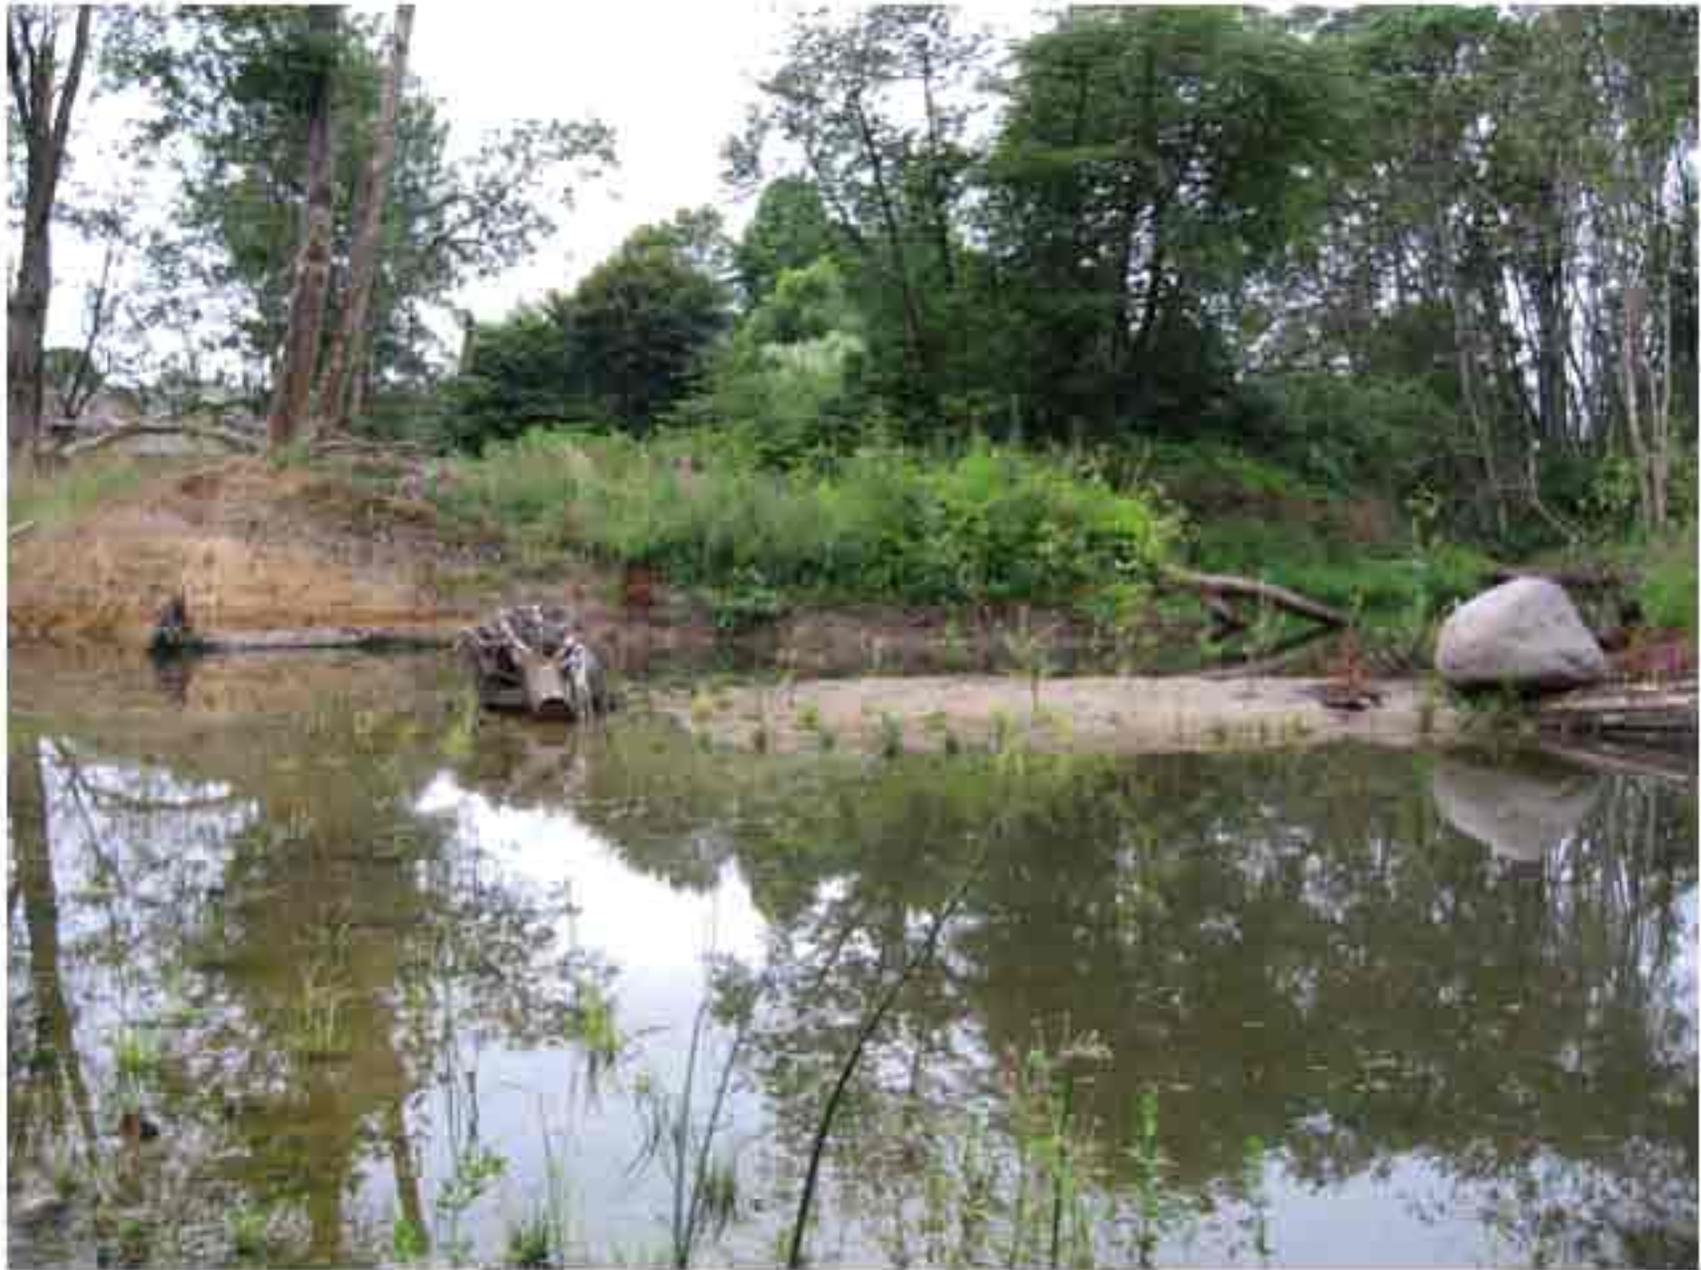
Hylebos Creek, Photo Point 3B, facing west. Photo taken July 13, 2006 at 8:28 P.M., tide at approximately 12.73 feet MLLW. [IMG_0100]

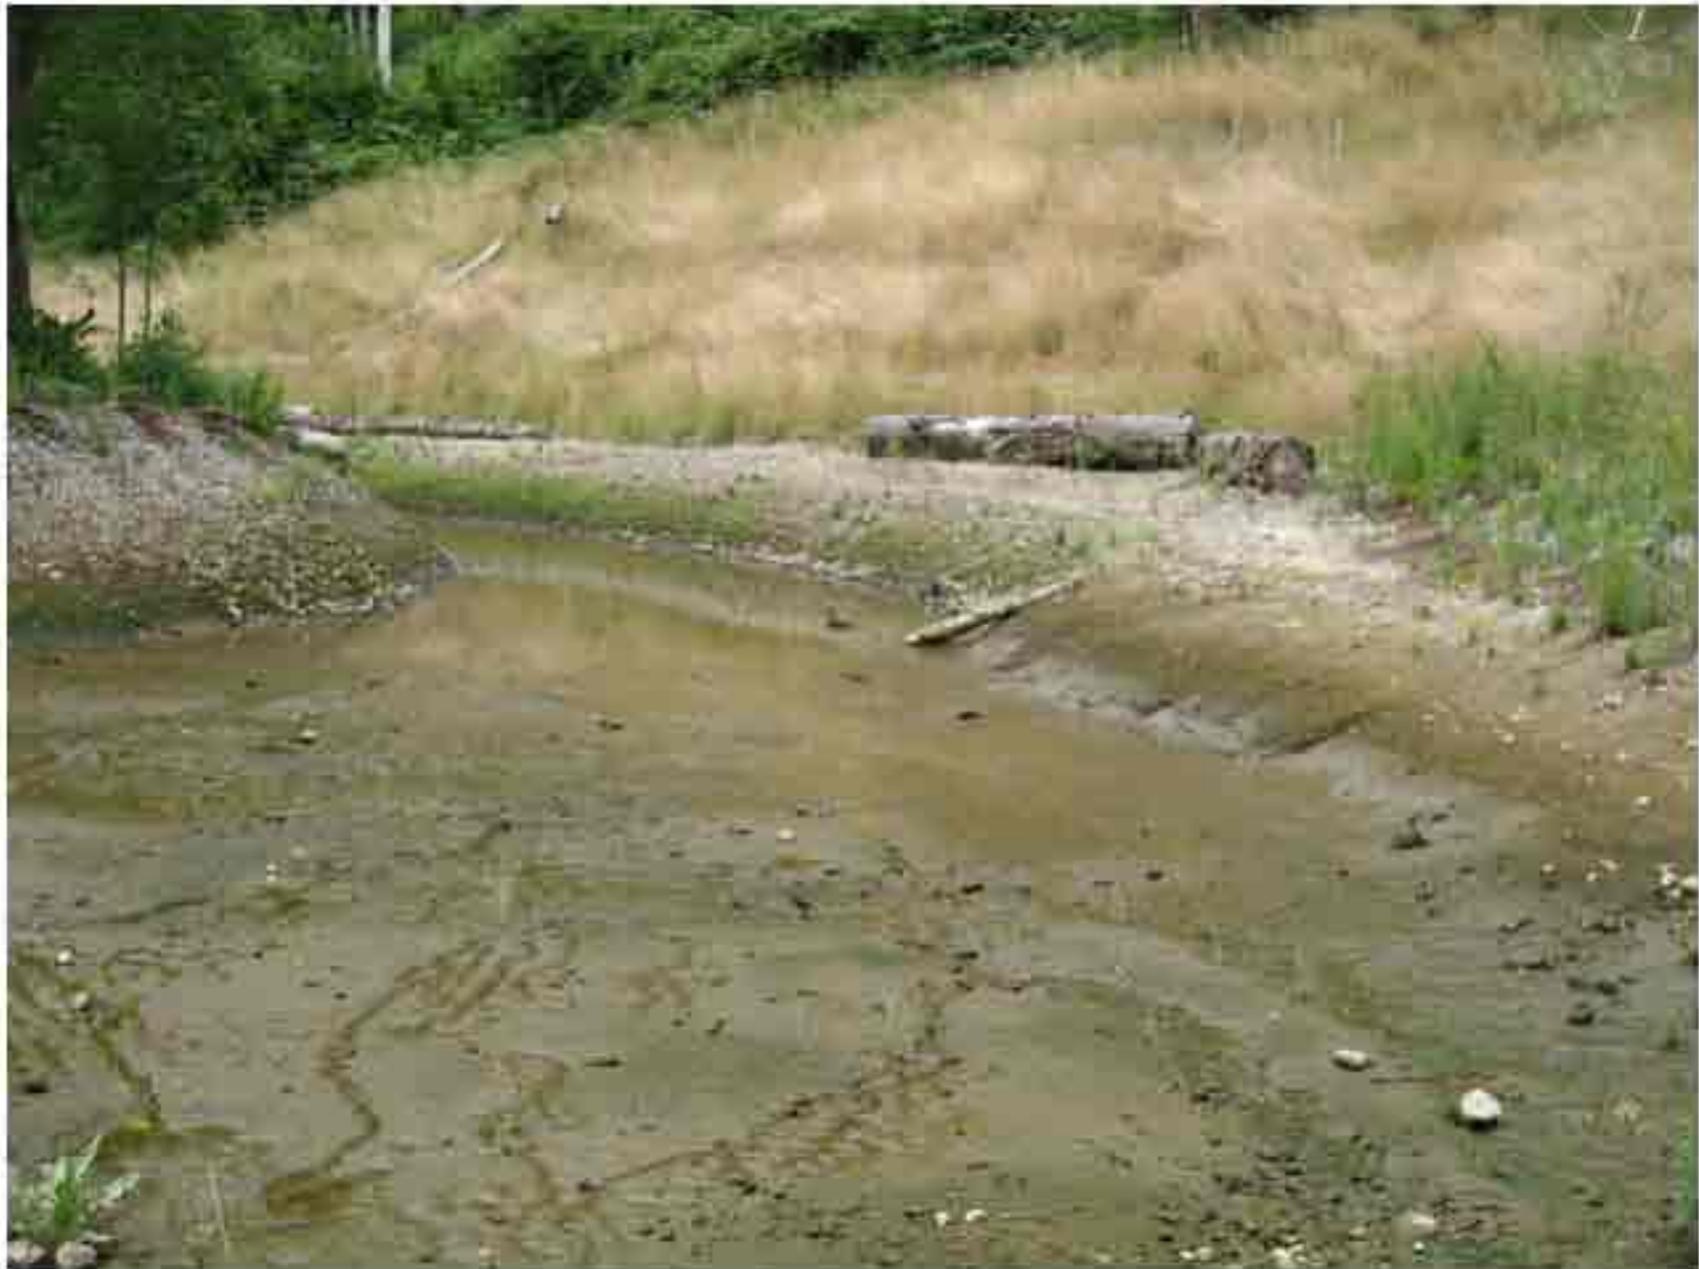
Hylebos Creek, Photo Point 3C, facing northwest. Photo taken July 11, 2006 at 2:32 PM, tide at approximately 2.14 feet MLLW. [M G_0040]

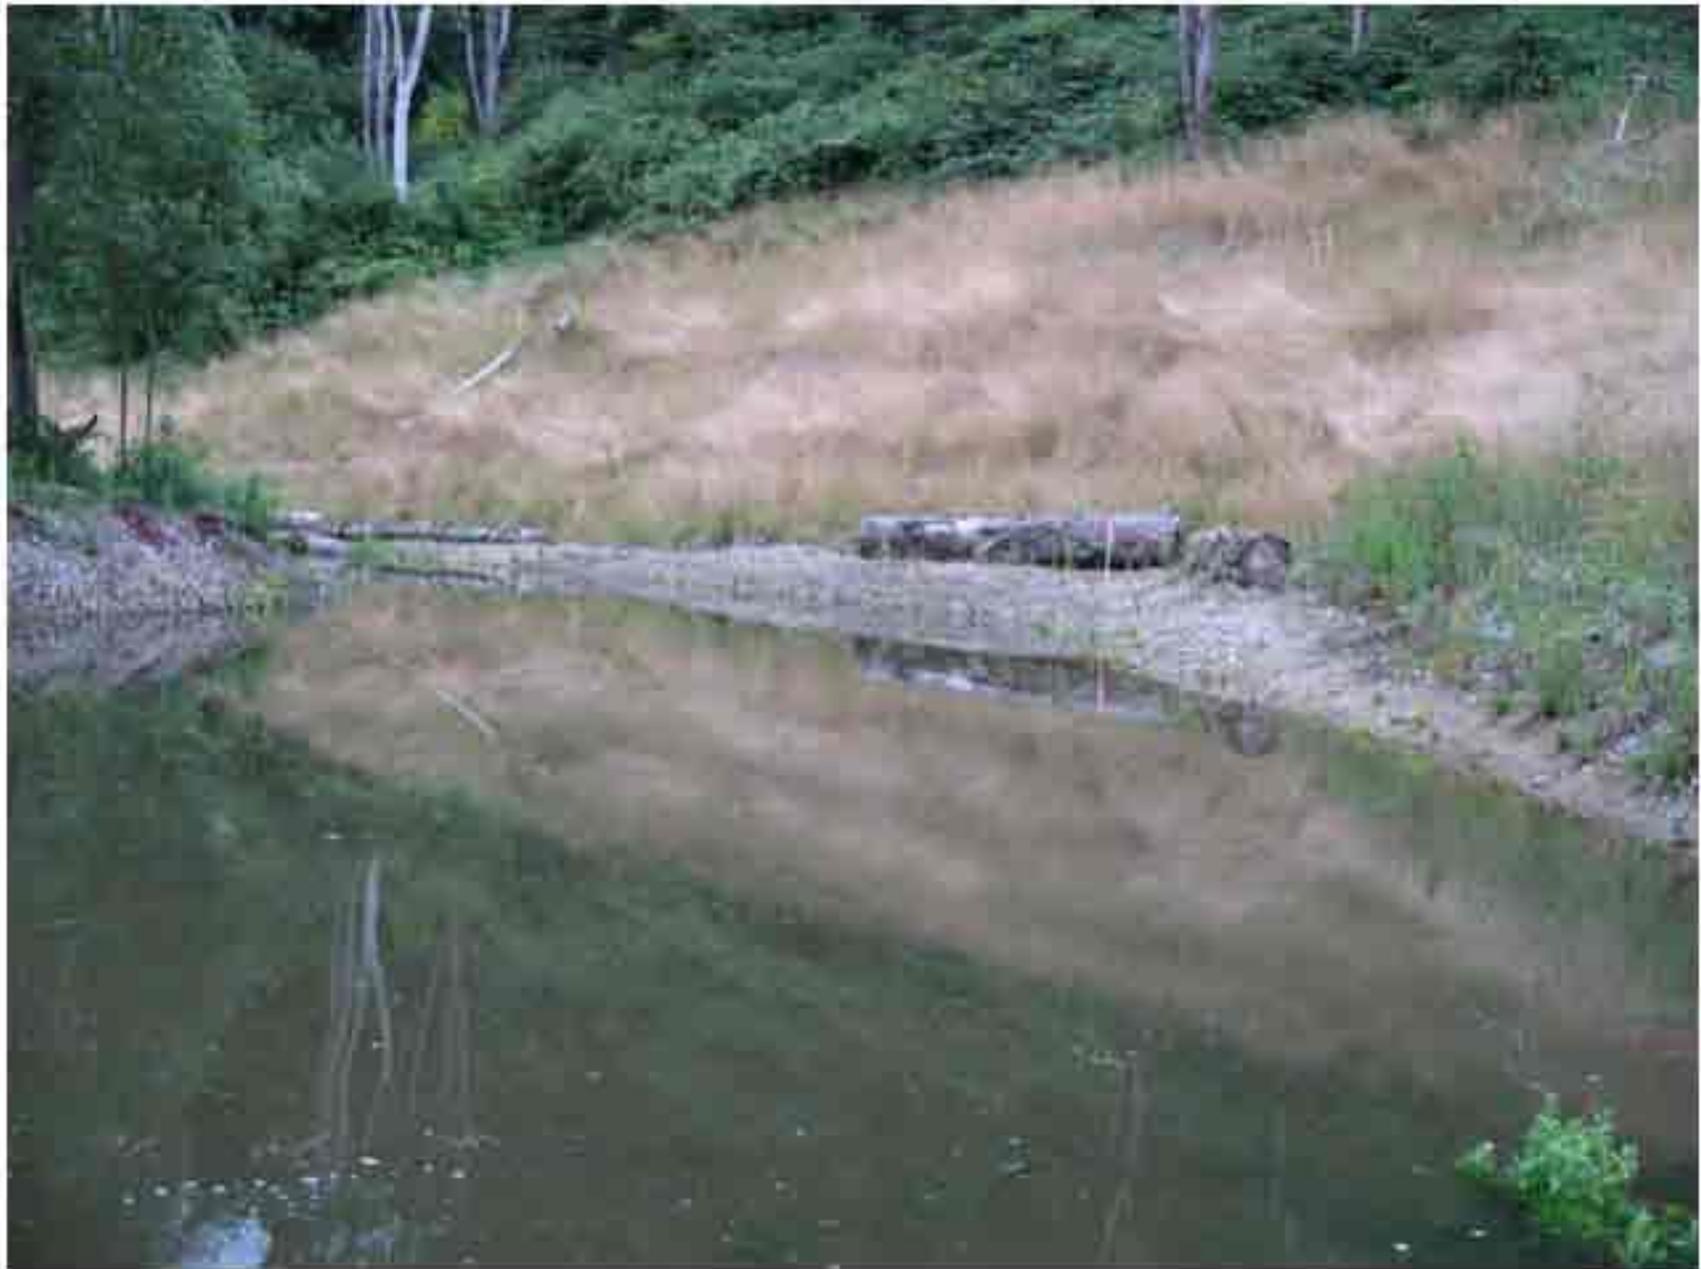
Hylebos Creek, Photo Point 3C, facing northwest. Photo taken July 13, 2006 at 8:28 PM, tide at approximately 12.73 feet MLLW. [M G_0101]
