THEA FOSS AND WHEELER-OSGOOD WATERWAYS REMEDIATION PROJECT

YEAR 0 BASELINE MONITORING

HABITAT MITIGATION AREA MONITORING PRELIMINARY FINDINGS MEMORANDUM

NOVEMBER 30, 2006

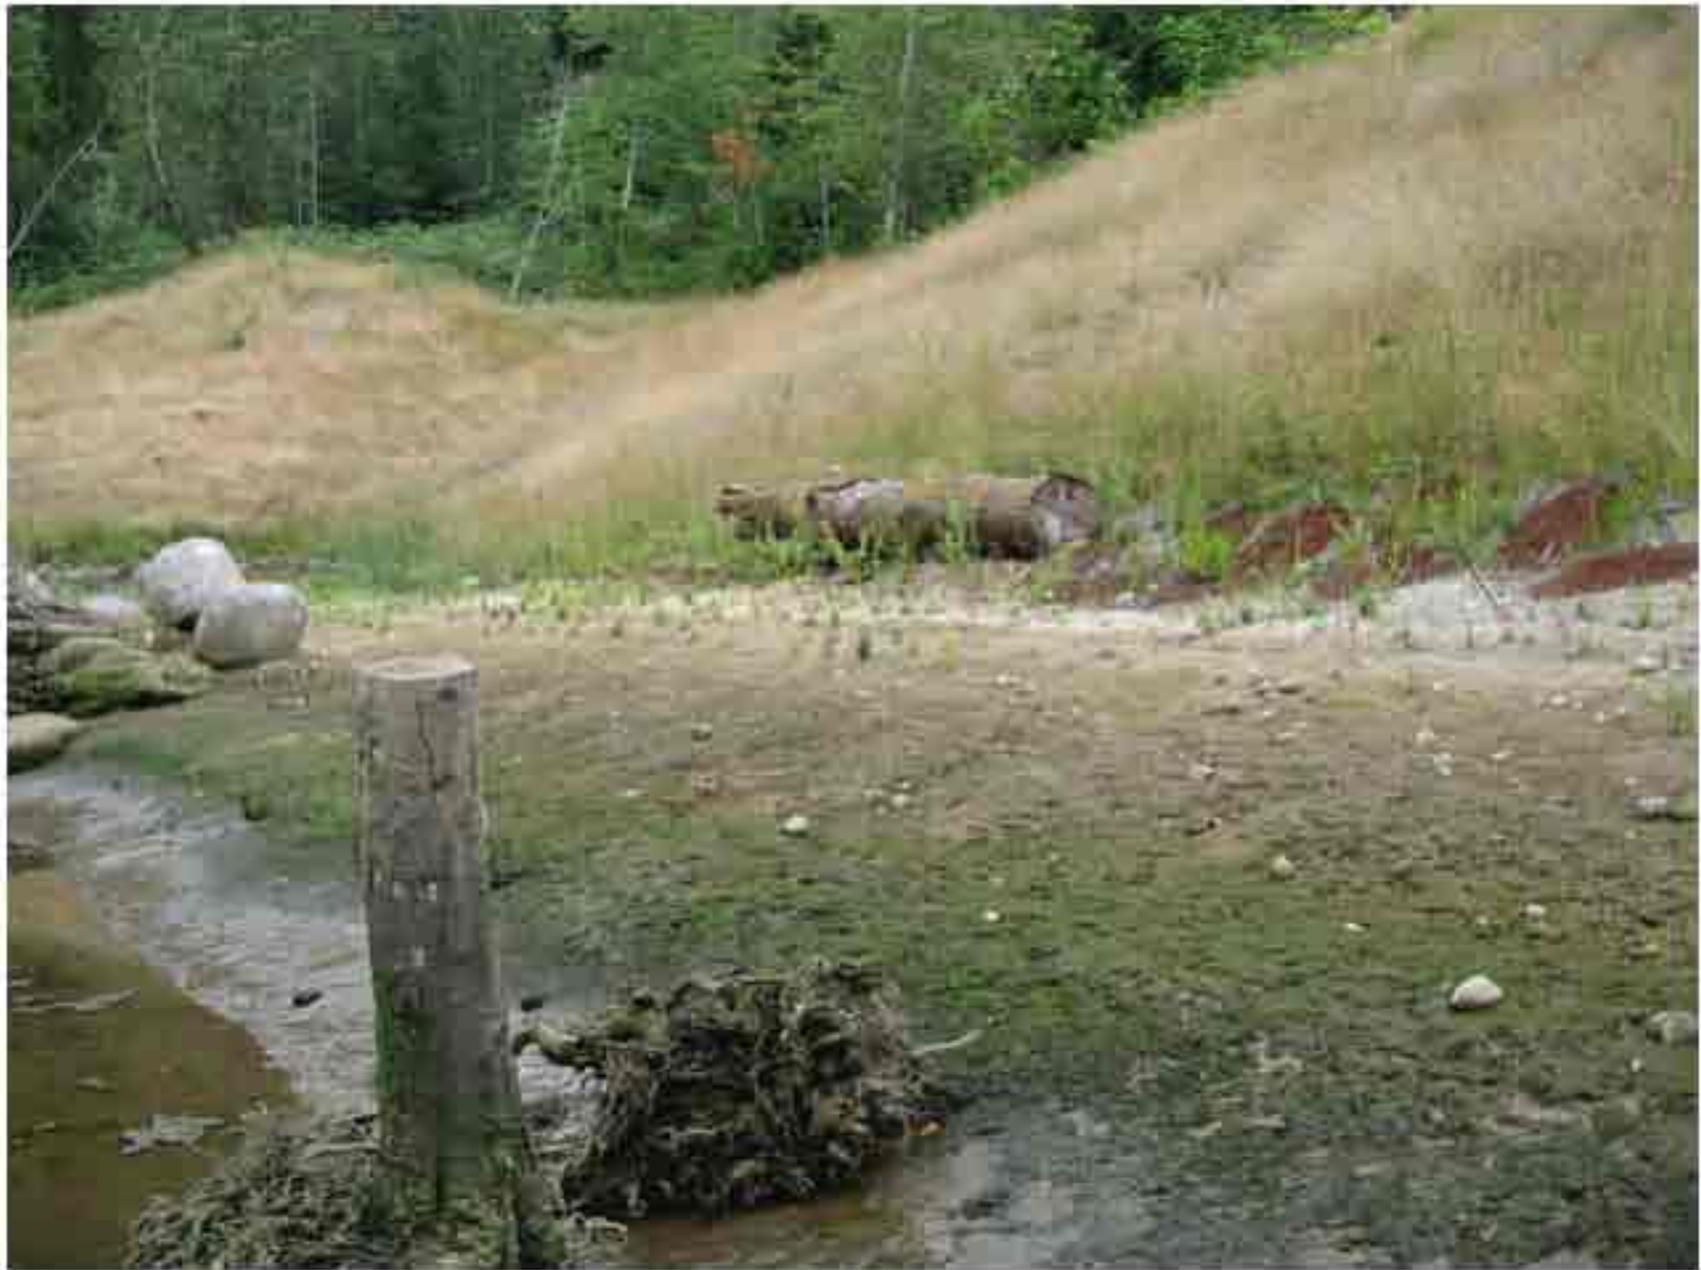
Hylebos Creek, Photo Point 4A, facing northeast. Photo taken July 11, 2006 at 2:20 PM, tide at approximately 1.5 feet MLLW. [IM G_0035]

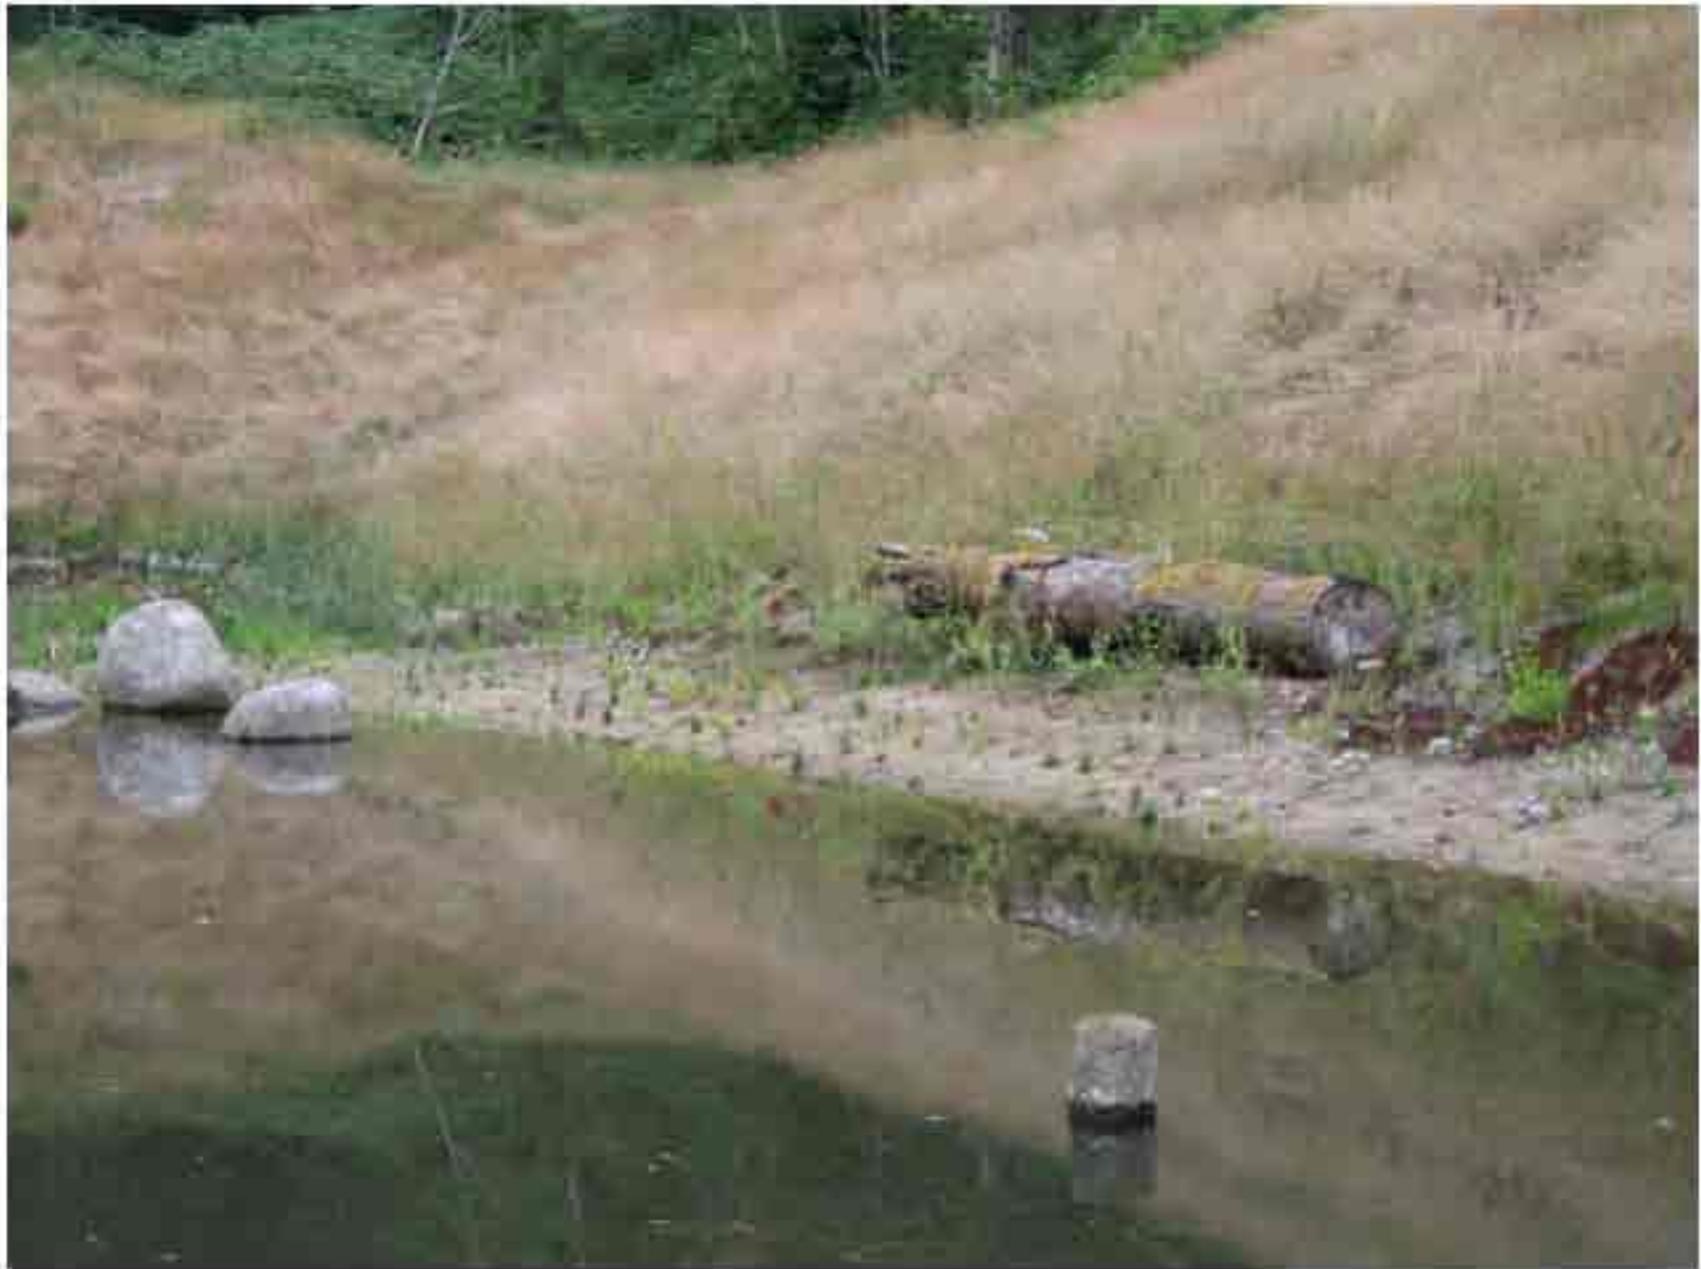
Hylebos Creek, Photo Point 4A, facing northeast. Photo taken July 13, 2006 at 8:32 PM, tide at approximately 12.73 feet MLLW. [IM G_0102]

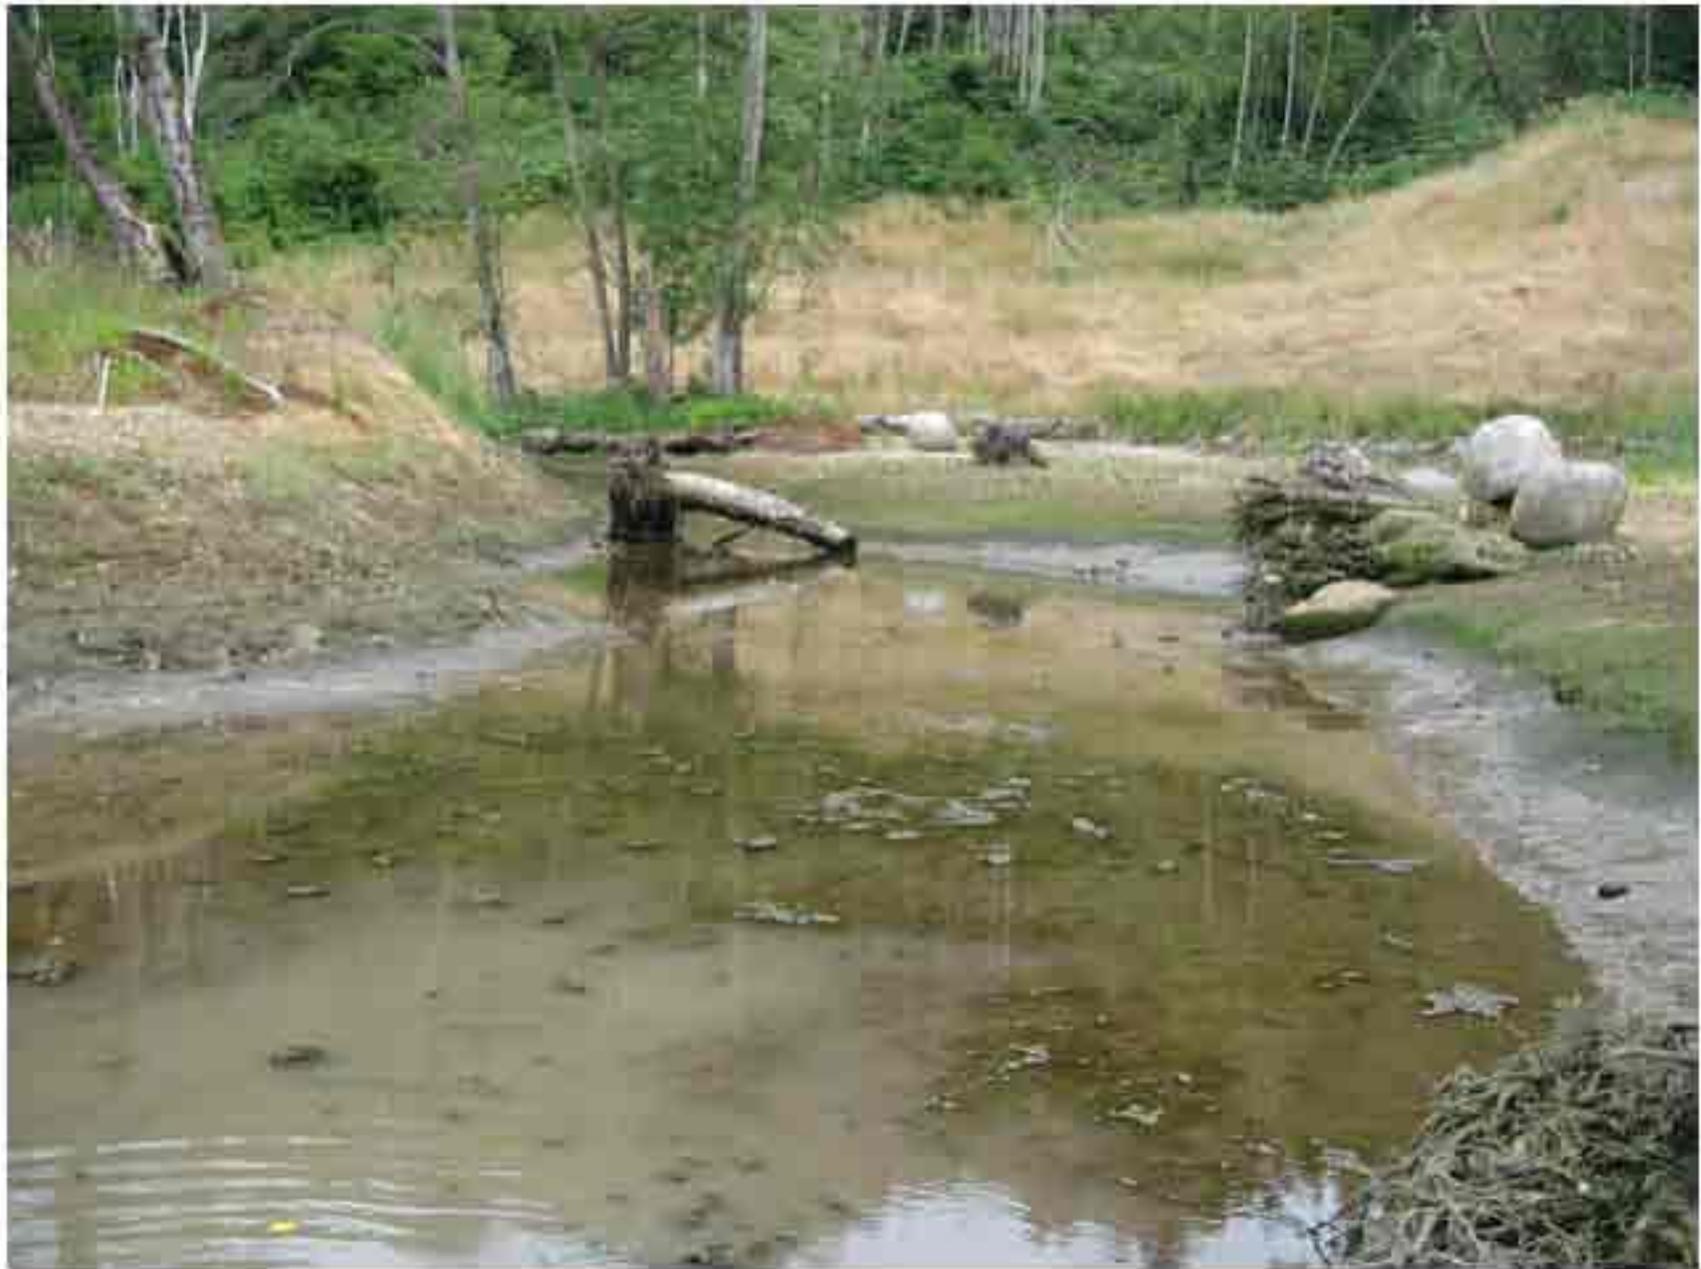
Hylebos Creek, Photo Point 4B, facing north. Photo taken July 11, 2006 at 2:20 PM, tide at approximately 1.5 feet MLLW.
[IM G_0036]

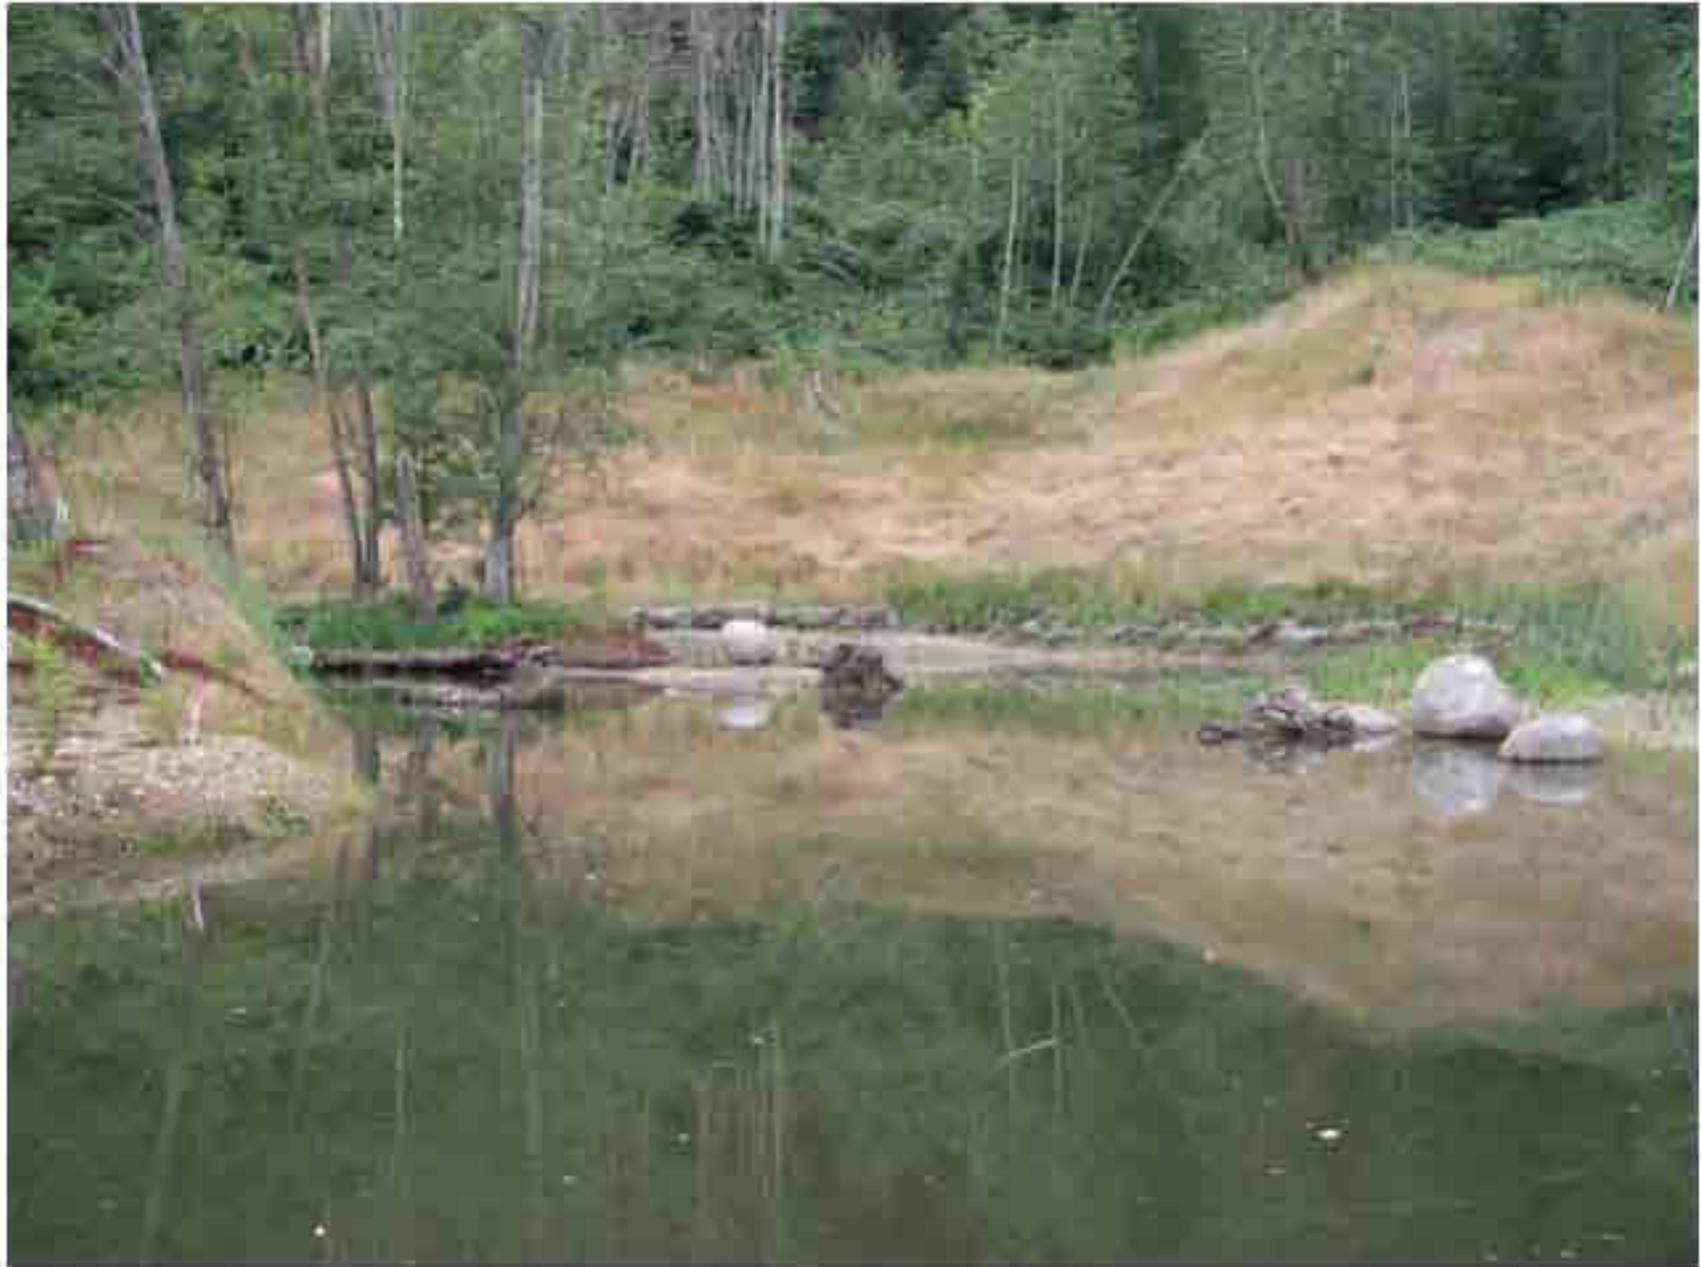
Hylebos Creek, Photo Point 4B, facing north. Photo taken July 13, 2006 at 8:32 P.M., tide at approximately 12.73 feet MLLW.
[M G_0104]

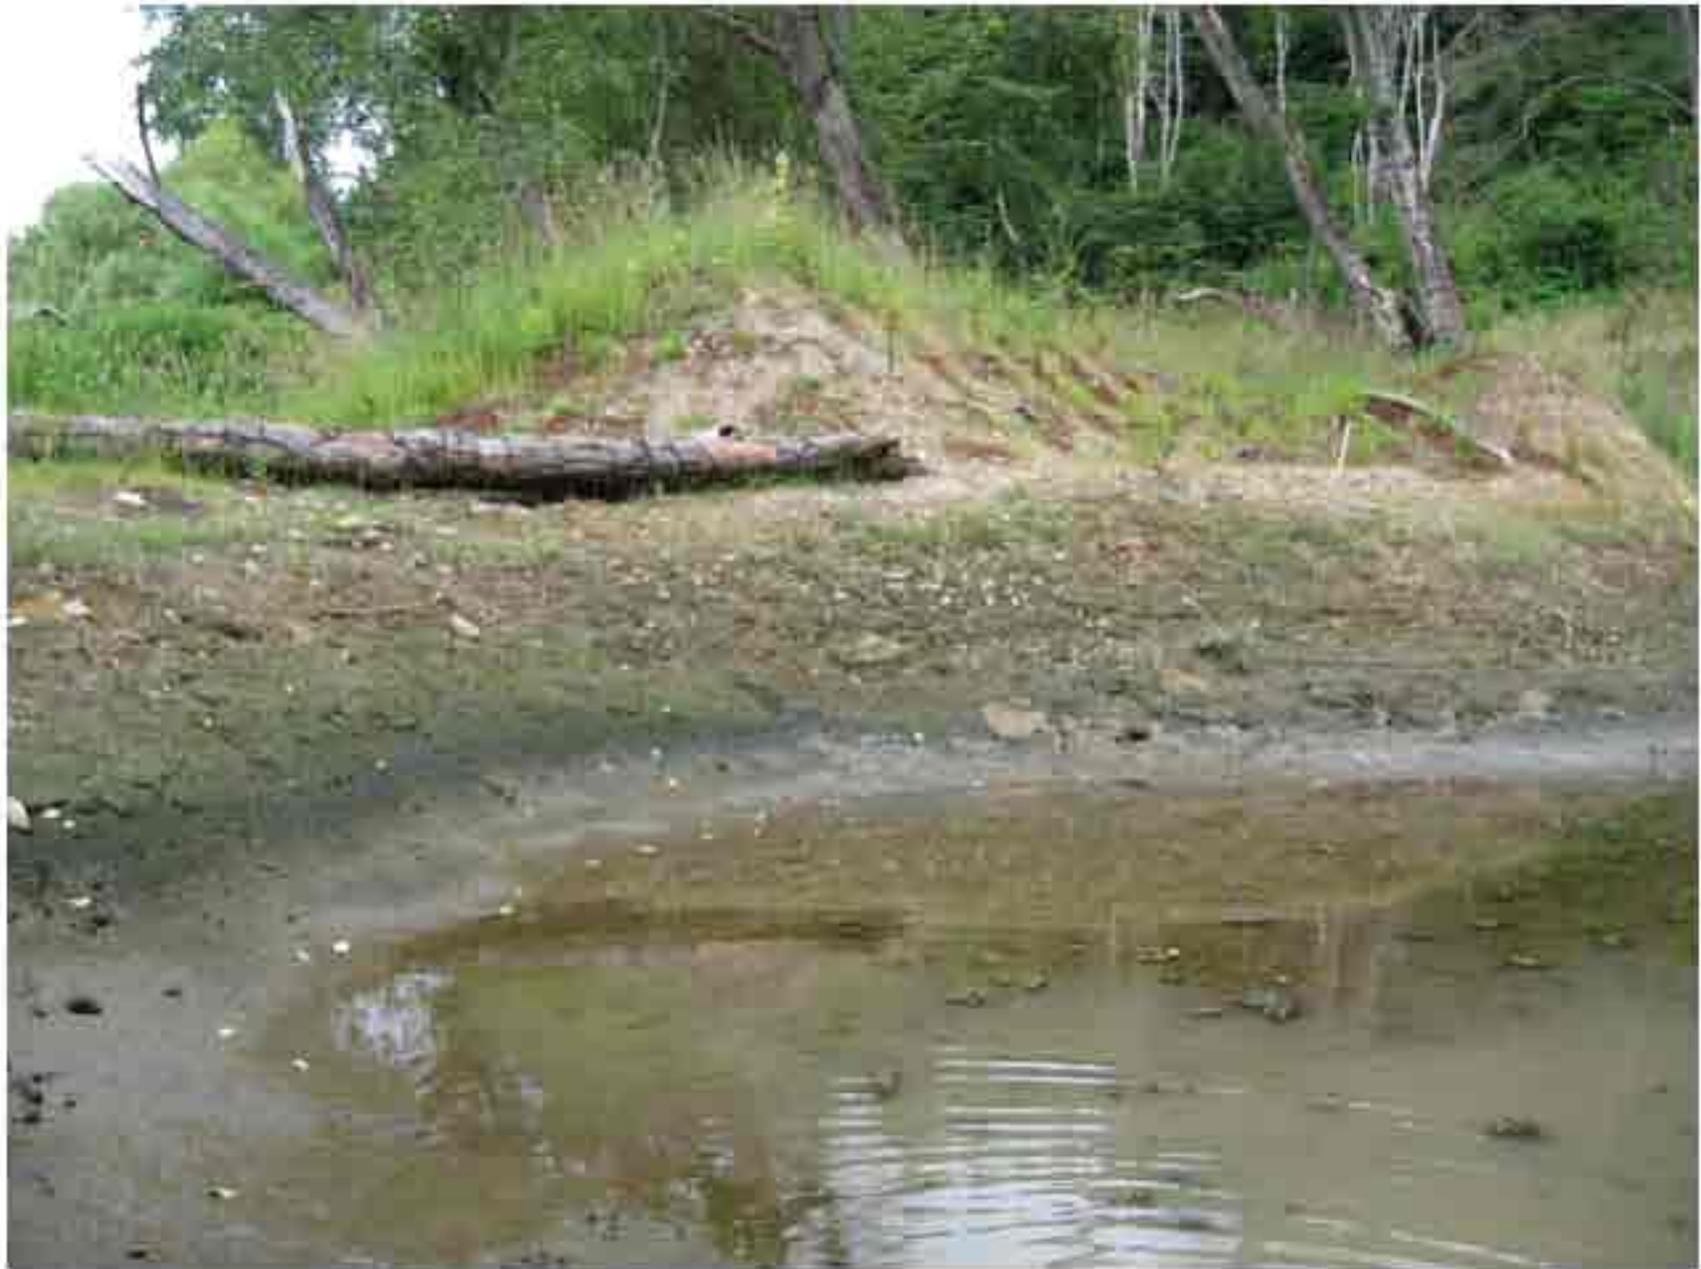
Hylebos Creek, Photo Point 4C, facing northwest. Photo taken July 11, 2006 at 2:20 PM, tide at approximately 1.5 feet MLLW.
[M G_0037]

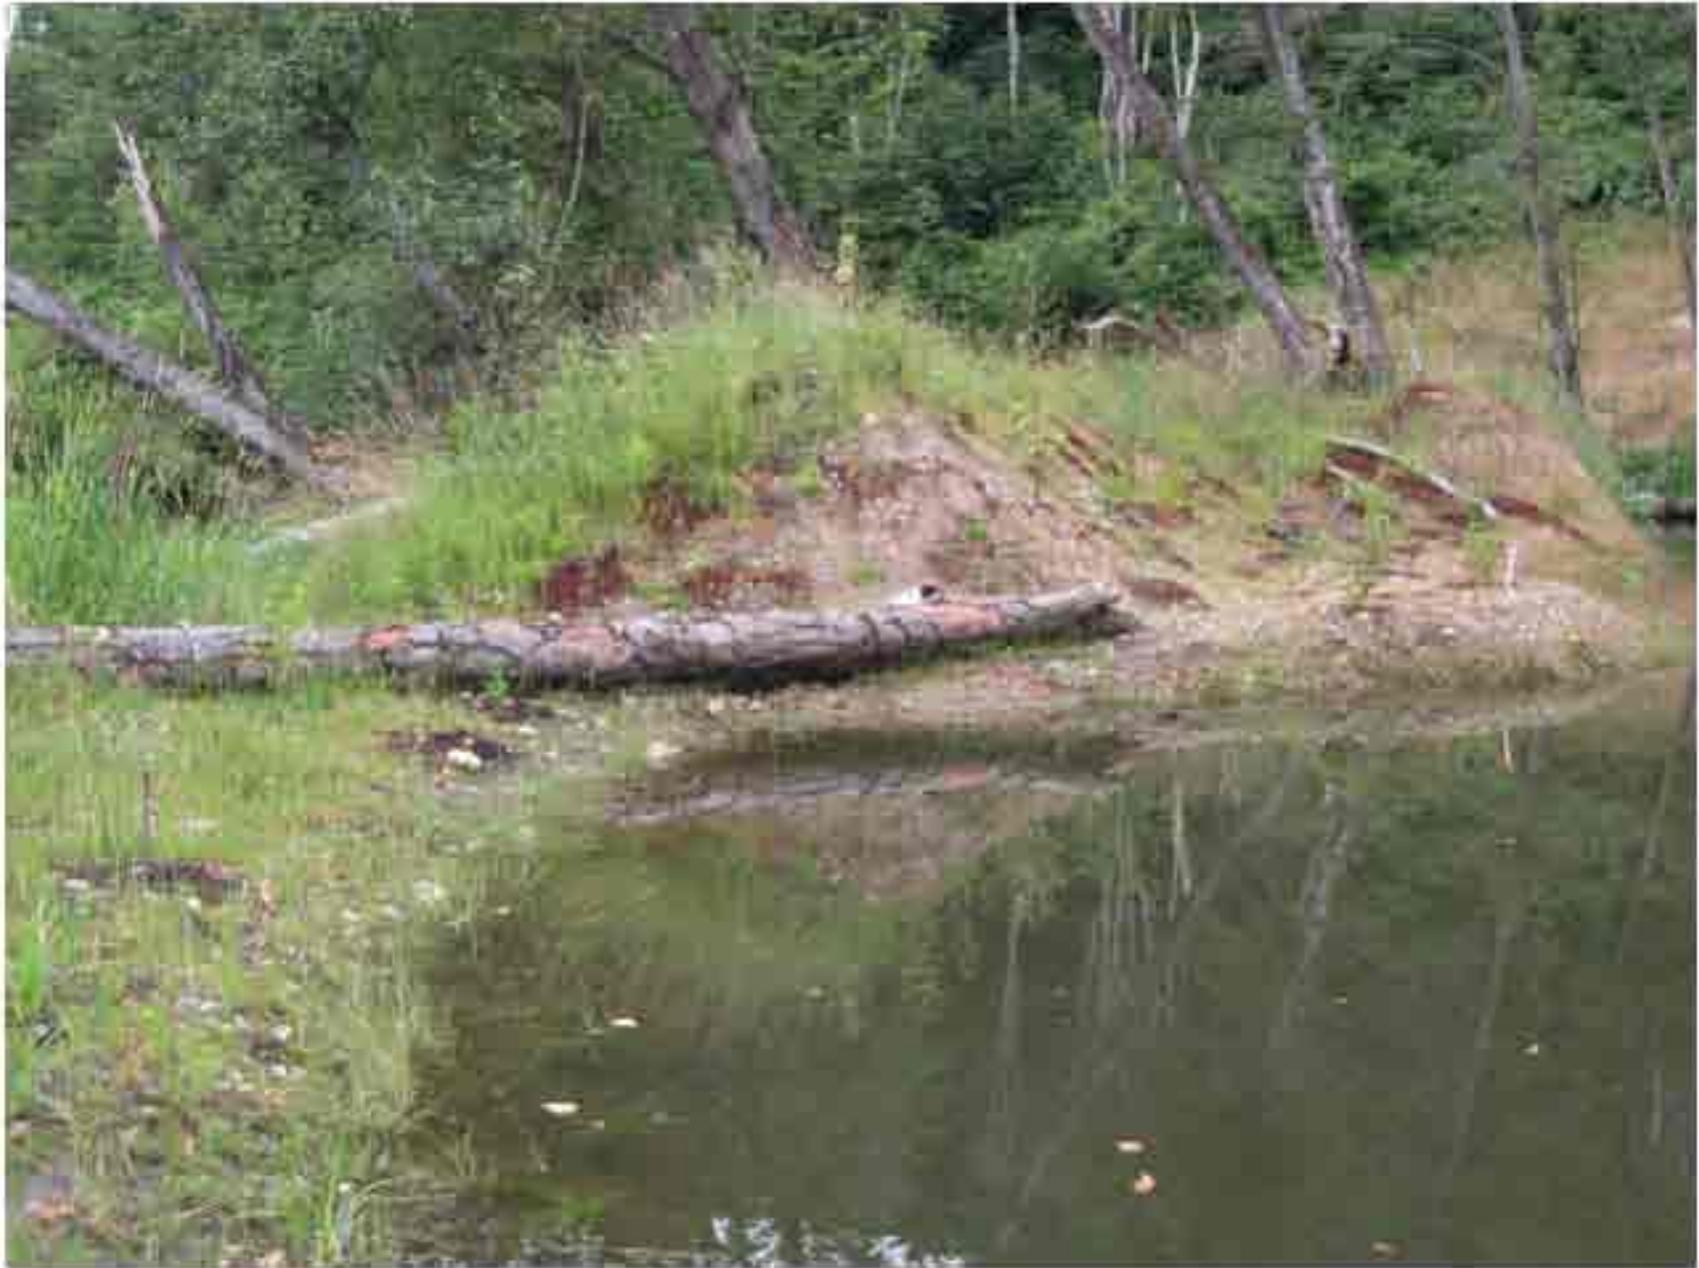
Hylebos Creek, Photo Point 4C, facing northwest. Photo taken July 13, 2006 at 8:32 PM, tide at approximately 12.73 feet MLLW. [IM G_0105]

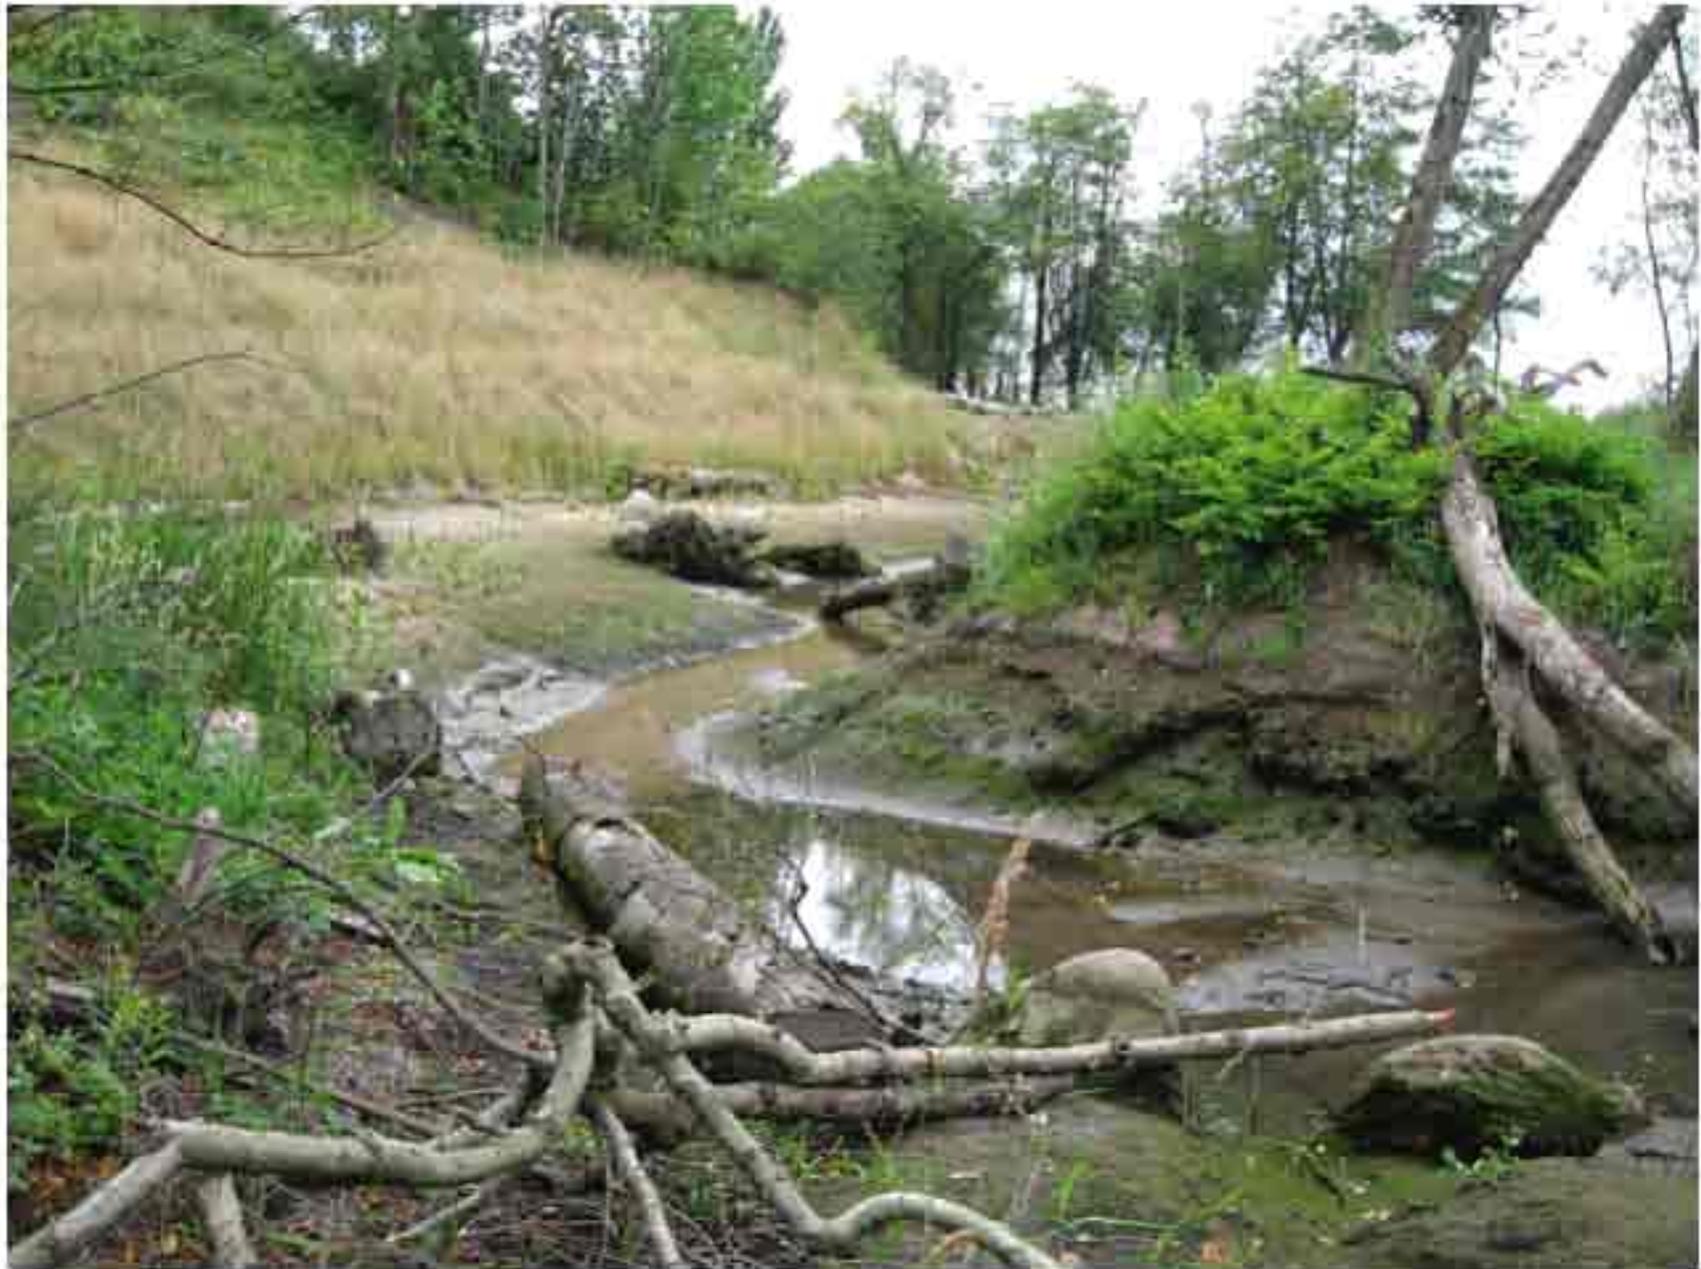
Hylebos Creek, Photo Point 5A, facing south. Photo taken July 11, 2006 at 2:41 PM, tide at approximately 2.65 feet MLLW. [M G_0041]

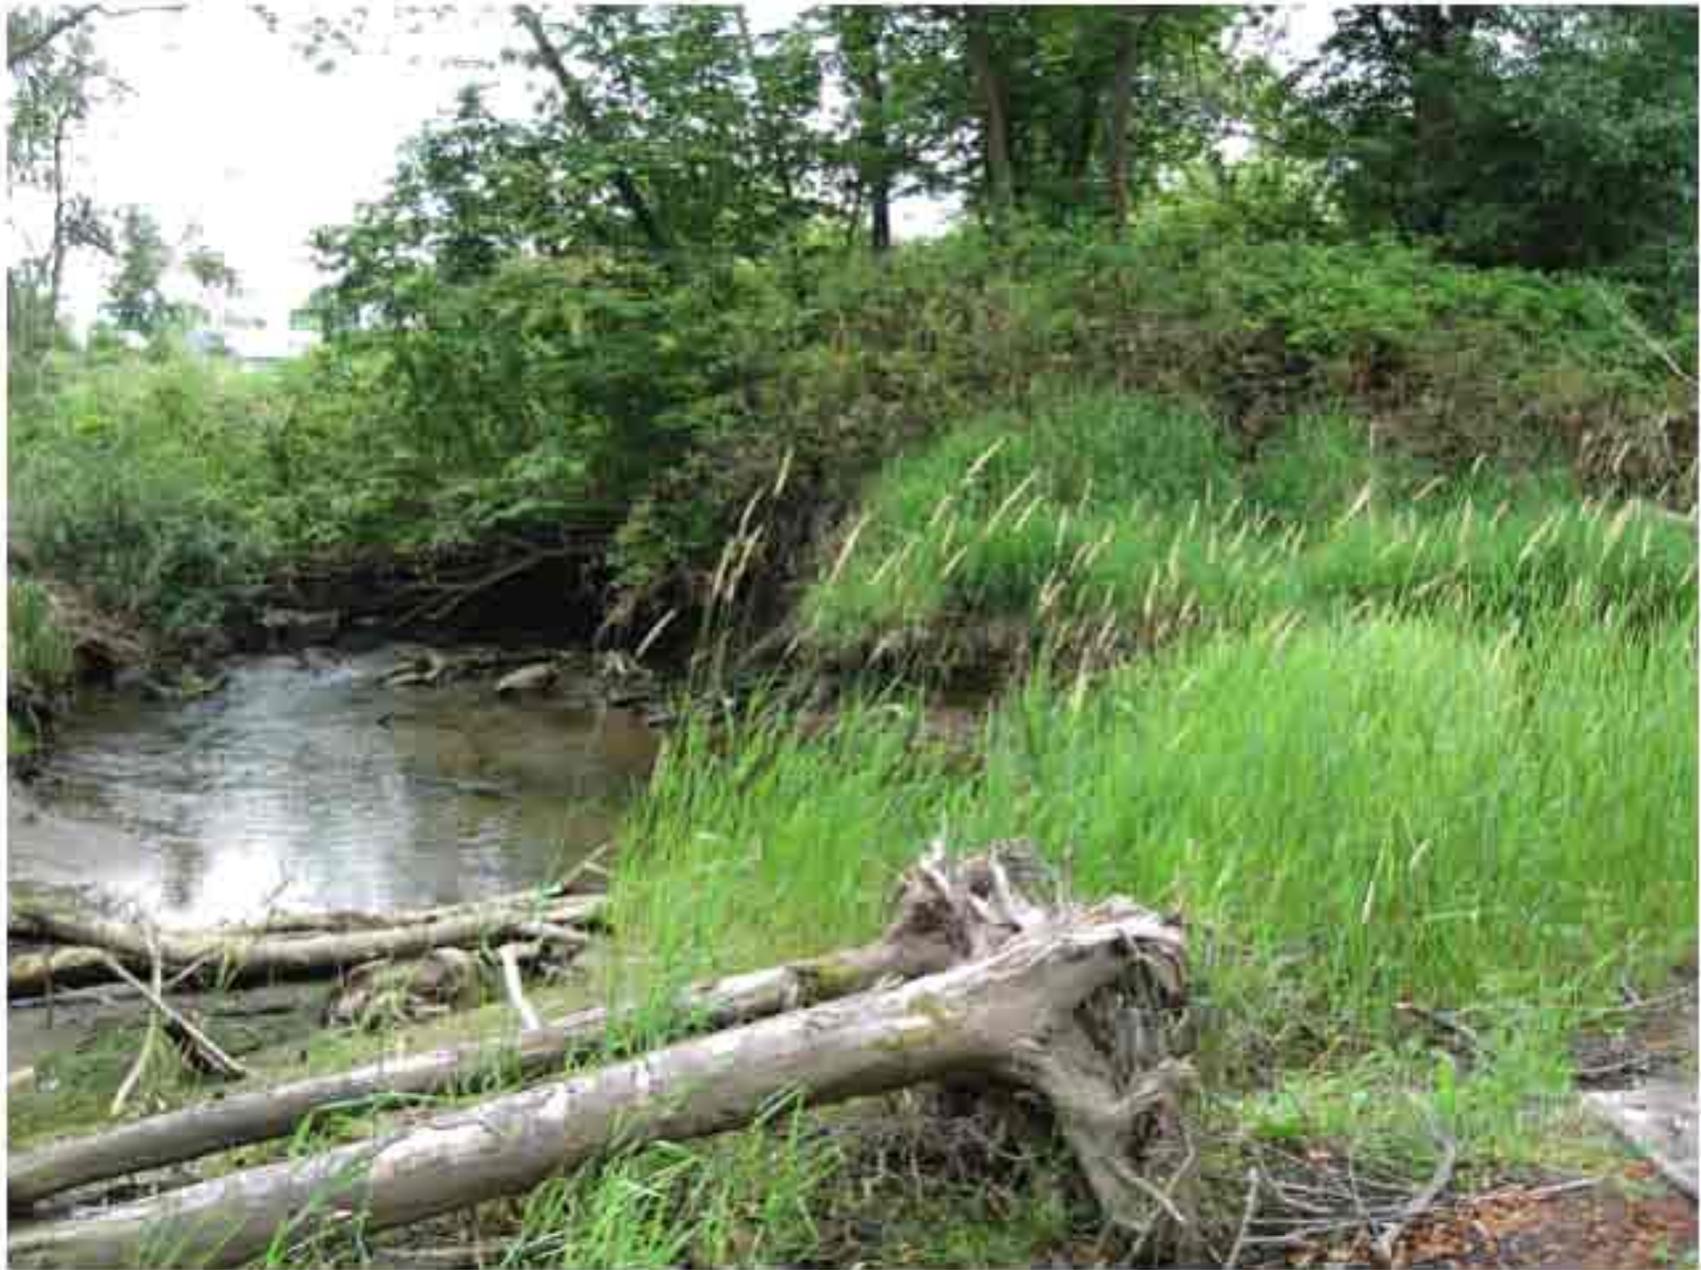
Hylebos Creek, Photo Point 5B, facing west. Photo taken July 11, 2006 at 2:41 P.M., tide at approximately 2.65 feet MLLW. [IM G_0042]

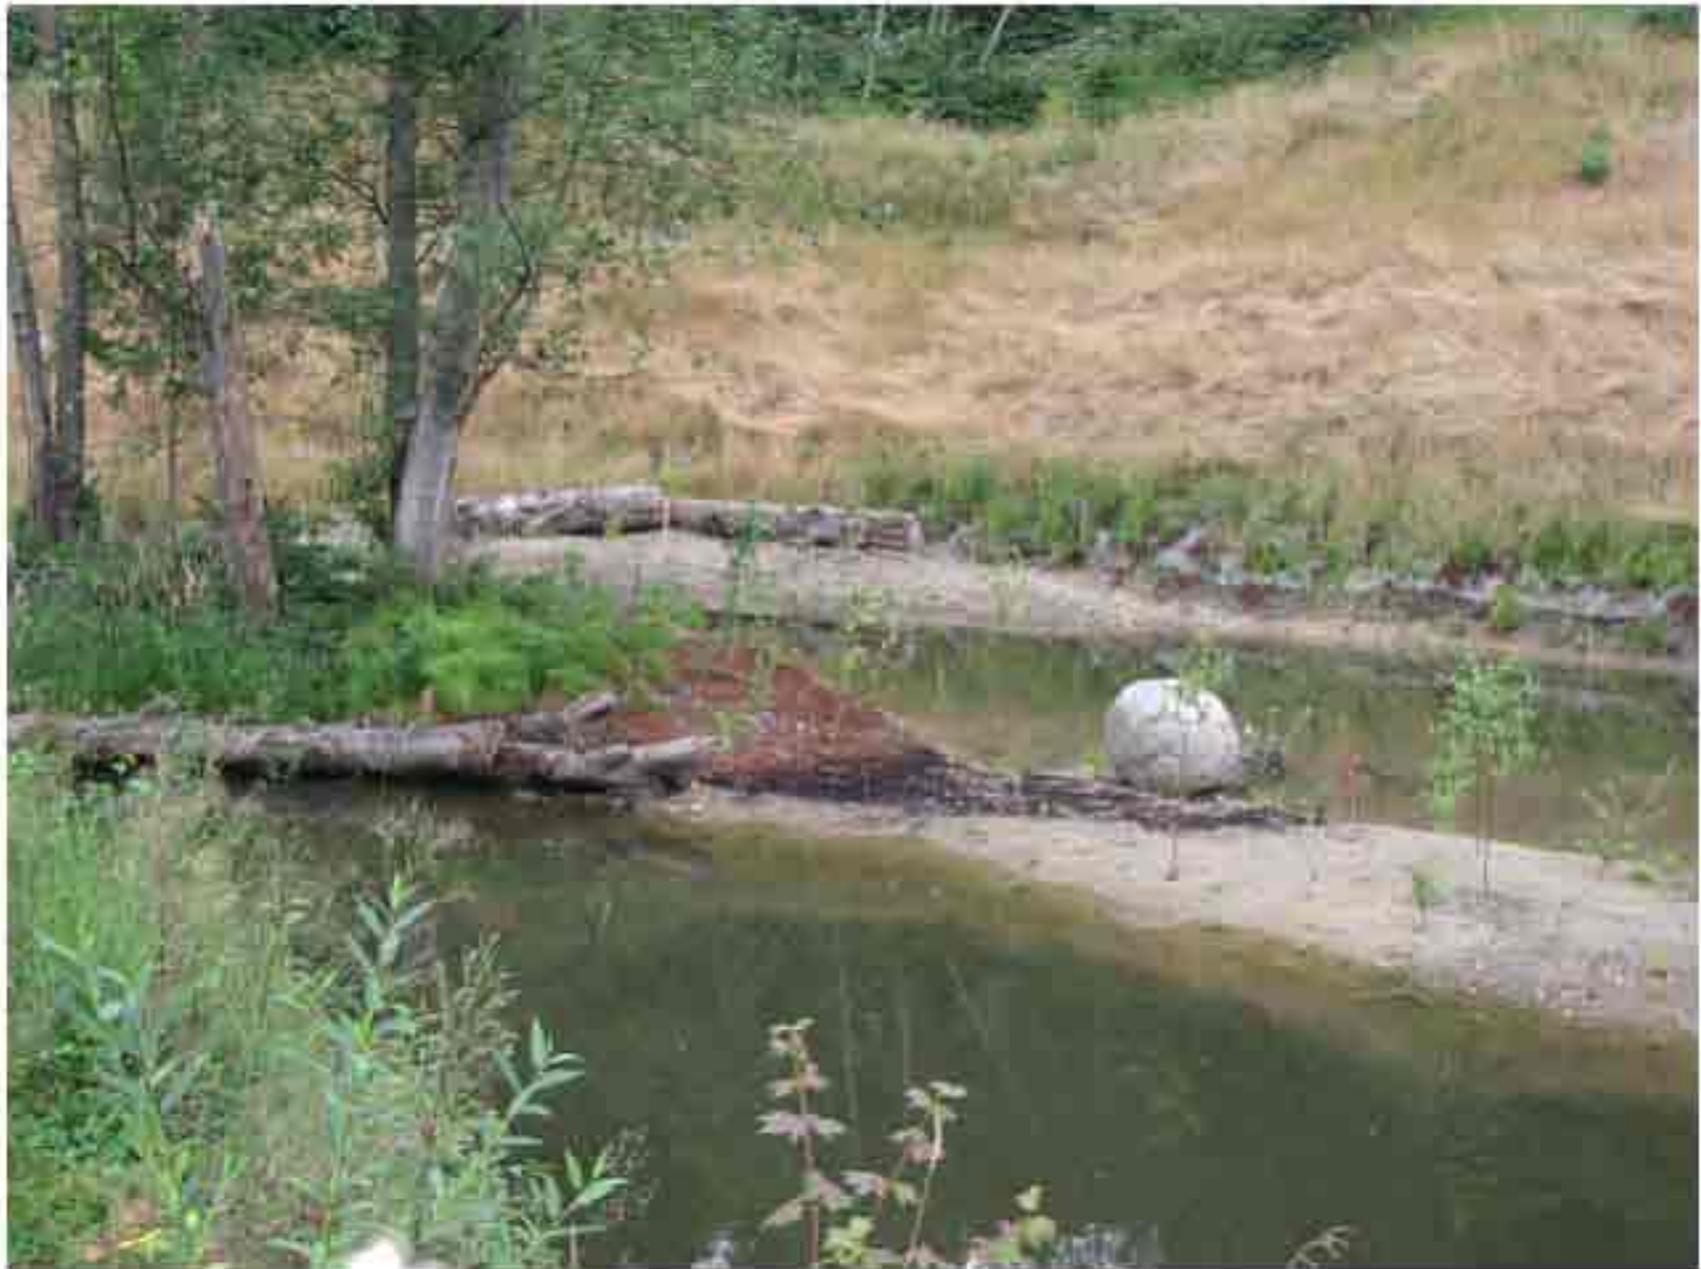
Hylebos Creek. Photo taken July 13, 2006 at 8:34 PM, tide at approximately 12.74 feet MLLW.
[IMG_0107]

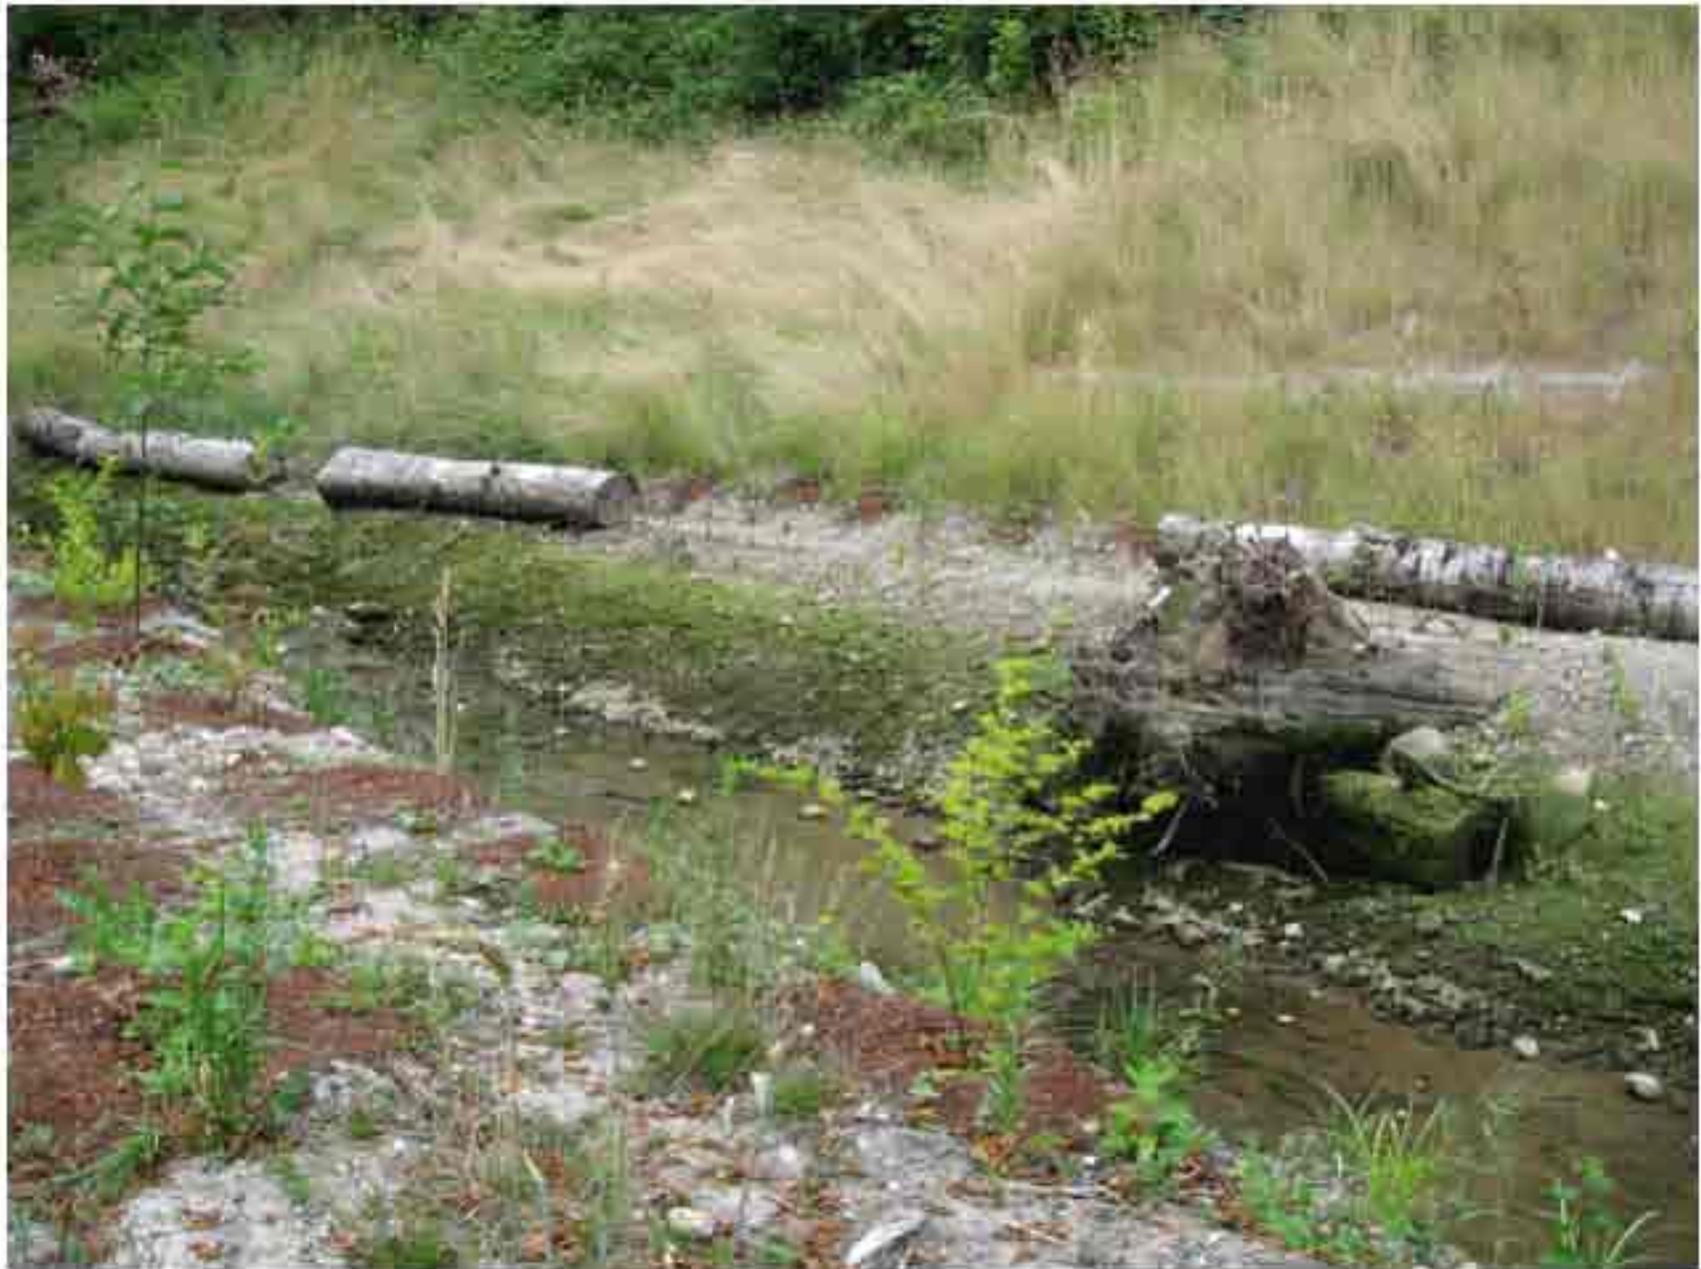
Hylebos Creek, Photo Point 5C, facing north. Photo taken July 11, 2006 at 2:41 PM, tide at approximately 2.65 feet MLLW.
[M G_0043]
