THEA FOSS AND WHEELER-OSGOOD WATERWAYS REMEDIATION PROJECT

YEAR 0 BASELINE MONITORING

HABITAT MITIGATION AREA MONITORING PRELIMINARY FINDINGS MEMORANDUM

NOVEMBER 30, 2006

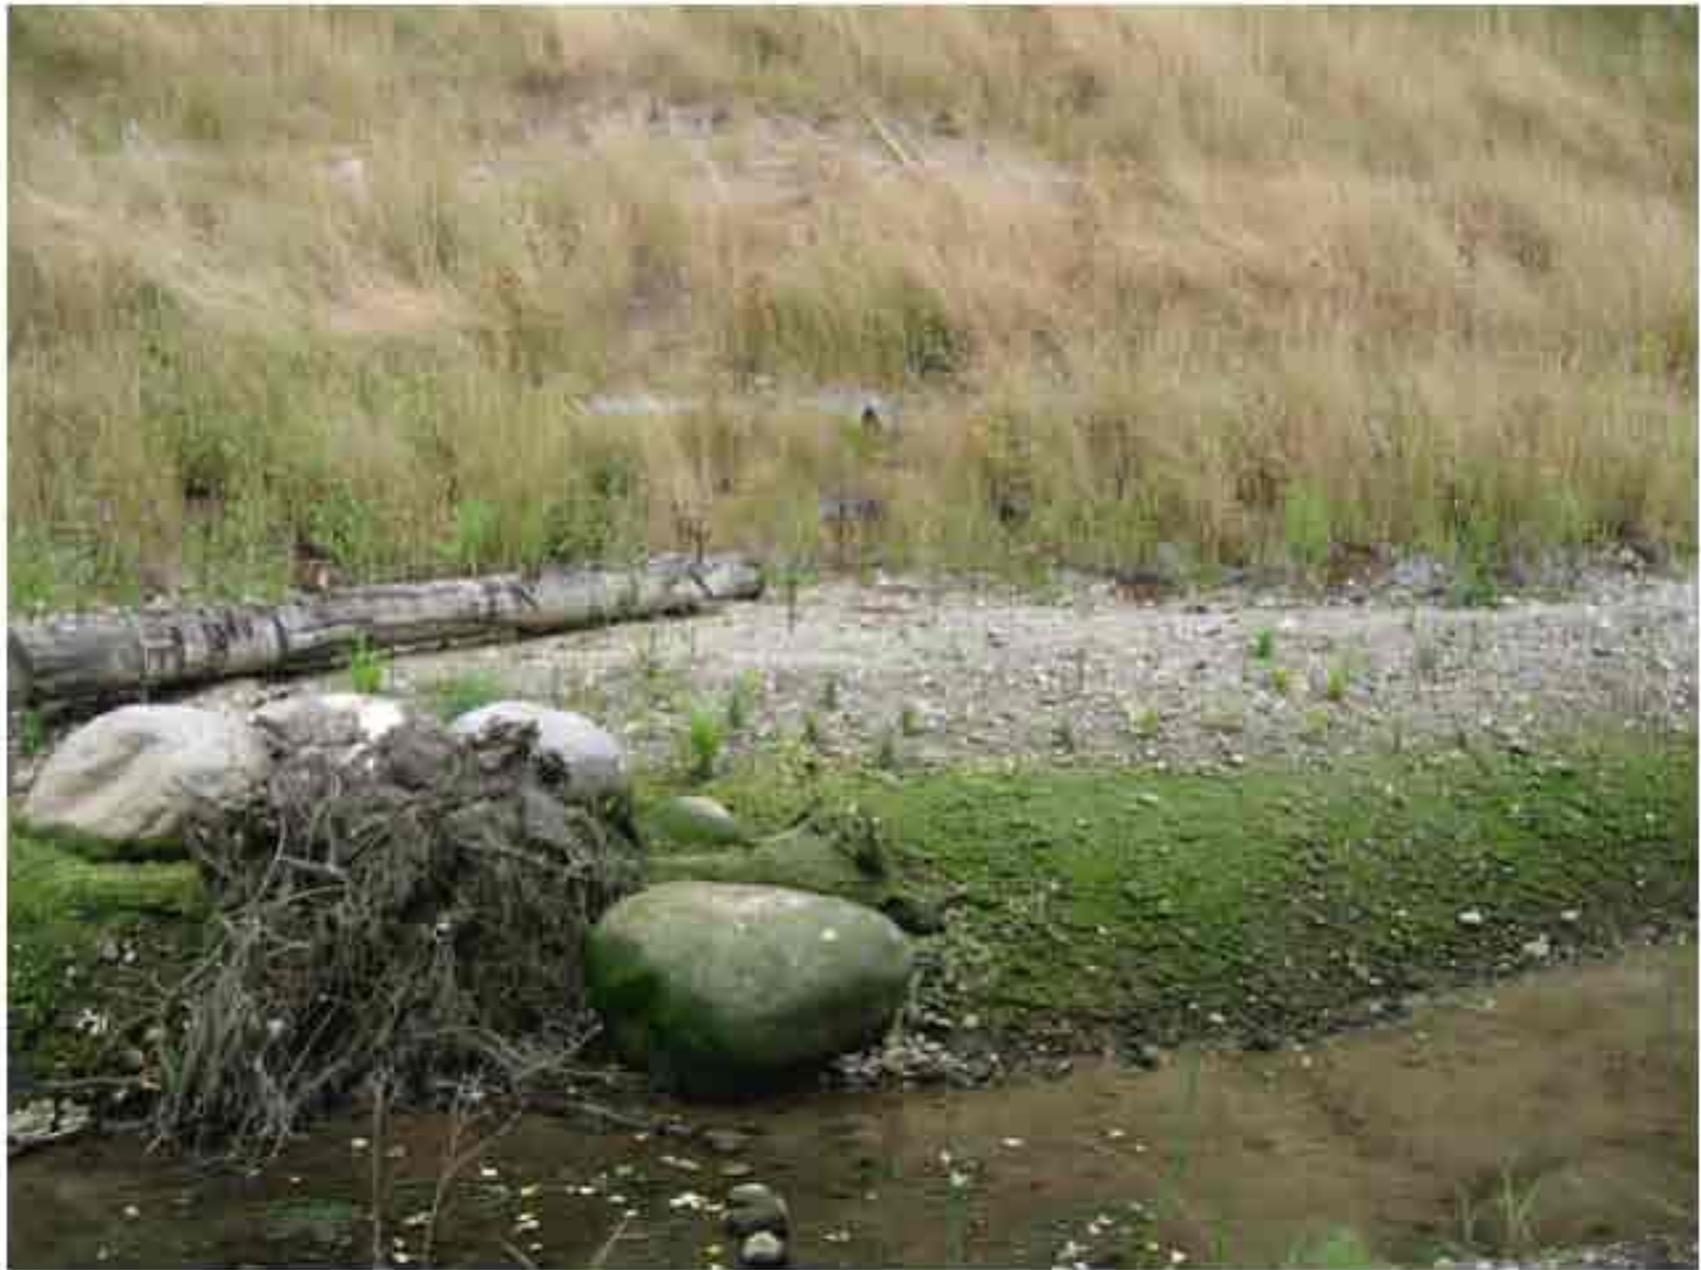
Hylebos Creek, Photo Point 5D, facing east. Photo taken July 11, 2006 at 2:41 PM, tide at approximately 2.65 feet MLLW. [IM G_0044]

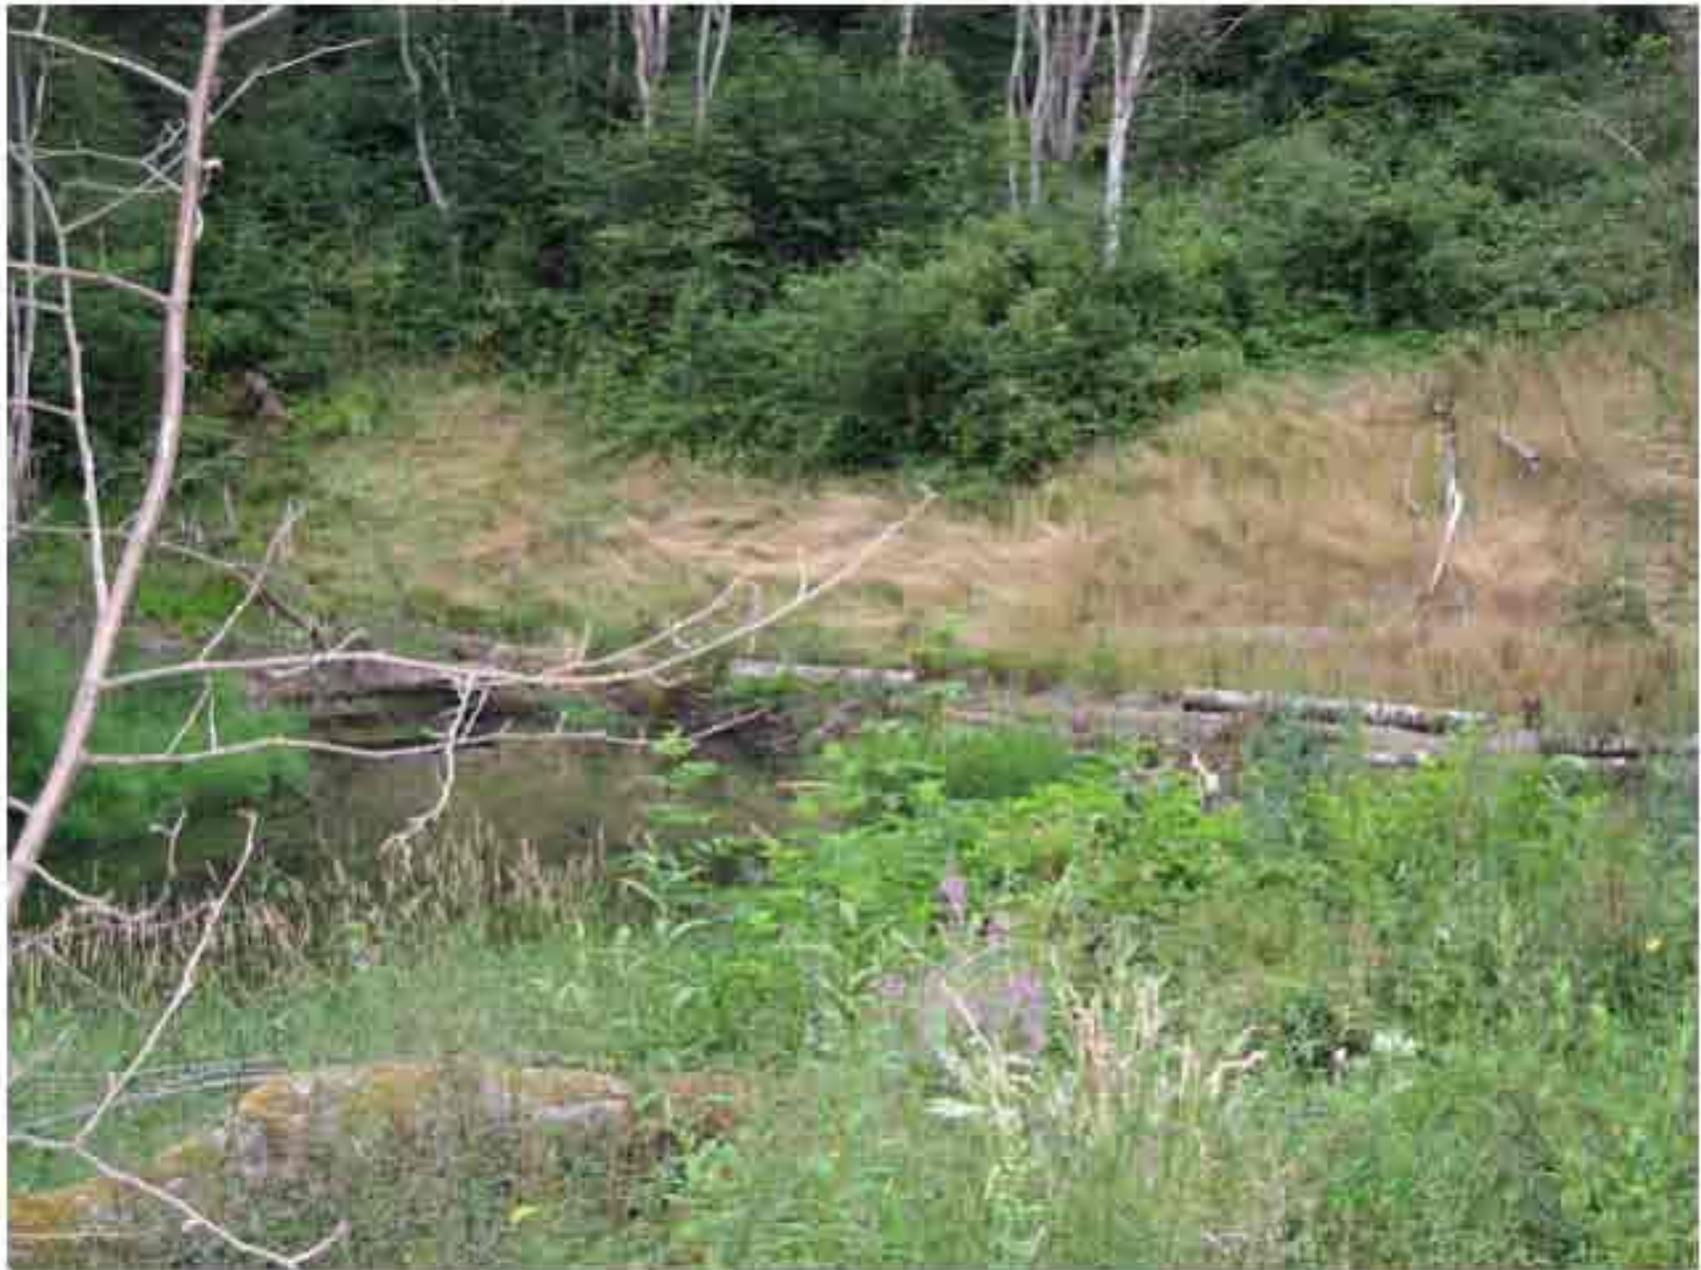
Hylebos Creek. Photo taken July 13, 2006 at 8:34 PM, tide at approximately 12.74 feet MLLW.
[M G_0106]

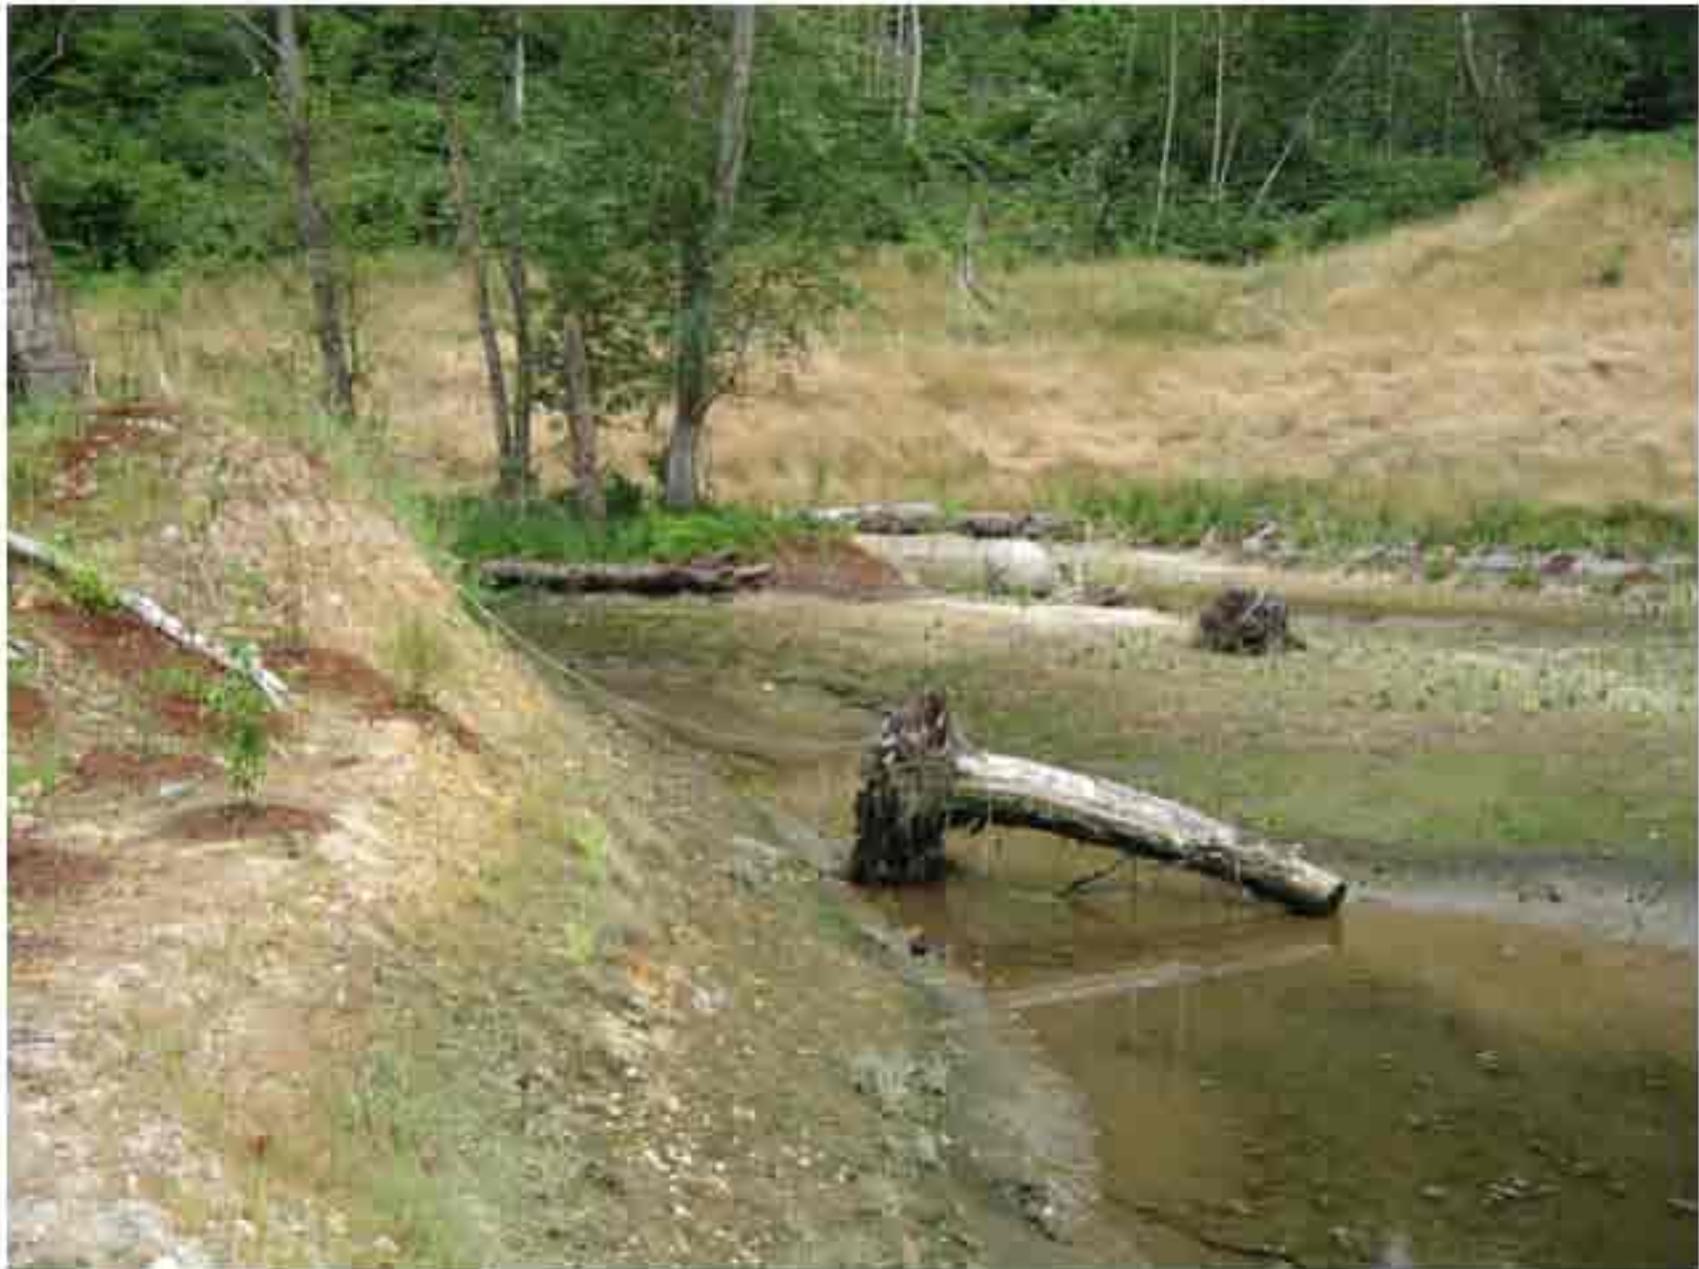
Hylebos Creek, Photo Point 6A, facing north. Photo taken July 11, 2006 at 2:06 P.M., tide at approximately 0.77 feet MLLW.
[IM G_0031]

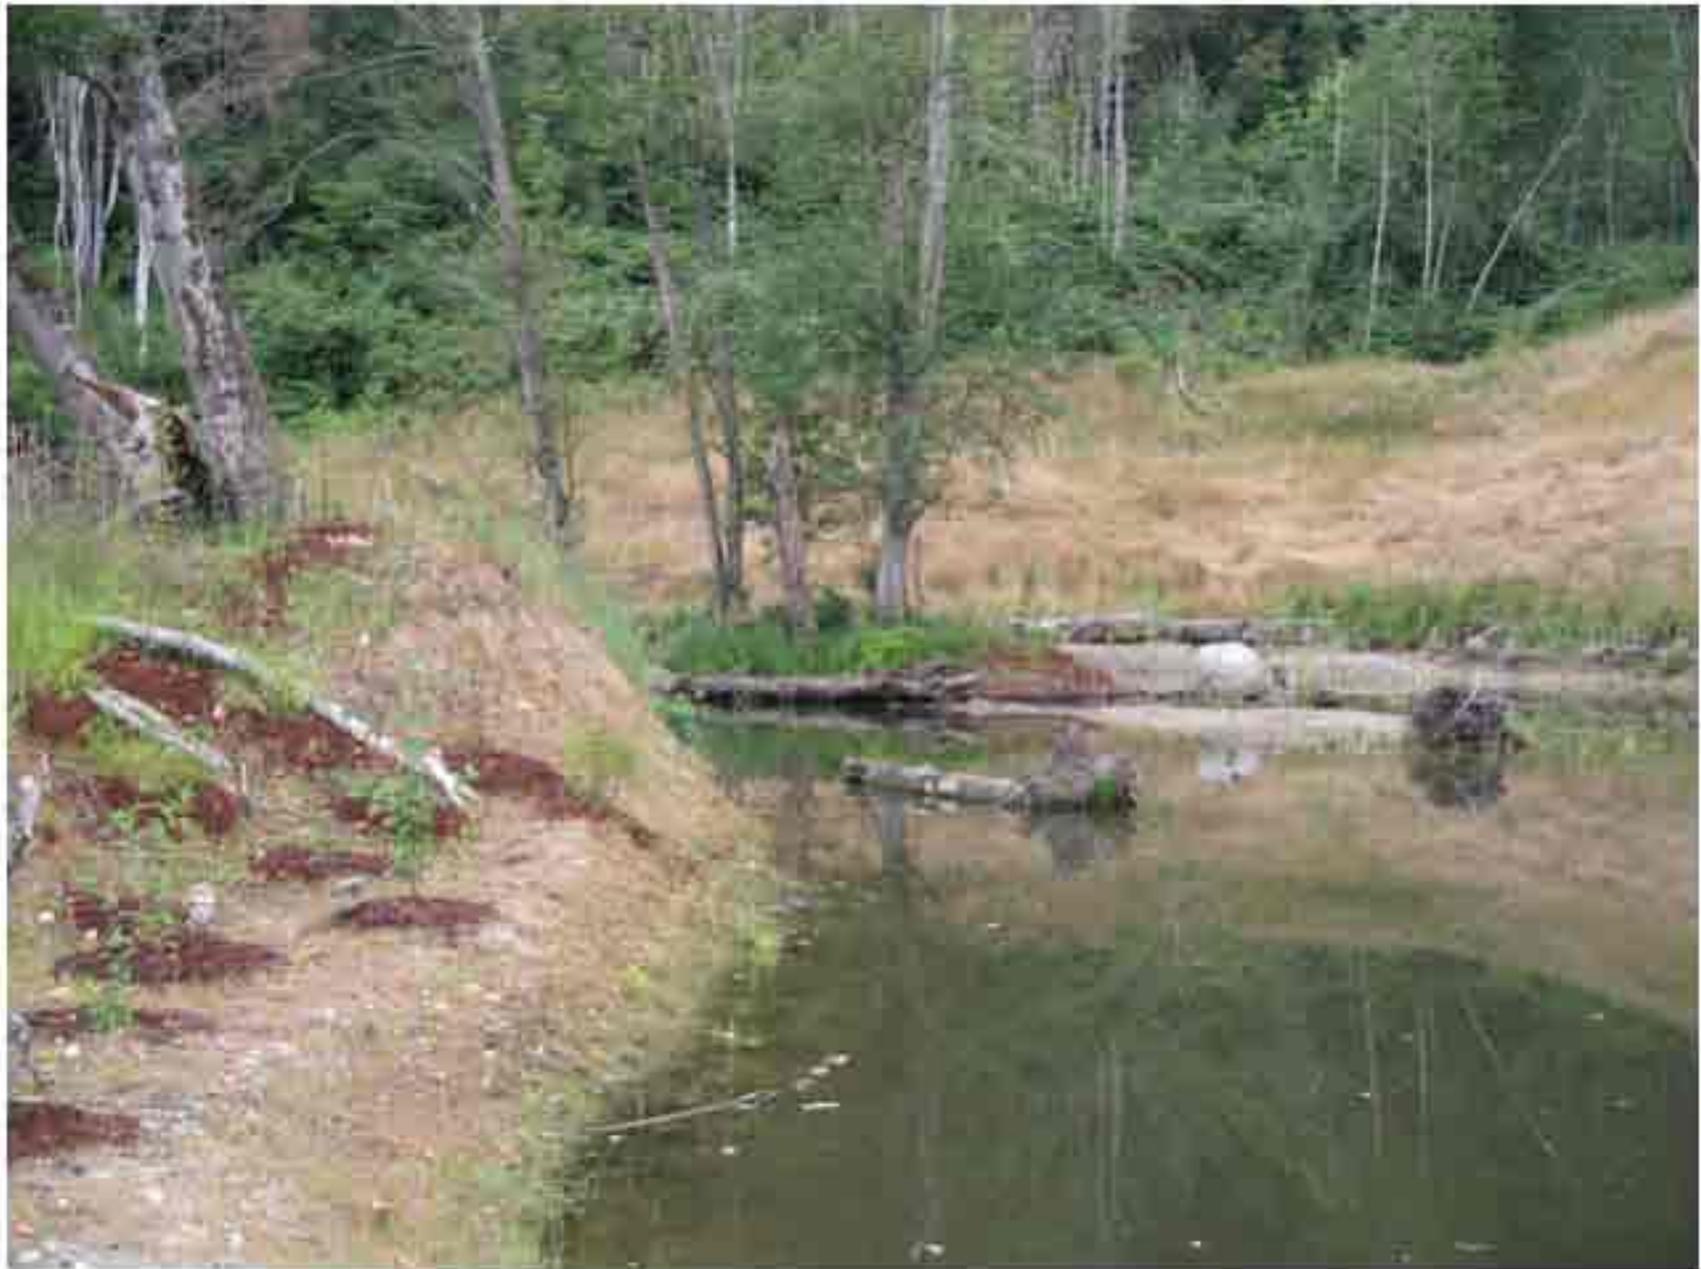
Hylebos Creek, Photo Point 6A, facing north. Photo taken July 13, 2006 at 8:35 P.M., tide at approximately 12.74 feet MLLW. [IM G_0108]

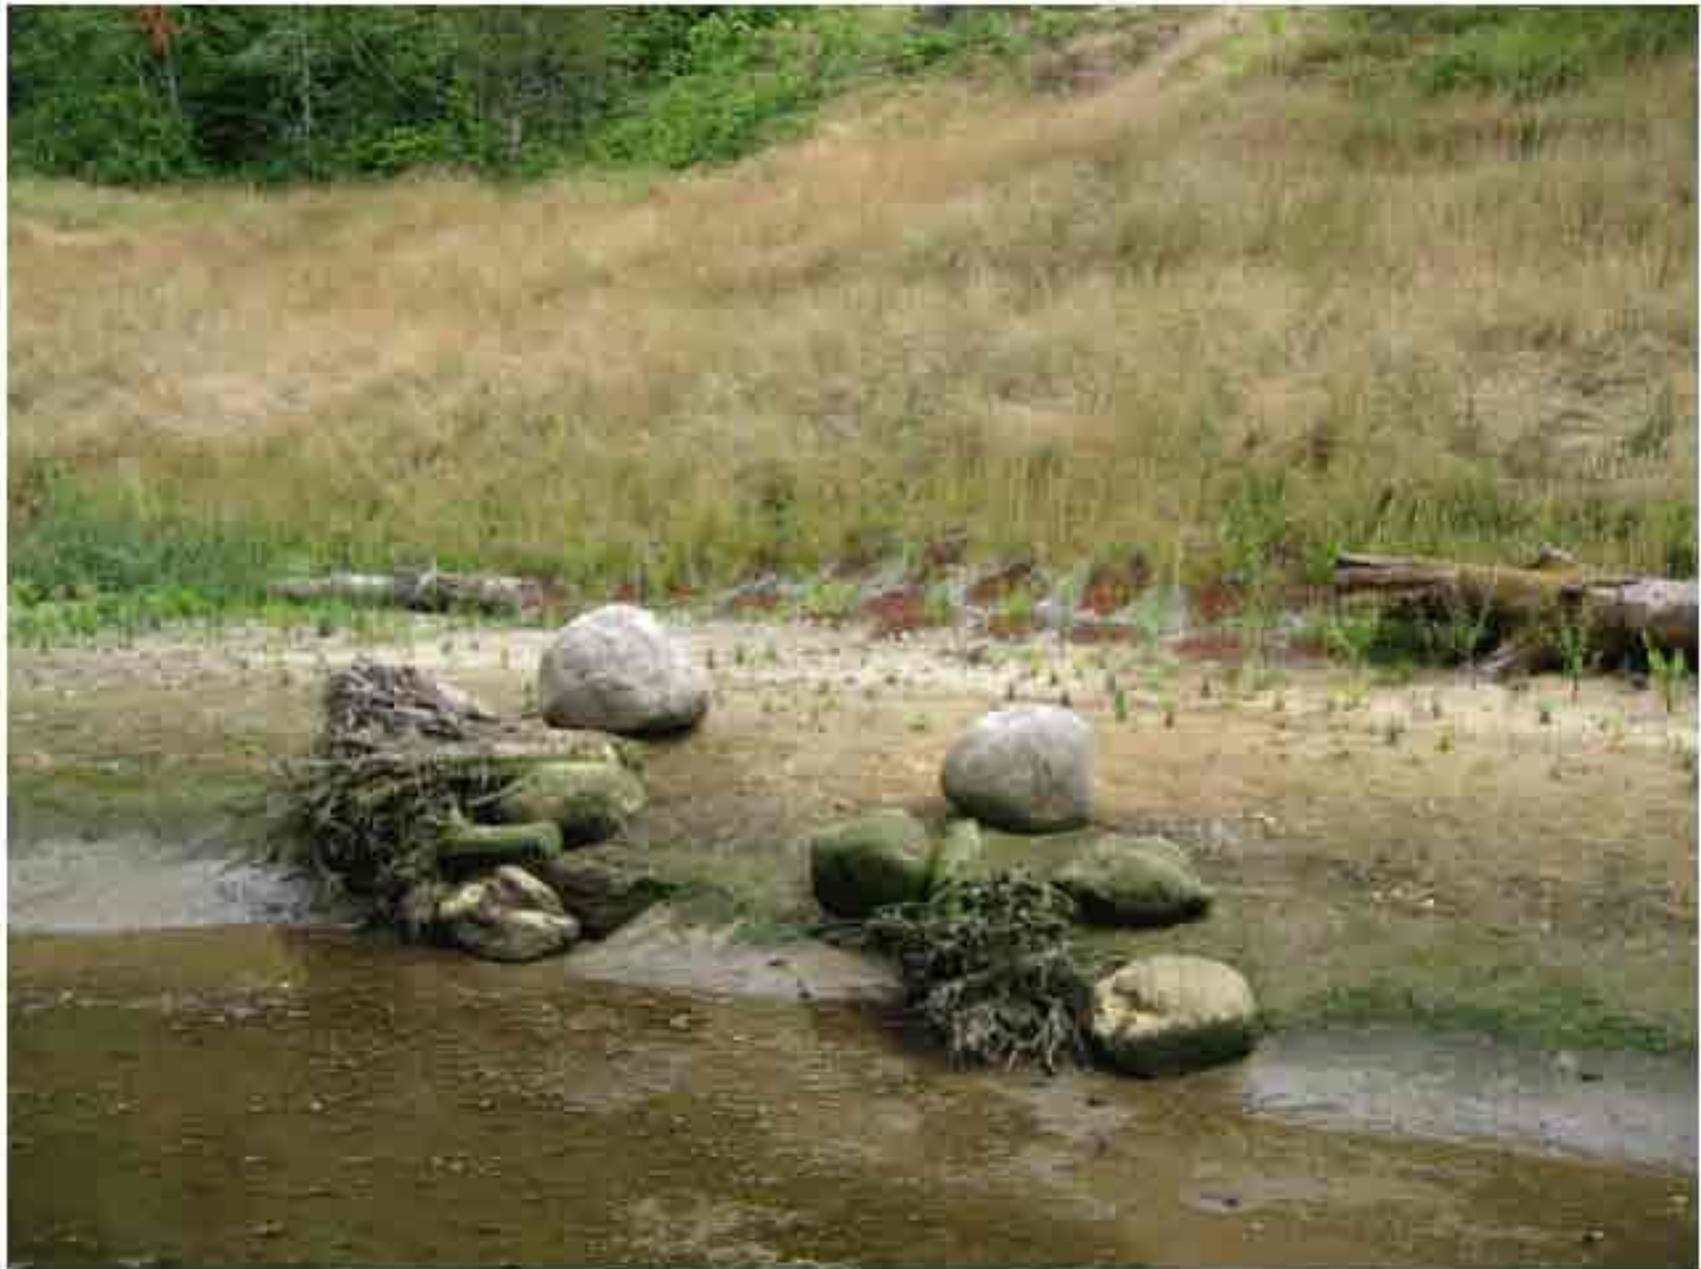
Hylebos Creek, Photo Point 6B, facing northeast. Photo taken July 11, 2006 at 2:06 PM, tide at approximately 0.77 feet MLLW. [IM G_0032]

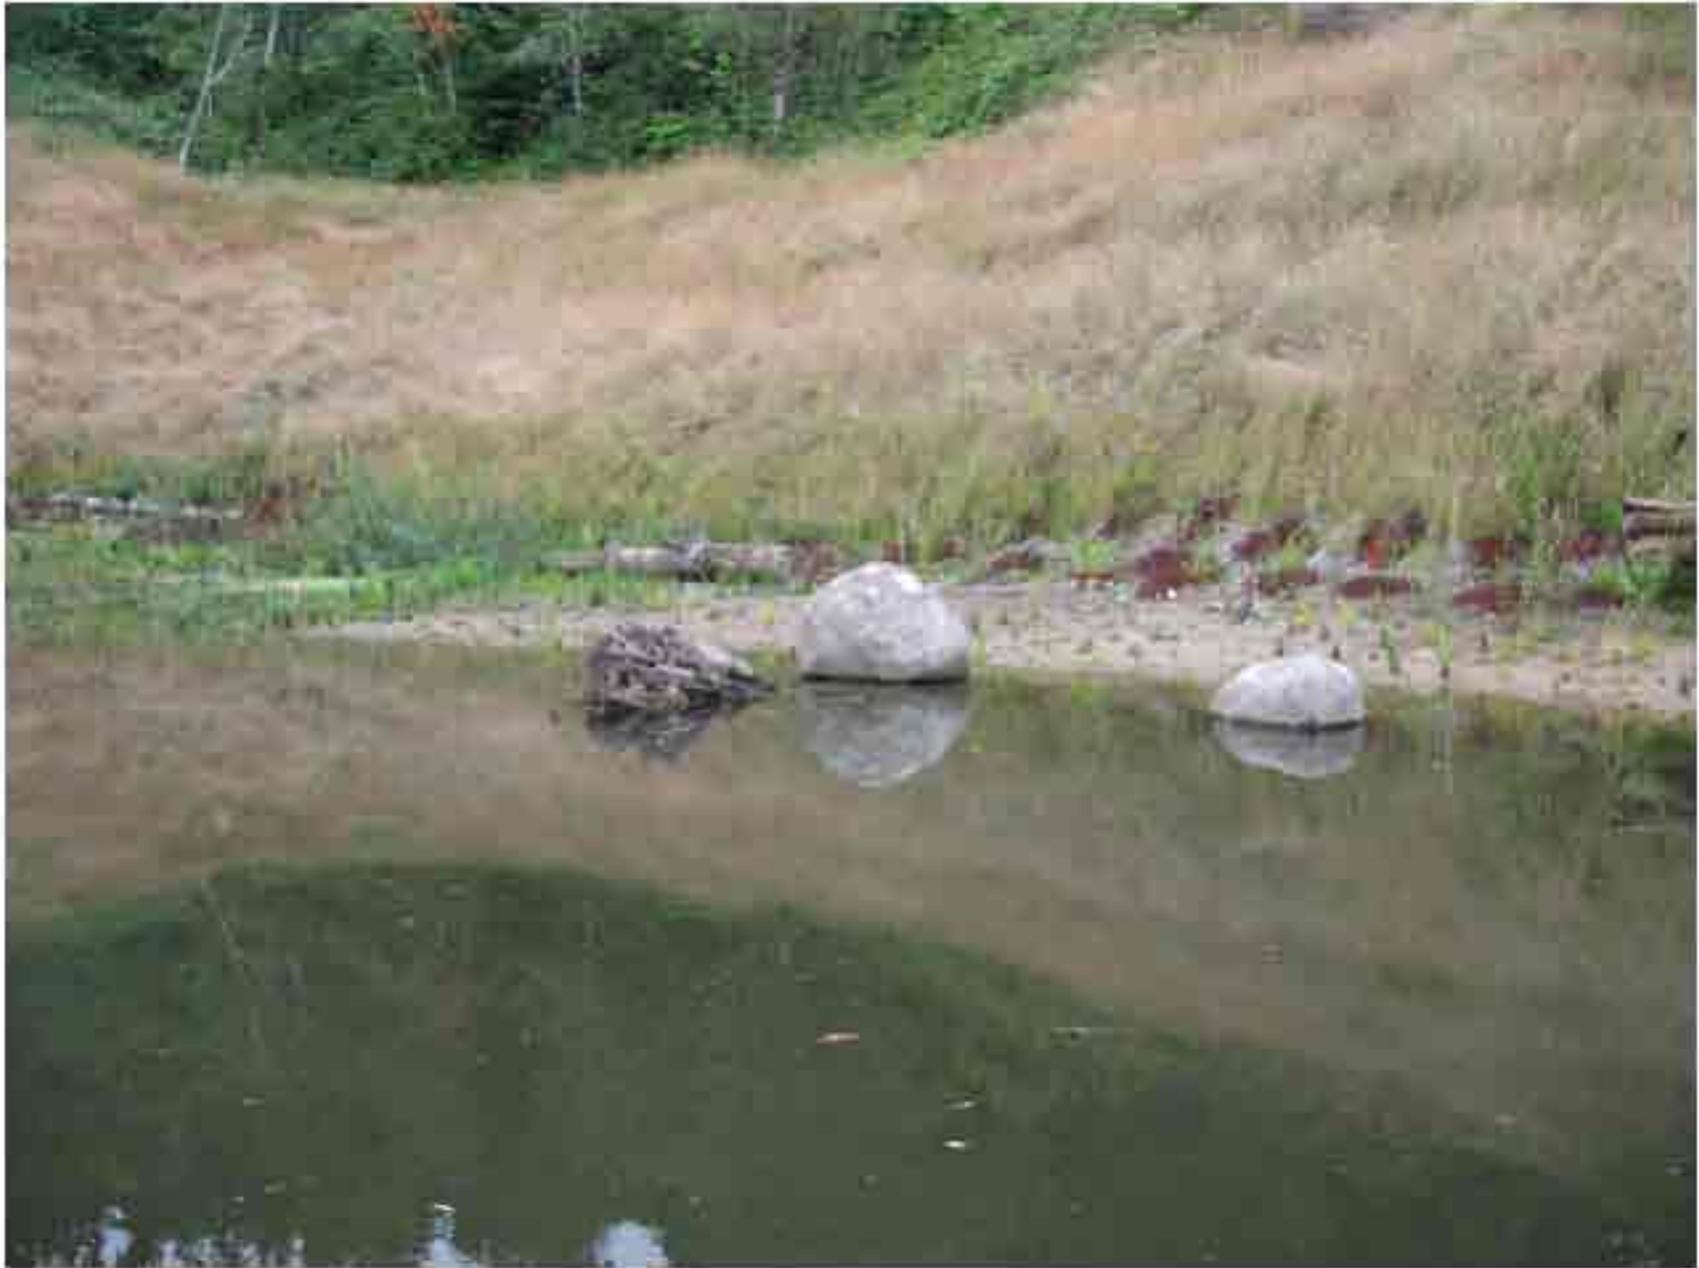
Hylebos Creek, Photo Point 6B, facing northeast. Photo taken July 13, 2006 at 8:35 PM, tide at approximately 12.74 feet MLLW. [M G_0109]

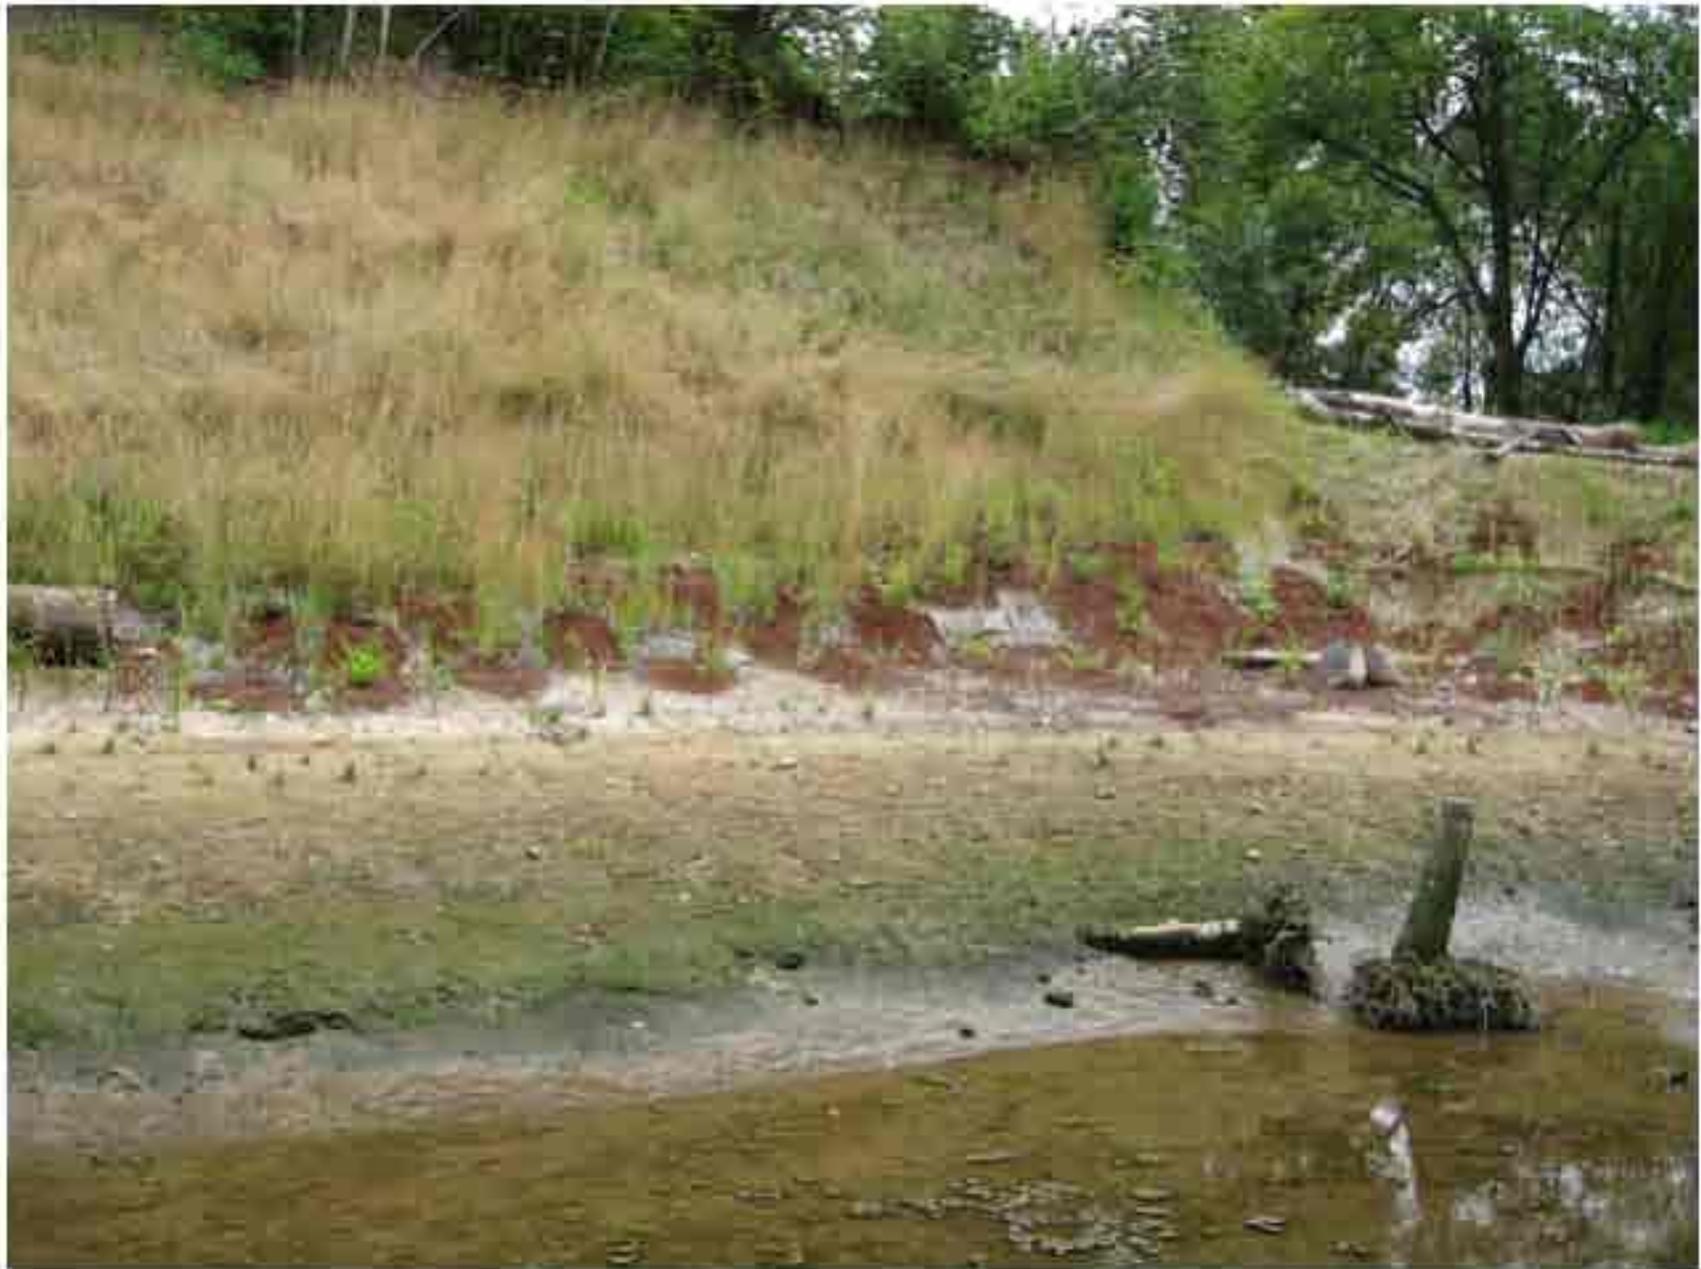
Hylebos Creek, Photo Point 6C, facing southeast. Photo taken July 11, 2006 at 2:06 PM, tide at approximately 0.77 feet MLLW. [IM G_0033]

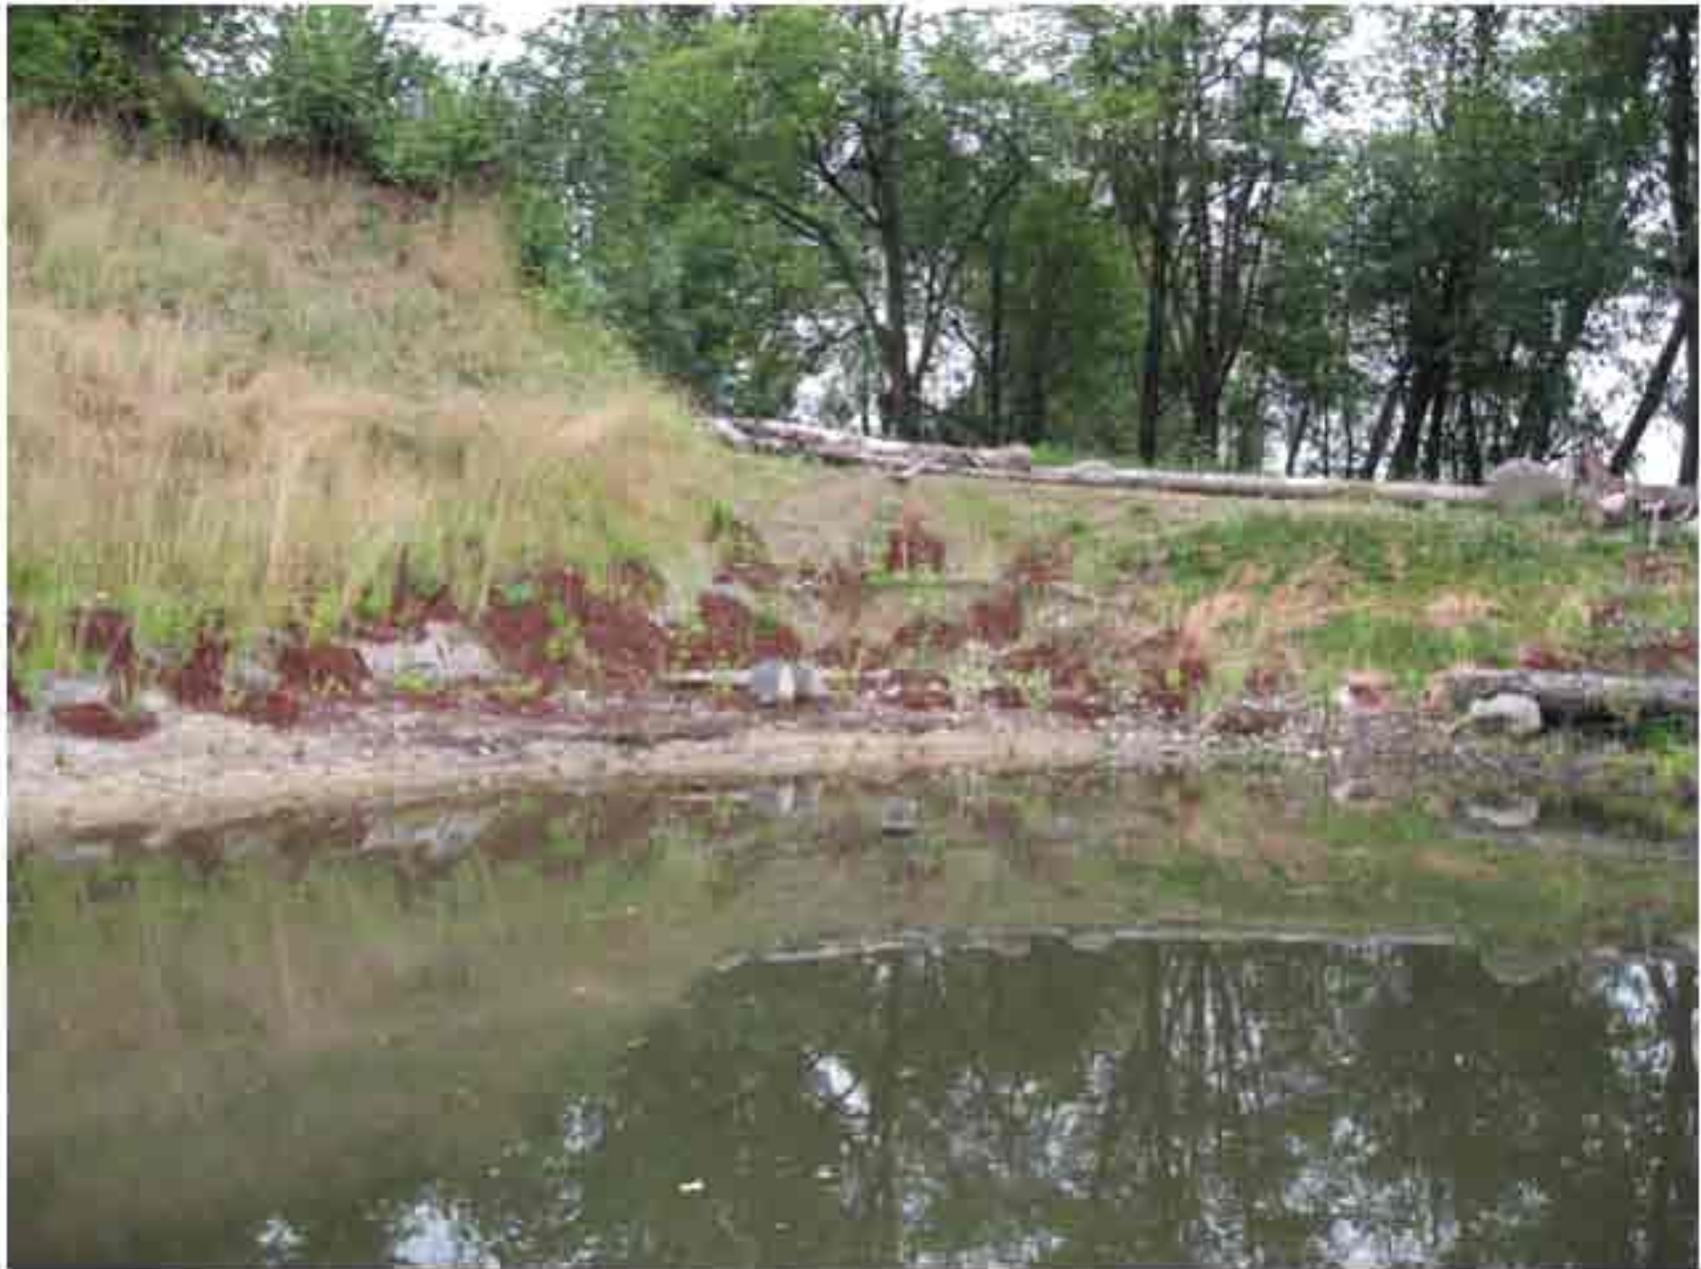
Hylebos Creek, Photo Point 6C, facing southeast. Photo taken July 13, 2006 at 8:35 PM, tide at approximately 12.74 feet MLLW. [IMG_0110]

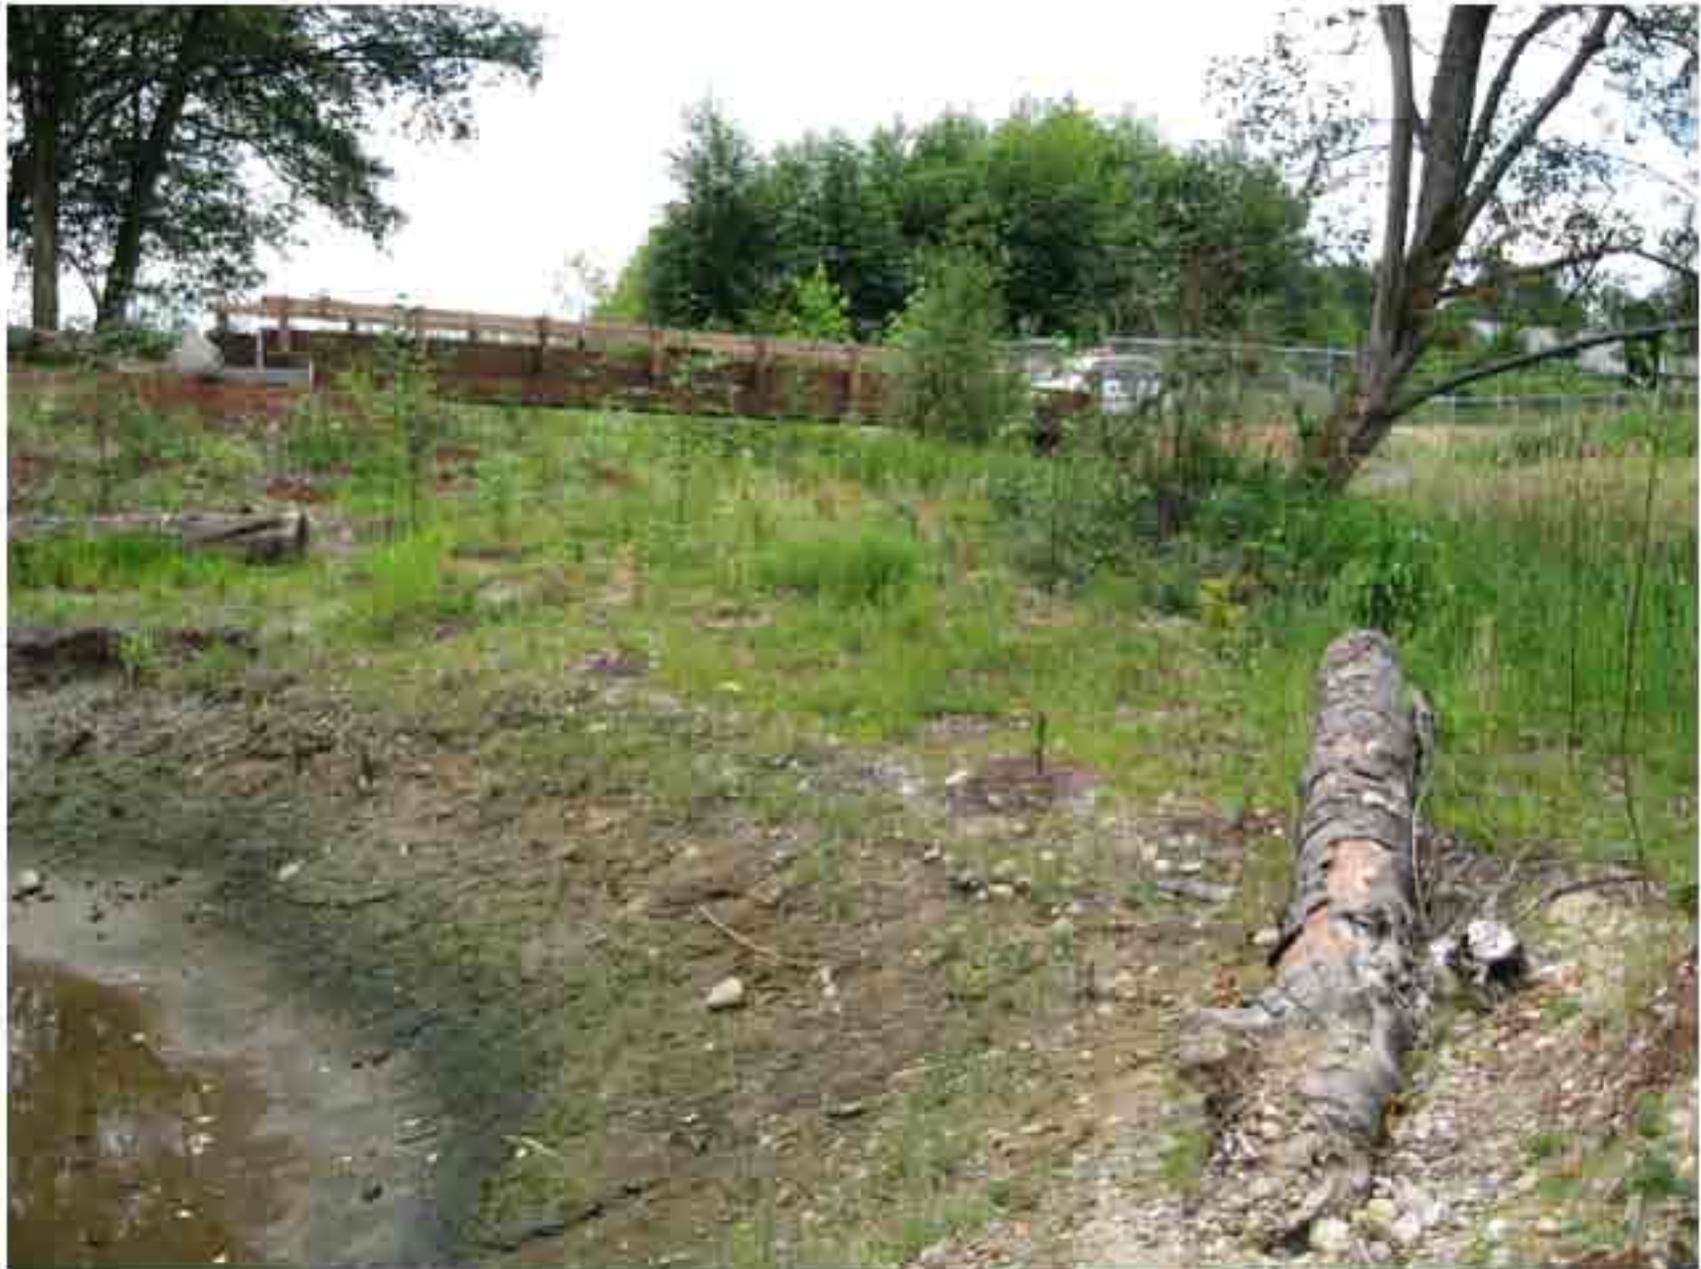
Hylebos Creek, Photo Point 6D, facing south. Photo taken July 11, 2006 at 2:06 PM, tide at approximately 0.77 feet MLLW. [IM G_0034]

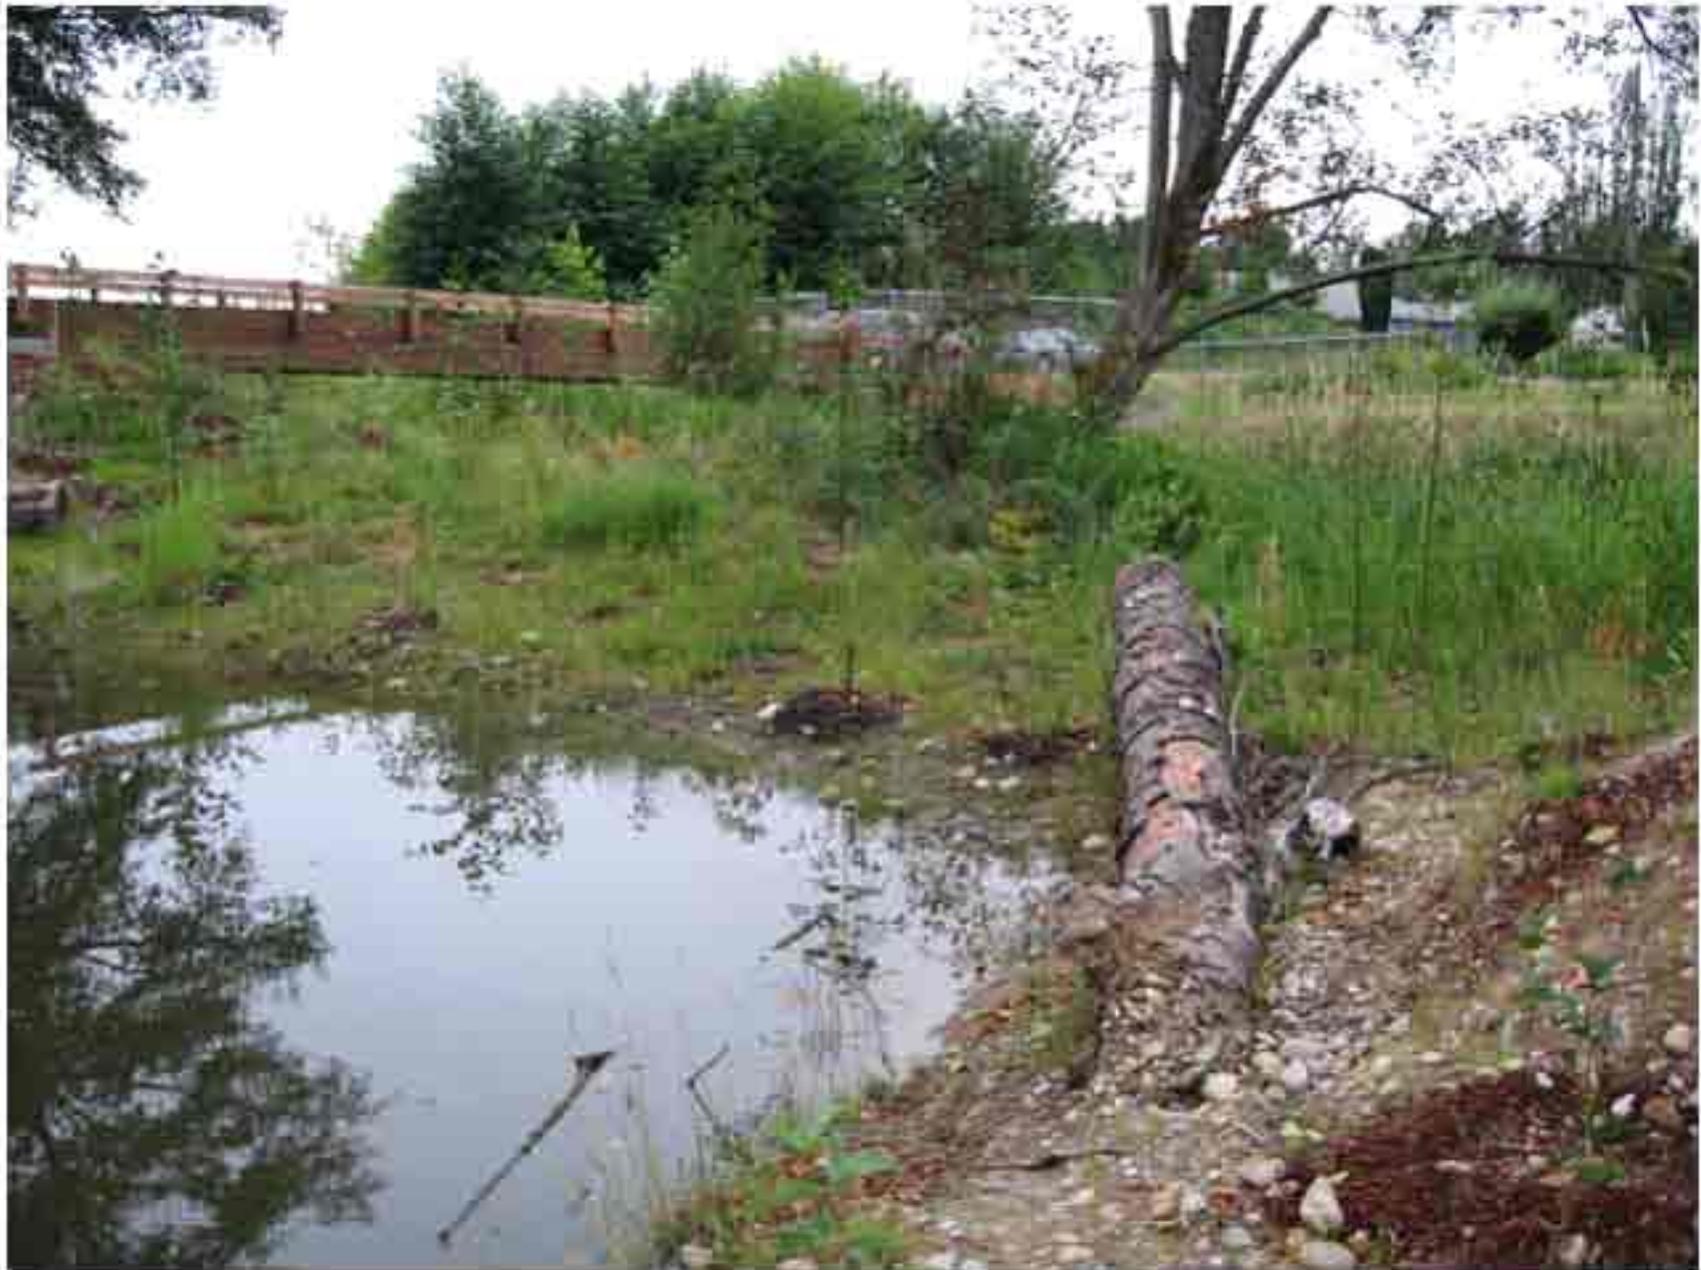
Hylebos Creek, Photo Point 6D, facing south. Photo taken July 13, 2006 at 8:35 PM, tide at approximately 12.74 feet MLLW. [IM G_0111]
