THEA FOSS AND WHEELER-OSGOOD WATERWAYS REMEDIATION PROJECT

YEAR 0 BASELINE MONITORING

HABITAT MITIGATION AREA MONITORING PRELIMINARY FINDINGS MEMORANDUM

NOVEMBER 30, 2006

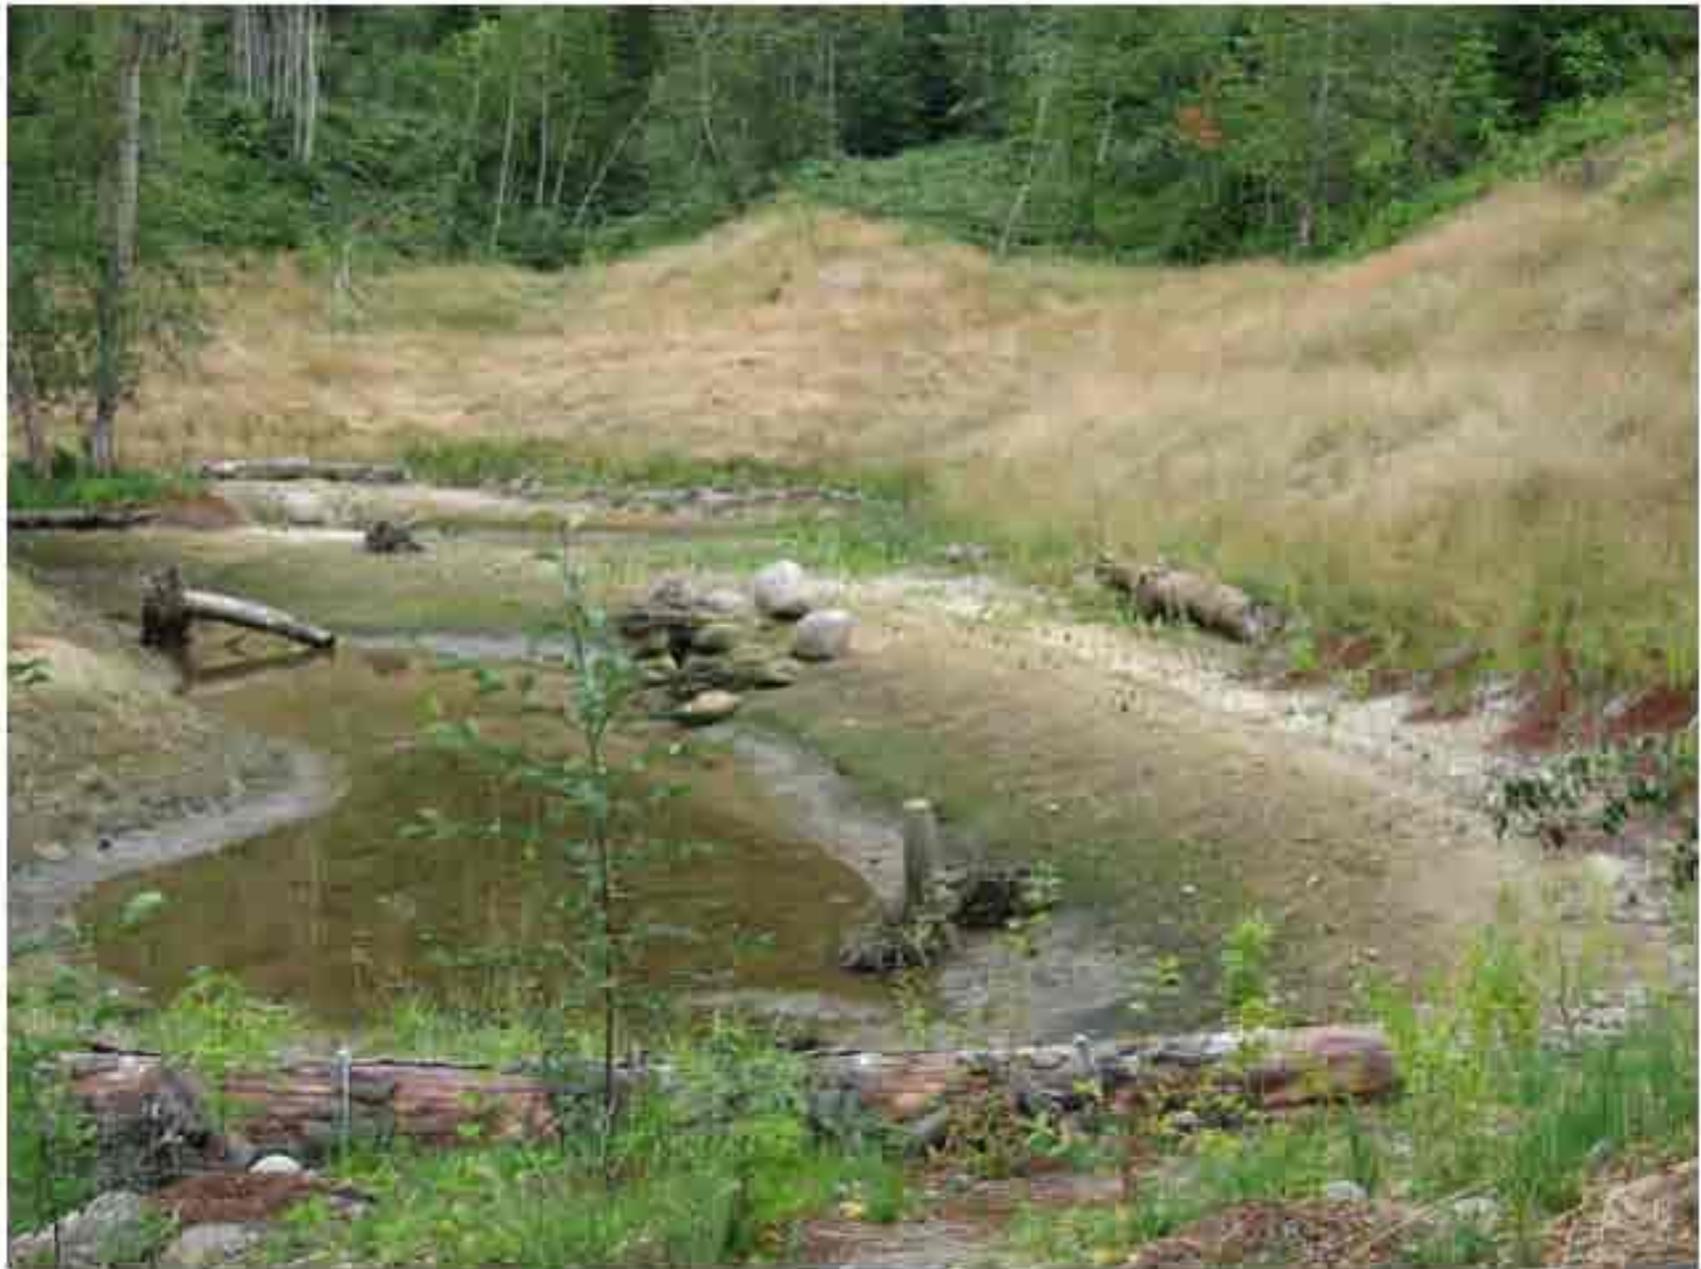
Hylebos Creek, Photo Point 7A, facing northeast. Photo taken July 11, 2006 at 2:02 PM, tide at approximately 0.58 feet MLLW. [IM G_0029]

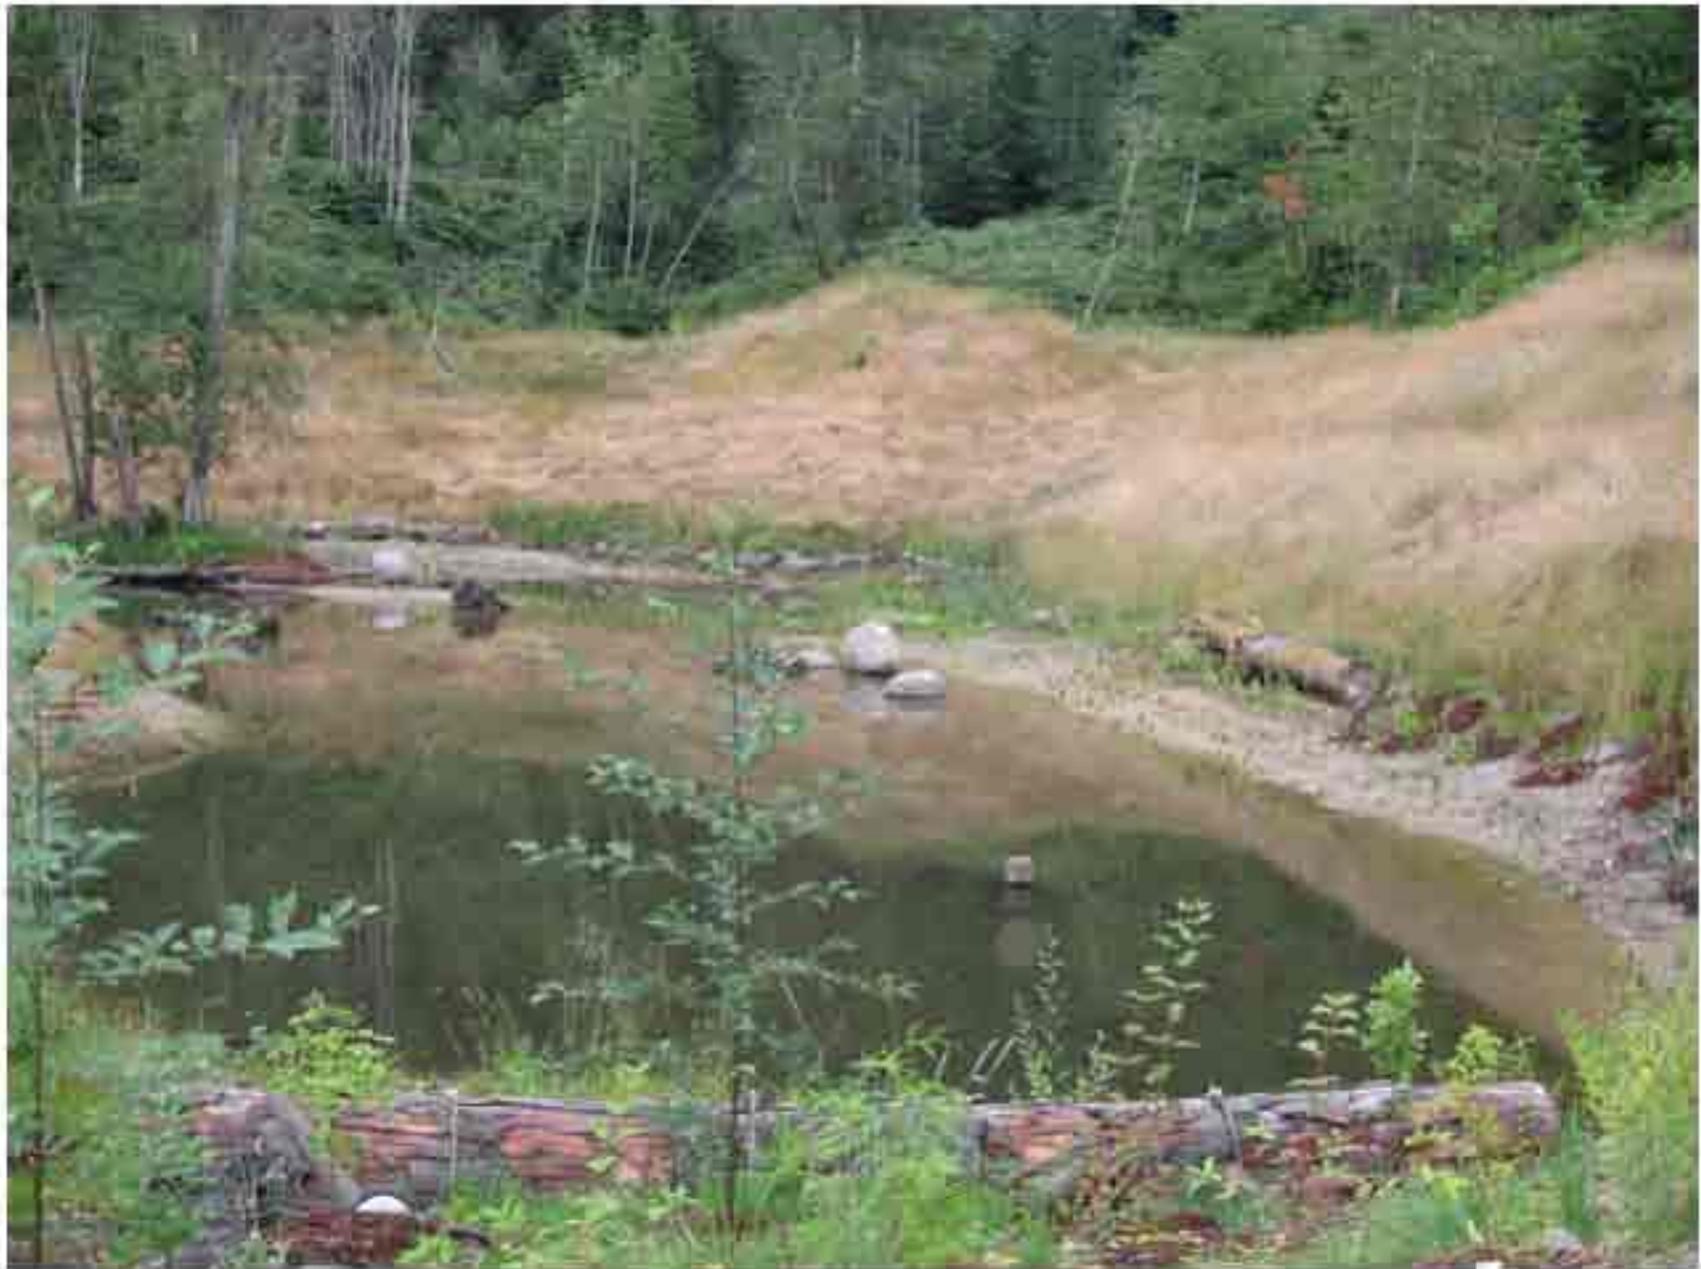
Hylebos Creek, Photo Point 7A, facing northeast. Photo taken July 13, 2006 at 8:36 PM, tide at approximately 12.74 feet MLLW. [IM G_0112]

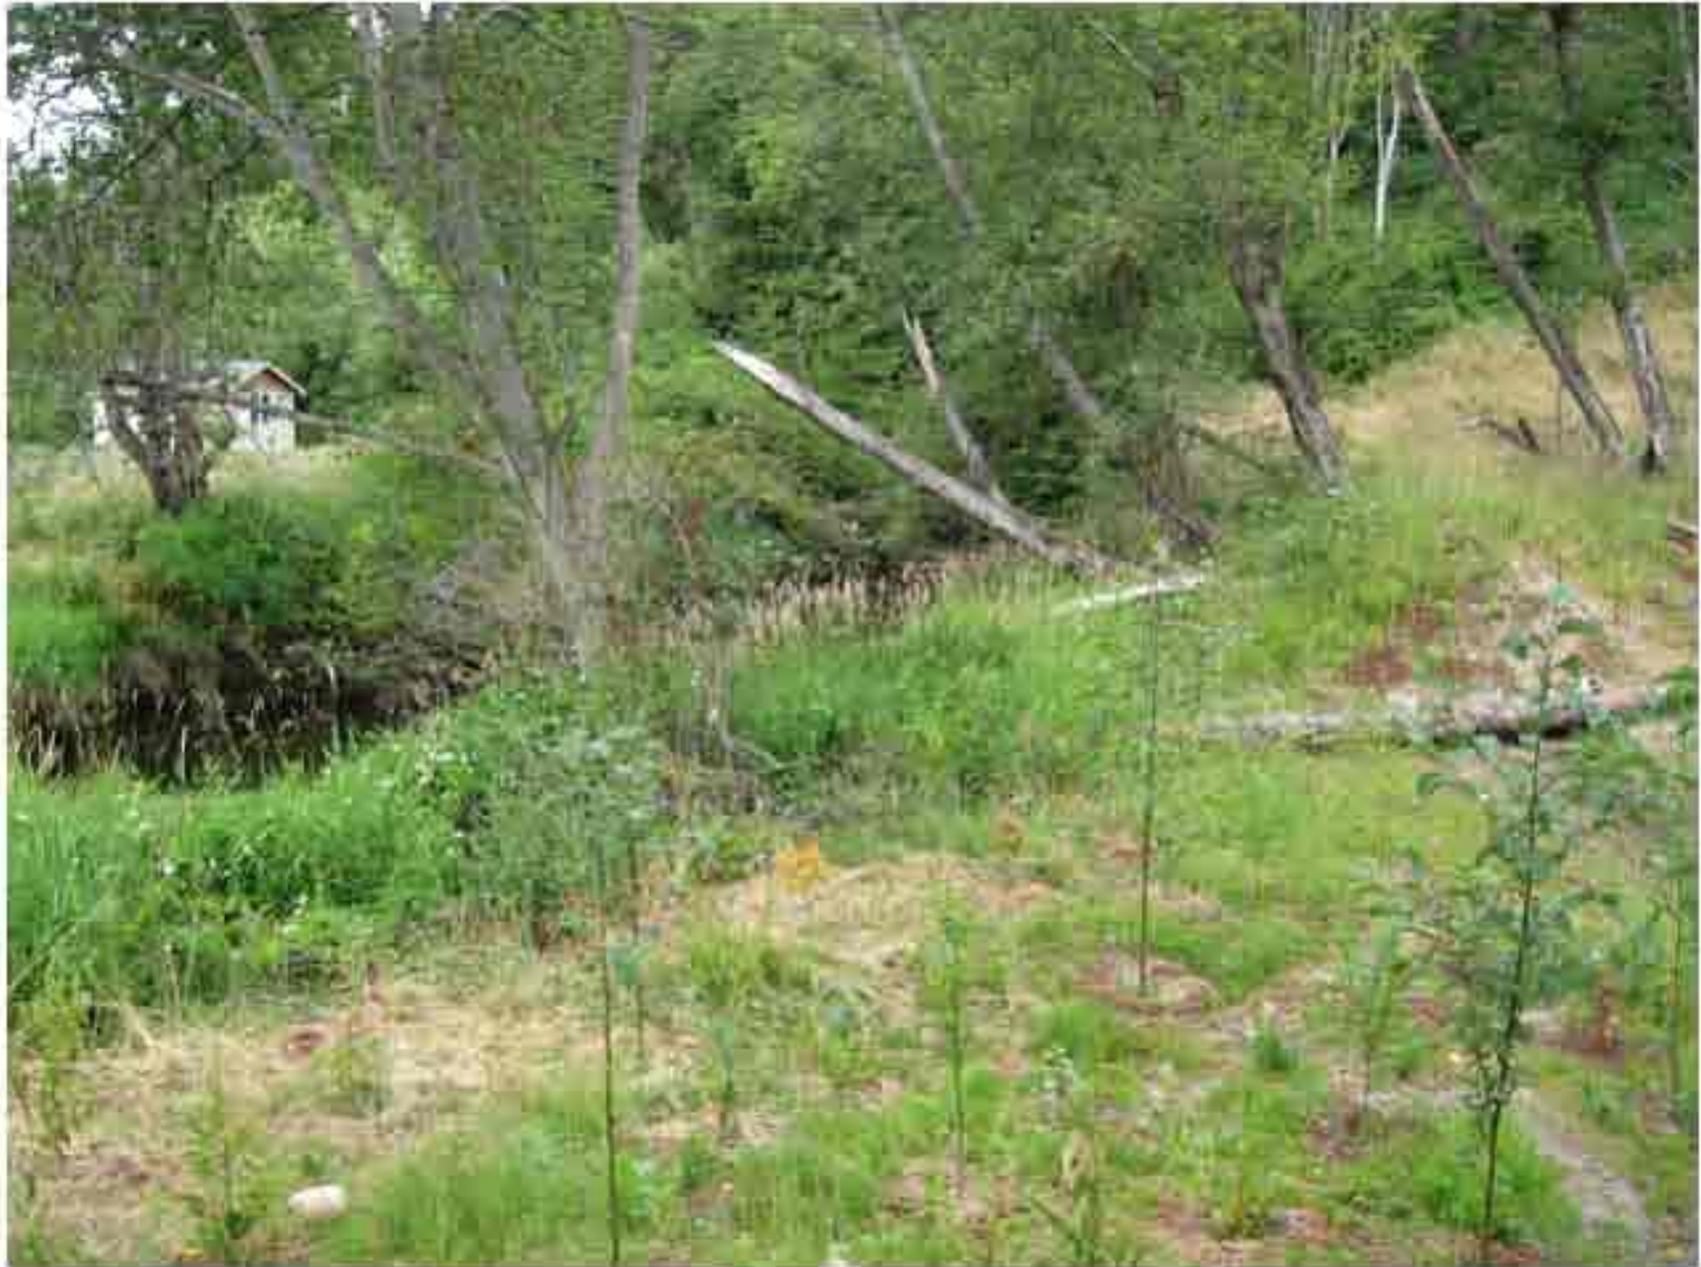
Hylebos Creek, Photo Point 7B, facing north. Photo taken July 11, 2006 at 2:02 P.M., tide at approximately 0.58 feet MLLW.
[M G_0030]

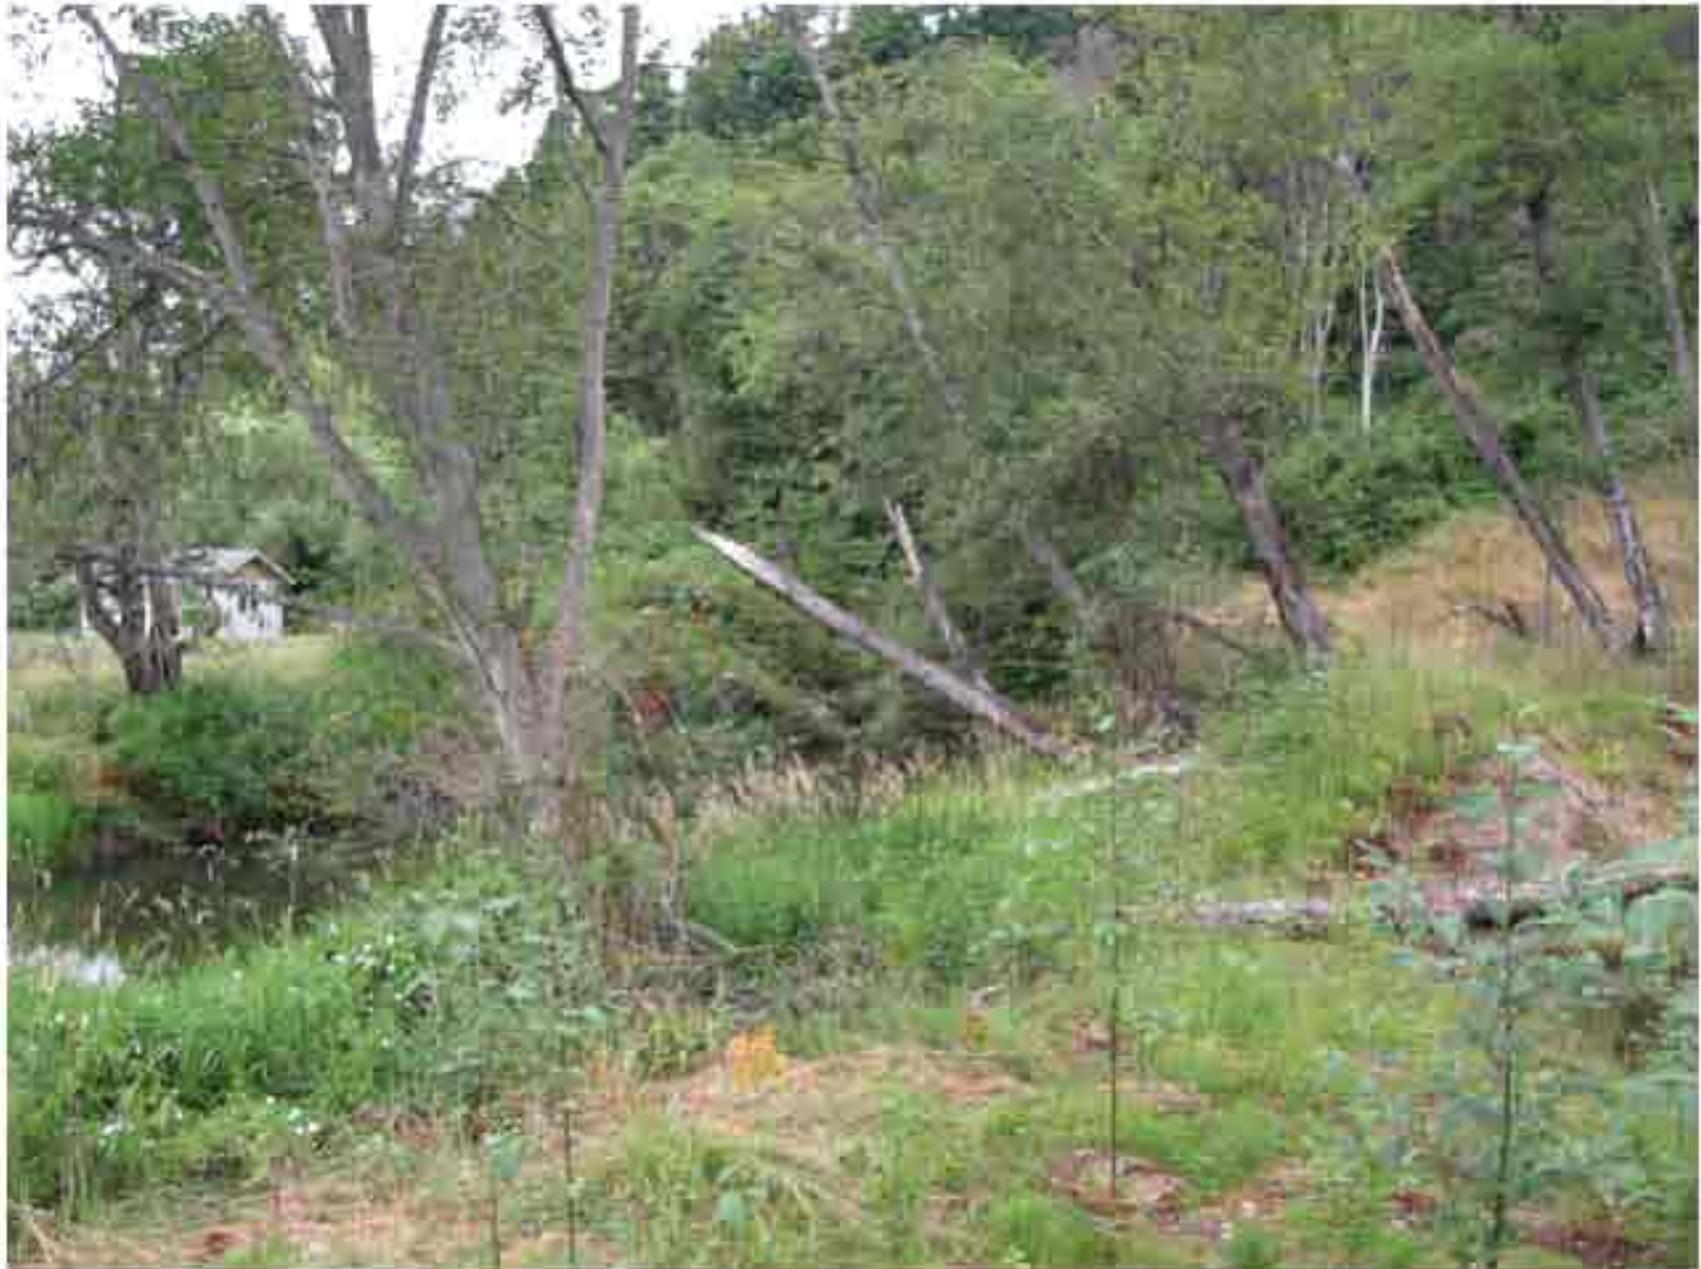
Hylebos Creek, Photo Point 7B, facing north. Photo taken July 13, 2006 at 8:36 P.M., tide at approximately 12.74 feet MLLW.
[M G_0113]

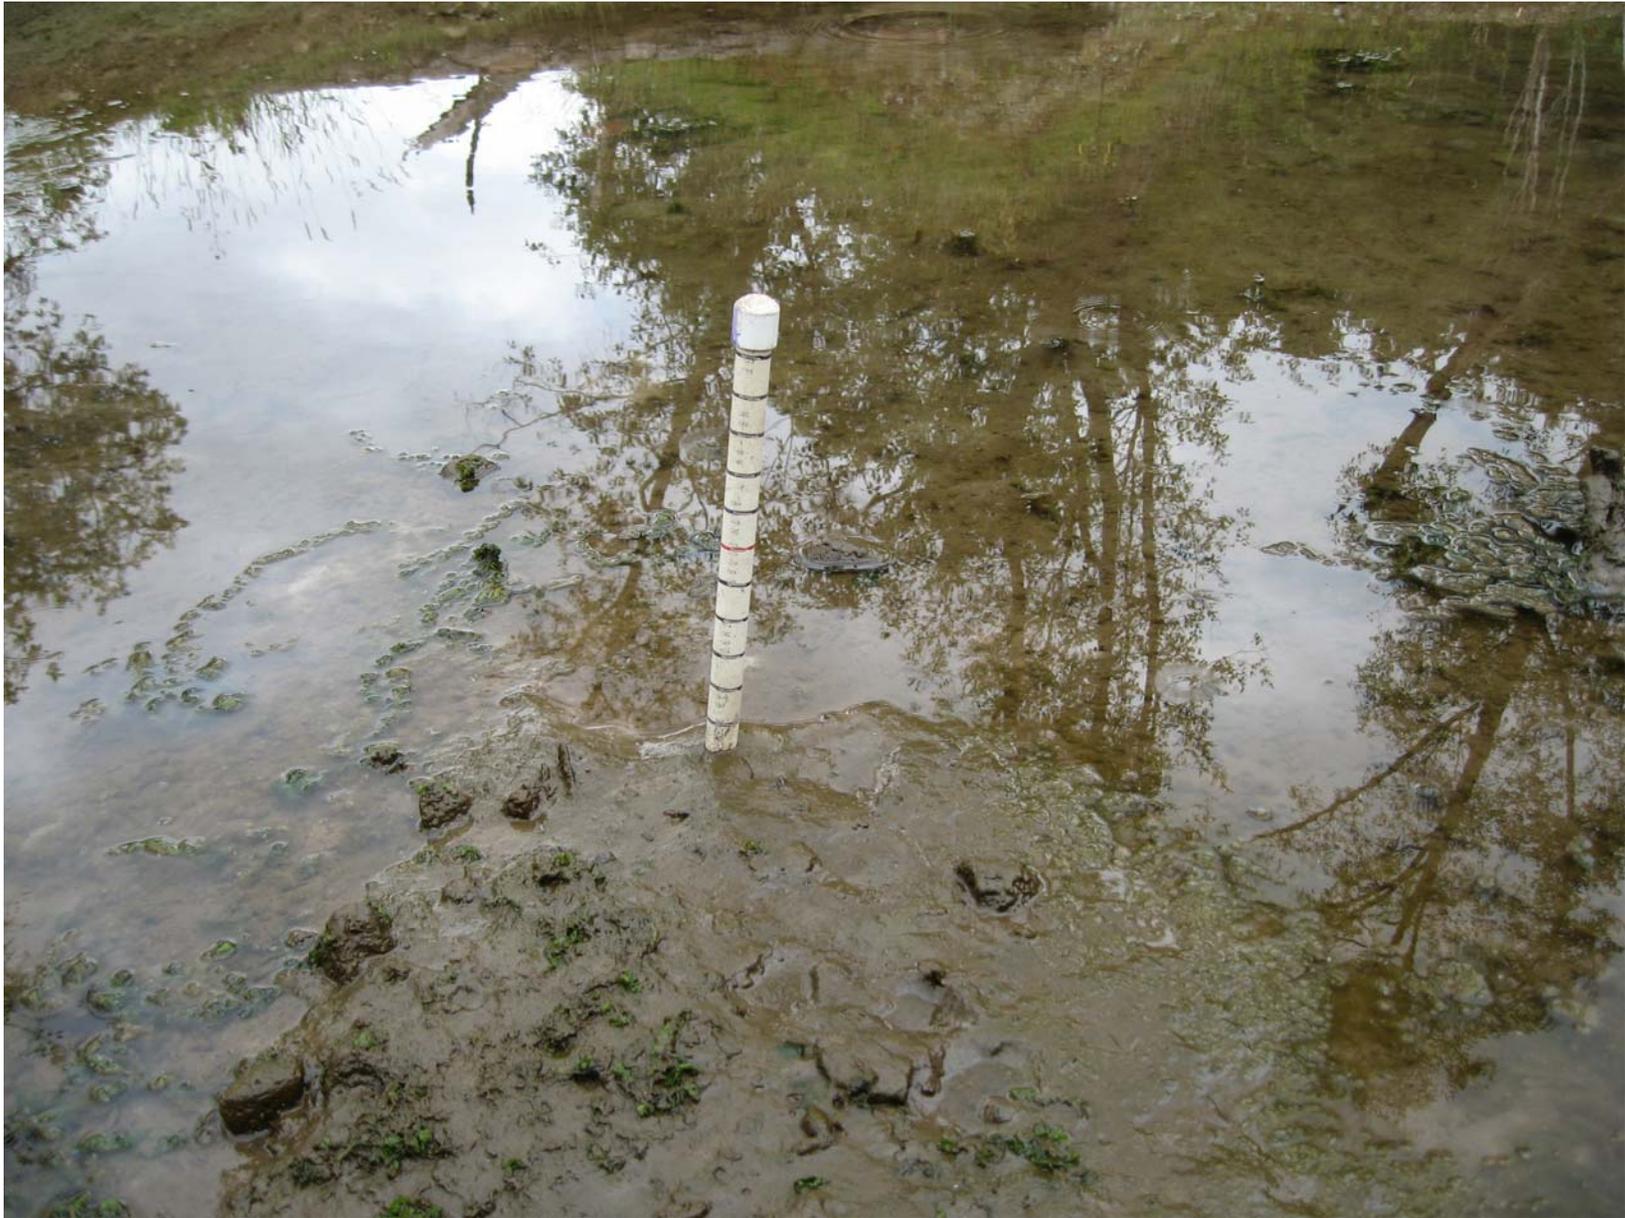
[IMG_0086]

Hylebos Creek, elevation stake E1. Photo taken July 13, 2006.

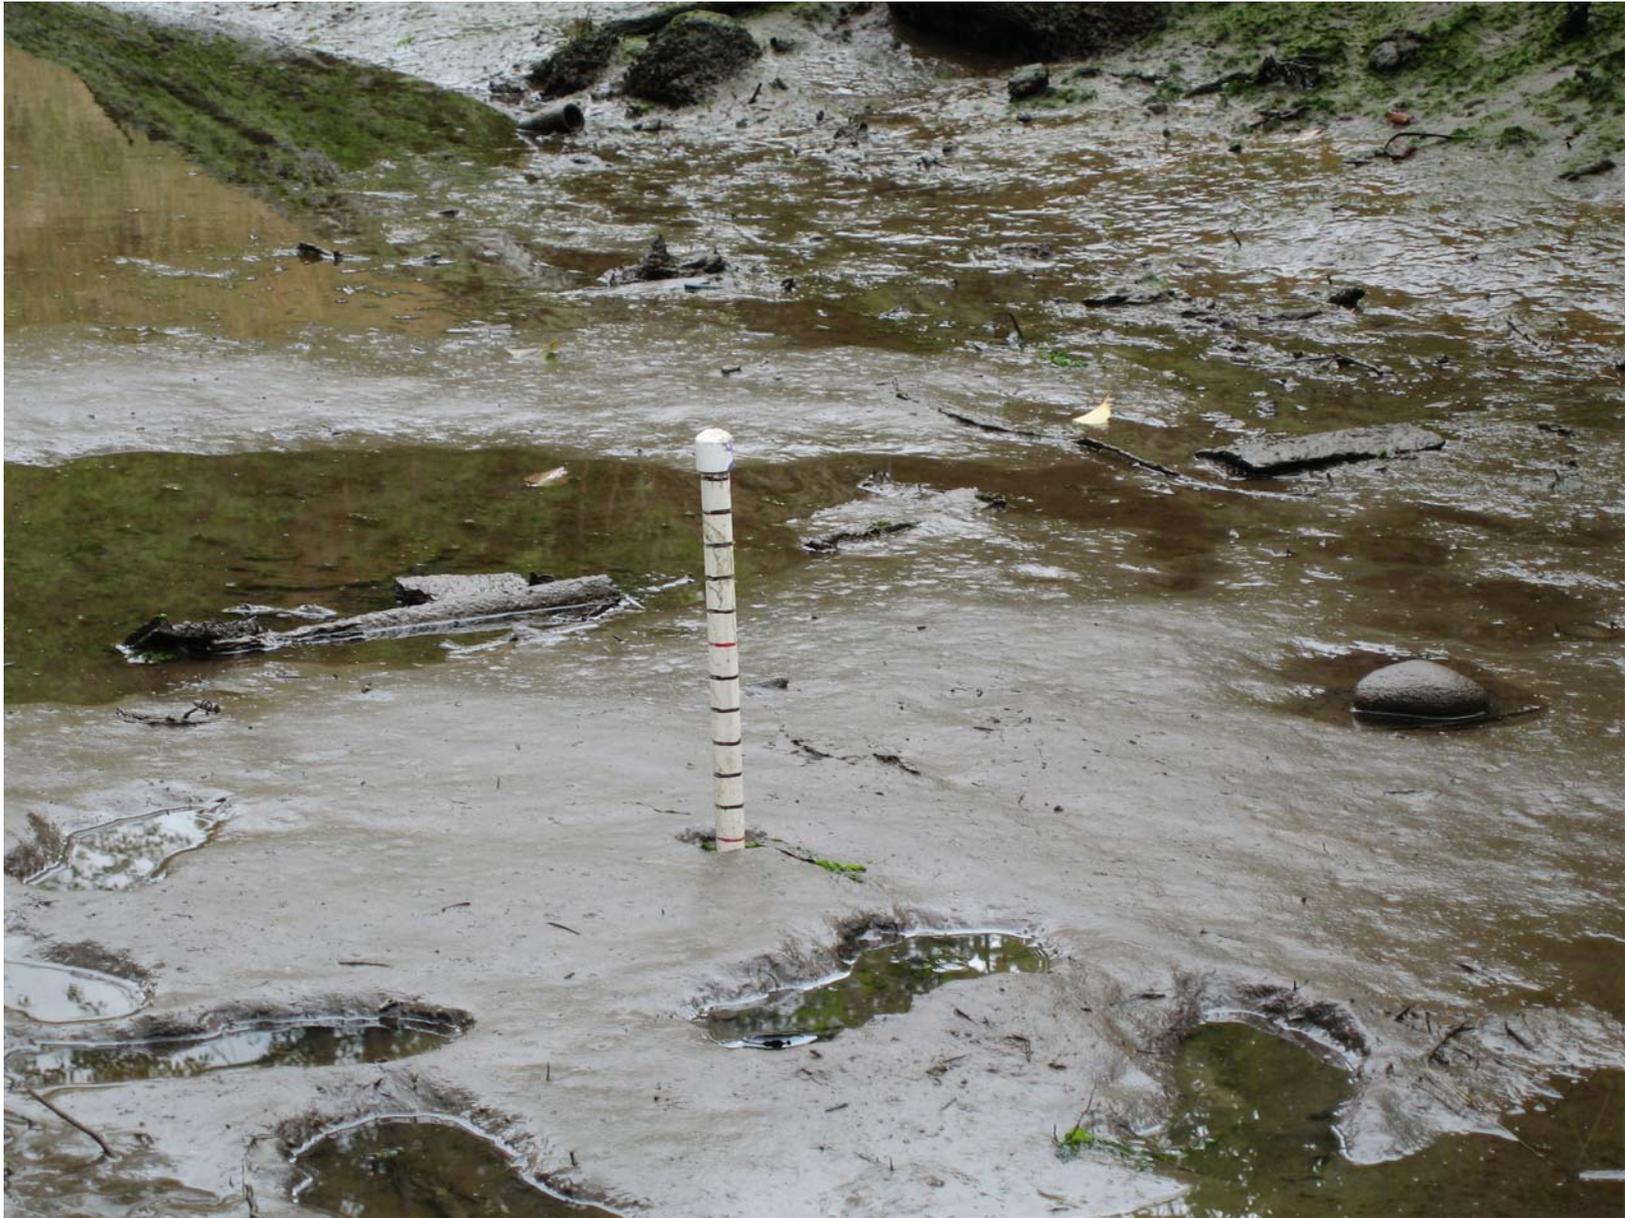
[IMG_0087]

Hylebos Creek, elevation stake E2. Photo taken July 13, 2006.

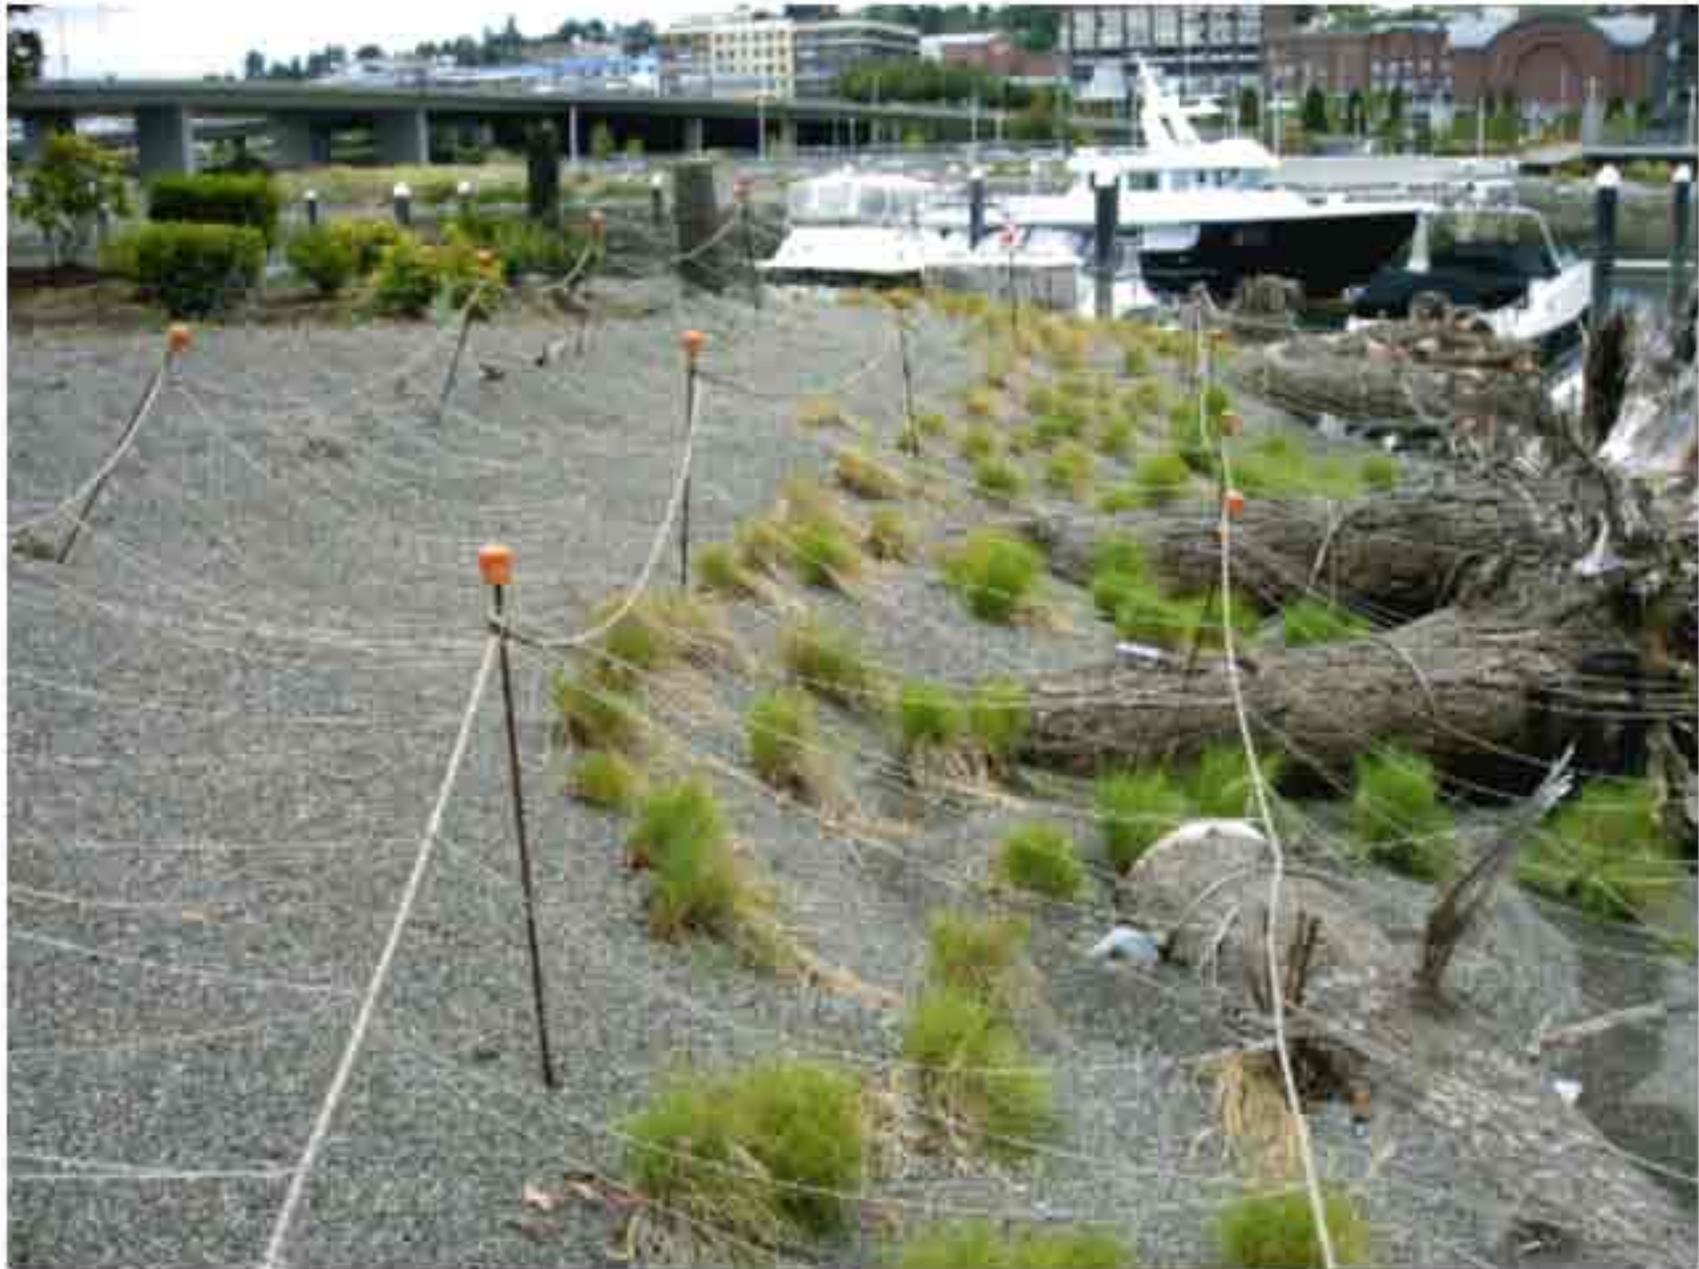
Johnny's Dock, Photo Point 1A, facing southwest. Photo taken July 10, 2006 at 11:25 AM, tide at approximately -2.82 feet MLLW. [MAG0009]

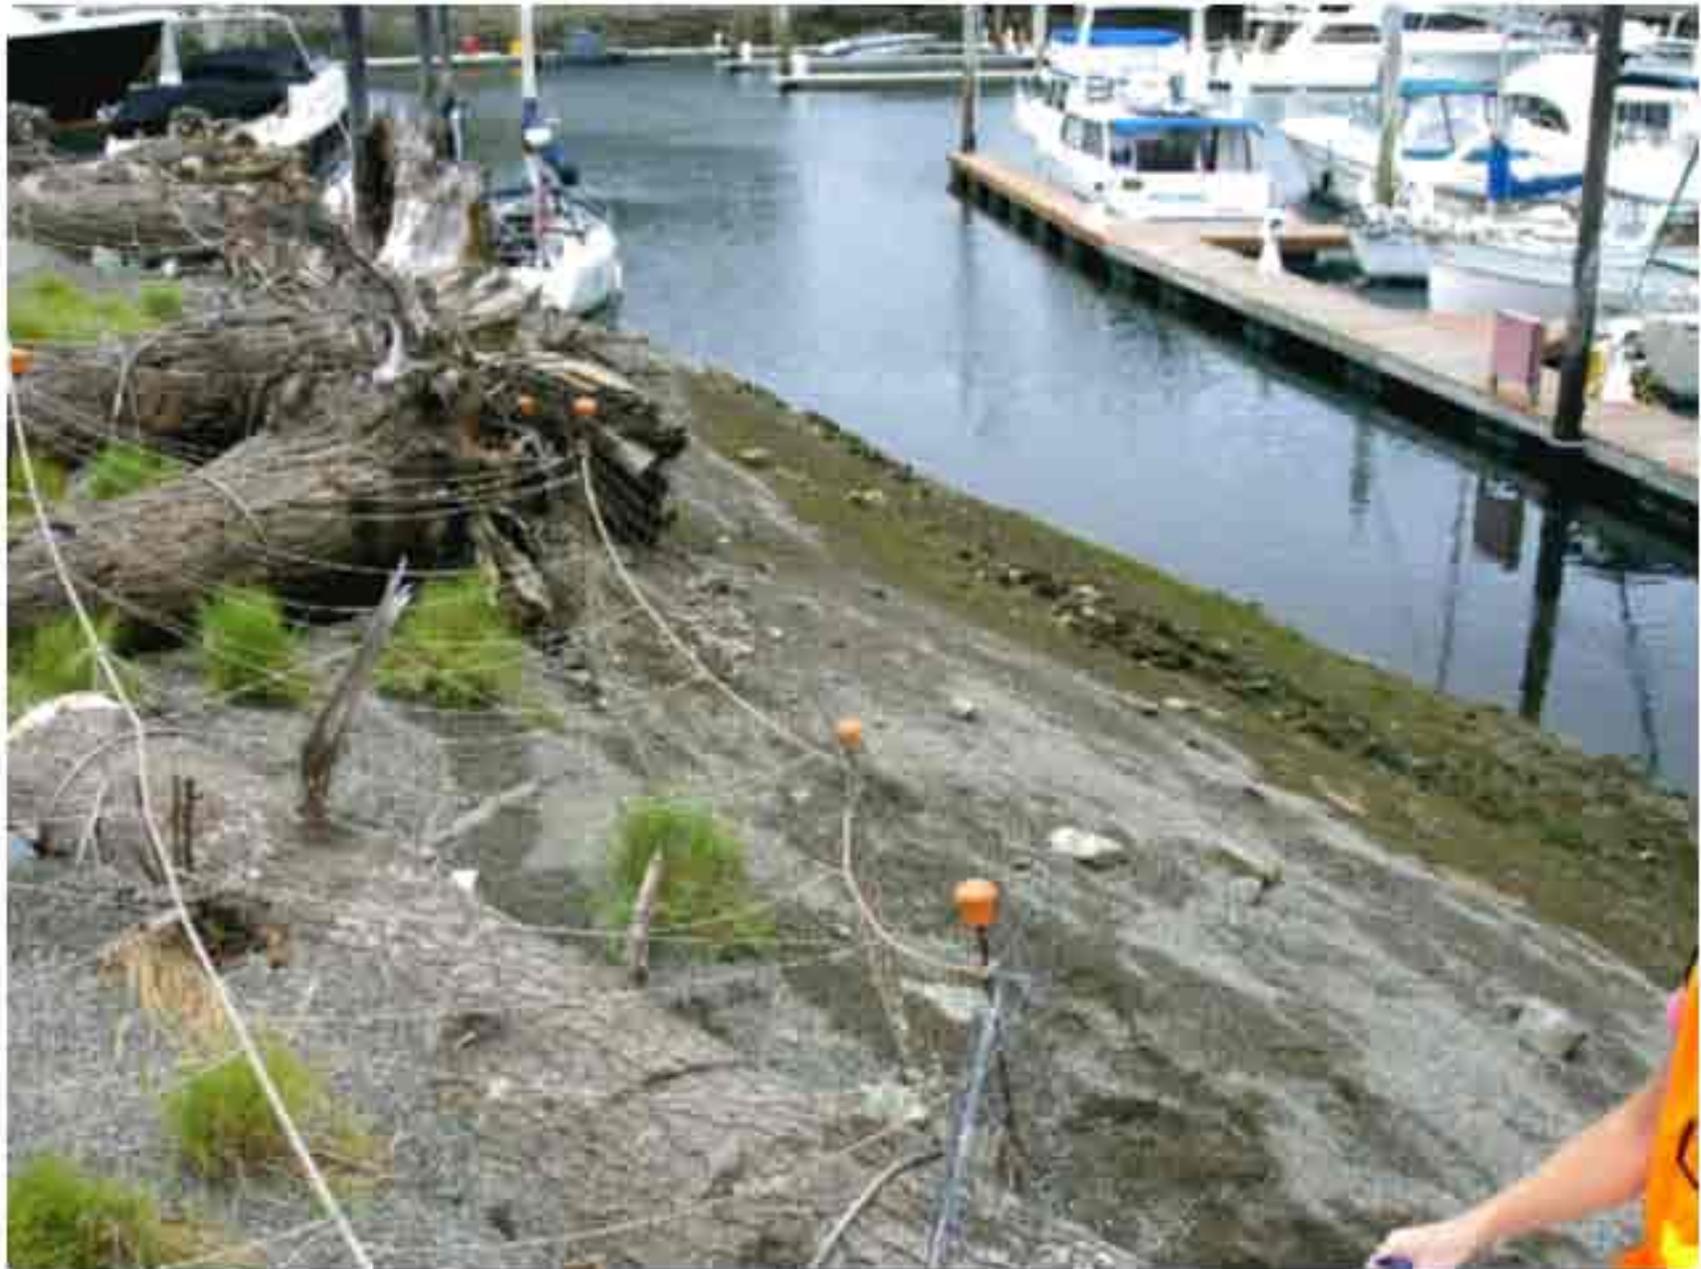
Johnny's Dock, Photo Point 1B, facing northwest. Photo taken July 10, 2006 at 11:25 AM, tide at approximately -2.82 feet MLLW. [MAG0010]

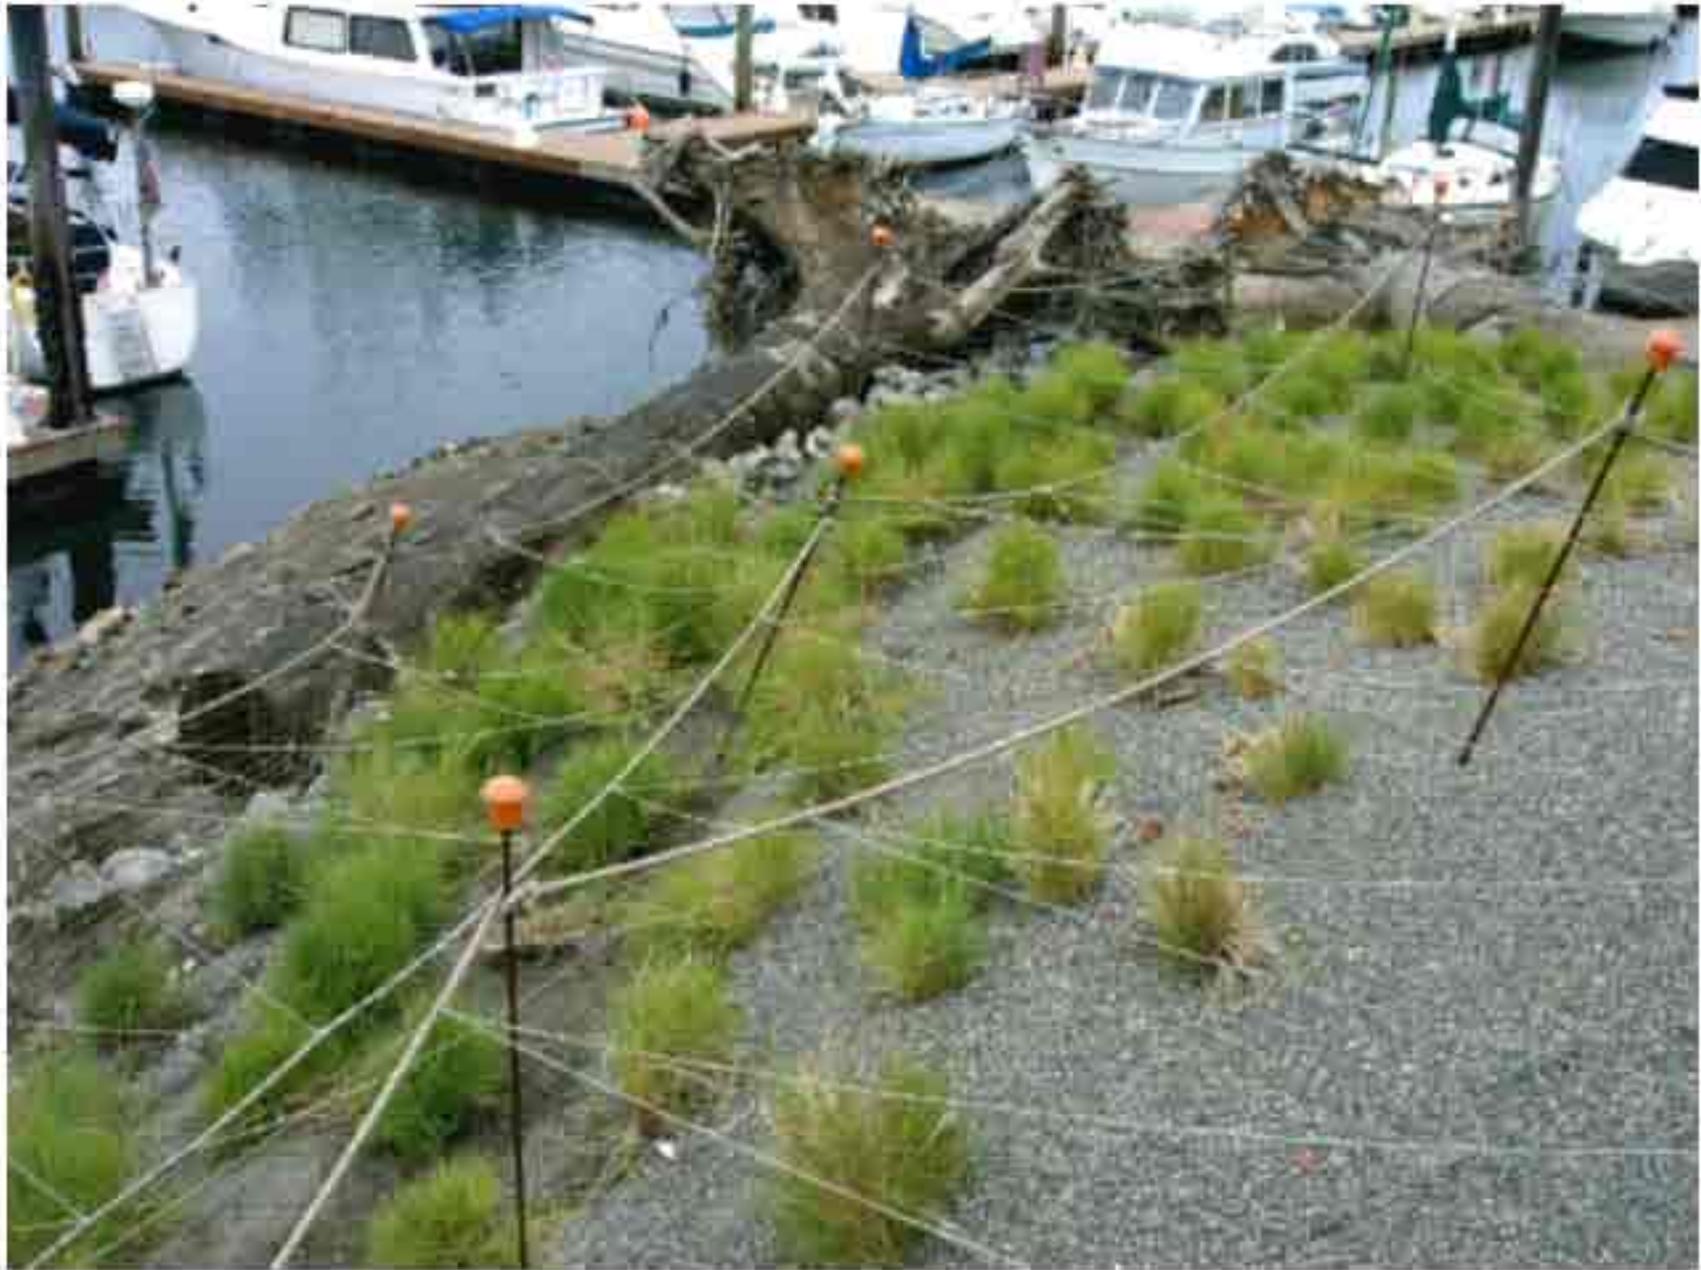
Johnny's Dock, Photo Point 2A, facing northwest. Photo taken July 10, 2006 at 11:31 AM, tide at approximately -2.75 feet MLLW. [MAG0011]

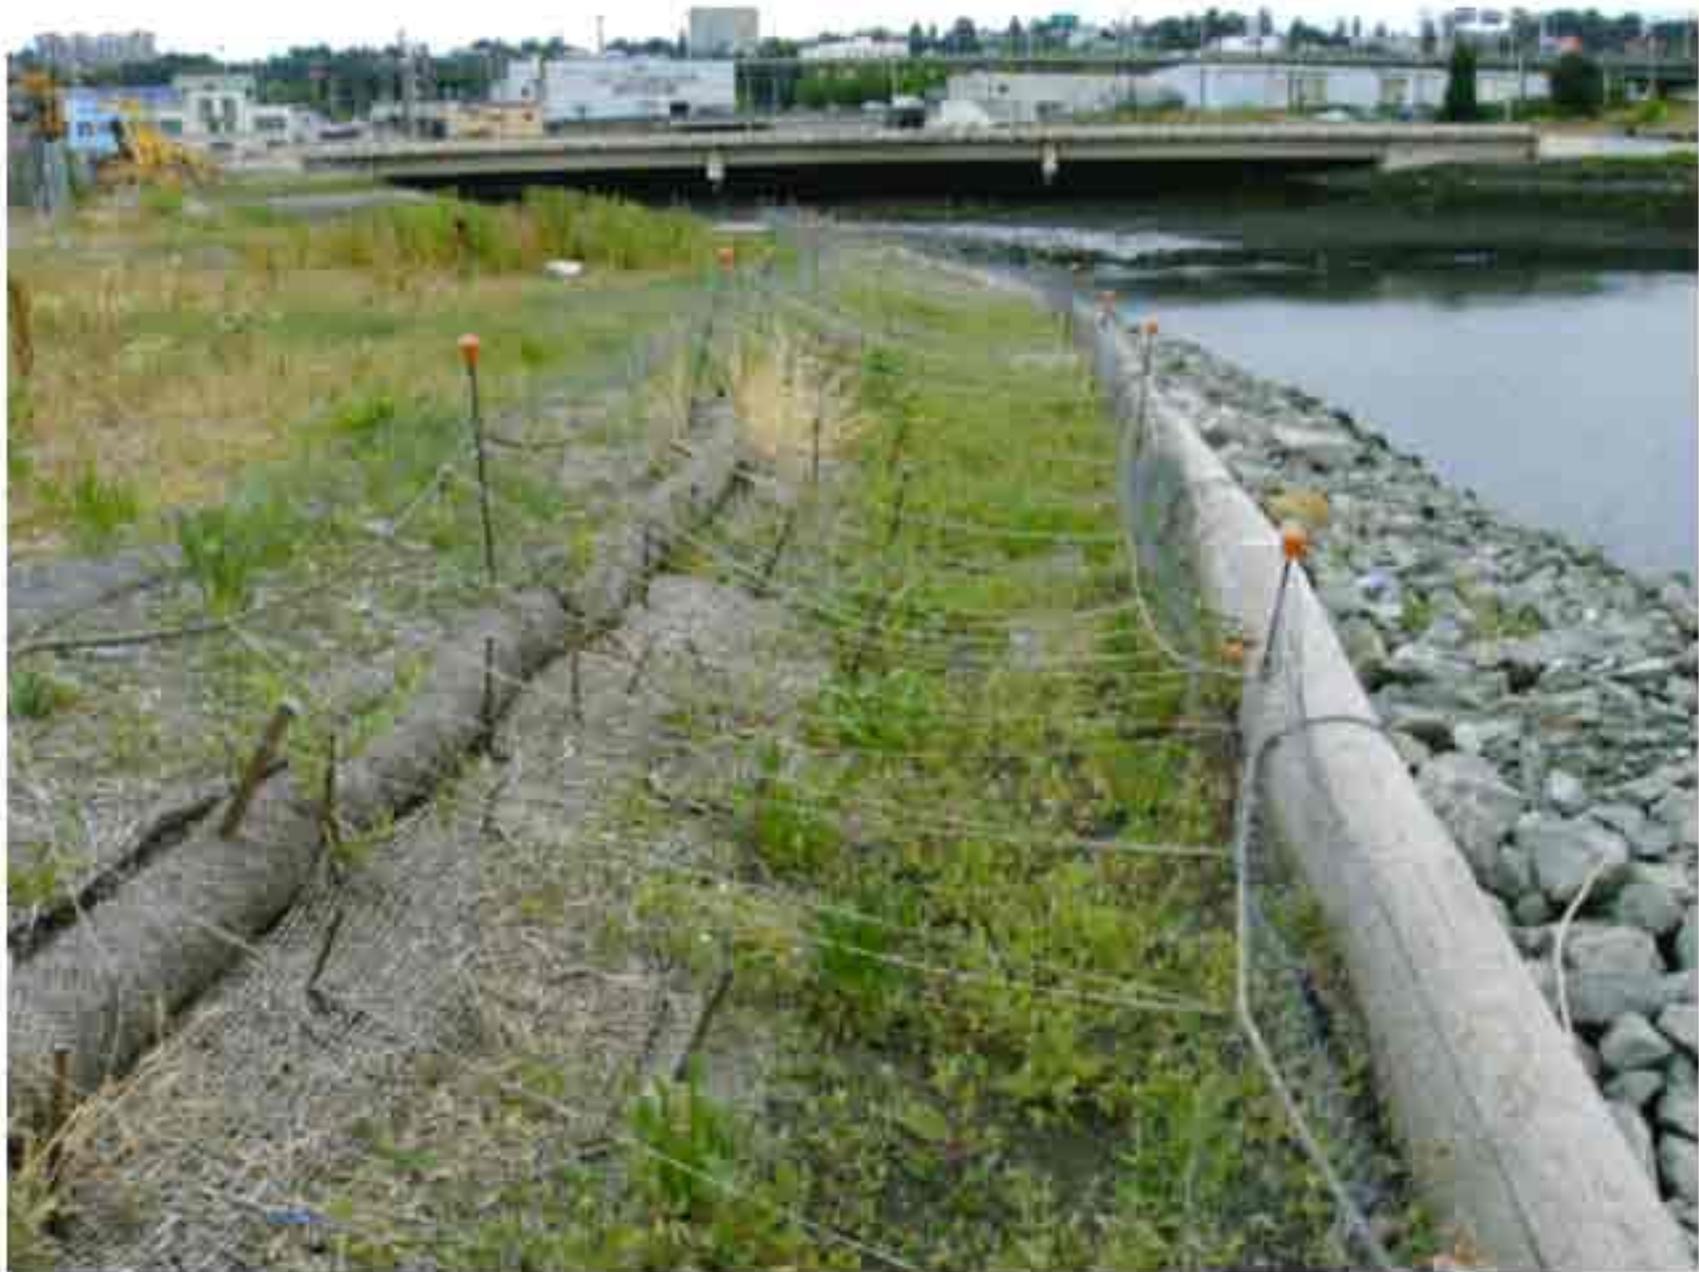
Head of Thea Foss, Photo Point 1, facing south. Photo taken July 10, 2006 at 10:41 AM, tide at approximately -2.89 feet MLLW. [MAG0007]
