THEA FOSS AND WHEELER-OSGOOD WATERWAYS REMEDIATION PROJECT

YEAR 0 BASELINE MONITORING

HABITAT MITIGATION AREA MONITORING PRELIMINARY FINDINGS MEMORANDUM

NOVEMBER 30, 2006

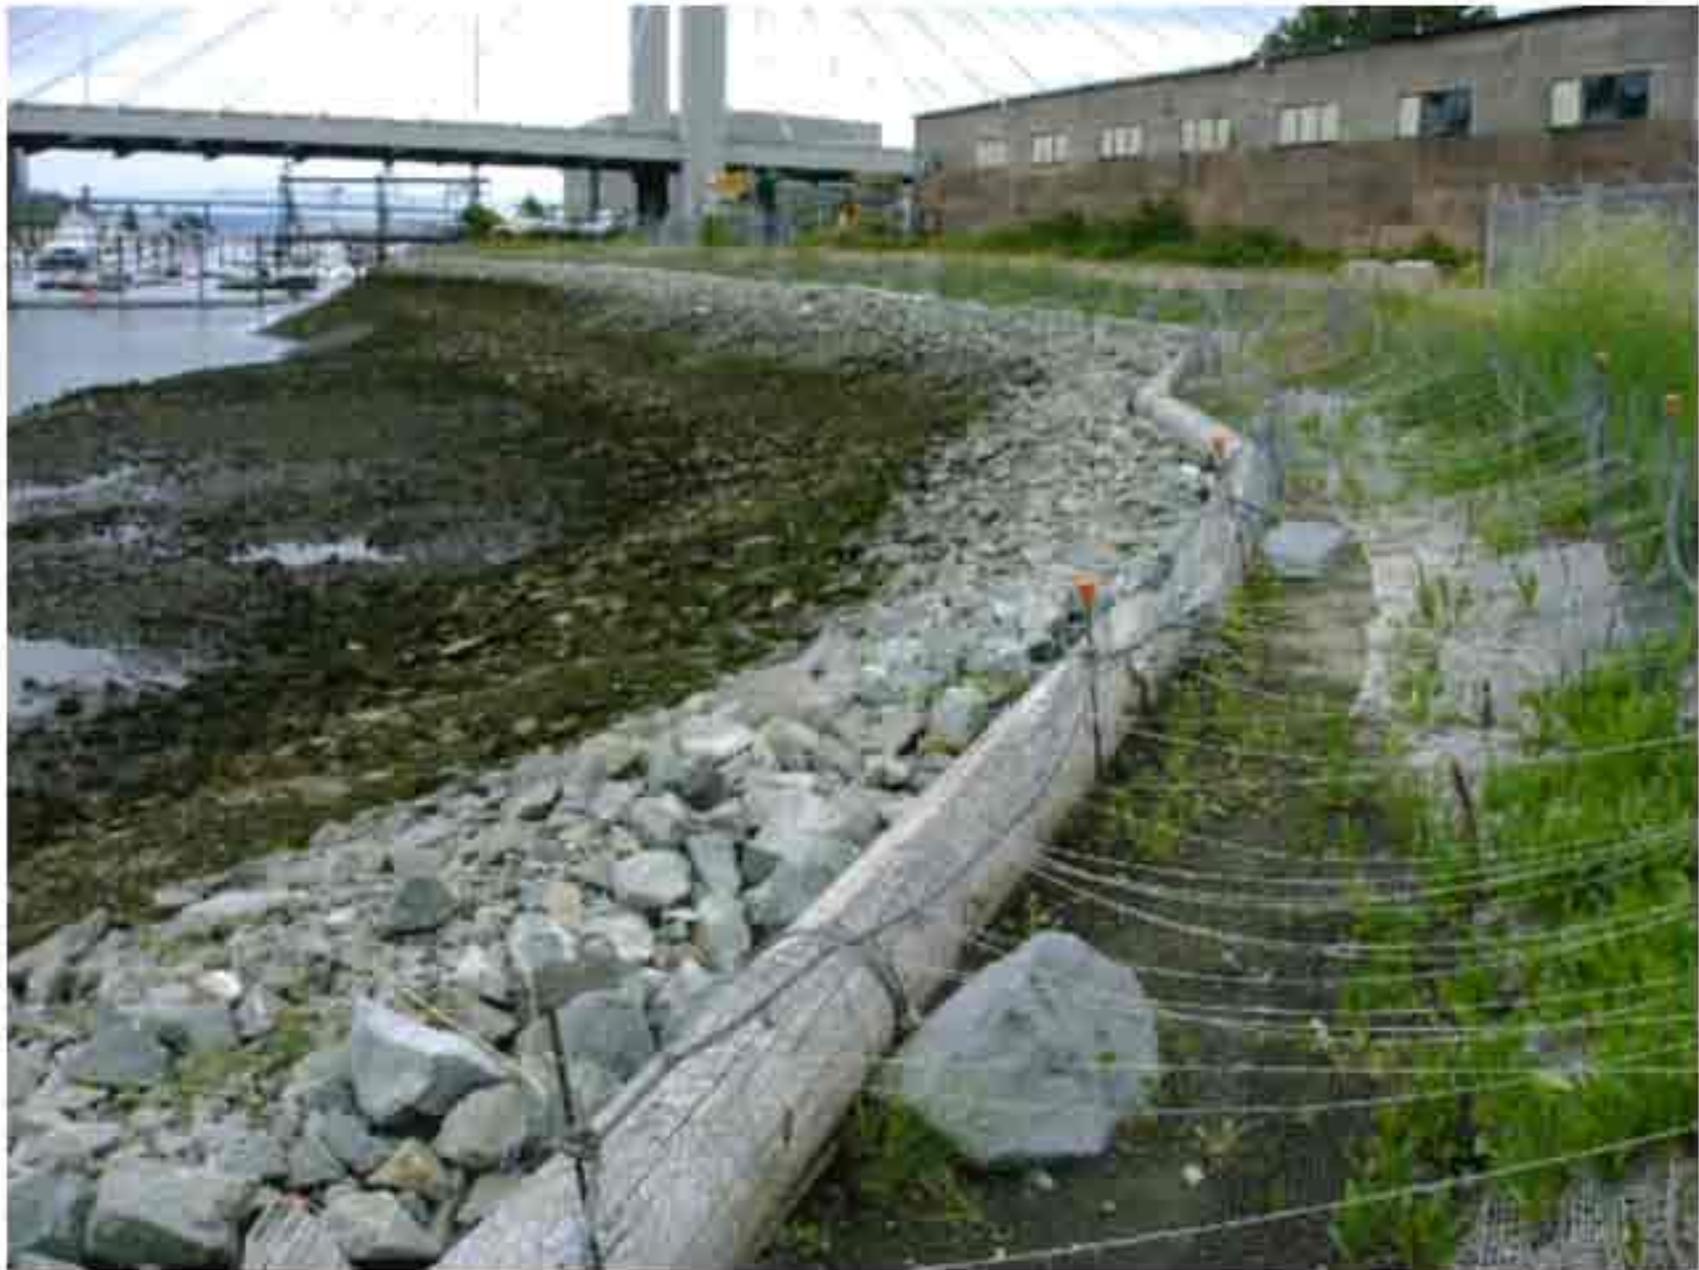
Head of Thea Foss, Photo Point 2, facing north. Photo taken July 10, 2006 at 10:55 AM, tide at approximately -2.96 feet MLLW. [MAG0008]

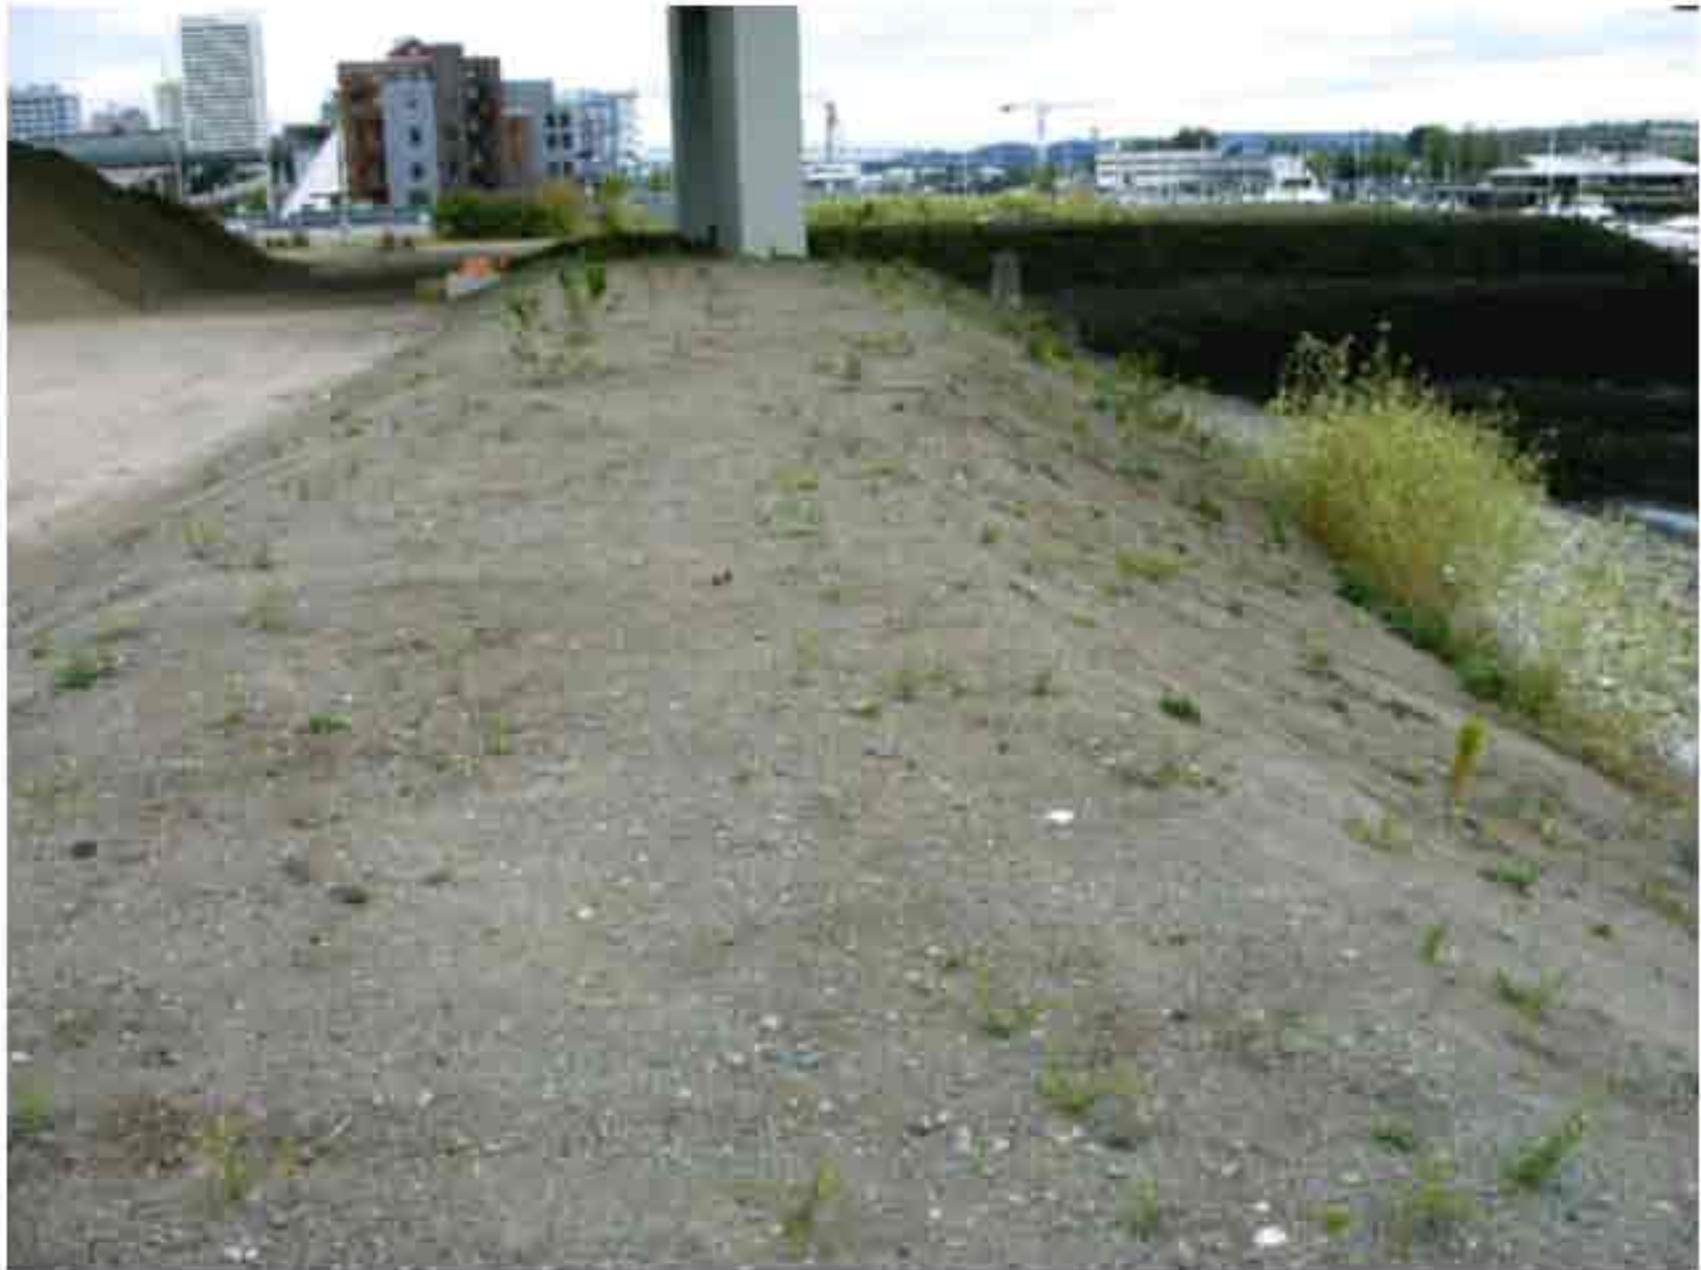
SR509 Esplanade, Photo Point 3, facing north. Photo taken July 10, 2006 at 10:03 AM, tide at approximately -2.28 feet MLLW. [MAG0002A]

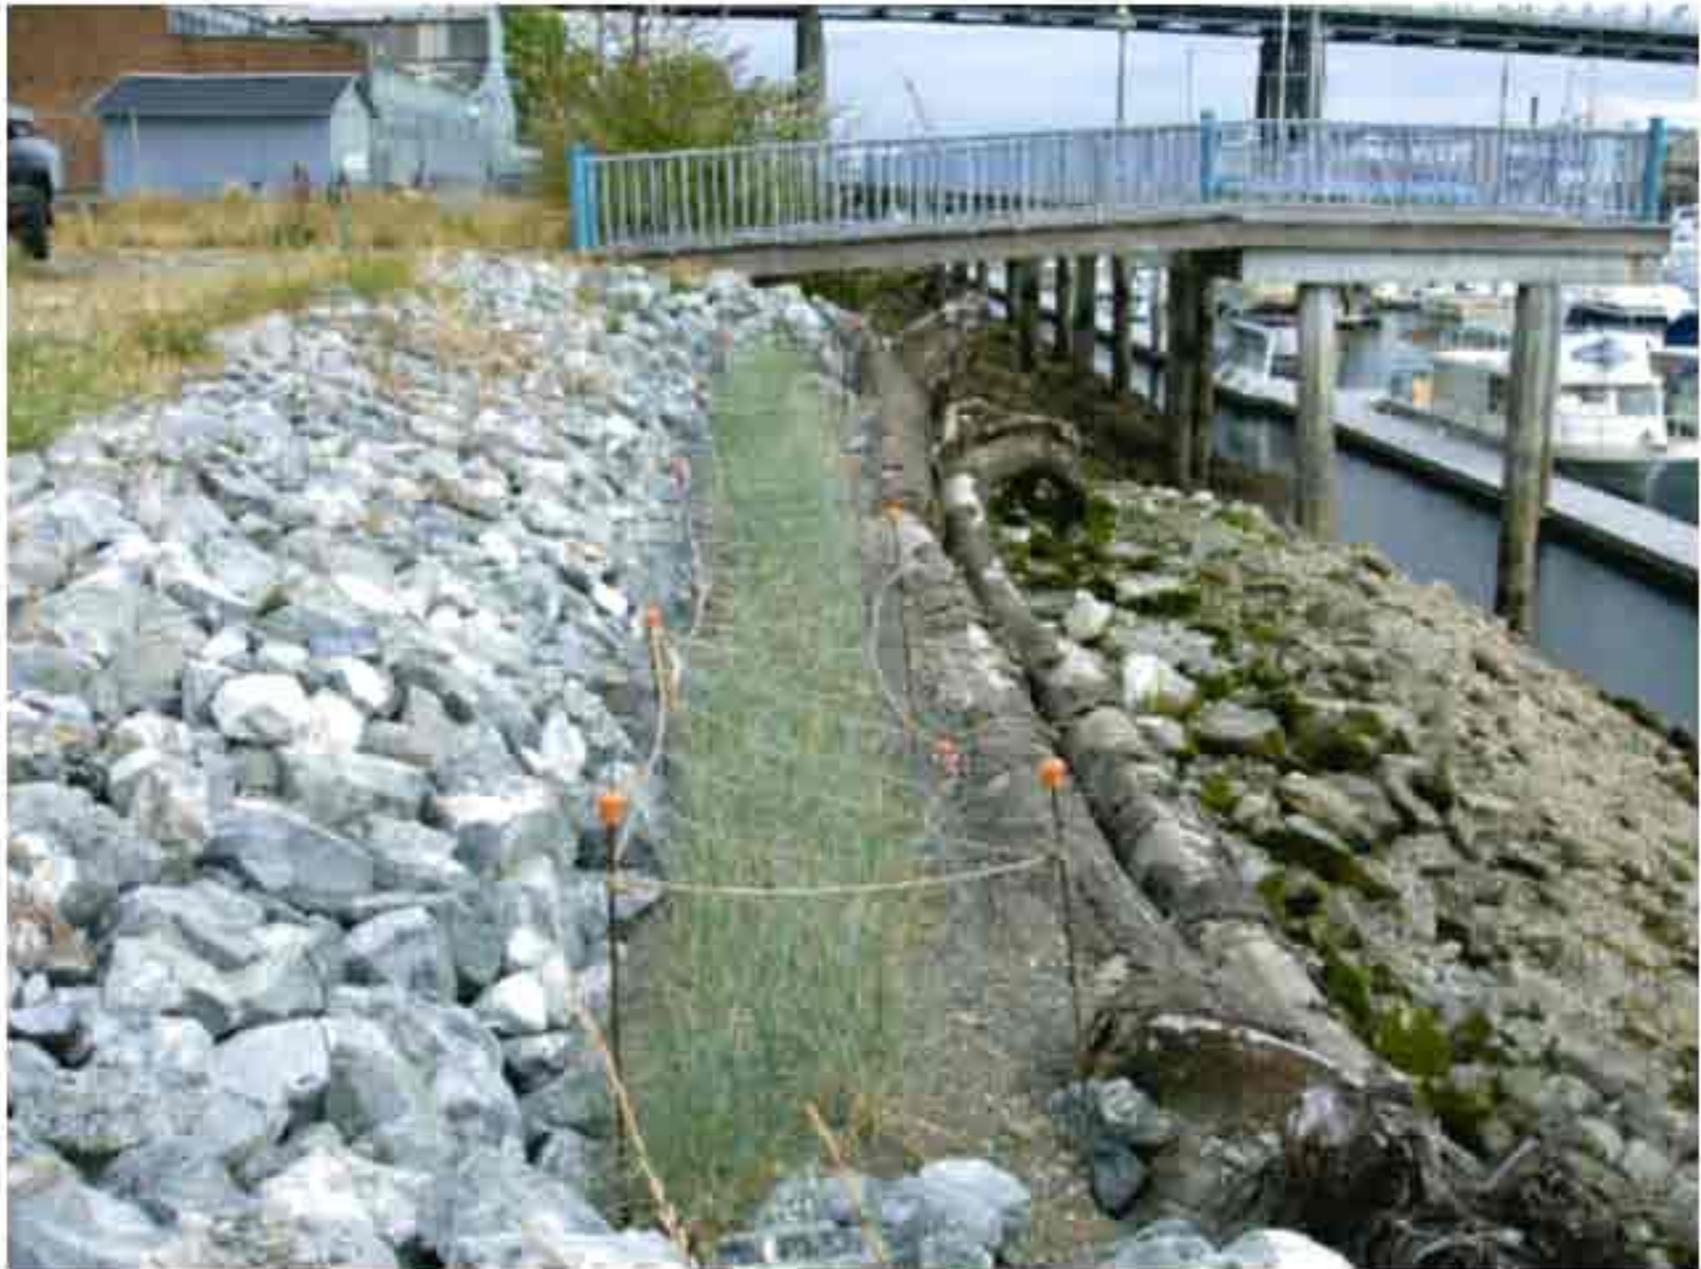
Log Step, Photo Point 1, facing north. Photo taken July 10, 2006 at 9:28 AM, tide at approximately -1.24 feet MLLW.
[MAG0001A]
