THEA FOSS AND WHEELER-OSGOOD WATERWAYS REMEDIATION PROJECT

YEAR 2 MONITORING

ANNUAL OPERATIONS, MAINTENANCE, AND MONITORING REPORT

MARCH 23, 2009

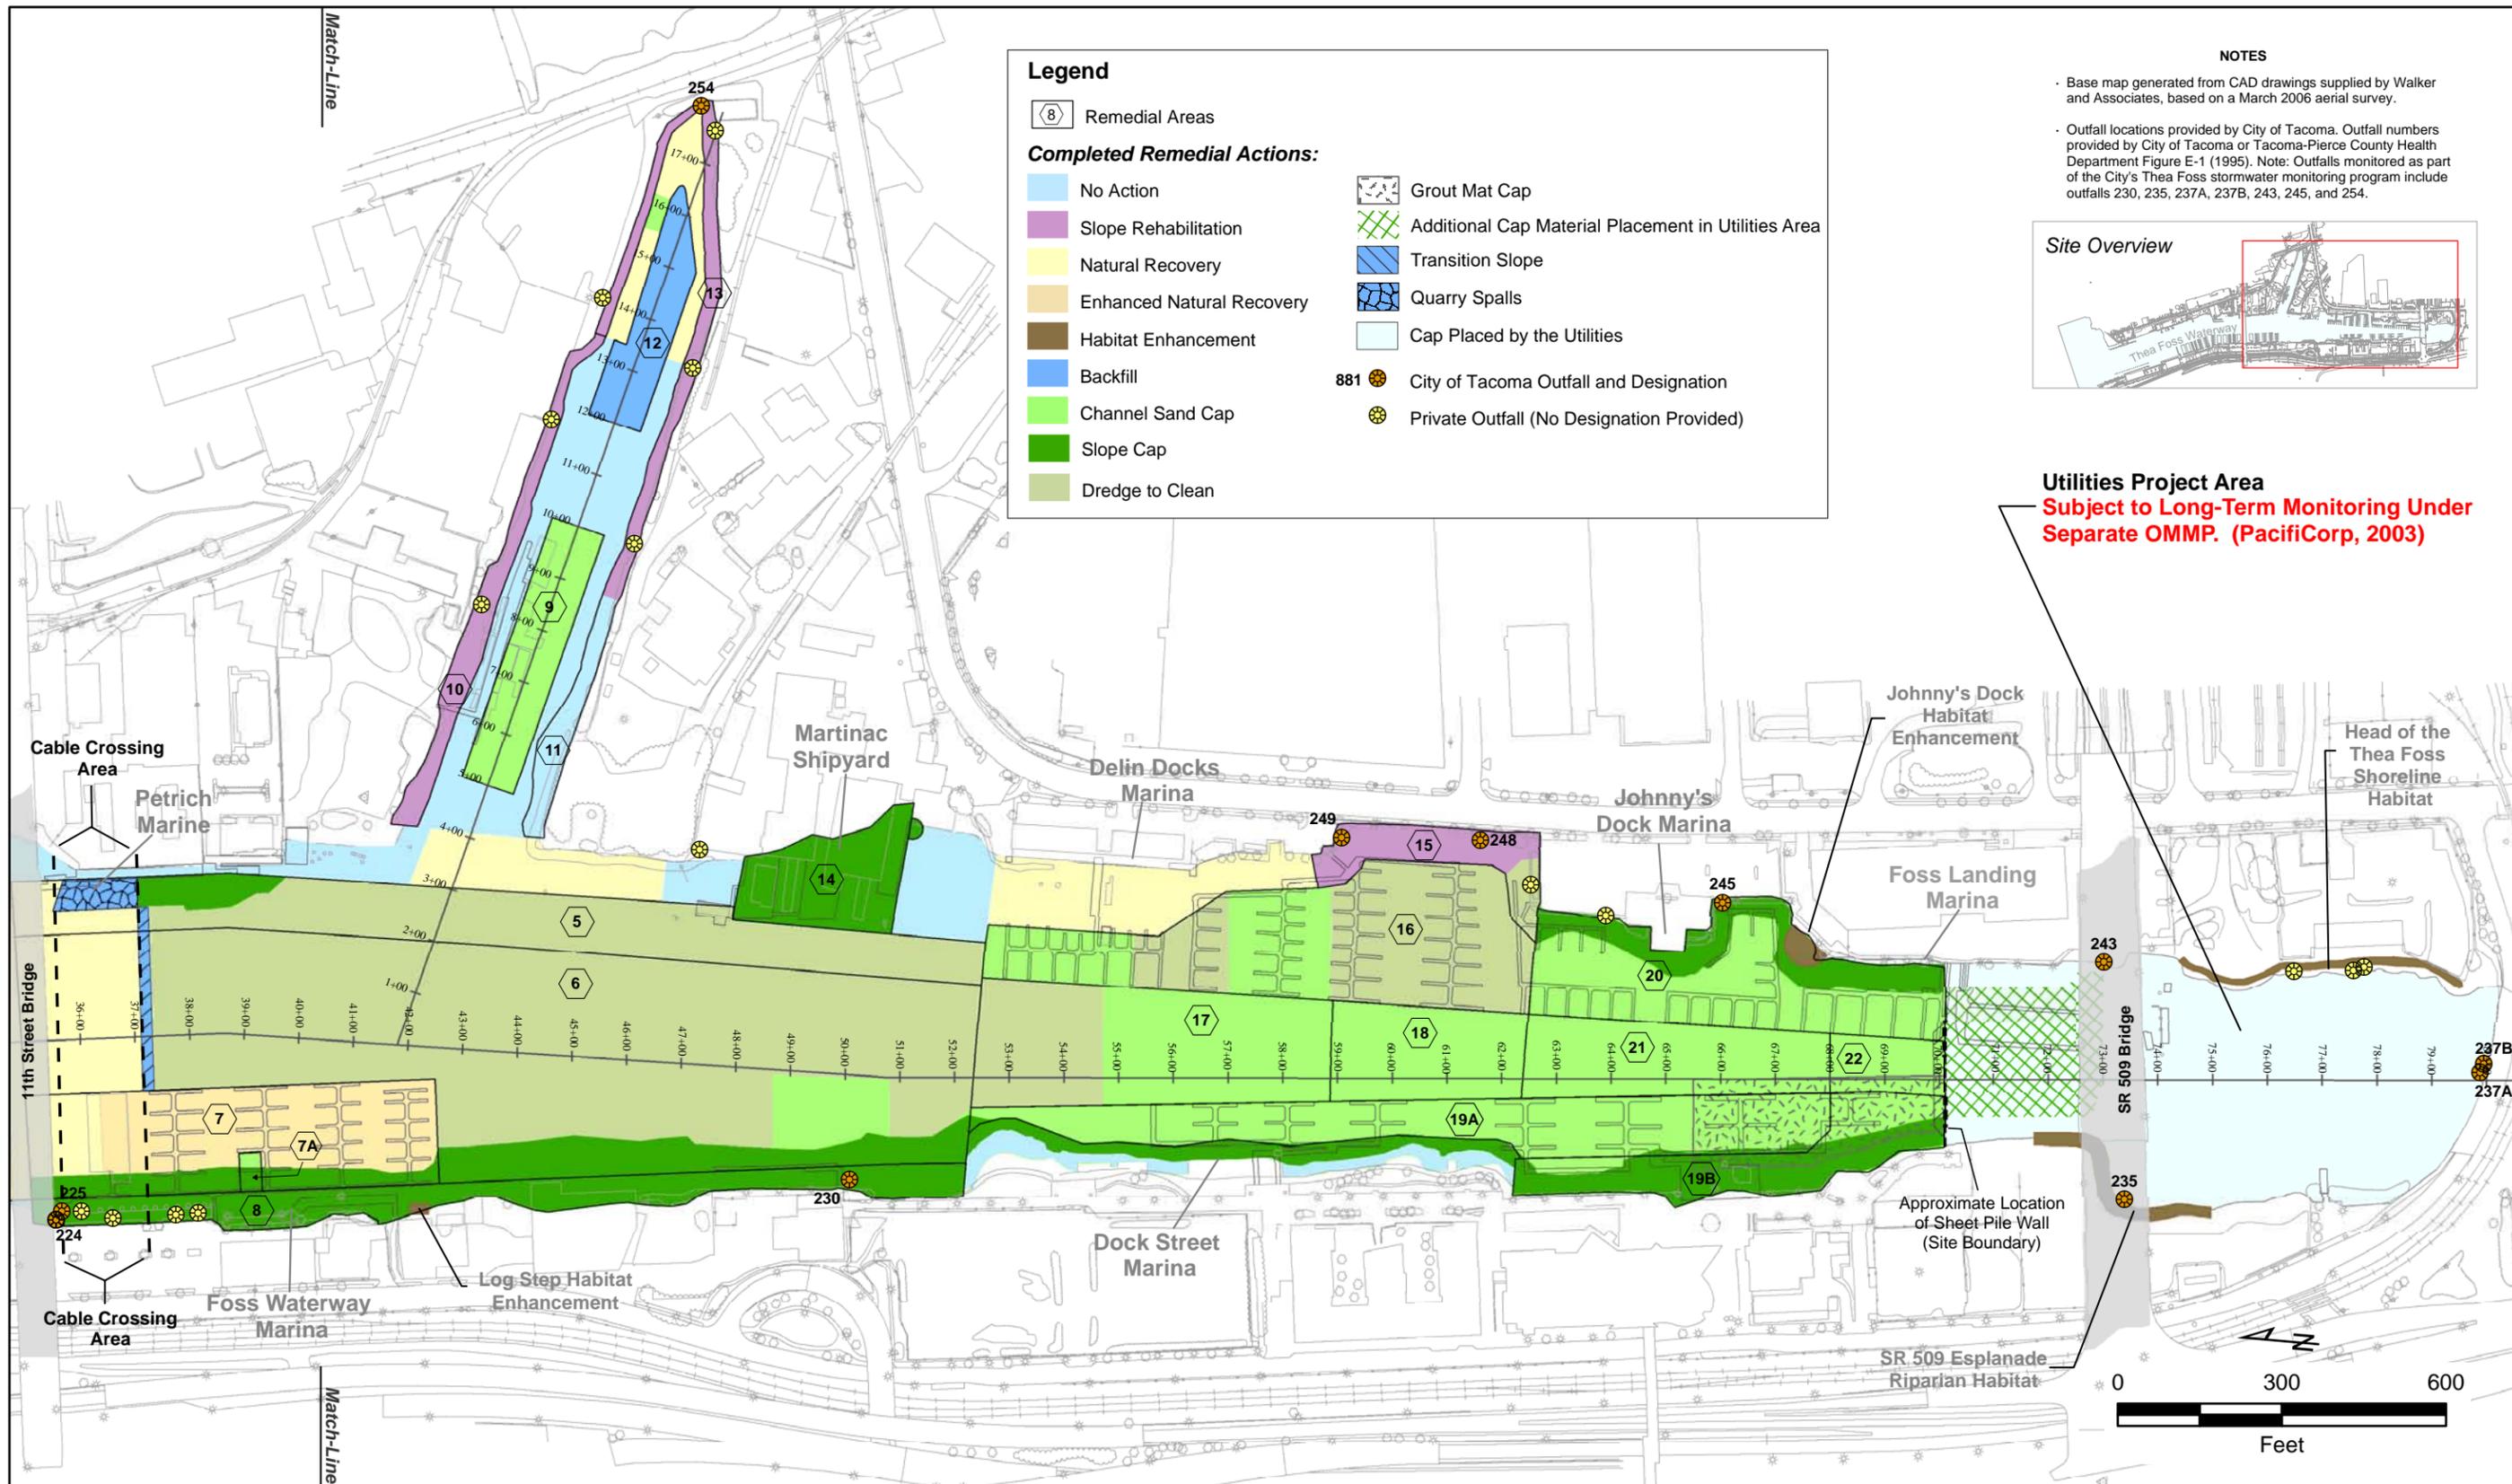
**Figure 1-2 (Page 1 of 2)
Completed Remedial Actions**

Figure 1-2 shows the remedial actions completed by the City in the Thea Foss and Wheeler-Osgood Waterways. The area in which the City performed remedial actions as part of the Foss Project is identified as the City's work area. Also identified on Figure 1-2 is the Utilities' work area at the head of the Thea Foss Waterway. In this area, monitoring is being performed by the Utilities in accordance with the Head of the Thea Foss Waterway Remediation Project, Operations, Maintenance and Monitoring Plan (PacifiCorp 2003). The City continues to work cooperatively with the Utilities work group to respond to the identified recontamination occurring in their work area.

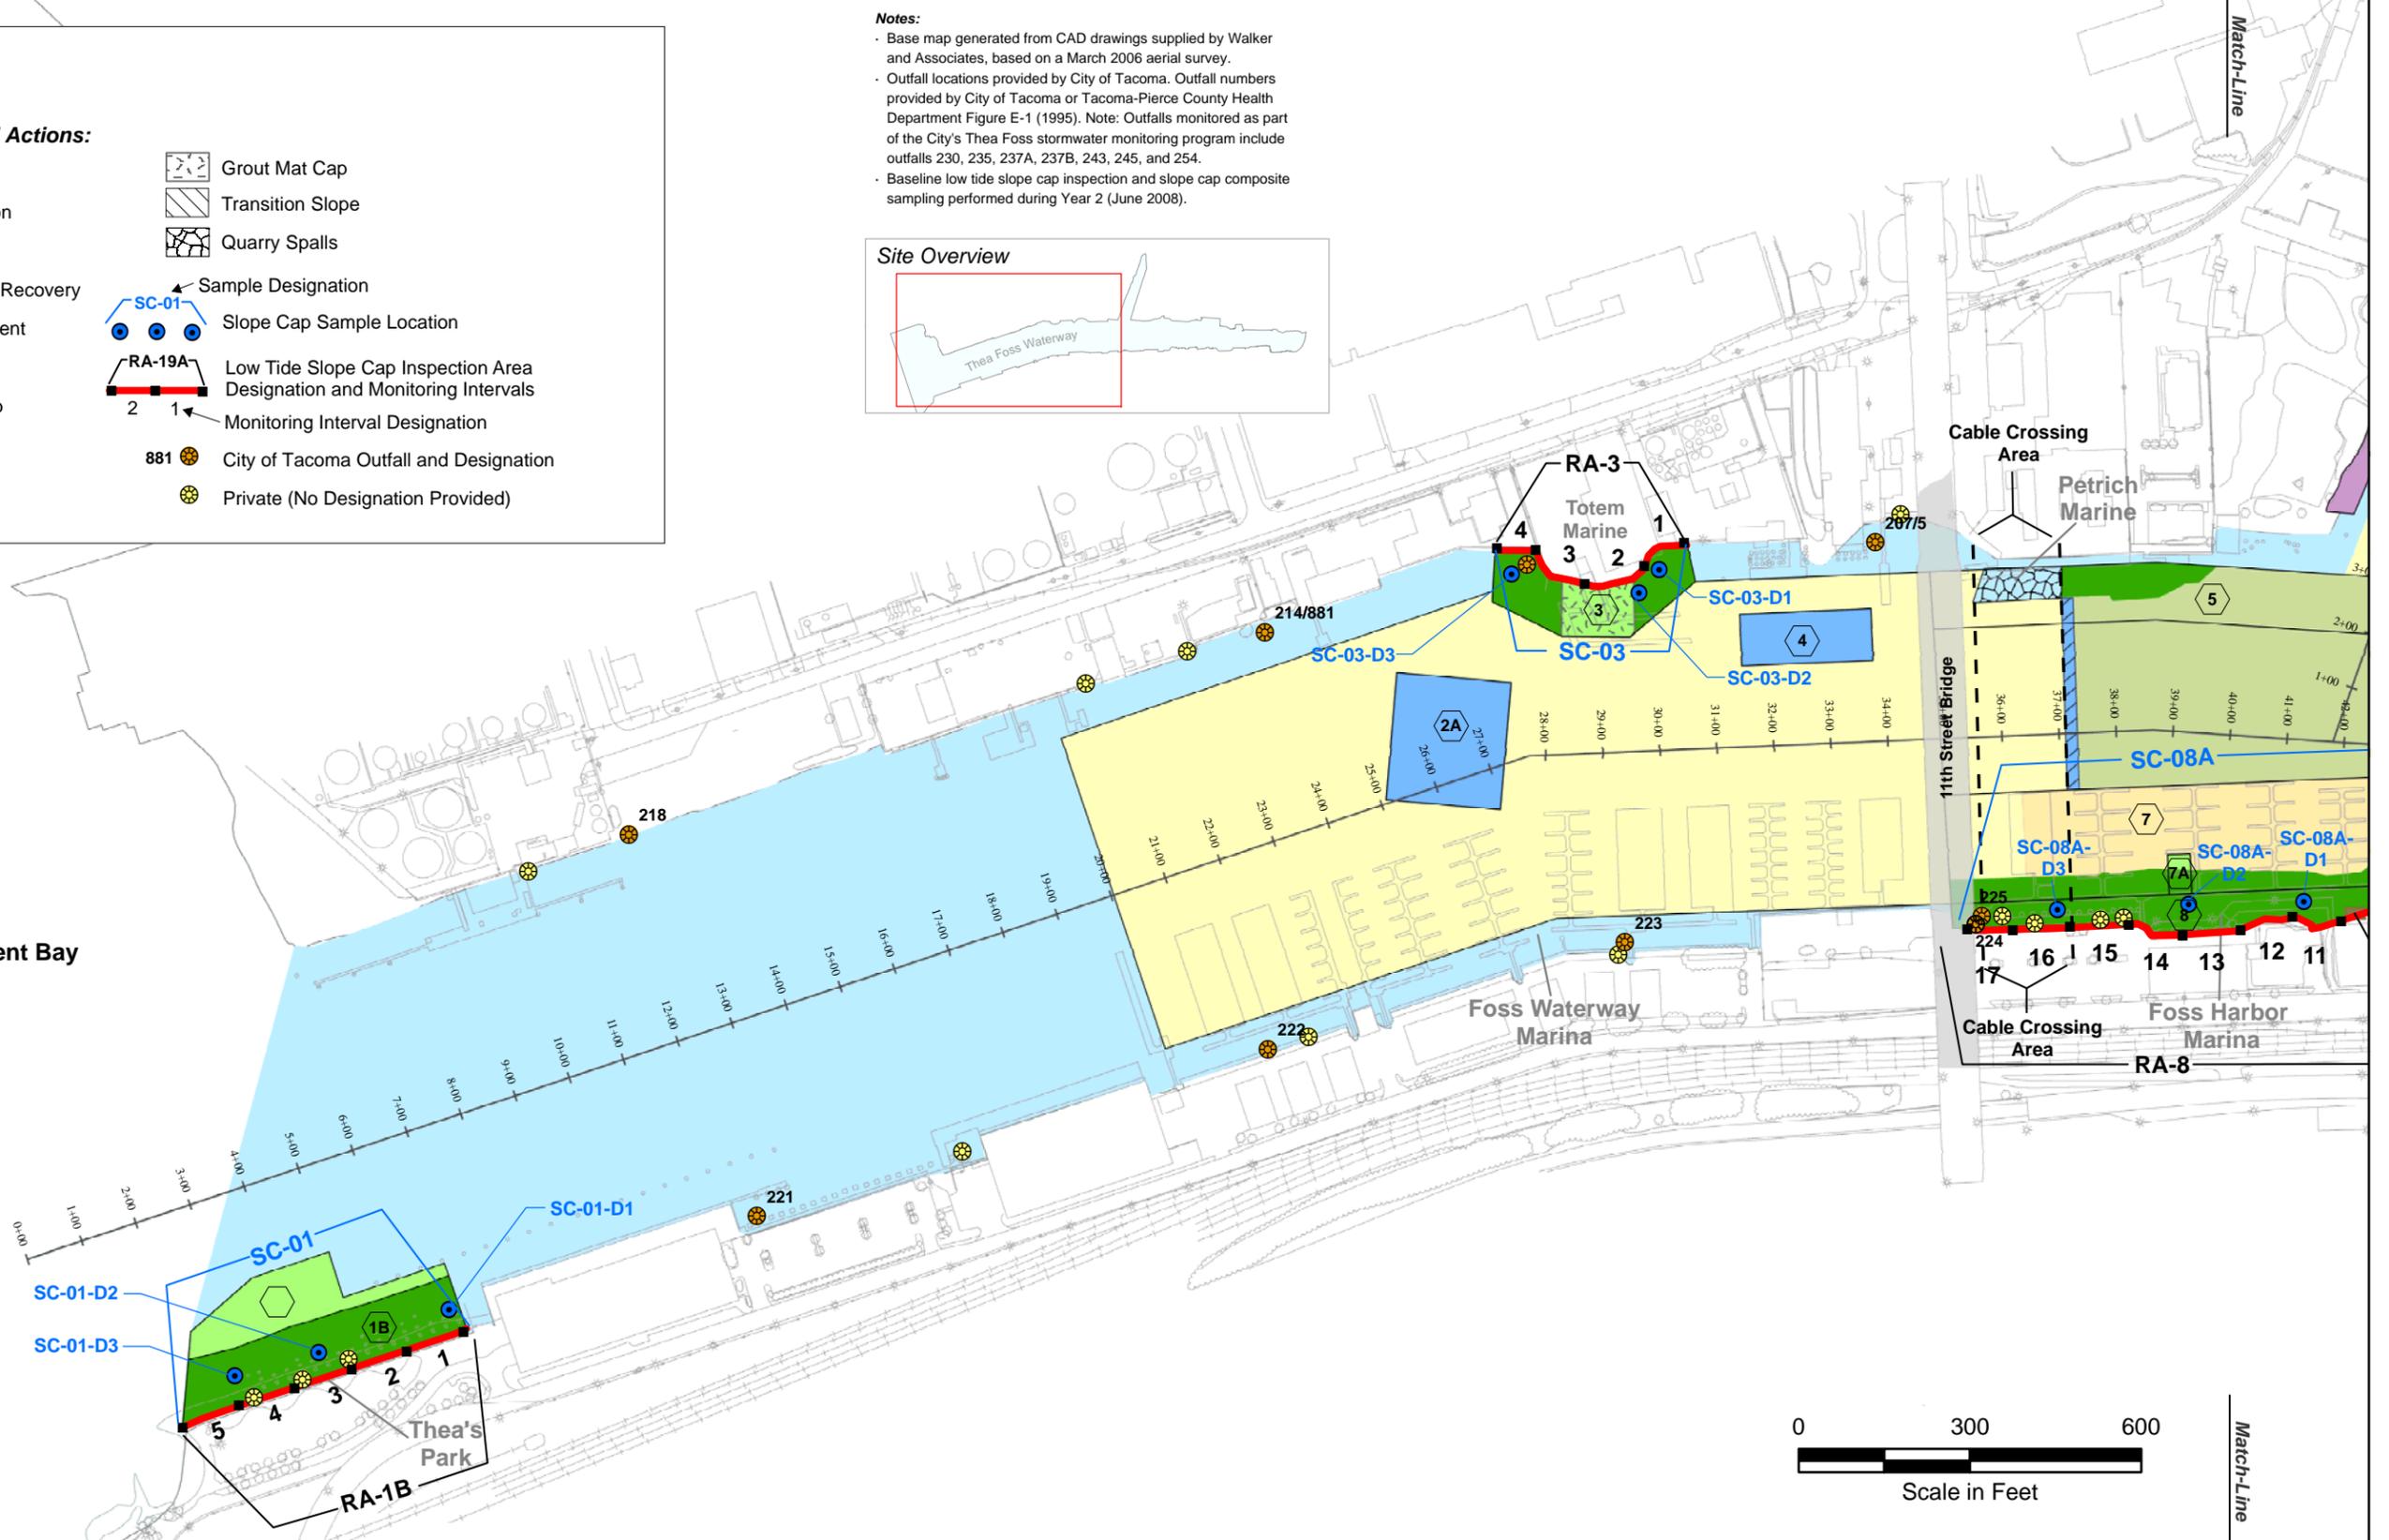
**Figure 2-1 (Page 1 of 2)
Low Tide Slope Cap Inspection
Monitoring Intervals and
Slope Cap Sample Locations**

composite subsample stations were selected in the field to be between approximately 0 feet and -2 feet MLLW and to be generally evenly spaced along the RA, while targeting any observed sediment accumulation areas on the slope cap. Figure 2-1 identifies the slope cap subsample locations.

Year 2 performance monitoring to evaluate the physical integrity of intertidal slope cap areas consisted of performing low tide inspection of the slope caps in Remedial Area (RA) 1B, RA 3, RA 8, RA 14, RA 19A, RA 19B, RA 20, and the Sheen Source Removal Area in the Wheeler-Osgood Waterway in accordance with the OMMP. The results of the low tide slope cap inspections are presented in the Year 2 Monitoring Low Tide Slope Cap Inspection Preliminary Findings Memorandum (City of Tacoma 2008) provided in Attachment A-1 in Appendix A and are summarized below to characterize the Year 2 conditions for the intertidal portions of capped areas and identify any areas needing maintenance.

- No disturbances to the cap were identified upon inspection of 16 of the 17 monitoring intervals in RA 8. One area is present in monitoring interval 10 of RA 8 where several pilings are located at the surface of the capped area. Further evaluation is being performed in this area to determine whether any repair actions are needed to remove or confine the pilings. Options for this area need further evaluation due to the already steep slope of the shoreline and the proximity of the authorized channel, since placing a toe berm and cap below this area would likely encroach on the channel and potentially block access to marina slips. A separate memorandum evaluating options for this area is being prepared for submittal to EPA for review.

- A float with a shed was observed to be grounded on the surface of the slope cap in monitoring interval 4 of RA 20, at Johnny's Dock Marina. Representatives of the Johnny's Dock Marina were notified by the City on July 3, 2008, and asked to relocate the float away from the area where grounding on the cap was occurring. Following notification, Johnny's Dock Marina moved the float so that it is no longer grounded; this was confirmed in an inspection by the City.

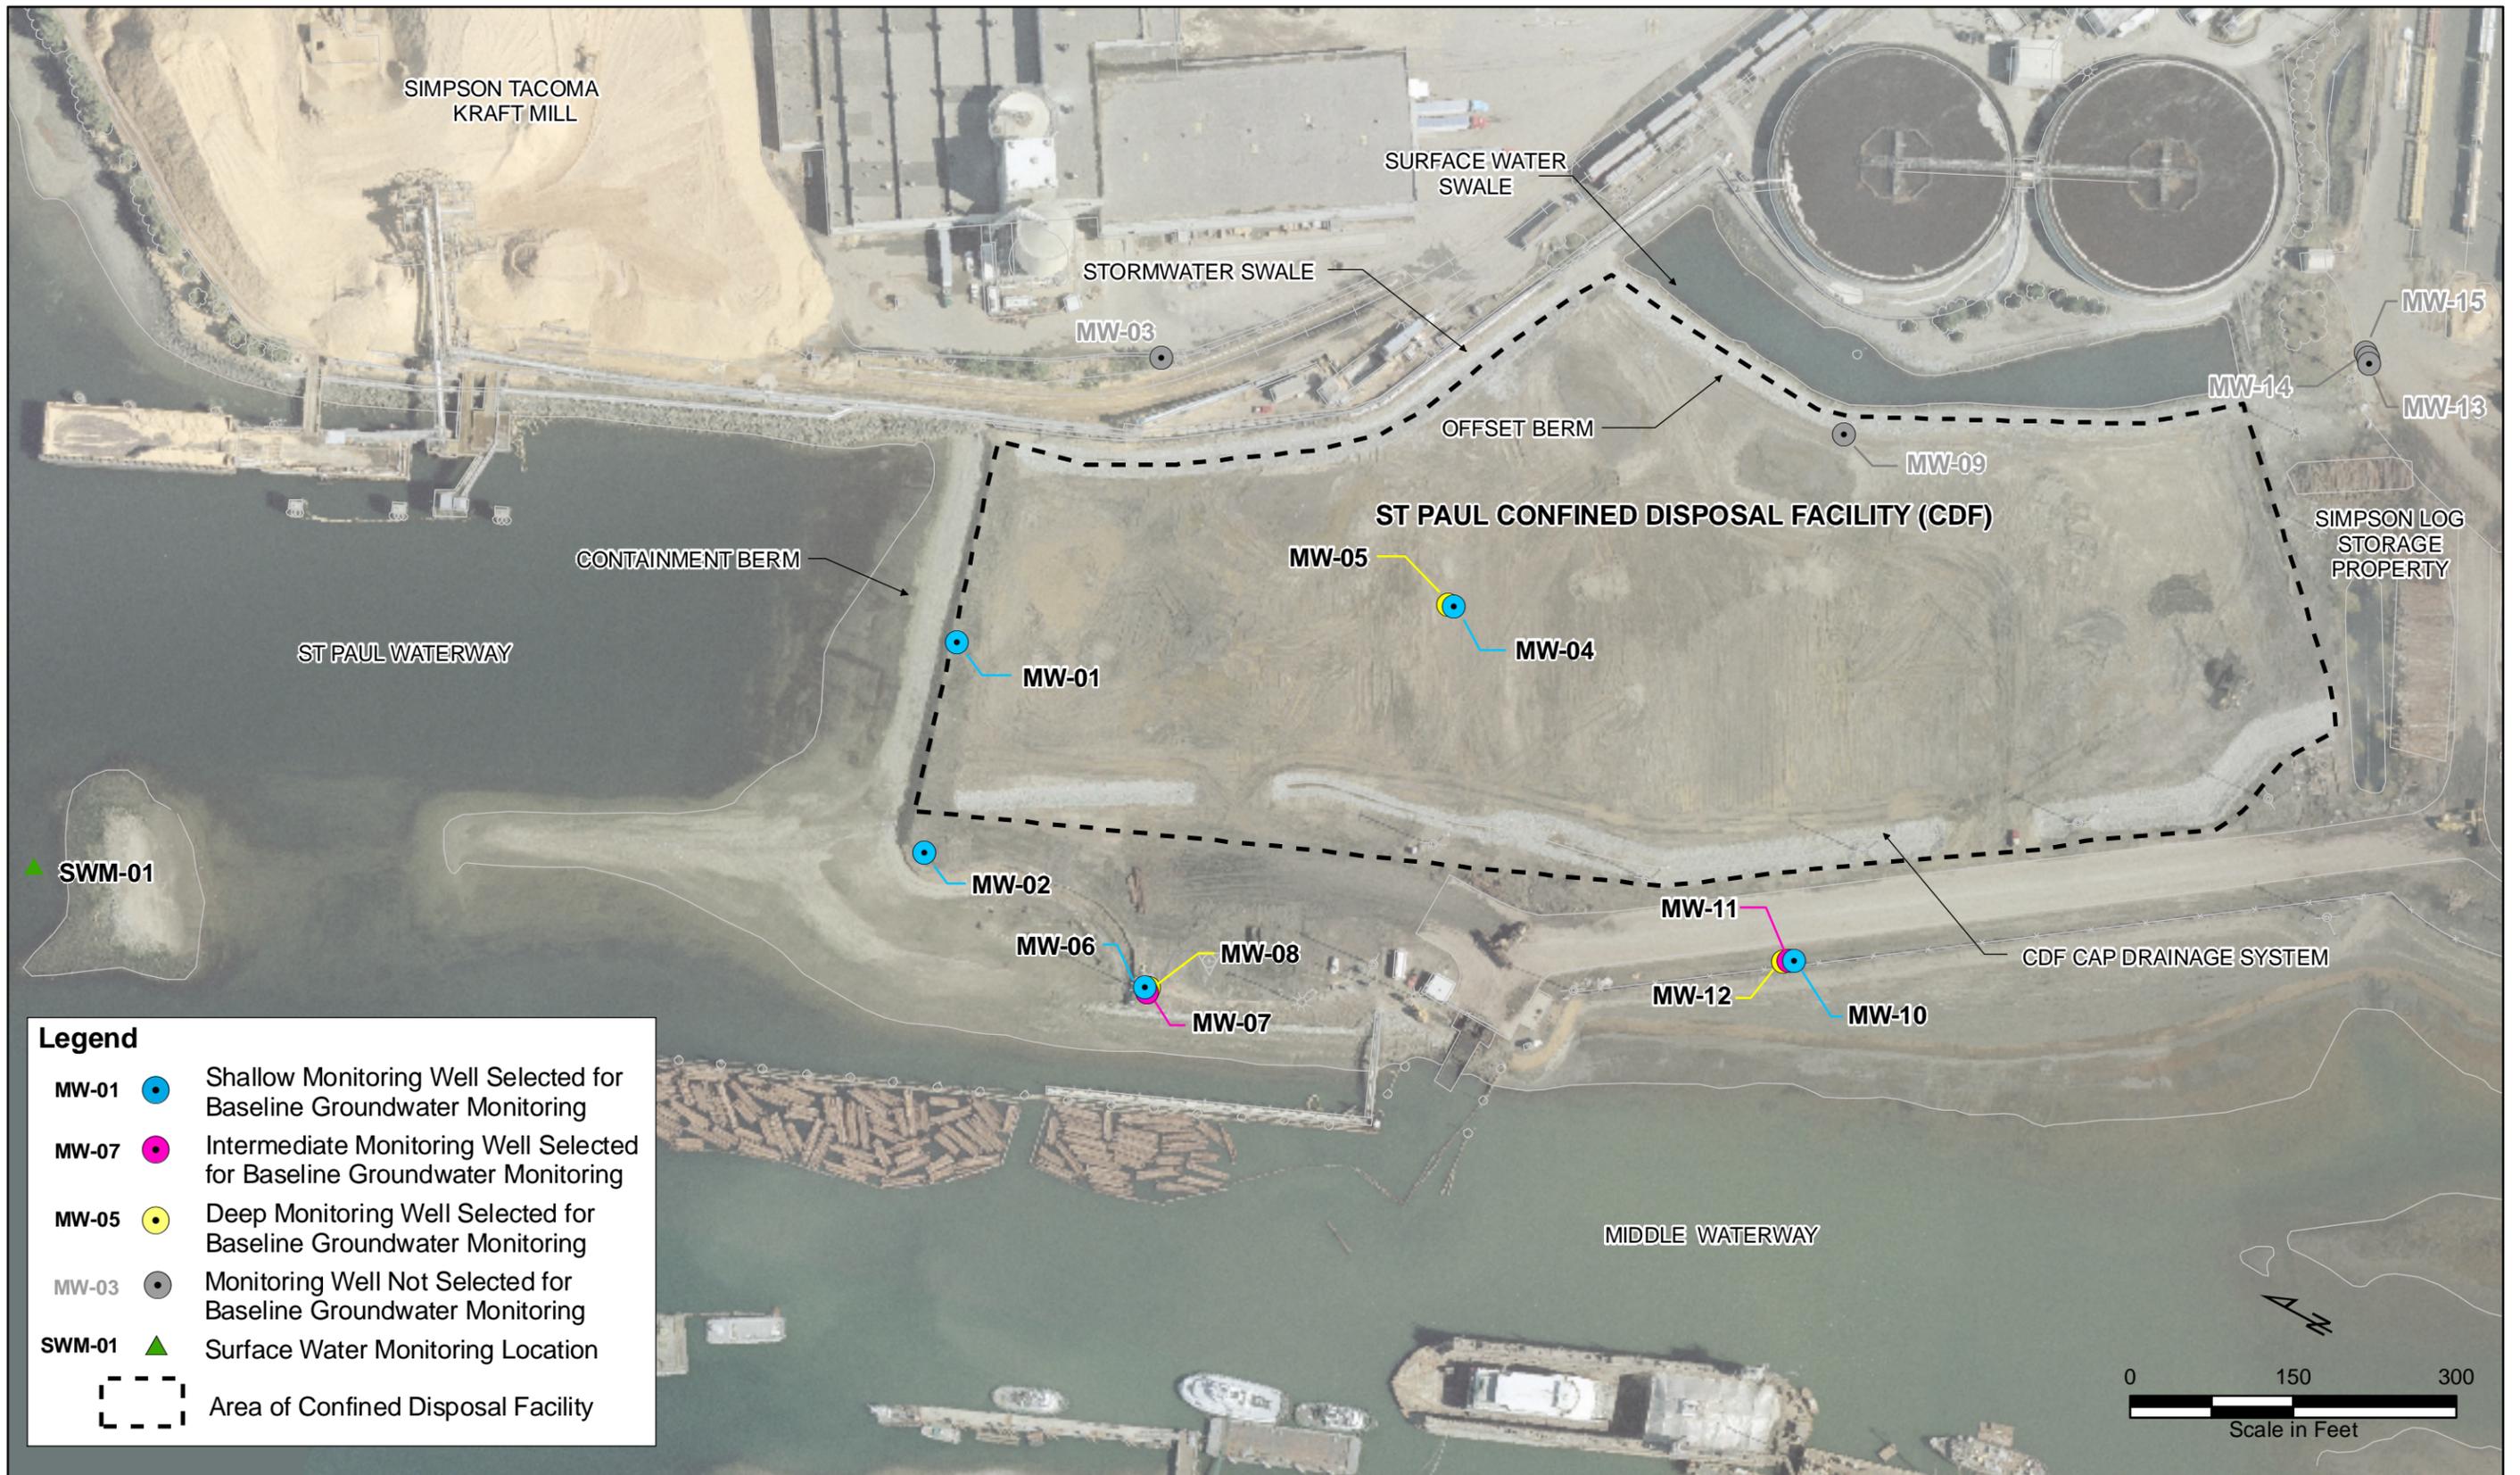
**Figure 5-1
Baseline CDF Surface Water and
Groundwater Monitoring Locations**

Baseline CDF monitoring included the collection of a surface water sample from one location as well as groundwater samples from 10 monitoring wells installed within and adjacent to the CDF (Figure 5-1). Surface water sampling and analysis was performed adjacent to the end of the St. Paul / Middle Waterway Peninsula near the mouths of the St. Paul and Middle Waterways and Puyallup River to establish ambient (i.e., background) surface water quality conditions. Baseline groundwater sampling and analysis was performed for the purpose of establishing baseline conditions to monitor possible future changes in groundwater conditions from contaminated sediment placed in the CDF. Groundwater samples were collected from CDF monitoring wells MW-01, MW-02, MW-04 thru MW-08, and MW-10 thru MW-12 that were selected for quarterly baseline monitoring.

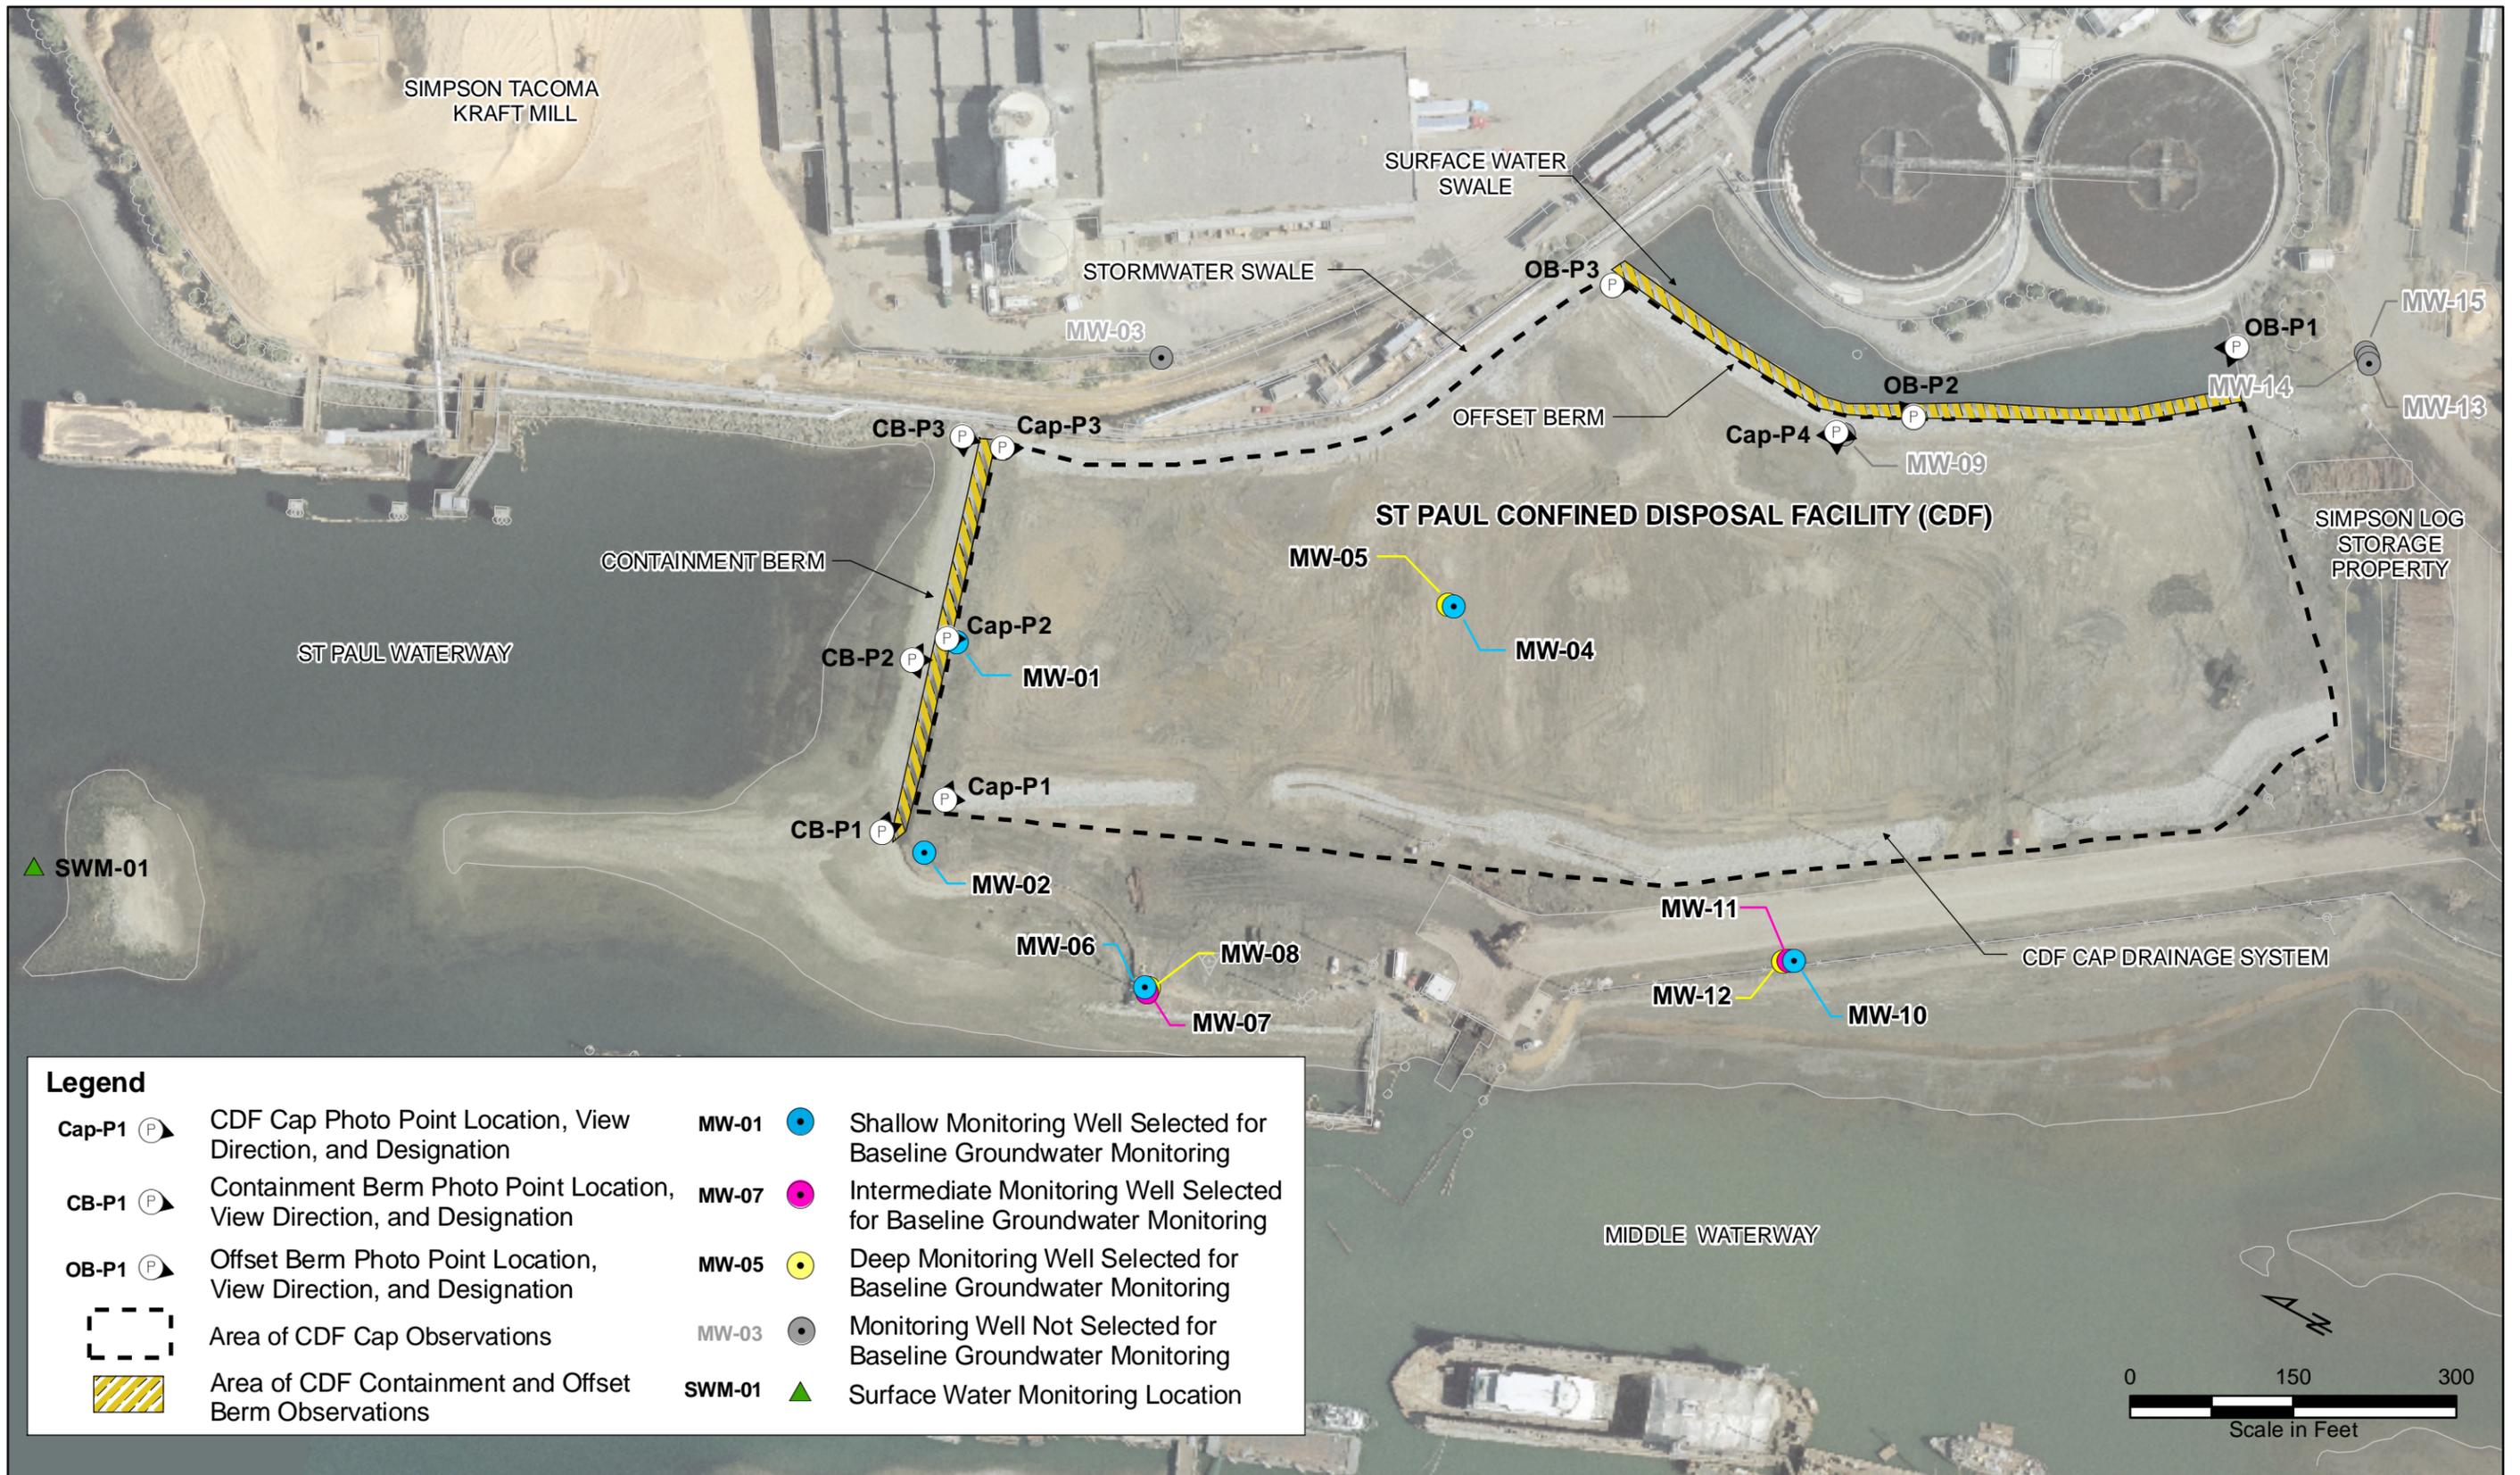
During each of the CDF monitoring events, surface water samples were collected using the City of Tacoma boat at the surface water monitoring station adjacent to the end of the St. Paul / Middle Waterway Peninsula (Figure 5-1). The surface water samples were collected during high tide in accordance with the OMMP. Surface water samples were submitted under chain of custody to Analytical Resources Incorporated (ARI) of Tukwila, Washington, for total mercury and dissolved metals analyses.

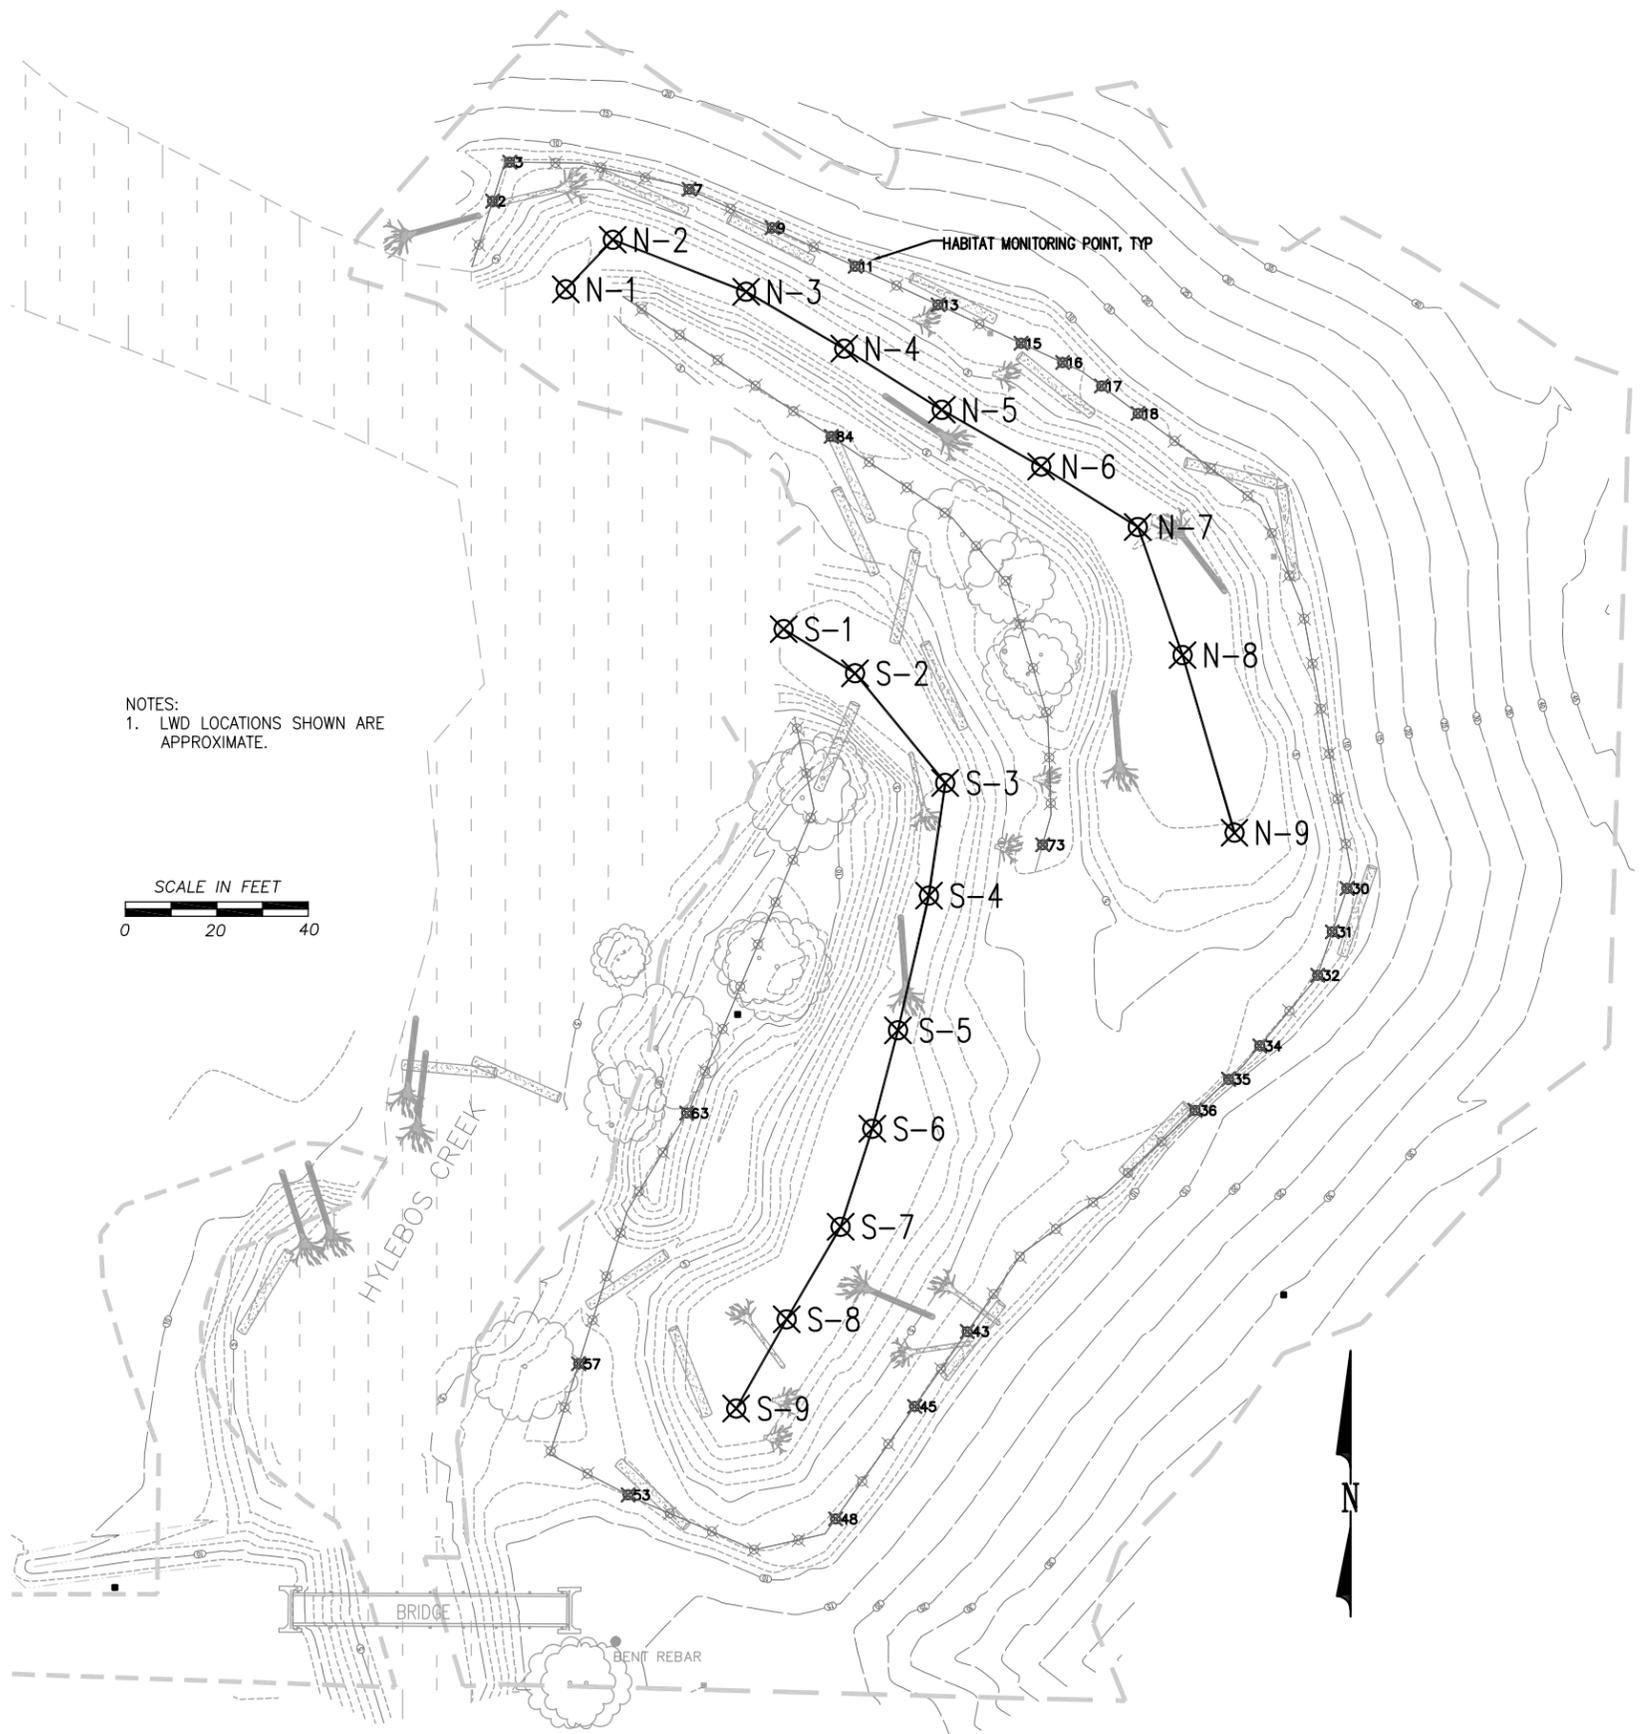
FIGURE 6-12
 HYLEBOS CREEK HABITAT
 QUANTITATIVE MONITORING LOCATIONS

SOUTH LOBE CENTERLINE			
POINT	NORTHING	EASTING	YR 2 ELEV.
S-1	705914.01	1181063.36	1.23
S-2 (E-2)	705904.40	1181079.00	1.44
S-3	705880.46	1181098.72	1.23
S-4	705855.87	1181095.14	1.36
S-5	705826.47	1181088.39	1.26
S-6	705804.98	1181082.76	0.71
S-7	705783.57	1181075.84	1.18
S-8	705763.37	1181064.01	1.04
S-9 (E-1)	705743.90	1181053.00	1.35
NORTH LOBE CENTERLINE			
POINT	NORTHING	EASTING	YR 2 ELEV.
N-1	705988.18	1181015.70	1.43
N-2 (E-6)	705999.00	1181026.00	1.68
N-3	705987.66	1181055.16	2.07
N-4	705975.21	1181076.61	1.91
N-5	705961.87	1181097.96	2.05
N-6	705949.49	1181119.73	1.93
N-7	705936.30	1181140.86	1.90
N-8	705908.34	1181150.64	1.97
N-9 (E-4)	705869.60	1181162.00	2.69
