**“STEP-OUT” SOLID MATRIX SAMPLING AND ANALYSIS RESULTS
AND SEDIMENT CHROMIUM SPECIATION
HALACO SUPERFUND SITE
REMEDIAL INVESTIGATION
OXNARD, CALIFORNIA**

EPA CONTRACT NO. EP-S9-08-04
EPA TASK ORDER NO. 015-RIRI-09X6
CH2M HILL PROJECT NO. 385135

Prepared for
U.S. Environmental Protection Agency
Region 9
75 Hawthorne Street
San Francisco, California 94105

January 2013

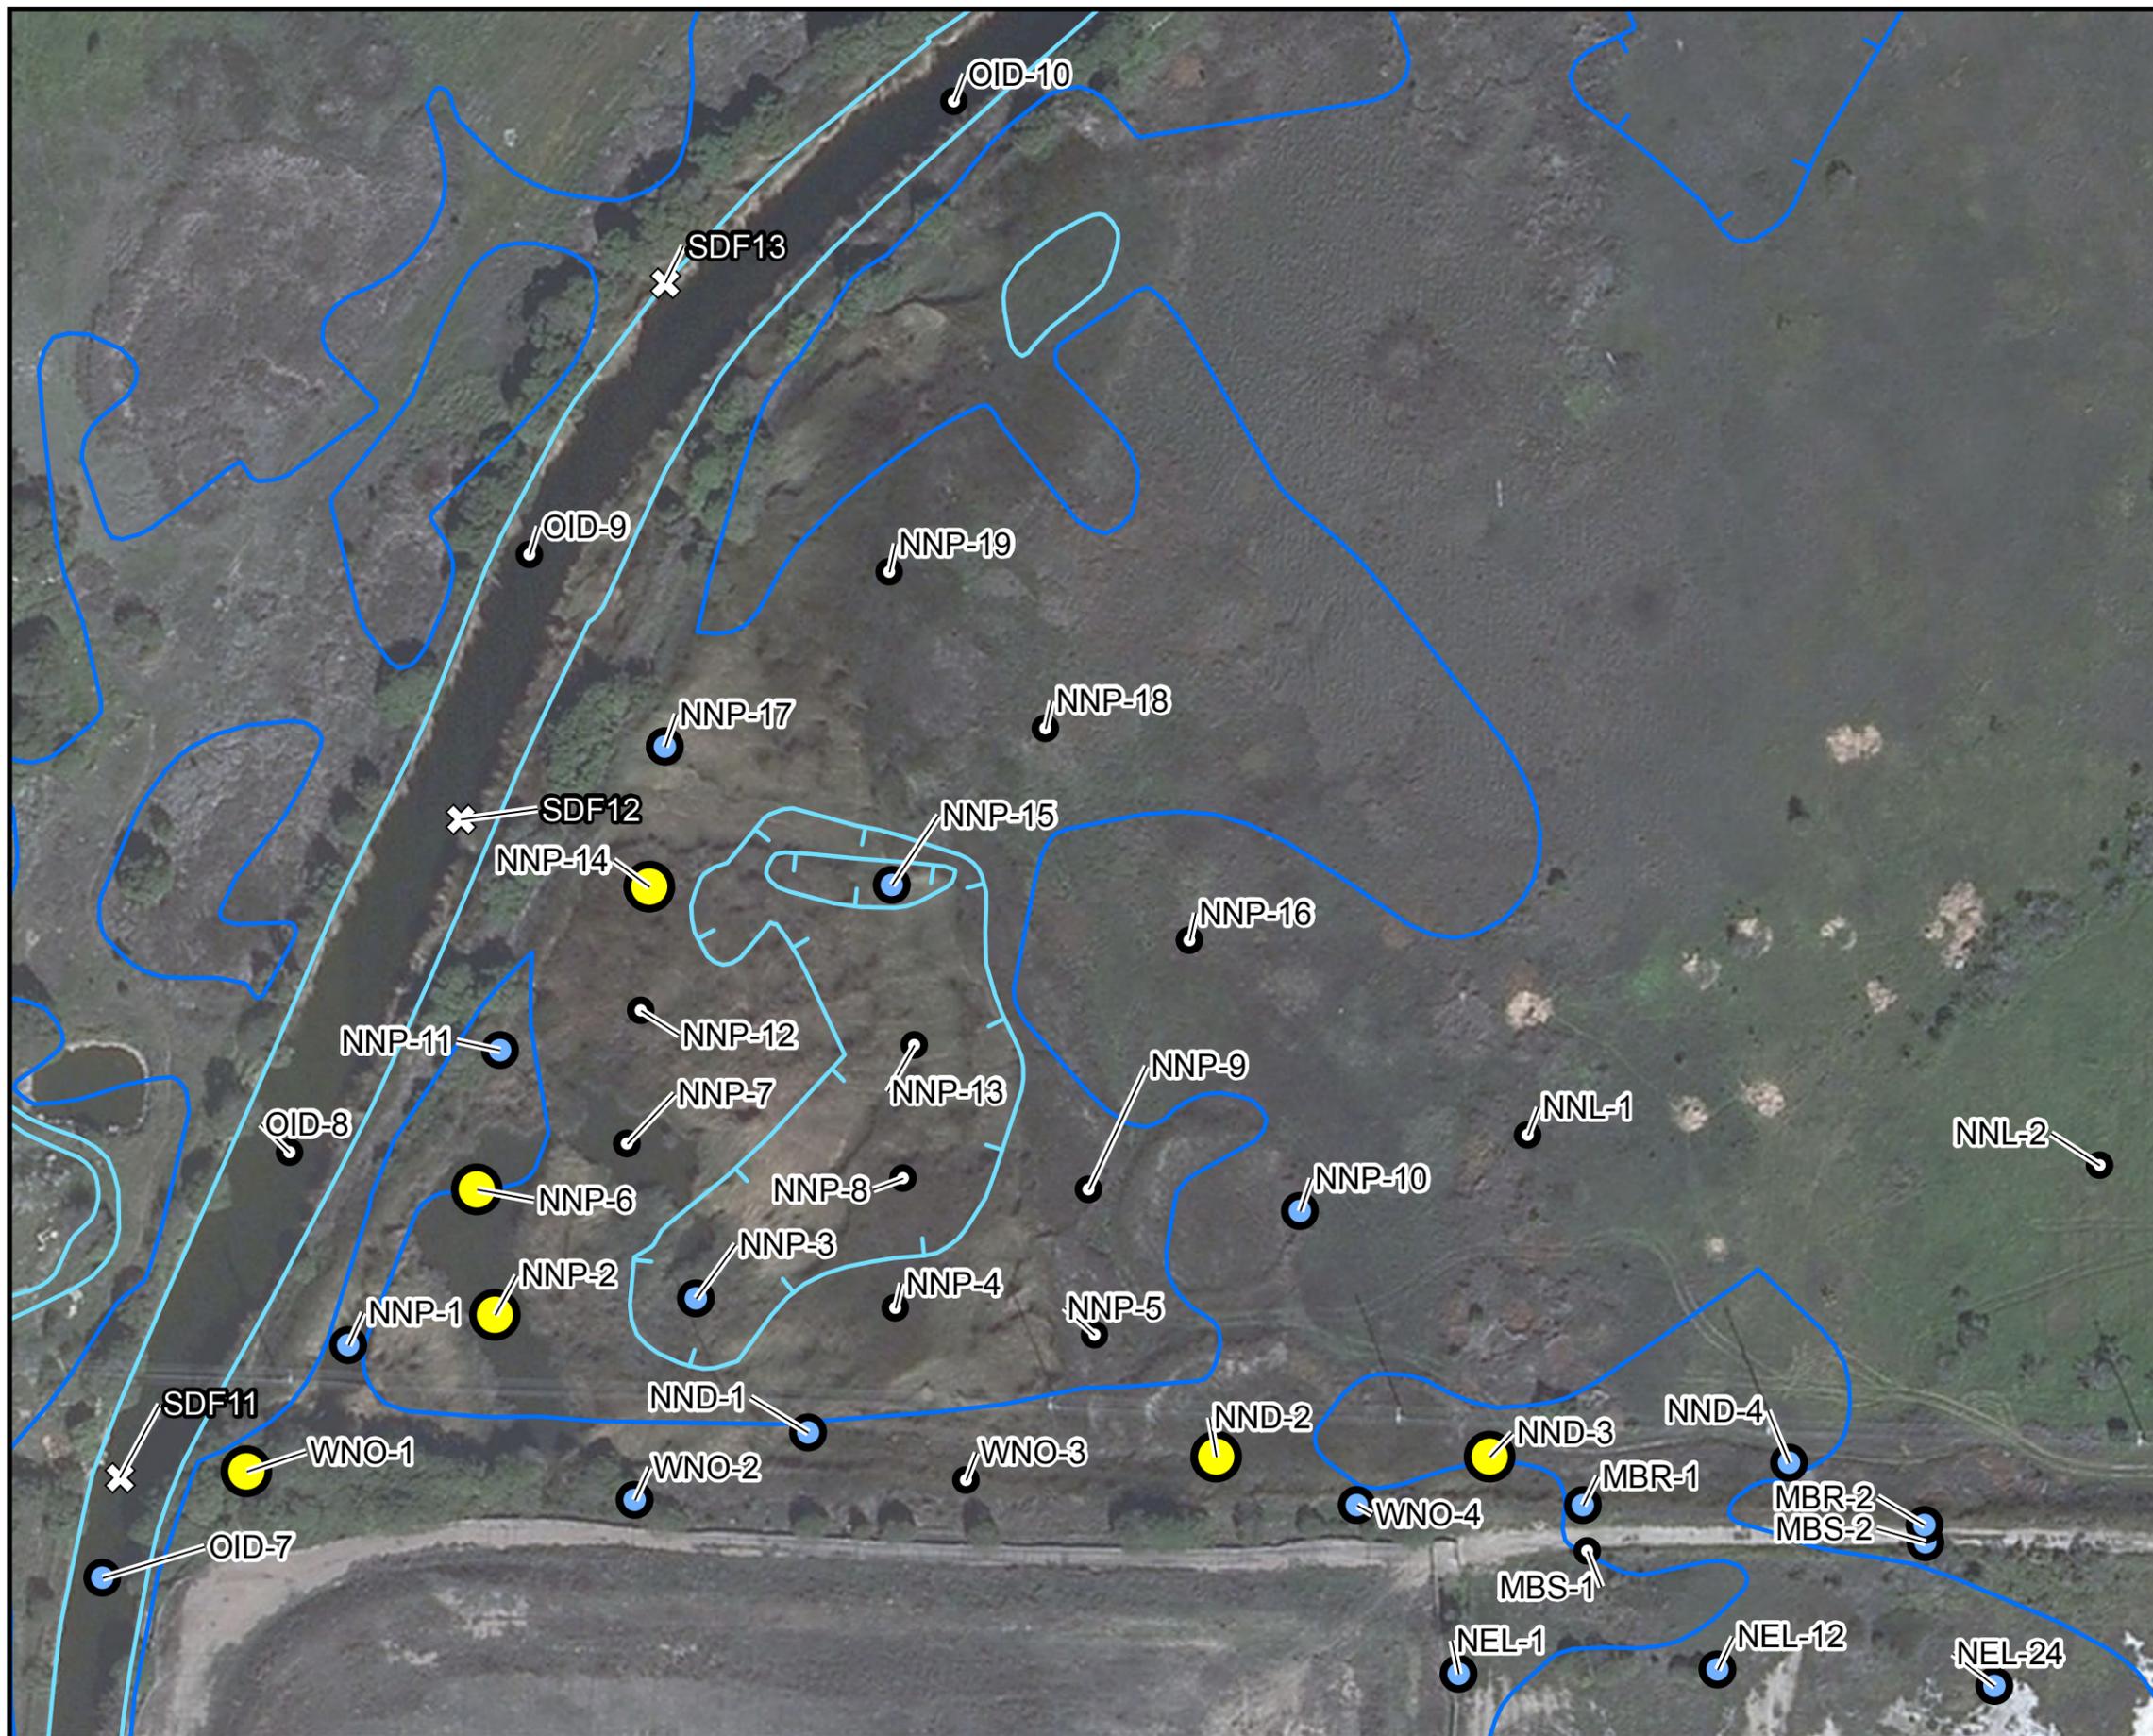
FIGURE 6a
**Lead Solid Matrix Concentrations,
 NCL North, Surface Samples**
 HALACO SITE REMEDIAL INVESTIGATION
 OXNARD, CALIFORNIA

**Lead Concentrations (mg/kg)
2010 and 2011 RI Sample Locations**

- To the north of the Waste Management Area, the contamination is limited primarily to the pond. Sediments in the pond were probably contaminated by Halaco process waste materials placed into a former OID channel or eroded into the pond from the Waste Management Area. Metals concentrations in samples collected to the northeast and east of the pond are consistent with background conditions.
