**DNAPL Extent in Saturated Zone**

Date: 03-05	Montrose Superfund Site	Figure
Project No. 76465	EarthTech	14
A Tyco International Ltd. Company

Montrose Chemical Corporation		Revised 03/03/05
<b>Extent of Elevated Headspace and DNAPL in Unsaturated Zone</b>		
Date: 03-05	Montrose Superfund Site	Figure
Project No. 76465	<b>EarthTech</b> A Tyco International Ltd. Company	15

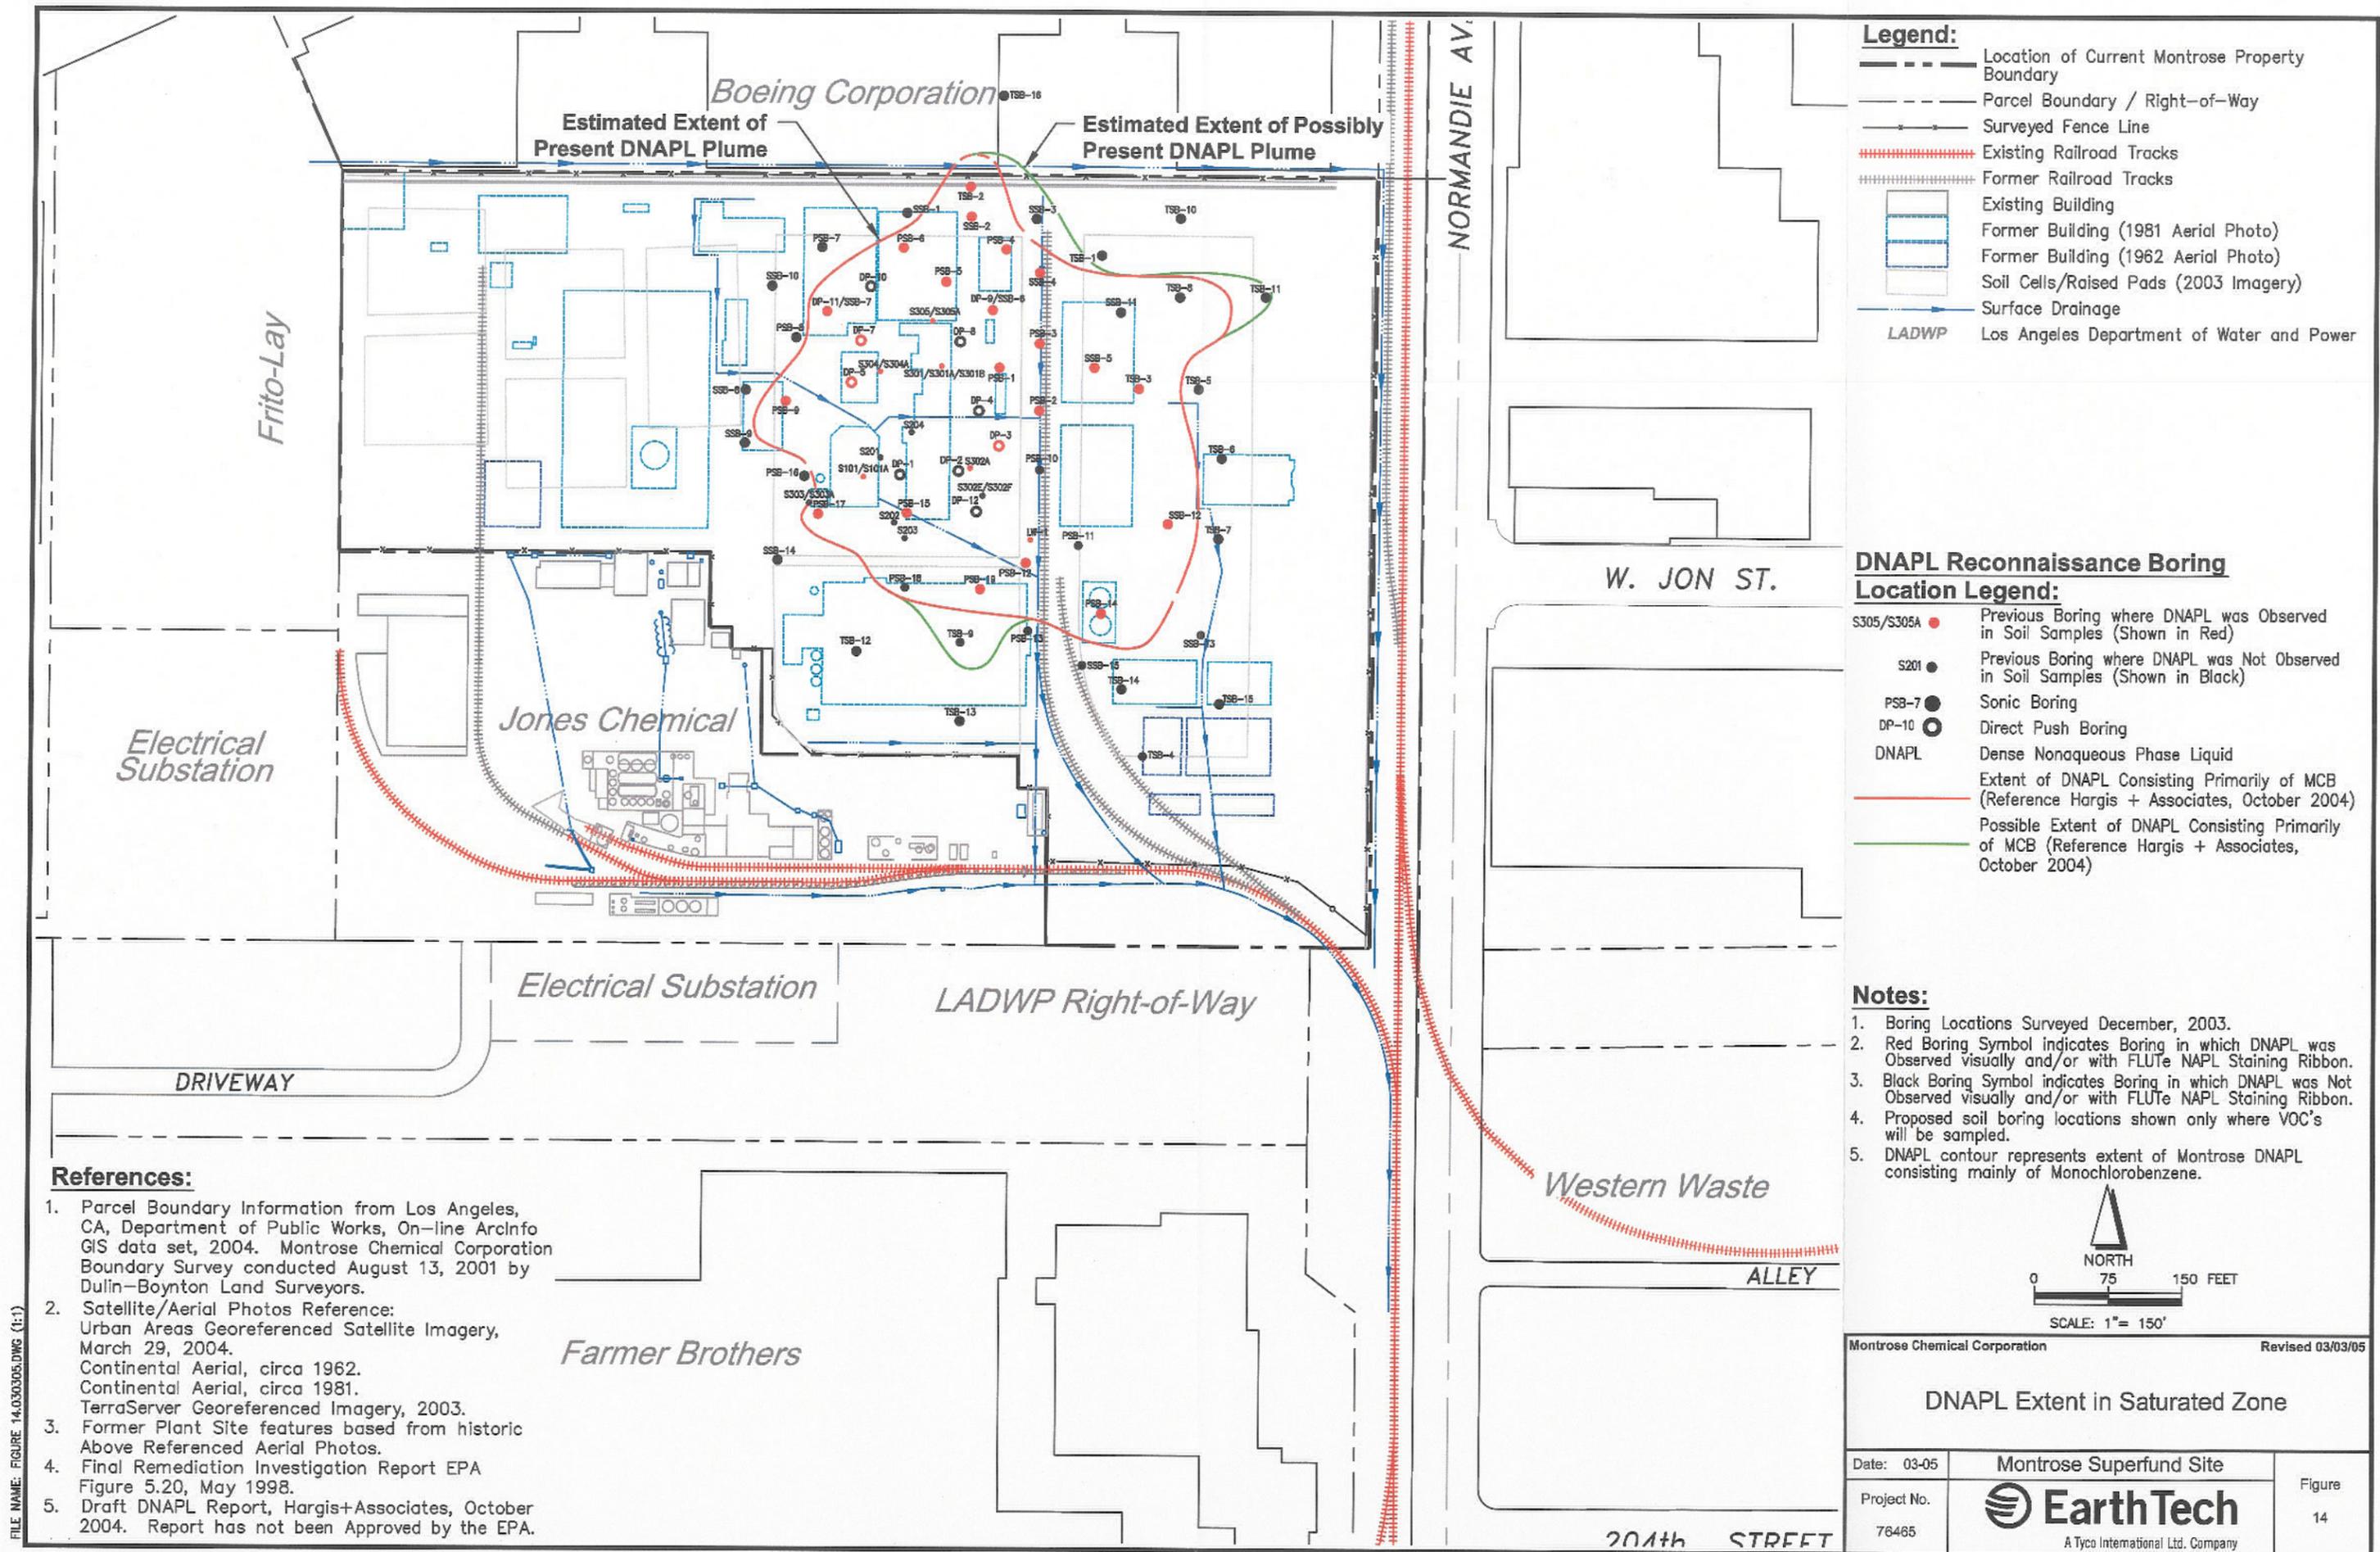
- DNAPL Reconnaissance Boring Location Legend:**
- S305/S305A ● Previous Boring where DNAPL was Observed in Soil Samples (Shown in Red)
  - S201 ● Previous Boring where DNAPL was Not Observed in Soil Samples (Shown in Black)
  - PSB-7 ● Sonic Boring
  - DP-10 ● Direct Push Boring
  - DNAPL Dense Nonaqueous Phase Liquid
  - Extent of DNAPL Consisting Primarily of MCB (Reference Hargis + Associates, October 2004)
  - Possible Extent of DNAPL Consisting Primarily of MCB (Reference Hargis + Associates, October 2004)

- Notes:**
1. Boring Locations Surveyed December, 2003.
  2. Red Boring Symbol indicates Boring in which DNAPL was Observed visually and/or with FLUTE NAPL Staining Ribbon.
  3. Black Boring Symbol indicates Boring in which DNAPL was Not Observed visually and/or with FLUTE NAPL Staining Ribbon.
  4. Proposed soil boring locations shown only where VOC's will be sampled.
  5. DNAPL contour represents extent of Montrose DNAPL consisting mainly of Monochlorobenzene.

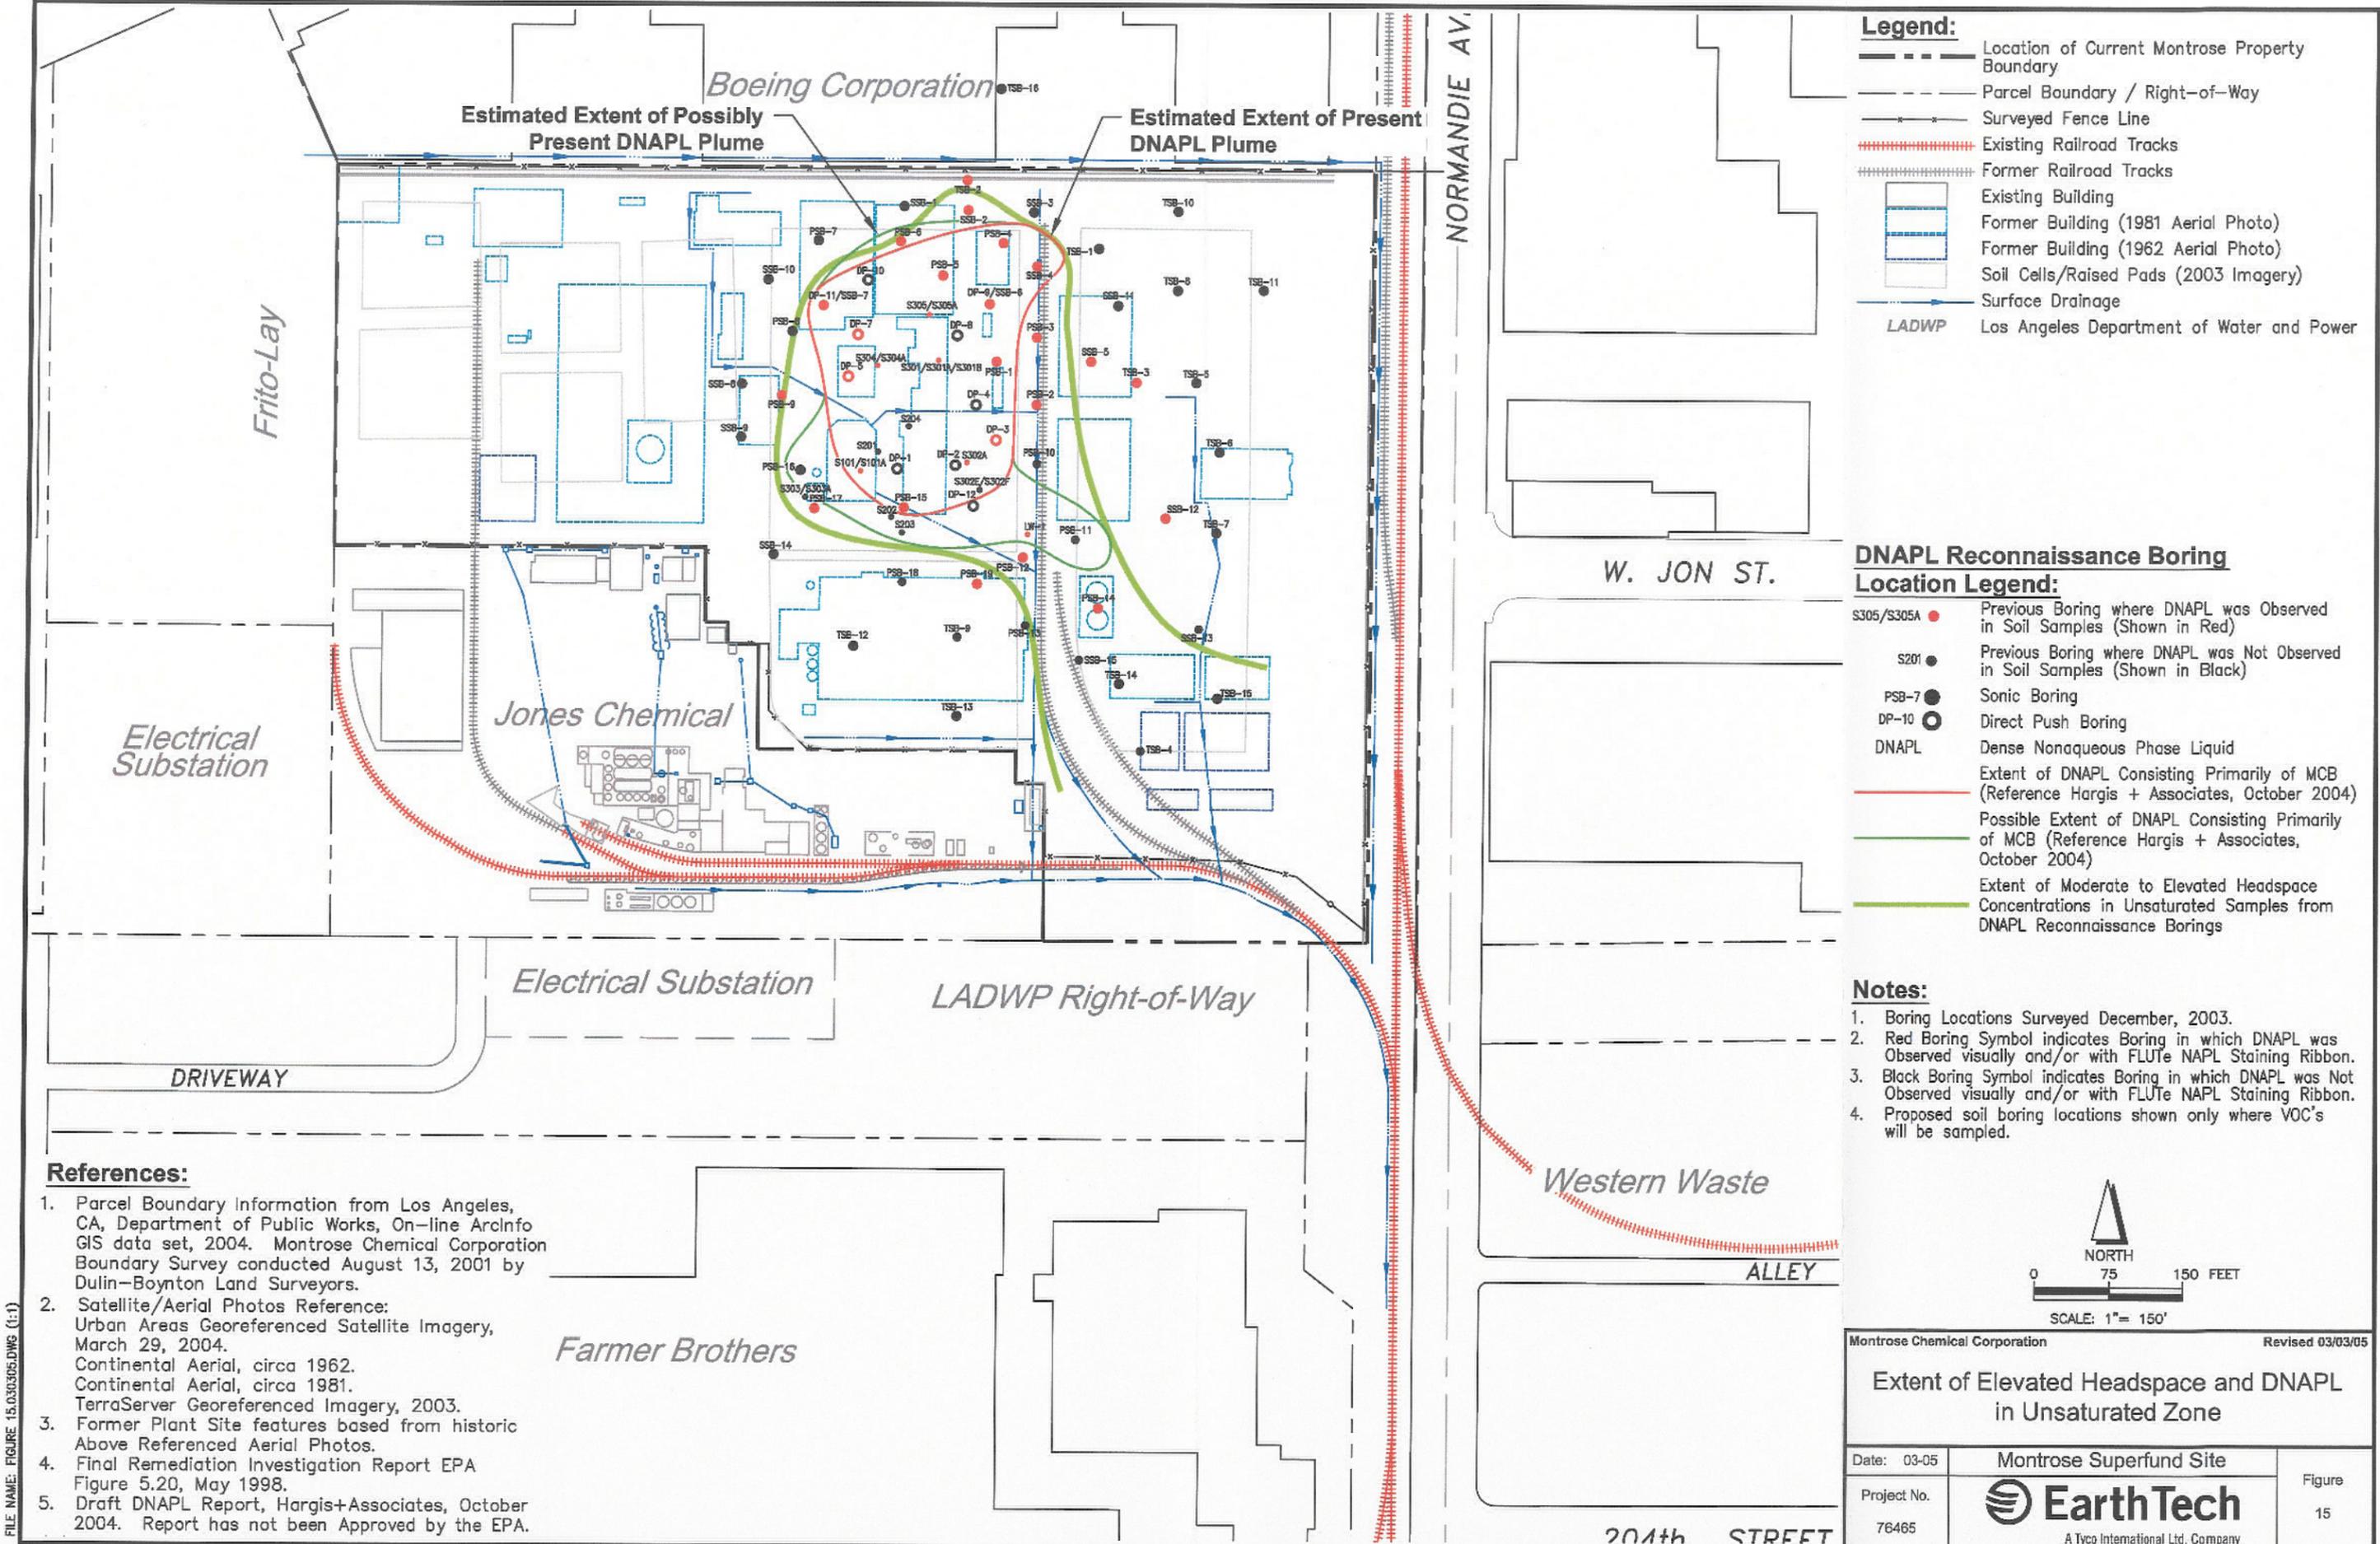
FILE NAME: FIGURE 15\_030305.DWG (1:1)

- DNAPL Reconnaissance Boring Location Legend:**
- S305/S305A ● Previous Boring where DNAPL was Observed in Soil Samples (Shown in Red)
  - S201 ● Previous Boring where DNAPL was Not Observed in Soil Samples (Shown in Black)
  - PSB-7 ● Sonic Boring
  - DP-10 ● Direct Push Boring
  - DNAPL Dense Nonaqueous Phase Liquid
  - Extent of DNAPL Consisting Primarily of MCB (Reference Hargis + Associates, October 2004)
  - Possible Extent of DNAPL Consisting Primarily of MCB (Reference Hargis + Associates, October 2004)
  - Extent of Moderate to Elevated Headspace Concentrations in Unsaturated Samples from DNAPL Reconnaissance Borings

- Notes:**
1. Boring Locations Surveyed December, 2003.
  2. Red Boring Symbol indicates Boring in which DNAPL was Observed visually and/or with FLUTE NAPL Staining Ribbon.
  3. Black Boring Symbol indicates Boring in which DNAPL was Not Observed visually and/or with FLUTE NAPL Staining Ribbon.
  4. Proposed soil boring locations shown only where VOC's will be sampled.
