**Environmental Restoration  
Five-Year Review Report**

**Third Five-Year Review Report  
For  
Bonneville Power Administration  
Ross Complex  
Vancouver, Washington**

**August 2009**

**PREPARED BY:  
Bonneville Power Administration  
Vancouver, Washington**

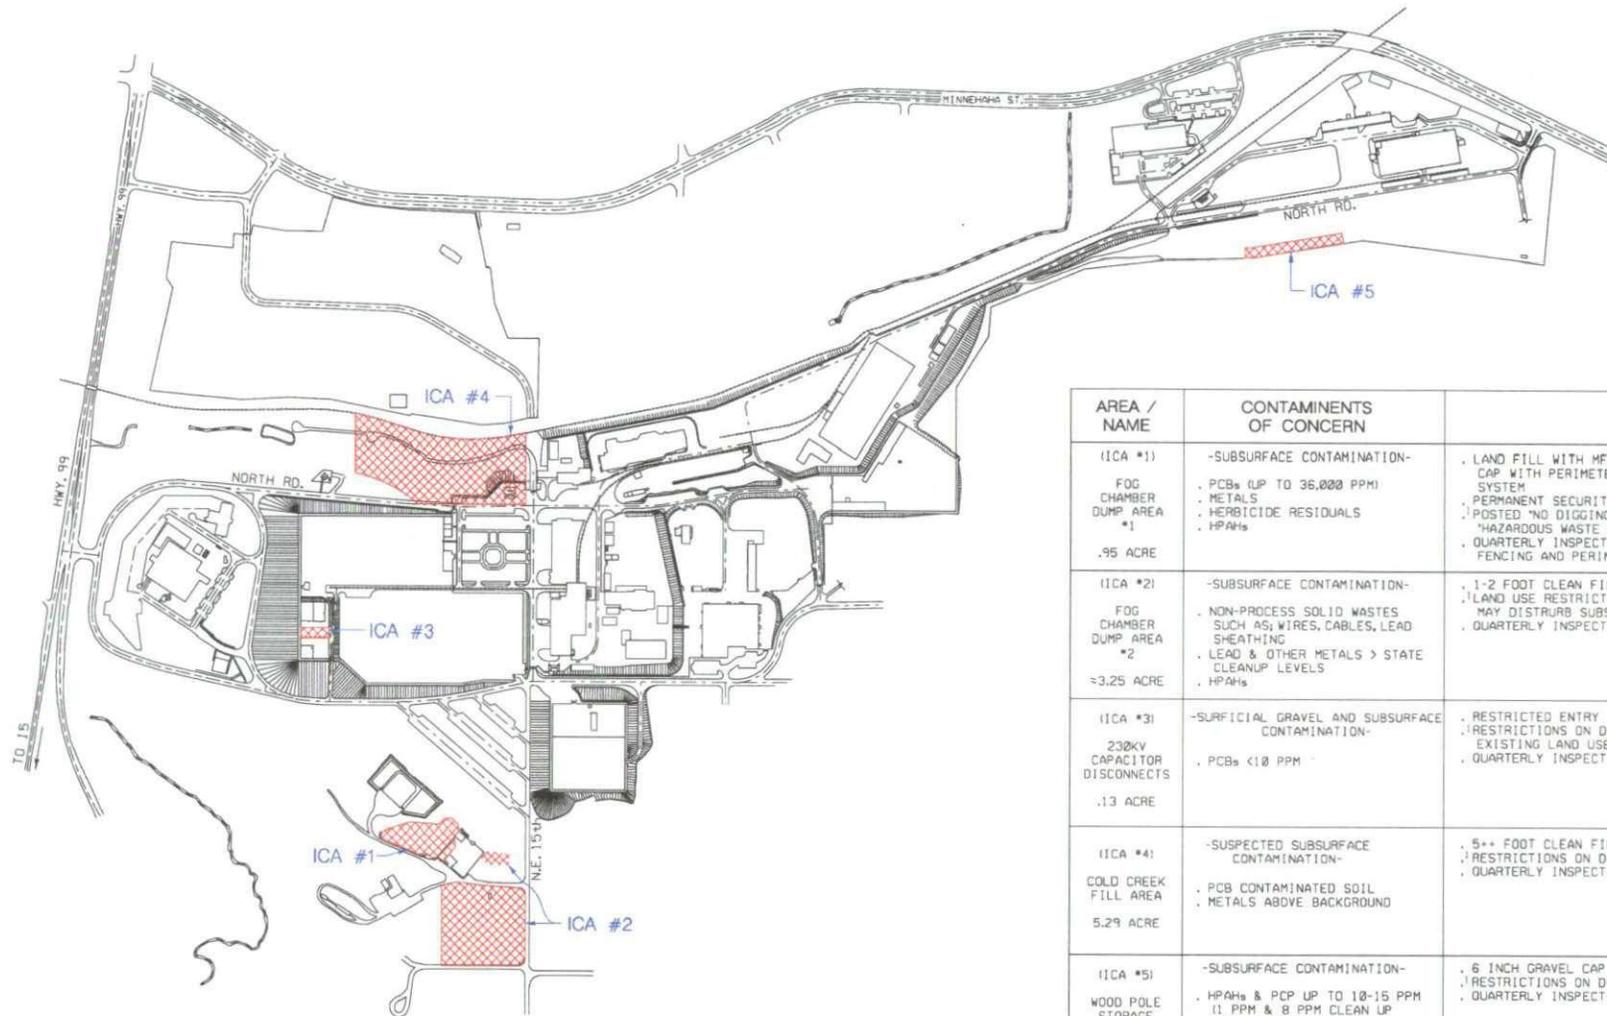
AREA / NAME	CONTAMINENTS OF CONCERN	CONTROL MEASURES	SEE FIG#
(ICA #1) FOG CHAMBER DUMP AREA #1 .95 ACRE	-SUBSURFACE CONTAMINATION- • PCBs (UP TO 36,000 PPM) • METALS • HERBICIDE RESIDUALS • HPAHs	• LAND FILL WITH MFS (IMPERVIOUS) ENGINEERED CAP WITH PERIMETER DRAINAGE COLLECTION SYSTEM • PERMANENT SECURITY FENCE AROUND AREA • POSTED "NO DIGGING" INSIDE OF FENCE, "HAZARDOUS WASTE LANDFILL" OUTSIDE FENCE • QUARTERLY INSPECTIONS OF CAP, PERIMETER FENCING AND PERIMETER DRAINAGE CLEANOUTS	FIG #1
(ICA #2) FOG CHAMBER DUMP AREA #2 ~3.25 ACRE	-SUBSURFACE CONTAMINATION- • NON-PROCESS SOLID WASTES SUCH AS; WIRES, CABLES, LEAD SHEATHING • LEAD & OTHER METALS > STATE CLEANUP LEVELS • HPAHs	• 1-2 FOOT CLEAN FILL MATERIAL COVER • LAND USE RESTRICTIONS ON ACTIVITIES WHICH MAY DISTURB SUBSURFACE CONTAMINATION • QUARTERLY INSPECTIONS	FIG #1
(ICA #3) 230KV CAPACITOR DISCONNECTS .13 ACRE	-SURFICIAL GRAVEL AND SUBSURFACE CONTAMINATION- • PCBs <10 PPM	• RESTRICTED ENTRY • RESTRICTIONS ON DIGGING AND NO CHANGE IN EXISTING LAND USE • QUARTERLY INSPECTIONS	FIG #2

(ICA #4) COLD CREEK FILL AREA 5.29 ACRE	-SUSPECTED SUBSURFACE CONTAMINATION- • PCB CONTAMINATED SOIL • METALS ABOVE BACKGROUND	• 5+ FOOT CLEAN FILL CAP • RESTRICTIONS ON DIGGING • QUARTERLY INSPECTIONS	FIG #3
(ICA #5) WOOD POLE STORAGE AREA, EAST .47 ACRE	-SUBSURFACE CONTAMINATION- • HPAHs & PCP UP TO 10-15 PPM (1 PPM & 8 PPM CLEAN UP LEVELS RESPECTIVELY)	• 6 INCH GRAVEL CAP • RESTRICTIONS ON DIGGING & LAND USE • QUARTERLY INSPECTIONS	FIG #4
