Third 5-Year Review for NAS Whidbey Island Ault Field and Seaplane Base

NAS Whidbey Island

Oak Harbor, Washington

Department of the Navy
Naval Facilities Engineering Command Northwest
1101 Tautog Circle
Silverdale, WA 98315

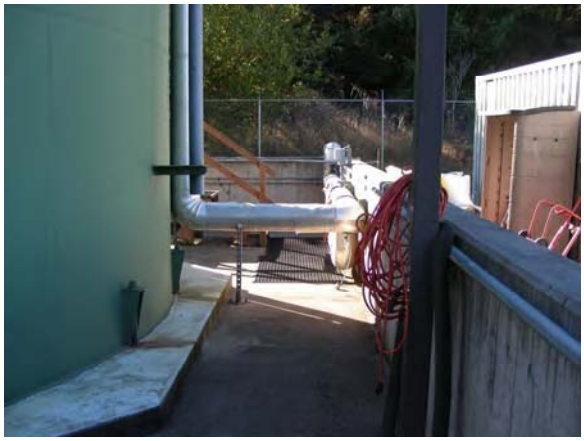
Area 6 Treatment Pad
Secondary Containment Wall
