**Public Summary: Final Removal Action Landfill Cap Closeout Report
Parcel E-2, Hunters Point Shipyard, San Francisco, California,
February 7, 2005**

Removal Action Landfill Cap Closeout Report Parcel E-2

Hunters Point Shipyard
San Francisco, California

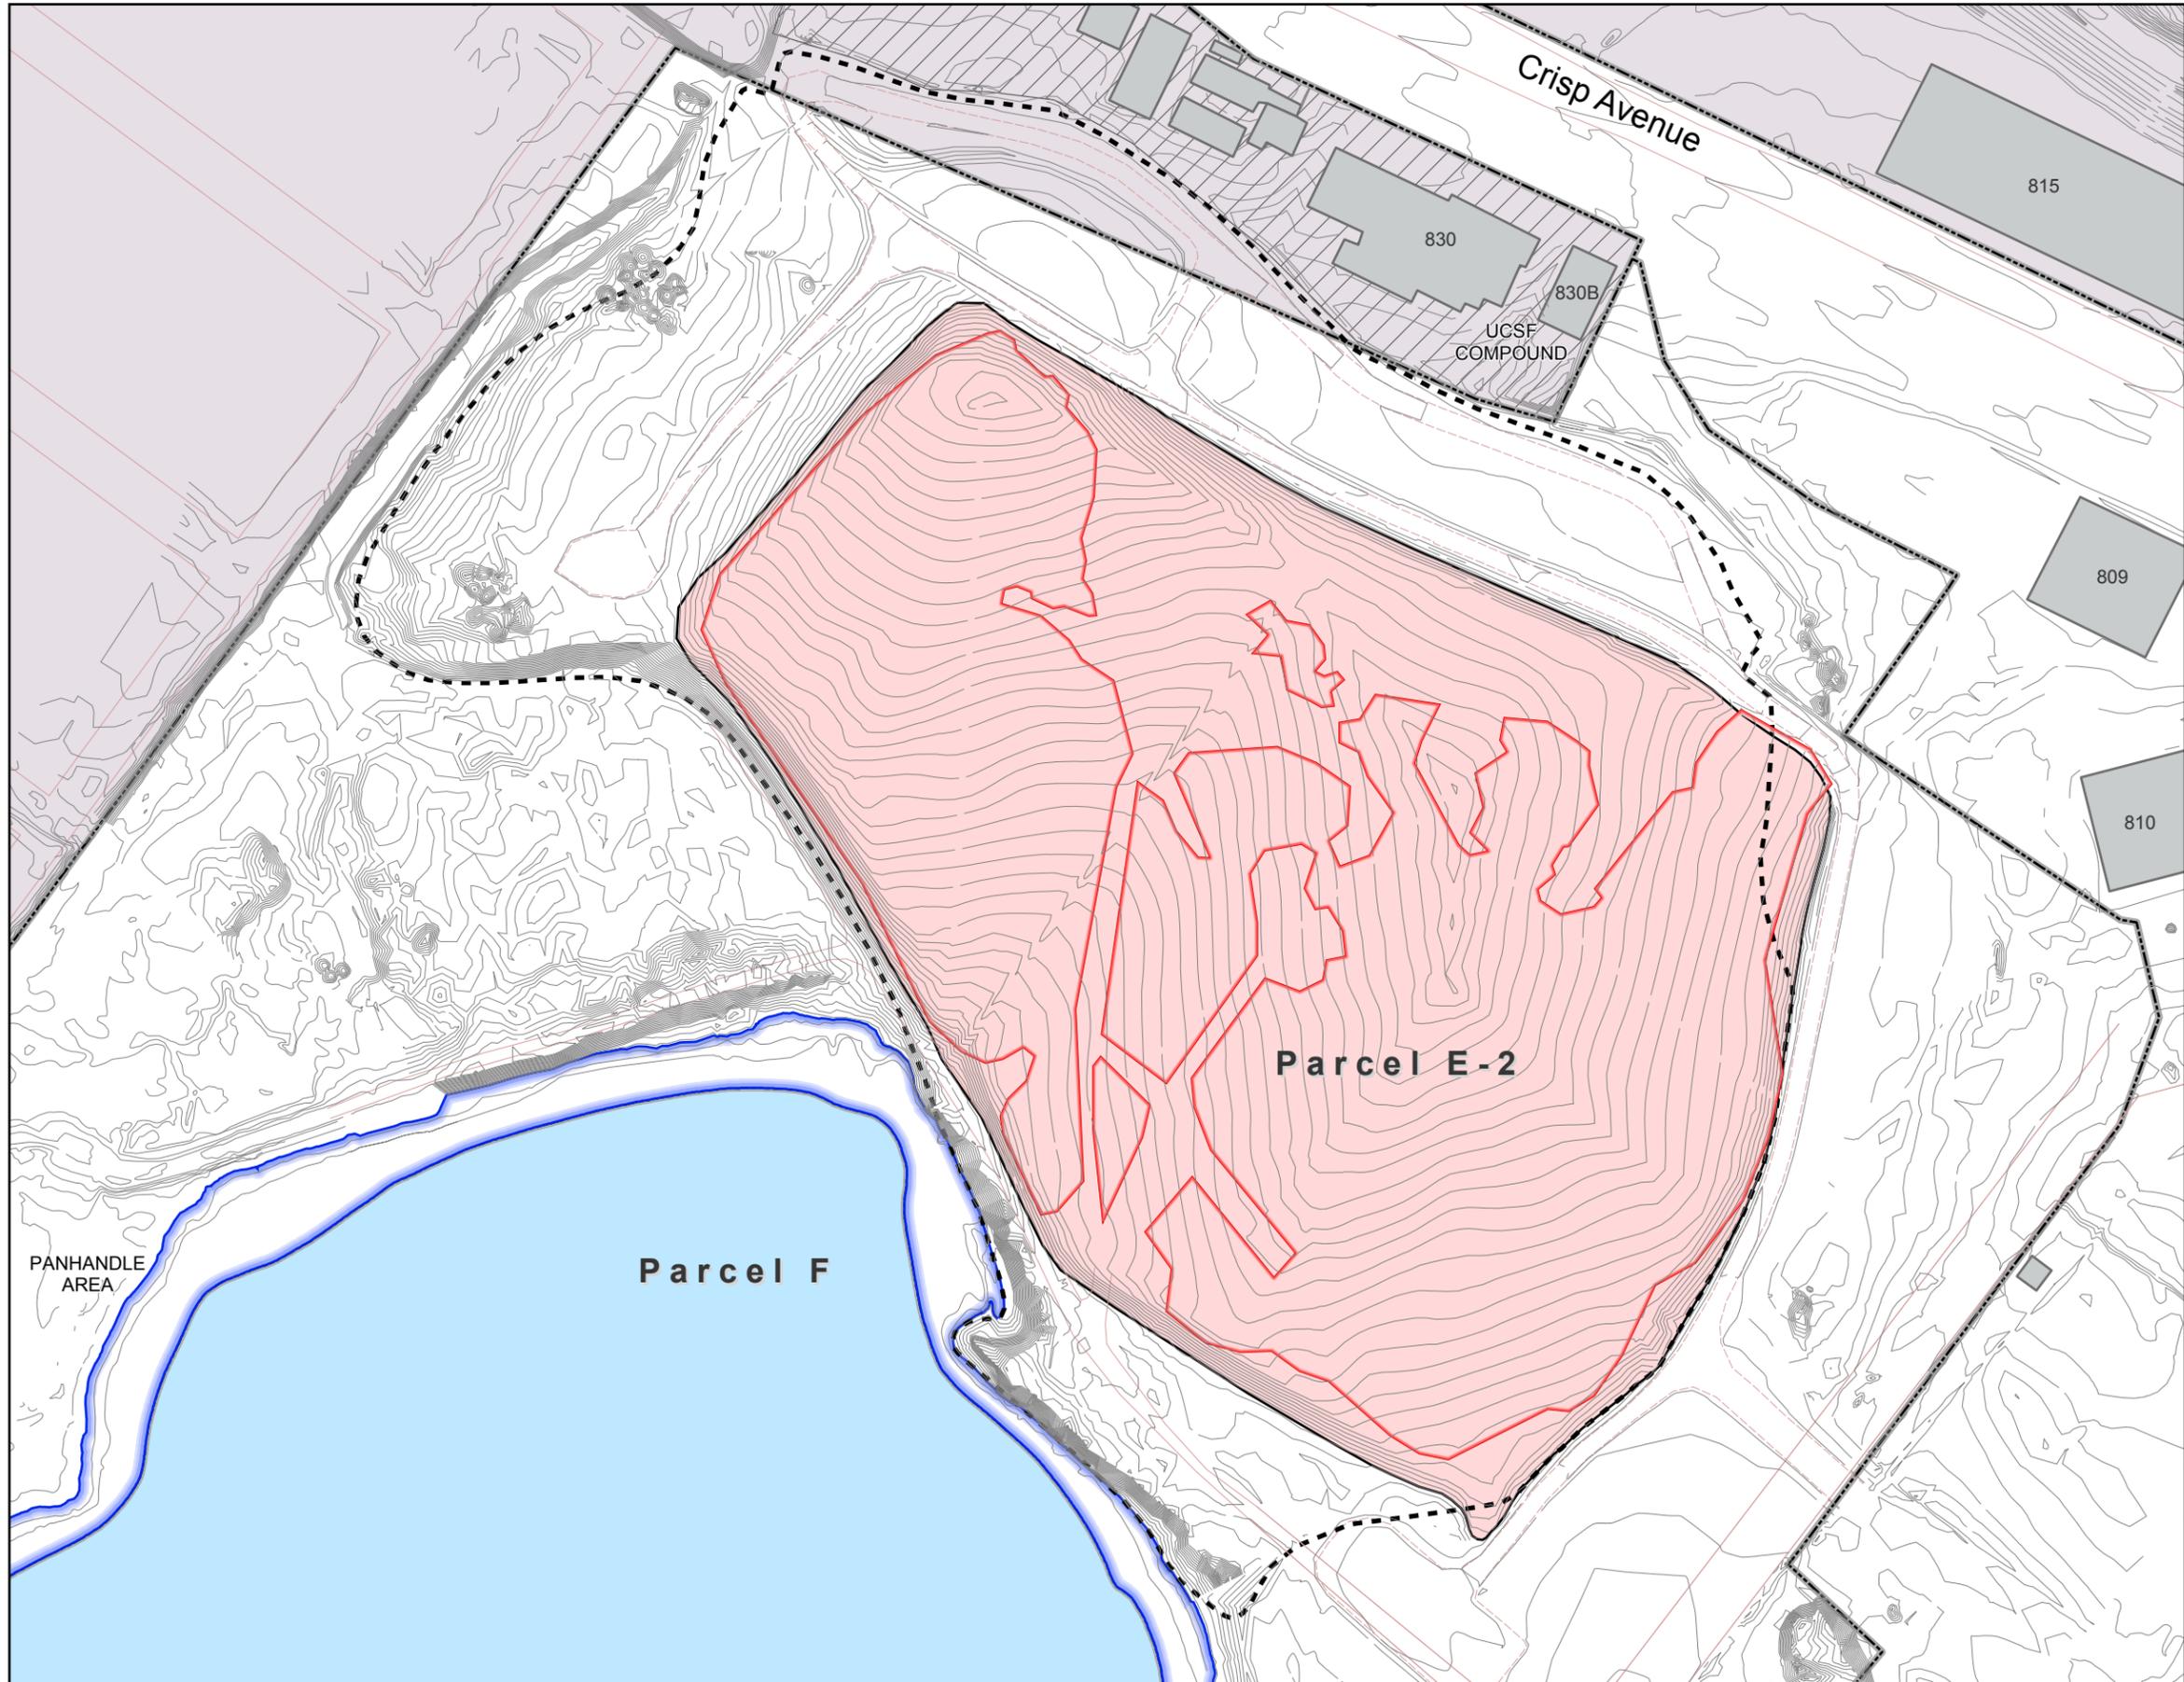
FIGURE 2
LATERAL EXTENT OF INTERIM CAP AND BURN AREA
Final Removal Action
Landfill Cap Closeout Report

- Parcel Boundary
- Shoreline Area
- Extent of Solid Waste
- Burn Area
- Landfill Cap Extent
- Non-Navy Property
- UCSF Compound
- Building
- Surface Contour (in feet)
- Road
- Gravel Road

This section summarizes the design and construction of the approximately 14-acre interim landfill cap installed as a response to the landfill fire. [Figure 2](#) shows the interim landfill cap in relation to the delineated waste and the burned surface area. The interim landfill cap is a multilayer cap designed to inhibit air and water intrusion into the Landfill. The design of the interim cap system is described in “Technical Specifications, Hunters Point Shipyard, Parcel E IR 1/21 Interim Landfill Cap” (IT 2000b). [Attachments B and C](#) of this report contain detailed documentation of the cap construction and the quality assurance and quality control procedures.

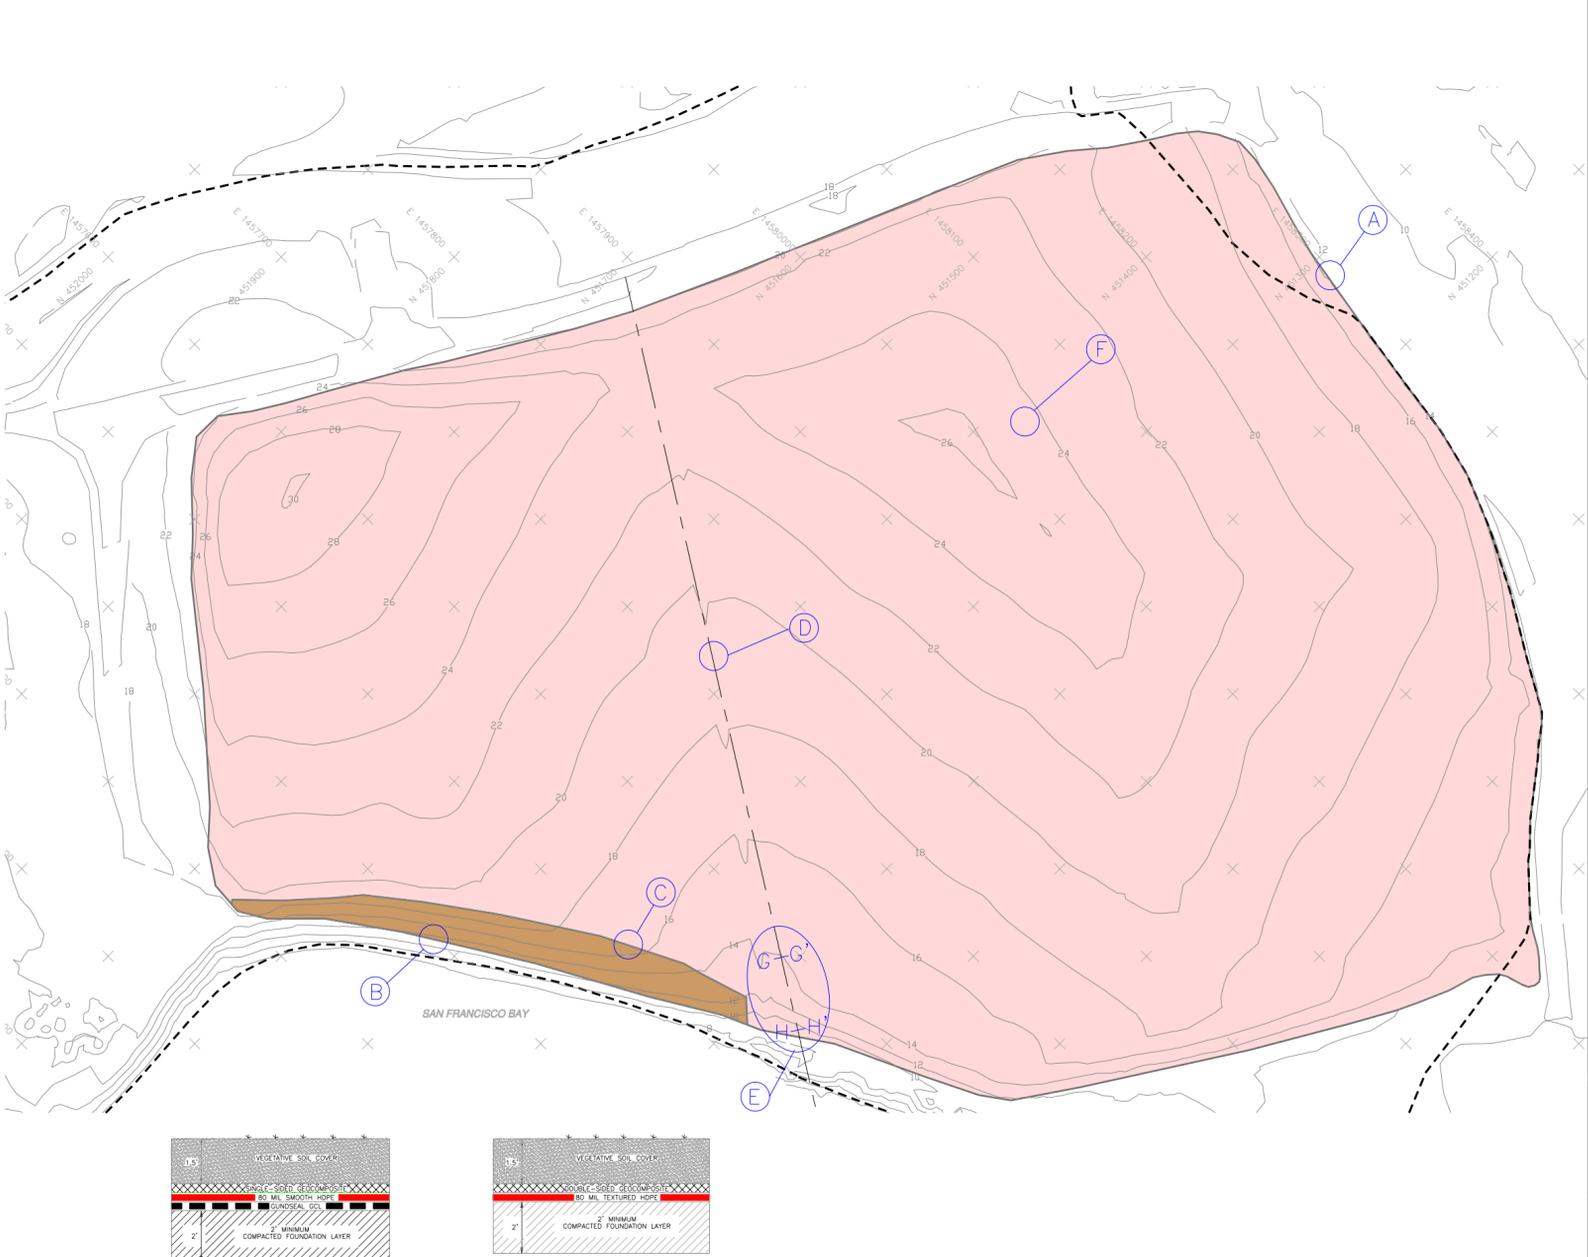
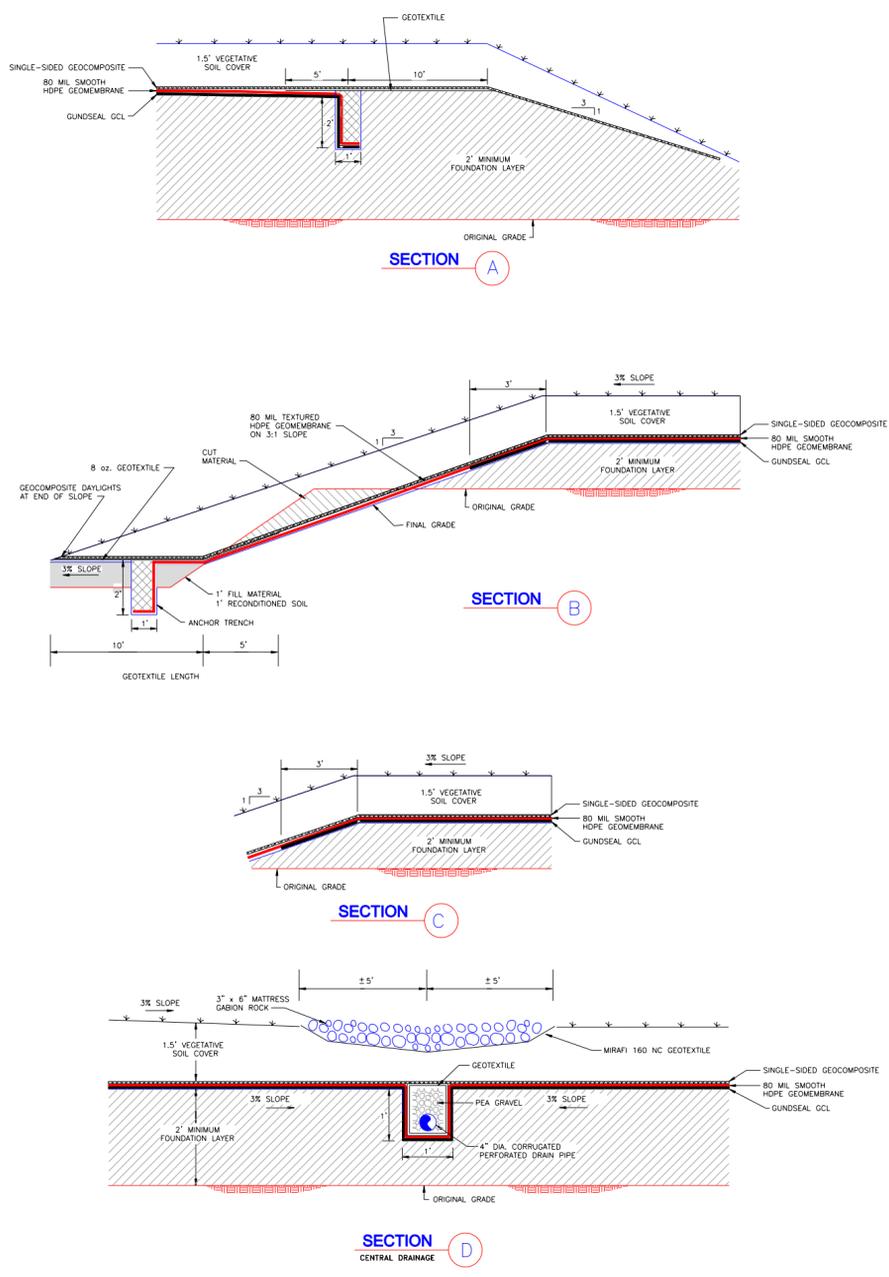
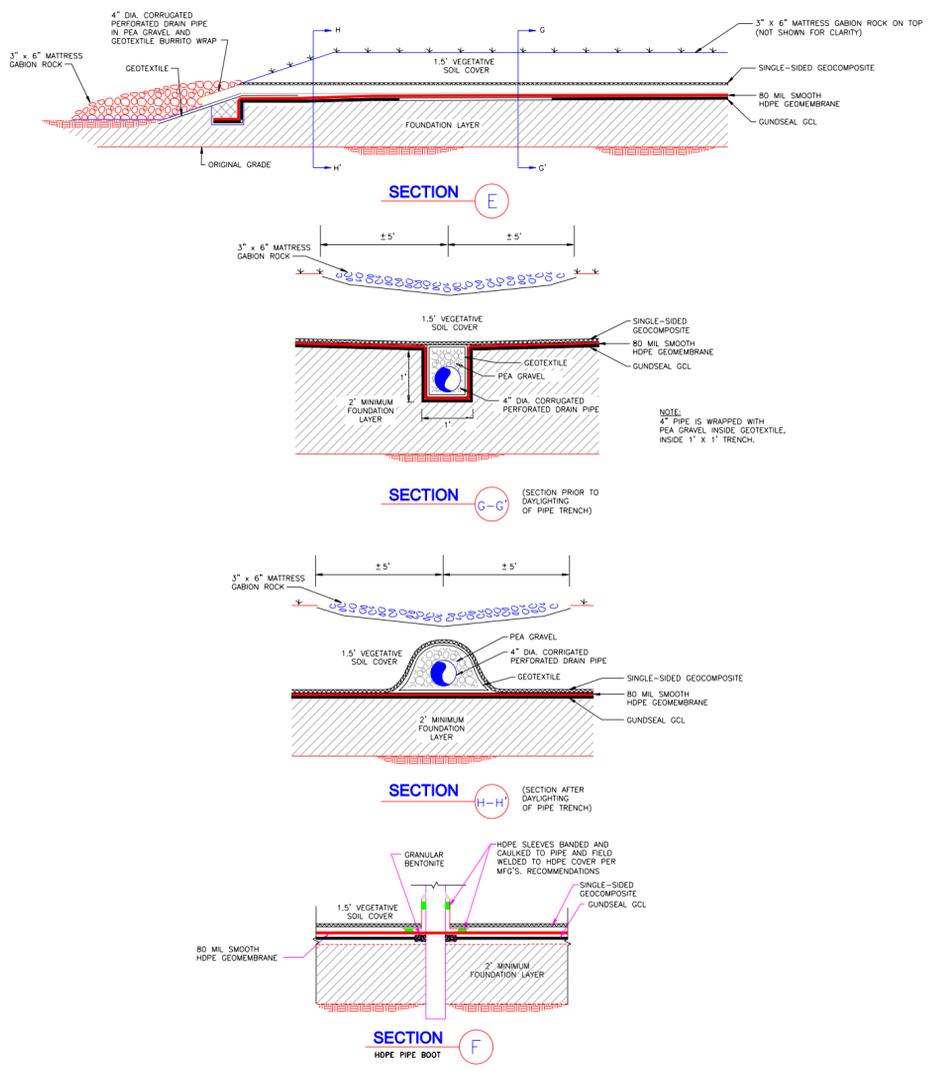
FIGURE 3
LOCATION OF FINAL COVER TYPES, SECTIONS, AND DETAILS
Final Removal Action
Landfill Cap Closeout Report

Reference:
Shaw (IT Corporation) drawing number 8125275-04
from as-built Cap Report Revision 1, approved 07-05-01

- Surface Contour (in feet above msl)
- Approximate Limit of Interim Landfill Cap - Cover A
- Approximate Limit of Interim Landfill Cap - Cover B
- Solid Waste Extent

Note:
Topography shown is as-built of top of the foundation layer.

Figure 3 shows the location of each type of cover.

[Figure 3](#), Sections A-F. A technical paper prepared by GSE detailing the installation of GSE Gundseal® was followed during the design process ([GSE 1997](#)). The GCL consists of a layer of natural sodium bentonite clay bonded with an adhesive to the HDPE backing. The design specified nonreinforced GCL. Because of a shortage in the available material, however, reinforced GCL was used for a portion of the Landfill. The nonreinforced material is GSE Gundseal®, and the reinforced material is Bentomat® ST. Although the two GCLs have slightly different installation techniques, they are functionally equivalent on the flat slopes where they were installed on this project.

The interim landfill cap is designed to channel most surface water to a central drainage swale that flows south to the Bay. The new drainage configuration generally followed the existing flow patterns at the site. The final drainage system was enhanced as required to handle the additional flows expected from the new cap. This enhancement included upgrading existing ditches and installing new ditches. Rock riprap was installed along the main central swale to inhibit erosion on the cap in areas expected to experience concentrated storm water flow. The riprap section is about 10 feet wide and 9 inches thick (Figure 3).

The subsurface drainage system below the central swale consists of a perforated 4-inch drainage pipe surrounded by pea gravel and geotextile and follows the centerline of the ditch (Figure 3). The drainage pipe is underlain by the geomembrane and the GCL and overlain by the composite drainage layer. The drainage pipe terminates above the geomembrane and outside of the cap, discharging beneath the rock riprap at the southern end of the cap.

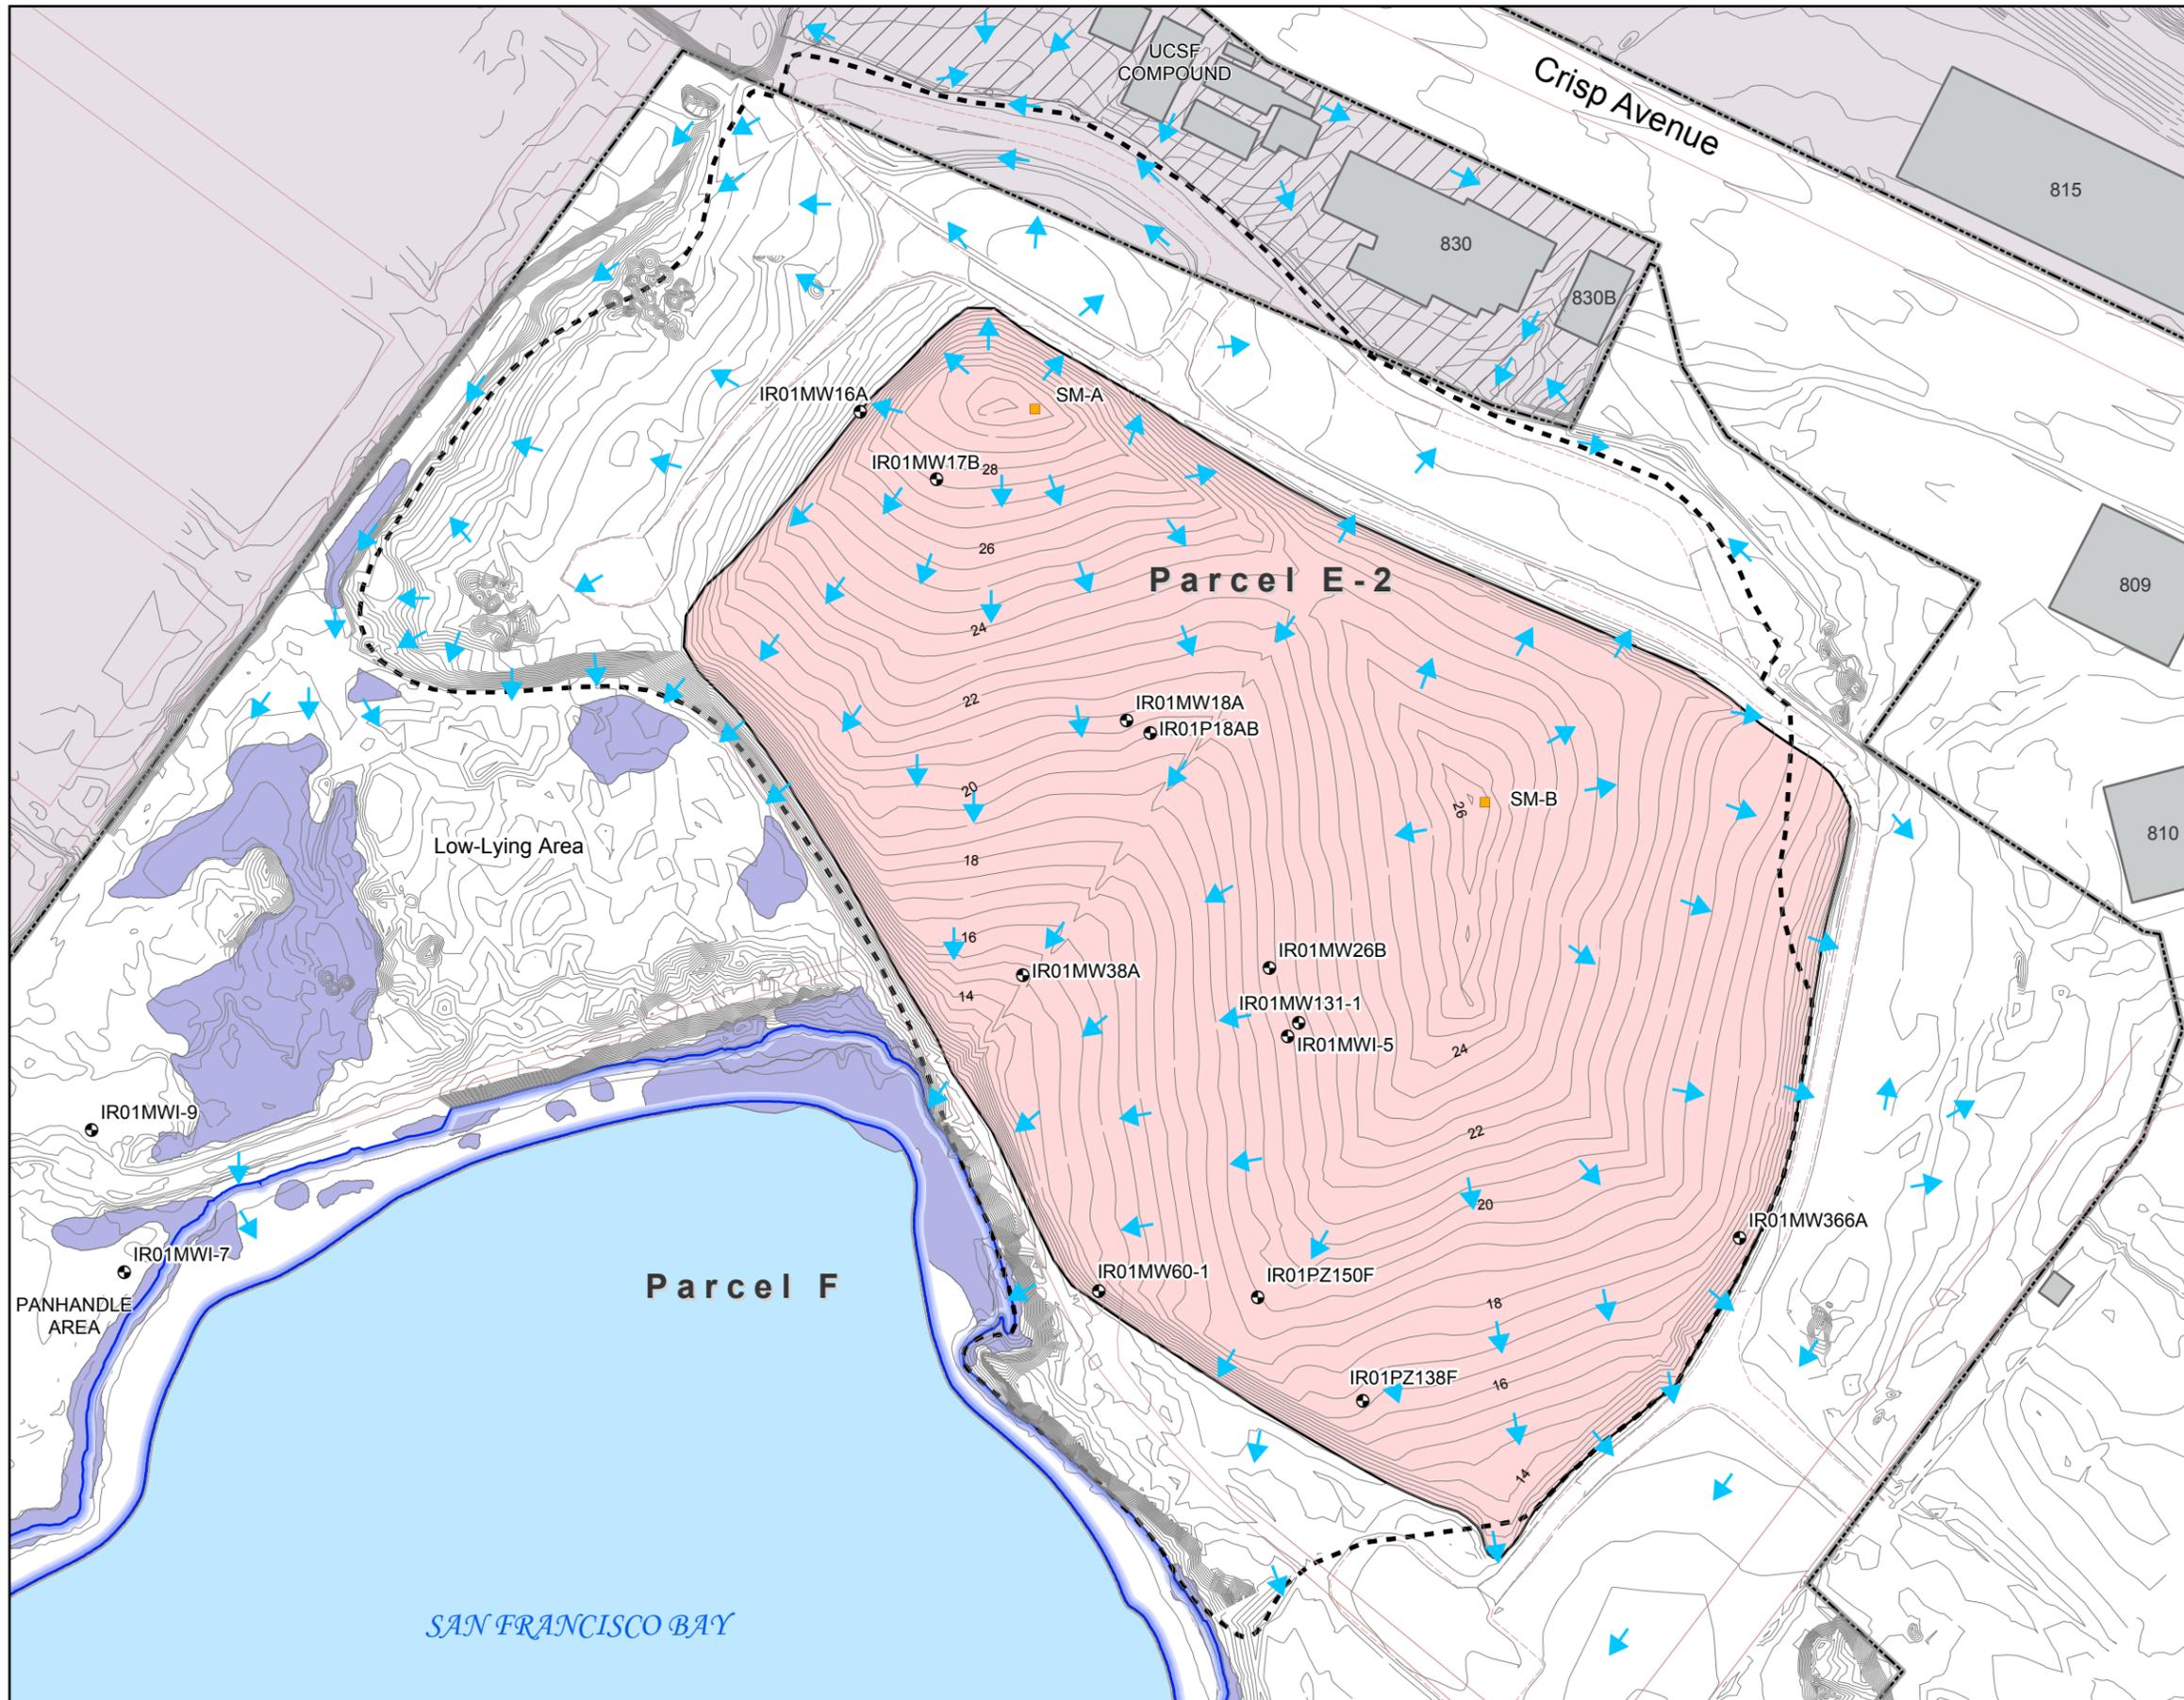
- Surface Flow Direction
- Settlement Marker
- Monitoring Well
- Parcel Boundary
- Shoreline Area
- Extent of Solid Waste
- Landfill Cap Extent
- Non-Navy Property
- UCSF Compound
- Wetland Area
- Building
- Surface Contour (in feet)
- Road
- Gravel Road

Edges of the cap slope outward toward the surrounding landscape. The surface elevations of the cap range from a high of 30 feet above mean sea level to an average of 15 feet above mean sea level around the edges where the cap meets the existing landscape. Storm water is controlled on the west and southwest side of the Landfill by constructed drainage channels that discharge indirectly to the Bay through the low-lying freshwater seasonal wetlands. Storm water runoff from the southeastern portion of the interim cap flows overland through existing swales south and east of the Landfill.
