FINAL
2000-2001 CLOSURE CONSTRUCTION AS-BUILT REPORT
HUNTERS POINT NAVAL SHIPYARD PARCEL E
IR 1/21 INTERIM LANDFILL CAP
SAN FRANCISCO, CALIFORNIA

Environmental Remediation
Contract Number N62474-98-D-2076
Contract Task Order 0025

Document Control Number 1697
Revision 0

July 6, 2001

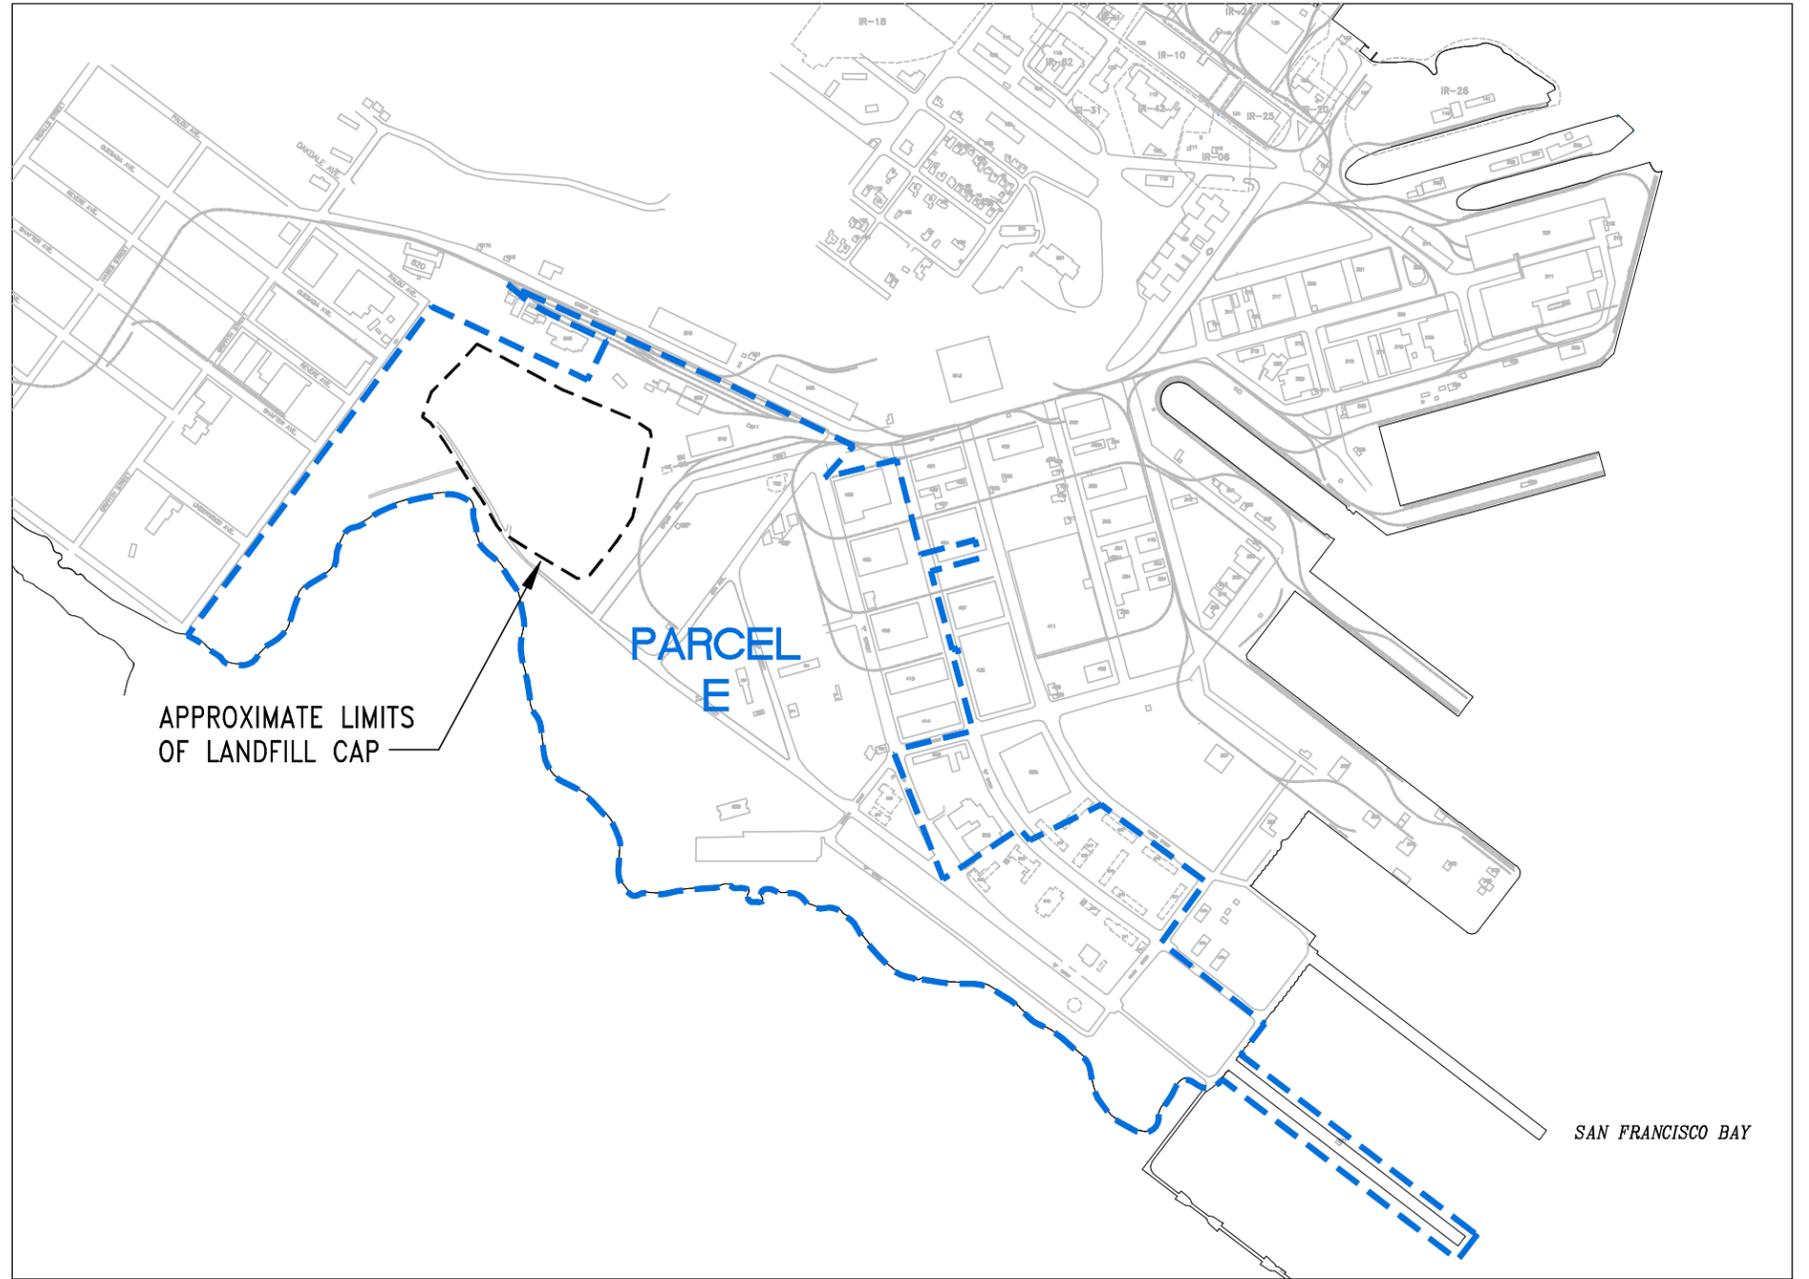
DEPARTMENT OF THE NAVY ENGINEERING FIELD ACTIVITIES WEST SAN BRUNO, CALIFORNIA CTO 025			
		SITE LOCATION MAP HUNTERS POINT SHIPYARD, PARCEL E SAN FRANCISCO, CALIFORNIA			
DESIGNED BY	B. YUREK	4/11/01	CHECKED BY		
DRAWN BY	T. SCHAEFFER	4/24/01	APPROVED BY		
SCALE:	AS SHOWN	DRAWING NO.	812575-D9	FIGURE NO.	
				1	
				0

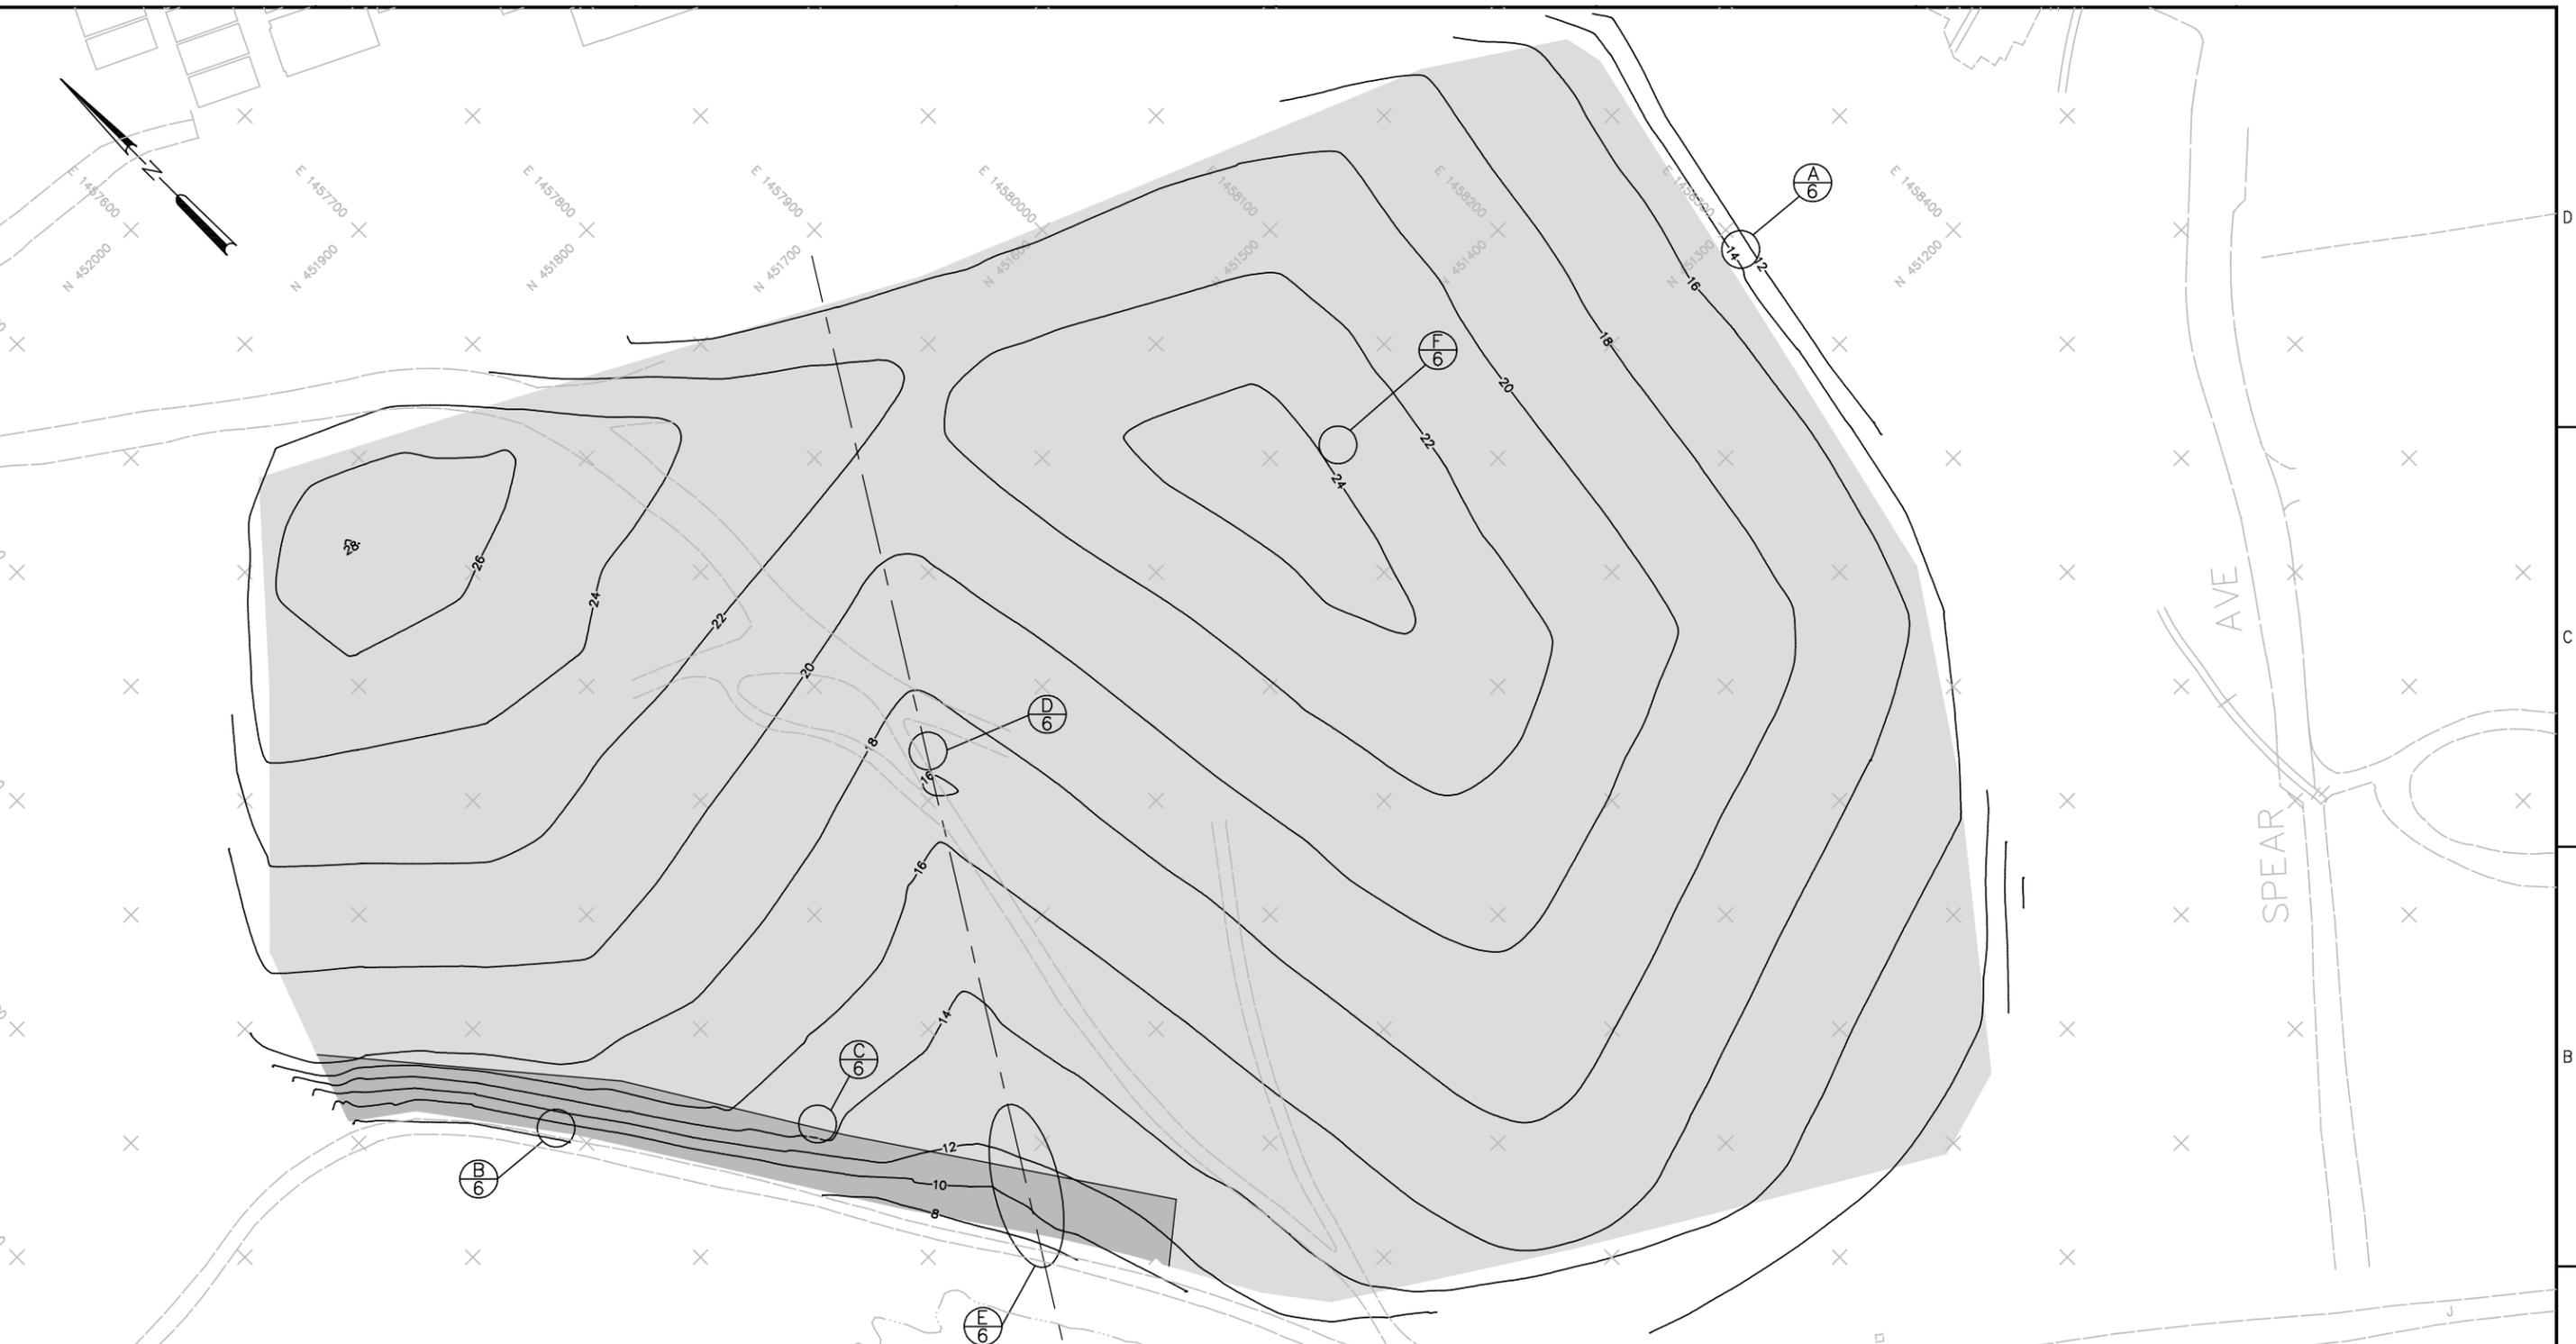
COVER A
 NOT TO SCALE

NOTE:
 TOPOGRAPHY SHOWN IS AS-BUILT OF
 TOP OF THE FOUNDATION LAYER.

REFERENCE:
 FOUNDATION LAYER CONTOURS SURVEYED
 BY FORESITE ENGINEERING, 2000.

DEPARTMENT OF THE NAVY HUNTERS POINT SHIPYARD SAN FRANCISCO, CALIFORNIA				
	PLAN AND LOCATIONS OF FINAL CLOSURE COVERS HUNTERS POINT SHIPYARD SAN FRANCISCO, CALIFORNIA				
DESIGNED BY	D. Hullings	10/1/00	CHECKED BY		
DRAWN BY	R. Bricker	4/24/01	APPROVED BY		
SCALE:	AS SHOWN	DRAWING NO.	812575-D6	FIGURE NO.	3
				REVISION NO.	0
