**Appendix A**  
**Site Photographs**

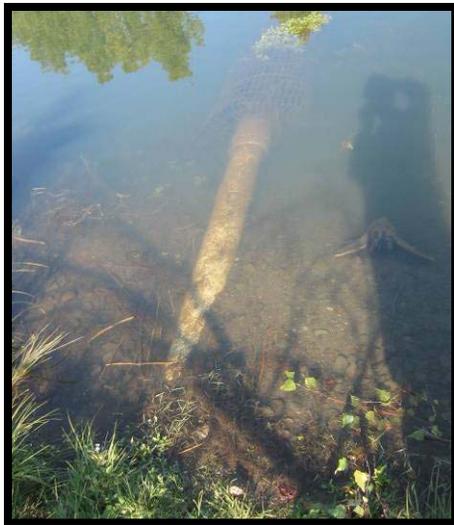
Photo 3: Pond drain outlet, southern part of pond behind Whitney Road

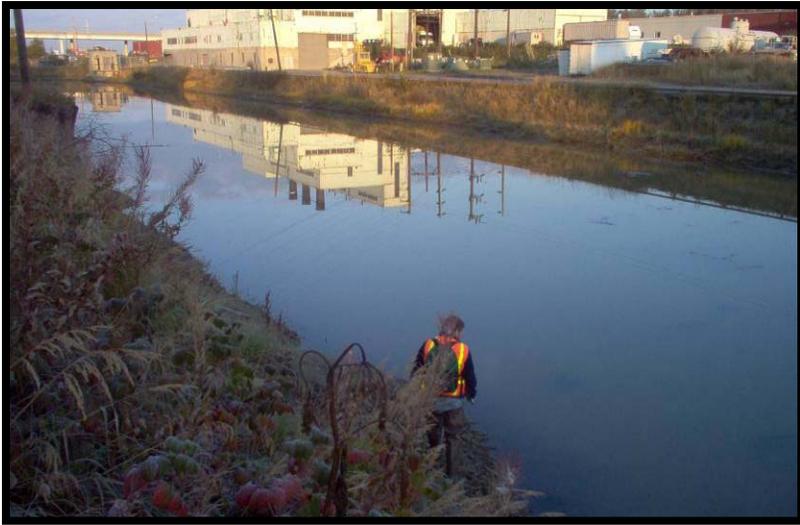
Photo 5: KAPP pond. Whitney Rd. and closed KAPP facility in background

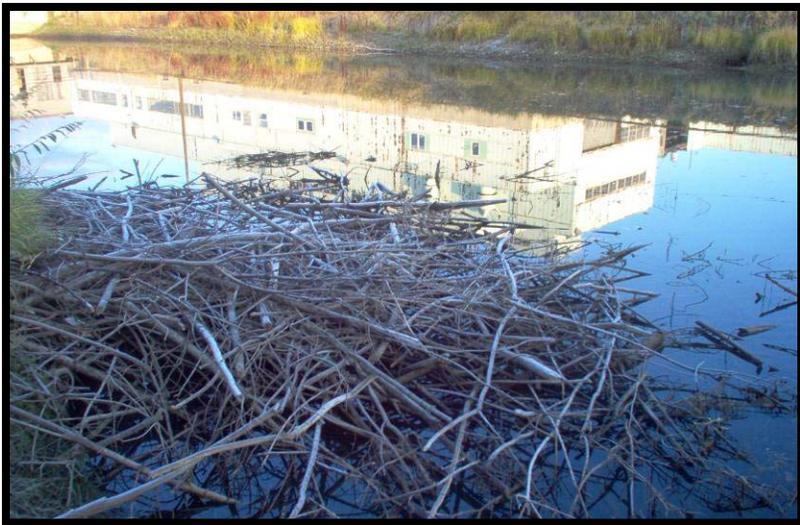
Photo 7: Beaver lodge in KAPP pond

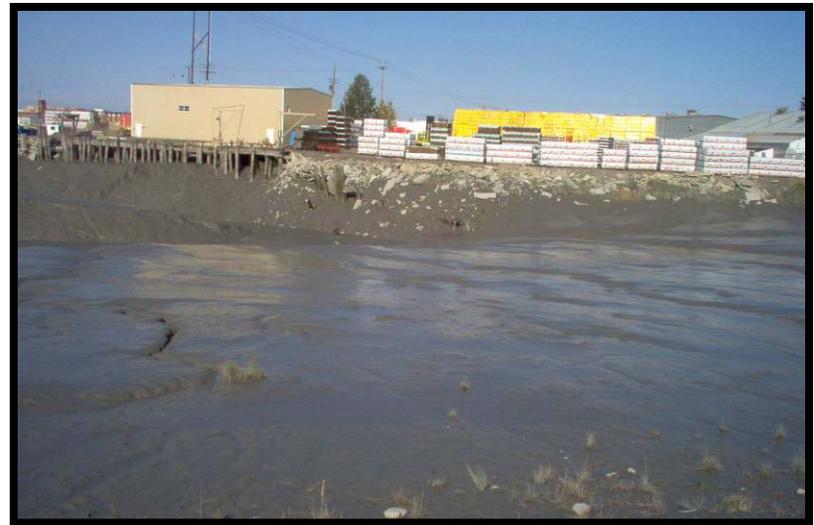
Photo 8: Mudflats looking north towards Swan Bay Docks. Ship Creek channel flows in cut near dock

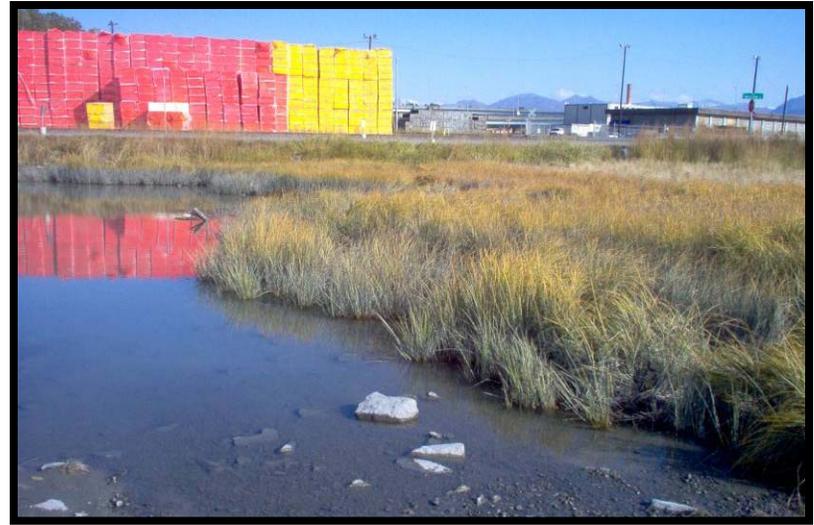
Photo 10: Salt marsh area at mouth of Ship Creek

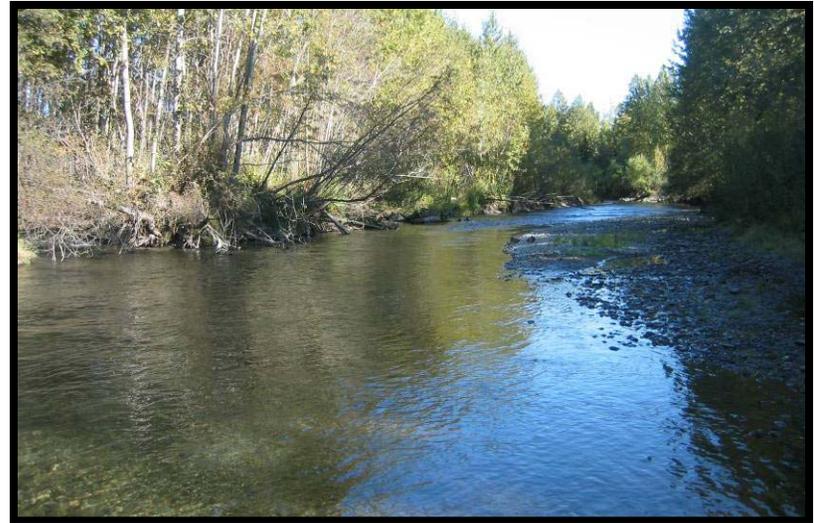
Photo 16: Reach 1, general appearance. Note similarity to Reach U

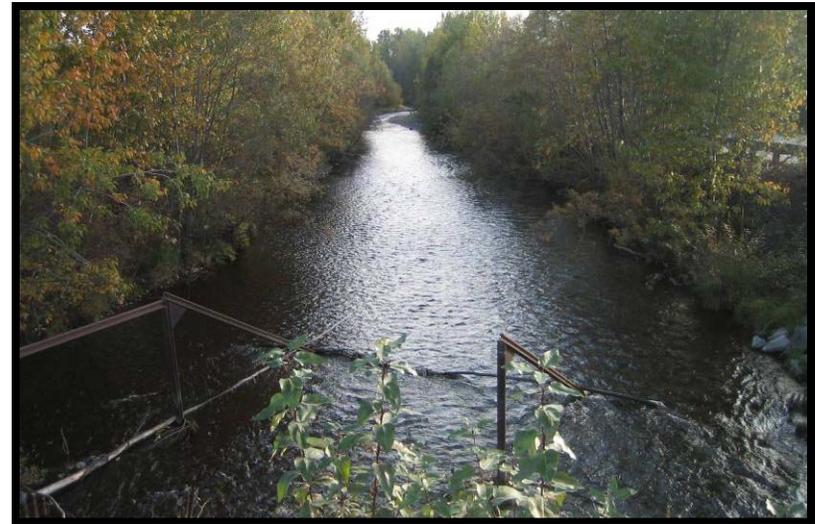
Photo 18: Reach 2, straightened channel upstream of Post Rd. Steel structure protects bridge from ice jams

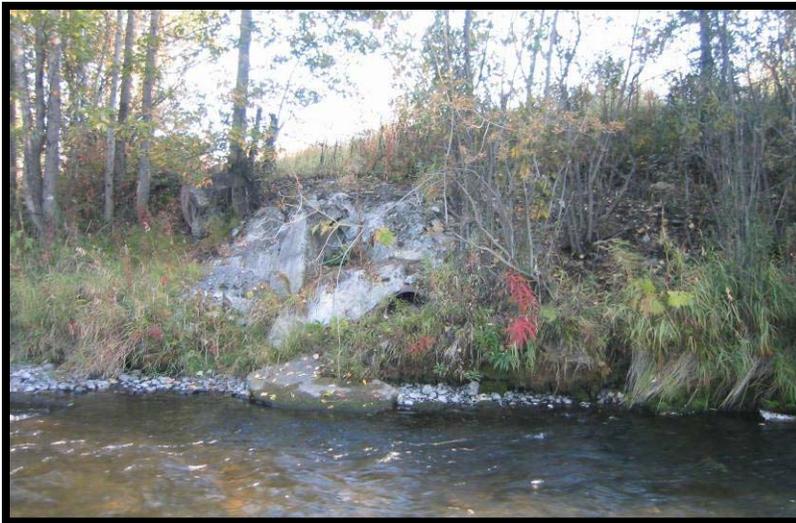
Photo 19: Reach 2, typical debris reinforced banks

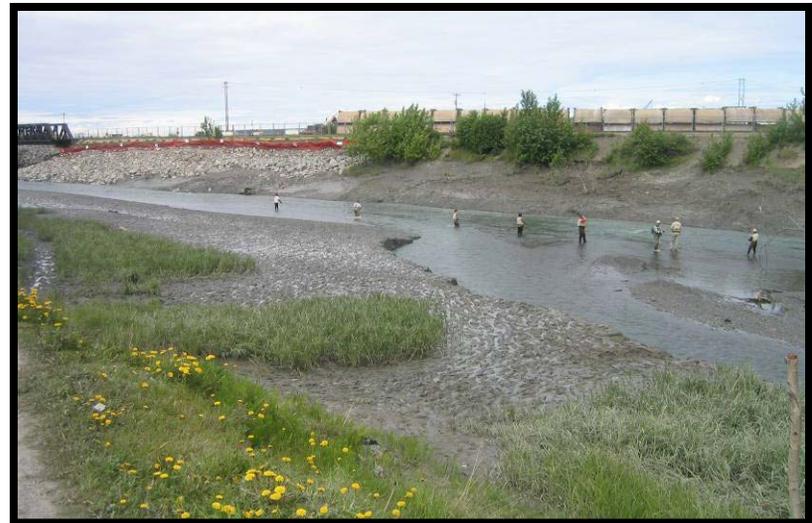
Photo 24 : Reach 4, channel looking downstream to lower railroad bridge. Limited riparian habitat and constructed banks.

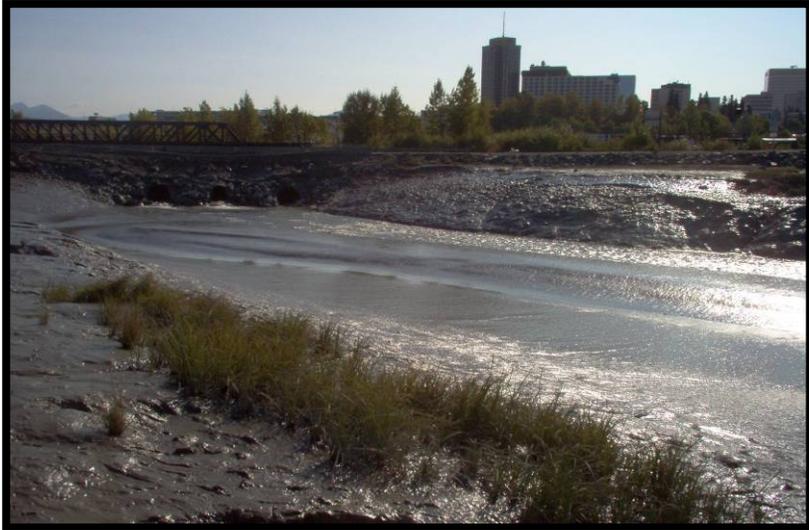
Photo 25: Reach 4: Mudflats along Ship Creek below lower railroad bridge

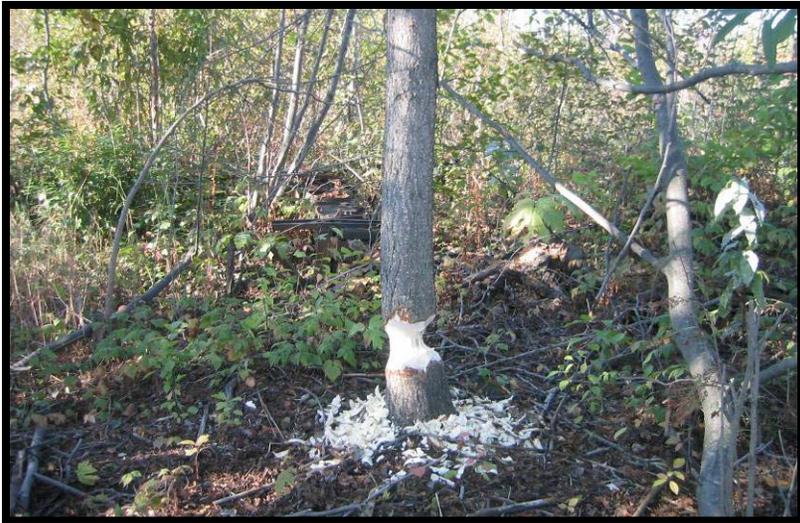
Photo 27: Reach 3, recent beaver activity

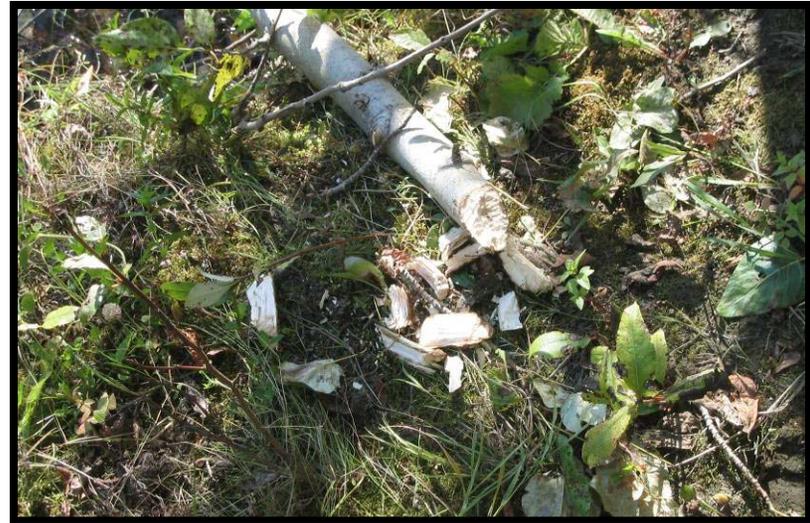
Photo 28: Reach 3, recent beaver activity

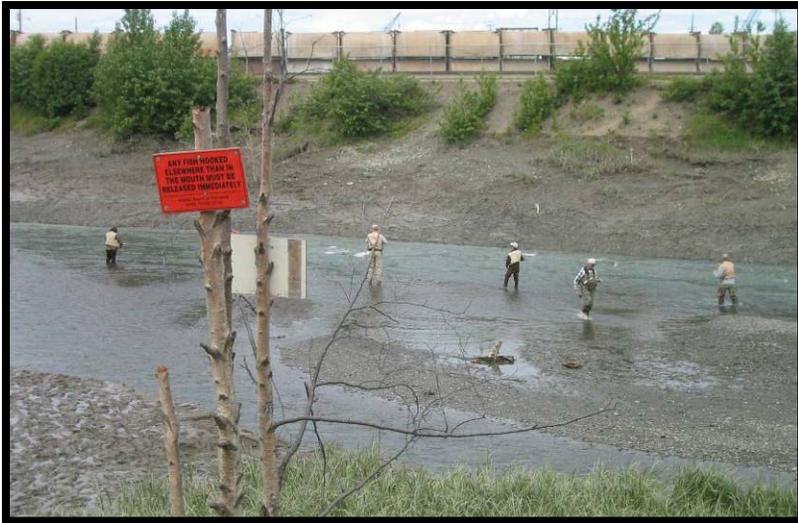
Photo 29: Reach 4, recreational fishing at low tide in channel next to ARRC office

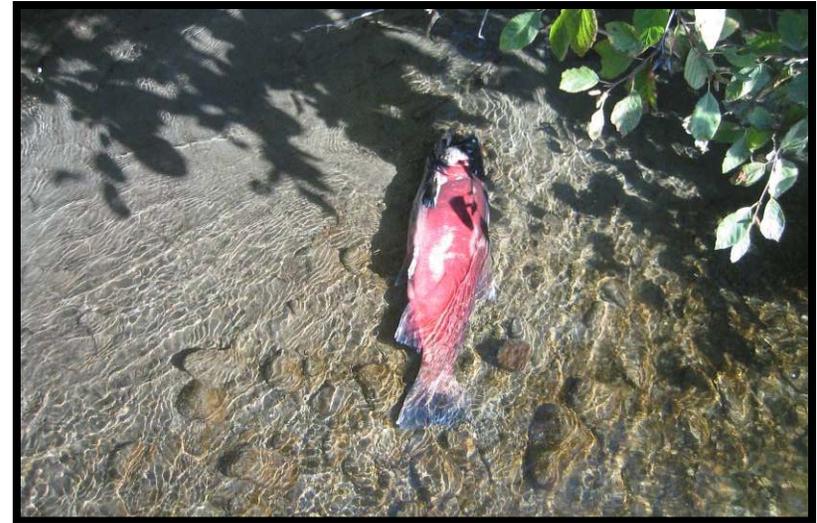
Photo 30: Reach 3, dead Coho salmon

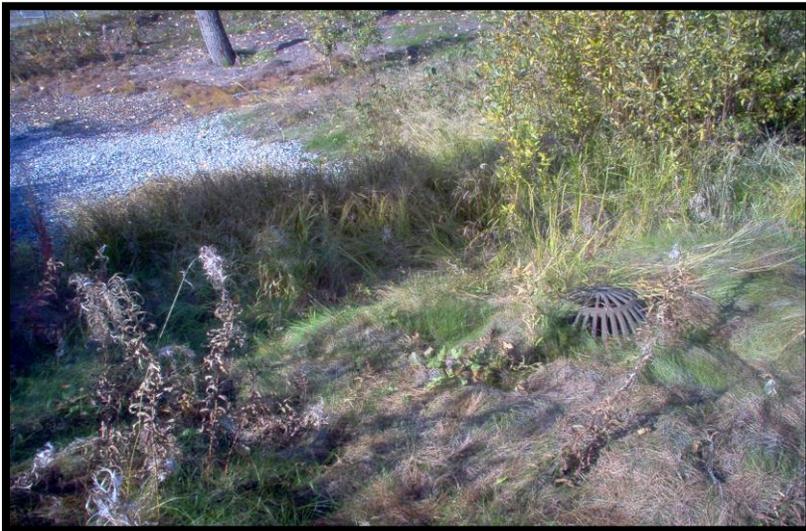
Photo 31: Storm drain from railroad right-of-way east of ARRC Terminal Reserve. Drains to Ship Creek upstream of Elmendorf hatchery

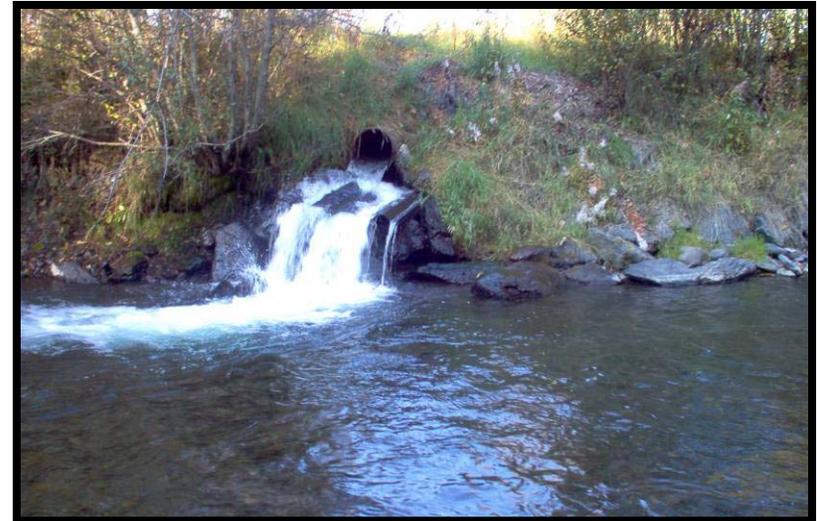
Photo 32: One of several hatchery return flows to Ship Creek

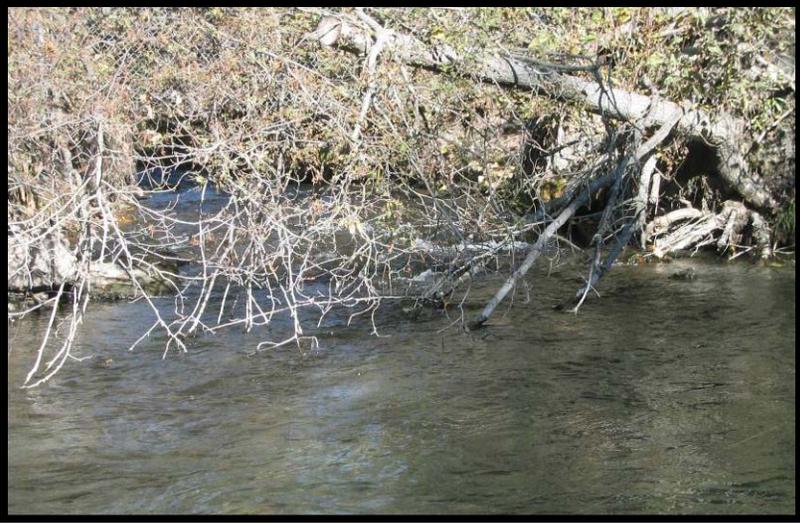
Photo 33: Reach U, outfall of hatchery drainage ditch, immediately upstream of Reeve Blvd. bridge. Abundant salmon noted at this location.

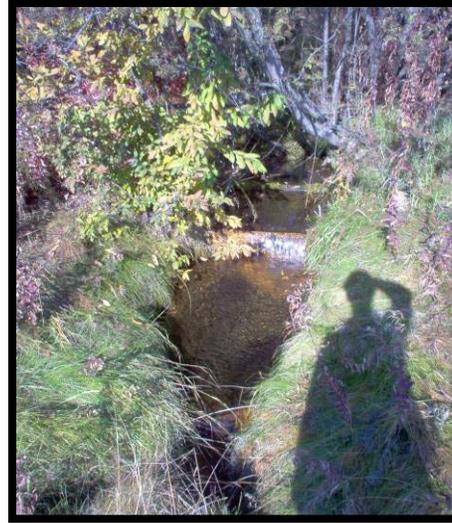
Photo 34: Reach U, Ditch draining south side near golf course

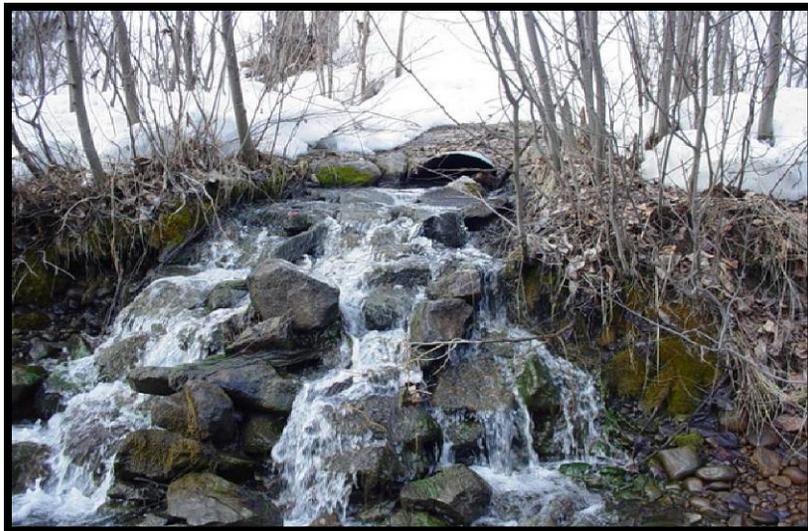
Photo 35: Reach 1, OU-5 outfall

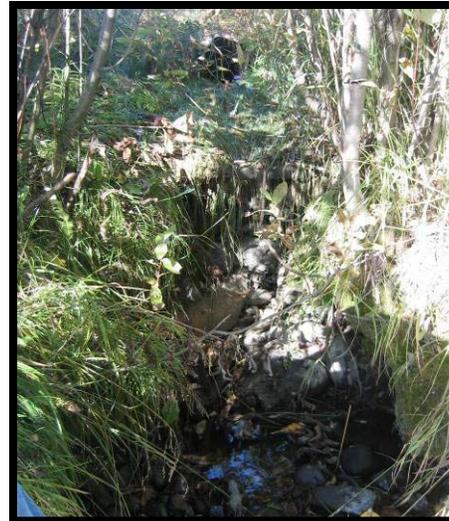
Photo 36: Reach 1: MOA 830-832 outfall (dry)

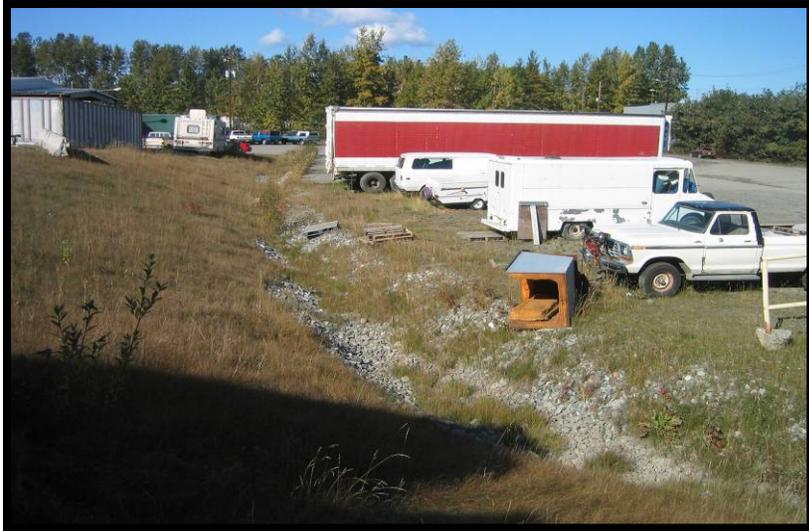
Photo 37: Reach 1, Ditch draining MOA 830/832 north of Ship Creek

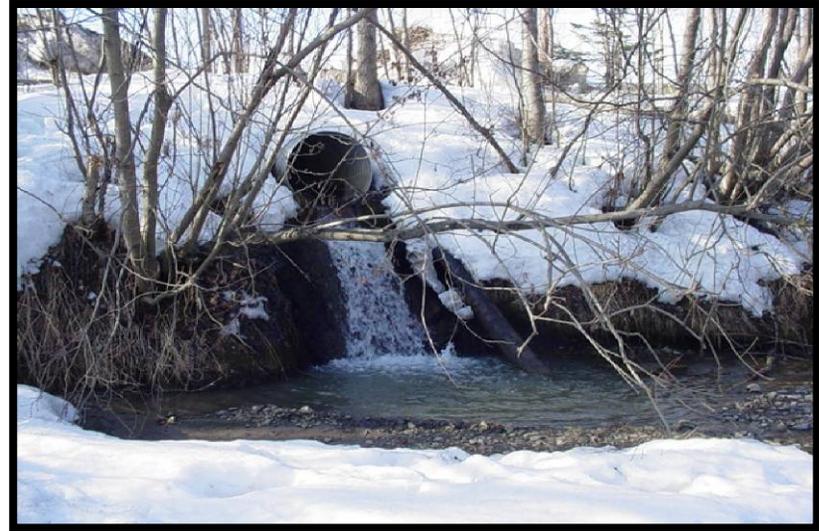
Photo 38: Outfall MOA 835, south bank

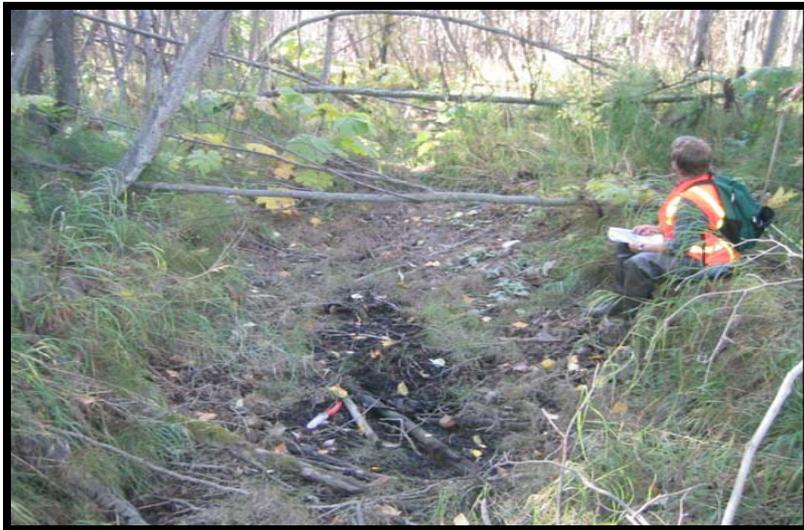
Photo 39: Reach 1, Abandoned ditch east of old Standard Steel facility

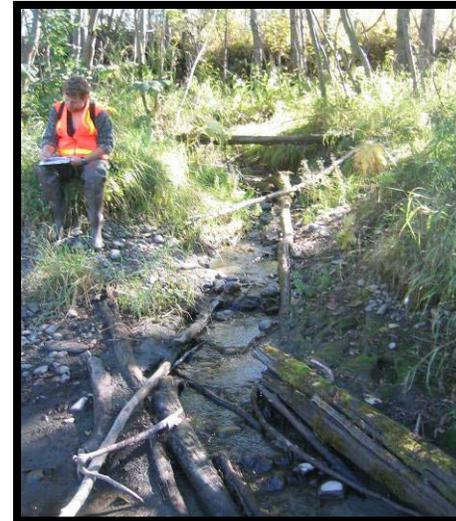
Photo 40: Reach 1, ditch behind Commercial Truck Services draining seepage to marsh

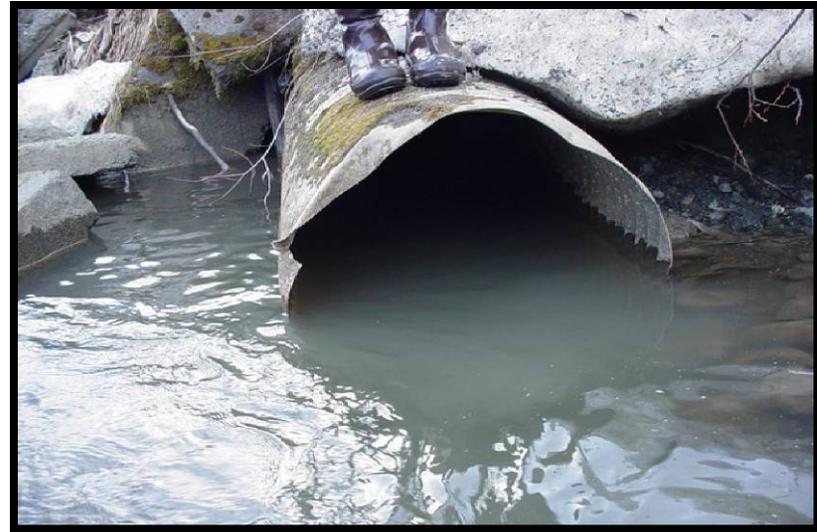
Photo 42: Reach 2, MOA 833 outfall (south side at Post Rd.). Minor sheening emanating from this storm drain.

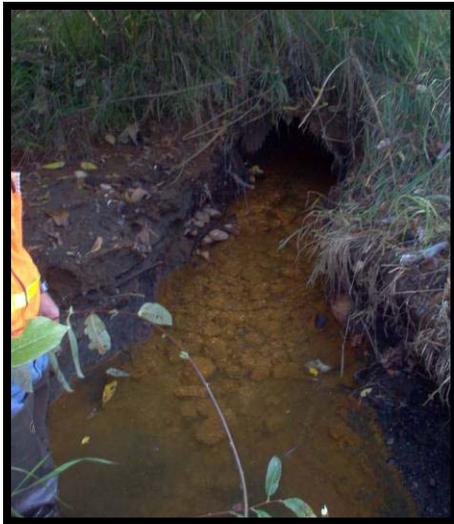
Photo 43: Reach 3, MOA 826 outfall (south side). Strong hydrocarbon odor present.

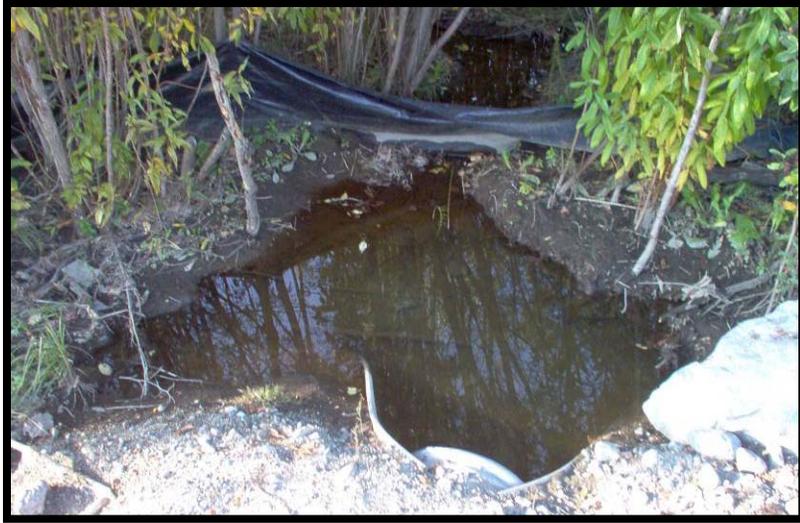
Photo 45: Reach 3, MOA 812B outfall, south side

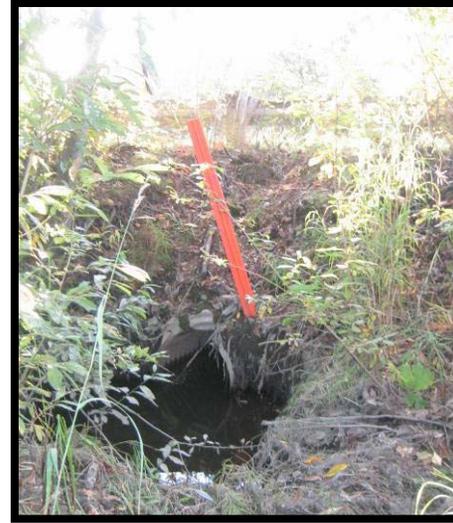
Photo 46: Reach 2: ARRC E-1 outfall north side, Whitney Rd. and Post Rd.

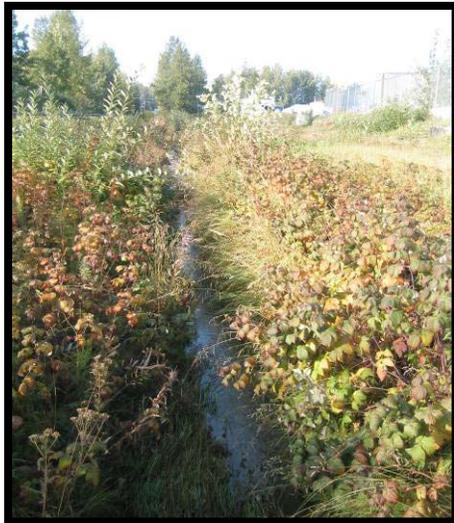
Photo 47: Reach 2: Ditch along railroad track draining ARRC E-1, looking northeast

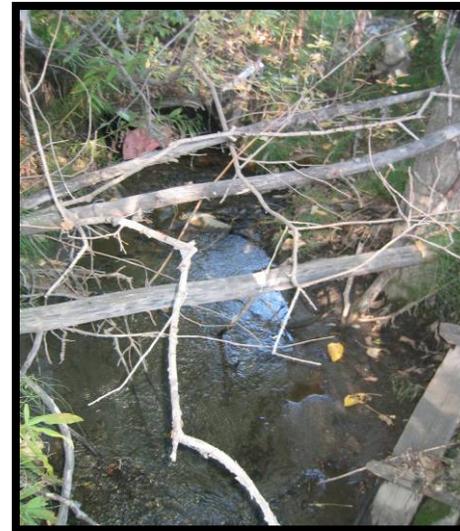
Photo 48: Reach 3, ARRC A-2 outfall. Note outfall is made of wood.

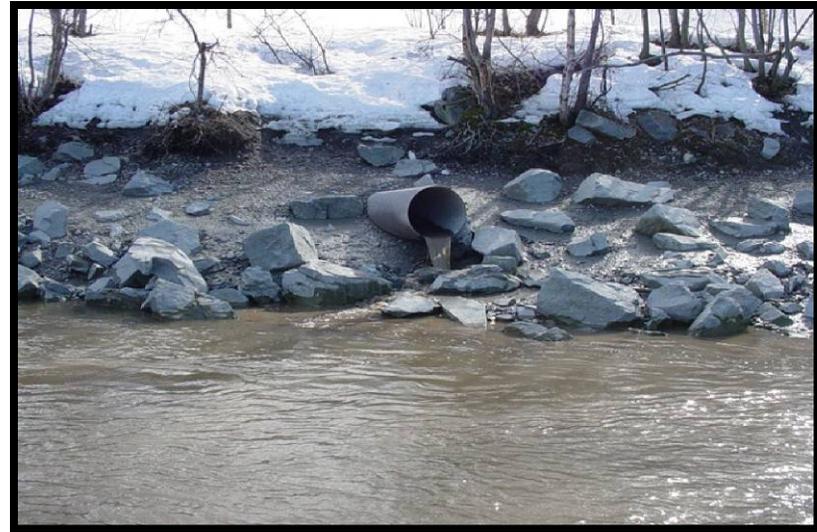
Photo 50: Reach 4, MOA 811 outfall

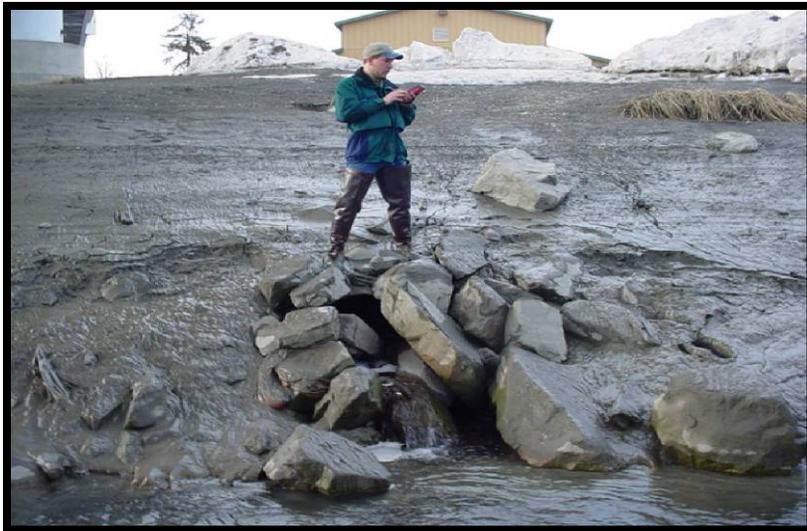
Photo 51: Reach 4: MOA 809A outfall west of covered bridge

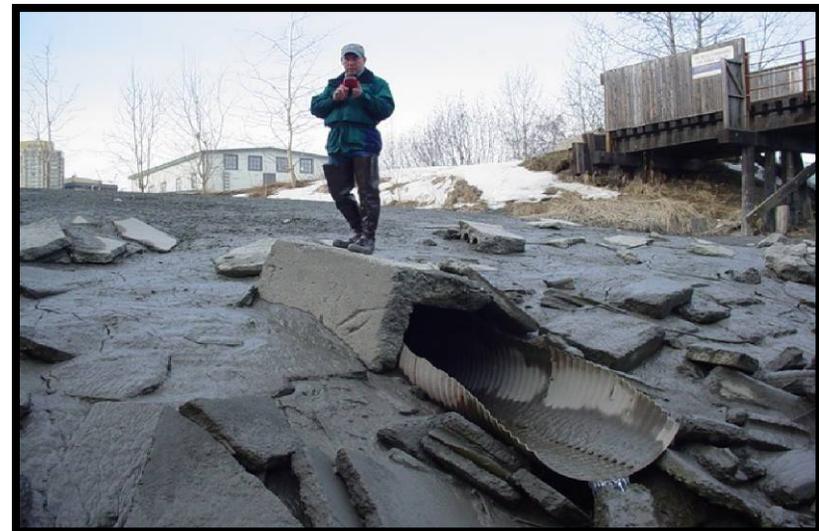
Photo 52: Reach 4: MOA 809B outfall east of covered bridge

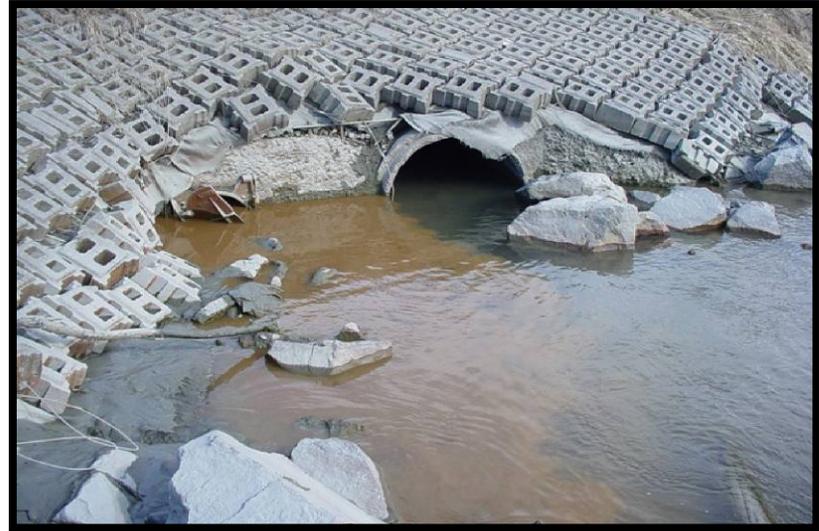
Photo 54: Reach 4, outfall ARRC B-1/MOA 825 on left, KAPP pond outfall on right. Located under north KAPP dam landing

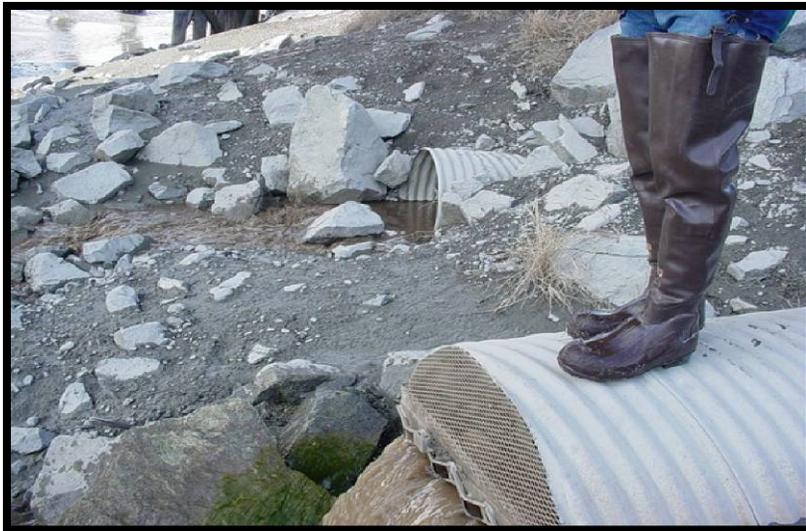
Photo 55: Reach 4, MOA 820/ADOT outfall on top, ARRC A-1 on bottom. Located adjacent to highway bridge on north side

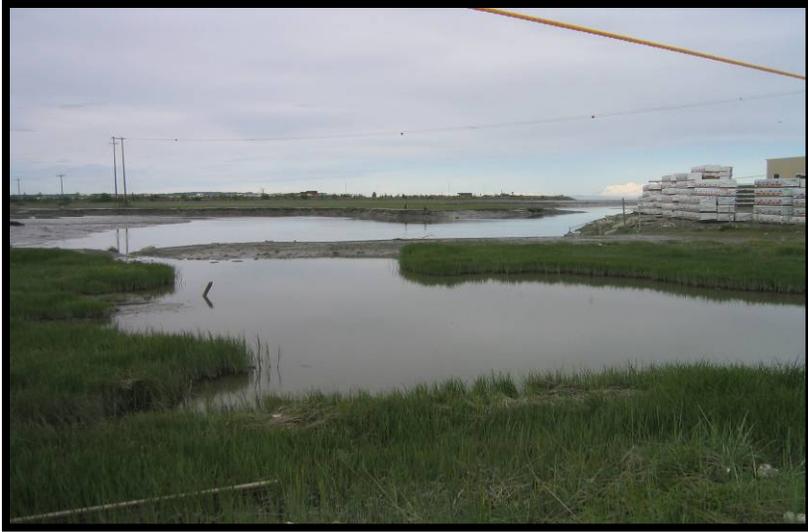
Photo 56: Reach 4, ARRC C-1 outfall, north bank adjacent to C St. bridge. Subdrainage may be inactive.

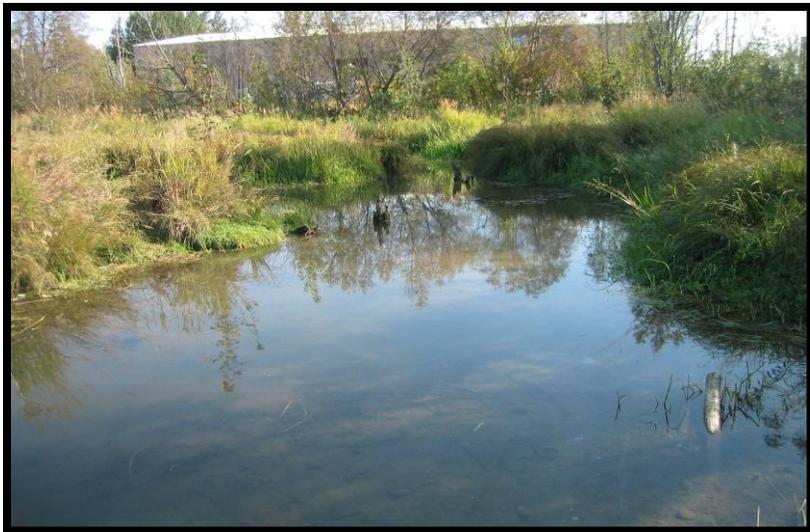
Photo 70: Outlet of ditch from MOA 826 outfall

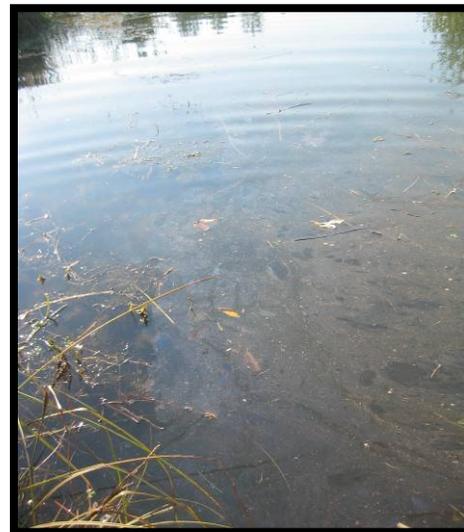
Photo 71: Reach 3, apparent sheens on pond surface

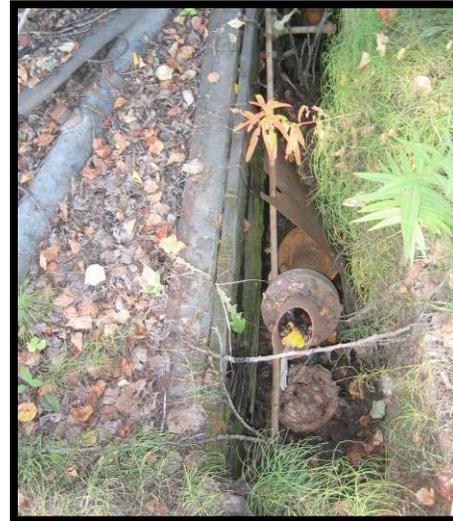
Photo 73: Reach 3, unidentified pumping structure: view of pit and abandoned pump house

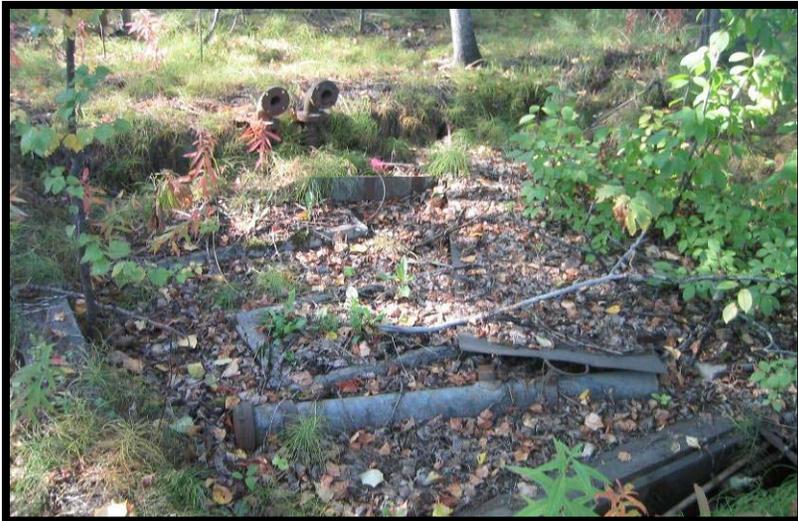
Photo 74: Reach 3, unidentified pumping structure: detail of pit

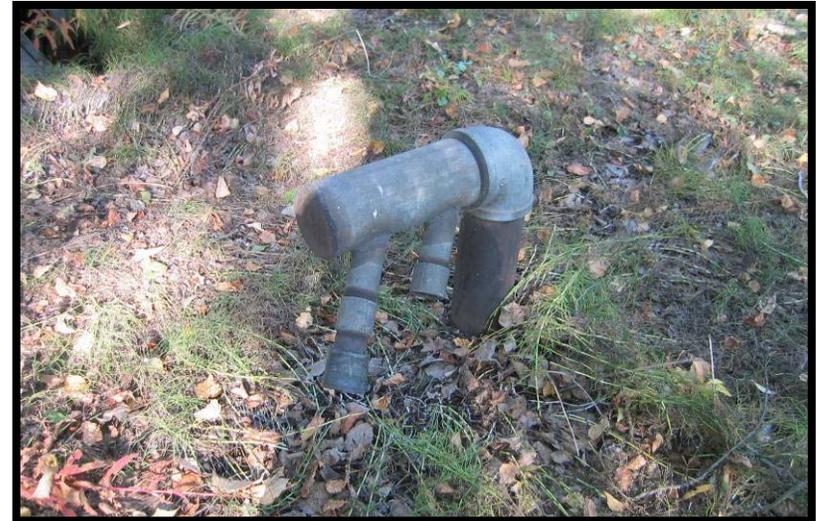
Photo 75: Reach 3, unidentified pumping structure: detail of pit

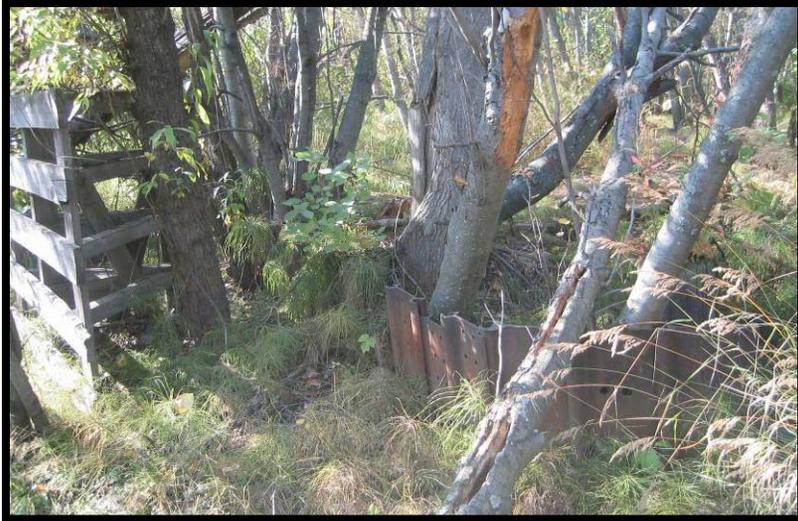
Photo 76: Reach 3, unidentified pumping structure: connector pipe emerging from ground

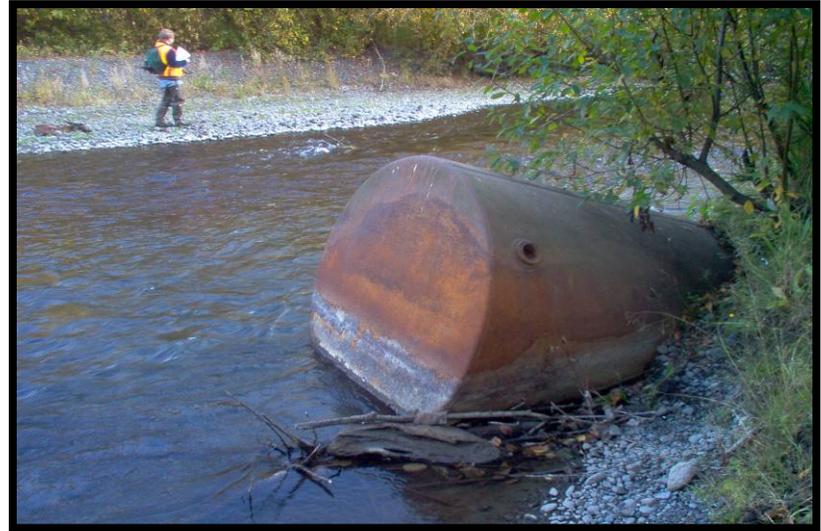
Photo 77: Reach 3, unidentified pumping structure: additional structures 75 feet north of pump housing

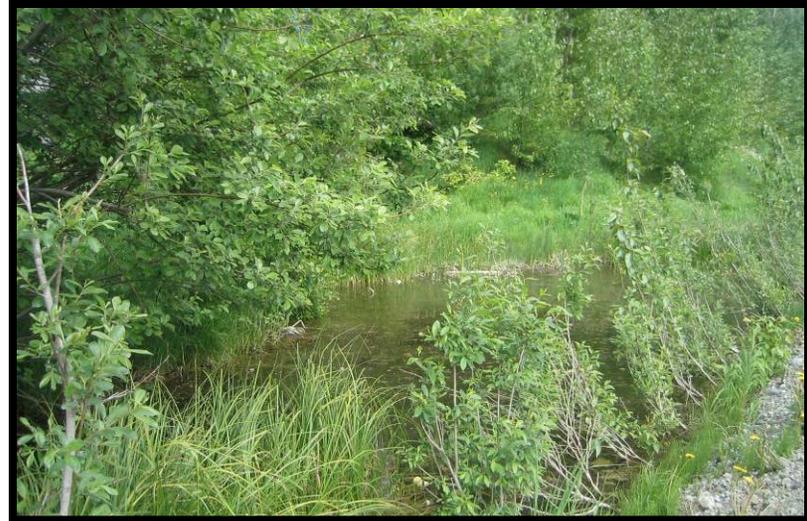
Photo 81: North Bluffs: small wetland area in the far eastern end of the railyard, adjacent to railroad spur.

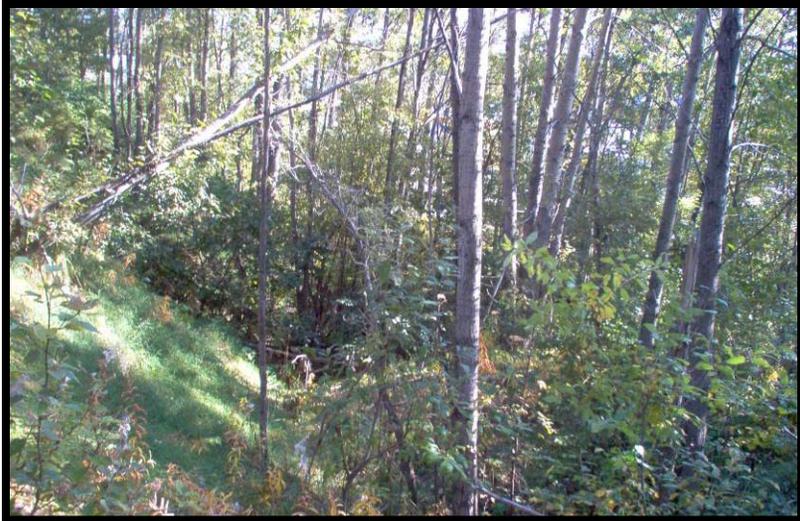
Photo 84: North Bluffs: forested slopes in central portion of bluffs. Trail visible on left leads to a gate in the fence to Elmendorf AFB

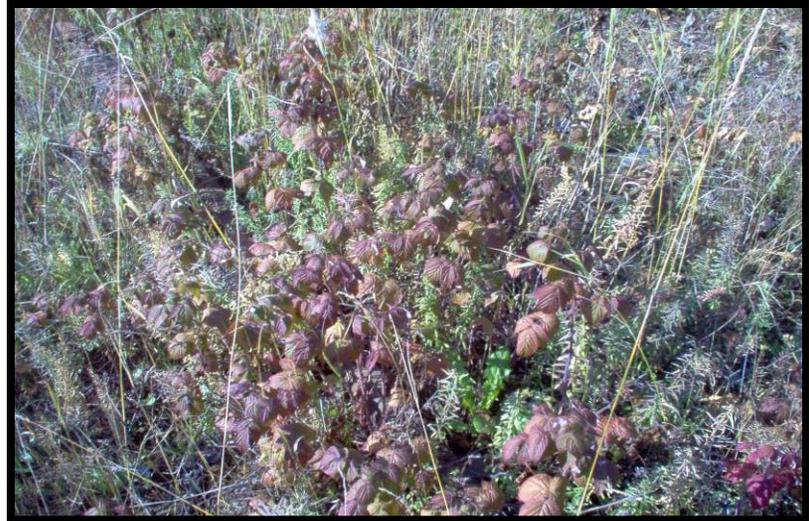
Photo 85: North Bluffs: typical understory vegetation

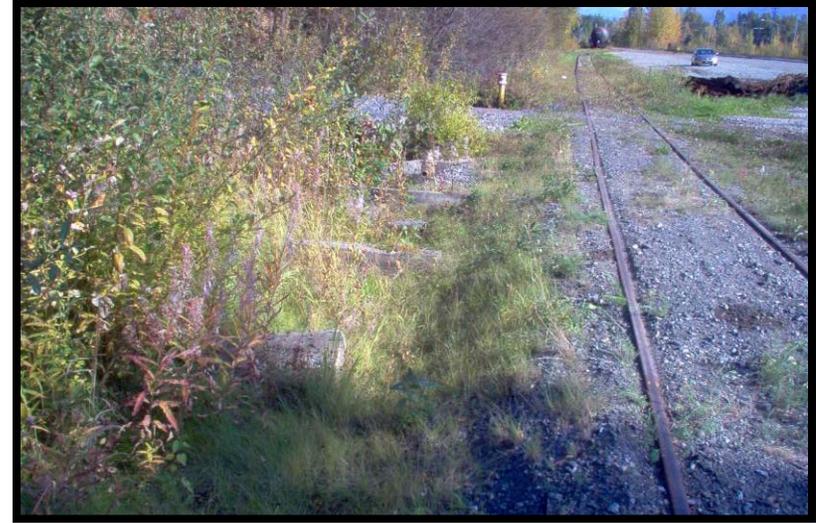
Photo 89: North Bluffs: remains of fueling rack along spur. Pipes remain in ground. OU-5 treatment pond on right
