THEA FOSS AND WHEELER-OSGOOD WATERWAYS REMEDIATION PROJECT

YEAR 0 BASELINE MONITORING

LOW TIDE SLOPE CAP INSPECTION PRELIMINARY FINDINGS MEMORANDUM

OCTOBER 26, 2006

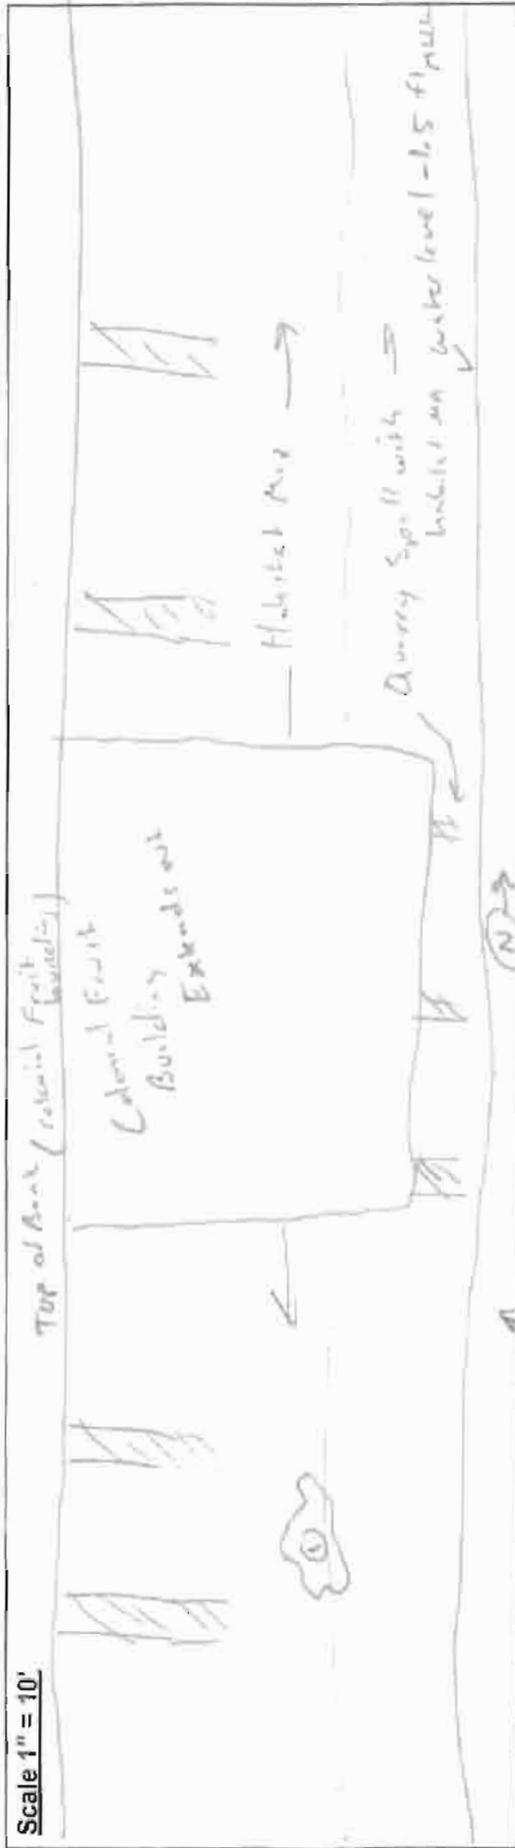
① Block debris

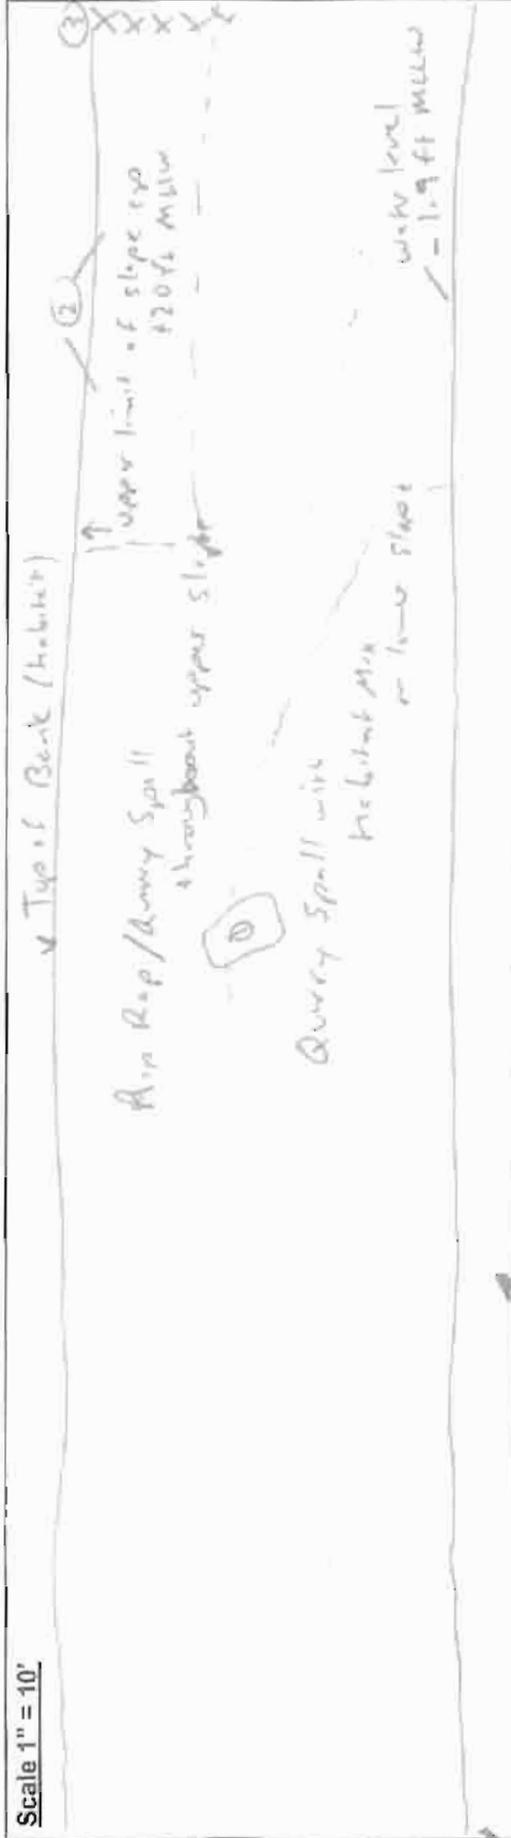
Photopoint @ 10ft S. of Interval Start (1) Photopoint @ 25ft (2) →

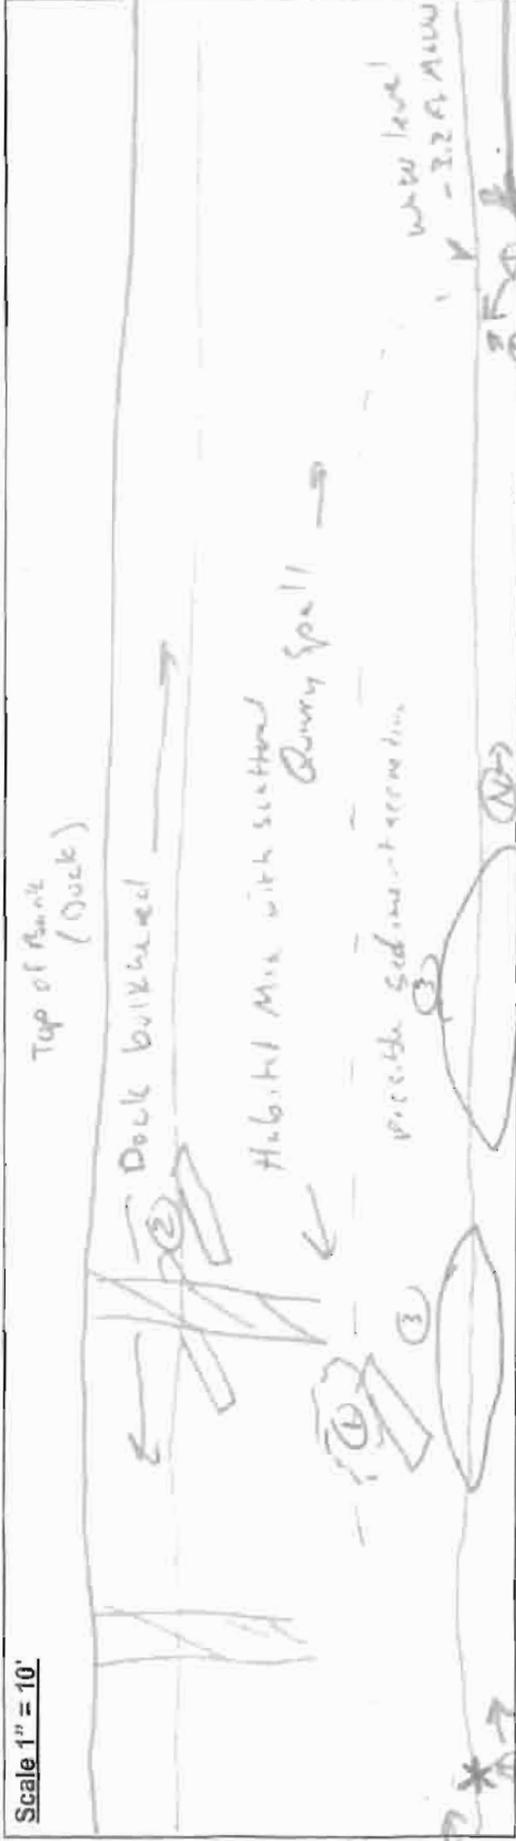
Photopoint @ 15 ft S. of Interval Start

③ Boats along water line

* Photopoint taken at Interval Start of Boats on water line

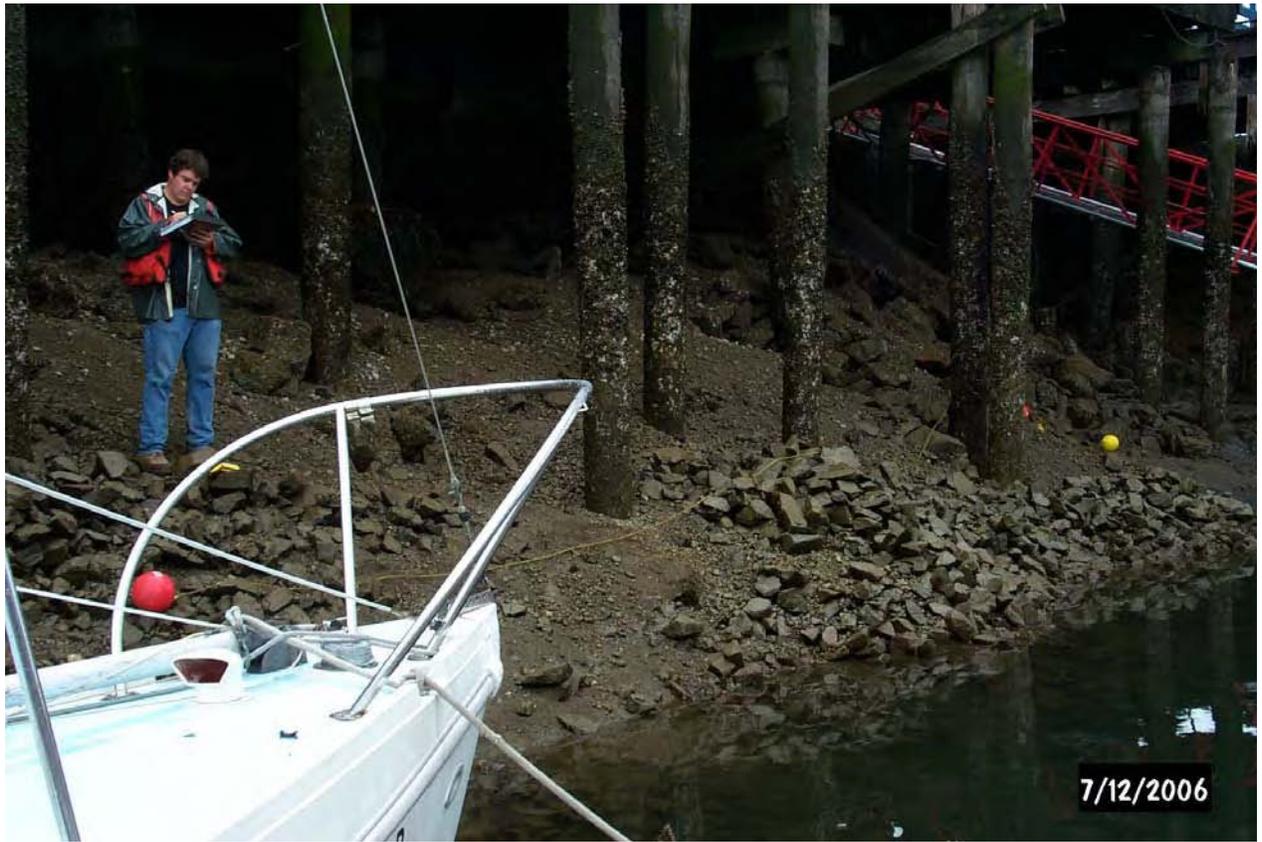
P0001494 7/12/2006 12:43:49 PM

Possible sediment accumulation
